Model: Z-C1:GW	Date: 12-Nov-10	No.: RM028001a
----------------	-----------------	----------------

Subject: Firmware Release Note:Web Uapl		Prepared by: T. Kiyohara	
From: MFP/Printer Tech Service Dept., 2nd Tech Service Sect.			
Classification:	<input type="checkbox"/> Troubleshooting	<input type="checkbox"/> Part information	<input type="checkbox"/> Action required
	<input type="checkbox"/> Mechanical	<input type="checkbox"/> Electrical	<input type="checkbox"/> Service manual revision
	<input type="checkbox"/> Paper path	<input type="checkbox"/> Transmit/receive	<input type="checkbox"/> Retrofit information
	<input type="checkbox"/> Product Safety	<input checked="" type="checkbox"/> Other ()	<input checked="" type="checkbox"/> Tier 2

Model: Z-C1		Date: 3-Apr-15	No.: RM028050a
Subject: The pressure roller damage may occur at an early stage.		Prepared by: Hayato Someya	
From: 1st Tech. Support Sec. Service Support Dept.			
Classification:	<input checked="" type="checkbox"/> Troubleshooting <input type="checkbox"/> Mechanical <input type="checkbox"/> Paper path <input type="checkbox"/> Product Safety	<input type="checkbox"/> Part information <input type="checkbox"/> Electrical <inp

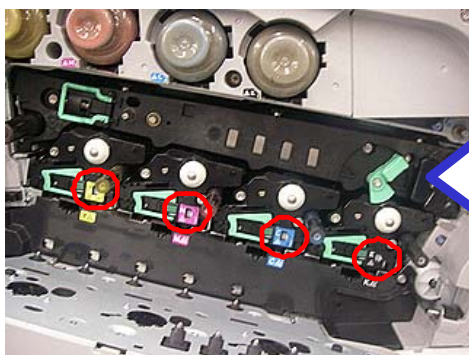
6. Check the pentagon-shaped window for all four colors. If you can see a red area, as shown in the "Incorrect" photo below, this means the unit was not *installed* correctly.

- When you *install* the PCDU, make sure to push it in **as far as it will go** (at least until you hear a click).
 - To emphasize this point, the installation procedure for the PCDU (Field Service Manual for Z-C1: pg. 193) was revised as follows.
5. Push the green PCDU lever with your finger, **as far as it will go** (at least until you hear a click).

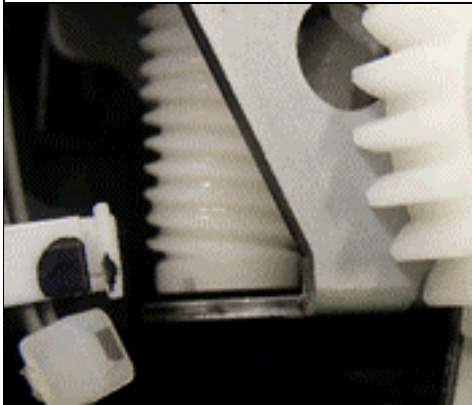
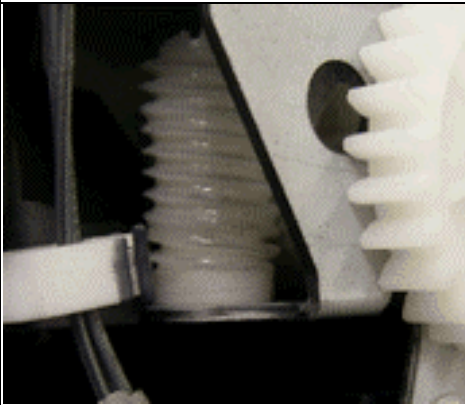
<u>CORRECT position of the gear and bracket (There is a gap)</u>		<u>WRONG position of the gear and bracket (There is NO gap)</u>

1-3. If the toner bottle rotates incorrectly, check to see if there is a gap between the worm gear and bracket on the toner hopper motor.

- **If the gap is less than the thickness of one sheet of paper, replace the toner hopper motor.**

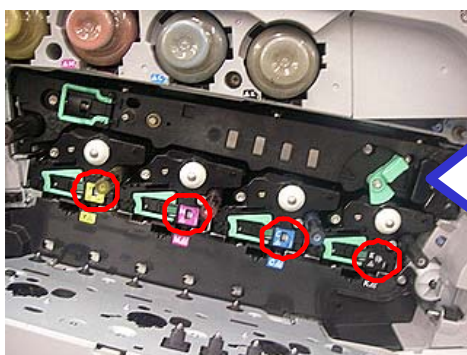
3-2. Check the pentagon-shaped window for all four colors. If you can see a red area, as shown in the "Incorrect" photo below, this means the unit was not installed correctly.

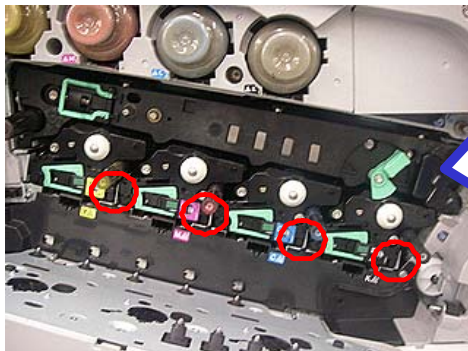
- 3-3. Make sure that the white locking tab on the PDCU (circled in red below) is inside the hole in the bracket. Do this for all four PDCUs.

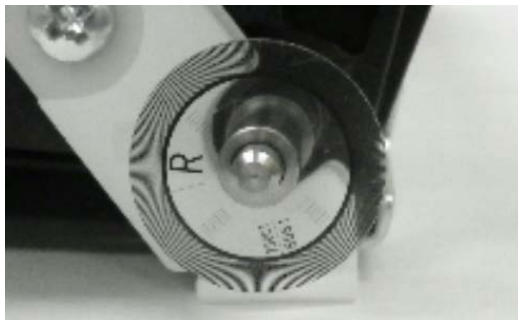
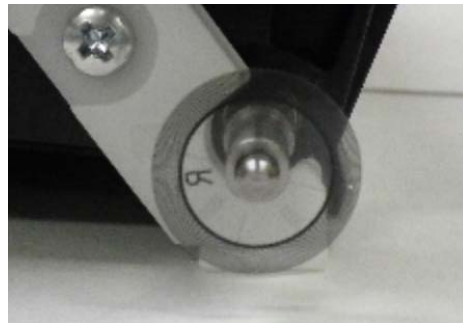
- Never bend the disc.
- Never scratch the disc.
- Make sure the reading surface is not dirtied.
- Make sure that the “R” on the disc is in the correct orientation (and not inverted).

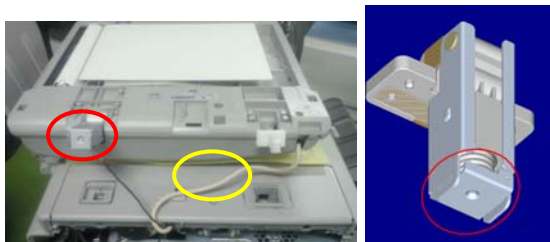
- Holder: Hinge left (M0261730) was broken.

7. Put the ADF on the Scanner. **Important:** To avoid the damage to the ADF cable, please loosen the cable. (yellow circle) Wipe off the oil dirt on the surface of the DF hinge bottom part with alcohol and cloth to prevent making dirt on the exposure glass. (Red circle)

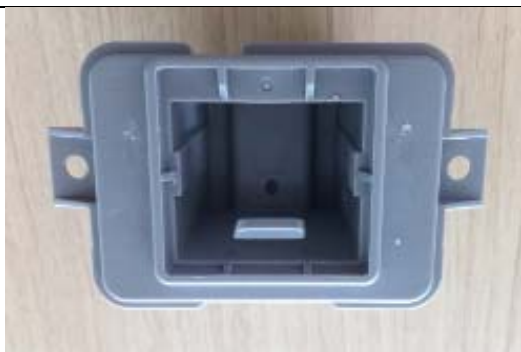
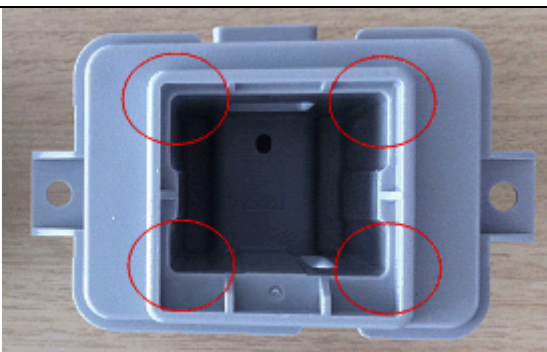
How to distinguish the new parts from the old parts

Old Parts: The edges are sharp.	New Parts: The edges are round.

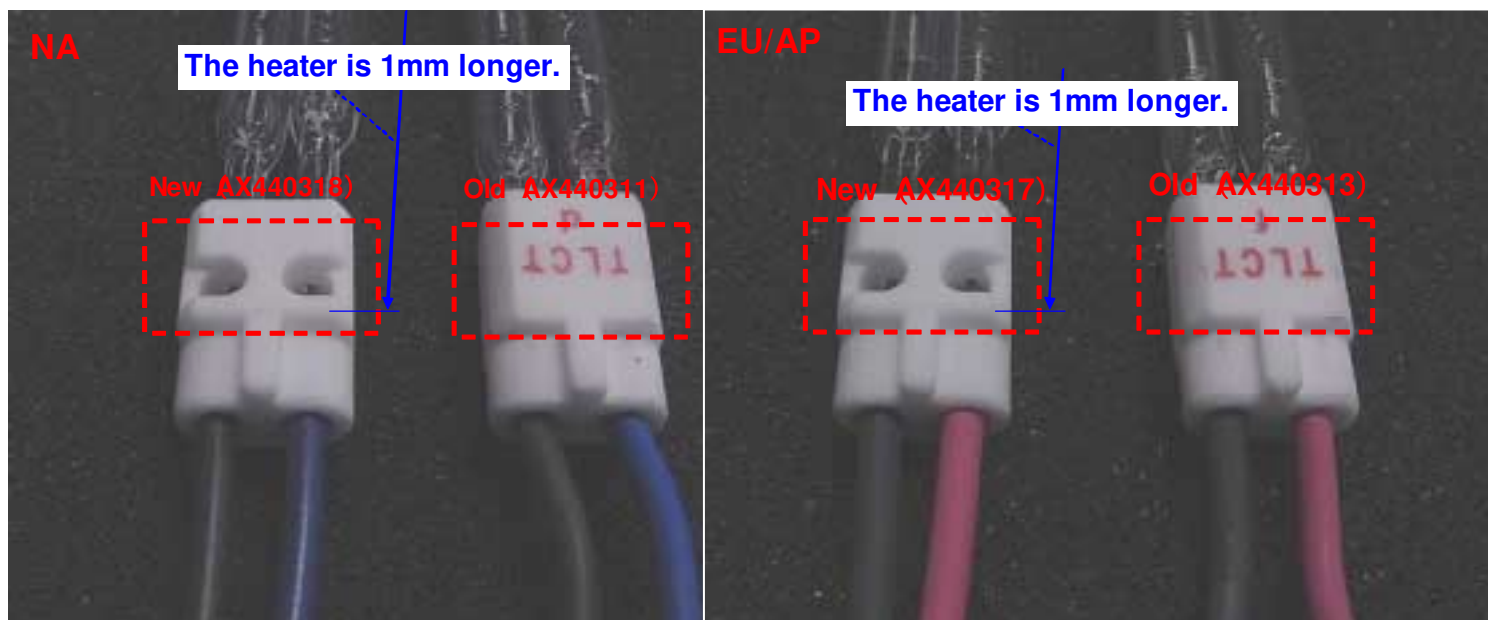
Note: The following shows the differences between the old and new parts.

- The shape of the sockets and the length of the heater are different.

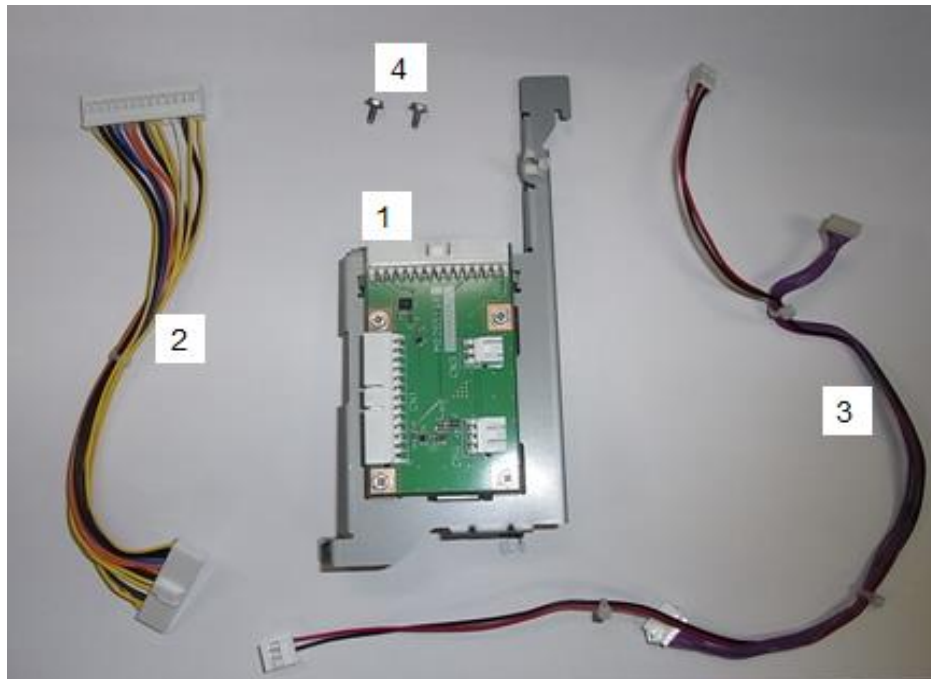
This is to inform about the countermeasure for SC240/241. If this symptom occurs, the LD unit which is very expensive, is damaged and must be replaced. Replacing the LD unit can be a temporary solution just to put the machine back to be ready to use, but cannot be a permanent countermeasure. The countermeasure is only installing the additional board as described below.

PROCEDURE for installing the Additional PCB Kit

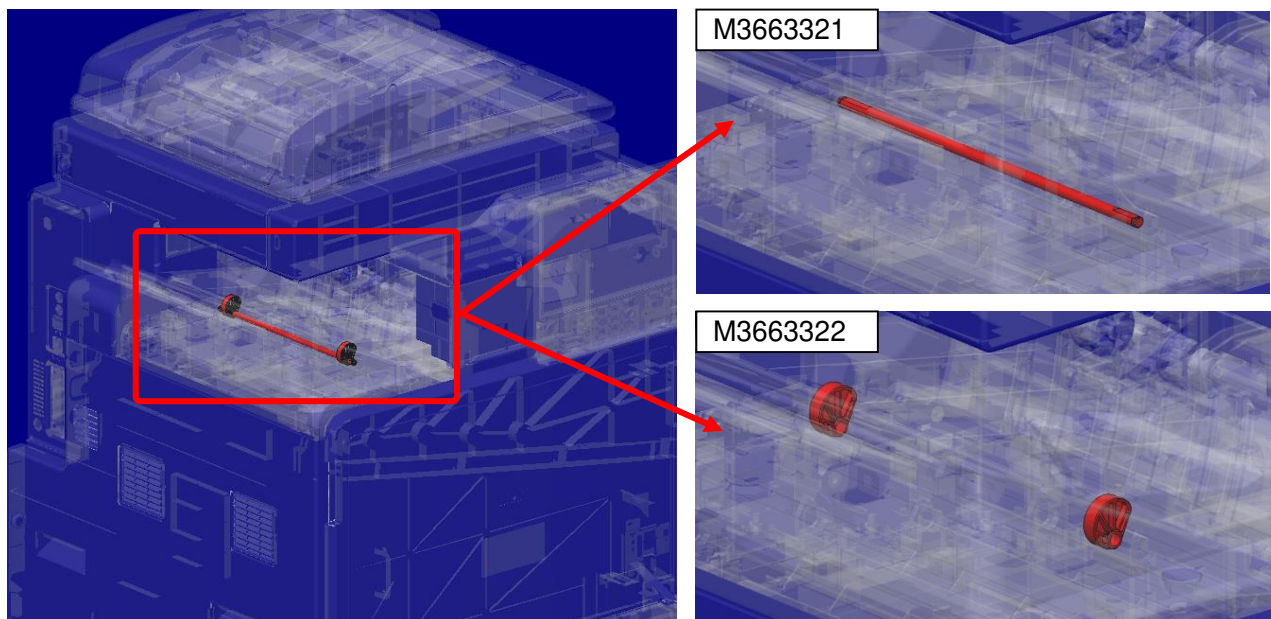
Note: Part information - M3663322 CAM:TRAY:MOVEABLE

Old part number	New part number	Description	Q'ty	Int	Page	Index	Note
M3663320		CAM:TRAY:MOVEABLE:ASS'Y	-	-	-	-	Delete
	M3663321	SHAFT:CAM:TRAY	-	-	-	-	Add

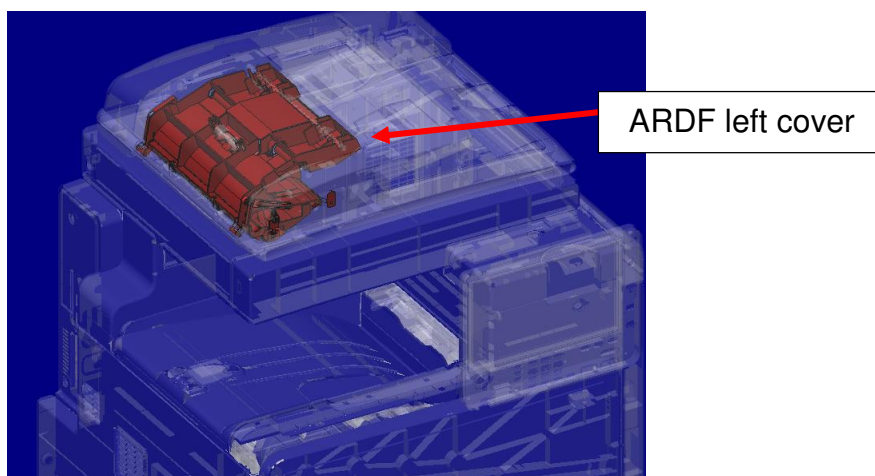
A linking part was added (in between the guide plate and side plate) to prevent the cover from opening too much.

Old part number	New part number	Description	Q'ty	Int	Page	Index	Group	Note
-	D7814651	LINK:GUIDE PLATE:OPEN AND CLOSE	-	-	-	-		Add
-	D7814652	STEPPED SCREW:LINK:GUIDE PLATE:OPEN AND CLOSE	-	-	-	-	A	Add
M3643416	D7813416	GUIDE PLATE:REVERSE	-	X/O	-	-	A	
D7834610	D7814610	COVER:PAPER FEED:ASS'Y		X/O			A	
M3644617	D7814617	GUIDE PLATE:COVER:PAPER FEED	-	X/O	-	-

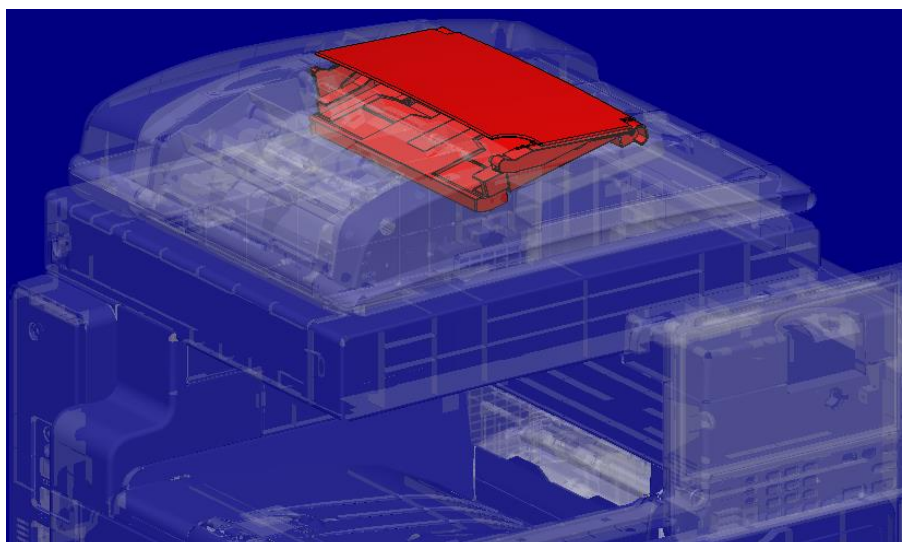
Reason: To prevent ADF jams caused by too many originals loaded on the original table.

- When you attach P/N **D7834730**, make sure to attach it **together with D7816021 and D7816011 as a set**. This is because D7834730 does not include D7816021 and D7816011.

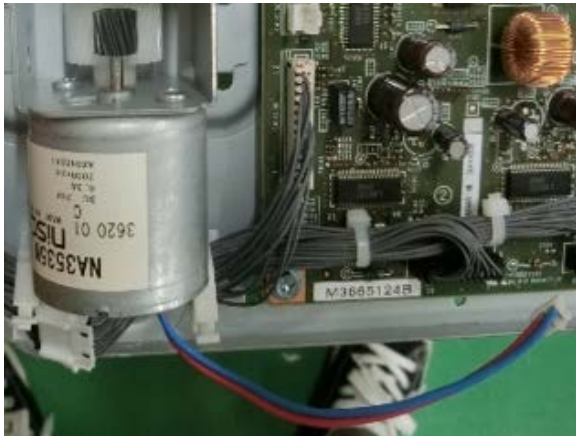
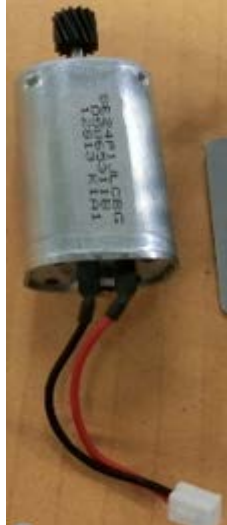
Reason: Production of the old motor has ended, and it has been changed to a new motor.

Old	New
	AX040241	D5865311
DC BRUSH MOTOR
