Model: Model AT-C1	Date: 29-May-06	No.: RB230001j
--------------------	-----------------	----------------

Subject: Firmware Release History (Engine)		Prepared by: H. Tamaki	
From: 1st Overseas Tech Support Sec., 1st PQM Dept.			
Classification:	<input type="checkbox"/> Troubleshooting	<input type="checkbox"/> Part information	<input type="checkbox"/> Action required
	<input type="checkbox"/> Mechanical	<input type="checkbox"/> Electrical	<input type="checkbox"/> Service manual revision
	<input type="checkbox"/> Paper path	<input type="checkbox"/> Transmit/receive	<input type="checkbox"/> Retrofit information
	<input type="checkbox"/> Product Safety	<input checked="" type="checkbox"/> Other ()

This RTB has been issued to announce the module release information for the **Engine**.

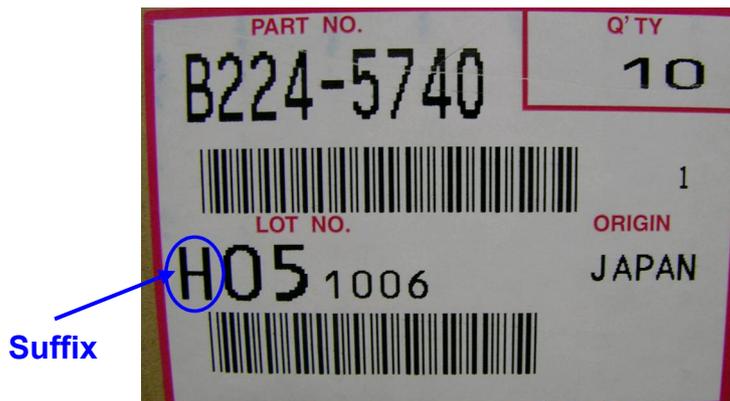
- If the noise occurs, **replace this drum unit and stop this procedure.**

B2332246, suffix **G** or later

B2332247, suffix **G** or later

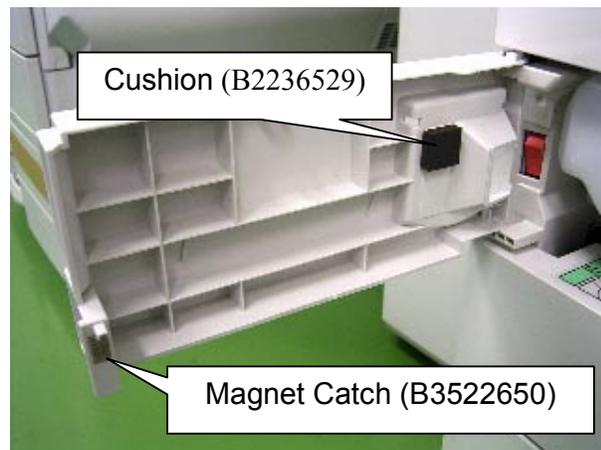
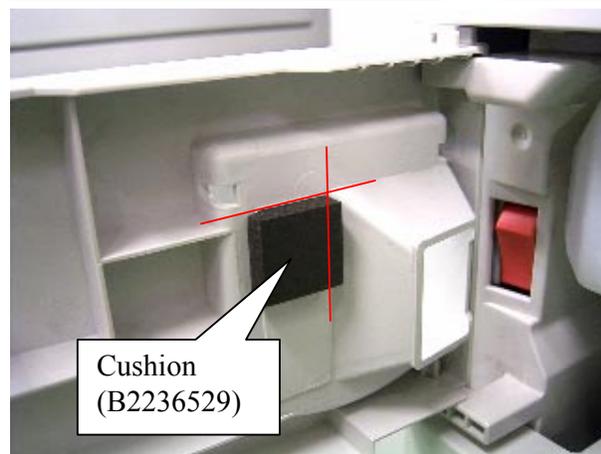
The low temperature causes the toner bottle to contract (shrink) slightly. As a result, sometimes the toner bottle does not touch the "toner bottle set switch".

Attach a cushion to the front door and replace the magnet catch.

Cushion: **B2236529**
 Magnet Catch: **B3522650**

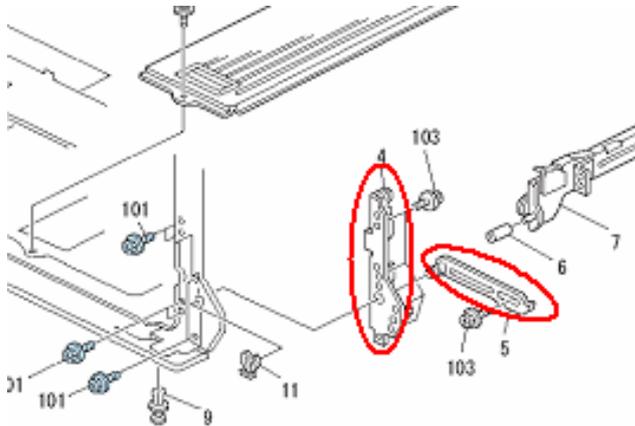
1. If the duplex link or peen on the mainframe is broken, do **Procedure A** below.
2. If the peen on the duplex unit is broken, do **Procedure B** below.

- Duplex Link: pg. 80, index #5
- Bracket Paper: Feed Unit: Peen: pg. 80, index #4

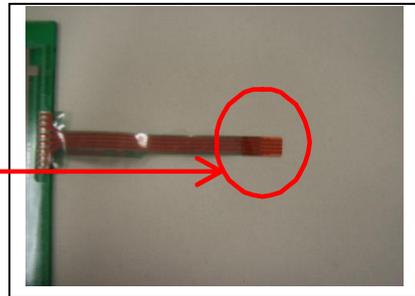
Old parts:
The tip of the electrode is **brown**.

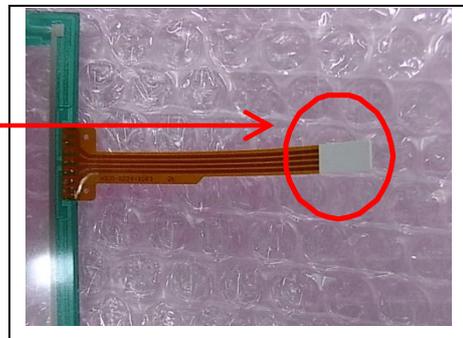
New parts:
The tip of the electrode is **white**.

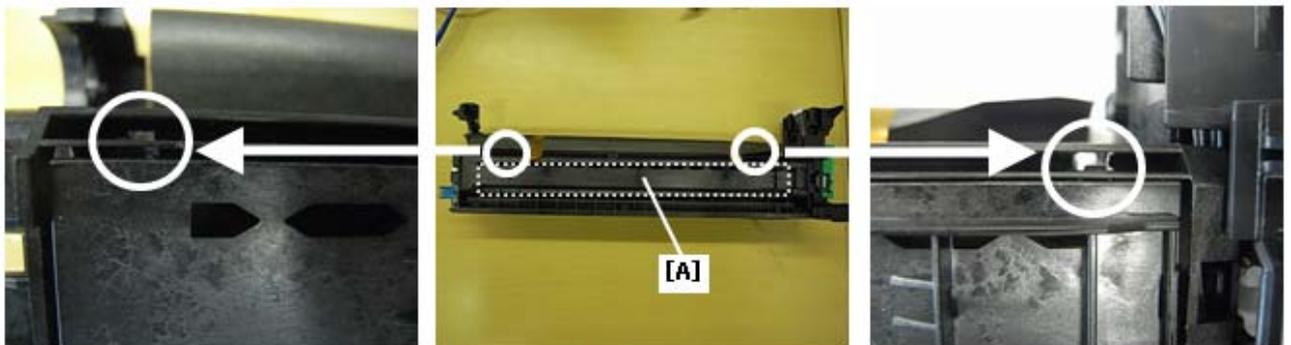
1. Increased electrical resistance on the charge roller surface from toner/powdered lubricant and paper dust that had built up on this surface, coupled with:
2. Increased electrical resistance on the charge roller surface caused by low-temperature conditions (around 15C)

1. Remove the drum unit from the machine.
2. Release the hooks on the charge roller cover [A] using a screwdriver to separate the cover (together with the two rollers) from the drum frame.

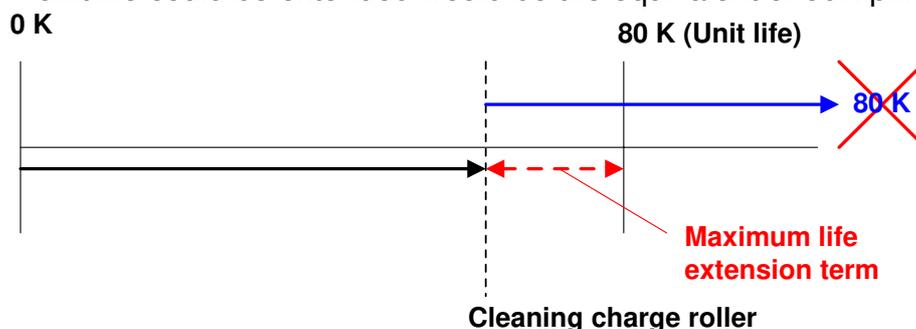
- If the unit is near its lifetime, there will be other parts inside the unit that have already experienced a certain amount of wear (cleaning blade, etc.). Therefore, after cleaning the charge roller surface, the dirtying will occur again sooner than it would with a completely new unit. (See illustration below). The maximum amount that the unit life could be extended would be the equivalent of 80K prints.

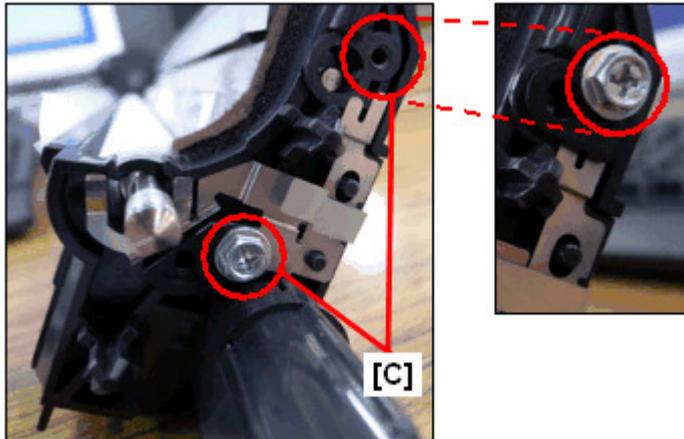
Sometimes, the GND plate at the rear side of the ITB cleaning unit [A] does not touch the lubrication application shaft [B]. As a result, a minor electrical leak occurs, which can trigger electrical noise. Sometimes, this effect appears as lines at 110mm intervals.

1. Attach the screw x 2 [C].

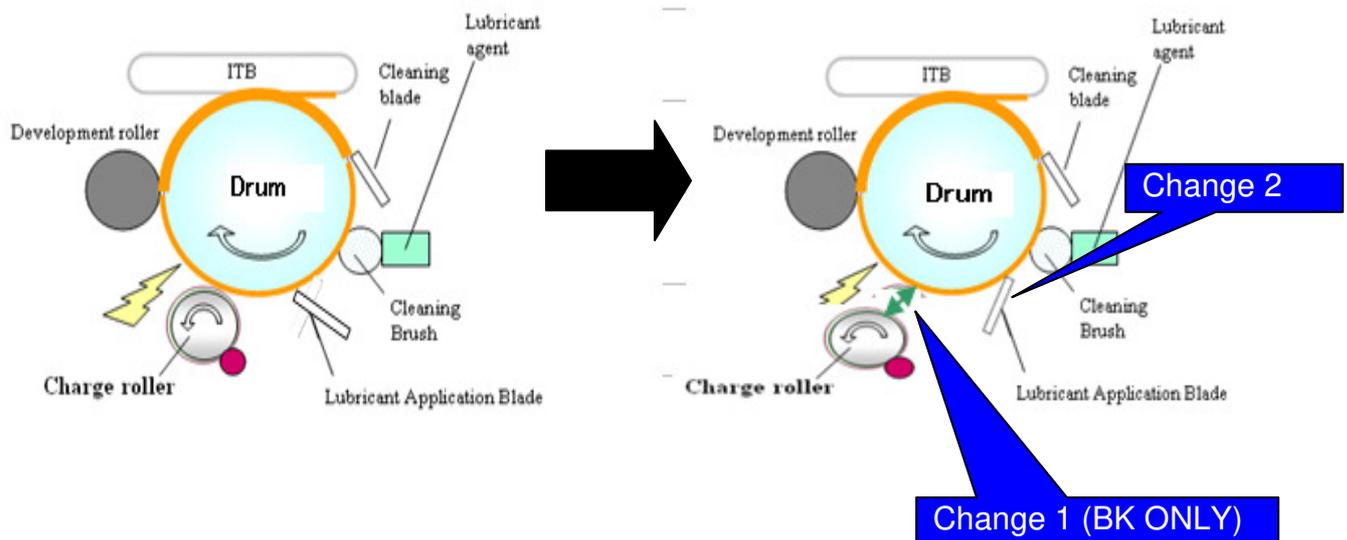
1. To further minimize the amount of toner particles that can stick to the charge roller surface (which makes it harder for dirty background and black lines to occur).
2. To increase the amount of toner that can be caught by the blade, improving cleaning performance.

Old part number	New part number	Description	Q'ty	Int	Page	Index
B2232042	B2242042	DRUM UNIT BK	1	O/O	47	4
B2232027	B2242027	DRUM UNIT CL	1	O/O	47	4

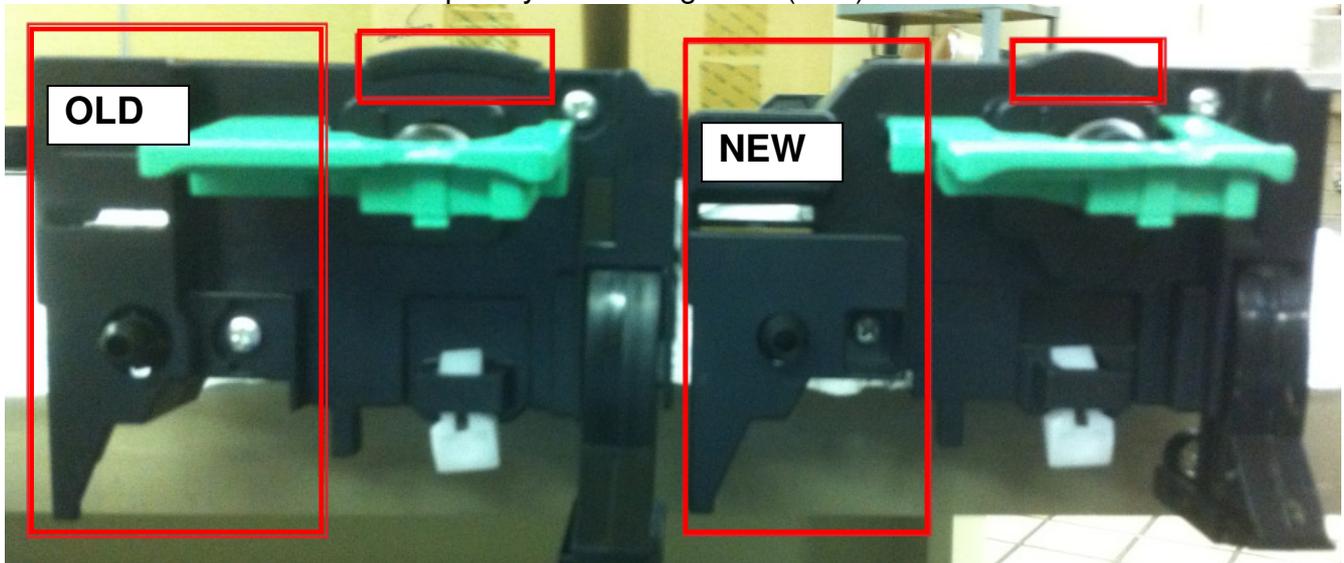
Areas of the PCU that have changed in shape:
The old and new units are completely interchangeable (O/O).
