Model: AT-C2.5	Date: 22-Oct-10	No.: RD087001n
----------------	-----------------	----------------

Subject: Firmware Release Note: System/Copy		Prepared by: Y. Taniguchi	
From: 1st Tech Service Sect., MFP/Printer Tech Service Dept			
Classification:	<input type="checkbox"/> Troubleshooting <input type="checkbox"/> Mechanical <input type="checkbox"/> Paper path <input type="checkbox"/> Product Safety	<input type="checkbox"/> Part information <input type="checkbox"/> Electrical <input type="checkbox"/> Transmit/receive <input checked="" type="checkbox"/> Other (Firmware)	<input type="checkbox"/> Action required <input type="checkbox"/> Service manual revision <input type="checkbox"/> Retrofit information <input checked="" type="checkbox"/> Tier 2

This RTB has been issued to announce the firmware release information for the **System/Copy**.

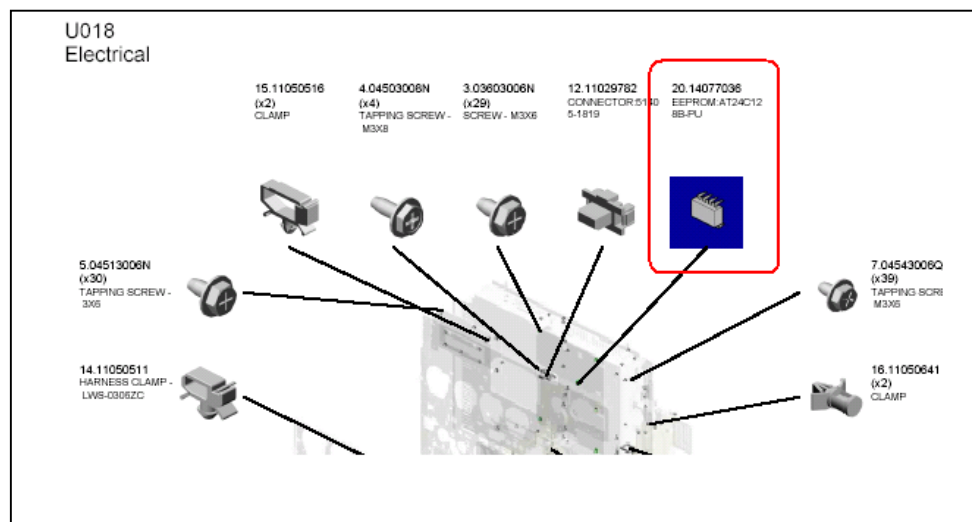
***The NVRAM on the BICU is shown above as [B] on the BICU board [A] (See Pg. 313 in the FSM)***

***The NVRAM on the BICU is called 'EEPROM' in the parts catalog on page "U018 Electrical".***

1. Output the SMC data ("ALL") using SP5-990-001.
2. Turn off the main switch.
3. Remove the VM card from SD card Slot #2 (lower slot).
4. Insert a blank SD card into Slot #2, and then turn on the main power switch.
5. Upload the NVRAM data to the blank SD card using SP5-824-001 (NVRAM Data Upload).
6. Turn off the main power switch, and then unplug the AC power cord.
7. Remove the SD card containing the NVRAM data from Slot #2.
8. Replace the NVRAM on the ***Controller Board*** with a new one.
9. Plug in the AC power cord, and then turn ON the main power switch.

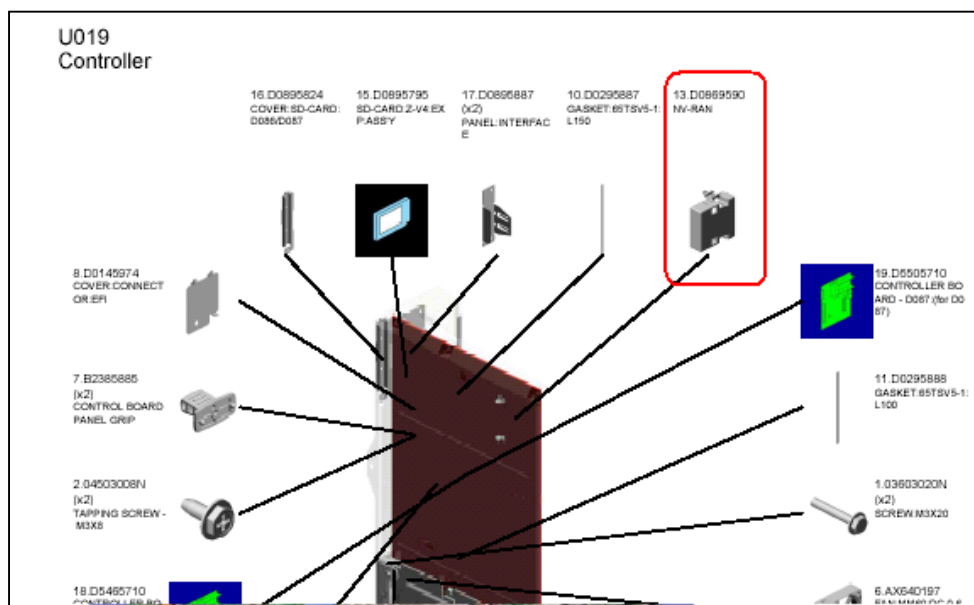
**Reissued:15-Feb-11**
**Model: AT-C2.5**
**Date: 25-Nov-10**
**No.: RD087014a**
**(2) NVRAM on the Controller Board**

**The NVRAM on the Controller Board is shown as [B] in the above photograph (See Pg. 318 in the FSM).**

**The NVRAM on the Controller Board is also called 'NVRAM' in the parts catalog on page "U019 Controller".**

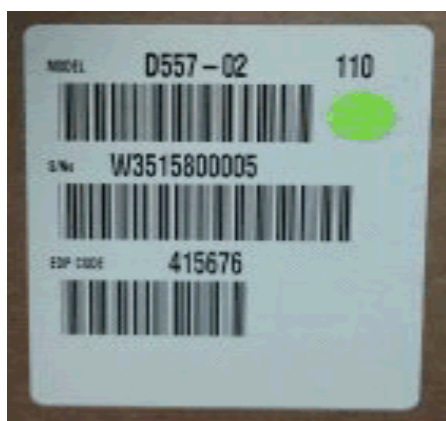
Under the conditions described above, a program bug with the 1-1AEV71 patch causes the controller to send the delete command for the wrong pages (pages not yet printed out).

A modified patch (1-1C5GYZ) has been applied to machines in production from November 1, 2011. These units have a green dot on the bar code label, as shown below.

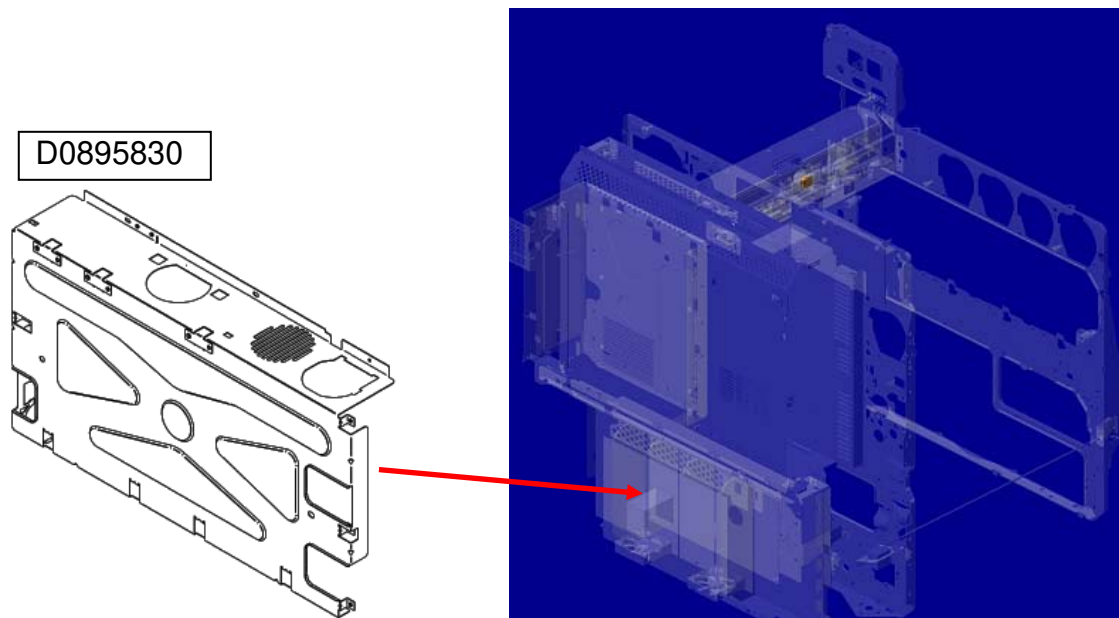
**Change:** The PSU bracket was added as a service part.

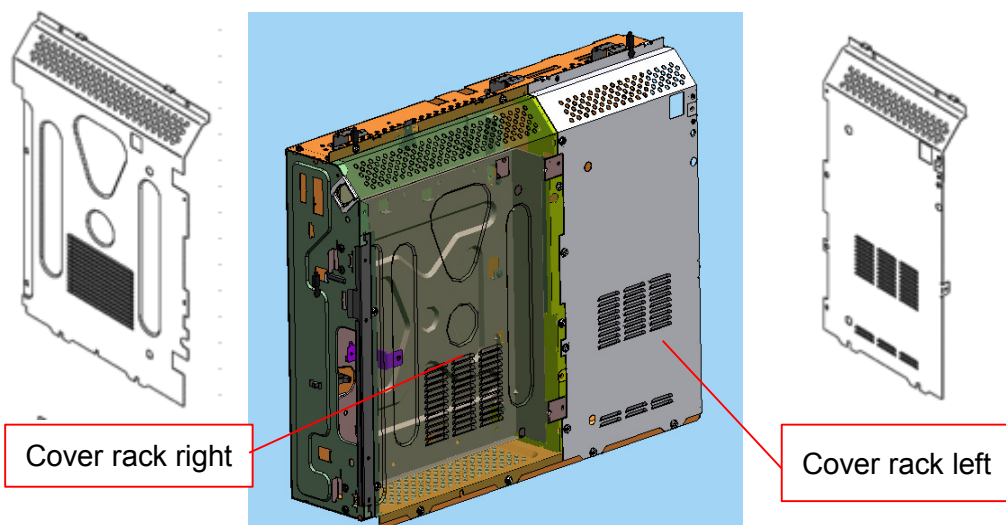
Cover rack right: D0295811

Cover rack left: D0295810

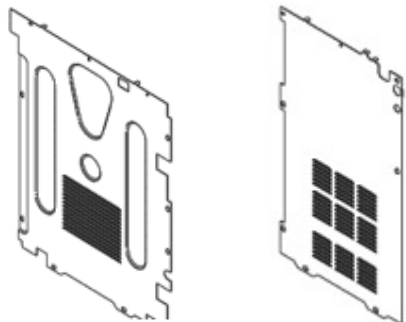
### AP-P2

Cover rack right: G1335811

Cover rack left: G1335810
