Model: AT-C3	Date: 15-Feb-12	No.: RD142001a
--------------	-----------------	----------------

Subject: Firmware Release Note: PowerSaving Sys		Prepared by: S. Hayami	
From: 1st Tech Service Sect., MFP/Printer Tech Service Dept.			
Classification:	<input type="checkbox"/> Troubleshooting <input type="checkbox"/> Mechanical <input type="checkbox"/> Paper path <input type="checkbox"/> Product Safety	<input type="checkbox"/> Part information <input type="checkbox"/> Electrical <input type="checkbox"/> Transmit/receive <input checked="" type="checkbox"/> Other (Firmware)	<input type="checkbox"/> Action required <input type="checkbox"/> Service manual revision <input type="checkbox"/> Retrofit information <input checked="" type="checkbox"/> Tier 2

This RTB has been issued to announce the firmware release information for the **PowerSaving Sys.**

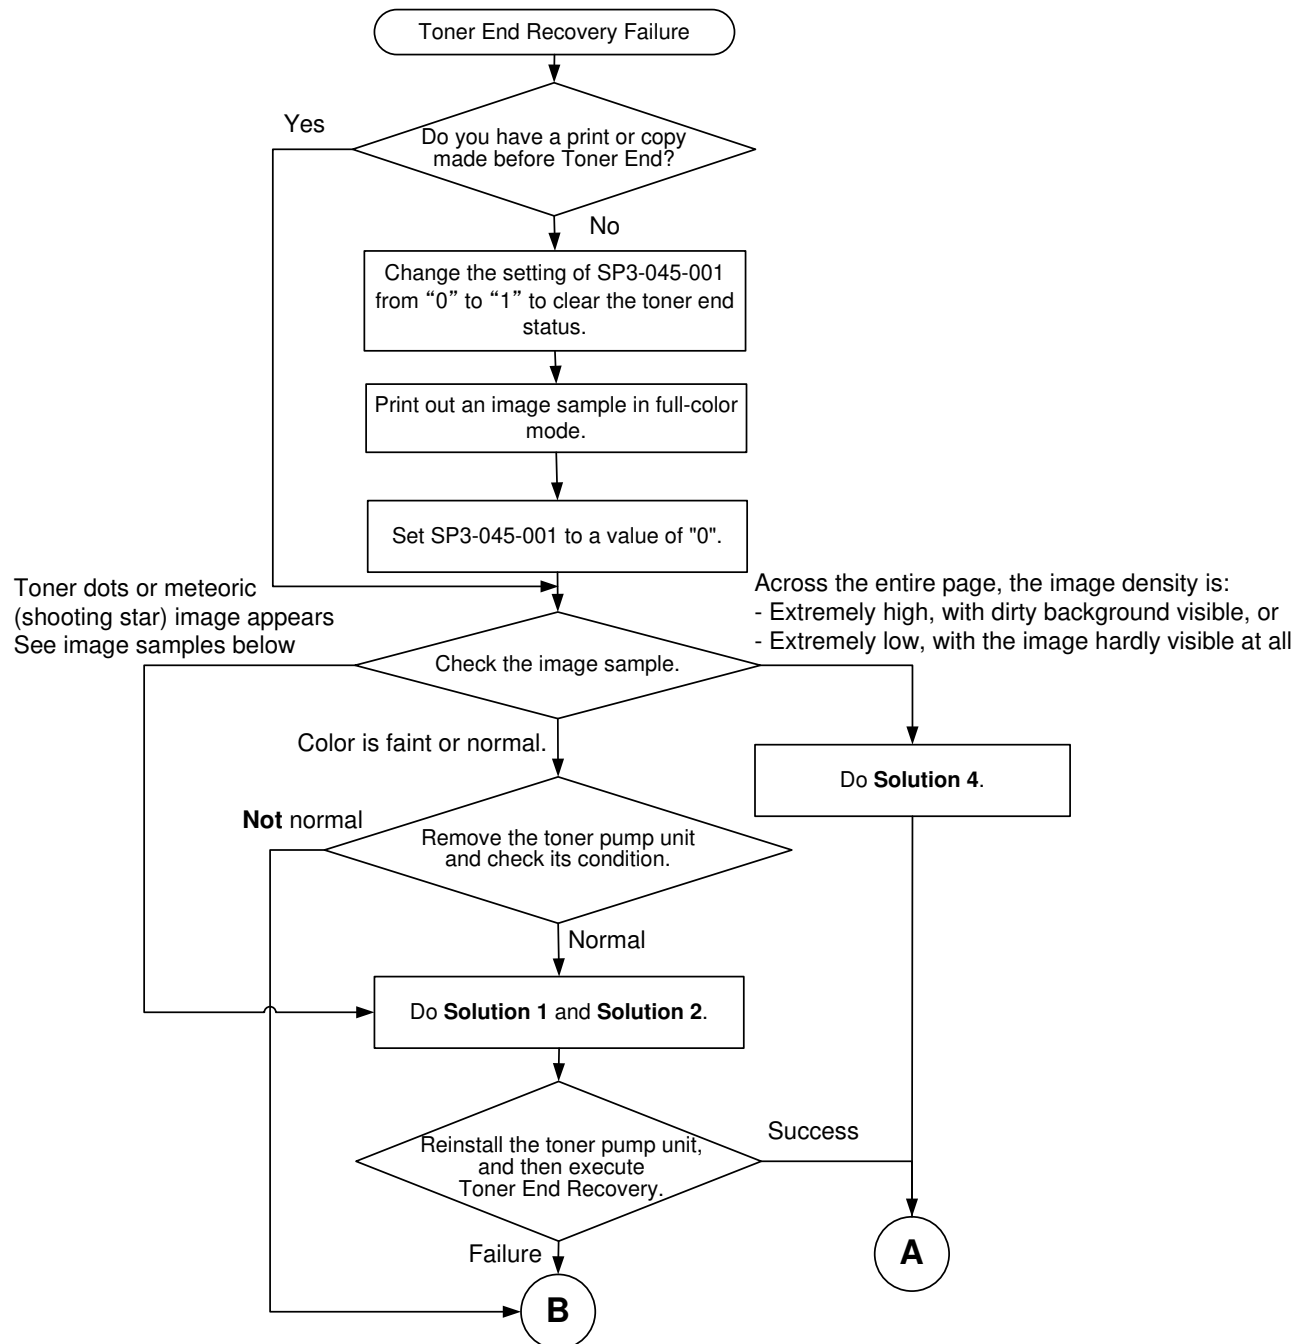
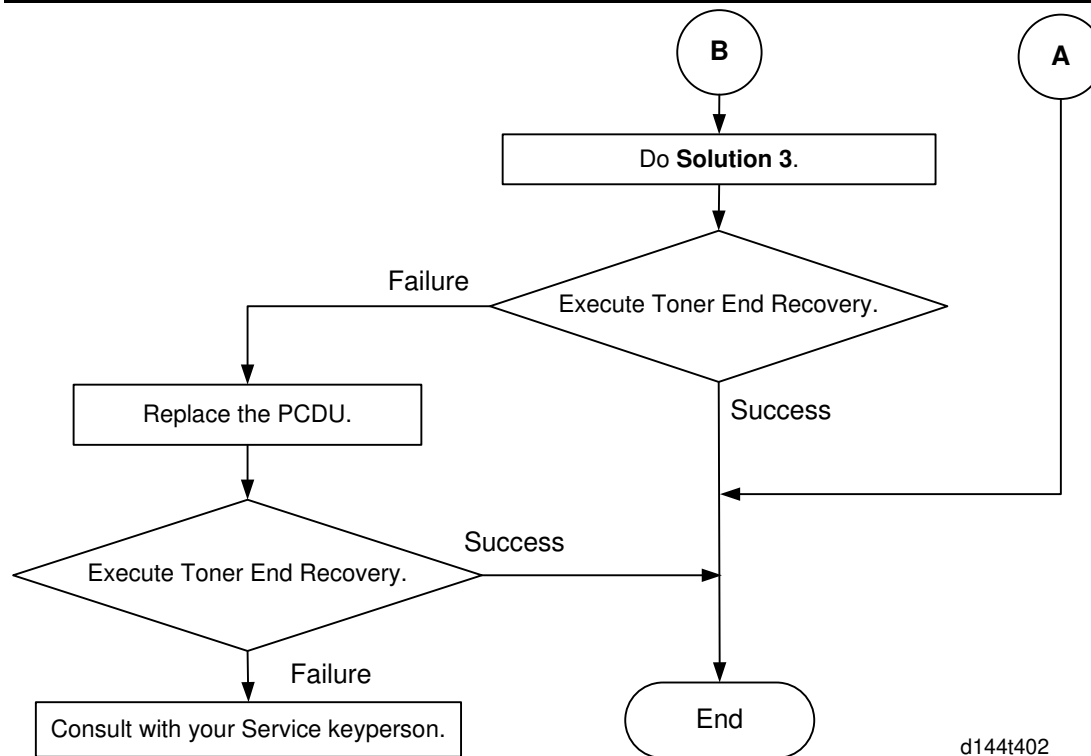
SOLUTION

Check the following flow chart in the "Solution" section.

Solution 1

1. Check the toner supply tube.
2. If it is bent or disconnected, straighten it out or connect it correctly.

Replace the toner pump unit.

Replace the Development unit

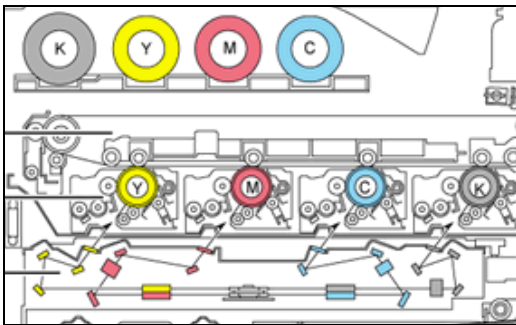
Page	Contents
p.24 p.26	Change: Wrong order of toner bottles and PCUs in the illustration. To:

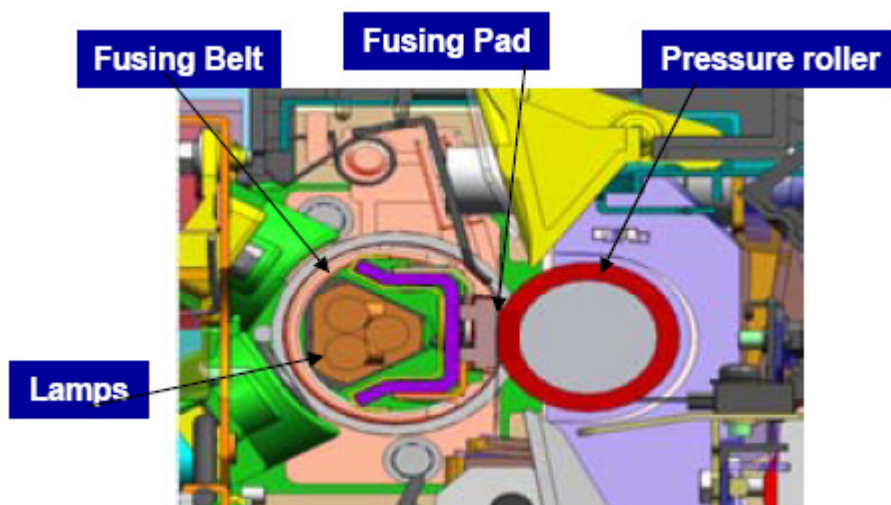
When the fusing belt is rotated after the paper is fed out, the inner layer of the belt rubs up against the fusing pad. As a result, the fusing pad vibrates and generates noise.

Note: The belt is rotated in this way in order to spread heat across the belt evenly, preventing it from getting too hot.

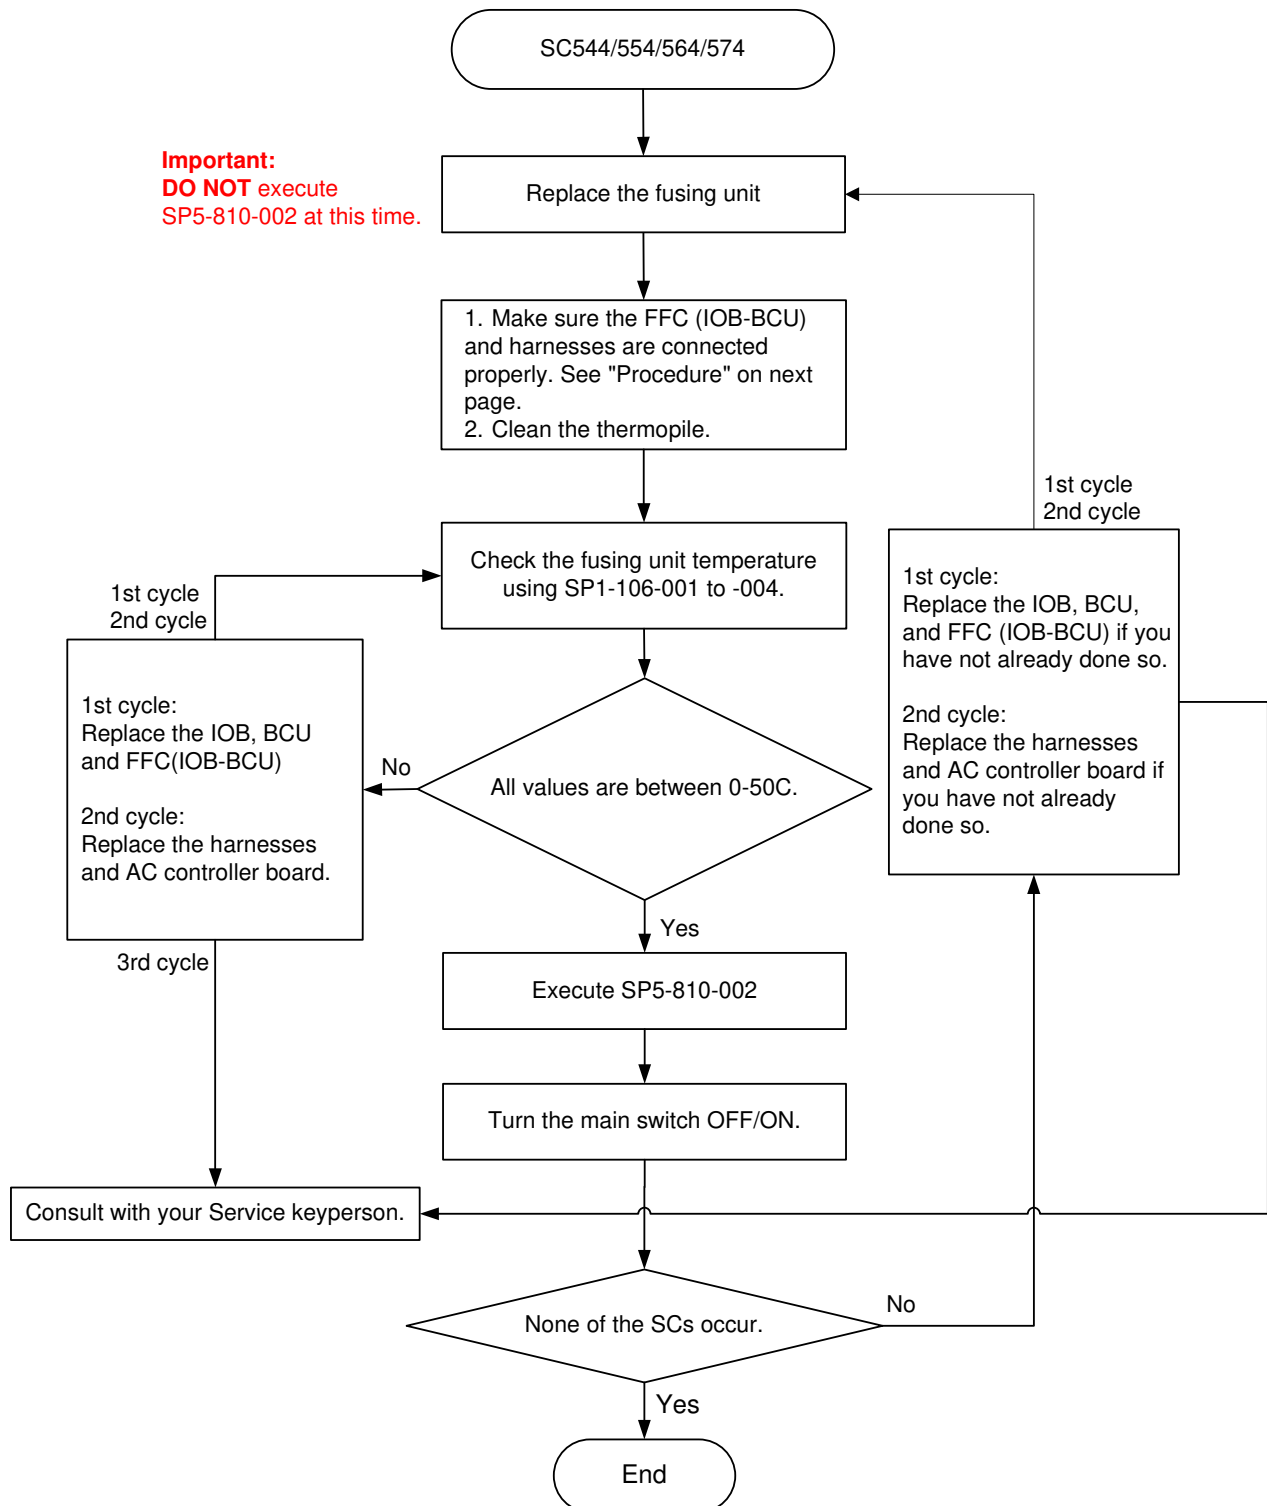
Solution

Several factors may cause this symptom.

See the flowchart in the “**Solution**” section below.

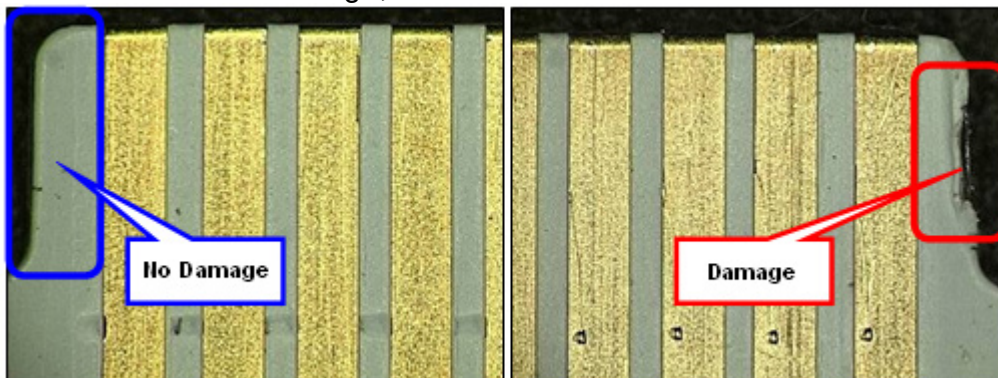
- c) Check for any damage to the FFC.

Use a loupe to check for any damage to the edges of the FFC. If you find any, replace the FFC. If there is no damage, follow the instructions in the flowchart.

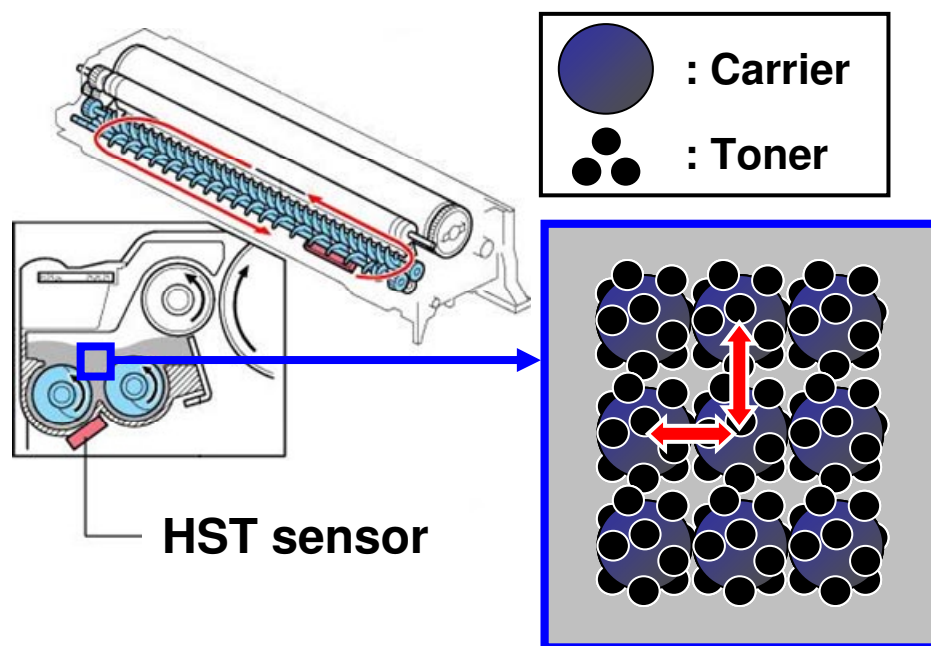
The machine mistakenly judges that the toner concentration is too high, and compensates by lowering it.

Under the conditions mentioned above (low temp., low humidity, carrier is relatively fresh), the carrier tends to take on a higher electrical charge than the target. As a result, the carrier particles are farther apart from one another, causing the machine to judge the toner concentration to be higher than it actually is.

- The HST sensor detects the distance between carrier particles. The farther apart they are from one another, the higher the machine judges the toner concentration to be. When the carrier particles reach a certain distance, the machine judges the toner concentration to be in balance (just right).
- However, if the carrier particles are charged too high, they will move even farther apart. So even with the same amount of toner between the carrier, the HST sensor will judge incorrectly that the concentration is too high.

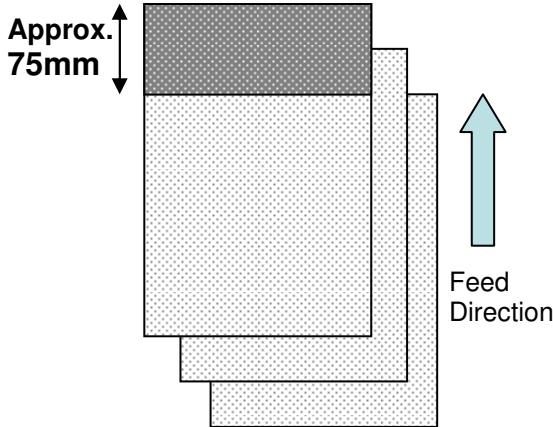
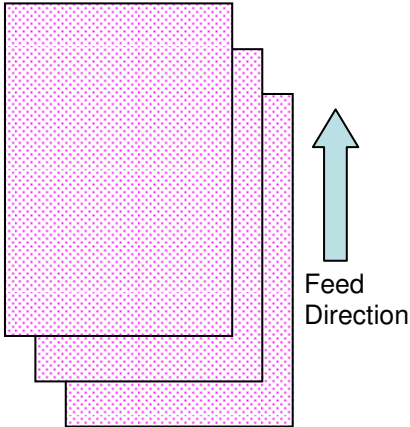
Black	Color (CMY)

The charge (Vd) applied to the drum via the charge roller tends to drop below the target when the temperature and humidity are low.

<p>The area that gets dirtiest is the leading edge of the first sheet. This is because the charge on the drum during the first rotation is lower than later rotations.</p>	<p>All pages are uniformly dirty, since the leading edge of the first sheet contacts the drum from the drum's second or later rotations. This is different from B/W printing, due to the difference in timing in the image creation process.</p>

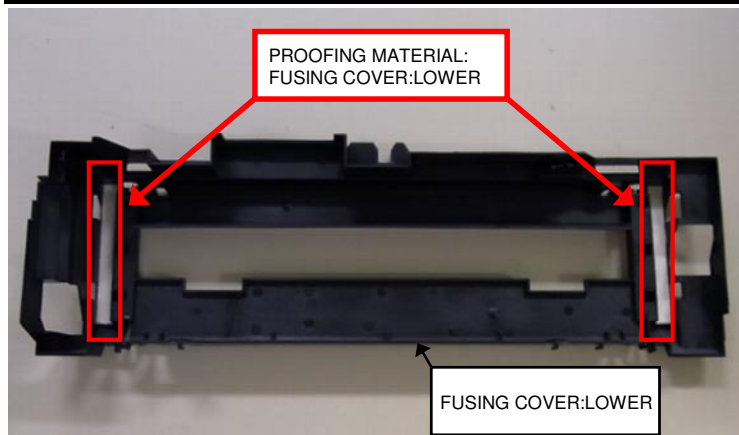
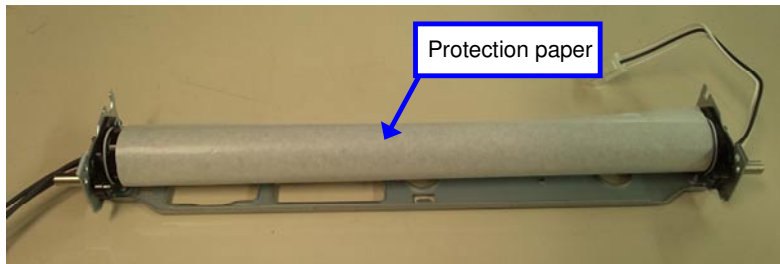
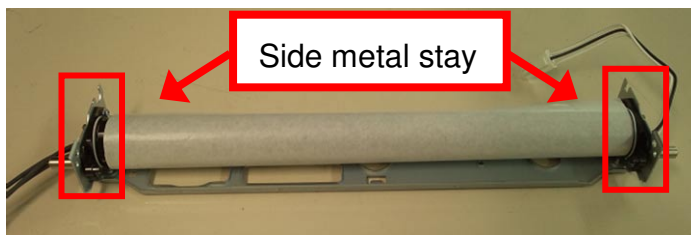
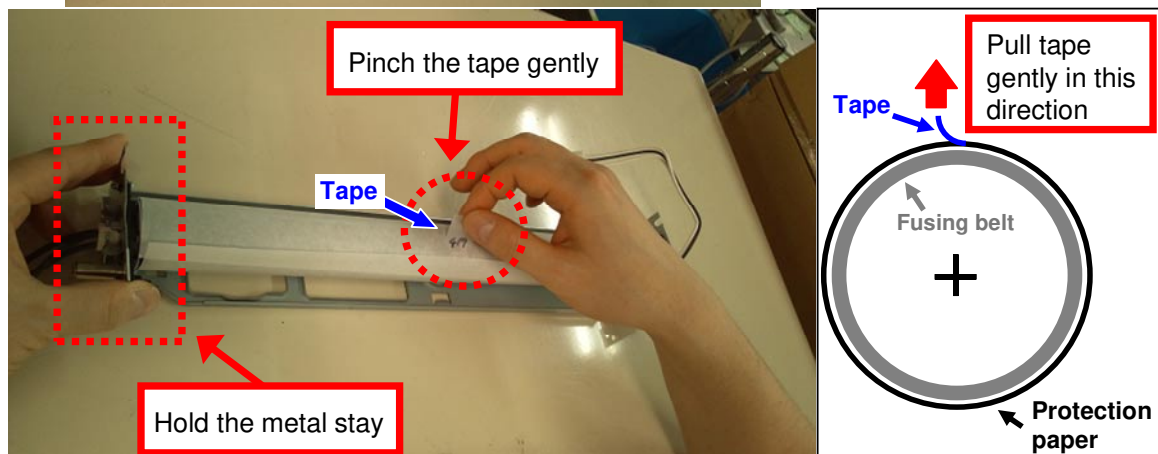
Note: This is necessary because it is possible to press the belt by mistake or press the belt's surface, forming a dent in the belt. This is a major cause of SC544/SC554.

1) Do the following when you remove the protective paper from the fusing belt.

1. Hold the lateral metal stays, and pinch the tape on the paper gently as shown.

IMPORTANT: Be careful not to press the fusing belt surface.

2. Peel off the tape very carefully, pulling the tape up in a vertical direction (90 degrees to the belt surface).

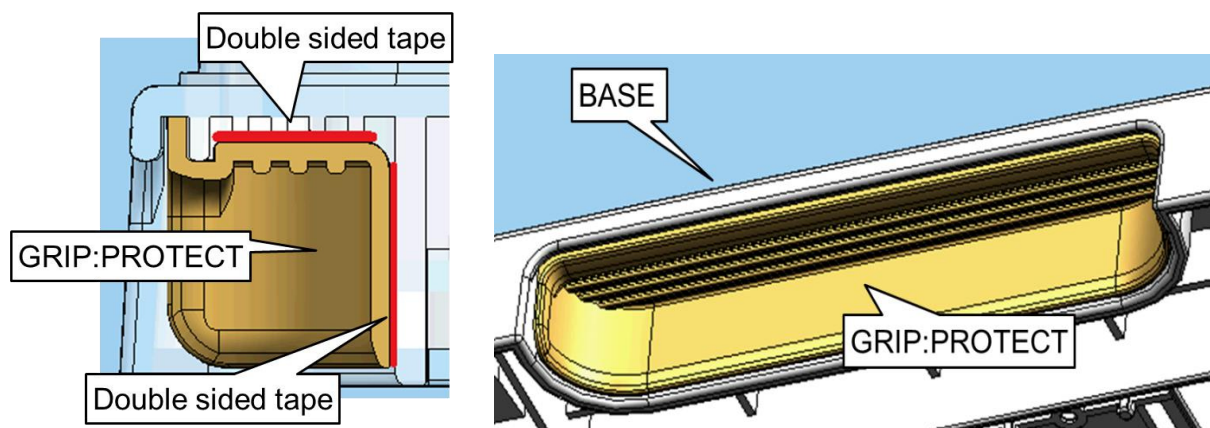
Note: The handgrip can be damaged when the DF is opened/closed repeatedly.

Important: Attach the grip to the base using double-sided tape.

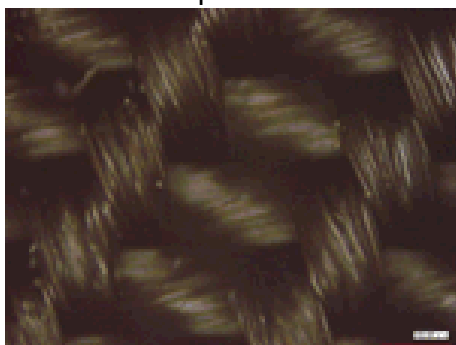
Current pad:

The fusing pad does not apply enough oil to the inside of the fusing belt. As a result, the torque between the pad and belt increases, causing the belt to slip and damage the fusing sleeve.

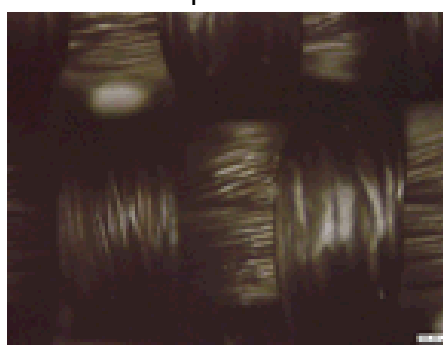
Modified pad:

The net for the fusing pad was changed so that it retains more oil and can apply the right amount of oil to the pad. This will increase the durability of the fusing sleeve.

If the symptom occurs, replace the fusing pad with the modified pad (see P/N below).
