Model: GR-C1	Date: 21-Mar-12	No.: RD117001b
--------------	-----------------	----------------

Subject: Firmware Release Note: (Java VM v10 for eDC)		Prepared by: H. Tamaki	
From: 1st Tech Service Sect., MFP/Printer Tech Service Dept.			
Classification:	<input type="checkbox"/> Troubleshooting	<input type="checkbox"/> Part information	<input type="checkbox"/> Action required
	<input type="checkbox"/> Mechanical	<input type="checkbox"/> Electrical	<input type="checkbox"/> Service manual revision
	<input type="checkbox"/> Paper path	<input type="checkbox"/> Transmit/receive	<input type="checkbox"/> Retrofit information
	<input type="checkbox"/> Product Safety	<input checked="" type="checkbox"/> Other (Firmware)	<input checked="" type="checkbox"/> Tier 2

This RTB has been issued to announce the firmware release information for the **Java VM v10 for eDC**.

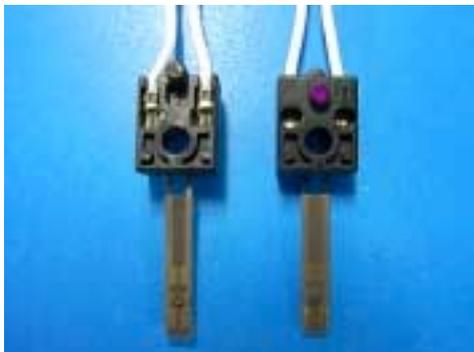
Pink dot on AW100149:

- The AW100149 fusing thermistor is marked with a pink dot. When you replace the thermistor, make sure that this pink dot faces the bracket, as shown in the photos below. (The dot is visible through the bracket after you attach it).
- Currently, this thermistor cannot be supplied. If you need to replace the fusing thermistor, use the AW100147 thermistor instead. It is the same thermistor.

**IMPORTANT:** The AW100147 thermistor is not marked with a pink dot, so make sure that the side of thermistor that covers the harnesses (shown in the right side of the photo) **faces the bracket**.

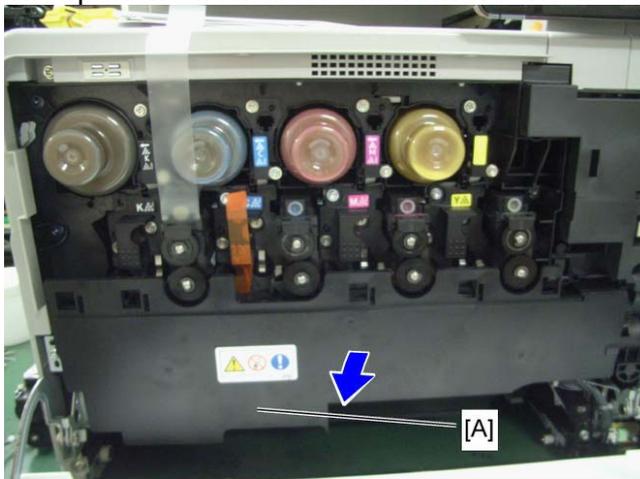
d1170012

**Important Information about Preventing SC492**

1. Open the front door and remove the waste toner bottle [A].

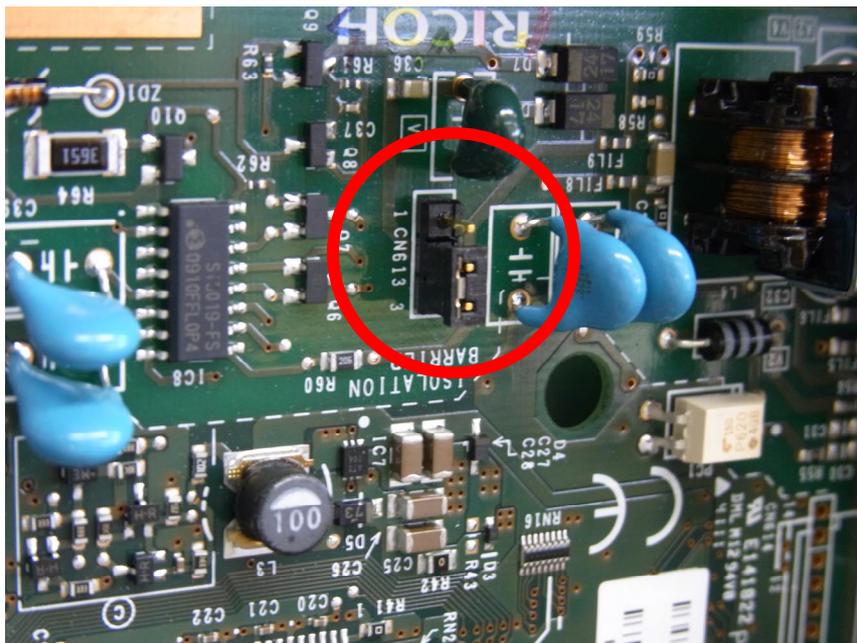
**Note:** In its default position, the switch covers the middle and "3" pin.

For installation in Brazil, move the jumper switch (CN613) on the fax board so that the edge is anchored at "1" (so that the middle pin and the "1" pin are covered).

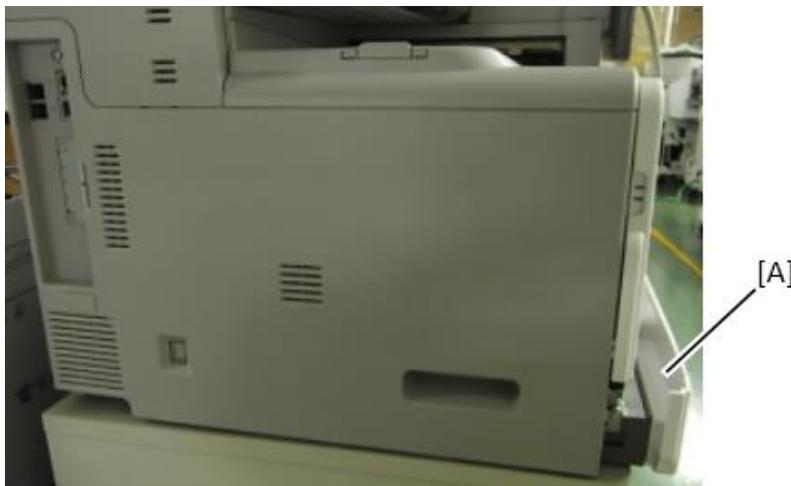
The user closes the tray with force, which causes the stretch pin [A] to ride up on the stretch unit [B]. The mechanical interference between these parts prevents the tray from being pulled out.

- 1. Pull out the the paper tray as far as possible.

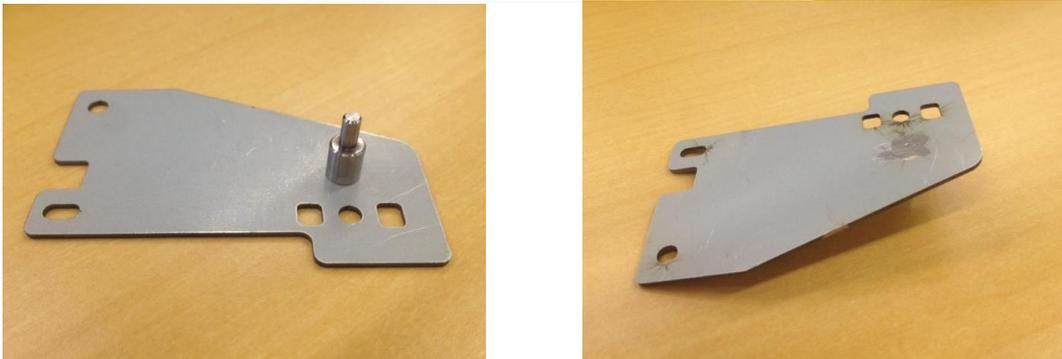
**Countermeasure Part (D1962849)**

The user closes the tray with force, which causes the stretch pin [A] to ride up on the stretch unit [B]. The mechanical interference between these parts prevents the tray from being pulled out.

This issue is solved by installing the countermeasure part.

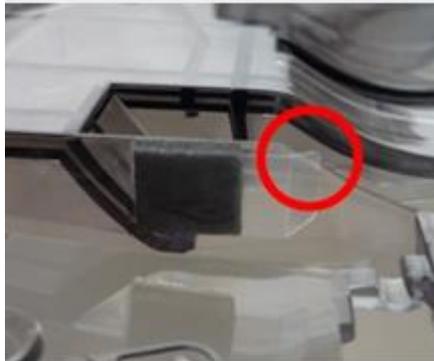
**[A] (Symptom)**

1. The customer uses an unsupported thin paper type (approx. 0.33gsm or thinner), which causes the ADF feed unit to interfere with the movement of the pick-up roller. As a result, the pick-up roller cannot be lowered to the proper position.

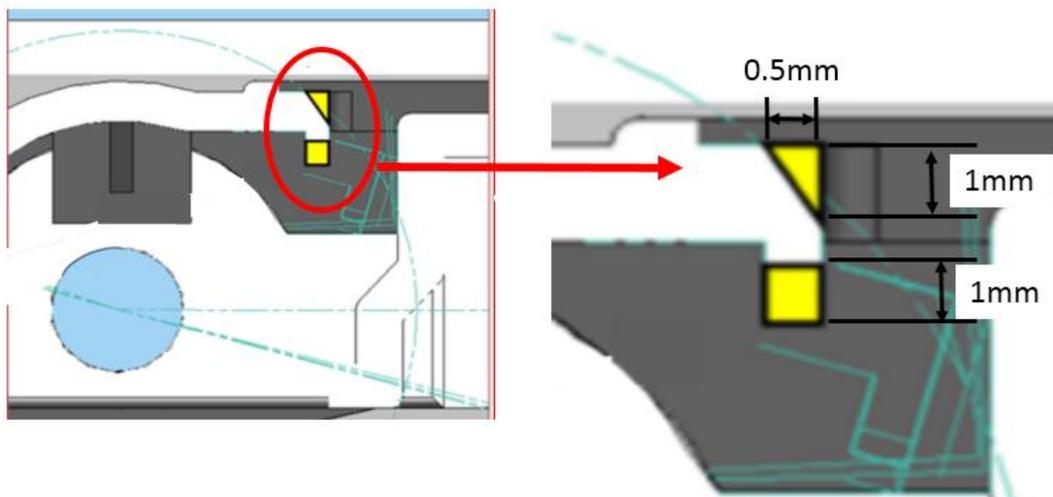
- The areas in yellow were cut away to prevent interference.
- See **Cut-in serial numbers** below.

- **If the customer is using an unsupported thin paper type** (approx. 0.33gsm or thinner), replace the ADF feed unit (P/N D6062122; HOLDER:PICKUP ROLLER).
- **In all other cases**, do the **Procedure** on the next page.

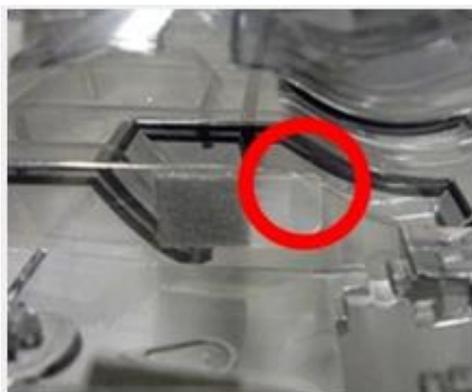
<Before>

**Note:** This will not affect the function of the Mylar. This Mylar prevents the separation cushion from peeling off.

4. Replace the separation cushion (with P/N D6063119) **OR**, cut off the portion of the Mylar that is sticking out.

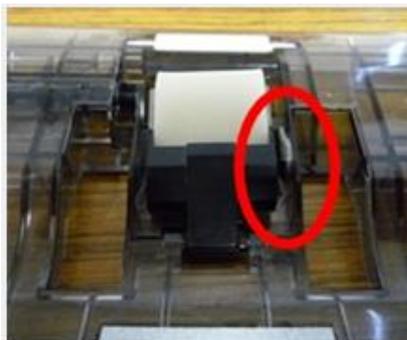
[A] Incorrect

- Make sure the Mylar **does not** slide under the separation pad holder when you attach the holder [B].

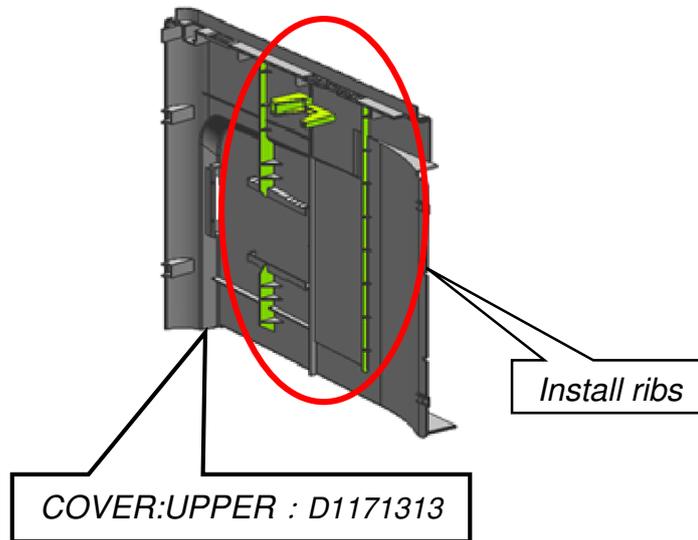
**Exit cover:**

The exit cover is pressed down with force when closed. This causes the cover to bend inward (downward) and move the laser unit slightly from its original position. As a result, the paths of the yellow and/or magenta beams are shifted.

**In the field:**  
**Replace the exit cover and attach the seal to the machine, as shown above.**

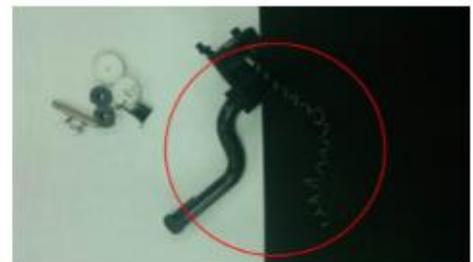
Toner concentration drops due to suspension of toner supply to the development unit after the coil in the toner supply hopper is twisted and broken. **This occurs after the PDCU is replaced or just after the machine is installed.**

Depending on how the PDCU is installed, in some cases, the toner hopper shutter may not open. If the toner hopper is then driven with the shutter closed, more toner is inside the tube, which places a greater load on the coil. This can cause the coil to warp and break.

Toner hopper coil  
twists/breaks

Replace the target color's toner hopper and check the PCDU installation procedure.

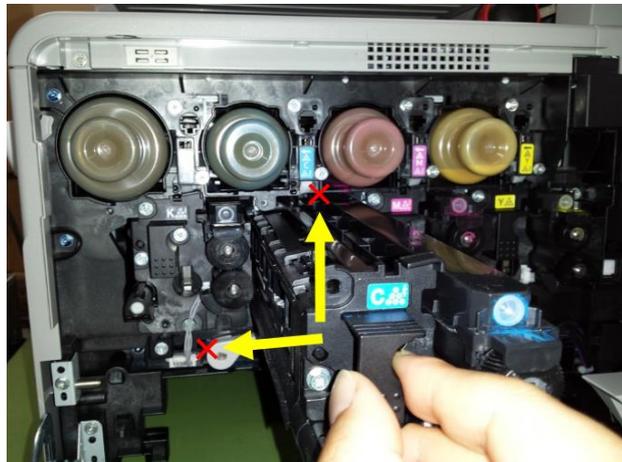
Do not insert while tipping up in the direction of the upper left.

If this issue still stays, replace the target color's toner hopper and PCDU as a set.

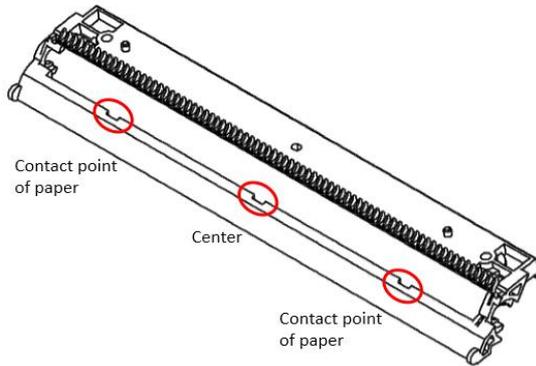
Before

If a customer uses a paper with rough edges, the mylar is gradually damaged at the center and at the contact points of the paper side edges (shown in the pictures), and then the mylar peels off from the molded part.

At a result of this, mylar damage causes Jam 017.

The molded part which has cutouts was modified to the following shape (flat shape).

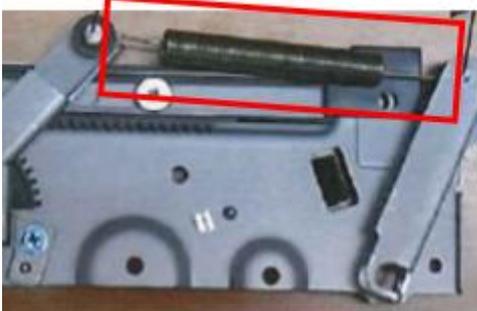
D5732734 TENSION SPRING:PAPER FEED

The tension spring breaks, causing the base plate of the paper tray to not move properly followed by failure in detecting paper within the specified time.

***Replace the following spring.***

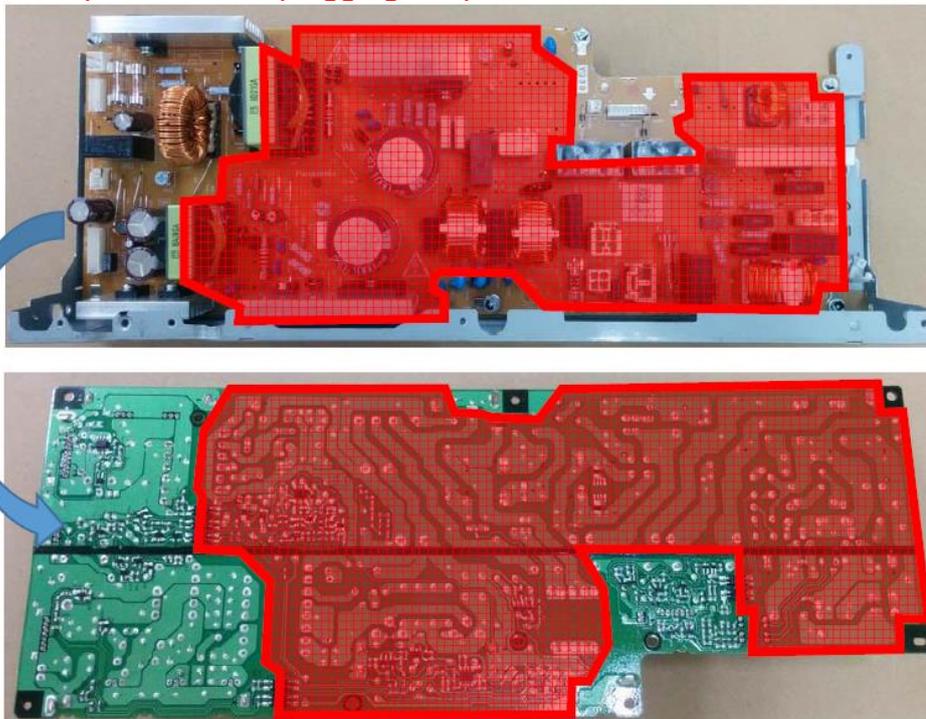
**NEVER touch** the areas outlined in red in the photos below to prevent electric shock caused by residual charge.

Residual charge of about 100V-400V remains on the PSU board for several months even when the board has been removed from the machine after turning off the machine power and unplugging the power cord.

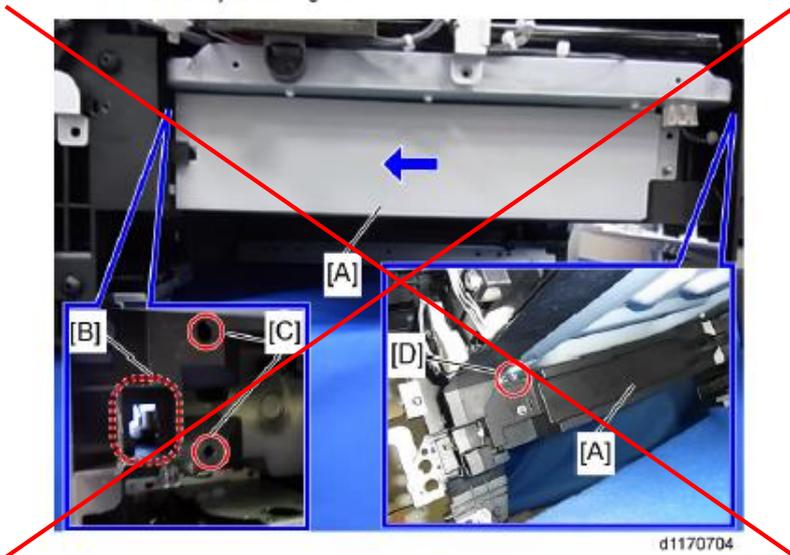
- ~~• Never press the main frame from above when the left stay [A] is removed. Otherwise, the mainframe may be damaged.~~
