Model: GR-C2_SOP	Date: 30-Jul-15	No.: RD196005
------------------	-----------------	---------------

Subject: Firmware Release Note: PowerSaving Sys		Prepared by: C. Shimaji	
From: 2nd Tech Service Sect., MFP/Printer Tech Service Dept.			
Classification:	<input type="checkbox"/> Troubleshooting <input type="checkbox"/> Mechanical <input type="checkbox"/> Paper path <input type="checkbox"/> Product Safety	<input type="checkbox"/> Part information <input type="checkbox"/> Electrical <input type="checkbox"/> Transmit/receive <input checked="" type="checkbox"/> Other (Firmware)	<input type="checkbox"/> Action required <input type="checkbox"/> Service manual revision <input type="checkbox"/> Retrofit information <input checked="" type="checkbox"/> Tier 2

This RTB has been issued to announce the firmware release information for the **PowerSaving Sys.**

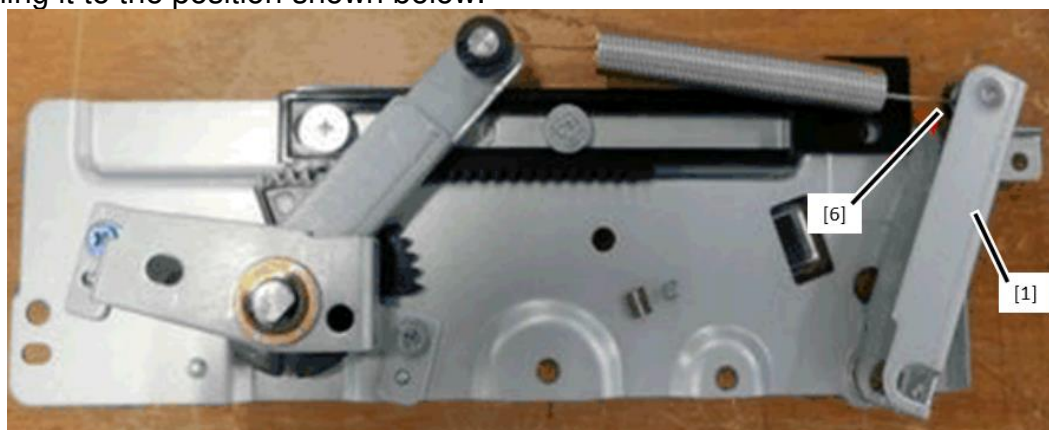
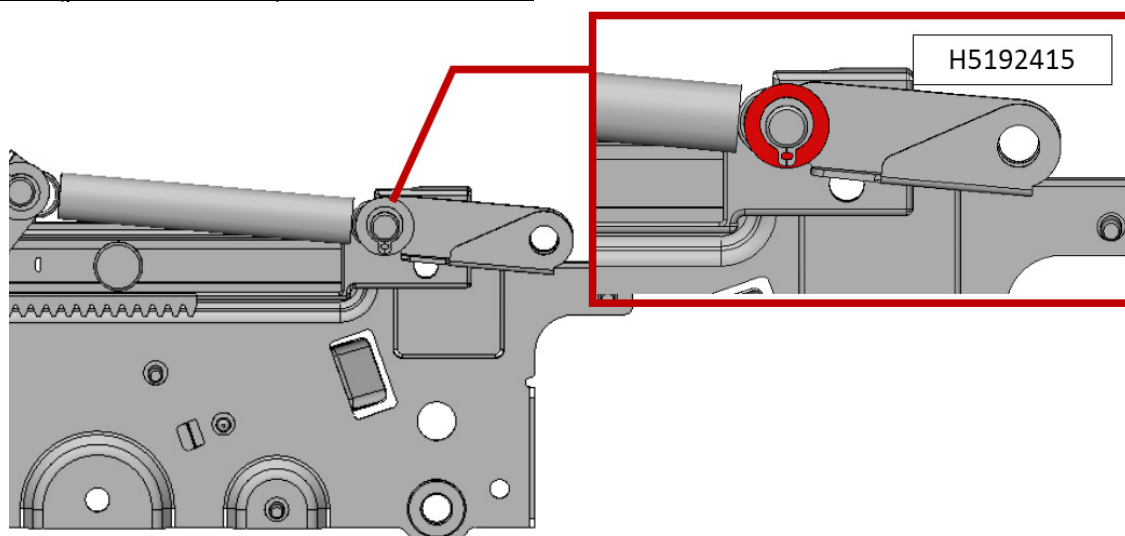
Reuse **WASHER:MM7.2** [6], by removing it from **LEVER:RISE:BASE:PEEN** [1] and reattaching it to the position shown below.

Washer (p/n: H5192415) attaches to here.

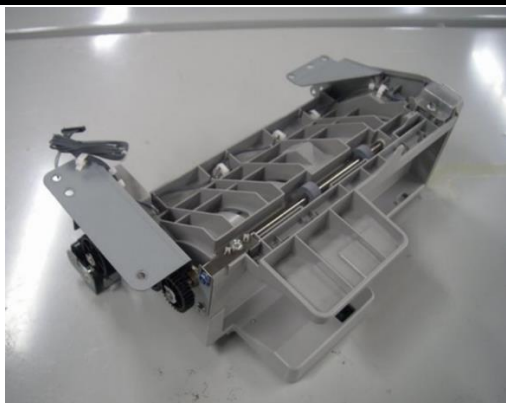
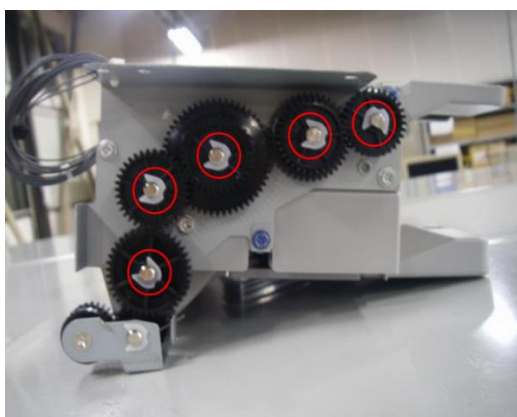
The viscosity of the grease applied to the shafts of the four gears (see below) increases under low-temperature (12C) conditions. As a result, the friction between the gear and mainframe increases, triggering the noise and/or Jam21.

1. Remove the covers.
2. Remove the FFC that connects the IPU and scanner.
3. Remove the scanner unit.
4. Remove the 1-bin unit.

5. Remove the five gears.

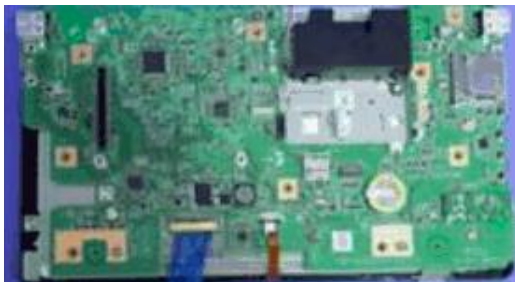
### 2. Sub board

HW	The Smart Operation Panel can be supplied with electrical power (blue LED lamp), but nothing can be displayed on the LCD.	1. Reconnect the LCD I/F cable. 2. Replace the LCD unit 3. Replace the Sub board. 4. Replace the LCD I/F cable.
3	A splash (blue) screen or "Please wait" message stays on the display.

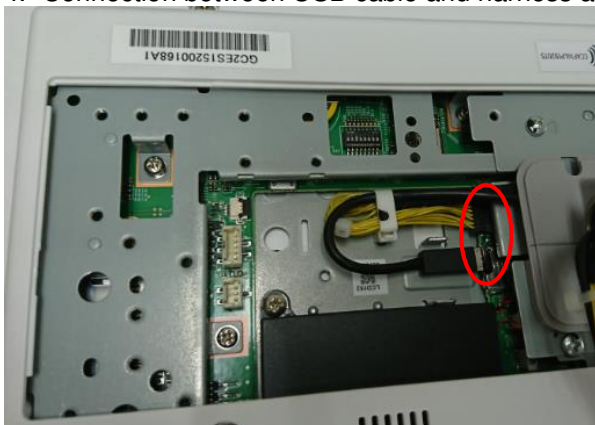
### 4. Connection between USB cable and harness and main board

HW	The Smart Operation Panel cannot be supplied with electrical power.	1. Reconnect the USB cable and harness between the BiCU and the Smart Operation Panel. 2. Replace the USB cable and harness. 3. Replace the Main board. 4. Replace the Sub board. 5. Replace the BiCU.
2	The Smart Operation Panel does not turn on, but the blue LED on the operation panel turns on.
