| Model: AT-C2 | Date: 10-Sep-08 | No.: RD025001b |

| Subject: Firmware Release Note: Language Install | | Prepared by: T.Kiyohara | |

| Model: AT-C2 | Date: 16-Sep-08 | No.: RD025002h |

| Subject: Firmware Release Note: Engine | | Prepared by: Y.Urushihara | |

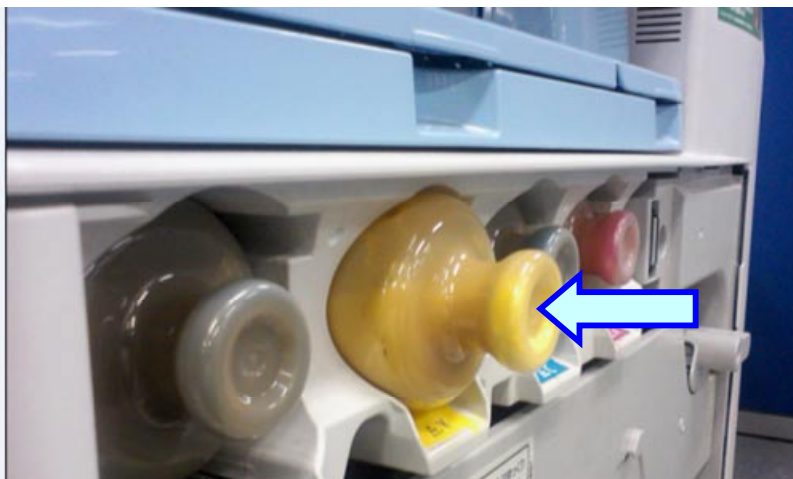
When you install a new toner bottle, please make sure to push the bottle in **as far as it can go** (past the point where you hear the click).

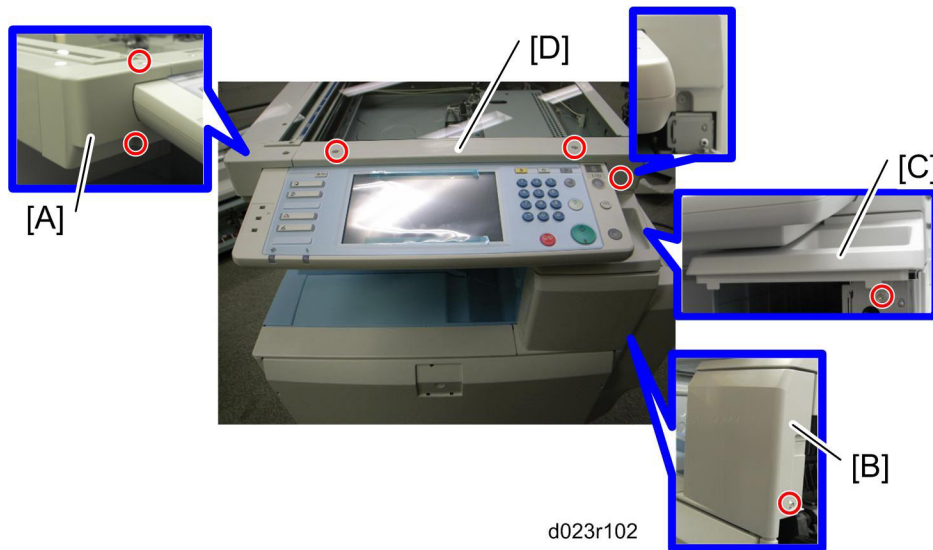
d023r102

The adhesive that binds electrodes to the touch panel surface contains a polymer that tends to expand under normal office environmental conditions.

1. Top left front cover [A] (screw x 2)
2. Open the right door.
3. Front right cover [B] (screw x 1)
4. Clip table cover [C] (screw x 1)
5. Top front cover [D] (screw x 3)

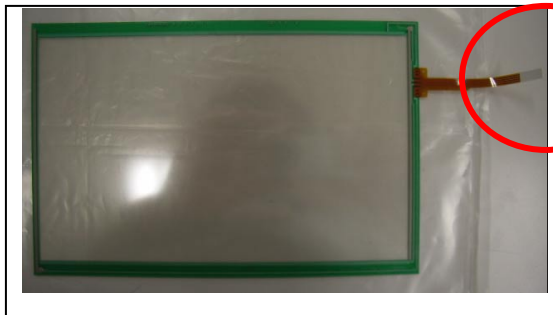
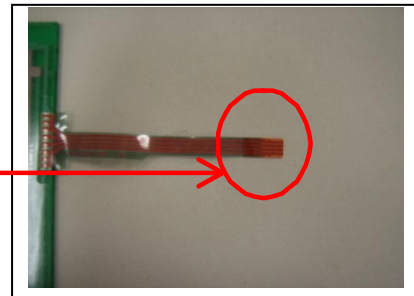
Old parts:
The tip of the electrode is **brown**.

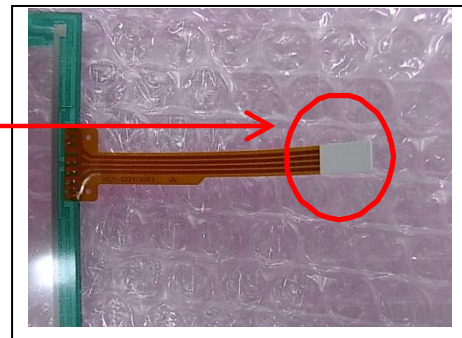
New parts:
The tip of the electrode is **white**.

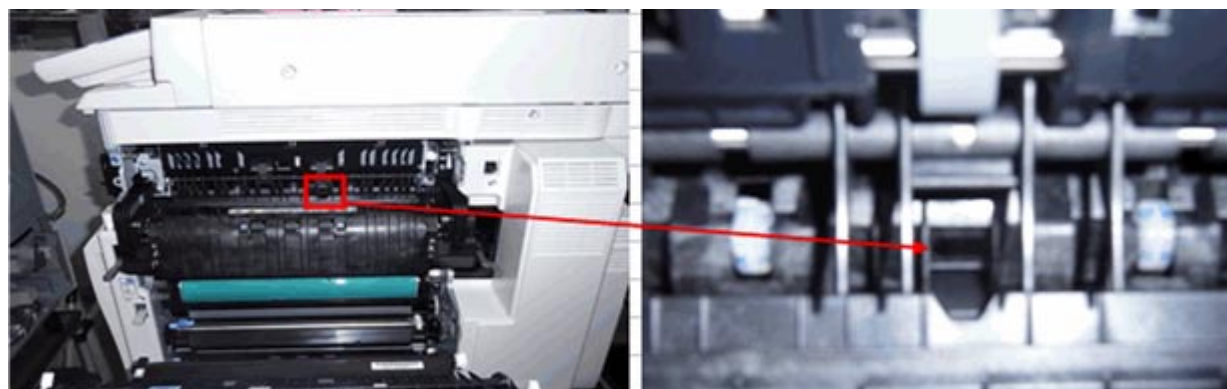
As the result of the above, the sensor detects a "No paper" condition continuously even if there is paper in the paper feed path.

Therefore, when the machine expects to detect paper at the sensor (based on the paper feed timing), paper is not detected, and the machine indicates an A, B, and C Jam.

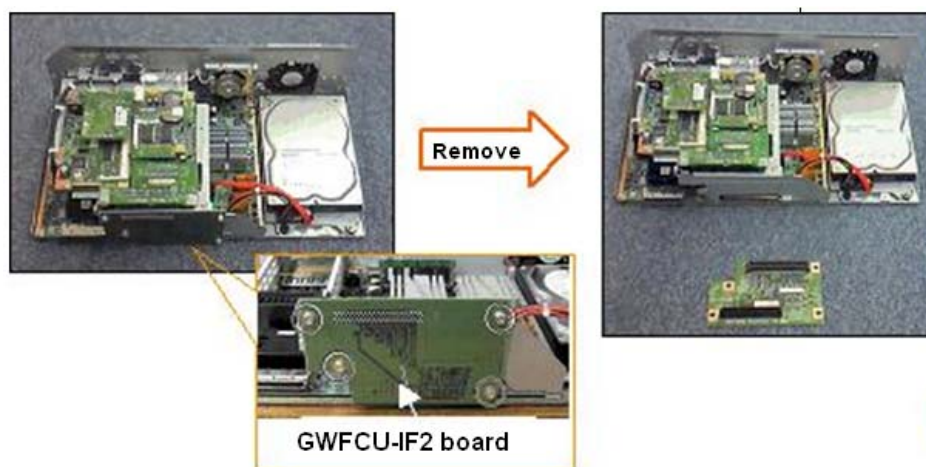
Note: In the flow chart, it is recommended to replace the **GWFCU-IF2 board** instead of the fax unit. This is an easier way to prevent the machine from detecting the fax unit. For the location of the GWFCU-IF2 board, see the photos below.

Follow the action in the attached flow chart.

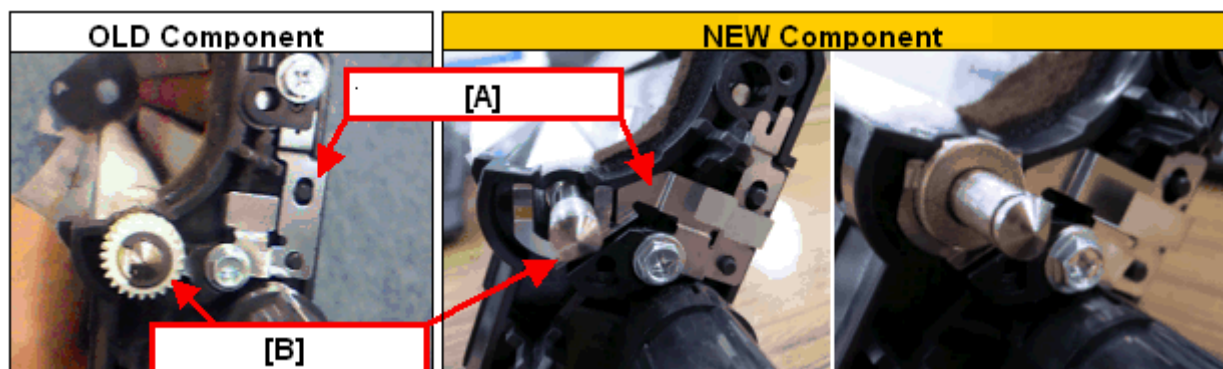
Sometimes, the GND plate at the rear side of the ITB cleaning unit [A] does not touch the lubrication application shaft [B]. As a result, a minor electrical leak occurs, which can trigger electrical noise. Sometimes, this effect appears as lines at 110mm intervals.

- The shape of the GND plate [A] was changed so that there is another contact point between the GND plate and the lubricant application shaft [B].

- If this symptom is reported, replace the ITB cleaning unit or GND plate with the following new parts:

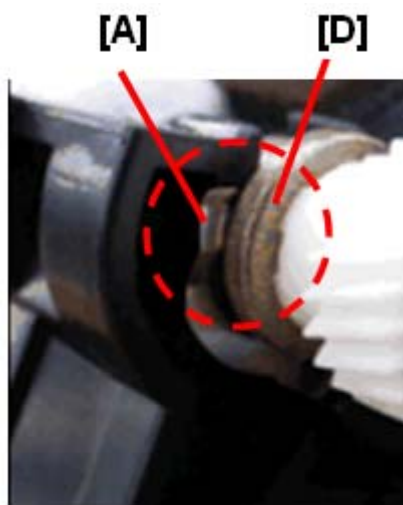
3. Make sure that the GND plate [A] and bushing [D] are touching each other.

- 1) This GND plate was registered as a service part for this symptom.
- 2) If you only replace the GND plate, use the procedure on the next page.

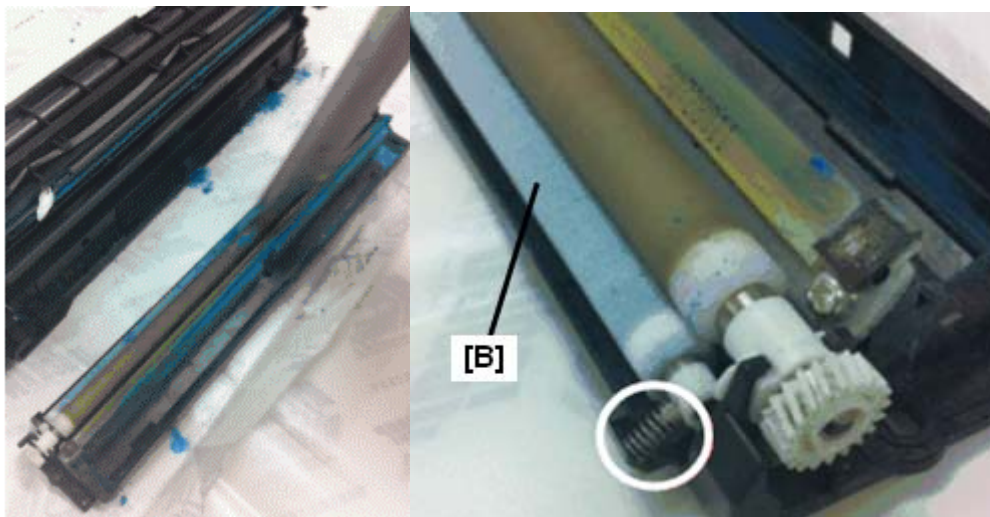
3. Remove the toner and lubricant that has built up around the **charge roller**.
Note: This can be done most easily using a vacuum cleaner.

- 1) As mentioned above, if you need to replace the drum unit but do not have one available, clean the charge roller now and replace the drum unit at a later date.
 - 2) Do the following cleaning procedure **very carefully**. This is because this type of charge roller was not designed to be cleaned individually.
1. Remove the drum unit from the machine.
 2. Remove the drum unit's lower frame [A] (screw x 2, clip x 2).

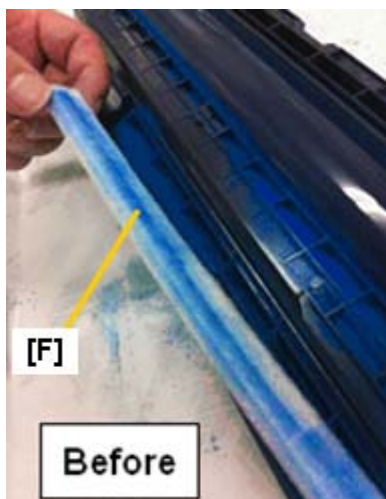
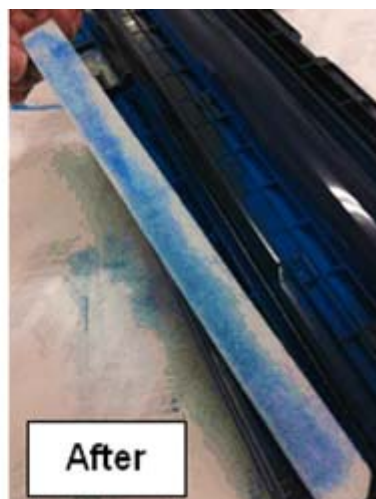
- It is not necessary to clean the filter completely. Clean it until it looks like the filter in the "After" photo below.
- DO NOT tilt the drum unit. If you do, a large amount of toner/developer will adhere to the surface. Under these conditions, the proper air compression cannot be maintained, which will cause toner blasting.

8. Remove the filter [F] and then clean the area around the filter.

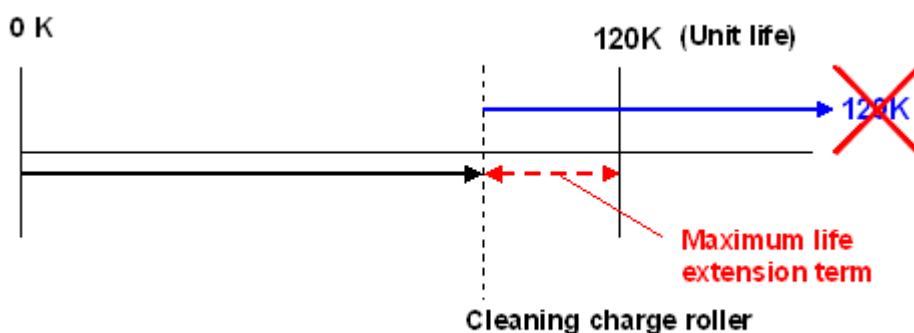
- If the unit is near its lifetime, there will be other parts inside the unit that have already experienced a certain amount of wear (cleaning blade, etc.). Therefore, after cleaning the charge roller surface, the dirtying will occur again sooner that it would with a completely new unit. (See the illustration below). The maximum amount that the unit life could be extended would be the equivalent of **120K** prints.

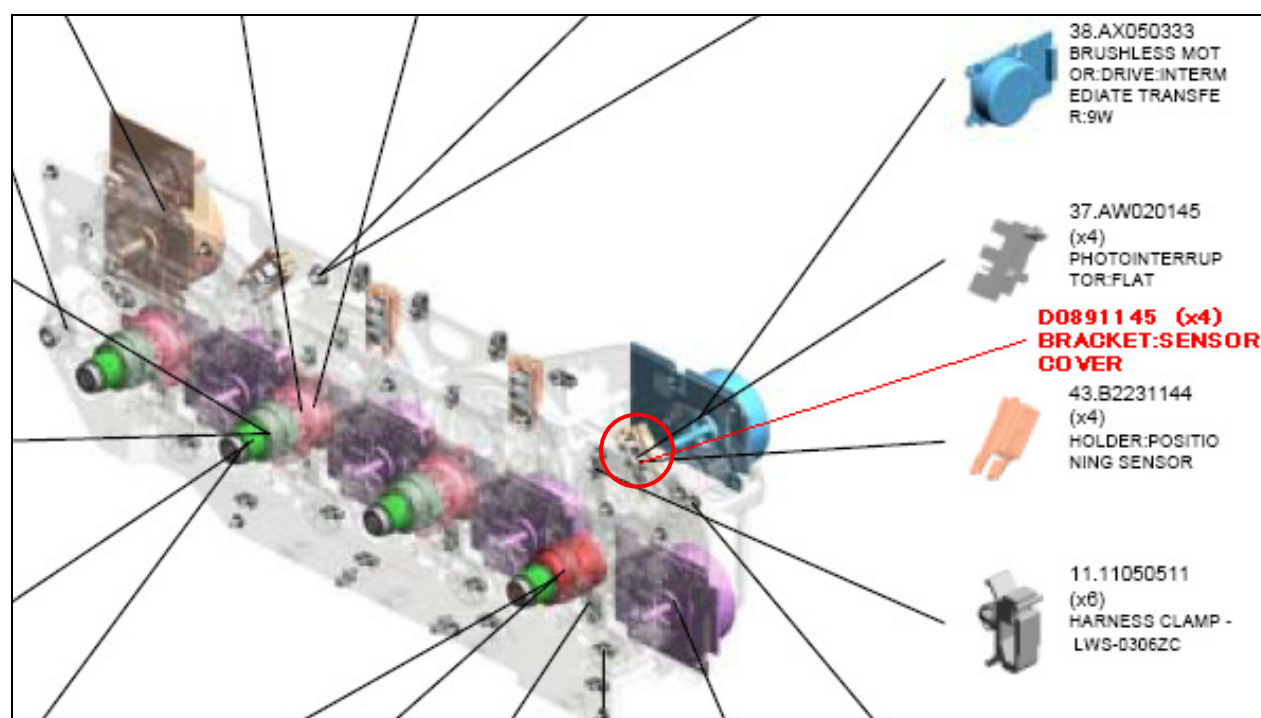
Change: *The phase control positioning sensor ass'y was added as a new part.*
 A sensor cover was added to the phase control positioning sensor.

Reason: To avoid electrostatic influence from drum gear.

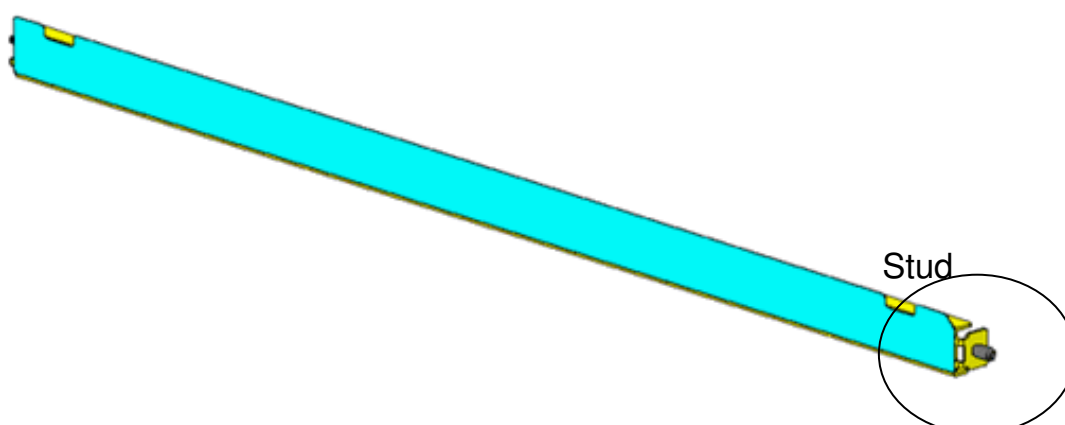
Fig. 1

1. The bracket with a screw hole at the front side of the stay was changed to a stud fixture.
2. The torque specification for the screw (still used at the rear side) was changed from $0.7 \pm 0.1 \text{ N/m}$ to $0.5 \pm 0.1 \text{ N/m}$.
3. This stay is now included in the service parts assembly shown in the table above (see Fig. 2)

Reason: To prevent paper jams by minimizing the range of motion (twisting) of the stay.
