Model: Apollon-C1	Date: 21-Jul-06	No.: RB222001b
-------------------	-----------------	----------------

Subject: Firmware Release History (Web Uapl)		Prepared by: T.Kiyohara	
From: 1st Tech. Support Sec. Service Support Dept.			
Classification:	<input type="checkbox"/> Troubleshooting	<input type="checkbox"/> Part information	<input type="checkbox"/> Action required
	<input type="checkbox"/> Mechanical	<input type="checkbox"/> Electrical	<input type="checkbox"/> Service manual revision
	<input type="checkbox"/> Paper path	<input type="checkbox"/> Transmit/receive	<input type="checkbox"/> Retrofit information
	<input checked="" type="checkbox"/> Other ( )

Model: Apollon-C1c/d		Date: 8-Mar-07	No.: RB222021
Subject: Rattling noise from paper separation area		Prepared by: K. Takagi	
From: 1st Tech. Support Sec. Service Support Dept.			
Classification:	<input checked="" type="checkbox"/> Troubleshooting <input type="checkbox"/> Mechanical <input type="checkbox"/> Paper path <input type="checkbox"/> Product Safety	<input type="checkbox"/> Part information <input type="checkbox"/> Electrical <input type="checkbox"/> Transmit/receive <input type="checkbox"/> Other (     )	<input type="ch

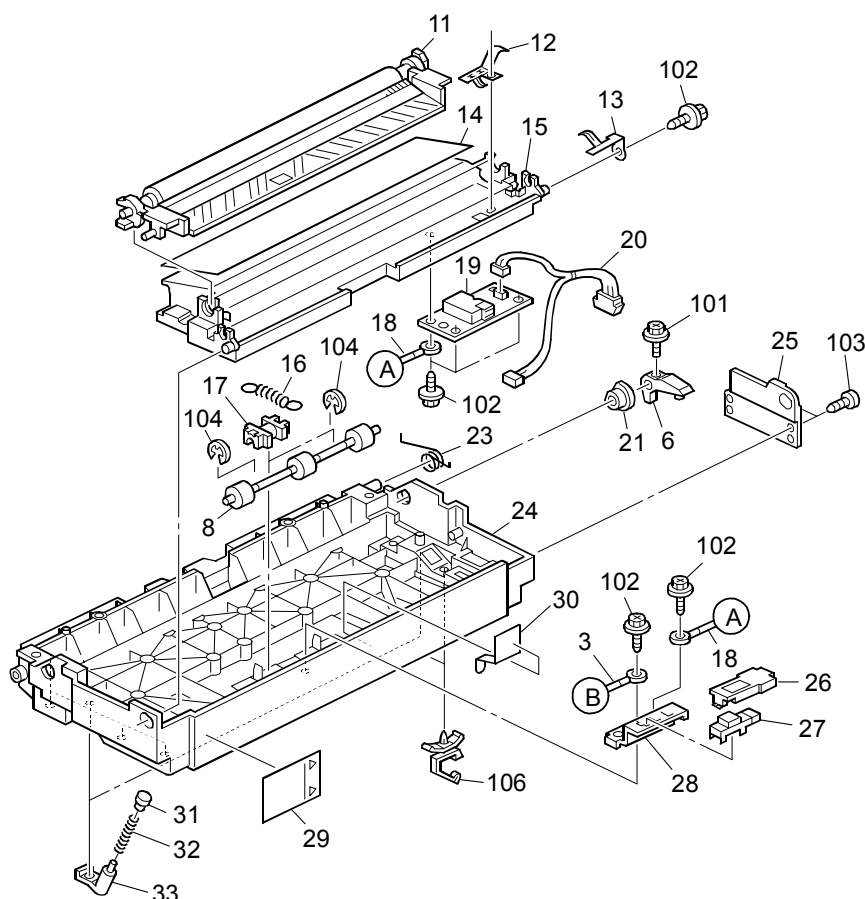
One of the hooks for the tension spring of the driven roller (index 8) breaks. As a result, the coil spring (index 16) comes loose and rattles inside the transfer unit holder.

Replace the two coil springs with two new plate springs (**P/N B2239004**).

**Important:** Attach both plate springs, even if only one came off the hook.

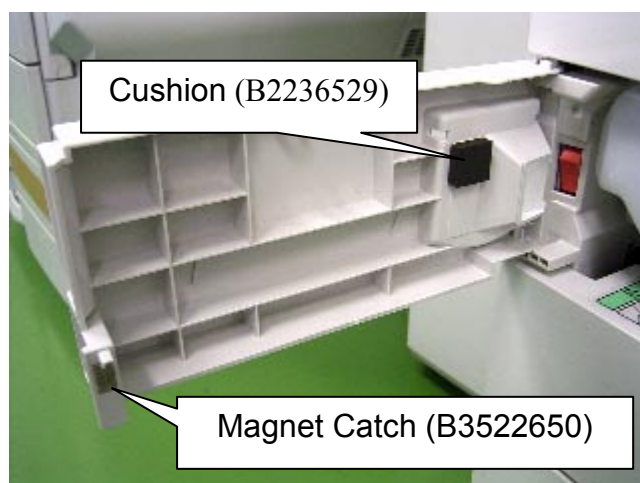
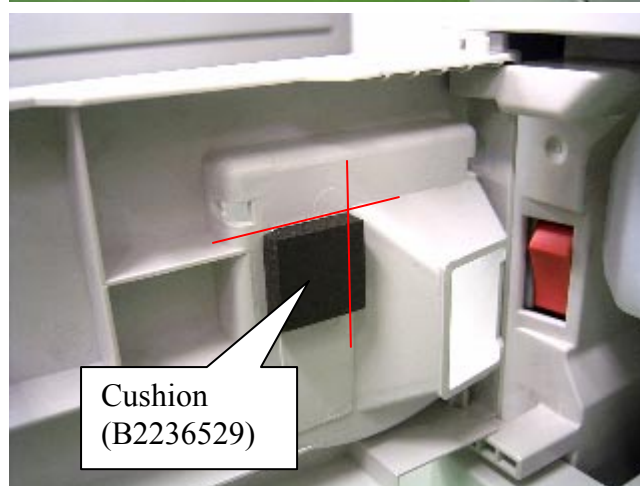
Low temperatures cause the toner bottle to contract (shrink) slightly. As a result, sometimes the toner bottle does not touch the "toner bottle set switch".

Attach a cushion to the front door and replace the magnet catch.

Cushion: **B2236529**

Magnet Catch: **B3522650**

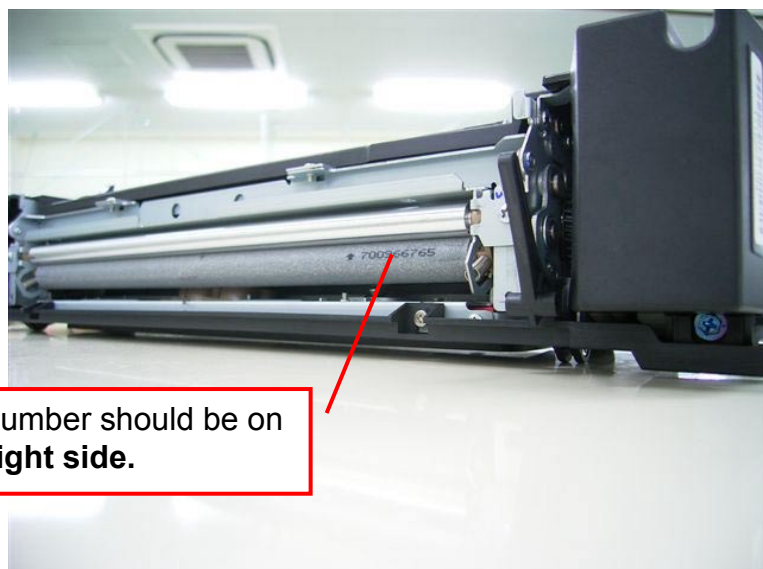
Heat from the pressure roller causes the surface of the lubricant roller to deform. As a result, the lubricant roller cannot rotate and vibrates in place.

If the symptom is reported on a lubricant roller with lot number "XXXXXXX**65**" (total 9 digits), replace the lubricant roller with the modified one.

**Important:** Attach the new lubricant roller so that the lot number is on the **right side**.

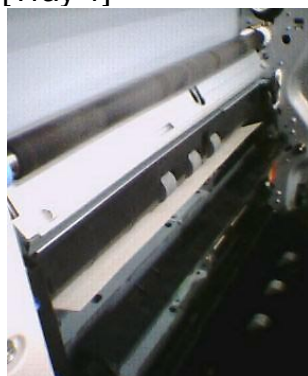
[Tray 1]

Vendor production error: The sensor's detection circuit was not soldered correctly to the inside of the sensor.

Replace the paper feed sensor (P/N AW010128) with one that is **not** from lots FF08 – FK26. (06.06.08-06.09.26)

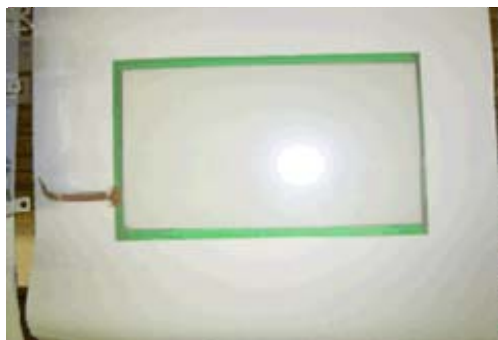
The adhesive that binds electrodes to the touch panel surface contains a polymer that tends to expand under normal office environmental conditions.

7. Attach the new touch panel (P/N **B2231484**) to the LCD.

**Important:** Only replace the touch panel. Do not replace the LCD.

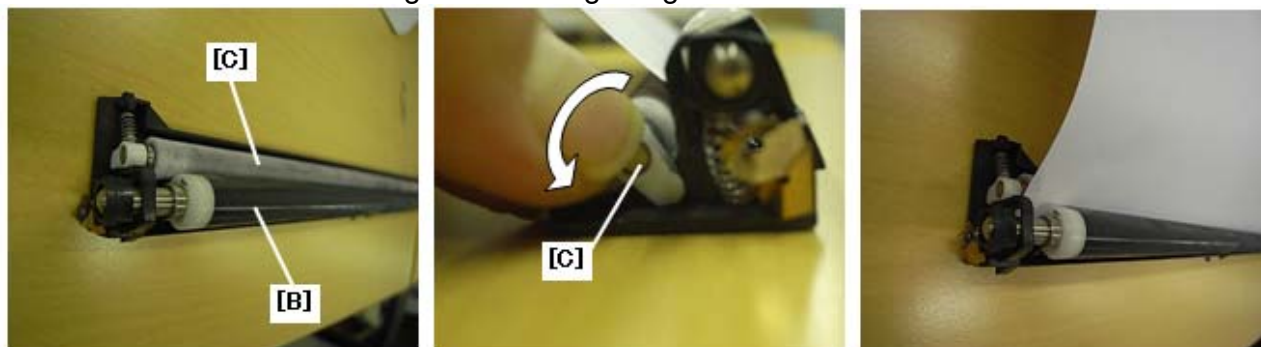
3. Tilt the Cleaning Roller [C] back, create a gap between the Cleaning Roller and the Charge Roller [B], and then insert a sheet of paper between the two rollers to prevent the surface of the cleaning roller from getting wet.

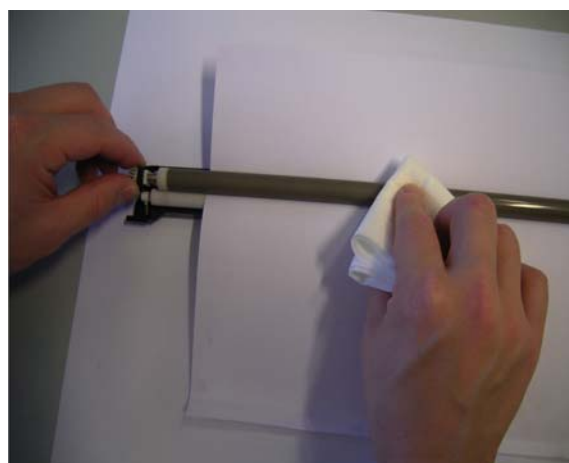
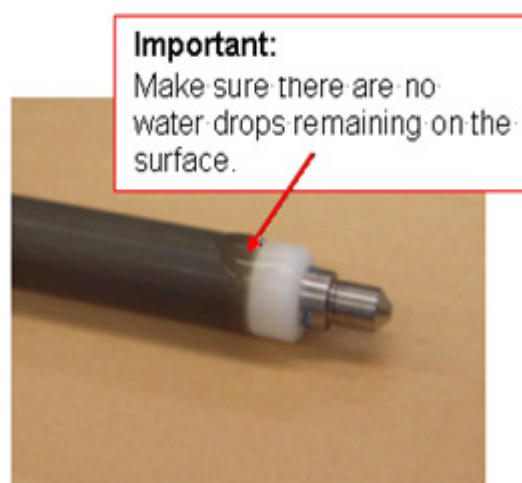
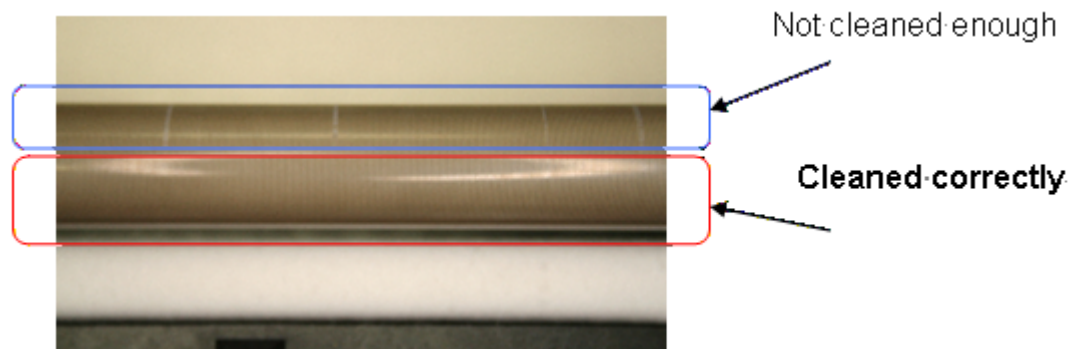
4. Clean the surface of the charge roller by rotating the roller while wiping it with a water-damp cloth.

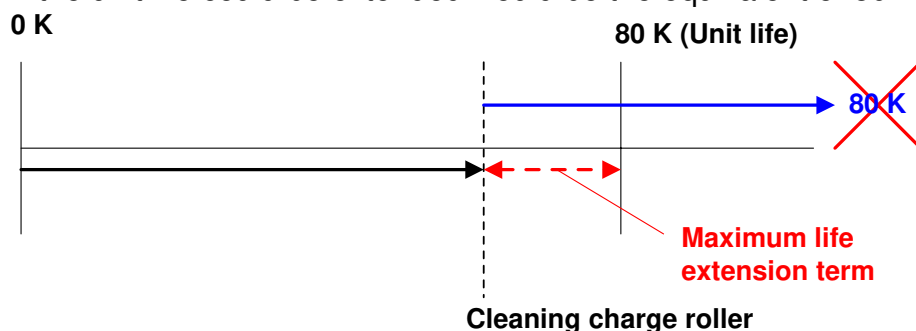
- If the unit is near its lifetime, there will be other parts inside the unit that have already experienced a certain amount of wear (cleaning blade, etc.). Therefore, after cleaning the charge roller surface, the dirtying will occur again sooner than it would with a completely new unit. (See the illustration below). The maximum amount that the unit life could be extended would be the equivalent of 80K prints.

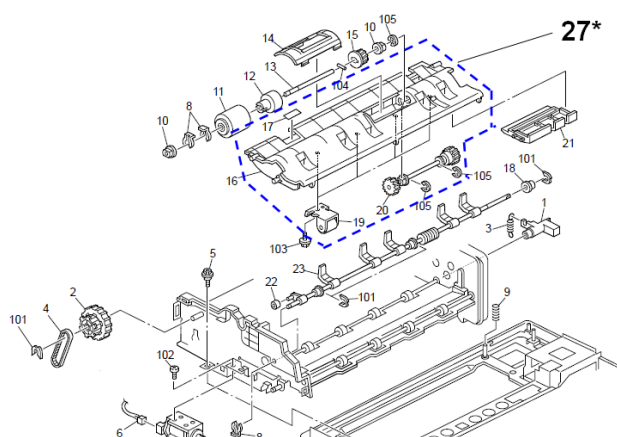
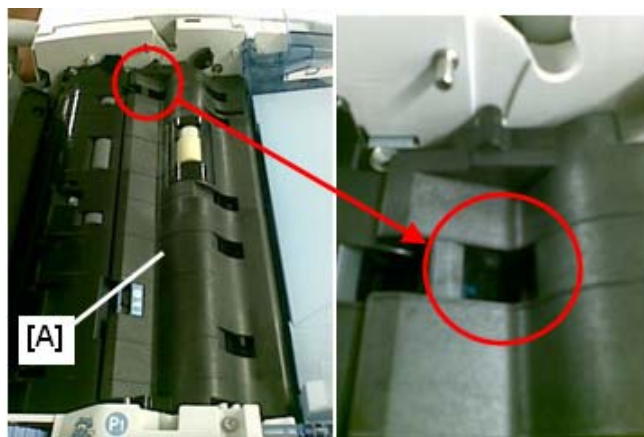
## 4.Original Feed 3 (B802)

[A]: Original exit cover

Replace the original exit cover and reverse cover with the following new parts.

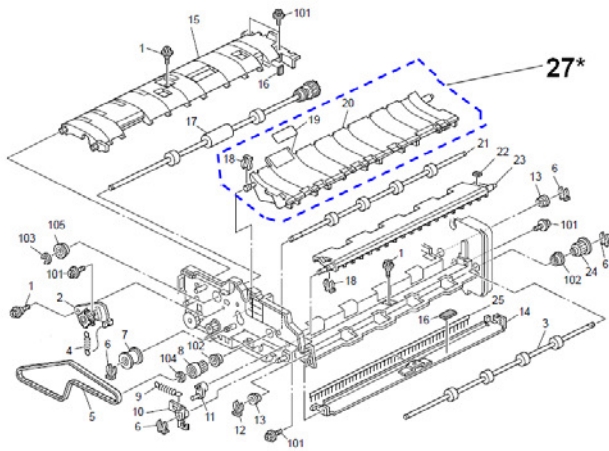
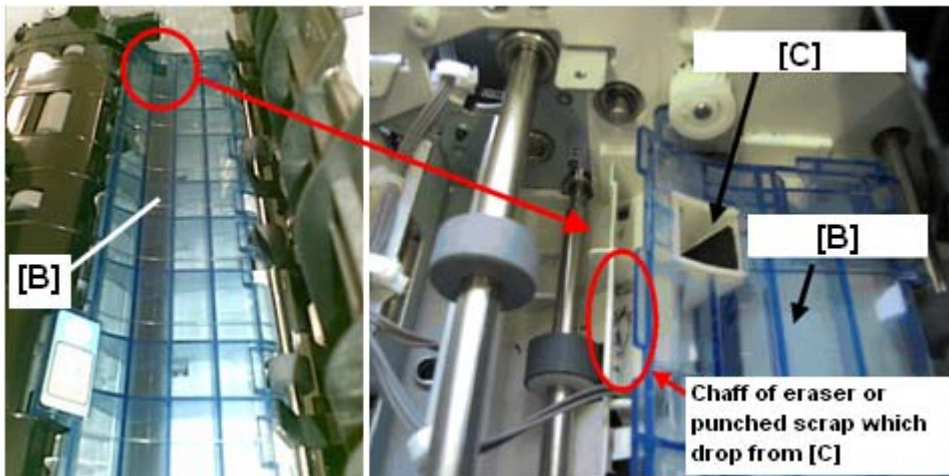
### 7.Original Transfer 3 (B802)

**[B]:** Reverse cover

**[C]:** Collection area/hole

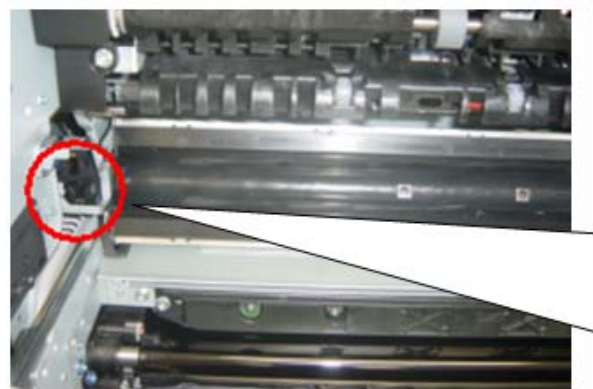
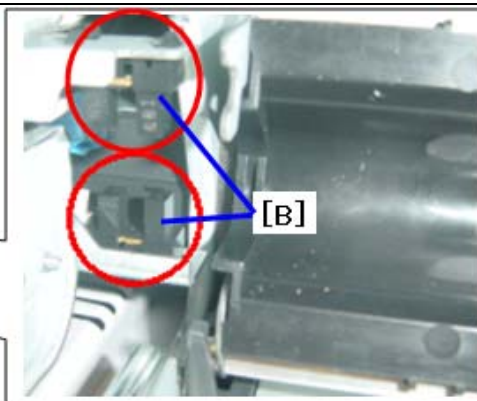
- 1) Engine firmware bug: A rotation detection error occurs while the fusing unit is rotating.
- 2) The fusing unit is tilted slightly when it is attached. This causes the encoders [A] to contact the sensors in the machine [B].

**Note:** The shapes of the above parts were changed to improve the reliability of contact between the encoder and sensor.

Replace the fusing unit encoder [A] and two sensors [B] on the machine side.

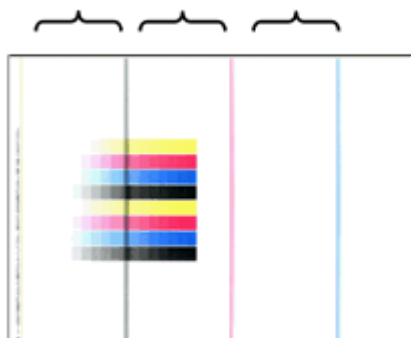
**110mm interval vertical line**  
(Drum unit interval)

Vertical black or colored lines appear at intervals of 110mm (the pitch of the drum unit).

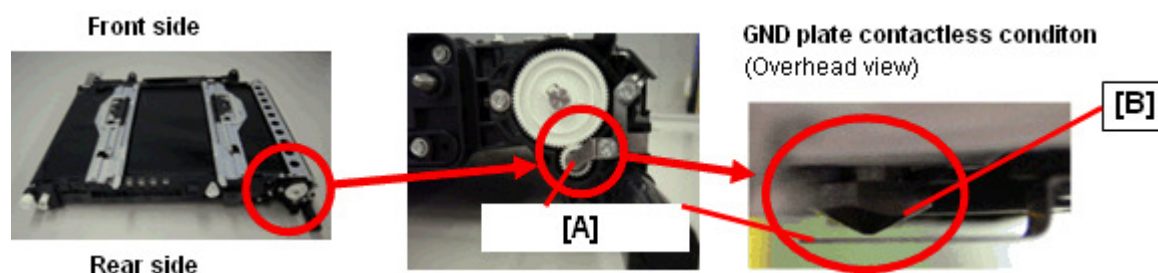
Sometimes, the GND plate at the rear side of the ITB cleaning unit [A] does not touch the lubrication application shaft [B]. As a result, a minor electrical leak occurs, which can trigger electrical noise. Sometimes, this effect appears as lines at 110mm intervals.

- If this symptom is reported, replace ~~the ITB cleaning unit or~~ **GND plate on the ITB cleaning unit** with the following new **part**:

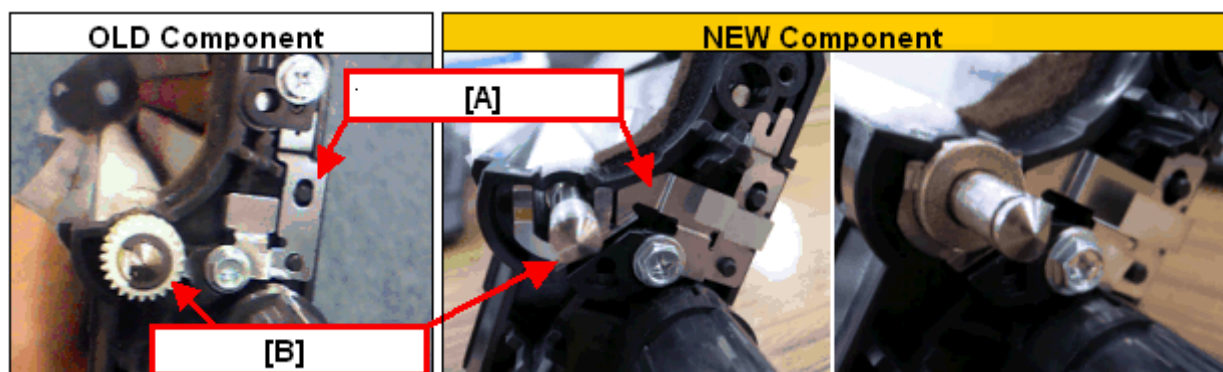
- The shape of the GND plate [A] was changed so that there is another contact point between the GND plate and the lubricant application shaft [B].

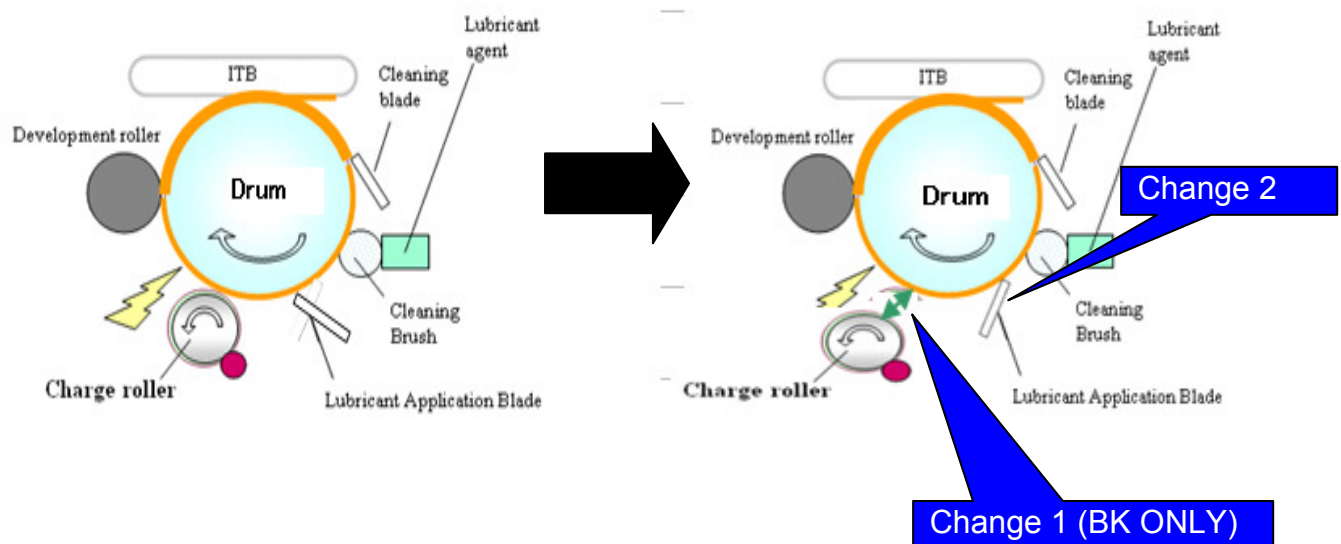
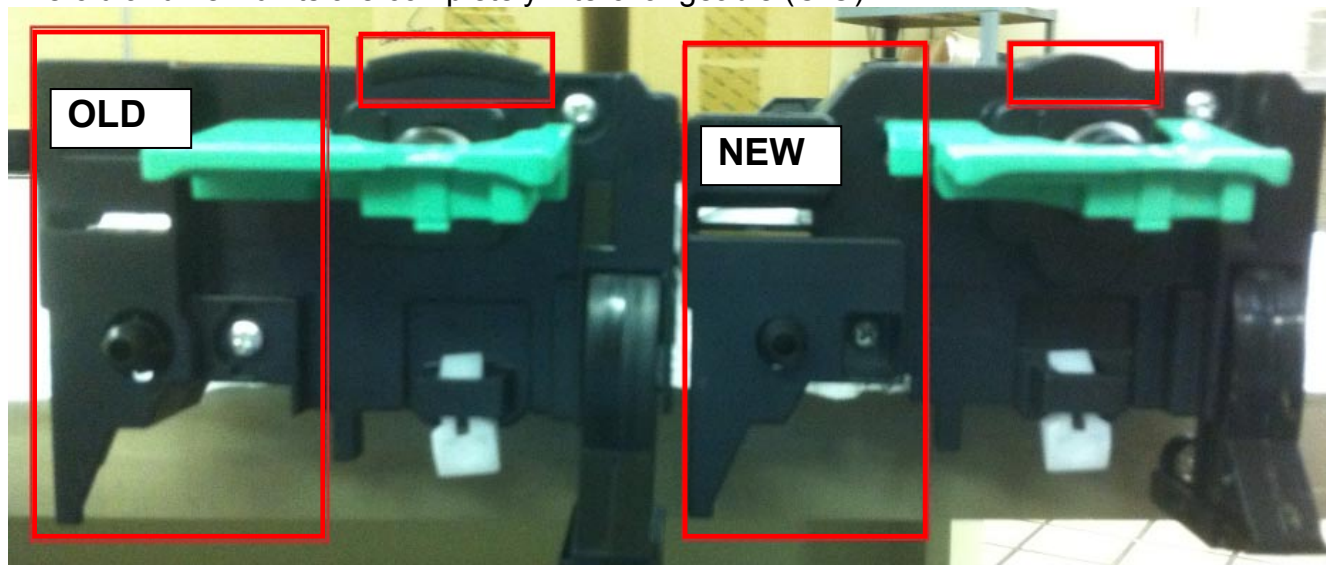
1. To further minimize the amount of toner particles that can stick to the charge roller surface (which makes it harder for dirty background and black lines to occur).
2. To increase the amount of toner that can be caught by the blade, improving cleaning performance.

Areas of the PCU that have changed in shape:

Old part number	New part number	Description	Q'ty	Int	Page	Index
B2232042	B2242042	DRUM UNIT BK	1	O/O	157	4
B2232027	B2242027	DRUM UNIT CL	1	O/O	157	4

The old and new units are completely interchangeable (O/O).
