Model: AP-C2.5	Date: 22-Oct-10	No.: RD089002h
----------------	-----------------	----------------

Subject: Firmware Release Note: Engine		Prepared by: Y. Taniguchi	
From: 1st Tech Service Sect., MFP/Printer Tech Service Dept			
Classification:	<input type="checkbox"/> Troubleshooting	<input type="checkbox"/> Part information	<input type="checkbox"/> Action required
	<input type="checkbox"/> Mechanical	<input type="checkbox"/> Electrical	<input type="checkbox"/> Service manual revision
	<input type="checkbox"/> Paper path	<input type="checkbox"/> Transmit/receive	<input type="checkbox"/> Retrofit information
	<input type="checkbox"/> Product Safety	<input checked="" type="checkbox"/> Other (Firmware)	<input checked="" type="checkbox"/> Tier 2

This RTB has been issued to announce the firmware release information for the **Engine**.

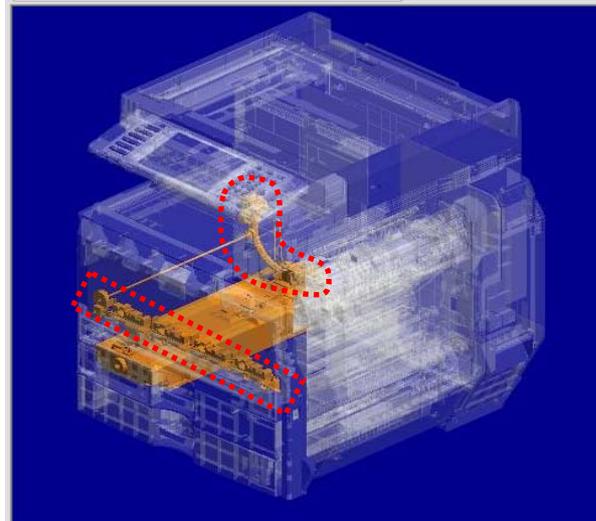
Mechanical noise is heard at the front (D0896481) and rear (D0896540) of the machine.

Note: If the noise goes unnoticed, the waste toner can overflow into the development unit or transfer belt-cleaning unit. In such cases, the machine may stop and display SC errors related to driven units.

Engine firmware bug

The machine cannot detect the Near Full or Full conditions for the waste toner bottle once it enters Energy Saver Mode (To detect the conditions again, the power must be turned OFF/ON). As a result, once the bottle is full, excessive load is placed on the waste toner transport coil, breaking the coil and producing the mechanical noise.

1. Check the waste toner bottle (D0896509), and if it is full or nearly full, replace it.
2. Upgrade the Engine firmware to **v1.07** or later.

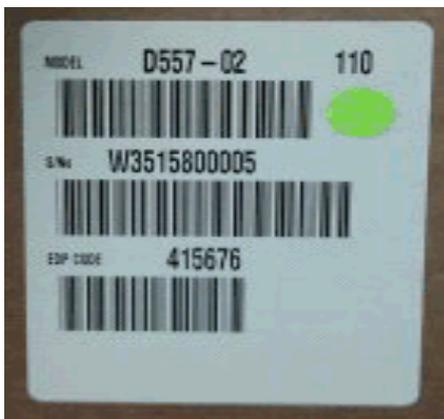
A modified patch (1-1C5GYZ) has been applied to machines in production from November 1, 2011. These units have a green dot on the bar code label, as shown below.

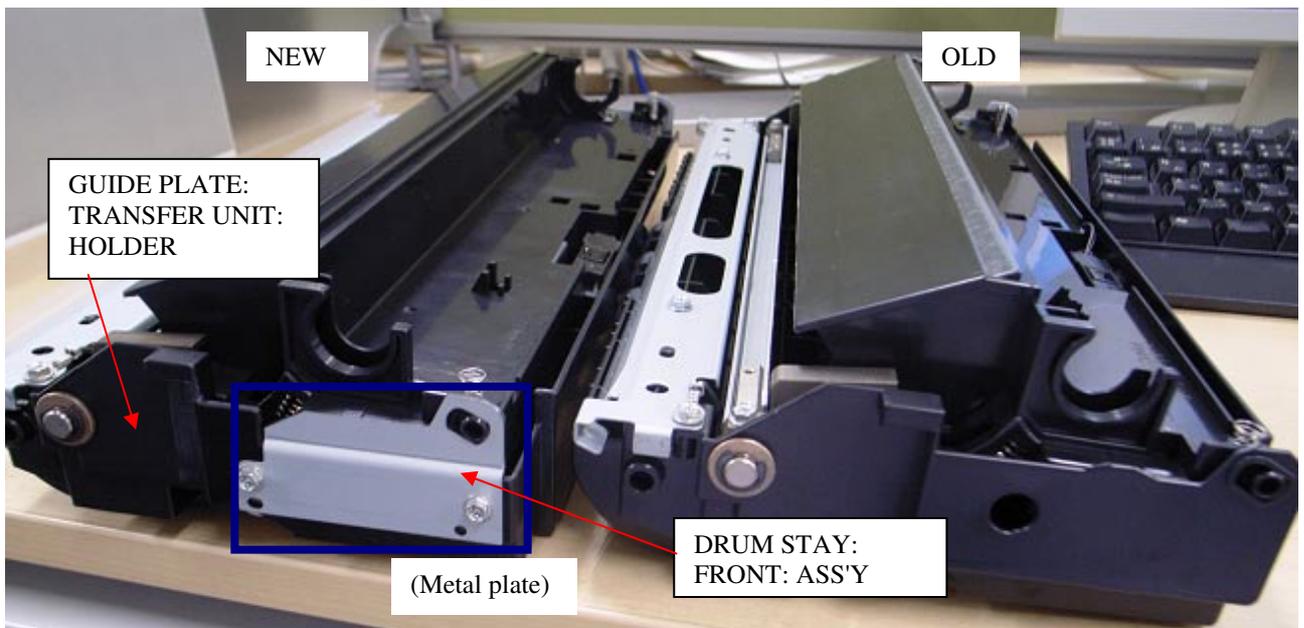
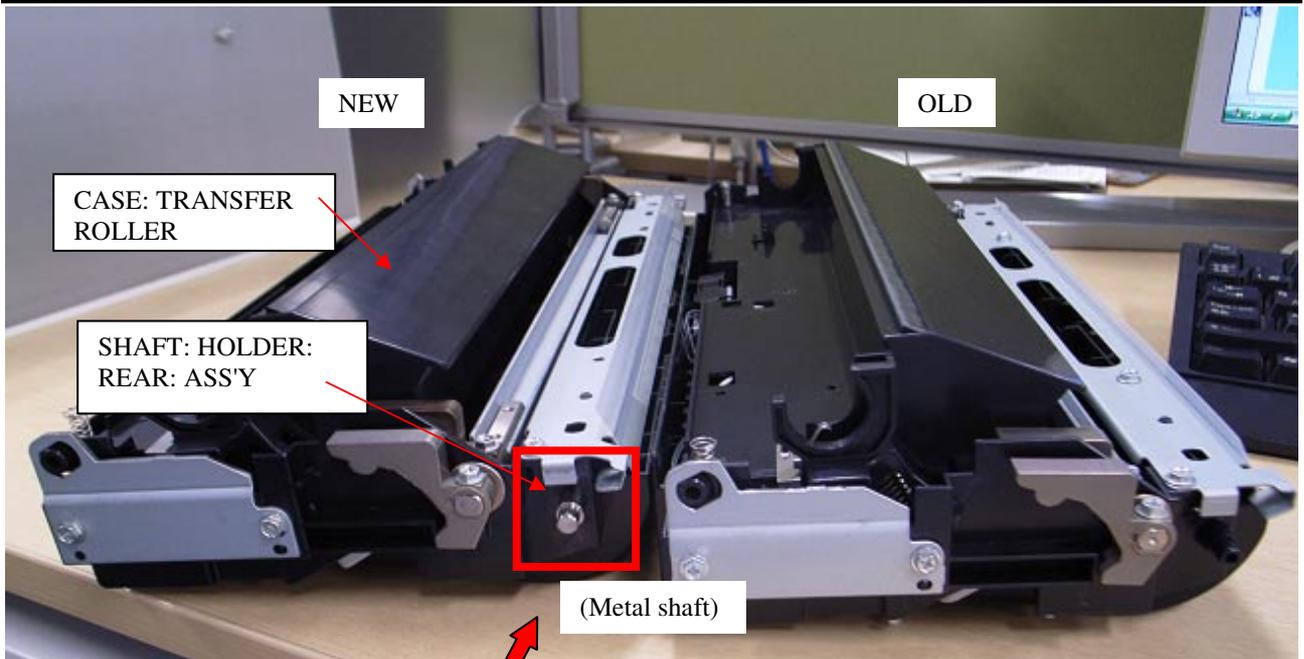
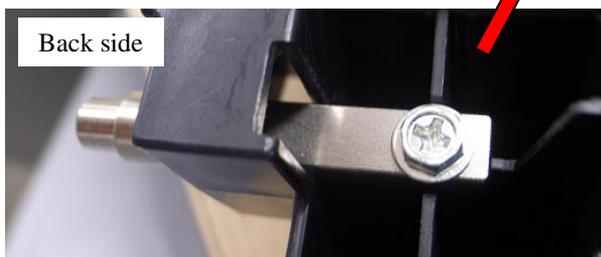
Reason: To further increase the load-bearing strength of the parts.

Important: Interchangeability is **X/O as a set** (all six parts together).
