Model: AP-C3	Date: 15-Feb-12	No.: RD144001
--------------	-----------------	---------------

Subject: Firmware Release Note: ADF_MANASLU_B		Prepared by: H. Tamaki	
From: 1st Tech Service Sect., MFP/Printer Tech Service Dept.			
Classification:	<input type="checkbox"/> Troubleshooting	<input type="checkbox"/> Part information	<input type="checkbox"/> Action required
	<input type="checkbox"/> Mechanical	<input type="checkbox"/> Electrical	<input type="checkbox"/> Service manual revision
	<input type="checkbox"/> Paper path	<input type="checkbox"/> Transmit/receive	<input type="checkbox"/> Retrofit information
	<input type="checkbox"/> Product Safety	<input checked="" type="checkbox"/> Other (Firmware)	<input checked="" type="checkbox"/> Tier 2

Model: AP-C3d		Date: 20-Apr-12	No.: RD144037
Subject: Granule of black toner on 1 st printed paper		Prepared by: S. Hayami	
From: 1st Tech Service Sect., MFP/P Tech Service Dept.			
Classification:	<input checked="" type="checkbox"/> Troubleshooting	<input type="checkbox"/> Part information	<input checked="" type="checkbox"/> Action required
	<input type="checkbox"/> Mechanical	<input type="checkbox"/> Electrical	<input type="checkbox"/> Servi

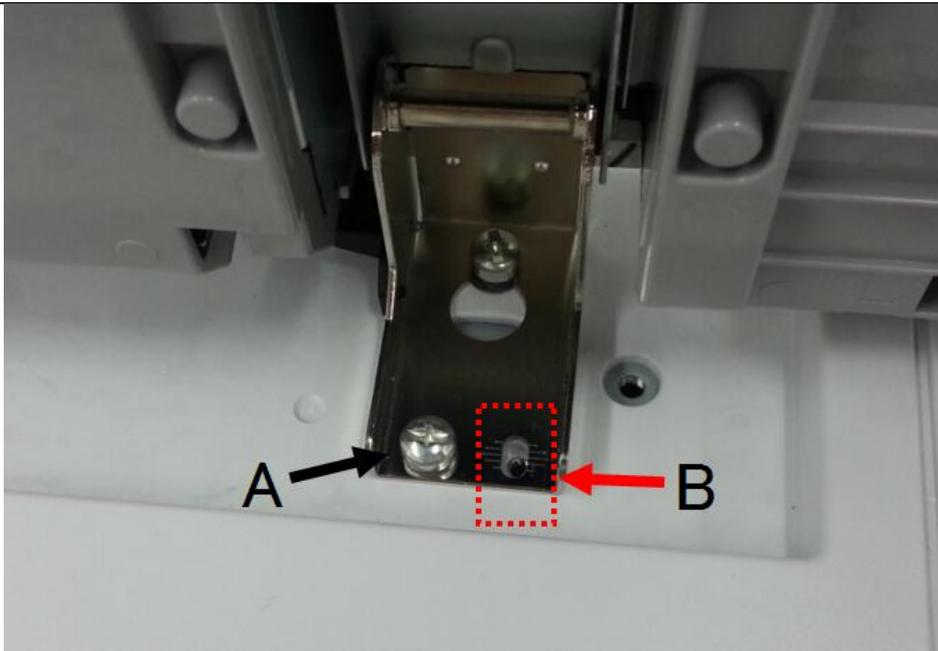
Do the following if the skew occurs with two-sided originals or with originals smaller than A4.

- Adjust the value of SP6006-013 to change the position of the original feed roller.

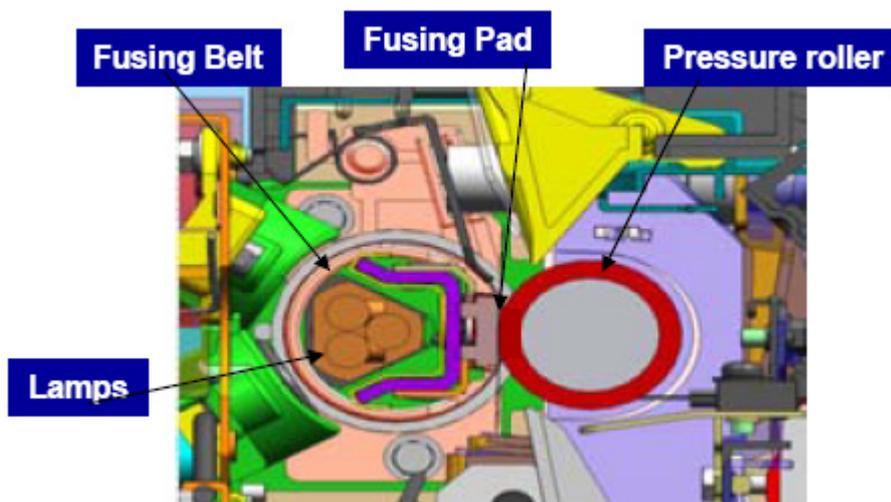
When the fusing belt is rotated after the paper is fed out, the inner layer of the belt rubs up against the fusing pad. As a result, the fusing pad vibrates and generates noise.

Note: The belt is rotated in this way in order to spread heat across the belt evenly, preventing it from getting too hot.

2. *Replace the fusing unit or fusing belt unit with the following.*

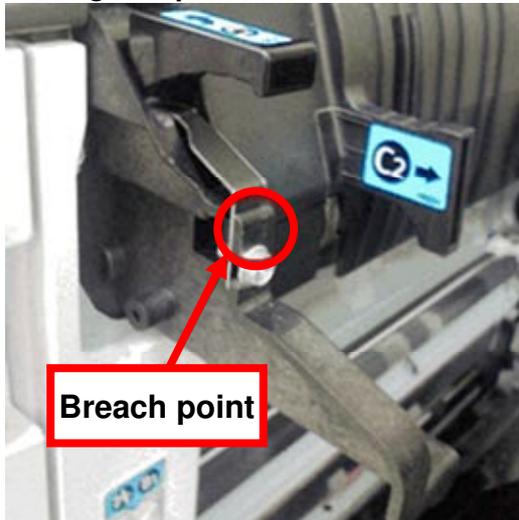
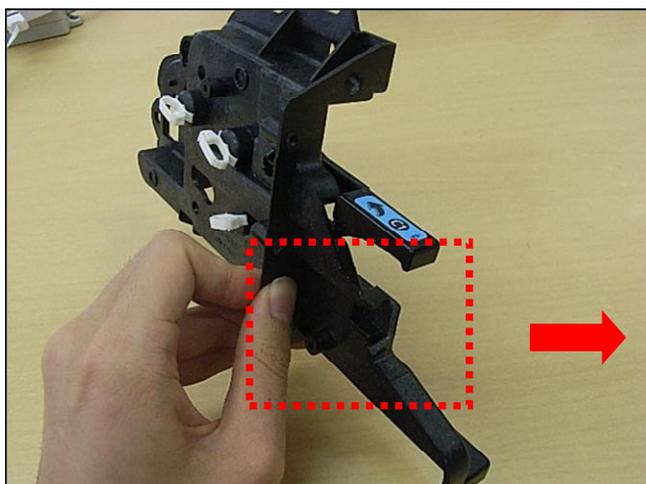
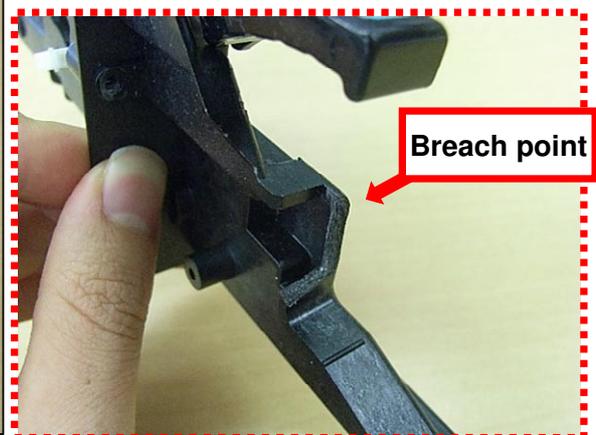
Front guide plate:

The front stopper and/or front guide plate of the fusing unit are damaged when the customer pulls the fusing unit out.

The user pulls out the unit with force, breaking the stopper that supports the unit, and in some cases, the front guide plate as well.

Also if the guide plate is damaged, replace the guide plate and the duct seal attached to the guide plate. Then, remove the lever lock [A] and all clamps from the old guide plate and use them to attach the new one.

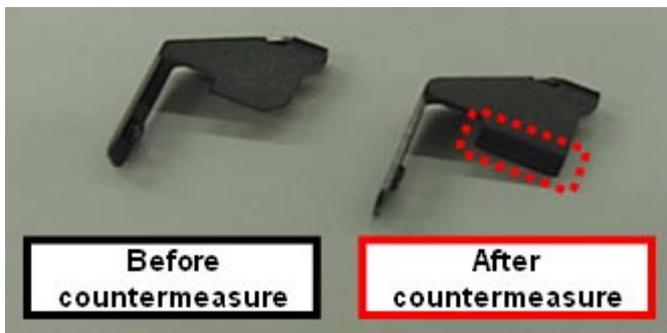
In order to distribute the stress more widely, the shape of the stopper was changed as follows, from September 2012 mass production.

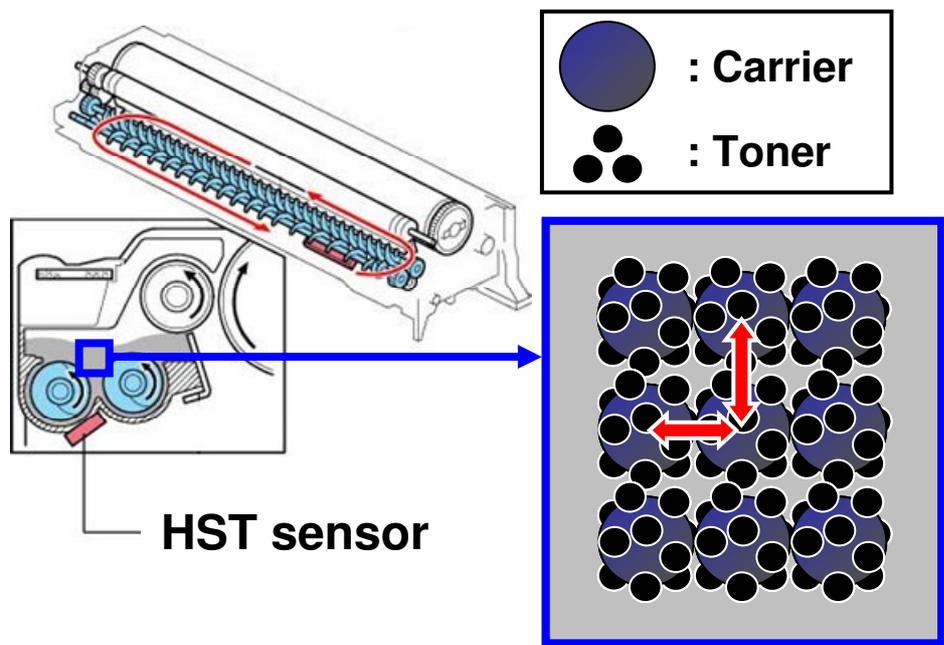
The machine mistakenly judges that the toner concentration is too high, and compensates by lowering it.

Under the conditions mentioned above (low temp., low humidity, carrier is relatively fresh), the carrier tends to take on a higher electrical charge than the target. As a result, the carrier particles are farther apart from one another, causing the machine to judge the toner concentration to be higher than it actually is.

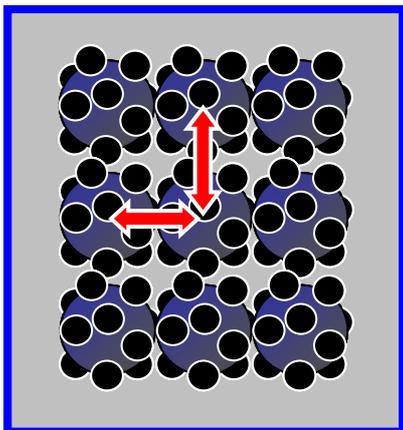
Distance between carrier particles (“x”) is **normal** for actual amount of toner (“y”):

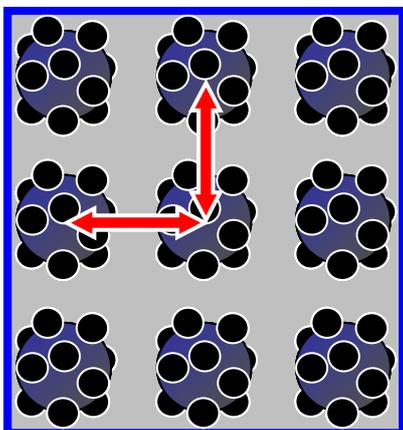
Distance between carrier particles is **too large** (>“x”) for that same amount of toner (“y”):

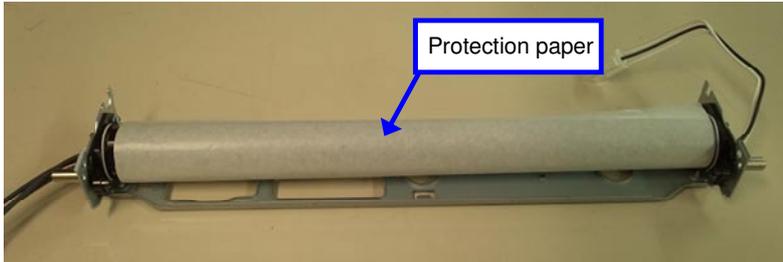
Note: This is necessary because it is possible to press the belt by mistake or press the belt's surface, forming a dent in the belt. This is a major cause of SC544/SC554.

1) Do the following when you remove the protective paper from the fusing belt.

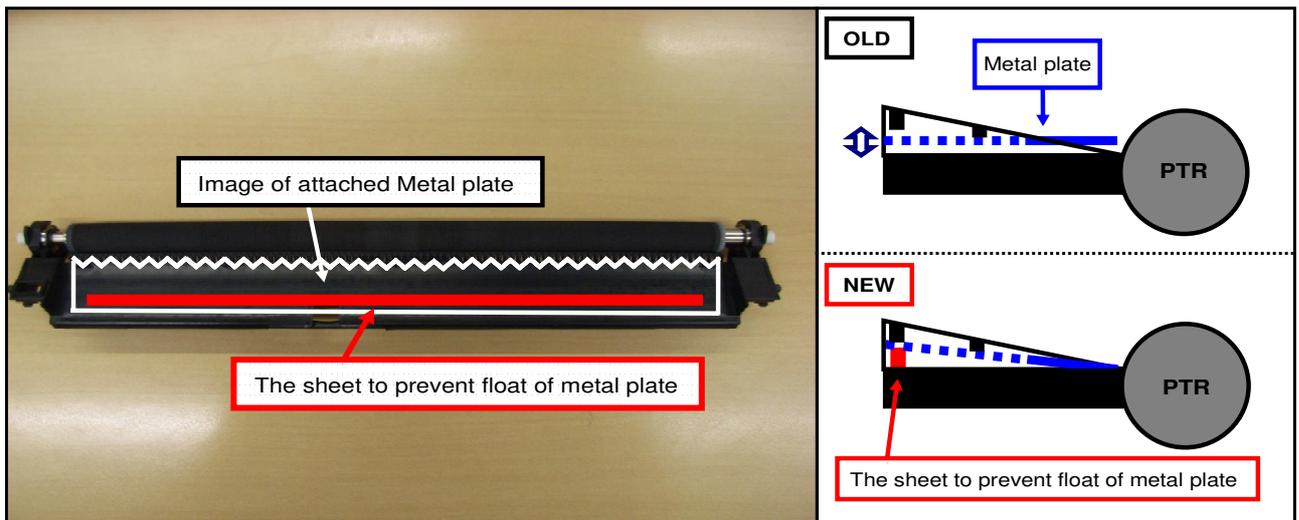
Components:

- Noise
- Paper damage
- Paper skew
- Paper wrinkles

If the symptom occurs, replace the PTR unit with the new one, which has the new sheet.

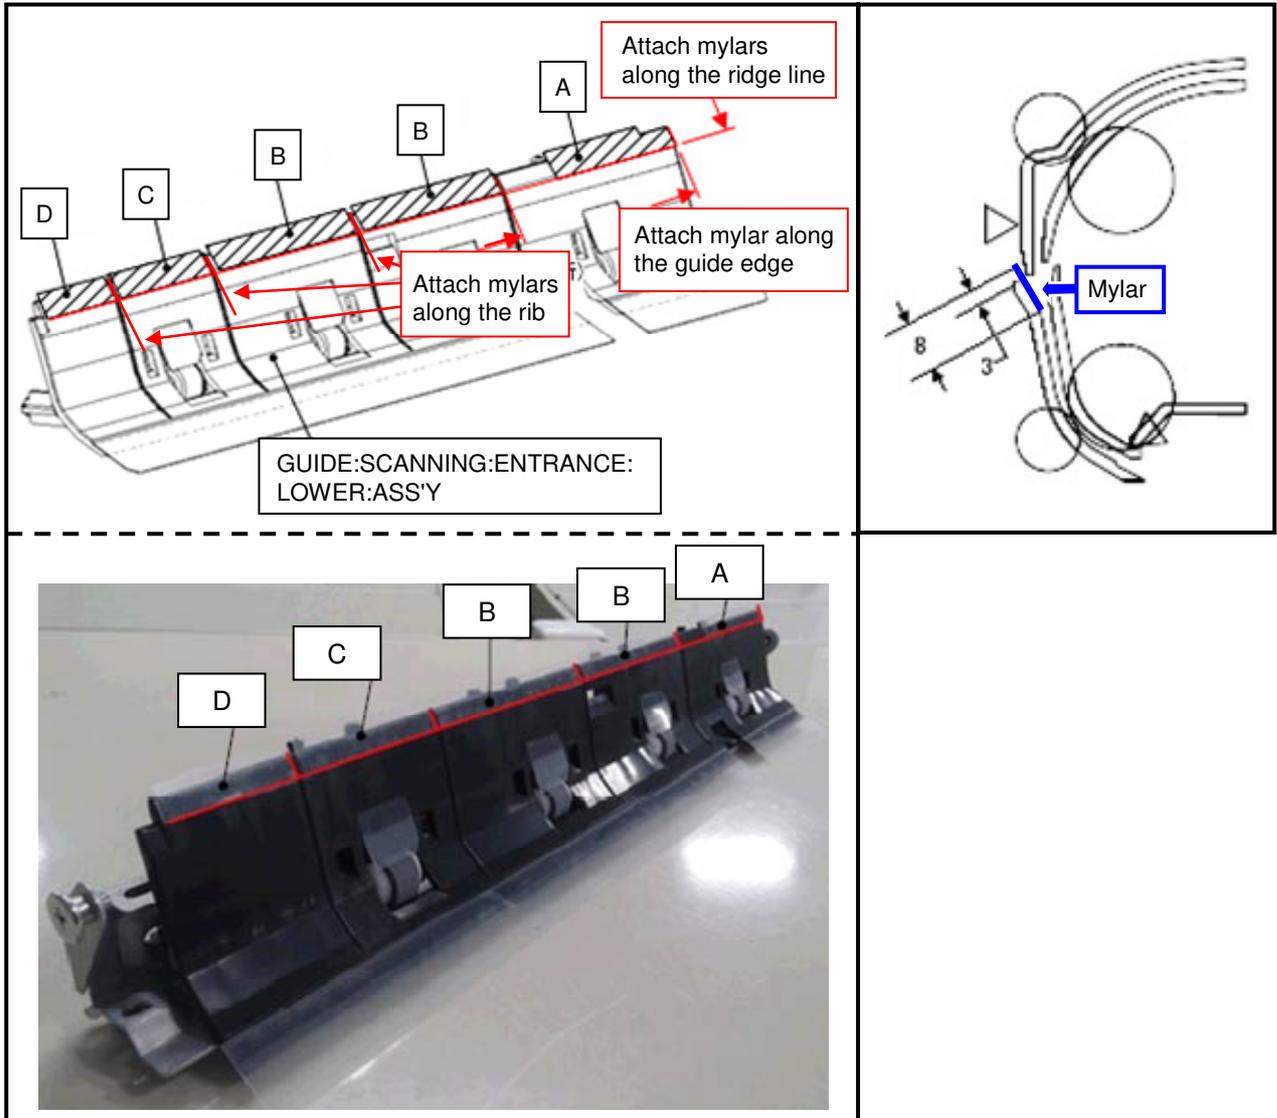
The lower paper feed guide is slightly warped, which can damage the original if the original is curled.

Or, the original may get caught in the relatively large gap between the “ROLLER:SCANNING:BEHIND:ASS'Y” and “GUIDE PLATE:CONTACT IMAGE if it is damaged or curled.

1. Attach the five Mylars to the "GUIDE:SCANNING:ENTRANCE:LOWER:ASS'Y" as follows.

A=60.0 +/- 0.3mm, B=67.5 +/- 0.3mm, C=**44.5 +/- 0.3mm**, D=**33.0 +/- 0.3mm**

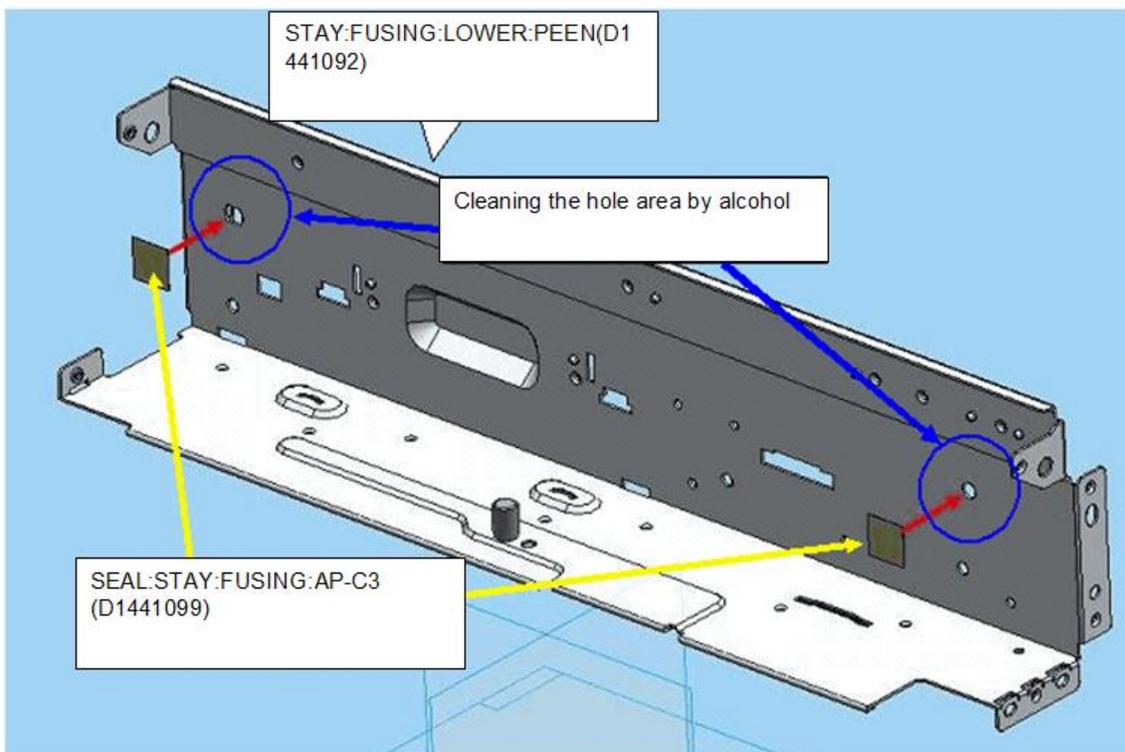
Location of new seal (D1441099)

Reason: To further ensure toner scattering inside the machine does not occur.

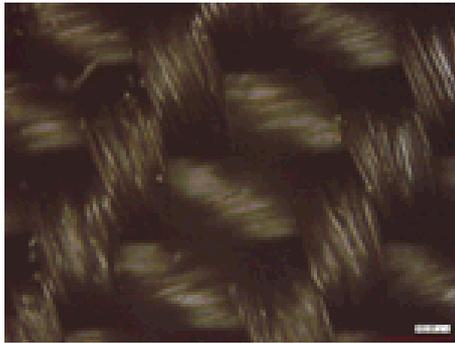
Current pad:

Damaged fusing sleeve (see CAUSE below):

The fusing pad does not apply enough oil to the inside of the fusing belt. As a result, the torque between the pad and belt increases, causing the belt to slip and damage the fusing sleeve.

The net for the fusing pad was changed so that it retains more oil and can apply the right amount of oil to the pad. This will increase the durability of the fusing sleeve.

If the symptom occurs, replace the fusing pad with the modified pad (see P/N below).

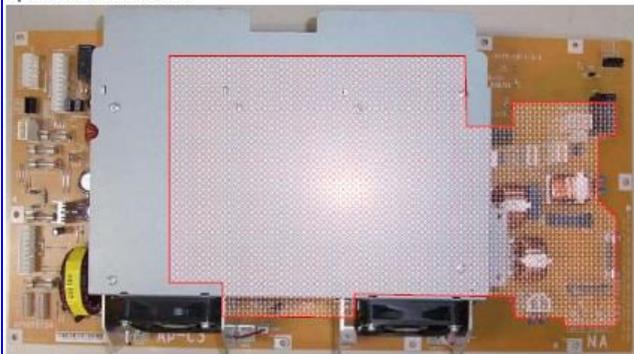
Apollon-C3: DOM/NA

NEVER touch the areas outlined in red in the photos below to prevent electric shock caused by residual charge.

Residual charge of about 100V-400V remains on the PSU board for several months even when the board has been removed from the machine after turning off the machine power and unplugging the power cord.

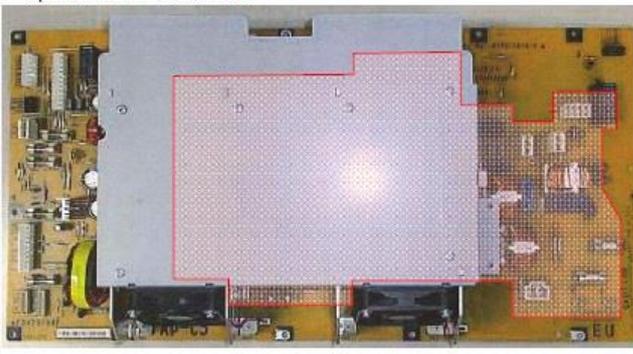
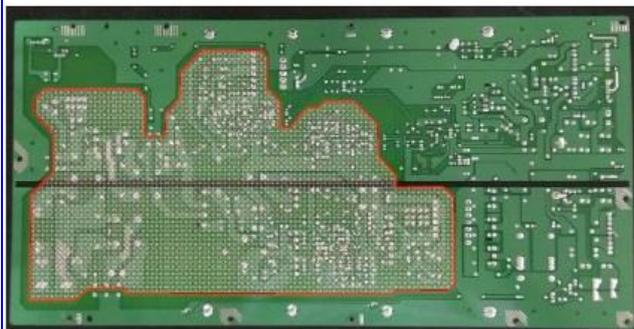
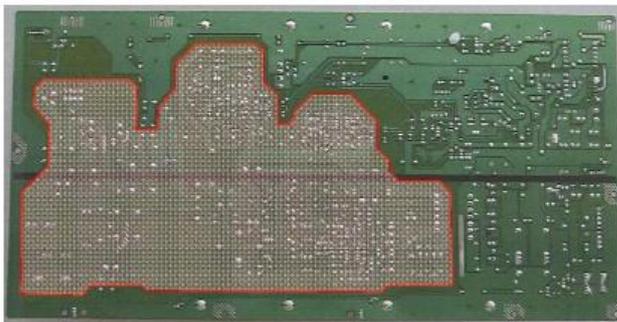
Apollon-C3: EU/AA/CHN

The areas outlined in red on the bracket mean the residual charge of about 100V-400V remains on the PSU board under the bracket.
