Model: MET-C1cde	Date: 18-Jun-13	No.: RD149007
------------------	-----------------	---------------

Subject: Firmware Release Note: Java VM v11 UpdateTool (METC1EXe)		Prepared by: N. Yoshida	
From: 1st Tech Service Sect., MFP/Printer Tech Service Dept.			
Classification:	<input type="checkbox"/> Troubleshooting	<input type="checkbox"/> Part information	<input type="checkbox"/> Action required
	<input type="checkbox"/> Mechanical	<input type="checkbox"/> Electrical	<input type="checkbox"/> Service manual revision
	<input type="checkbox"/> Paper path	<input type="checkbox"/> Transmit/receive	<input type="checkbox"/> Retrofit information
	<input type="checkbox"/> Product Safety	<input checked="" type="checkbox"/> Other (Firmware)	<input checked="" type="checkbox"/> Tier 2

This RTB has been issued to announce the firmware release information for the **Java VM v11 Update Tool (METC1EXe)**.

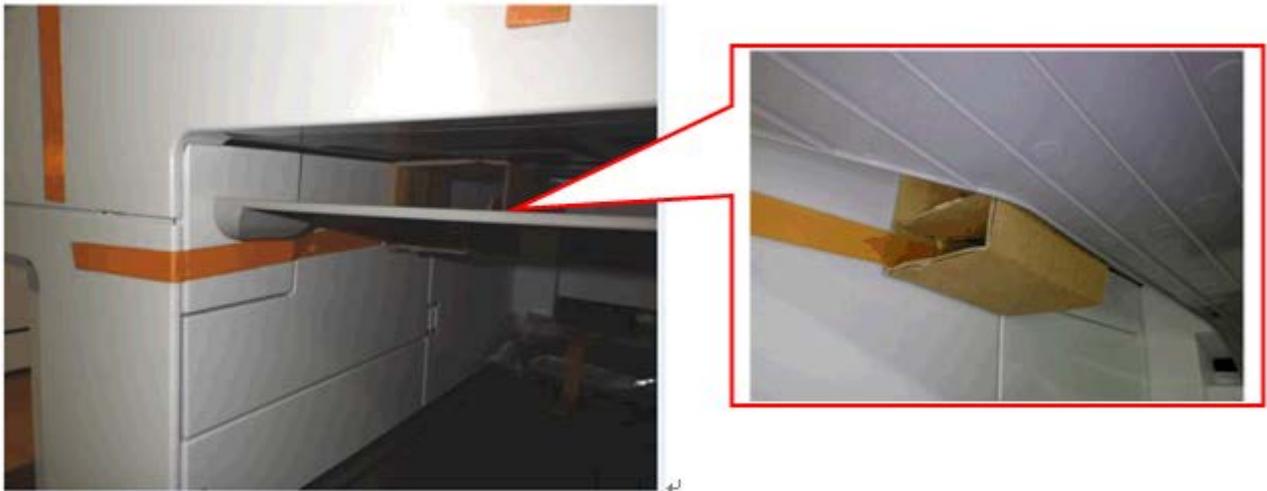
Make sure to **remove the cardboard stabilizer shown below**. If you do not, JAM 27 or JAM 64 may occur when printing out onto B4, DLT, or SRA3 sized paper in duplex mode.

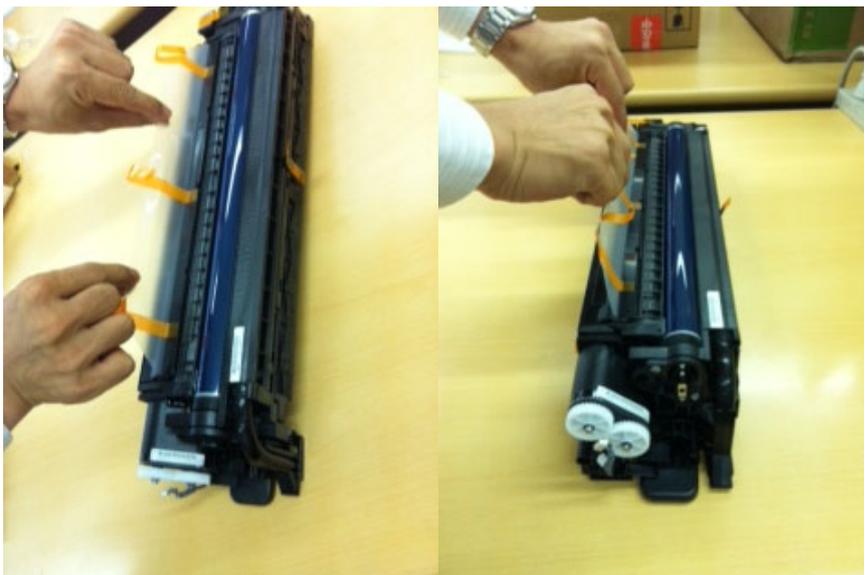
INCORRECT:

- 1) Make sure to remove the tape (Do Step 3) before you do this step. **DO NOT** pull the preset seal with the tape still attached.

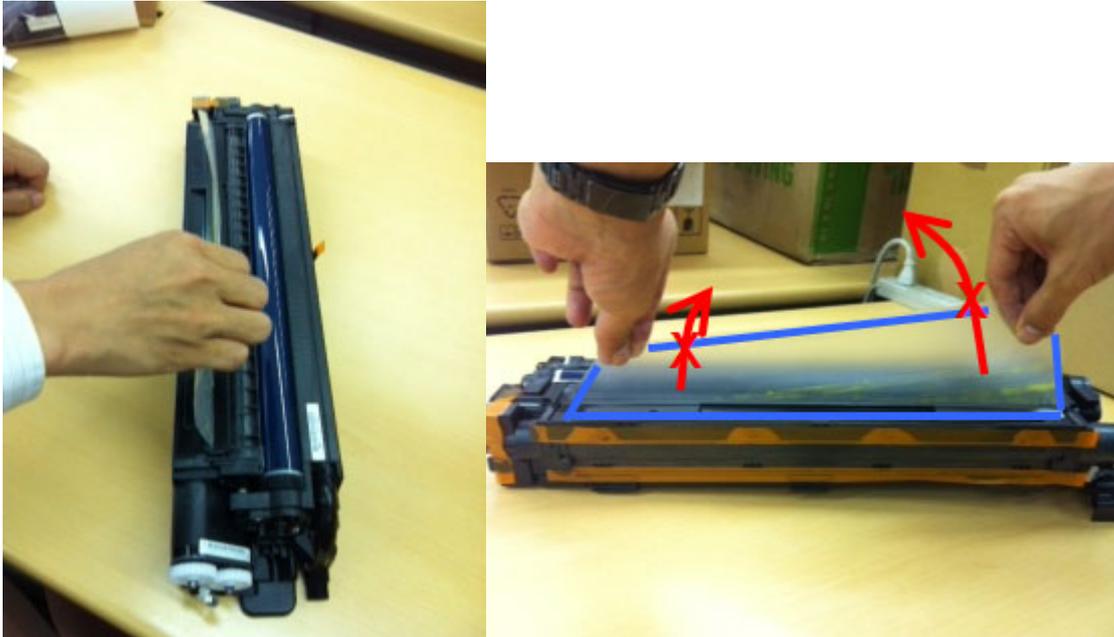
INCORRECT:

- 2) **DO NOT** pull the seal **by force**, or hold the seal only at one end. This is because the seal will skew or develop slack.

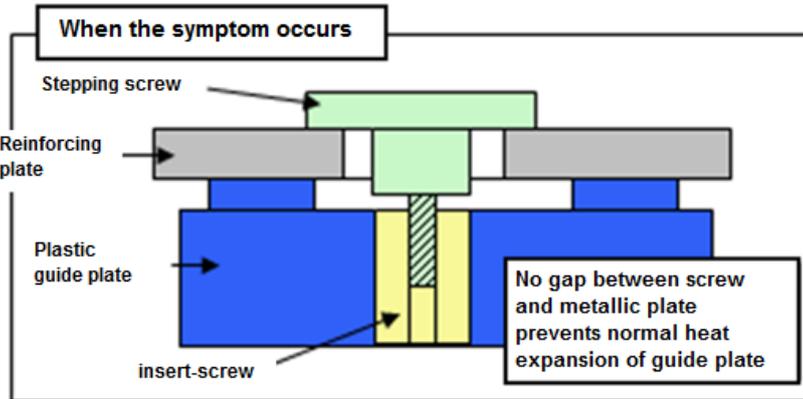
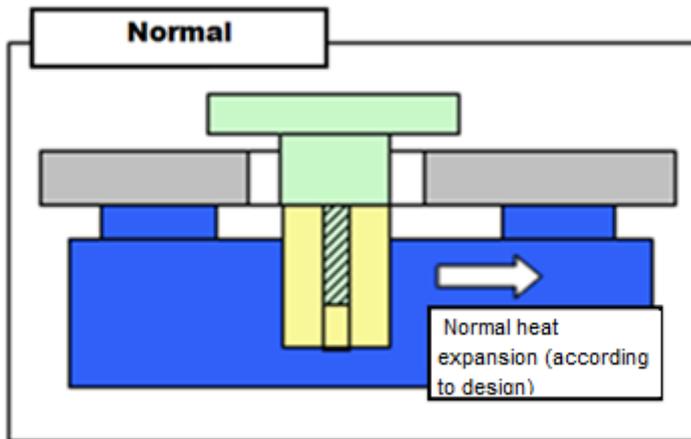
Note: The deformation occurs after feeding at least 100 sheets, and does not get worse once it happens. The guide plate returns to its original shape after cooling down.

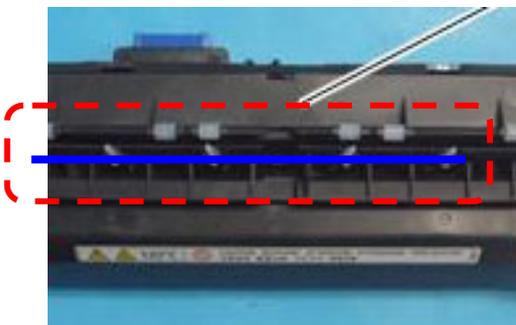
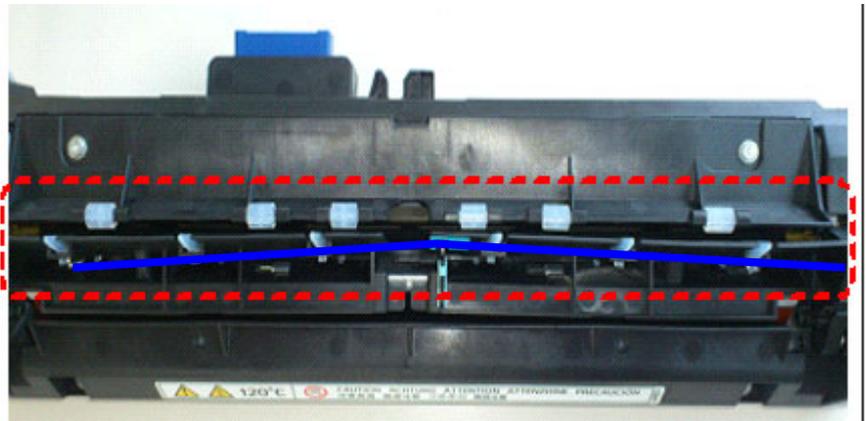
Normal: The guide plate is straight.

After heat deformation: The guide plate is warped.

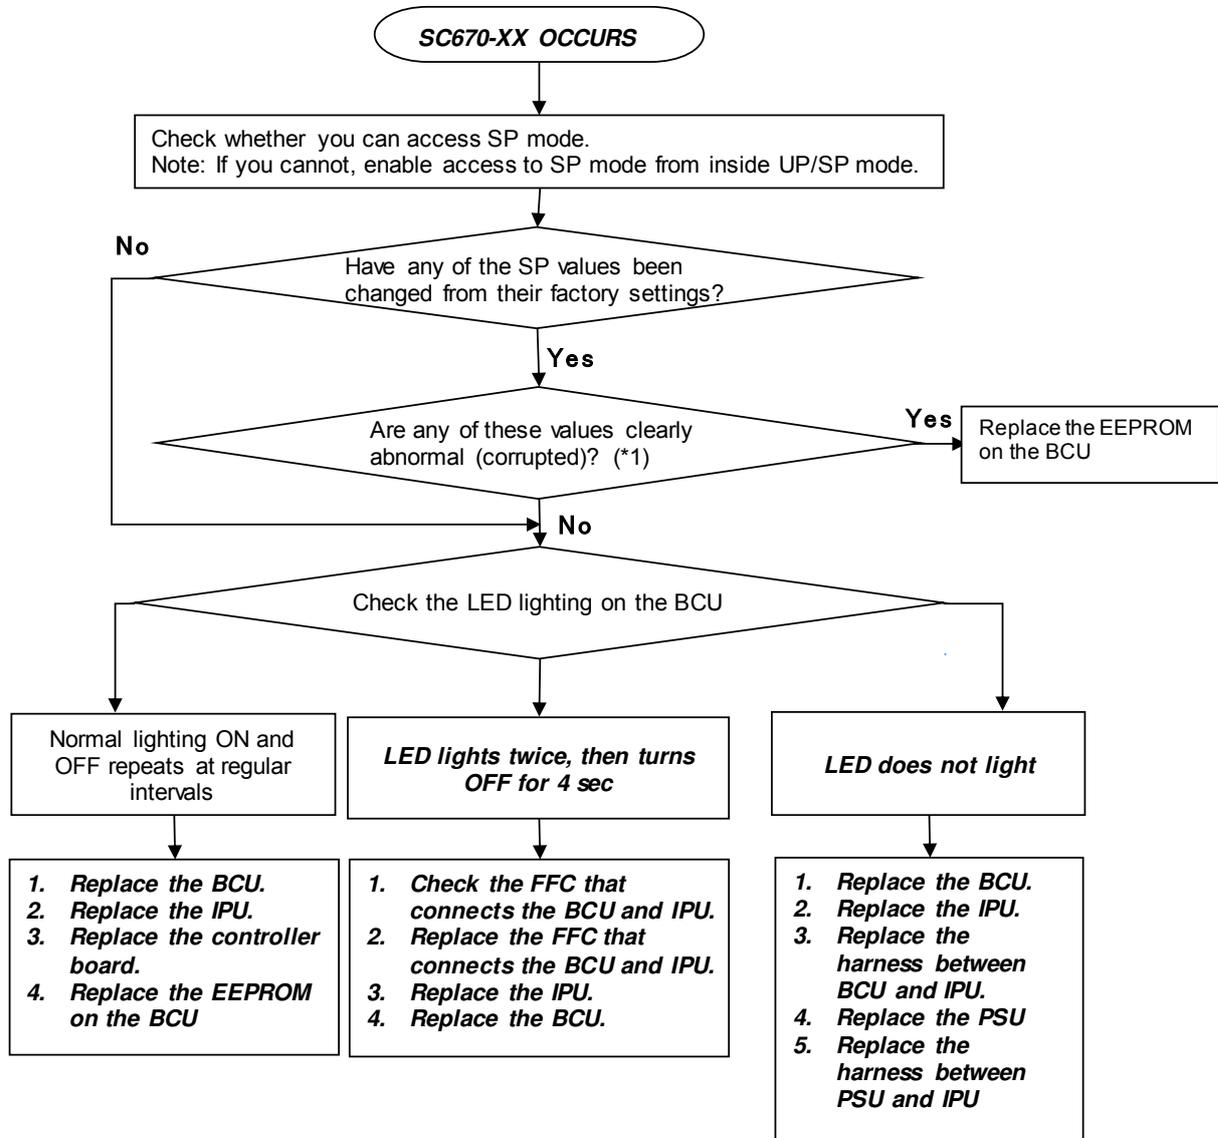
The BCU, Imaging IOB, Transport IOB, Controller board, IPU and PSU are defective or there is a connection error between the boards.

If the symptom occurs, use the following flow chart to determine the cause and decide the best course of action.

- 1. Replace the BCU.*
- 2. Replace the IPU.*
- 3. Replace the PCU.*
- 4. Replace the controller board.*

- 1. Replace the IPU.*
- 2. Replace the PSU.*
- 3. Replace the controller board.*
- 4. Replace the harness between PSU and IPU.*

- 1. Replace the IPU.*
- 2. Replace the controller board.*

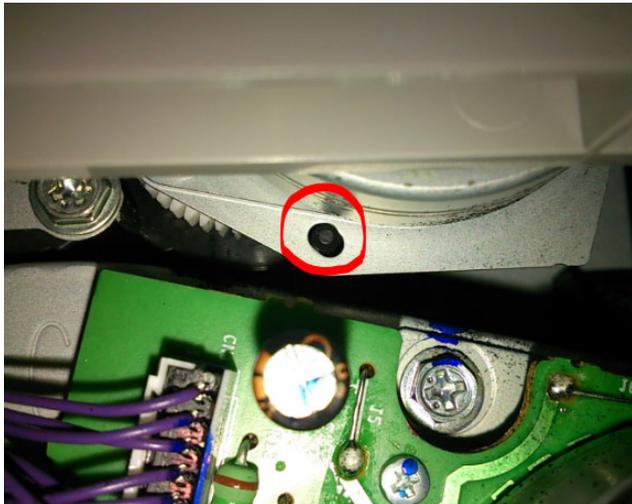
Correct:

1. The pin for the toner transport motor was not fitted into the bracket hole correctly at the factory.

1. For each color, check the pin for the toner transport motor.
2. If the pin was not fitted into the bracket hole correctly, remove the transport motor unit assembly [A] and fit the pin through the hole. If necessary, replace the unit.
See the “Correct” and “Incorrect” photos above.

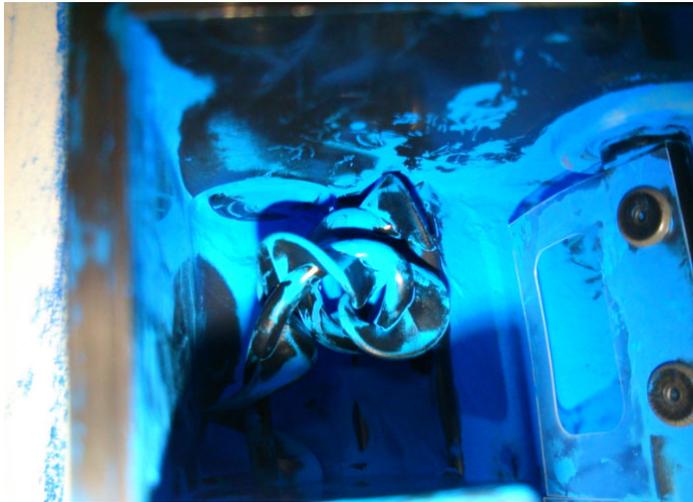
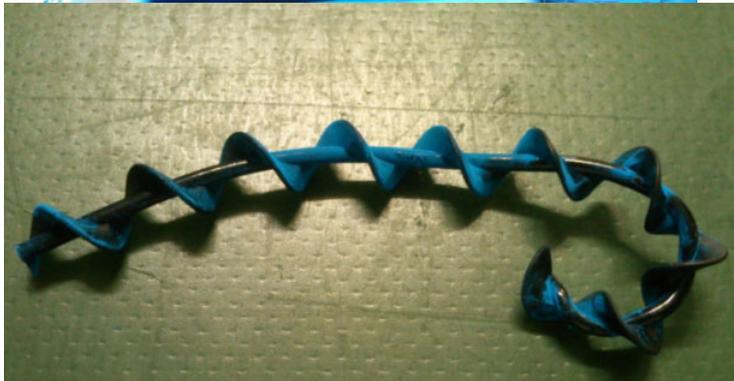
2. The toner transport screw was twisted or bent during factory assembly.

3. Check the toner transport screw.
4. If the screw is bent as shown in the photos above, replace the sub hopper [A].

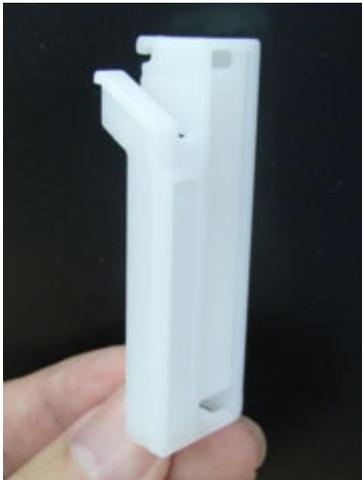
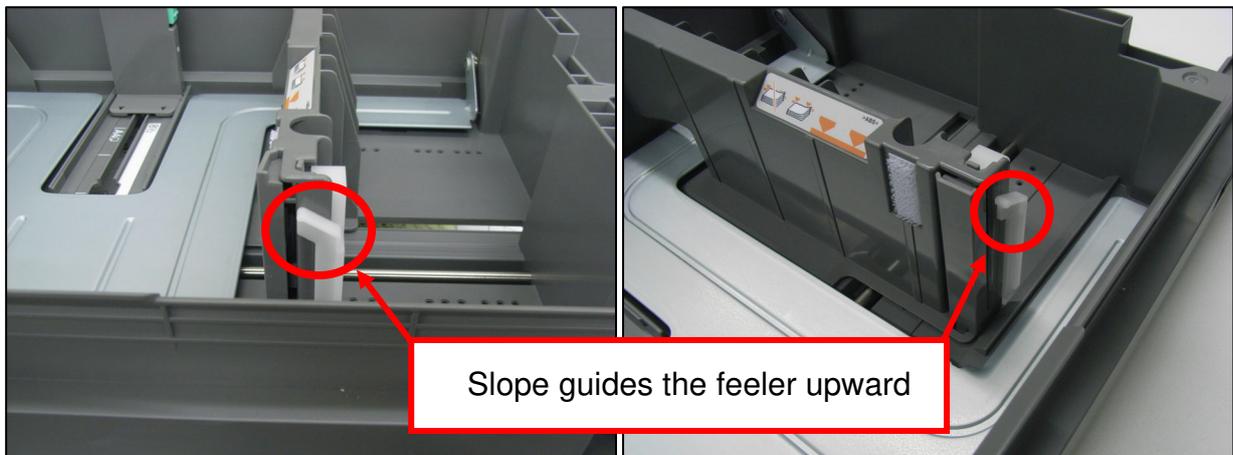
A feeler guide was added to reduce the chances that the paper stack will contact the feeler.

Note: When the tray is closed, the guide pushes the paper end feeler up before the paper stack has a chance to contact it.

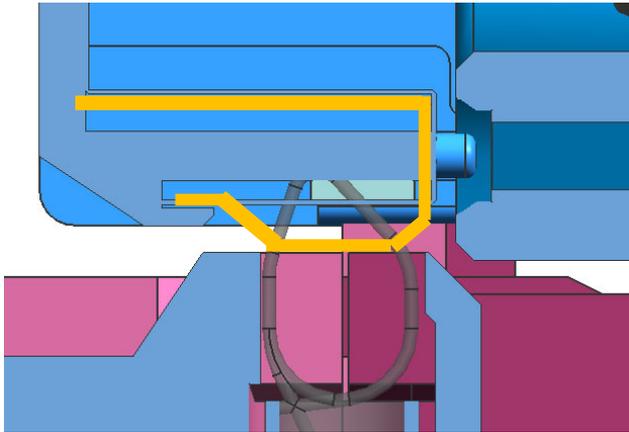
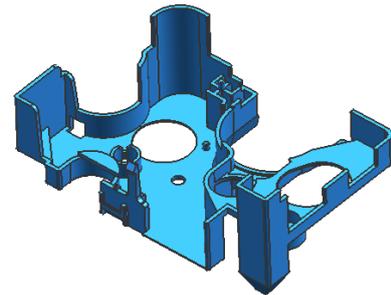
New part number: D1492329

- The shape of the gold plate in the rear of the PCDU which contacts the bias terminal was also changed (planned for application to the production line in Dec.)

.Note: This allows the correct development bias to be applied, even if the spring is bent.

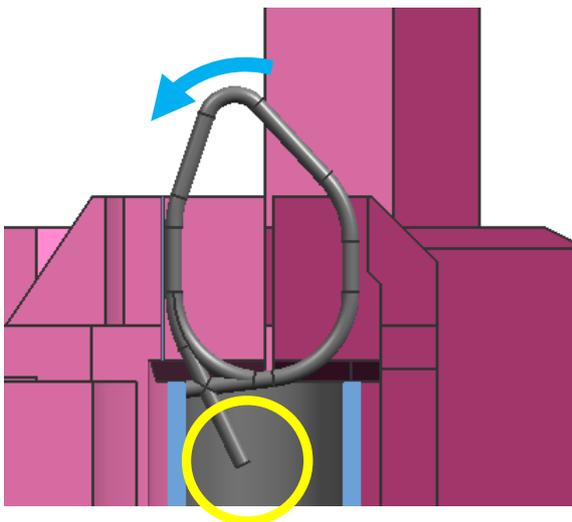
After

- The shape of the spring in the rear of the PCDU which contacts the bias terminal was also changed (planned for application to the production line in Dec.)
- The shape of the bias terminal spring on the mainframe was changed (July 8).

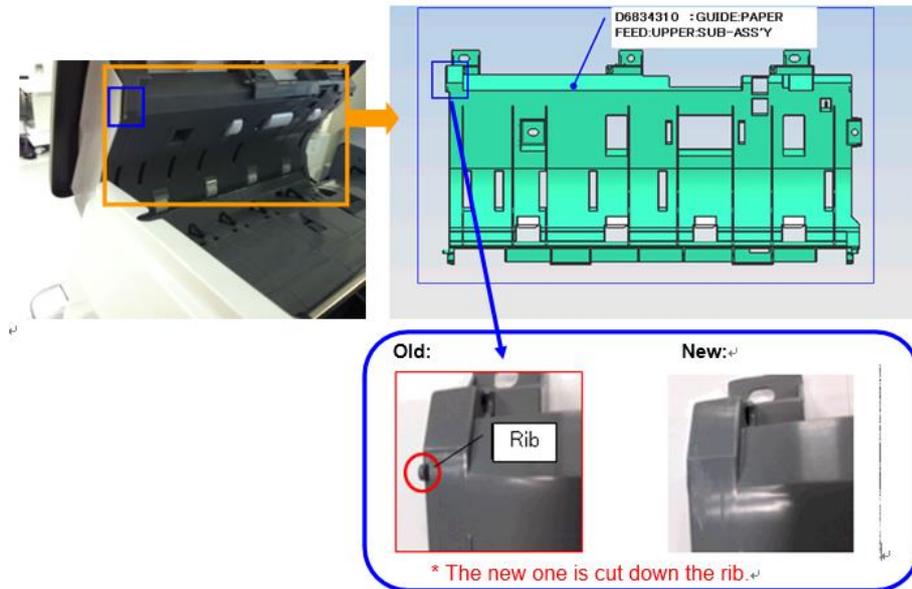
Photo 1 (Level 1):

Model: MET-C1d		Date: 06-Feb-14	No.: RD149061a
Production level	Change		
Level 1	The rib on the SPDF guide plate was deleted (see Photo 1).		
Level 2: Permanent countermeasure	The rib was moved as shown in Photo 2 to provide a wider space through which the original can pass.

Note: Although this rib functions to maintain a certain amount of width/space in the paper path, there is no side effect to removing the rib (unless a load is applied intentionally on the top of the guide plate).

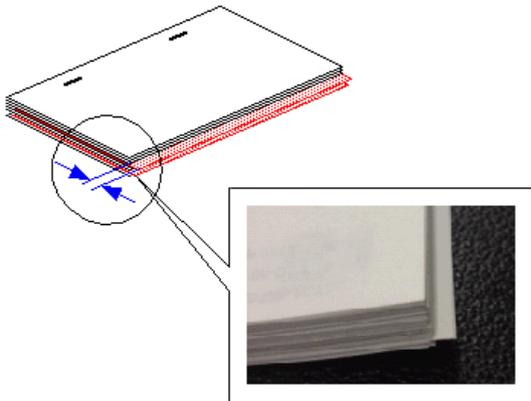
Example 1: Misalignment along the paper exit direction

Some sheets of paper may skew (become misaligned) when sent to the staple tray of the SR3140/SR3150 finisher.

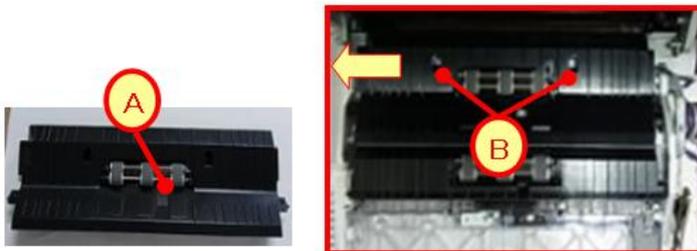
IMPORTANT: If you do not do this step, the guide plate will be out of alignment and the noise will occur again.

9. Insert the two small projections on the edge of guide plate No. 2 [A] into the two holes in the frame.

10. Gently push the guide plate No. 2 toward this side (in the direction of the arrow in the photo) as far as it will go.

11. Tighten the two screws [B] to fix the guide plate in place.

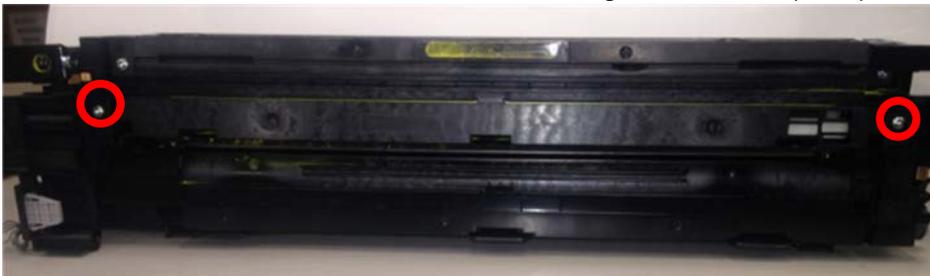
Increased electrical resistance on the charge roller surface from toner/powdered lubricant and paper dust builds up on the surface. Also, electrical resistance builds up on the roller surface precipitated by low-temperature conditions (around 15C).

7. Rotate the PCU unit and remove the charge roller unit (⚙️ x2).

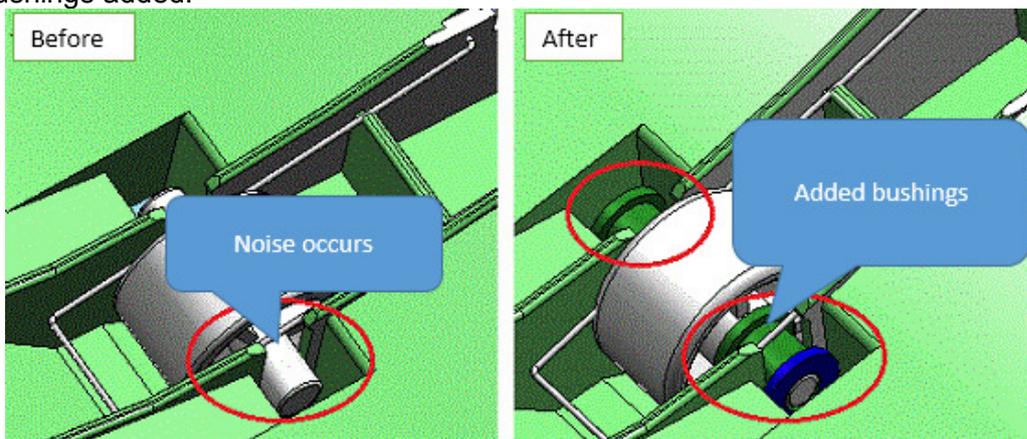
Bushings added:

Reason: To minimize noise that may occur when the gear contacts the roller.

IMPORTANT: Due to the above changes, make sure to replace the cover, side guide plate, and roller shaft **together as a set**.

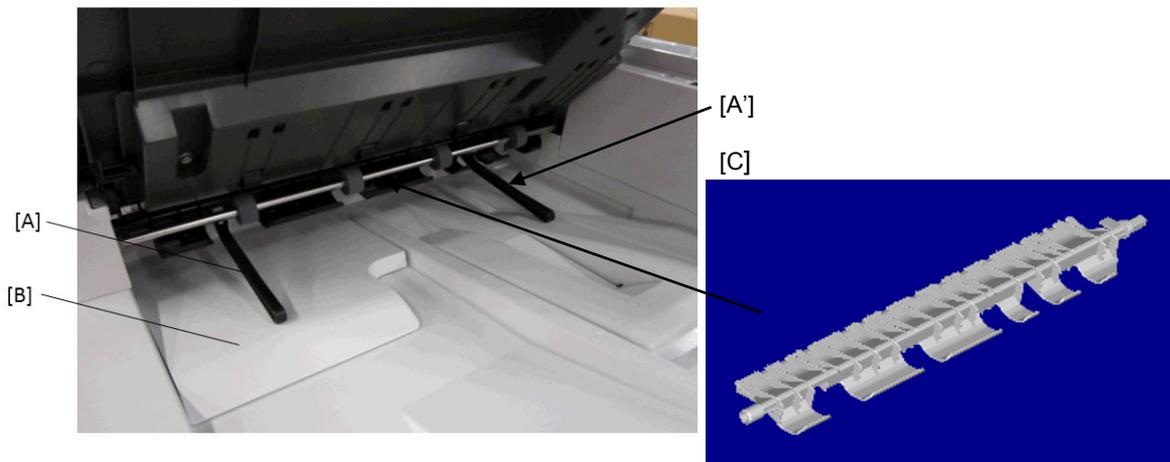
1. Added one more paper exit lever.
Note: The photo below shows the existing exit lever [A] and additional exit lever [A].
2. Added an auxiliary tray [B].
3. Modified the gate pawl [C] (to enable addition of a lever).

2. Add the lever [A] and tray [B], and replace with the gate pawl [C].

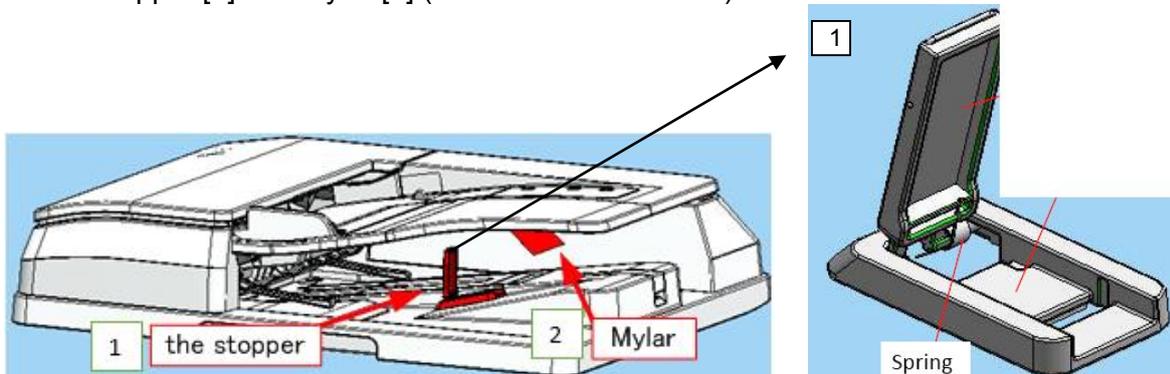
If poor stacking still occurs with A4/LT LEF, attach the following parts.

Attach stopper [1] and Mylar [2] (See **Procedure** below).

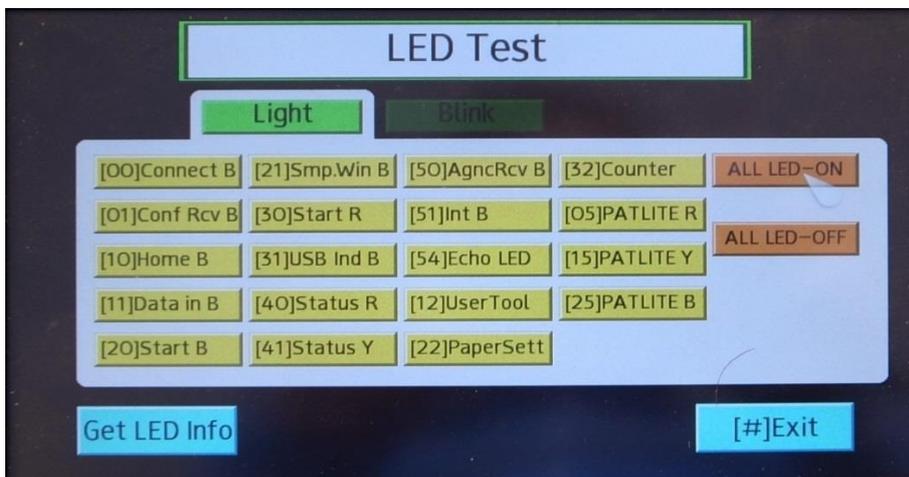
The right PCB (D1491488) applies a reverse voltage higher than specification to the LED chips (for example, when the Start button is pressed, a fax is received, or the data-in lamp lights). This causes a chemical reaction (Ag migration) under high-temperature/high-humidity conditions. The reaction then produces unexpected current, which causes a buildup of heat on the LED chips. As a result, the wire bonding comes off.

1. Access the self-diagnostics menu (Press [Reset] -> [1] [9] [9] [3] -> [Clear] 5 times).
2. Press [2]: LED test.
3. ***Press [ALL LED-ON] and check the LED lamps on the display.***

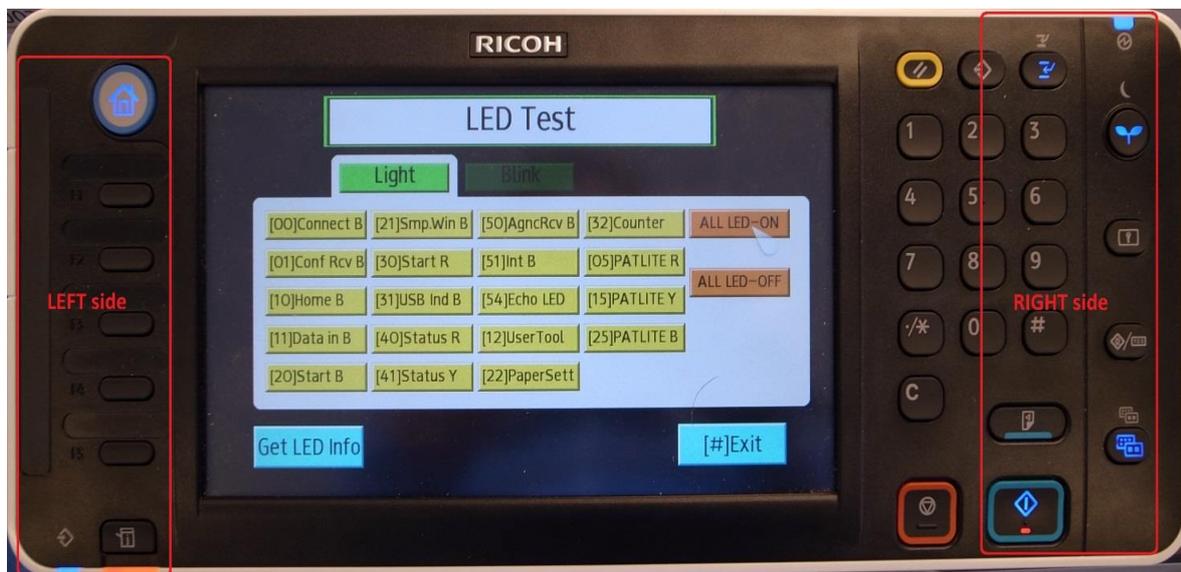
Note: When the LED lamp on the left PCB burns out, both the left and right PCBs have to be replaced as a set, as the root cause is the right PCB. .

4. Replace the following parts:
- **If the fax reception or Data-in LEDs on the left side of the operation panel do not light:**
 - Replace the left and right PCBs (PCB:OP-L:USB:ASS'Y and PCB:OP-R:ASS'Y), or
 - Replace the entire operation panel

- **If the START button LED on the right side of the operation panel does not light:**
 - Replace the right PCB (PCB:OP-R:ASS'Y), or
 - Replace the entire operation panel

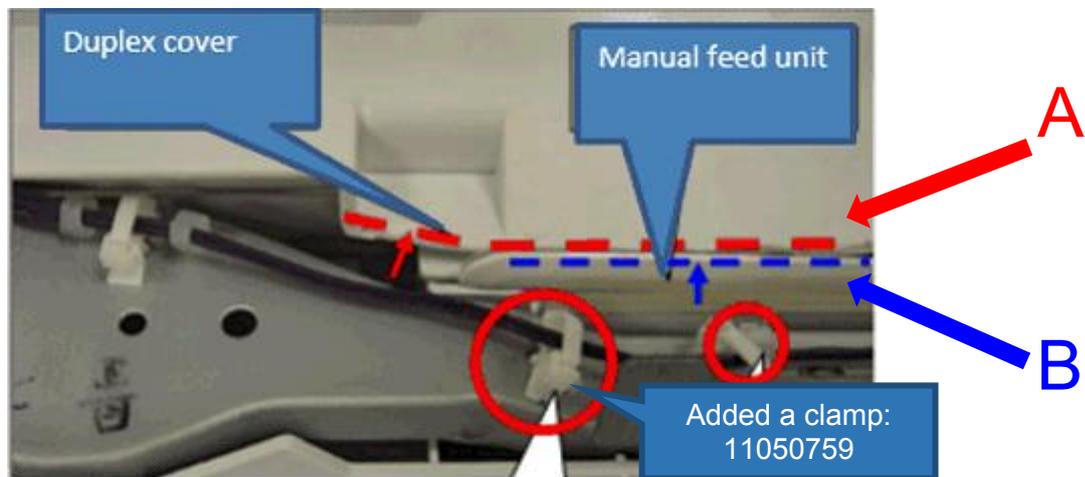
After change

Reason: To ensure that the manual feed harness is not pinched/damaged.

(Edge of the duplex cover [A] was cut, wall of manual feed unit [B] was raised).

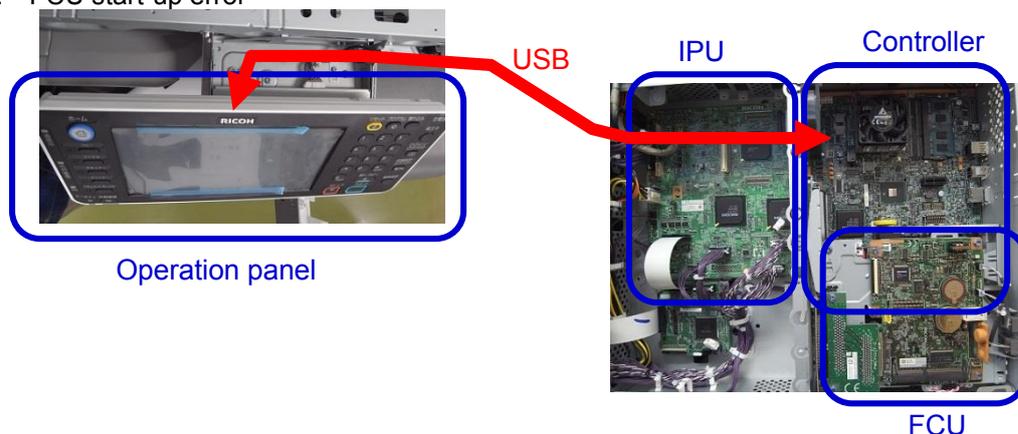
Figure 1: Operation panel, IPU and Controller / FCU

1. Failure of USB communication path (USB cable, IPU)
2. Data corruption of CTL onboard Flash memory
3. Poor supply voltage for CTL onboard ASIC
4. Firmware bug related to energy saving system
5. Defective CTL onboard converter
6. Defective CTL onboard resistors
7. FCU start-up error

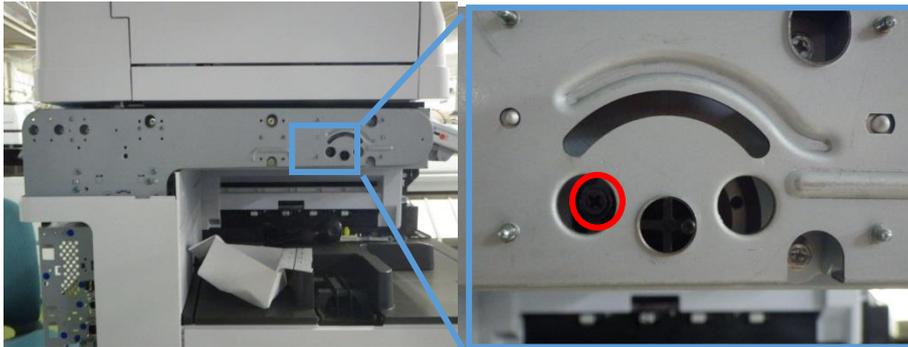
Never loosen or remove the following screw when you remove or re-attach the unit. This is because this screw fixes the scanner cam in place. If the position of the scanner cam changes, the scanner will be misaligned. This will result in image skew and other image alignment issues.

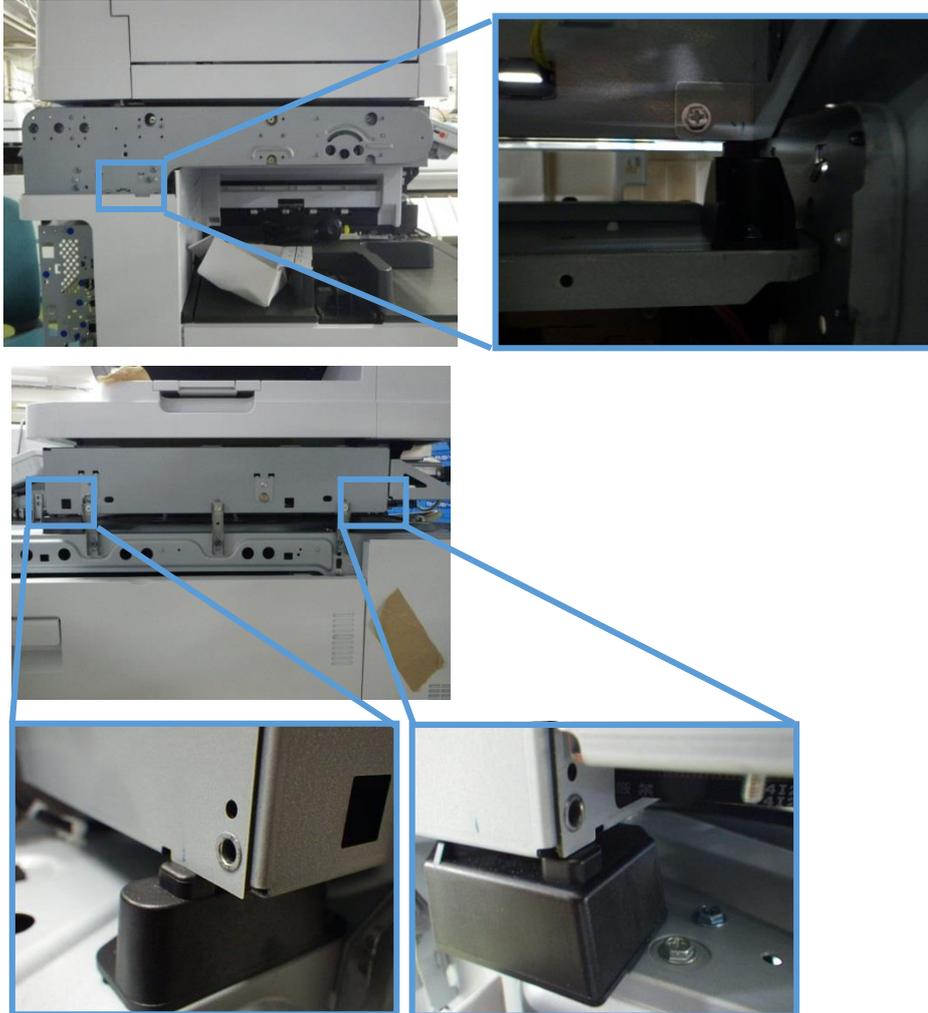
Make sure that there is no space between the machine frame and the following three areas of the scanner unit when you re-attach the scanner unit.

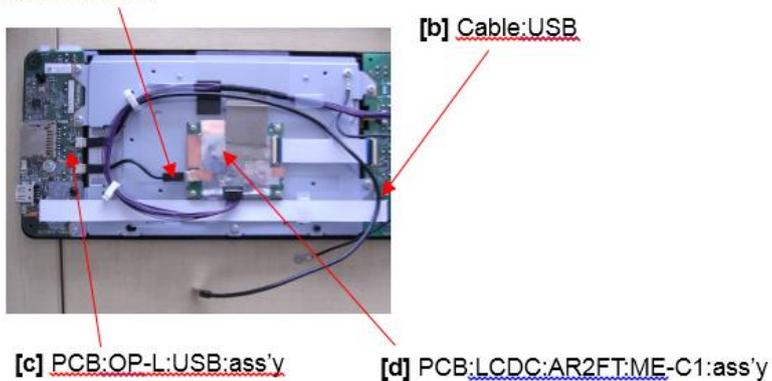
[a] Cable:LCDC:USB

Do the following procedure step-by-step if the USB cable replacement does not solve the symptom. Stop the procedure at any step if the symptom is solved.

1. Reconnect **[a]** (Cable:LCDC:USB) and **[b]** (Cable:USB).
2. Replace **[a]** (Cable:LCDC:USB) and **[b]** (Cable:USB).
3. Replace **[c]** (PCB:OP-L:USB:ass'y).
4. Replace **[d]** (PCB:LCDC:AR2FT:ME-C1:ass'y).

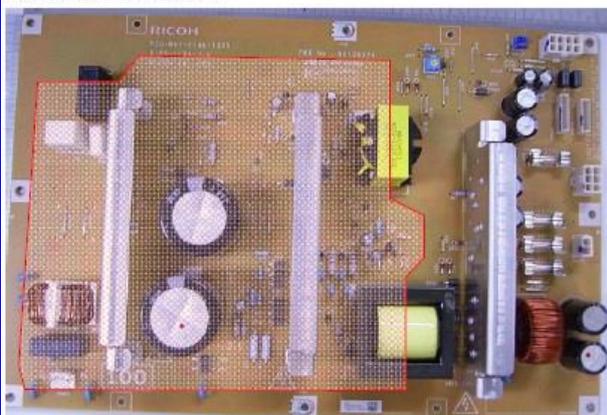
D146, D147: DOM/NA

NEVER touch the areas outlined in red in the photos below, to prevent electric shock caused by residual charge.

The procedure to discharge residual charge from the machine by unplugging the power cord from the AC wall outlet and pressing the main power switch works only for the DC circuits on this board. Residual charge remains in the AC circuits.

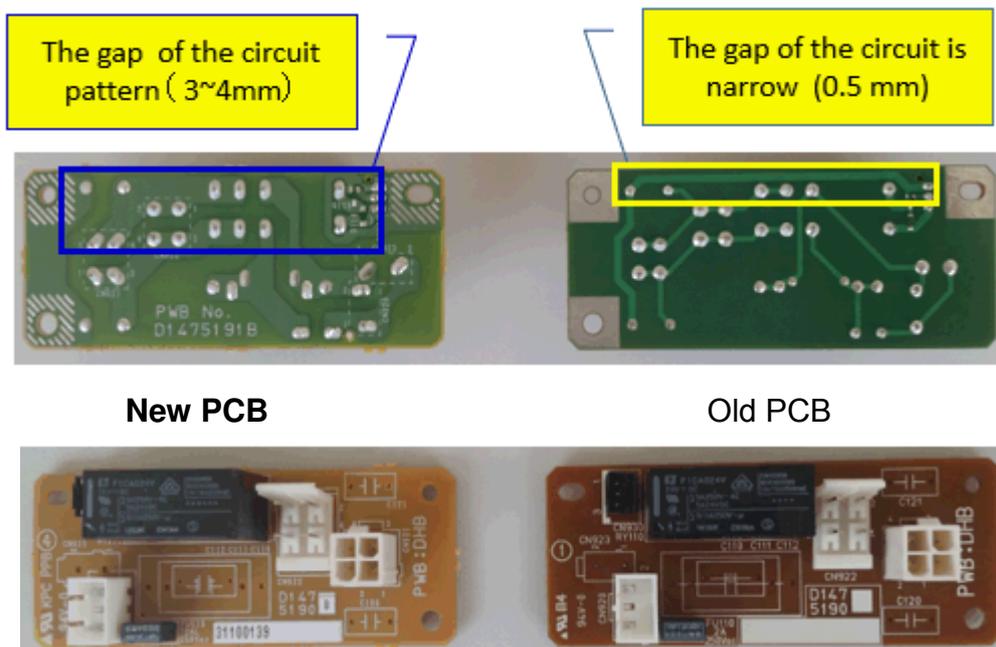
Reason: To further protect against shorts triggered by high voltage, which can happen if the lines on the PCB are too close to one another.

Changed: The design of the PCB: DHB (relay board) was changed.

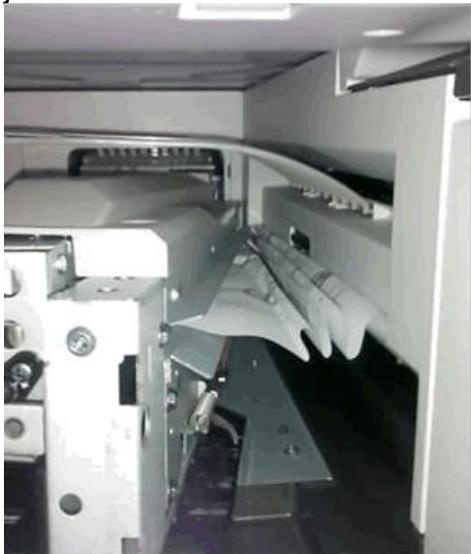
SYMPTOM

Jam code 100 is triggered (detected) earlier to make it easier for the operator to clear the jam.

**CAUSE**

Paper feed amount (unit distance) and paper specifications

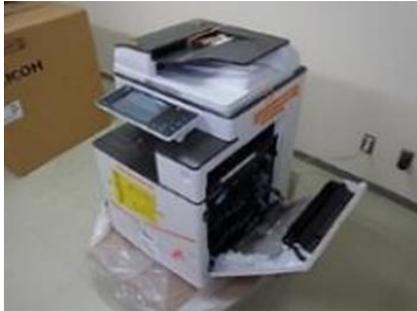
SYMPTOM

The front lever is broken when the duplex unit is opened and closed.

If the symptom occurs, replace the lever (P/N: D2399901).

1. Open the duplex unit.

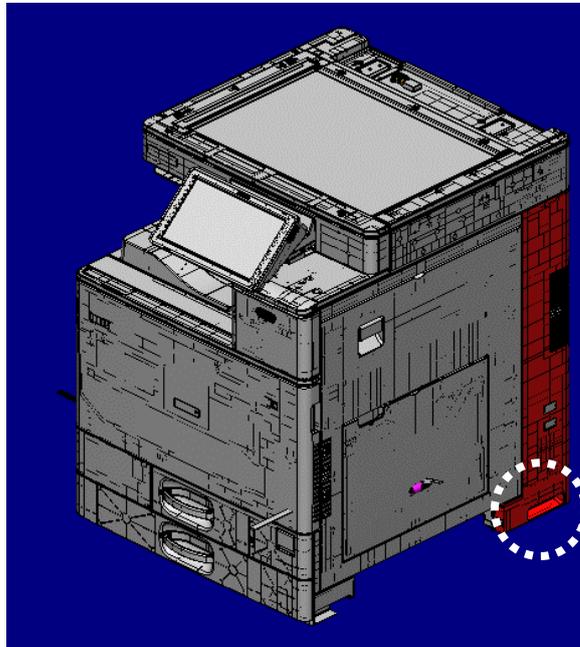
Figure1 right rear cover

- Make sure to do the following when installing the machine:
Hold the grip of the right rear cover as shown in **Fig. 2 (CORRECT)**.
Insert your fingers **all the way up and inside the grip**.
- If you do not, the right cover will break, as shown in Fig. 4.

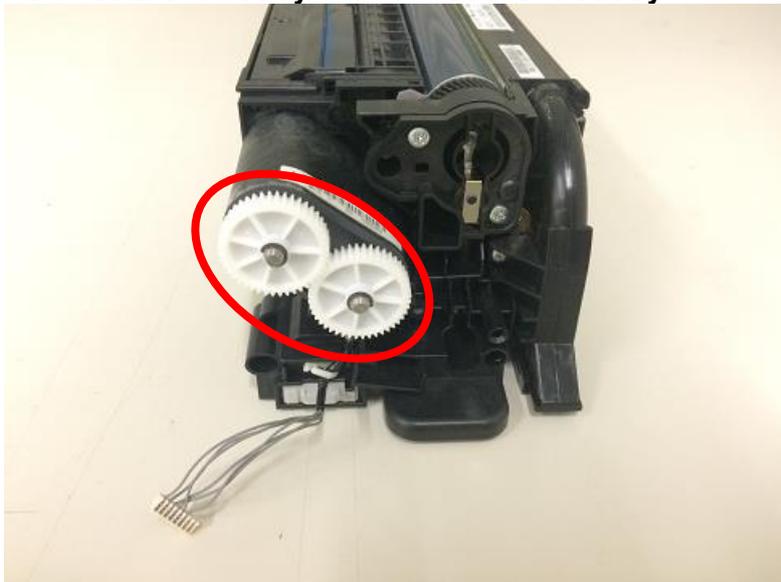
For Metis-C1abcdeyzk and Metis-C2abcdeyz

As one of the reasons that cause this symptom, the development unit was stored/transported in a certain position prior to its installation. This causes the developer to accumulate on the gears at either end of the unit, disabling proper rotation of the development roller.

At the front side of the unit, rotate the white gears (circled in red), to agitate the developer.

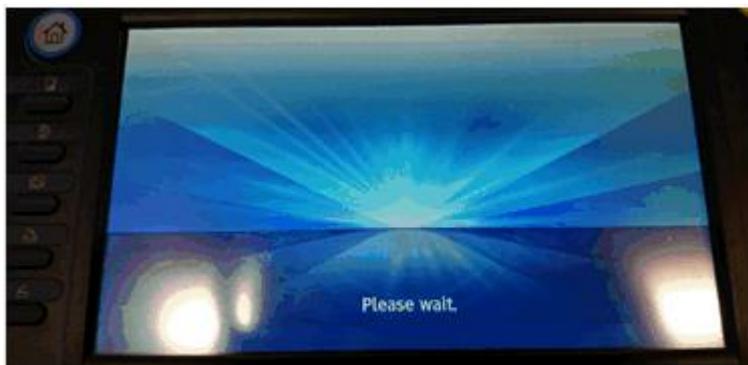
Standard operation panel

“Please wait” remains displayed (standard operation panel), or no icon appears (Smart Operation Panel) at main power ON when both of the **Conditions** below are met.

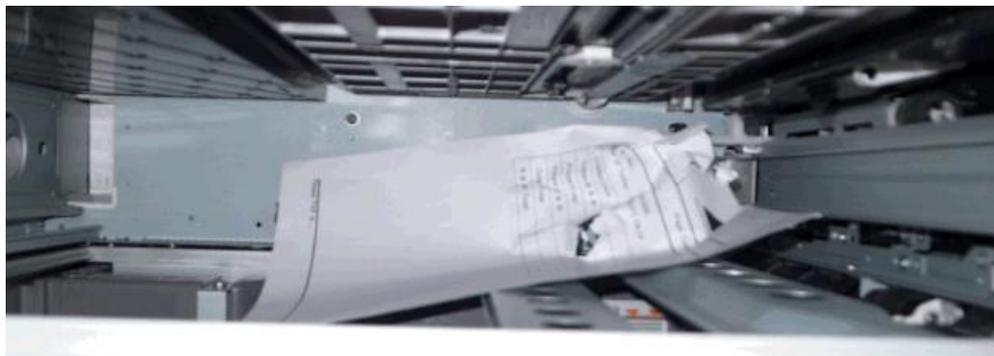
- Paper jam at the rear side of the paper tray

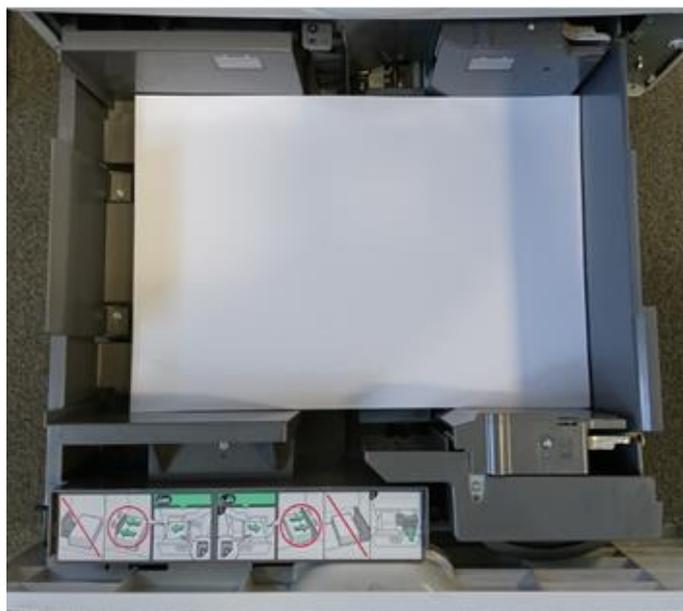
- A3/DLT paper mistakenly loaded in A4/LT tandem tray

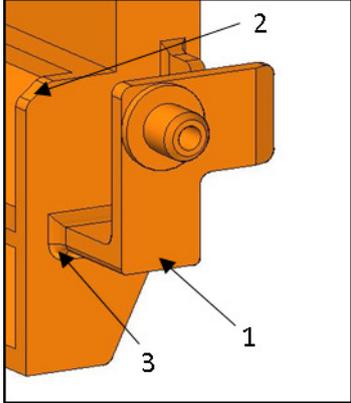
Old D1492721	New D6942721
Shape

Reason: To further strengthen and prevent breaking of the guide plate.

<ul style="list-style-type: none"> 1. Deleted stopper 2. Changed angle regulation 3. Strengthened part

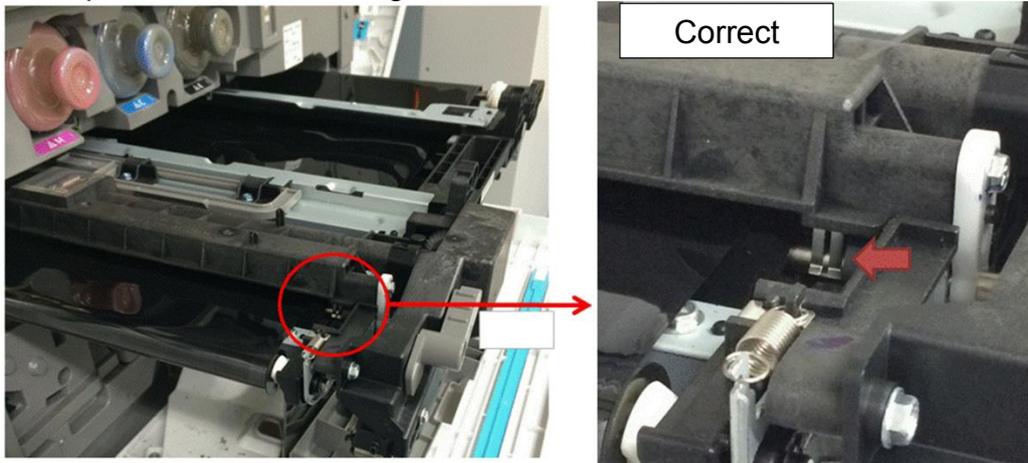
A grounding failure occurs with the belt cleaning unit in the ITB unit or paper transfer roller unit, either of which can generate electrical noise.

1. Check the grounding of the belt cleaning unit on ITB unit.
2. Replace the belt cleaning unit.

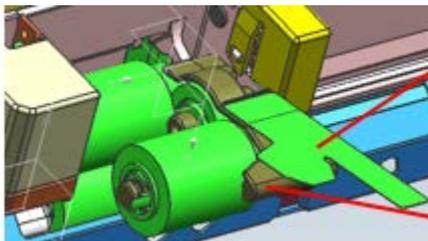
Change 2: The material and the color of the pickup arm has been changed and the seat of the pickup arm also removed.

Old P/N <Group B>	New P/N	Description	Int	Q'ty	Note
D2022617	D0BQ2623	ARM:PICKUP:MANUAL FEED	X/O	1	B
D2022618	-	SHEET:PICKUP	-	1->0	B

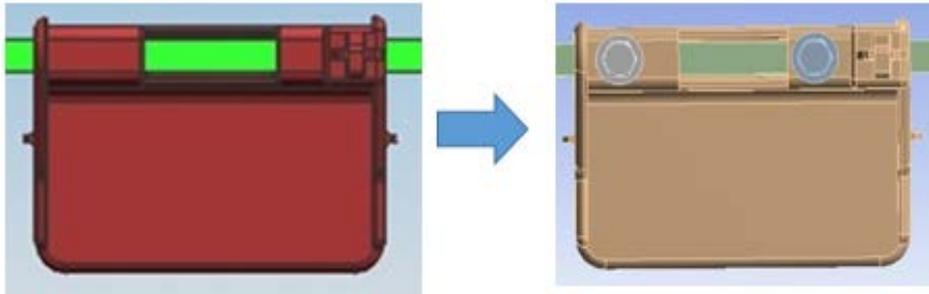
Change 5: The grip of duplex unit has been changed from press fit to screw type.

Old P/N <Group A/B/D>	New P/N	Description	Int	Q'ty	Note
-	03603006N	SCREW - M3X6	-	0->2	E
D1754654	D0BQ4654	SHAFT:LEVER:LOCK	X/X	1	E
D1494655	D2894655	GRIP:DUPLEX UNIT	X/X	1	E
