Model: MET-C1k	Date: 10-Nov-14	No.: RD237002
----------------	-----------------	---------------

Subject: Firmware Release Note: Network Support		Prepared by: E. Hinata	
From: 1st Tech Service Sect., MFP/Printer Tech Service Dept.			
Classification:	<input type="checkbox"/> Troubleshooting	<input type="checkbox"/> Part information	<input type="checkbox"/> Action required
	<input type="checkbox"/> Mechanical	<input type="checkbox"/> Electrical	<input type="checkbox"/> Service manual revision
	<input type="checkbox"/> Paper path	<input type="checkbox"/> Transmit/receive	<input type="checkbox"/> Retrofit information
	<input type="checkbox"/> Product Safety	<input checked="" type="checkbox"/> Other (Firmware)	<input checked="" type="checkbox"/> Tier 2

Model: MET-C1k	Date: 10-Nov-14	No.: RD237004
----------------	-----------------	---------------

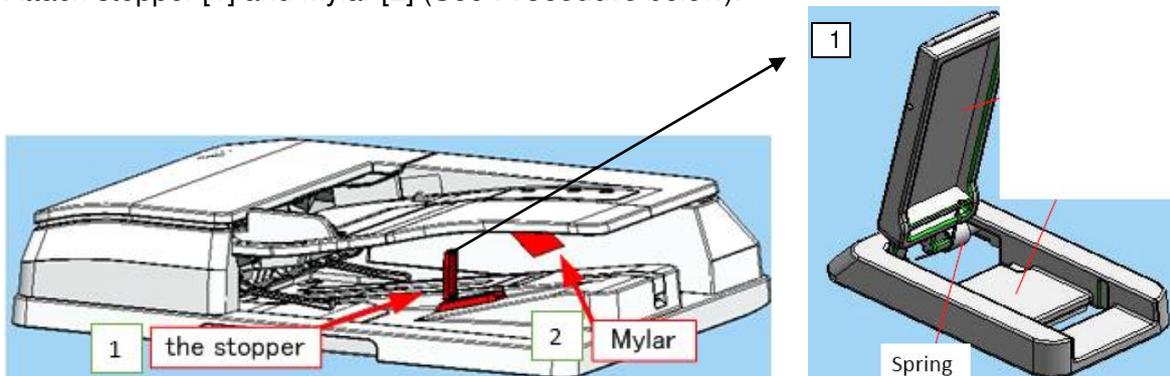
If poor stacking still occurs with A4/LT LEF, attach the following parts.

Attach stopper [1] and Mylar [2] (See **Procedure** below).

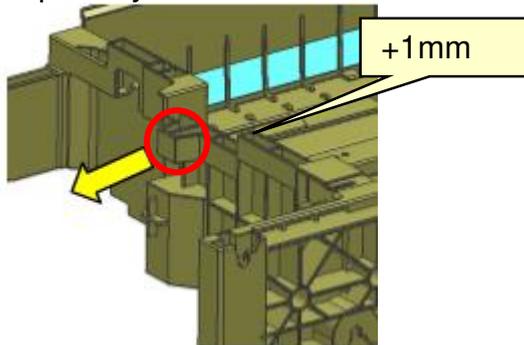
Paper tray rear side:

The part of the paper tray that contacts the push switch was increased in size by 1mm. See the diagram below.

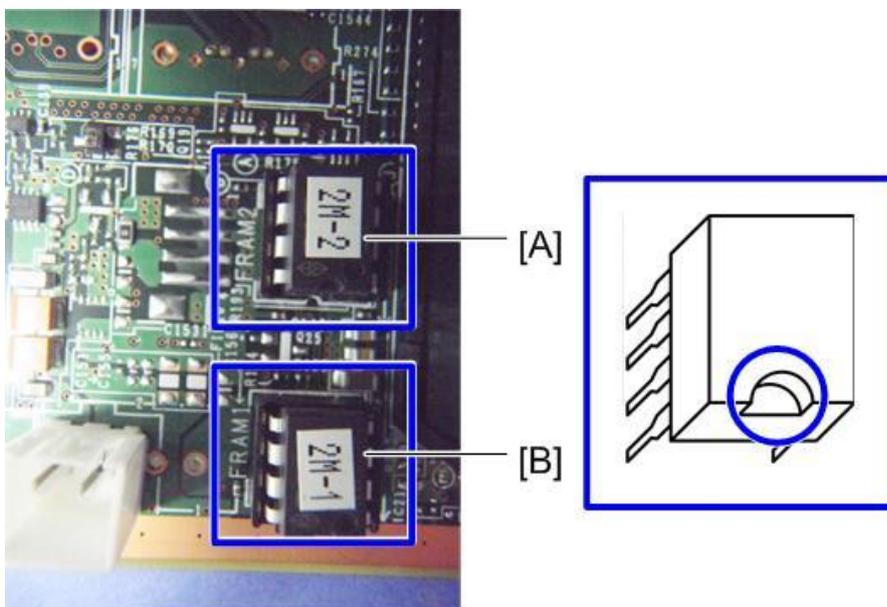
Mounting position and orientation of the NVRAMs

Correspondence table			
	Position	Label on the board	Label on the NVRAM
[A]	Upper	FRAM2	2M-2
[B]	Lower	FRAM1	2M-1

- Referring to the following procedure, be sure that there are no mistakes in the mounting position and orientation of the NVRAMs.
- SC195 (Machine serial number error) will be displayed if you forget to attach the NVRAM.
- If you mounted the NVRAM in the wrong direction, each component needs to be replaced because a short circuit was caused in the controller board and the NVRAM.
- **Passwords for the Supervisor and Administrator 1 will be discarded later in this procedure.**

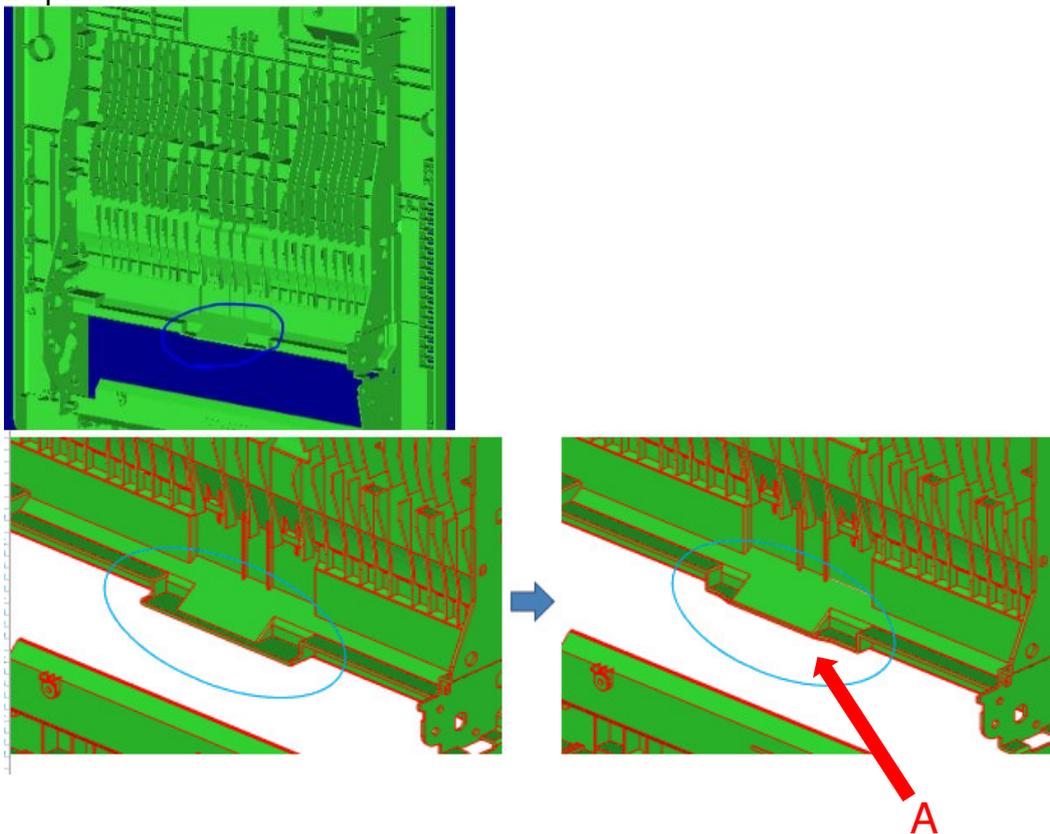
Duplex cover:

(Harness is pinched between manual feed unit and duplex cover and then damaged).

Manual feed unit and duplex cover need to be replaced together.

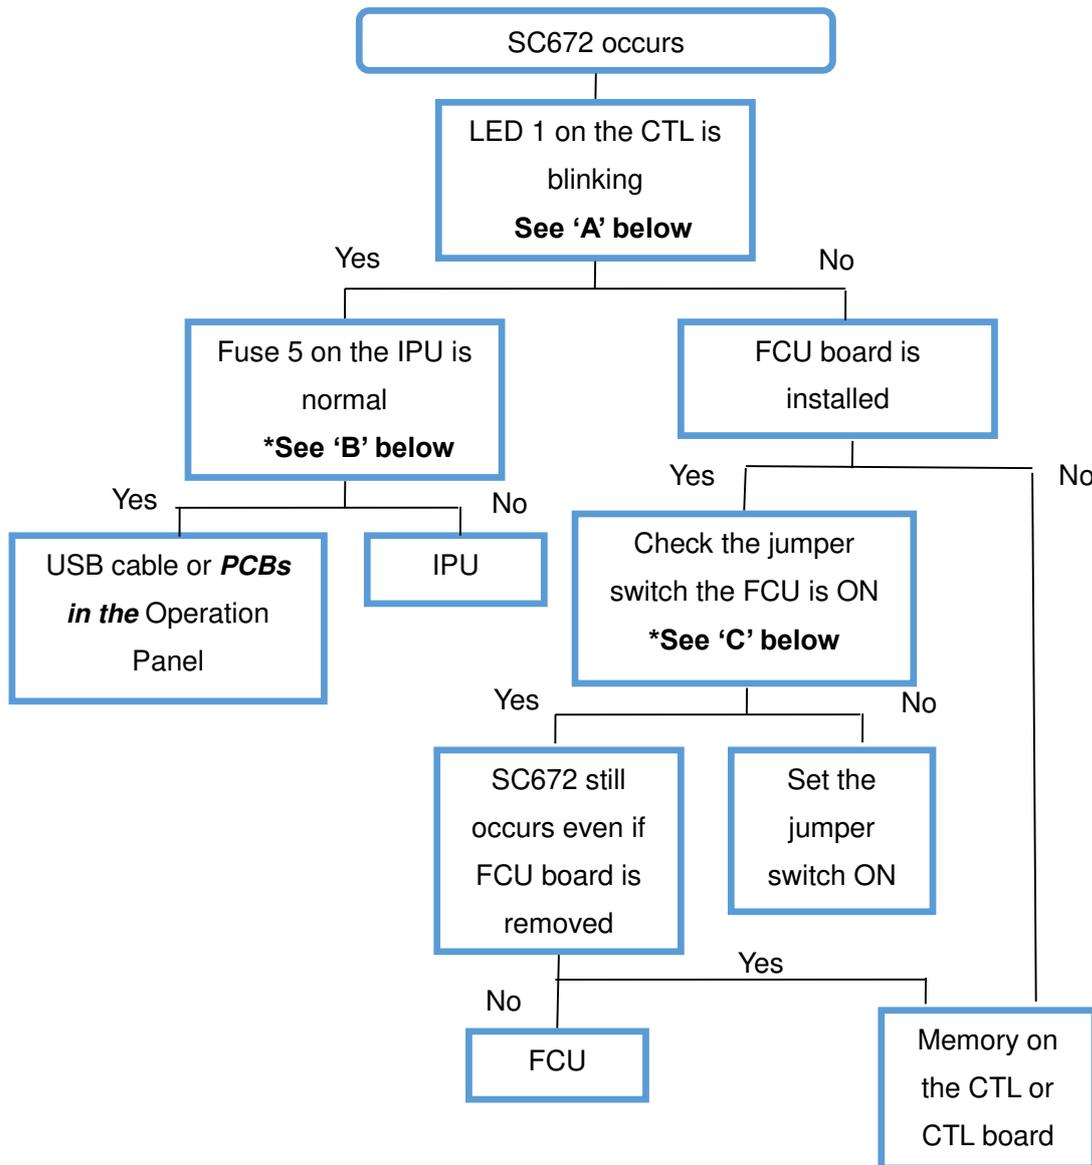
MP C3003/3503, MP C2003/2503, MP C2011

1. Failure of USB communication path (USB cable, IPU)
2. Data corruption of CTL onboard Flash memory
3. Poor supply voltage for CTL onboard ASIC
4. Firmware bug related to energy saving system
5. Defective CTL onboard converter
6. Defective CTL onboard resistors
7. FCU start-up error

4. Do the action in the **flowchart on the next page** to determine the cause and best course of action. ***If the USB cable and/or the CTL board needs to be replaced, make sure to refer to page 15 of this bulletin for the latest parts number.***
 - USB cable
 - Memory (DIMM) on the CTL
 - CTL board
 - IPU board
 - FCU board
 - ***PCBs in the*** operation panel

- If SC819 (cache error) in SC history, please replace controller board.
- If SC991 (SCS: scs time count level c') appears in the SC history, replace the controller board and USB cable.

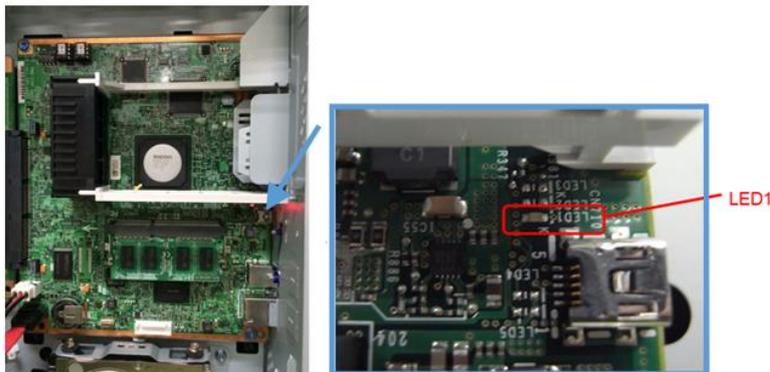
Figure 4: LED 1 on the CTL

No.	Note
LED	For CPU
1	- LED blinks when the CPU is operating normally. - LED is lit or off when there is a problem with the CPU.

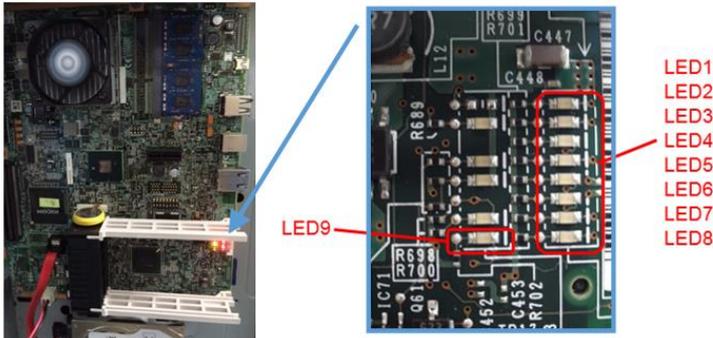
Figure 5: LEDs 1 to 9 on the CTL

No.	Note
LEDs 1-8	1. For self-diagnosis code (BIOS). 2. After the BIOS starts up, LEDs 1 to 7 turn off and LED 8 blinks . LED 8 is lit or off when there is a problem with the CPU.
LED 9	- LED is lit when the BIOS is running. - LED blinks when the OS is running.

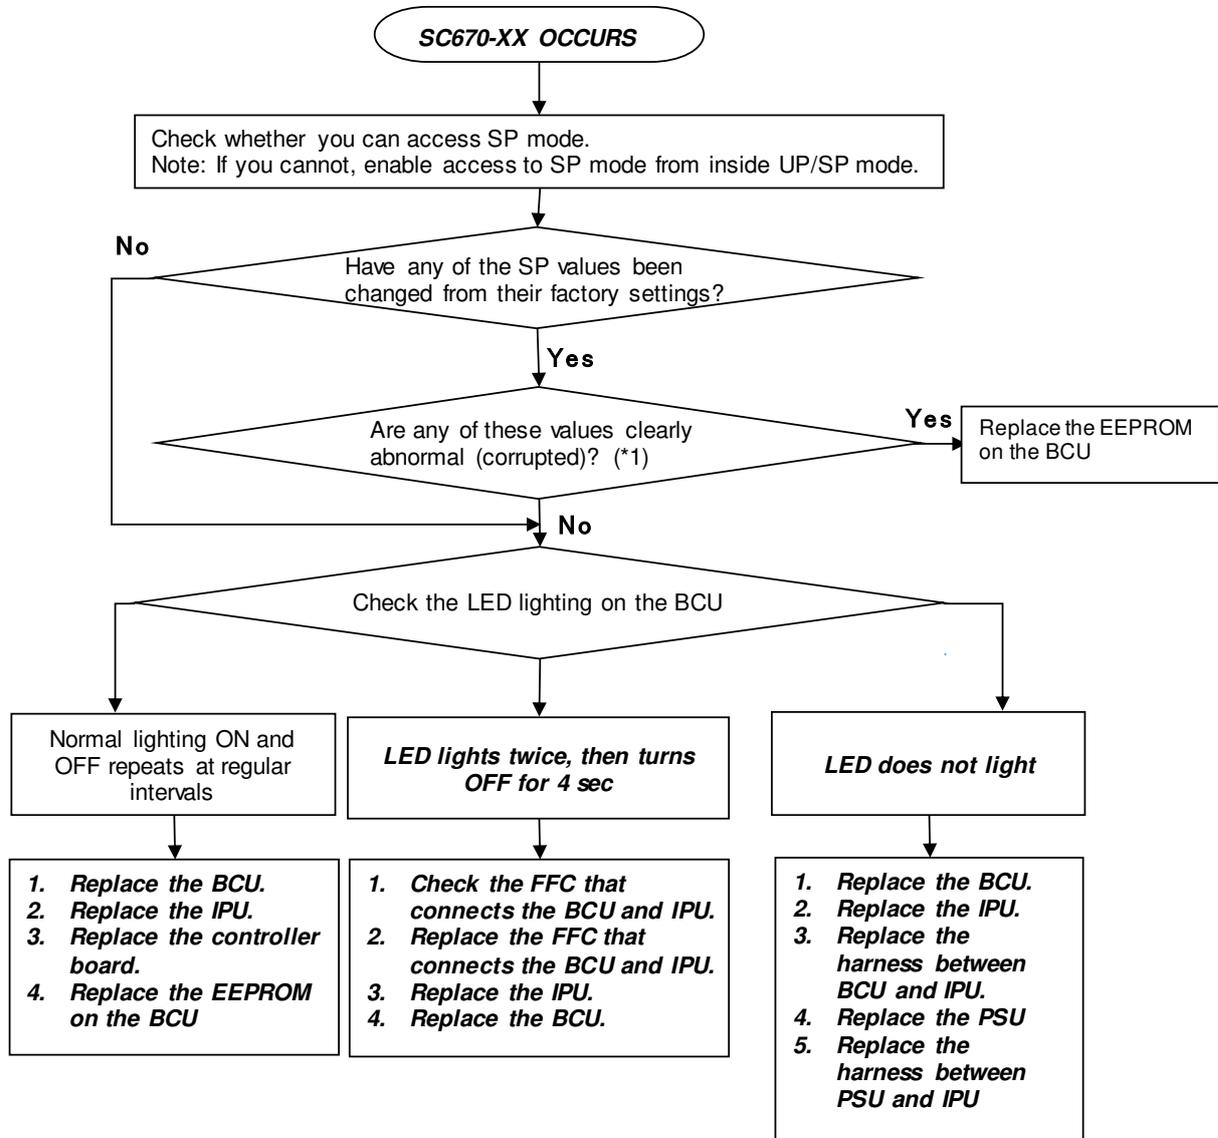
The BCU, Imaging IOB, Transport IOB, Controller board, IPU and PSU are defective or there is a connection error between the boards.

If the symptom occurs, use the following flow chart to determine the cause and decide the best course of action.

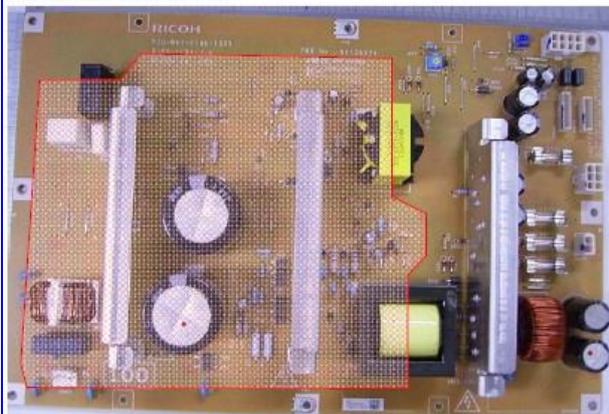
D146, D147: DOM/NA

NEVER touch the areas outlined in red in the photos below, to prevent electric shock caused by residual charge.

The procedure to discharge residual charge from the machine by unplugging the power cord from the AC wall outlet and pressing the main power switch works only for the DC circuits on this board. Residual charge remains in the AC circuits.

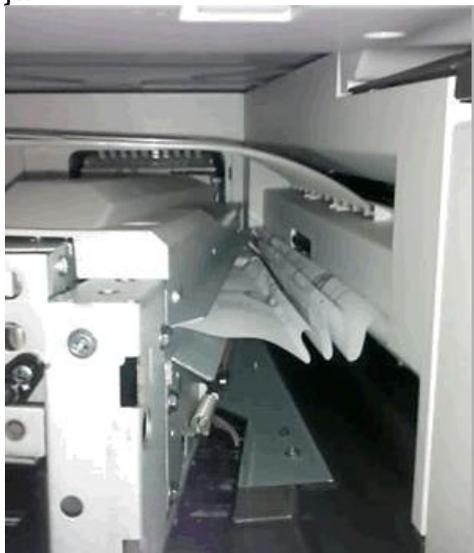
Jam code 100 is triggered (detected) earlier to make it easier for the operator to clear the jam.

Paper feed amount (unit distance) and paper specifications

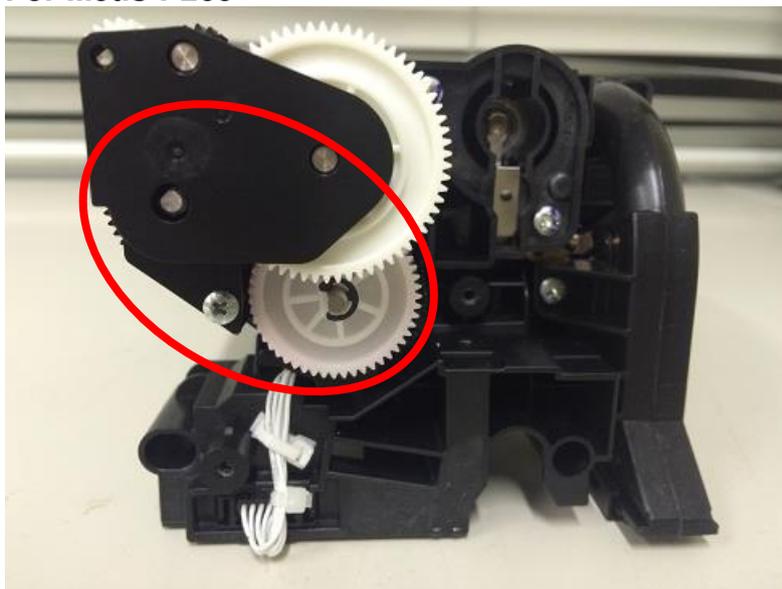
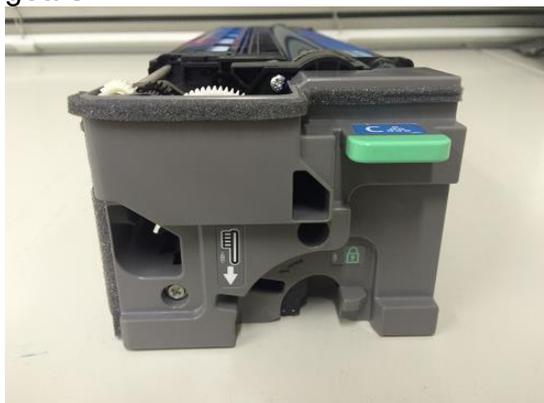
For Metis-P2ce

Note: For Metis-P2ce, the PCDU front cover needs to be released before rotating the gears.

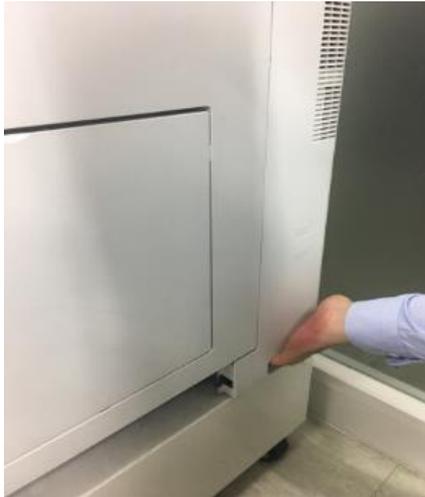
Figure.2 Correct

- Make sure to do the following when installing the machine:
Hold the grip of the right rear cover as shown in **Fig. 2 (CORRECT)**.
Insert your fingers **all the way up and inside the grip**.
- If you do not, the right cover will break, as shown in Fig. 4.

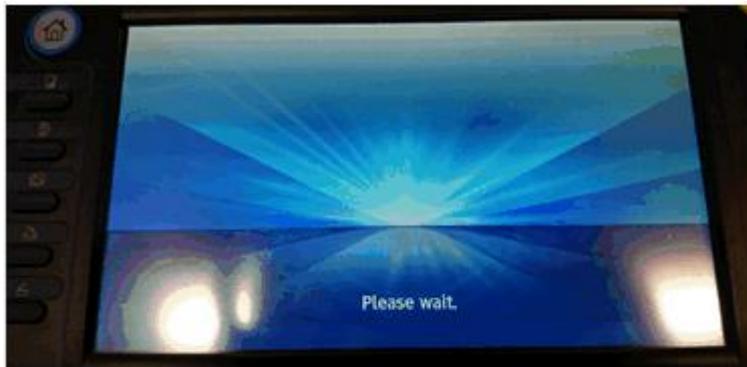
Standard operation panel

“Please wait” remains displayed (standard operation panel), or no icon appears (Smart Operation Panel) at main power ON when both of the **Conditions** below are met.

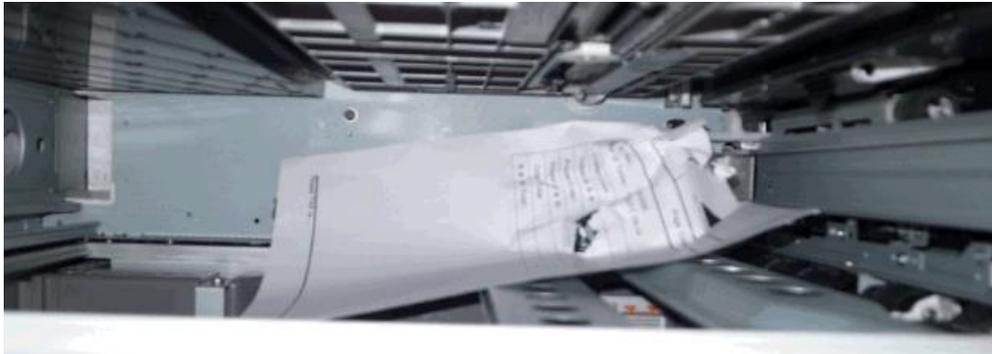
- Paper jam at the rear side of the paper tray

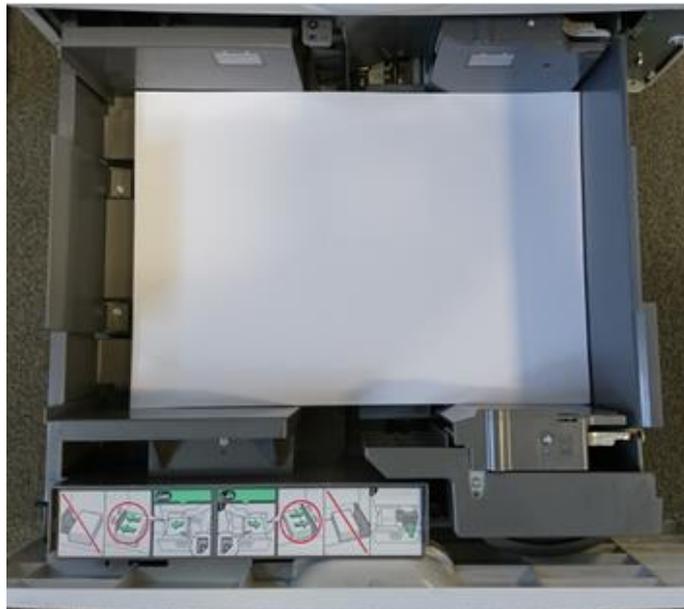
- A3/DLT paper mistakenly loaded in A4/LT tandem tray

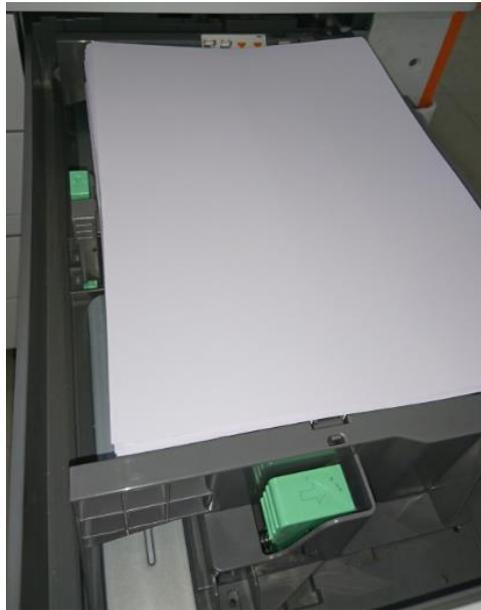
- Paper tray is over-loaded

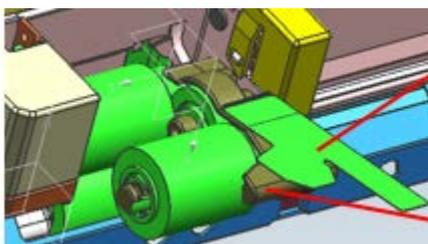
Change 2: The material and the color of the pickup arm has been changed and the seat of the pickup arm also removed.

Old P/N <Group B>	New P/N	Description	Int	Q'ty	Note
D2022617	D0BQ2623	ARM:PICKUP:MANUAL FEED	X/O	1	B
D2022618	-	SHEET:PICKUP	-	1->0	B
