Model: MET-C2ab		Date: 17-Apr-17	No.: RD0AD002
Subject: HE Model Installation Procedure		Prepared by: E.Hinata	
From: 1st Tech Service Sect., MFP/P Tech Service Dept.			
Classification:	<input type="checkbox"/> Troubleshooting <input type="checkbox"/> Part information <input type="checkbox"/> Action required <input type="checkbox"/> Mechanical <input type="checkbox"/> Electrical <input type="checkbox"/> Service manual revision <input type="checkbox"/> Paper path <input type="checkbox"/> Transmit/receive <input type="checkbox"/> Retrofit information <input type="checkbox"/> Product Safety <input checked="" type="checkbox"/> Other (New model) <input type="checkbox"/> Tier 2

Model: MET-C2.1ab	Date: 10-Feb-17	No.: RD0AD001f
-------------------	-----------------	----------------

Subject: New model release information: MP C3004ex/3504ex/4504ex/5504ex/6004ex, MP C2004ex/2504ex		Prepared by: A.Shigeta	
From: 1st Tech Service Sect., MFP/P Tech Service Dept.			
Classification:	<input type="checkbox"/> Troubleshooting <input type="checkbox"/> Mechanical <input type="checkbox"/> Paper path <input type="checkbox"/> Product Safety	<input checked="" type="checkbox"/> Part information <input typ

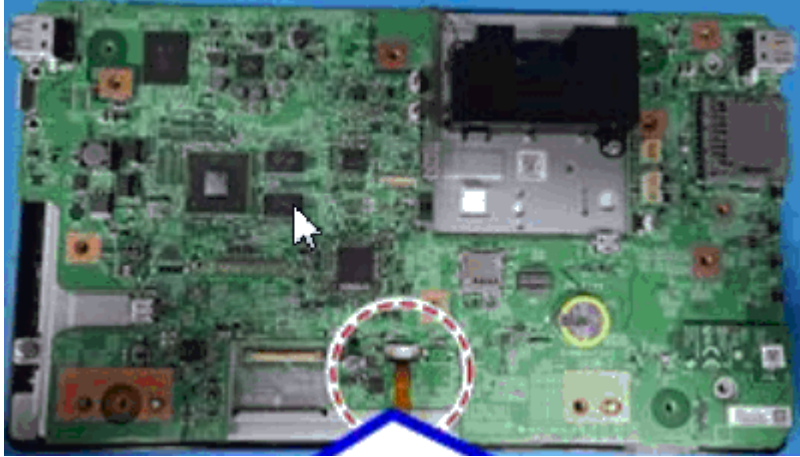
1. Board

Components to Check during Troubleshooting

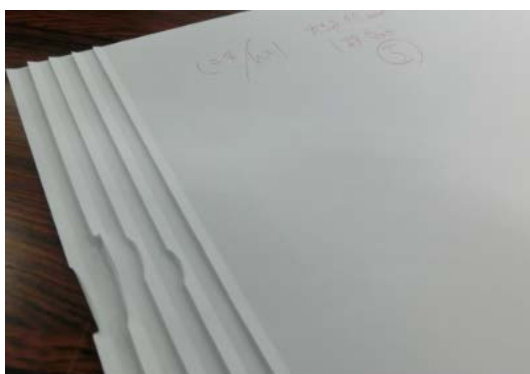
- The P/N will be announced once it is available.
- As a side effect with this separation pad, the leading edge of some paper types may crease when touching the pad, as shown in the photo below.
- Because of this, this pad is only used in cases in which the firmware upgrade is ineffective (It is not installed on machines in mass-production).

2. If this does not solve the issue, replace the separation pad with the following one, which has been customized specifically for this symptom.

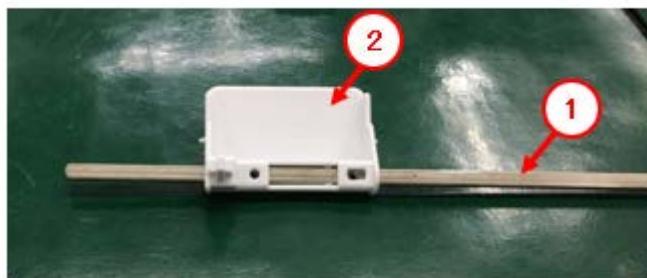
Lubricant contacts the shaft for the grip of the duplex unit, causing a chemical crack. As a result, the hook for the grip breaks and the spring detaches.

24. Replace the grip.

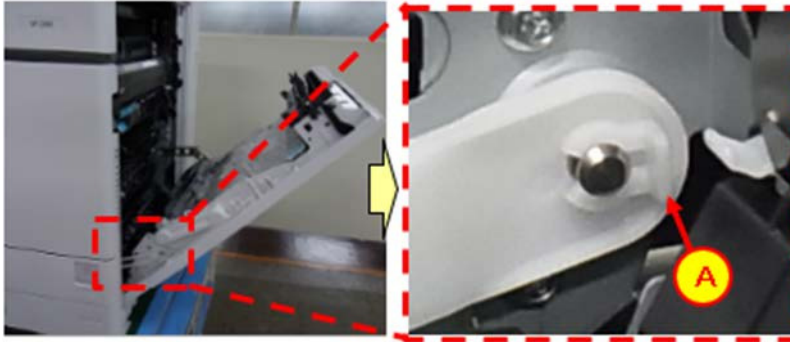
49. Attach [A].

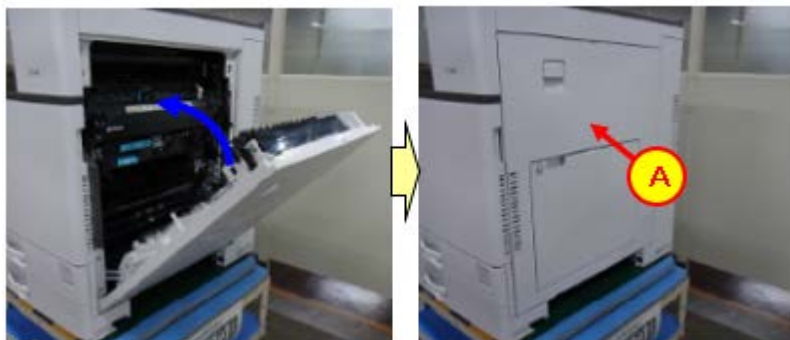
50. Close [A].

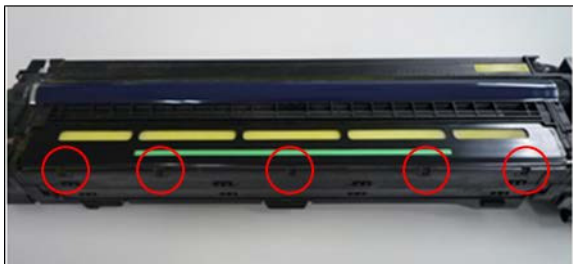
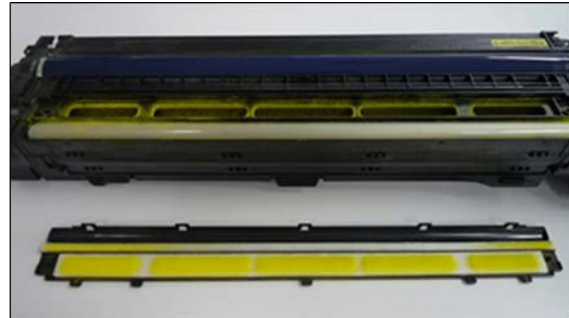
CAUSE

The upper cover of the development unit deforms, and combined with the compressive force of the filter, this causes the gap between the cover and development roller to narrow. As a result, when making continuous prints in half-speed mode, the developer in the central area of the unit cannot be fully retrieved (the amount scooped in this mode is larger), and then leaks out.

1. Remove the hooks (X5) and the filter cover.
