Model: MET-C2.1cde	Date: 10-Feb-17	No.: RD0AF001f
--------------------	-----------------	----------------

Subject: New model release information: MP C3004ex/3504ex/4504ex/5504ex/6004ex, MP C2004ex/2504ex		Prepared by: A.Shigeta	
From: 1st Tech Service Sect., MFP/P Tech Service Dept.			
Classification:	<input type="checkbox"/> Troubleshooting <input type="checkbox"/> Mechanical <input type="checkbox"/> Paper path <input type="checkbox"/> Product Safety	<input checked="" type="checkbox"/> Part information <input type="checkbox"/> Electrical <input type="checkbox"/> Transmit/receive <input type="checkbox"/> Other ()	<input type="checkbox"/> Action required <input checked="" type="checkbox"/> Service manual revision <input type="checkbox"/> Retrofit information <input type="checkbox"/> Tier 2 <input type="checkbox"/> Tier 0.5

With the release of the new model for successor of MP C3004/3504/4504/5504/6004 and MP C2004/2504, this RTB was released to announce differences between the predecessor models and the new models.

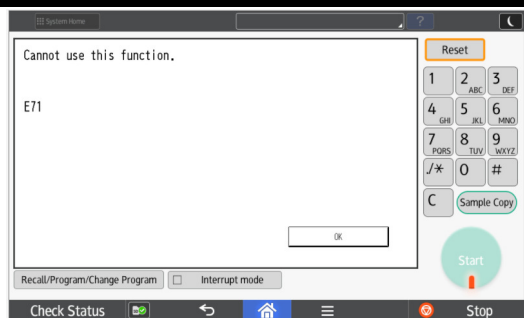
- **E71: Network communication error occurs at the reserved date/time of the package firmware update from the network.**

4. When the machine tries to update through ARFU, Error code 5: Version information obtaining error is logged in SP7-520-051 to 060.

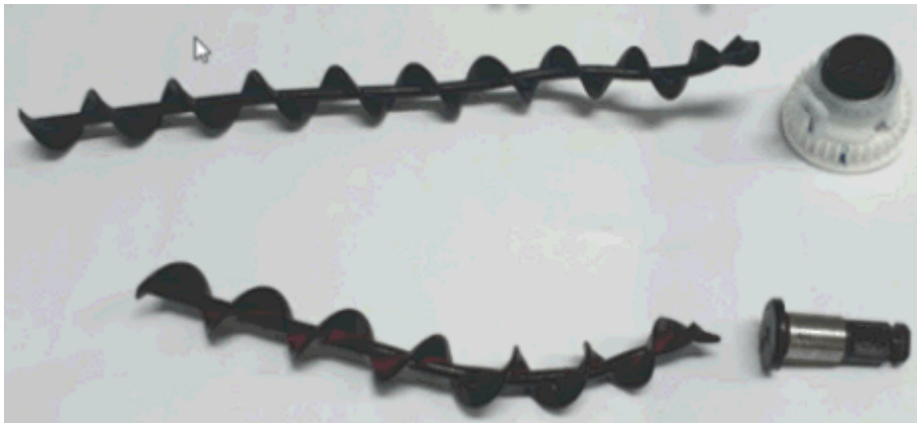
The toner hoppers break, triggering early Toner End, white lines, and/or noise.

Replace the hopper and development unit at the same time.

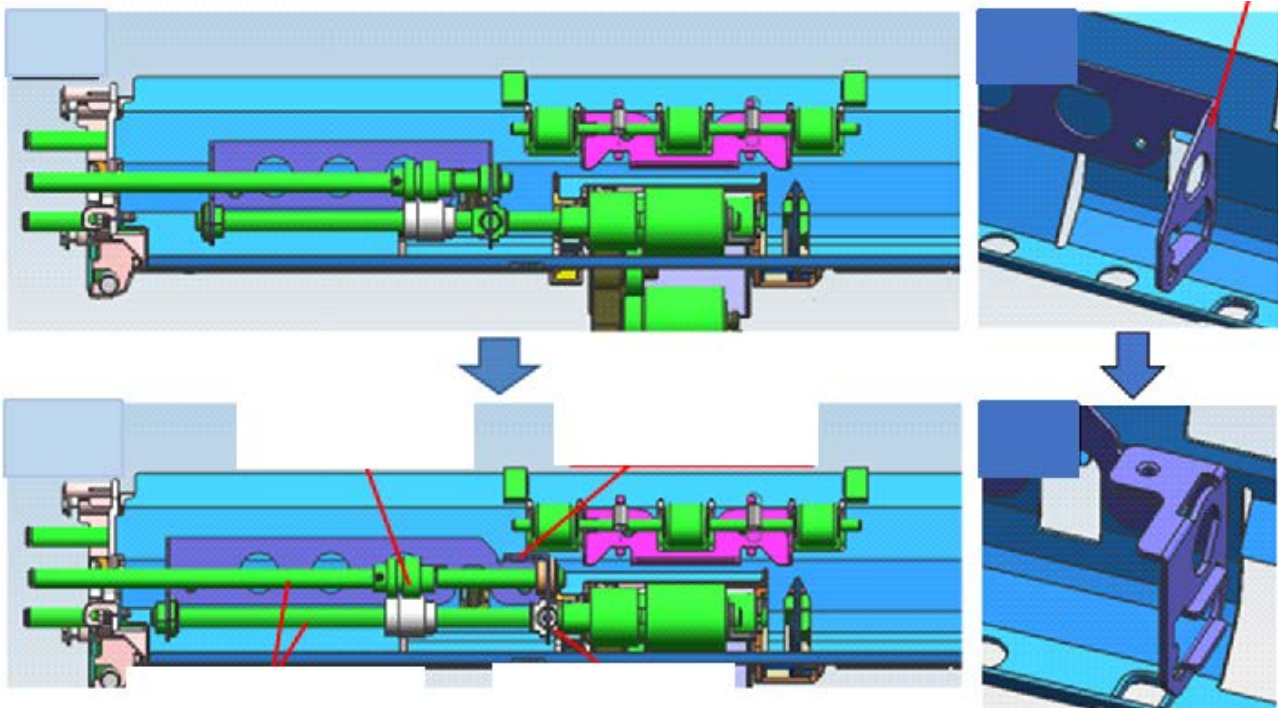
Change 3: The shape of the brackets and bearings, length of the roller shaft, and the gear position has changed. Also e-rings added.
