Model: MET-C2.1yz	Date: 10-Feb-17	No.: RD0AH001f
-------------------	-----------------	----------------

Subject: New model release information: MP C3004ex/3504ex/4504ex/5504ex/6004ex, MP C2004ex/2504ex		Prepared by: A.Shigeta	
From: 1st Tech Service Sect., MFP/P Tech Service Dept.			
Classification:	<input type="checkbox"/> Troubleshooting	<input checked="" type="checkbox"/> Part information	<input type="checkbox"/> Action required
	<input type="checkbox"/> Mechanical	<input type="checkbox"/> Electrical	<input checked="" type="checkbox"/> Service manual revision
	<input type="checkbox"/> Paper path	<input type="checkbox"/> Transmit/receive	<input type="checkbox"/> Retrofit information
	<input type="checkbox"/> Product Safety	<input type="checkbox"/> Other ( )	<input type="checkbox"/> Tier 2 <input type="checkbox"/> Tier 0.5

With the release of the new model for successor of MP C3004/3504/4504/5504/6004 and MP C2004/2504, this RTB was released to announce differences between the predecessor models and the new models.

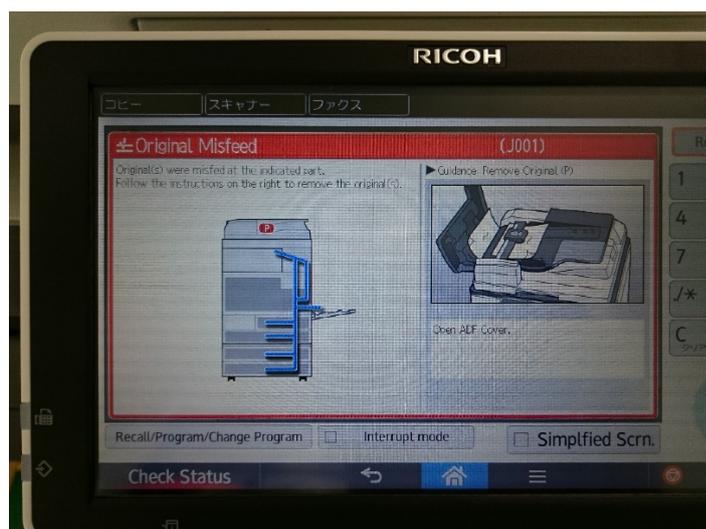
**Affected models:** Met-C2.1a/b/y/z, Cor-C1.5c/d/f/g with ARDF3090 installed.

**Note:** This does not occur when using the DF for copies, because the scanning speed is different.

The original feeler rebounds and chattering of the original detection sensor occurs due to parts variation.

Replace the feeler with the modified part.

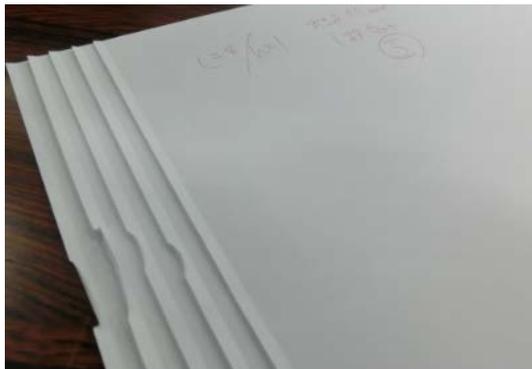
- The P/N will be announced once it is available.
- As a side effect with this separation pad, the leading edge of some paper types may crease when touching the pad, as shown in the photo below.
- Because of this, this pad is only used in cases in which the firmware upgrade is ineffective (It is not installed on machines in mass-production).

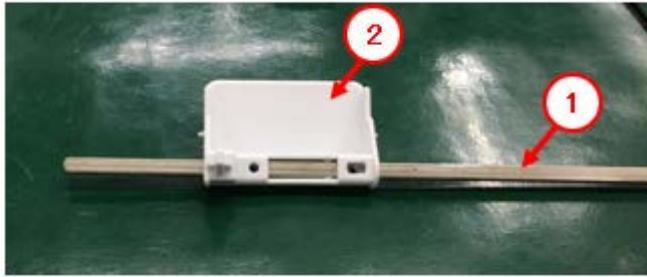
Lubricant contacts the shaft for the grip of the duplex unit, causing a chemical crack. As a result, the hook for the grip breaks and the spring detaches.

24. Replace the grip.

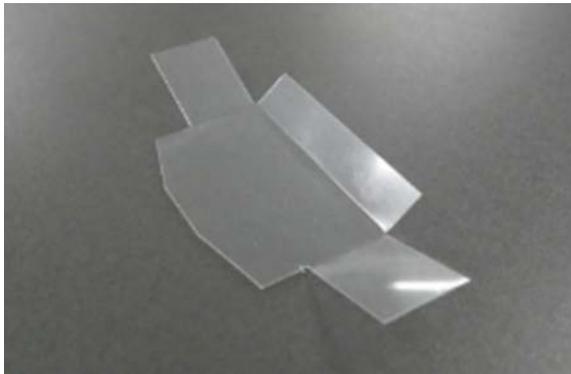
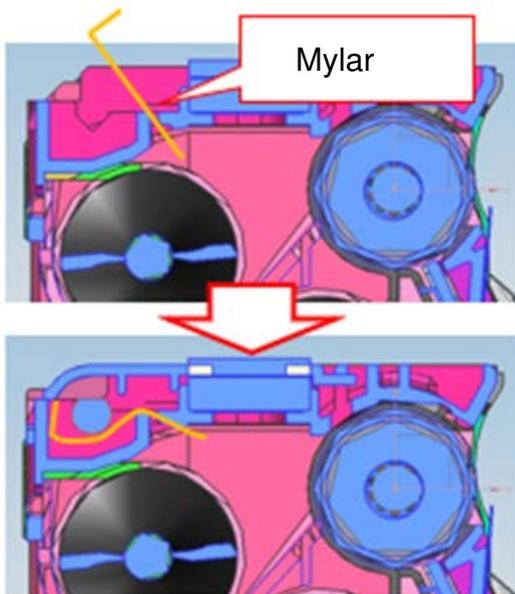
The upper cover of the development unit deforms, and combined with the compressive force of the filter, this causes the gap between the cover and development roller to narrow. As a result, when making continuous prints in half-speed mode, the developer in the central area of the unit cannot be fully retrieved (the amount scooped in this mode is larger), and then leaks out.

P/N	Description	Q'ty
M0AJ3138	SHEET:PROTECT:COVER:DEVELOPMENT	1-1

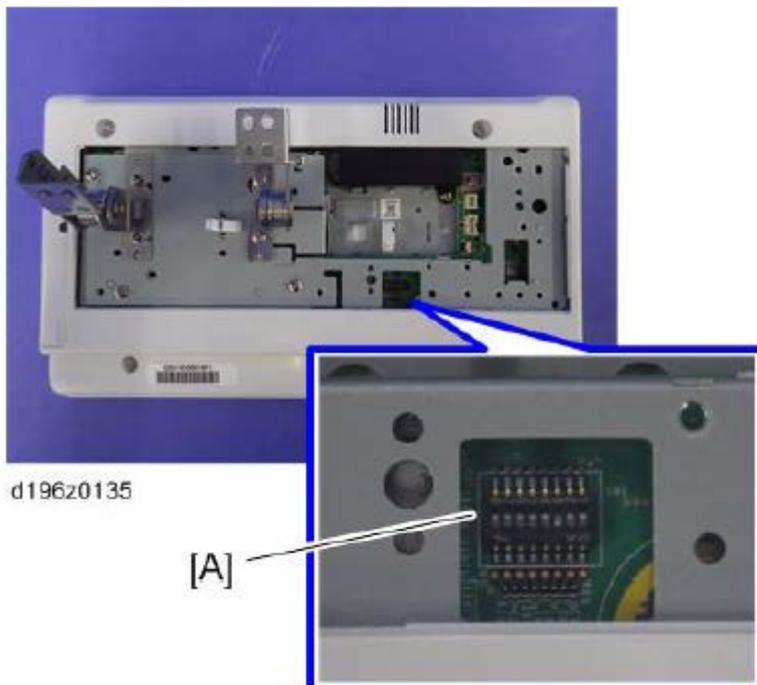
By factory default, switches No.3 and No.7 of the DIP switch [A] on the micro computer board are set to ON. When installing the operation panel unit, make sure that the DIP switch setting is correct for the MFP on which you are installing the panel.

**IMPORTANT:** Note the DIP switch settings for the old operation panel unit before replacing it, and then apply the same settings to the new Smart Operation Panel. These settings are common to all MFP models.

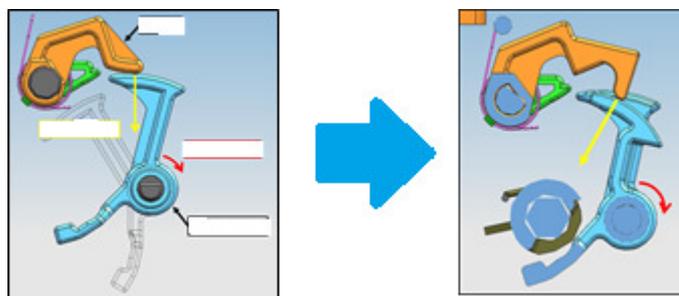
**Change:** The hit position of the two parts has changed because the shape of the Paper stopper and the Paper stopper link have been changed.

Old P/N	New P/N	Description	Int	Q'ty	Note
D1492638	D0BQ2638	LINK:PAPER STOPPER:MANUAL FEED	X/X	1	A
D2412638	D0BQ2637	PAPER STOPPER:MANUAL FEED	X/X	1	A

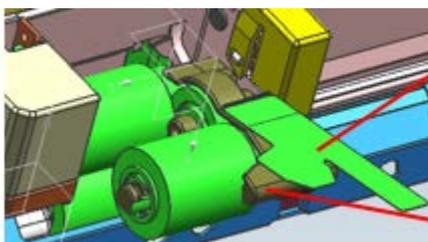
**Change 2:** The material and the color of the pickup arm has been changed and the seat of the pickup arm also removed.

Old P/N <Group B>	New P/N	Description	Int	Q'ty	Note
D2022617	D0BQ2623	ARM:PICKUP:MANUAL FEED	X/O	1	B
D2022618	-	SHEET:PICKUP	-	1->0	B
