Model: MET-C2ab	Date: 13-May-16	No.: RD239006
------------------------	-----------------	---------------

Subject: Firmware Release Note: PowerSaving Sys		Prepared by: M. Kumagai	
From: 1st Tech Service Sect., MFP/Printer Tech Service Dept.			
Classification:	<input type="checkbox"/> Troubleshooting <input type="checkbox"/> Mechanical <input type="checkbox"/> Paper path <input type="checkbox"/> Product Safety	<input type="checkbox"/> Part information <input type="checkbox"/> Electrical <input type="checkbox"/> Transmit/receive <input checked="" type="checkbox"/> Other (Firmware)	<input type="checkbox"/> Action required <input type="checkbox"/> Service manual revision <input type="checkbox"/> Retrofit information <input checked="" type="checkbox"/> Tier 2

This RTB has been issued to announce the firmware release information for the **PowerSaving Sys.**

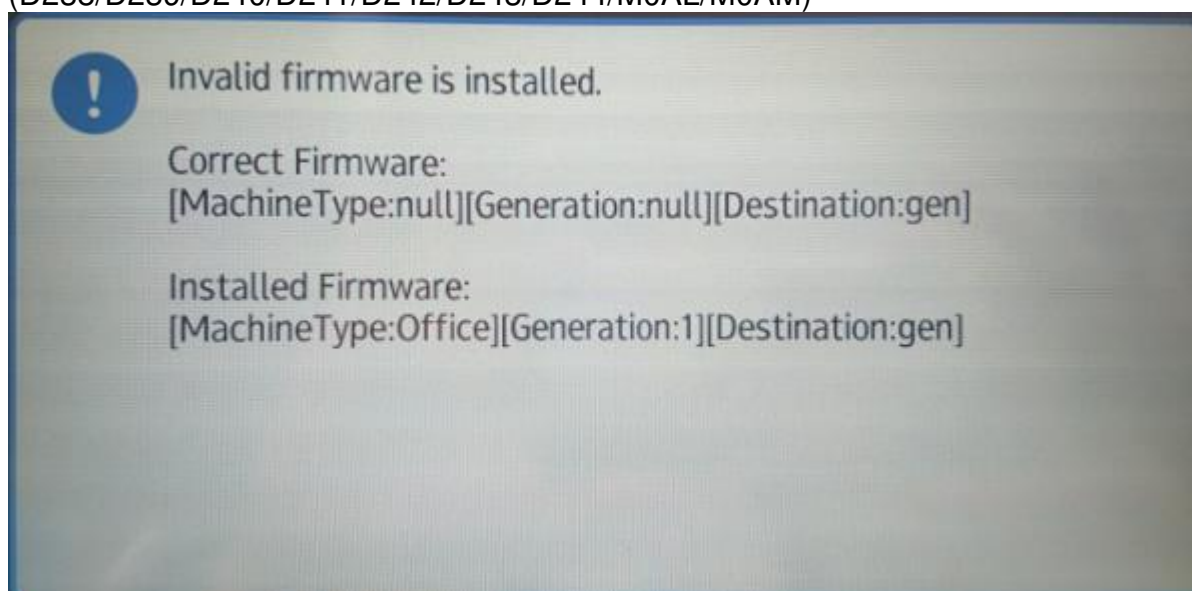
The following error is displayed at machine installation.

Corruption of the program files in the operation panel control chip.

Note: There is no damage to the hardware.

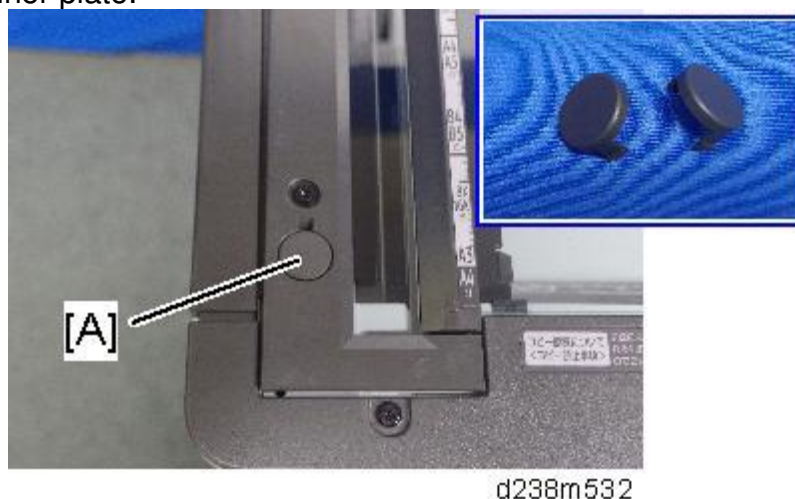
- On machines produced from the cut-in S/N listed below, the cap covers for the scanner are now located inside a small plastic bag affixed to the area shown below. Make sure to attach the caps to the holes [A] shown below, as mentioned in the Service Manual. If these caps are not used, dust can get inside the holes in the scanner plate.

- On machines produced before this, the cap covers are contained in a plastic bag together with the AC power cord, affixed to the larger bag that covers the machine. Make sure to attach these caps, as described above.

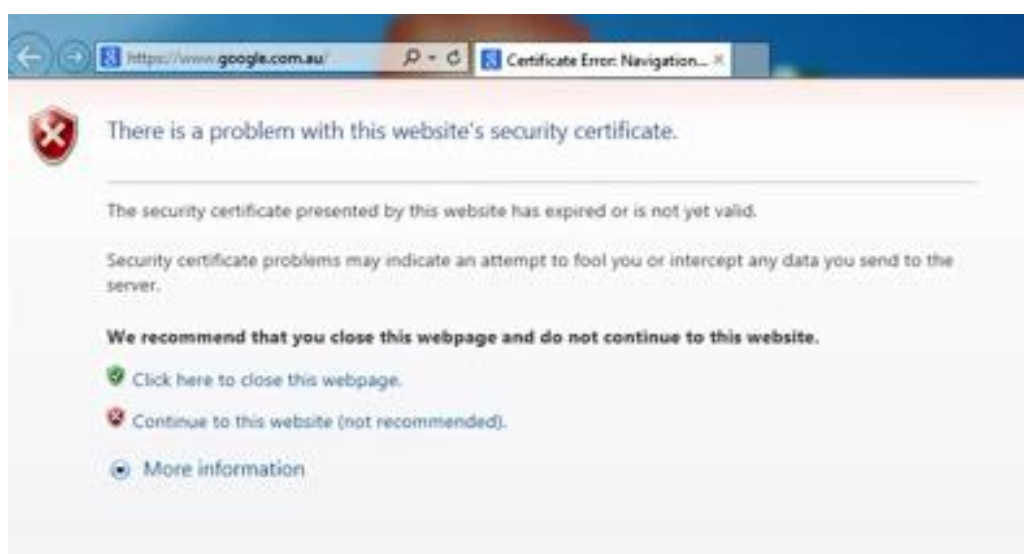
The following CAUTION is displayed when using WIM (Web Image Monitor).

The security certification has been installed on the machine before shipment. As a result, the SSL/TLS communication setting was set to "Encryption priority".

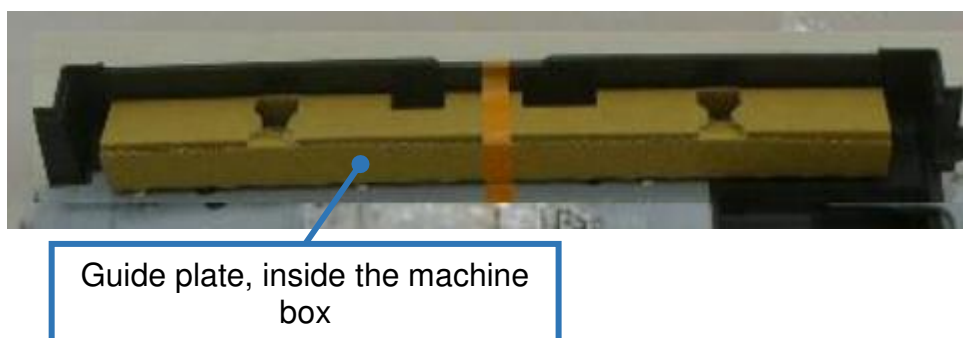
- In particular, the guide plate is contained inside a long, thin cardboard box inside the machine box. It may look like empty cardboard boxes, so **make sure NOT to dispose of it.**

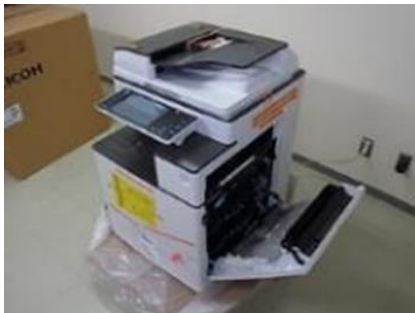
The front lever is broken when the duplex unit is opened and closed.

If the symptom occurs, replace the lever (P/N: D2399901).

1. Open the duplex unit.

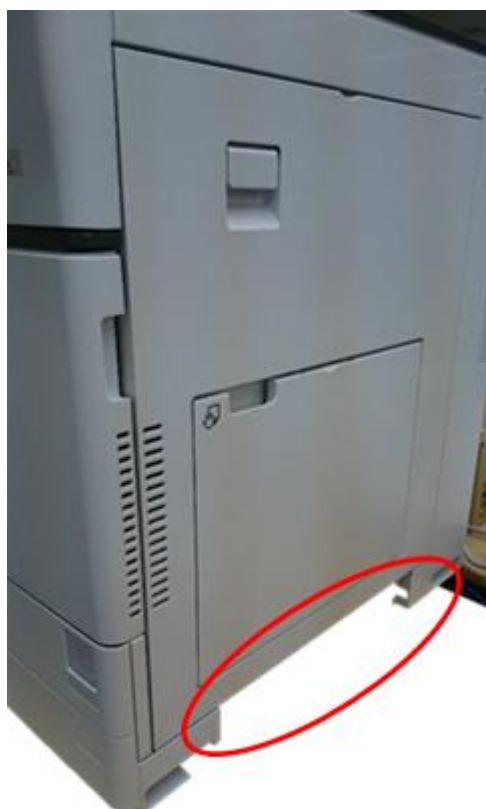
PROBLEM

Small insects may get inside the machine from the open space at the bottom right.

Procure and install the cover [A] below.

No	Part Number	Description	Qty
1	D1491268	COVER:RIGHT:LOWER	1

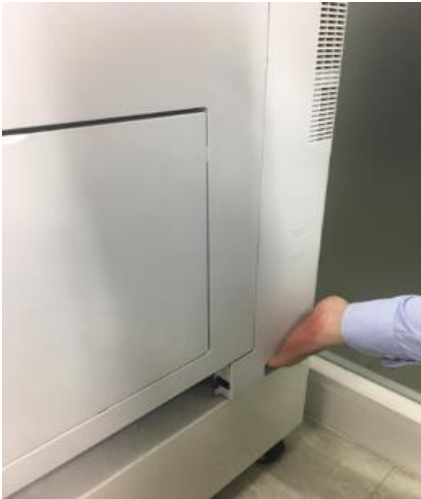
Figure.2 Correct

- Make sure to do the following when installing the machine:
 Hold the grip of the right rear cover as shown in **Fig. 2 (CORRECT)**.
 Insert your fingers **all the way up and inside the grip**.
- If you do not, the right cover will break, as shown in Fig. 4.

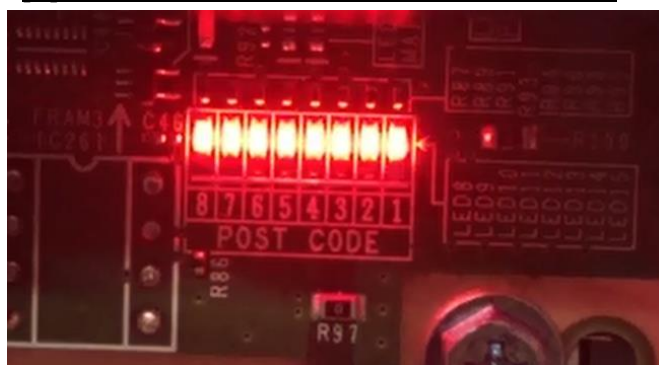
Figure 5: LEDs 1 to 8 are lit constantly

[B]: Abnormal mode: LEDs on the controller board

No.	Note
POSTCODE 1-8	<ol style="list-style-type: none"> 1. For self-diagnosis code (BIOS). 2. After the BIOS starts up, LEDs 4,5,7 turn off and LEDs 1,2,3 ,6 turn on and LED 8 blinks. LED 8 remains lit or off when there is a problem with the CPU. <p>Note: When a DIMM connection failure, defective CMOS, or defective BIOS occurs, postcode LEDs 1-8 are lit constantly.</p>
BIOS/OS LED	<ul style="list-style-type: none"> - LED is lit when the BIOS is running. - LED blinks when the OS is running.

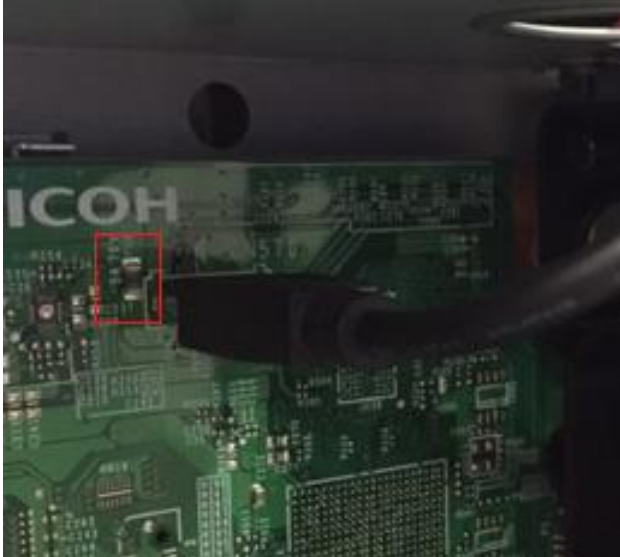
Figure 13: Fuse on the IPU

Check fuse 3 on the IPU is operating correctly.

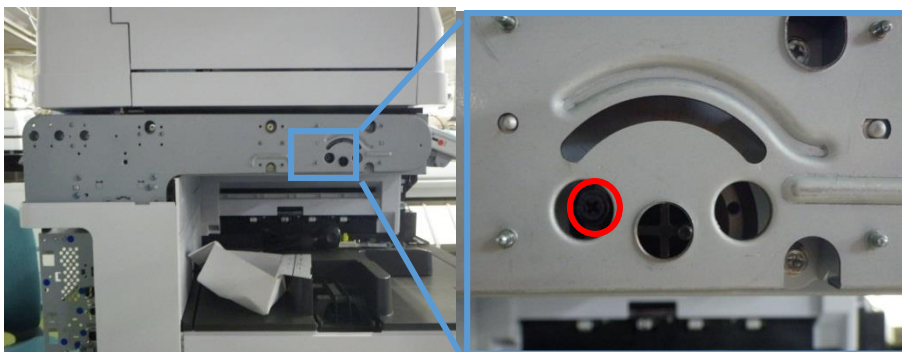
Never loosen or remove the following screw when you remove or re-attach the unit. This is because this screw fixes the scanner cam in place. If the position of the scanner cam changes, the scanner will be misaligned. This will result in image skew and other image alignment issues.

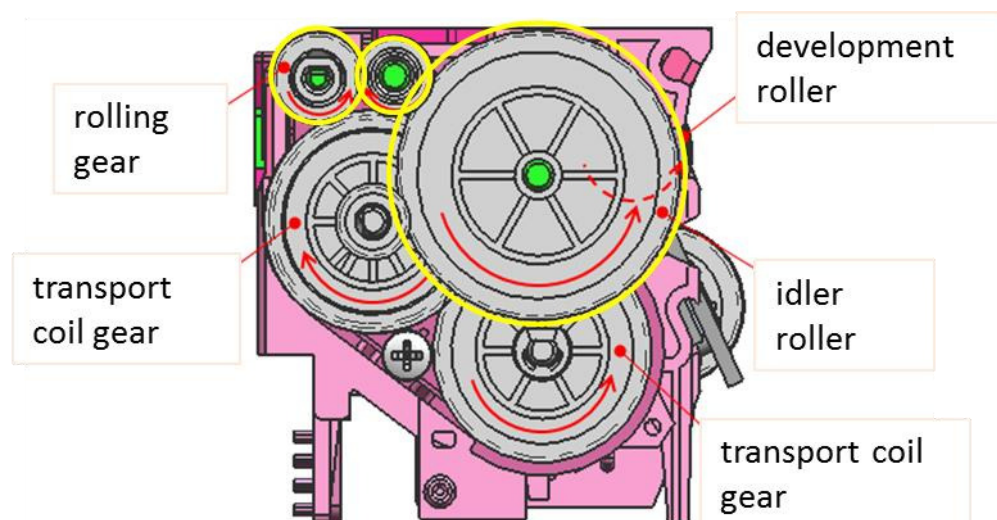
Three new gears (yellow circles) are added. They are driven from the developer collection coil gear, so the seal is automatically wound. This mechanism works at installation and/or replacement.

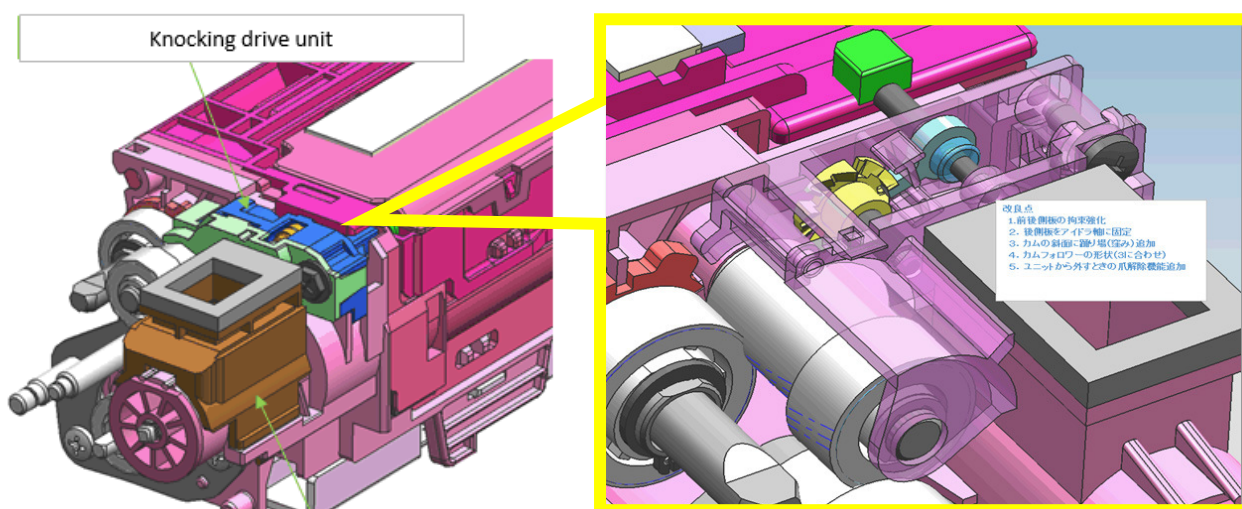
Figure.1

A new knocking mechanism has been added (Fig.1). Normally, the air flows from the development roller to the filter in the development unit (Fig. 2). However, when the filter is full of toner, the inner pressure increases and reverse air flow occurs, which causes toner blasting to occur (Fig.3). To prevent this, the knocking mechanism periodically knocks the development unit cover, so toner in the filter drops back into the development unit. This mechanism works by reverse rotation of the development roller.

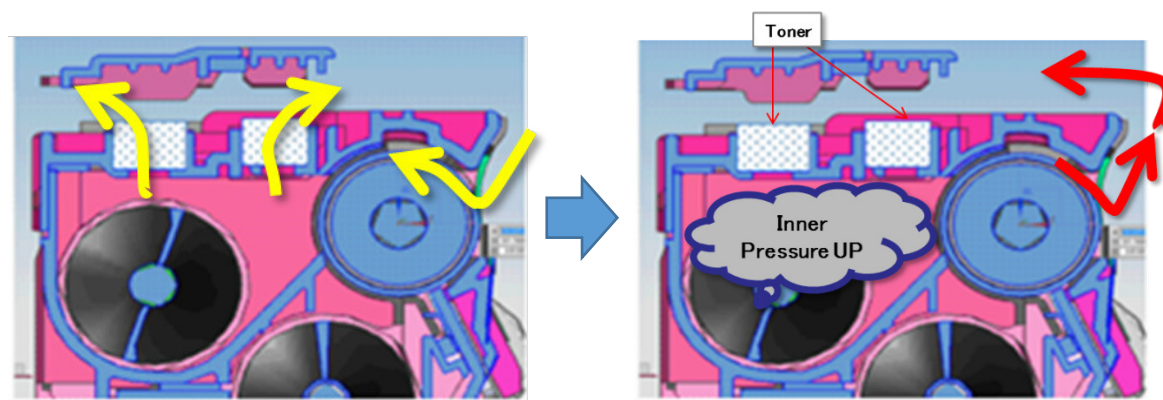
Fig.2 At first, air flow as shown by the yellow arrows

Fig.3 Toner blasting occurs

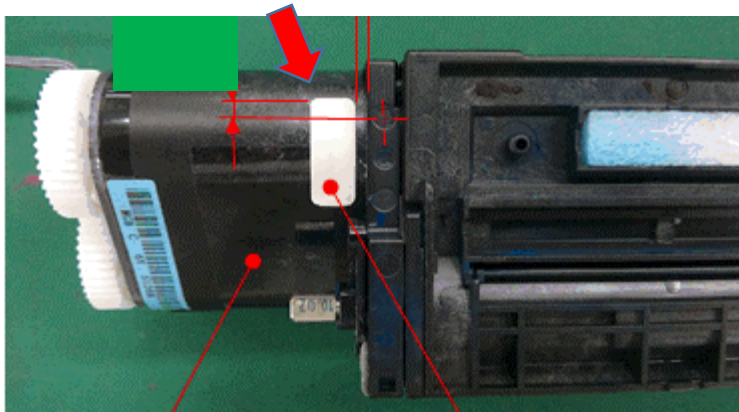
A white decal is attached to units with the new mechanism.

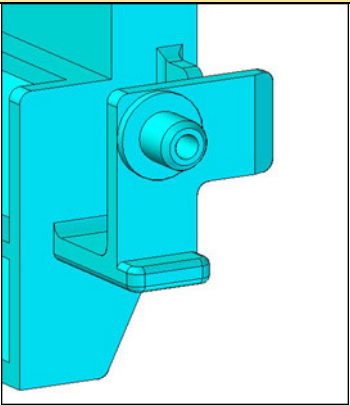
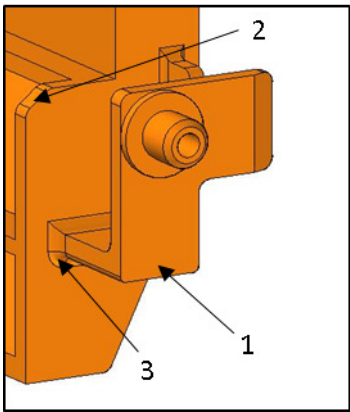
Old D1492721	New D6942721
Shape

Reason: To further strengthen and prevent breaking of the guide plate.

<ol style="list-style-type: none"> Deleted stopper Changed angle regulation Strengthened part

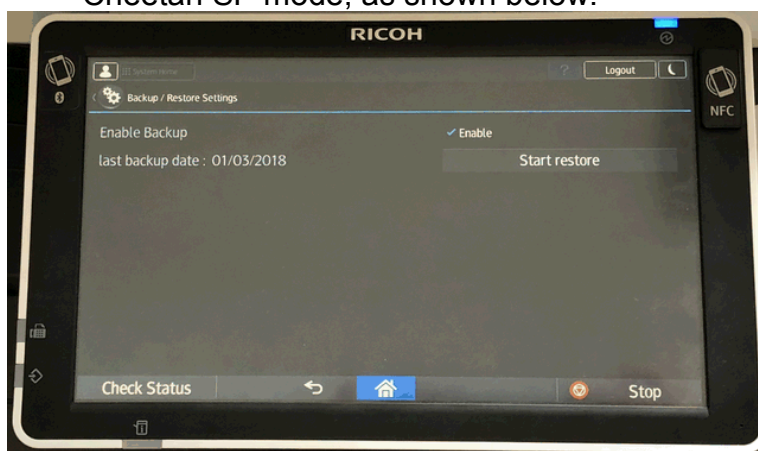
- This is because there is a bug with the operation panel backup feature.
Specifically, the machine enters Energy Saver mode and freezes during the first backup performed (in early morning hours) after the feature is installed.
- To ensure this does not occur, **disable** the operation panel backup feature in the Cheetah SP mode, as shown below.

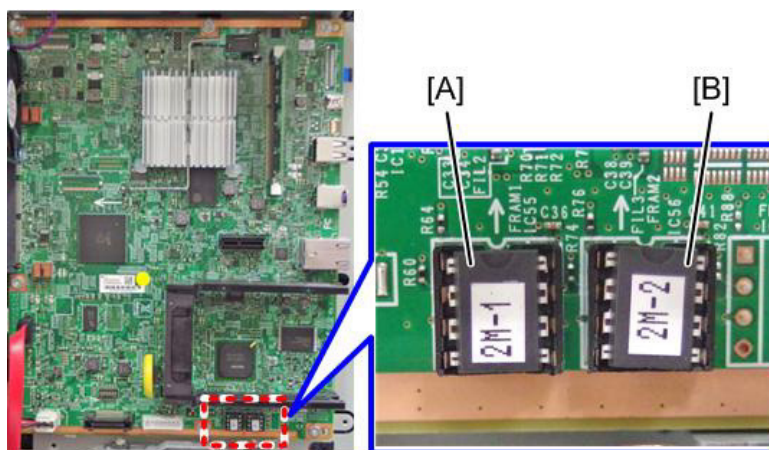
- Referring to the following procedure, be sure that there are no mistakes in the mounting position and orientation of the NVRAMs. Incorrect installation of the NVRAM will damage both the controller board and NVRAM.

Make sure to attach the NVRAM in the CORRECT ORIENTATION, boxed in blue below. As shown here, the cutout in the NVRAM should be facing UP.

If you attach the NVRAM in the reverse orientation, a short will occur and may (in the worst) melt the NVRAM.

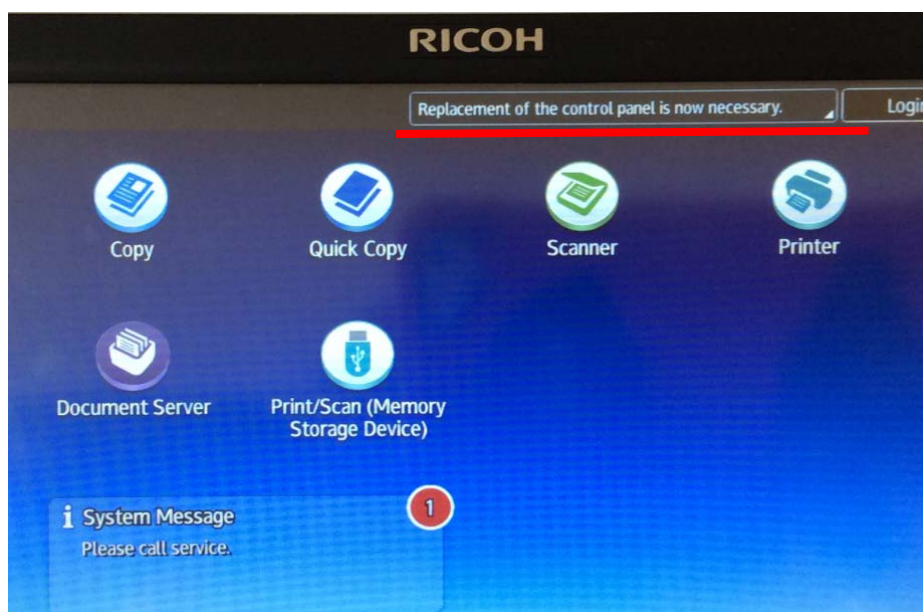
"Replacement of the control panel is now necessary" is displayed and SC843-02 occurs.

Replace the PCB board for the Smart Operation Panel.

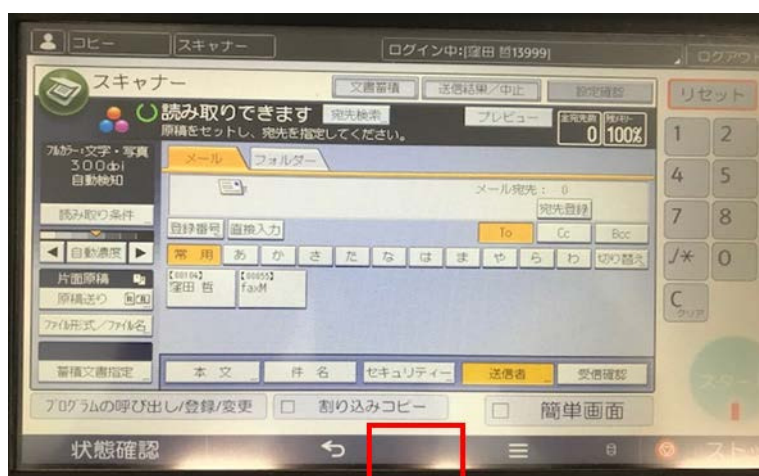
With firmware combination **#3** below, the Home button is not displayed, making it impossible to switch between applications.

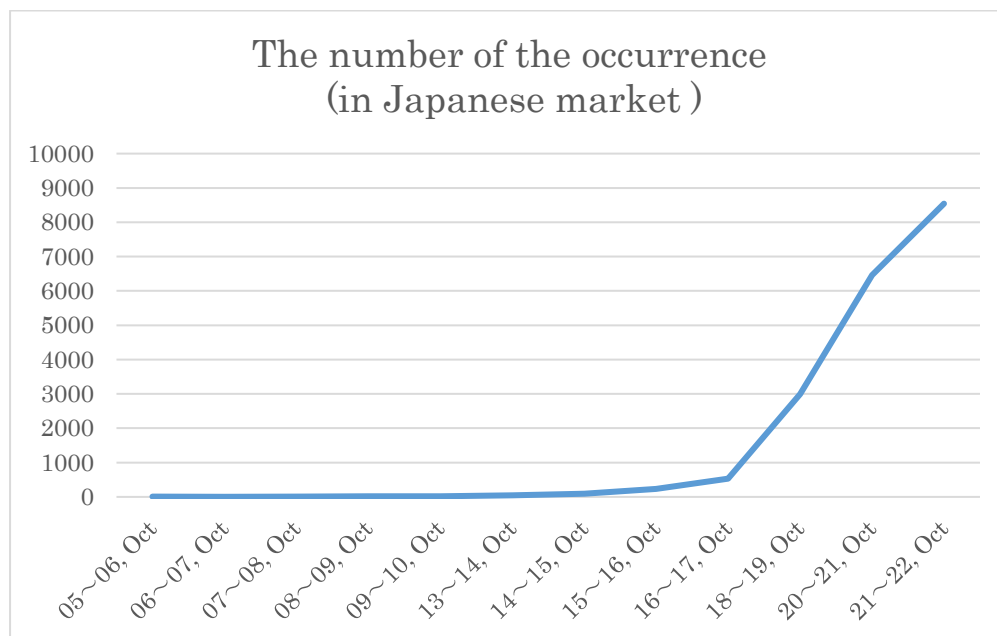
- Occurrence number of SC899 occurrence (in Japanese domestic market)

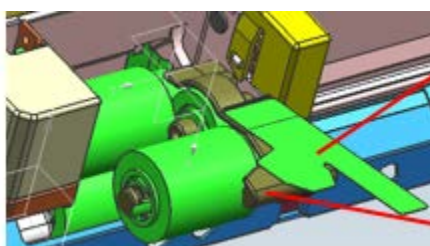
Change 2: The material and the color of the pickup arm has been changed and the seat of the pickup arm also removed.

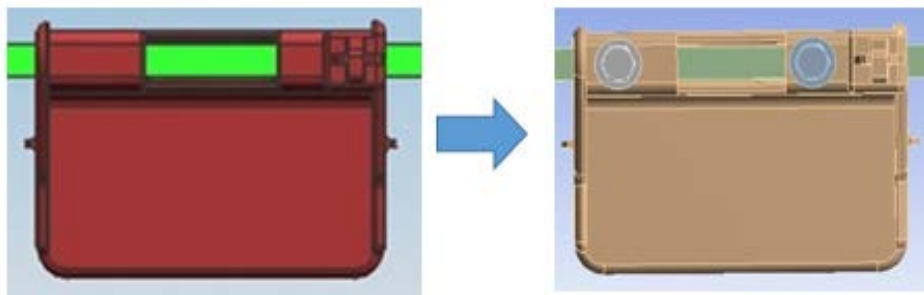
Change 5: The grip of duplex unit has been changed from press fit to screw type.
