Model: MET-C2cde	Date: 13-May-16	No.: RD242006
-------------------------	-----------------	---------------

Subject: Firmware Release Note: PowerSaving Sys		Prepared by: M. Kumagai	
From: 1st Tech Service Sect., MFP/Printer Tech Service Dept.			
Classification:	<input type="checkbox"/> Troubleshooting	<input type="checkbox"/> Part information	<input type="checkbox"/> Action required
	<input type="checkbox"/> Mechanical	<input type="checkbox"/> Electrical	<input type="checkbox"/> Service manual revision
	<input type="checkbox"/> Paper path	<input type="checkbox"/> Transmit/receive	<input type="checkbox"/> Retrofit information
	<input type="checkbox"/> Product Safety	<input checked="" type="checkbox"/> Other (Firmware)	<input checked="" type="checkbox"/> Tier 2

This RTB has been issued to announce the firmware release information for the **PowerSaving Sys.**

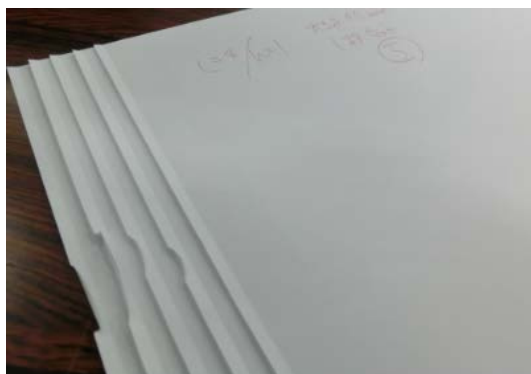
- The P/N will be announced once it is available.
- As a side effect with this separation pad, the leading edge of some paper types may crease when touching the pad, as shown in the photo below.
- Because of this, this pad is only used in cases in which the firmware upgrade is ineffective (It is not installed on machines in mass-production).

2. If this does not solve the issue, replace the separation pad with the following one, which has been customized specifically for this symptom.

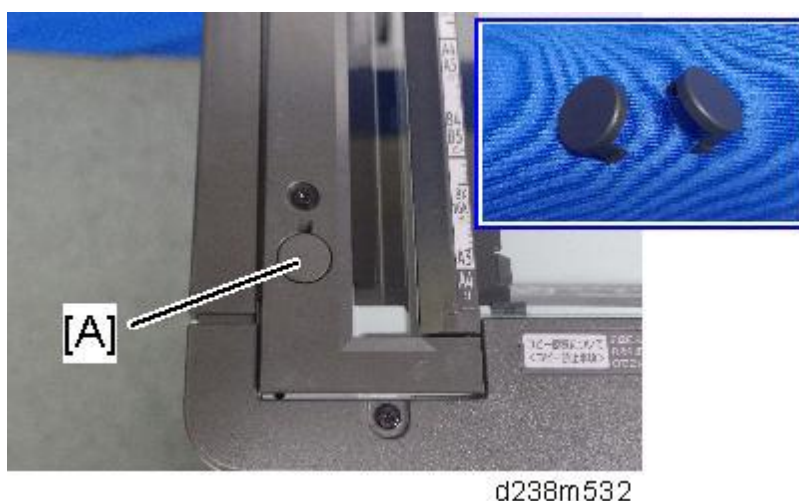
- On machines produced from the cut-in S/N listed below, the cap covers for the scanner are now located inside a small plastic bag affixed to the area shown below.
- Make sure to **attach the caps** to the holes [A] shown below, as mentioned in the Service Manual. If these caps are not used, dust can get inside the holes in the scanner plate.

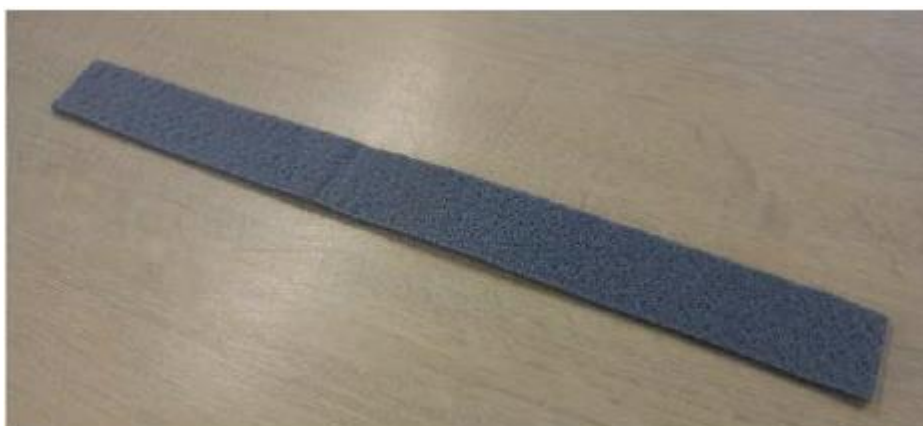
This is to avoid damaging the surface on which the finisher is installed, which can happen when the saddle stitch unit is opened. When the unit is opened, the edge of the support stand can sometimes scratch the installation surface.

When installing the **Booklet Finisher SR3240** on a fragile surface (e.g., any kind of coated, metallic, tile, stone, or wooden floor or flooring), make sure to **attach a cushion sheet to the bottom of the support stands** of the saddle stitch unit.

Old P/N	New P/N	Description	Q'ty	Int	Set
-	D3CH3941	CUSHION:SADDLE STAPLER UNIT:PULL OUT:T1.0	1	-	-

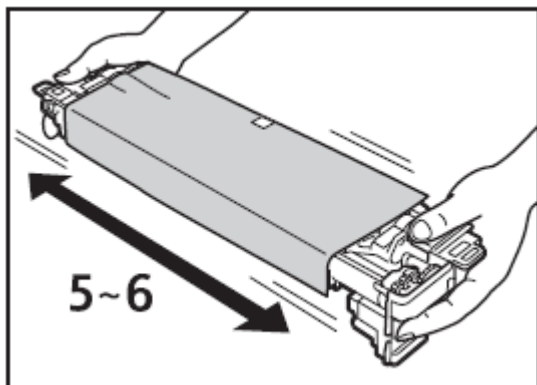
As one of the reasons that cause this symptom, the development unit was stored/transported in a position prior to its installation. This causes developer to accumulate on the gears at either end of the unit, disabling proper rotation of the development roller.

When installing a new PCDU or a new development unit, take out the unit from the package and shake it 5 or 6 times horizontally. This will reduce the chances of SC324-01 and SC324-05.

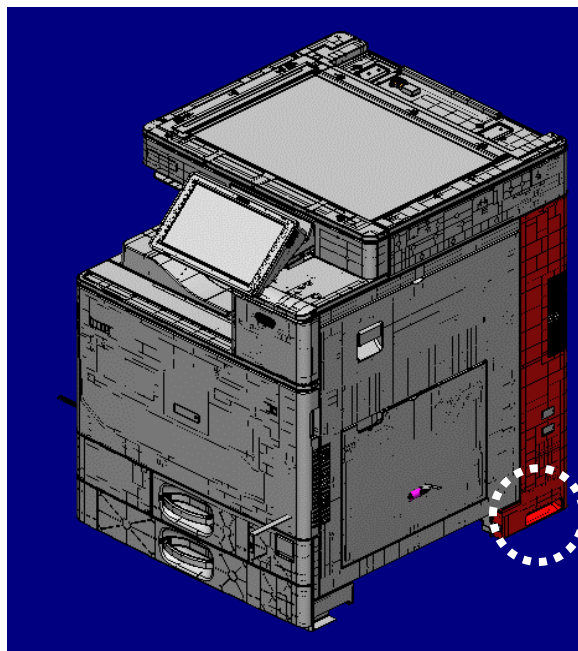
Figure1 right rear cover

- Make sure to do the following when installing the machine:
 Hold the grip of the right rear cover as shown in **Fig. 2 (CORRECT)**.
 Insert your fingers **all the way up and inside the grip**.
- If you do not, the right cover will break, as shown in Fig. 4.

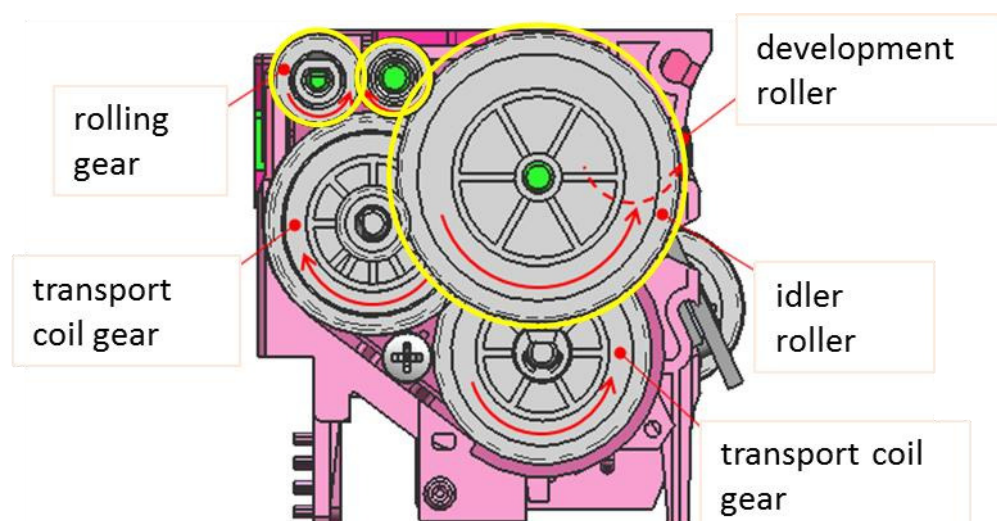
Three new gears (yellow circles) are added. They are driven from the developer collection coil gear, so the seal is automatically wound. This mechanism works at installation and/or replacement.

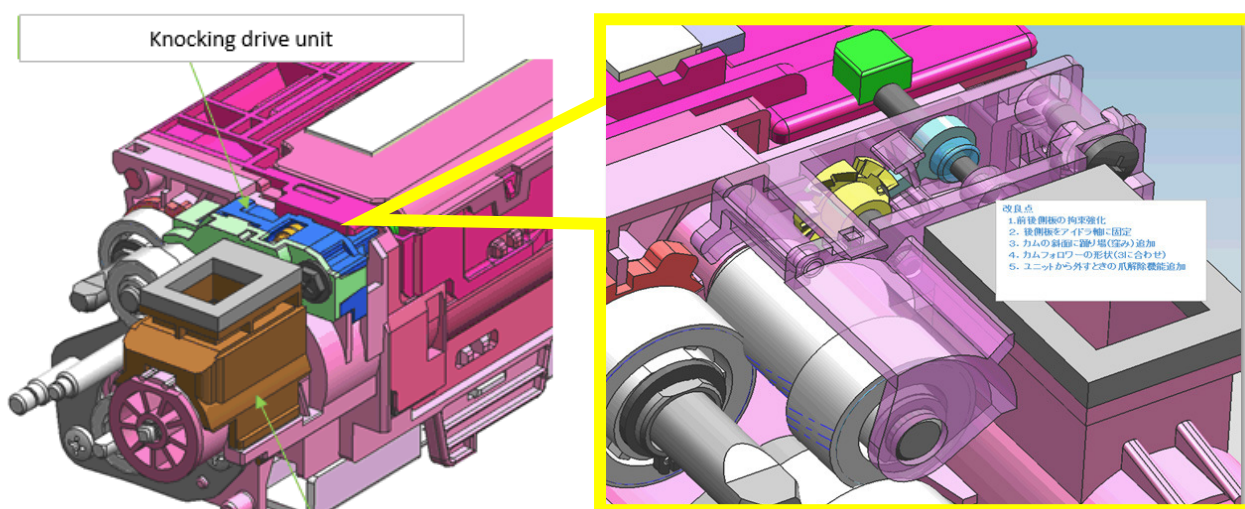
Figure.1

A new knocking mechanism has been added (Fig.1). Normally, the air flows from the development roller to the filter in the development unit (Fig. 2). However, when the filter is full of toner, the inner pressure increases and reverse air flow occurs, which causes toner blasting to occur (Fig.3). To prevent this, the knocking mechanism periodically knocks the development unit cover, so toner in the filter drops back into the development unit. This mechanism works by reverse rotation of the development roller.

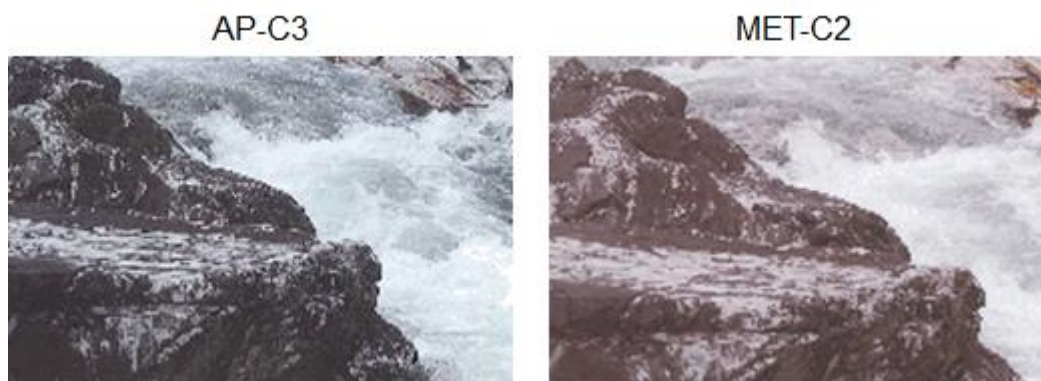
MET-C2 has been designed to produce a slight difference in color compared to previous models, such as the AP-C3. The gray color tone of the MET-C2 tends to have a red tint:

By installing the color profile, the color balance can be slightly adjusted to the gray tone that the AP-C3 produces.

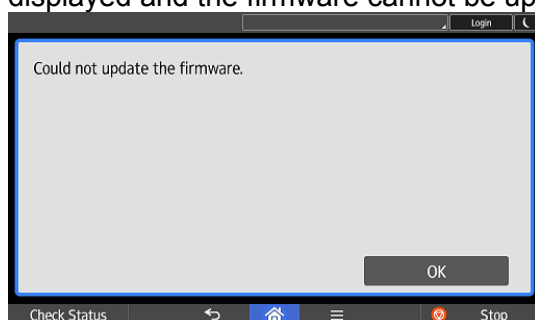
1. When users try to update the firmware from the Application Site, the following message is displayed and the firmware cannot be updated:

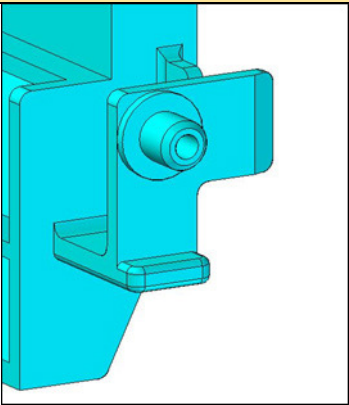
Reason: To further strengthen and prevent breaking of the guide plate.

<ol style="list-style-type: none"> Deleted stopper Changed angle regulation Strengthened part

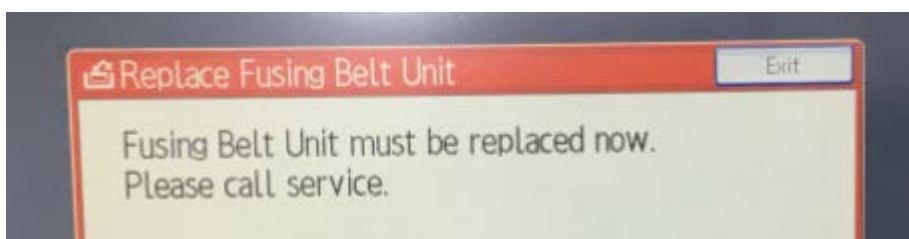
SYMPTOM

The message "Fusing Belt unit must be replaced now." is displayed before the target yield.

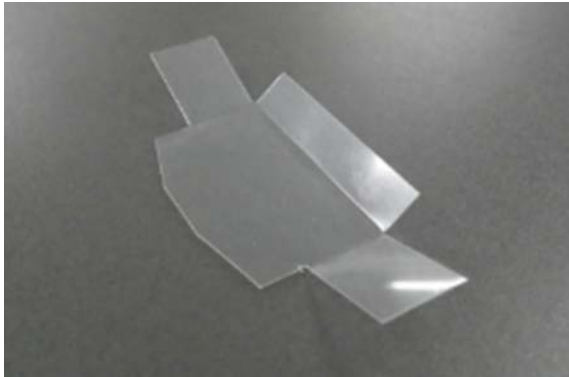
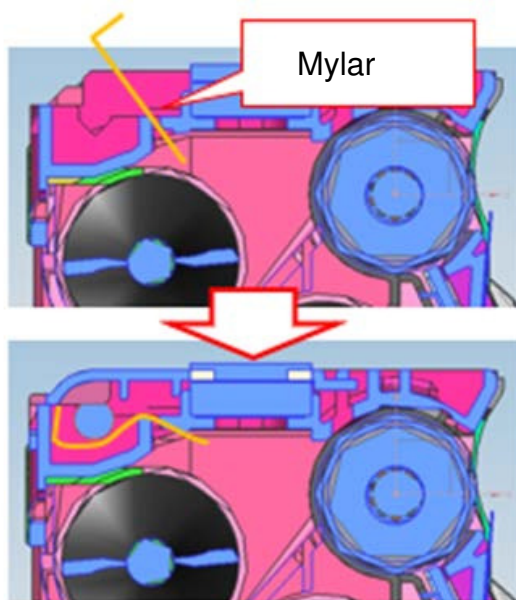
The upper cover of the development unit deforms, and combined with the compressive force of the filter, this causes the gap between the cover and development roller to narrow. As a result, when making continuous prints in half-speed mode, the developer in the central area of the unit cannot be fully retrieved (the amount scooped in this mode is larger), and then leaks out.

P/N	Description	Q'ty
M0AJ3138	SHEET:PROTECT:COVER:DEVELOPMENT	1-1

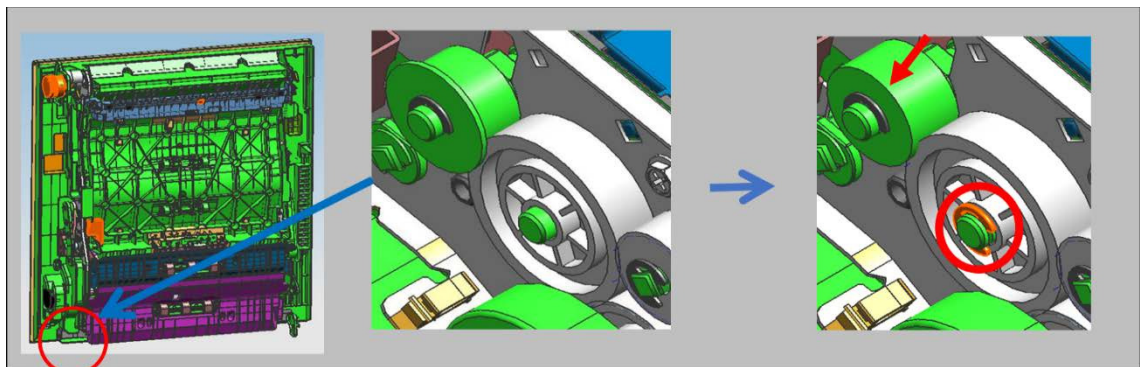
Change 4: There are no protruding parts to hold the gear. An e-ring added to stop the gear in position, and a groove added to the shaft for the e-ring.

Old P/N <Group B>	New P/N	Description	Int	Q'ty	Note
07200040E	07200040E	RETAINING RING - M4	-	3->4	D
D2414631	D0BQ4631	SIDE PLATE:REAR:DUPLEX:PEEN	X/X	1	D
D2414644	D0BQ4644	GEAR:MECHANICAL ROLLER CLUTCH	X/X	1	D
