Technical Bulletin

Model: MET-C2yz	Date: 13-May-16	No.: RD244001i
-----------------	-----------------	----------------

Subject: Firmware Release Note: System/Copy		Prepared by: M. Kumagai	
Classification:	<input type="checkbox"/> Troubleshooting <input type="checkbox"/> Mechanical <input type="checkbox"/> Paper path <input type="checkbox"/> Product Safety	<input type="checkbox"/> Part information <input type="checkbox"/> Electrical <input type="checkbox"/> Transmit/receive <input checked="" type="checkbox"/> Other (Firmware)	<input type="checkbox"/> Action required <input type="checkbox"/> Service manual revision <input type="checkbox"/> Retrofit information <input checked="" type="checkbox"/> Tier 2

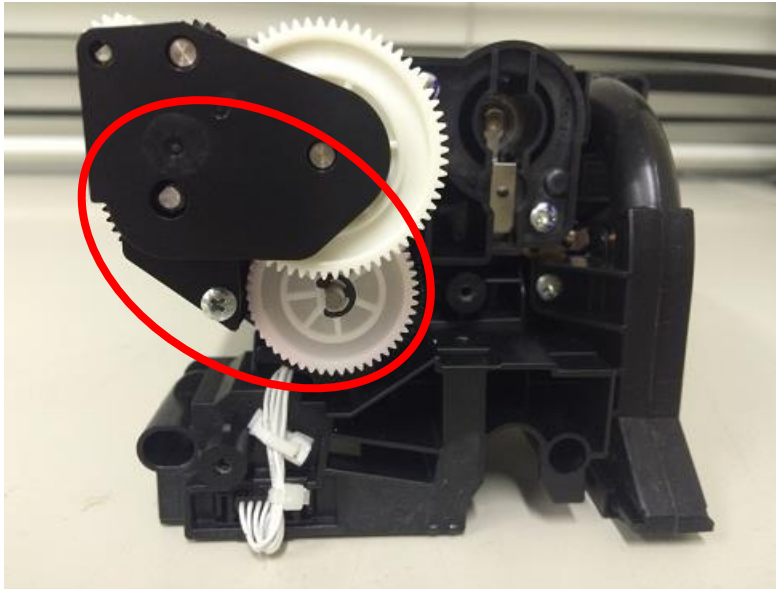
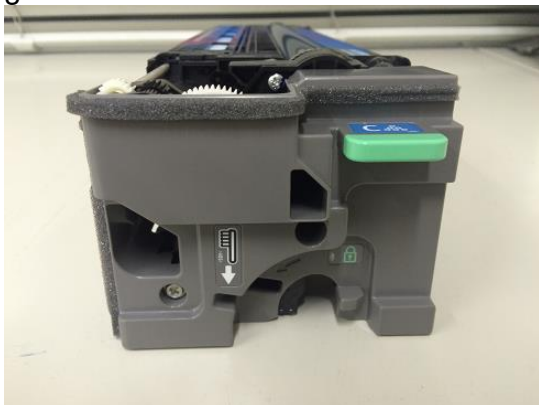
For Metis-P2ce

As one of the reasons that cause this symptom, the development unit was stored/transported in a position prior to its installation. This causes developer to accumulate on the gears at either end of the unit, disabling proper rotation of the development roller.

Note: For Metis-P2ce, the PCDU front cover needs to be released before rotating the gears.

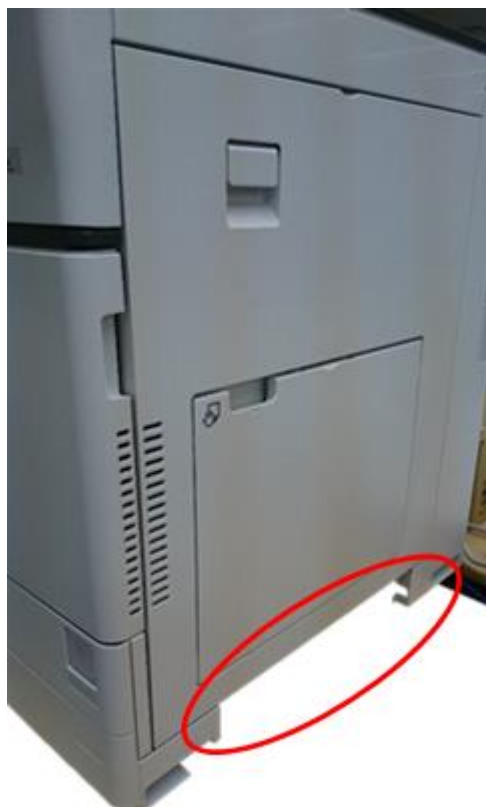
PROBLEM

Small insects may get inside the machine from the open space at the bottom right.

Procure and install the cover [A] below.

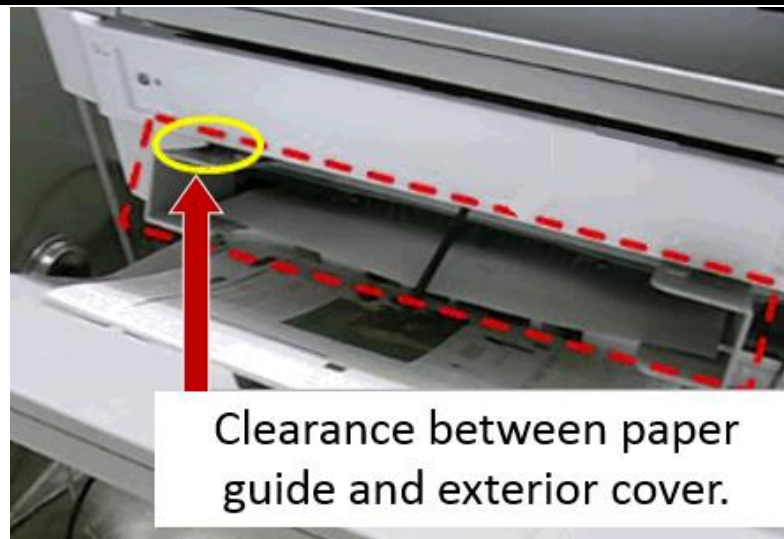
Fig.2

The broken piece drops into the clearance between the paper guide (GUIDE: PAPER: REAR: ASS'Y) and the exterior cover (COVER: PAPER: GUIDE) circled in YELLOW. (Fig.2)

Check the clearance between the paper guide (GUIDE: PAPER: REAR: ASS'Y) and the exterior cover (COVER: PAPER: GUIDE) to see if there is a broken piece.

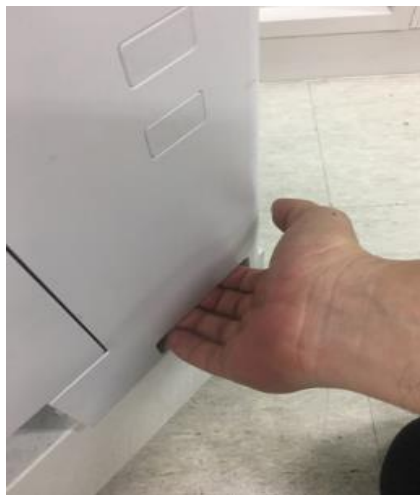
Figure.3 Incorrect

- Make sure to do the following when installing the machine:
 Hold the grip of the right rear cover as shown in **Fig. 2 (CORRECT)**.
 Insert your fingers **all the way up and inside the grip**.
- If you do not, the right cover will break, as shown in Fig. 4.

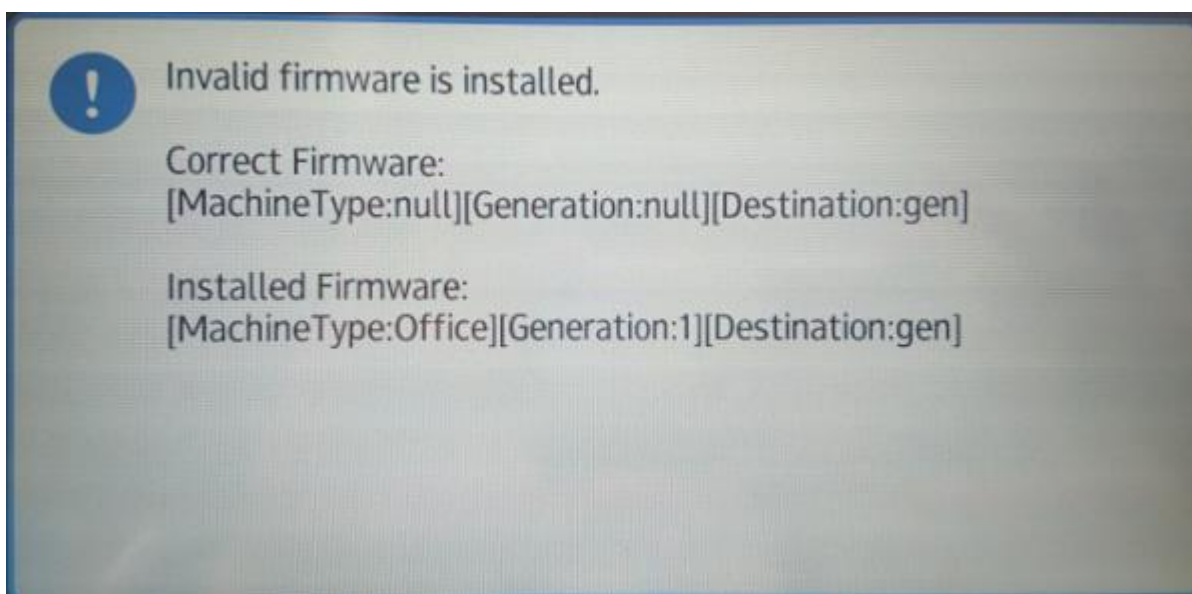
The following error is displayed at machine installation.

CAUSE

Corruption of the program files in the operation panel control chip.

Note: There is no damage to the hardware.

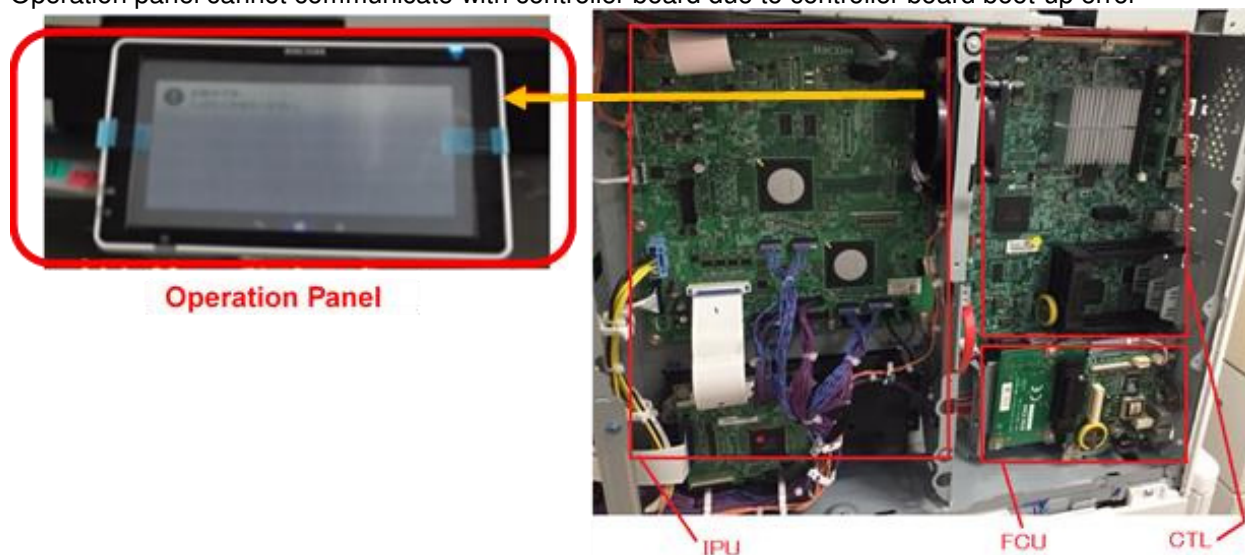
Figure 1: Operation panel, IPU and Controller / FCU

Possible causes of SC672-XX include:

- USB communication path failure (USB cable, IPU)
- Controller board boot up error and/or operation panel boot up error due to abnormal break in operations of controller board.

Possible causes of operation panel cannot light include:

- USB communication path failure (USB cable, IPU)
- Operation panel cannot communicate with controller board due to controller board boot-up error

1. Turn the machine power OFF/ON.
2. Do the action in the **flowchart below** to determine the cause and best course of action when SC672-XX occurs.

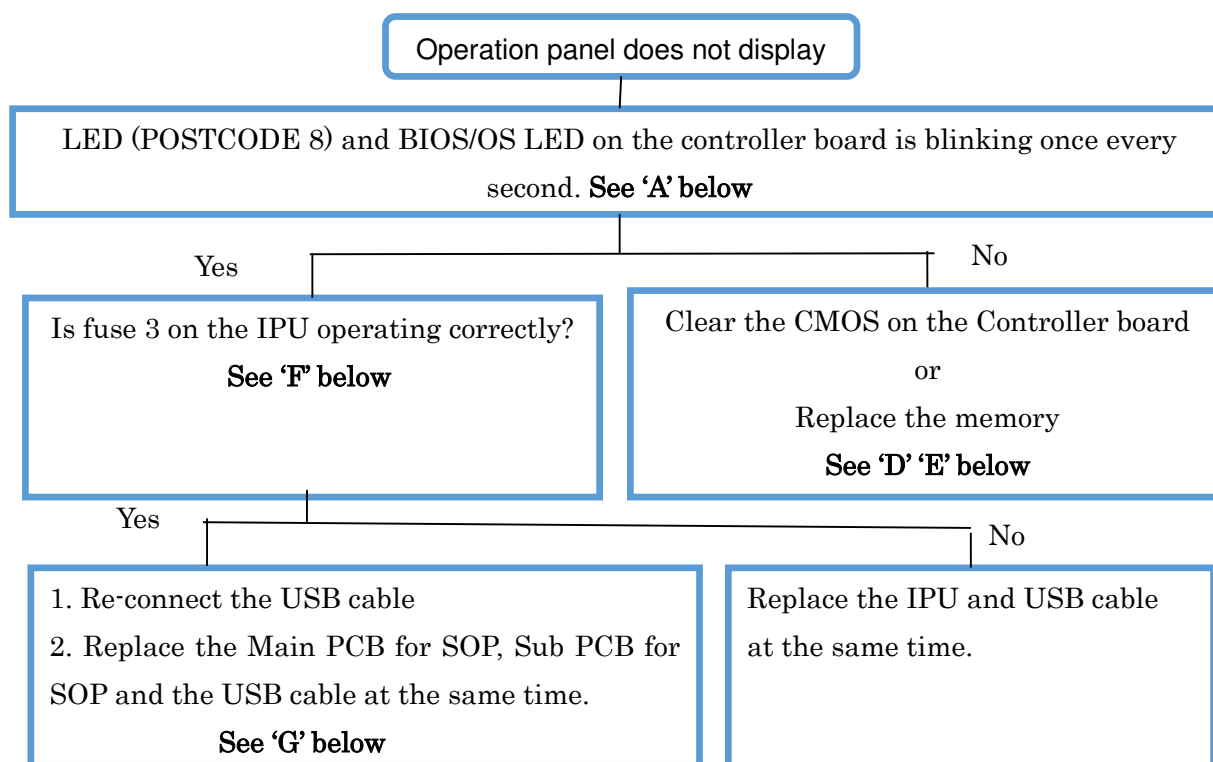
Flowchart to determine parts to replace when no display on operation panel

Parts	How to determine the cause
USB cable	LEDs on the controller board blink once every second
<i>Main PCB for SOP, Sub PCB for SOP</i>	LEDs on the controller board blink once every second
IPU	Fuse 3 on the IPU
CTL	LEDs on the controller board do not blink
Memory	LEDs on the controller board do not blink

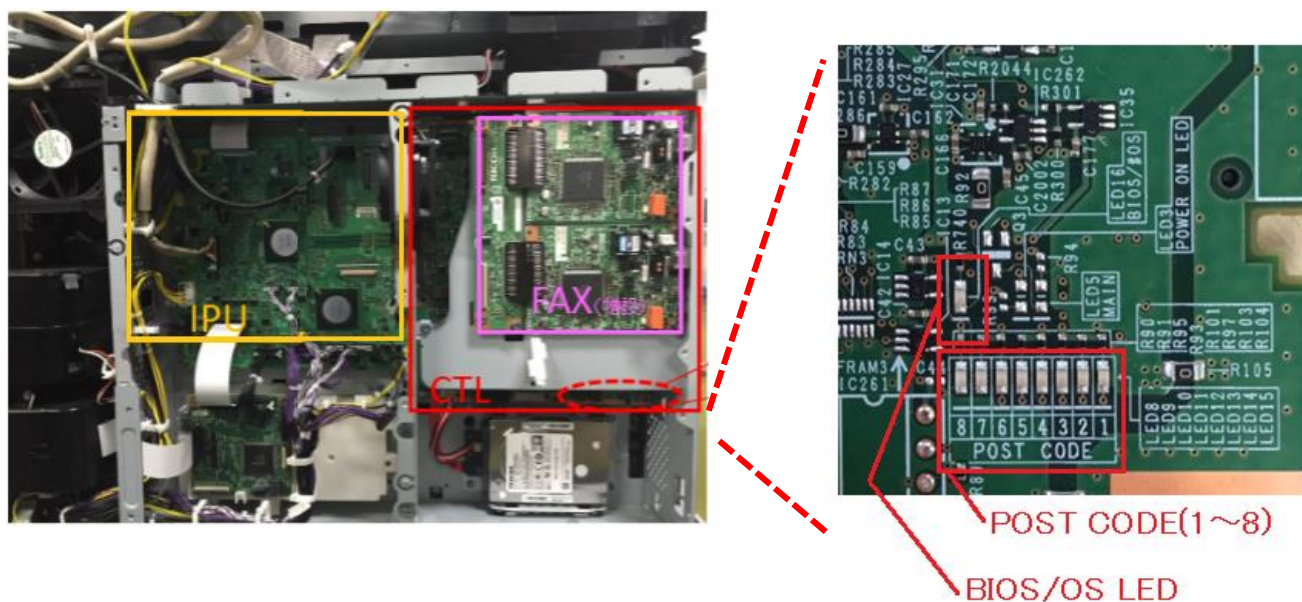
Figure 2: LED /POSTCODE AREA on the CTL

Check the condition (lit, off, blinking) of the LEDs on the CTL.

Normal situation: POSTCODE LED 8 and BIOS/OS LED blink once every second.

Note: The LEDs remain lit or are off when there is a problem with the CPU.

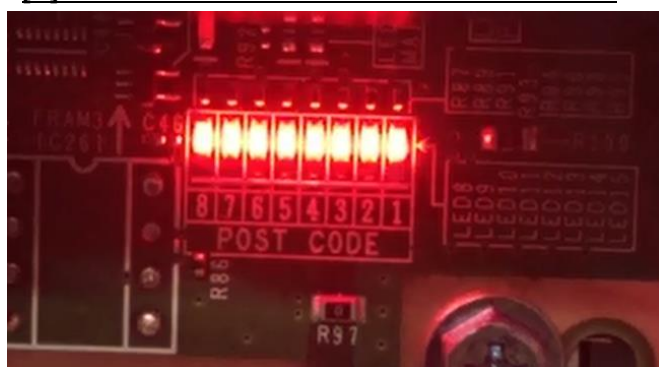
Figure 5: LEDs 1 to 8 are lit constantly

No.	Note
POSTCODE 1-8	<p>1. For self-diagnosis code (BIOS).</p> <p>2. After the BIOS starts up, LEDs 4,5,7 turn off and LEDs 1,2,3 ,6 turn on and LED 8 blinks. LED 8 remains lit or off when there is a problem with the CPU.</p> <p>Note: When a DIMM connection failure, defective CMOS, or defective BIOS occurs, postcode LEDs 1-8 are lit constantly.</p>
BIOS/OS LED	<ul style="list-style-type: none"> - LED is lit when the BIOS is running. - LED blinks when the OS is running.

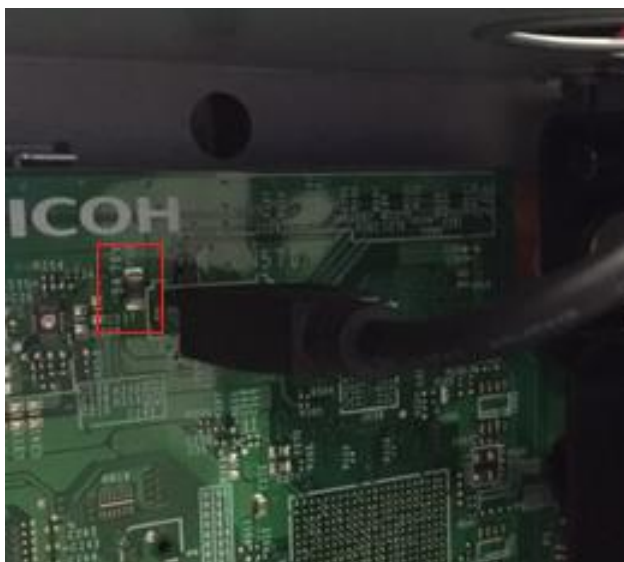
Figure 13: Fuse on the IPU

Check fuse 3 on the IPU is operating correctly.

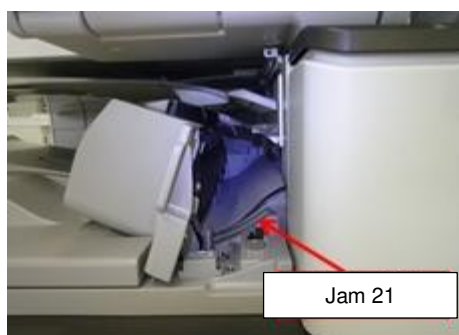
JAM21 occurs when the booklet feature is used with the Bridge Unit BU3070 and internal Finisher SR3130/3180.

The paper support guide was incorrectly installed.

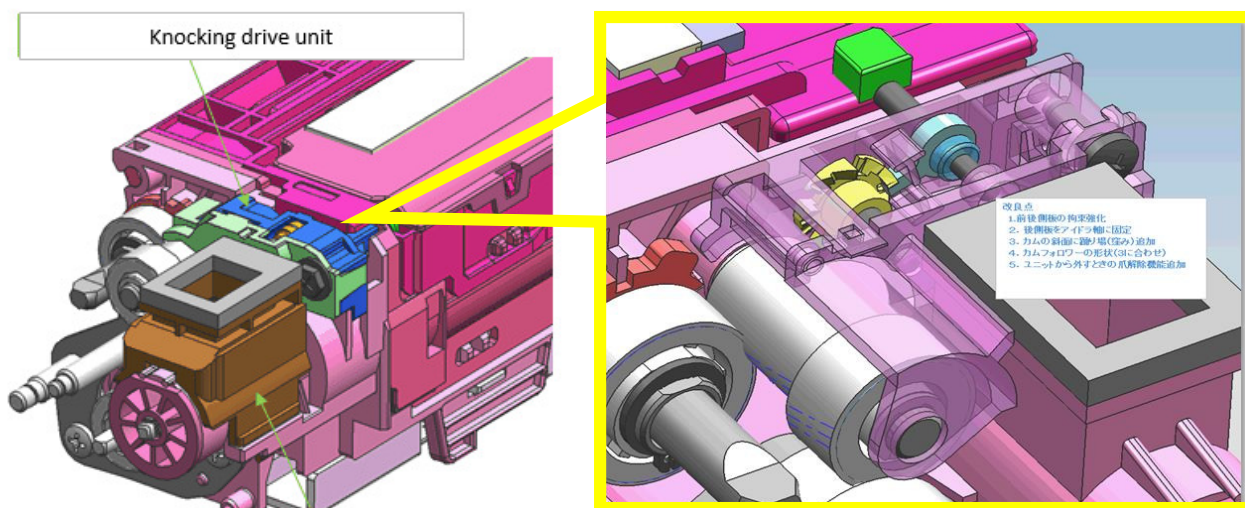
Figure.1

~~A new knocking mechanism has been added (Fig.1). Normally, the air flows from the development roller to the filter in the development unit (Fig. 2). However, when the filter is full of toner, the inner pressure increases and reverse air flow occurs, which causes toner blasting to occur (Fig.3). To prevent this, the knocking mechanism periodically knocks the development unit cover, so toner in the filter drops back into the development unit. This mechanism works by reverse rotation of the development roller.~~

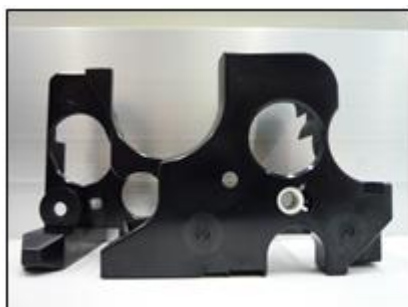
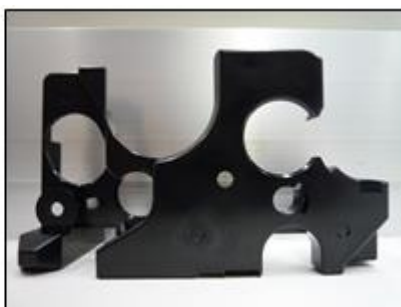
Old: _____ New: _____

The duct cover is included to the new development unit and PCDU. Please replace together when you replace development unit or PCDU.

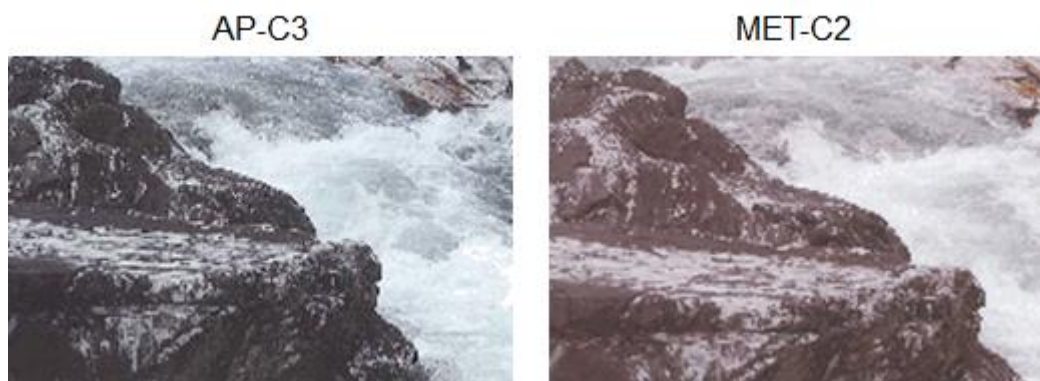
Example:

MET-C2 has been designed to produce a slight difference in color compared to previous models, such as the AP-C3. The gray color tone of the MET-C2 tends to have a red tint:

By installing the color profile, the color balance can be slightly adjusted to the gray tone that the AP-C3 produces.

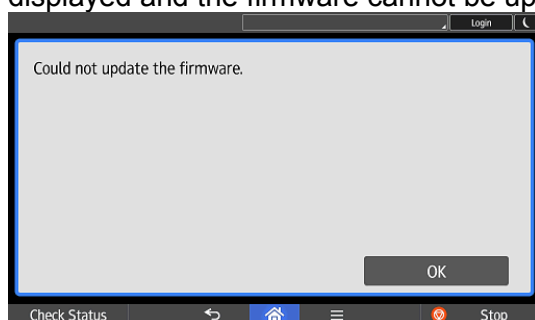
1. When users try to update the firmware from the Application Site, the following message is displayed and the firmware cannot be updated:

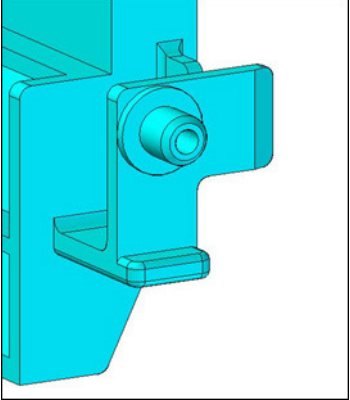
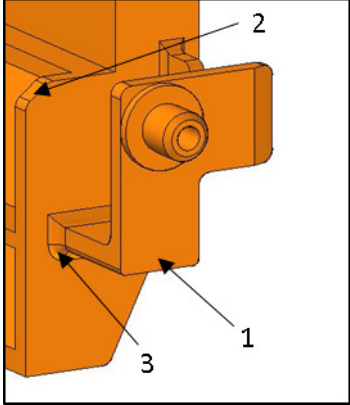
Old D1492721	New D6942721
Shape

Reason: To further strengthen and prevent breaking of the guide plate.

<ol style="list-style-type: none"> Deleted stopper Changed angle regulation Strengthened part

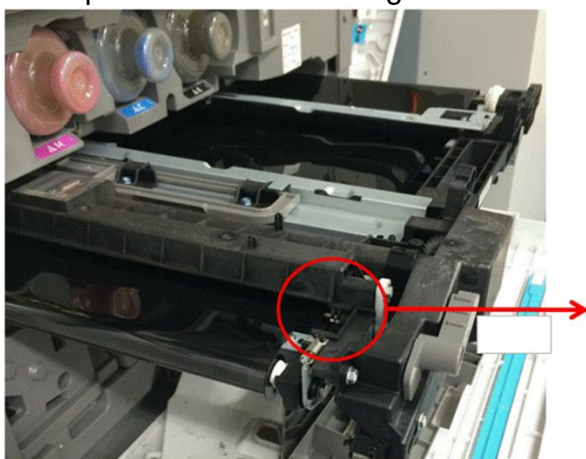
A grounding failure occurs with the belt cleaning unit in the ITB unit or paper transfer roller unit, either of which can generate electrical noise.

1. Check the grounding of the belt cleaning unit on ITB unit.
2. Replace the belt cleaning unit.

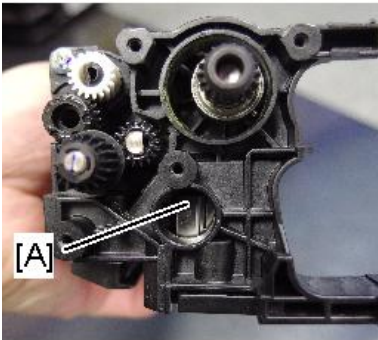
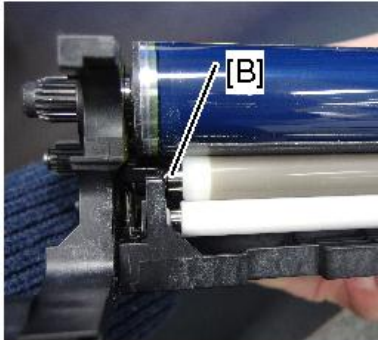
SC No.	Type	Error Name/Error Condition/Major Cause/Solution
<p>Check if the SC occurs by turning the power OFF then ON. If the SC occurs again, do the following steps. Check if the SC reoccurs by cycling the power after each step.</p> <ol style="list-style-type: none"> Check the PCU for the following points and recover or replace the PCU if there are any defects. <ul style="list-style-type: none"> Checking contaminants on the Charge Roller terminal [A] Checking damage or deformation of the Charge Roller terminal [A] Checking continuity to the Charge Roller terminal core bar [B] 		
<div style="display: flex; justify-content: space-around;">

</div> <p style="text-align: right;">d238m0900</p>		
<ol style="list-style-type: none"> Check if all connectors related to PCDU are connected securely. Replace the connectors if they are disconnected, or loose. Recover or replace the parts of the main machine if there are any defects after checking the following points. <ul style="list-style-type: none"> Checking contaminants on the charged power supplying plate [C] Checking damage or deformation of the charged power supplying plate [C] Checking continuity between the Charge Roller terminal core bar and the HVP (CB)

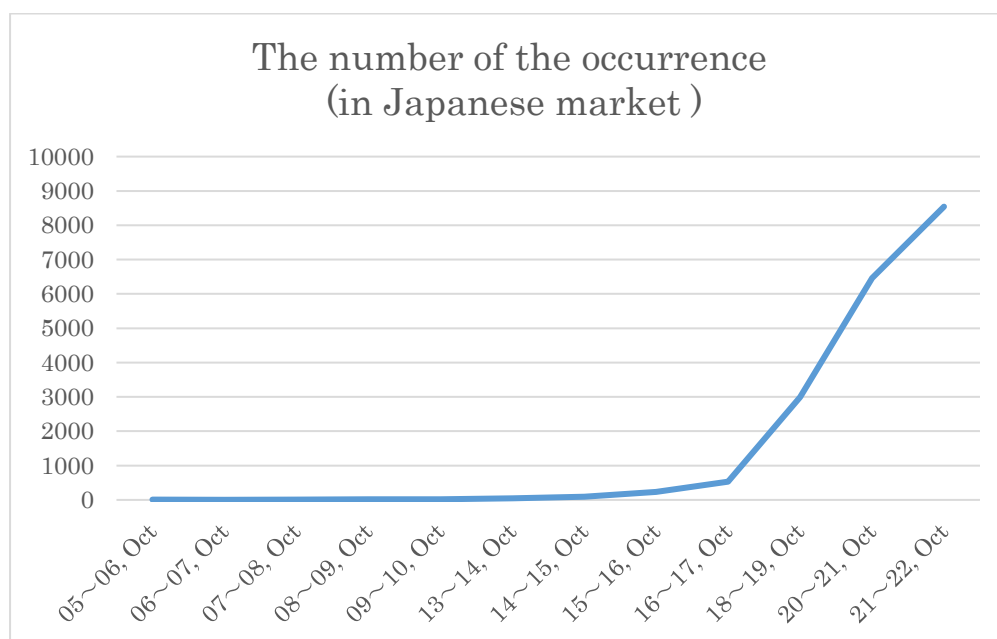
- Occurrence number of SC899 occurrence (in Japanese domestic market)

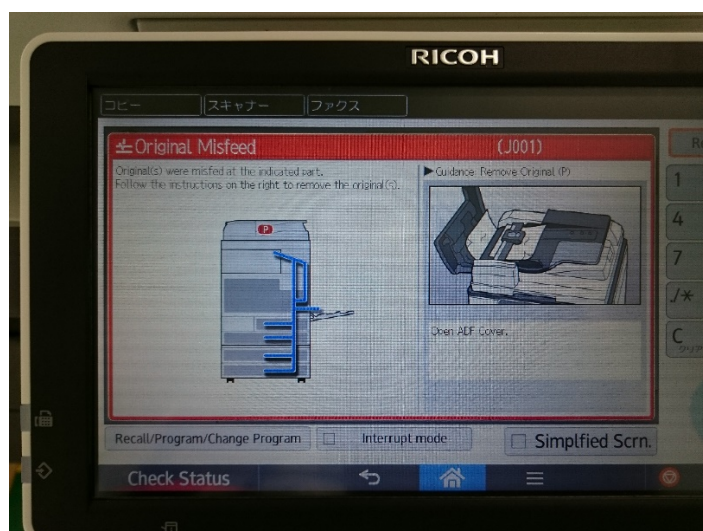
The original feeler rebounds and chattering of the original detection sensor occurs due to parts variation.

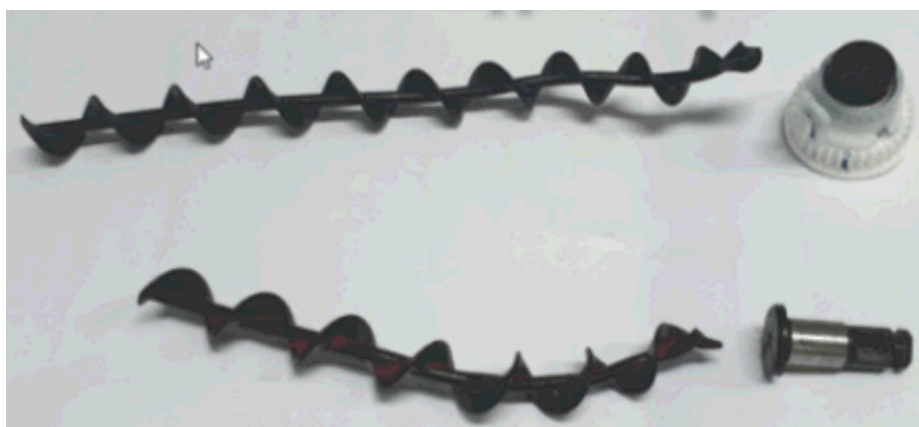
The toner hoppers break, triggering early Toner End, white lines, and/or noise.

Replace the hopper and development unit at the same time.

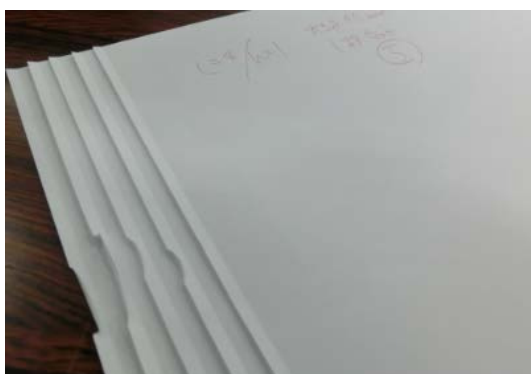
- The P/N will be announced once it is available.
- As a side effect with this separation pad, the leading edge of some paper types may crease when touching the pad, as shown in the photo below.
- Because of this, this pad is only used in cases in which the firmware upgrade is ineffective (It is not installed on machines in mass-production).

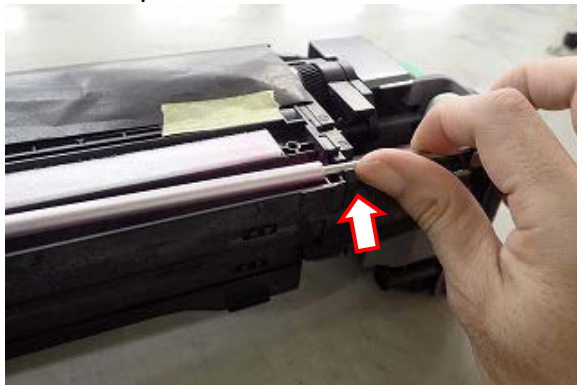
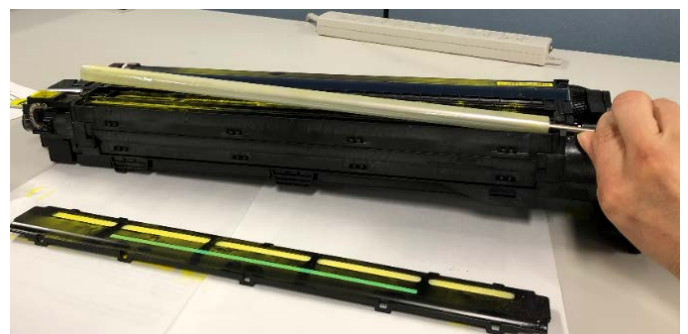
The upper cover of the development unit deforms, and combined with the compressive force of the filter, this causes the gap between the cover and development roller to narrow. As a result, when making continuous prints in half-speed mode, the developer in the central area of the unit cannot be fully retrieved (the amount scooped in this mode is larger), and then leaks out.

2. Lift the preset seat shaft.

3. Insert the Mylar into the **slit** of the upper cover.

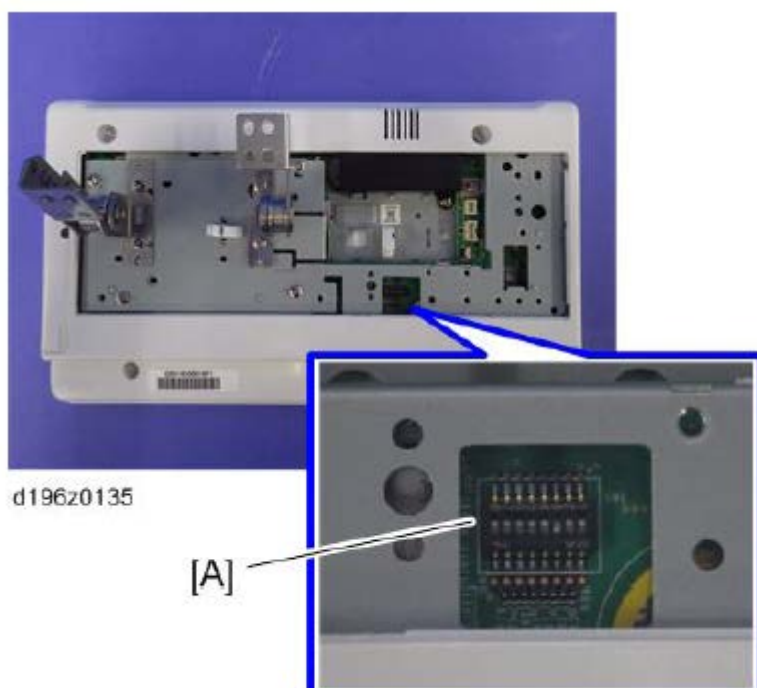
Operation Panel Unit

By factory default, switches No.3 and No.7 of the DIP switch [A] on the micro computer board are set to ON. When installing the operation panel unit, make sure that the DIP switch setting is correct for the MFP on which you are installing the panel.

IMPORTANT: Note the DIP switch settings for the old operation panel unit before replacing it, and then apply the same settings to the new Smart Operation Panel. These settings are common to all MFP models.

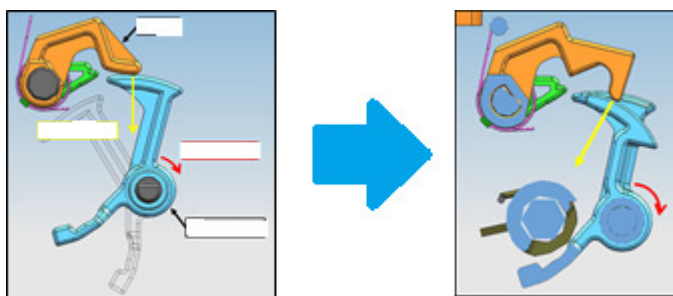
Change: The hit position of the two parts has changed because the shape of the Paper stopper and the Paper stopper link have been changed.

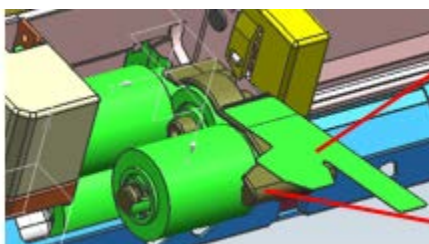
Change 2: The material and the color of the pickup arm has been changed and the seat of the pickup arm also removed.

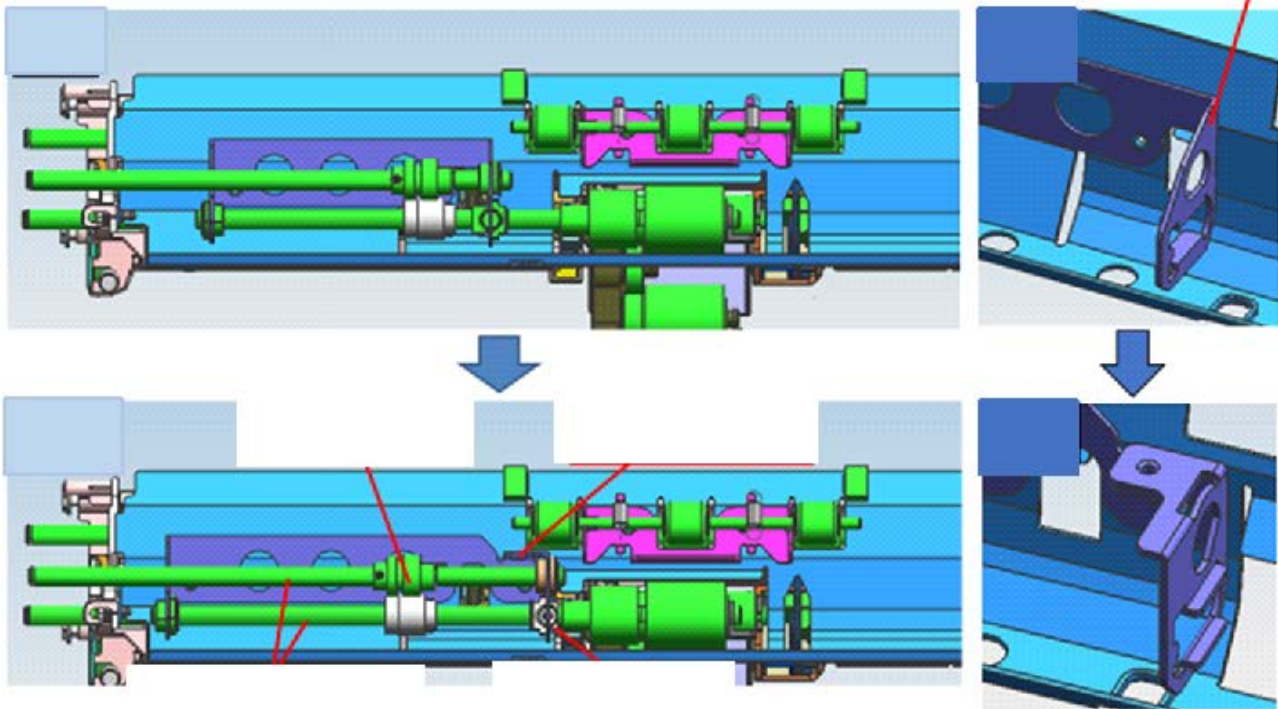
Change 3: The shape of the brackets and bearings, length of the roller shaft, and the gear position has changed. Also e-rings added.

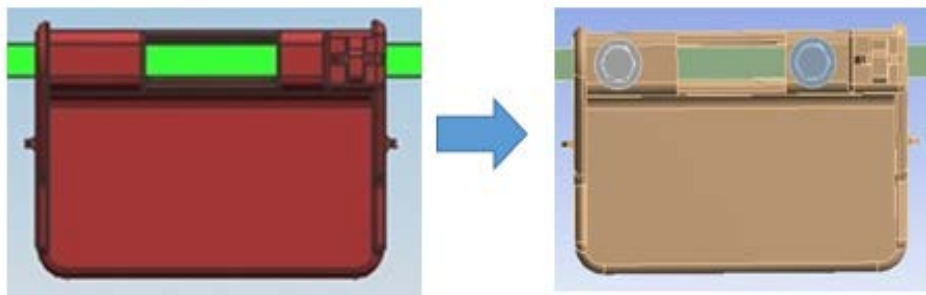
Change 5: The grip of duplex unit has been changed from press fit to screw type.

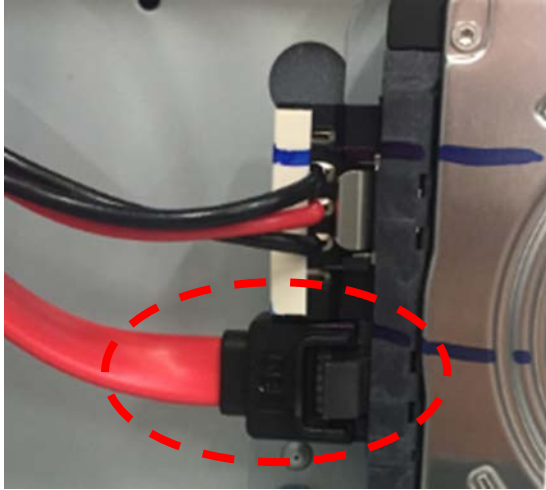
HDD cable provided from the vendor (D2415250:CABLE:HDD:SATA:210) is defective.

Occurrence ratio: 0.08% (=4/5,808 machines)

The HDD cable has been modified since July 2019 production.

1. Replace the HDD cable when SC8XX occurs.
2. If the symptom still occurs, replace the HDD or other parts (see Service Manual for procedure).
