Model: AP-C2	Date: 10-Sep-08	No.: RD029001b
--------------	-----------------	----------------

Subject: Firmware Release Note: Language Install		Prepared by: T.Kiyohara	
From: 2nd Tech. Support Sec. Service Support Dept.			
Classification:	<input type="checkbox"/> Troubleshooting	<input type="checkbox"/> Part information	<input type="checkbox"/> Action required
	<input type="checkbox"/> Mechanical	<input type="checkbox"/> Electrical	<input type="checkbox"/> Service manual revision
	<input type="checkbox"/> Paper path	<input type="checkbox"/> Transmit/receive	<input type="checkbox"/> Retrofit information
	<input type="checkbox"/> Product Safety	<input checked="" type="checkbox"/> Other ()	<input checked="" type="checkbox"/> Tier 2

Subject: Firmware Release Note: Engine		Prepared by: Y.Urushihara	
From: 1st Tech Service Sect., MFP/Printer Tech Service Dept			
Classification:	<input type="checkbox"/> Troubleshooting	<input type="checkbox"/> Part information	<input type="checkbox"/> Action required
	<input type="checkbox"/> Mechanical	<input type="checkbox"/> Electrical	<input type="checkbox"/> Service manual revision
	<input type="checkbox"/> Paper path	<input type="checkbox"/> Trans

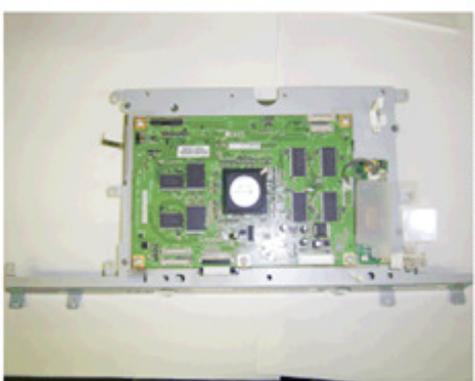
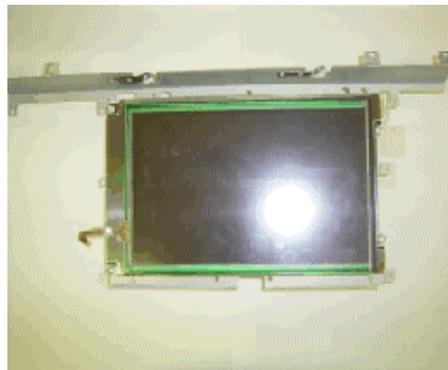
Touch panel + LCD

Rear side

Front side

- Remove the old touch panel from the LCD.
Note: The touch panel is attached to the LCD.
- Attach the new touch panel (P/N **B2231484**) to the LCD.
Important: Only replace the touch panel. Do not replace the LCD.

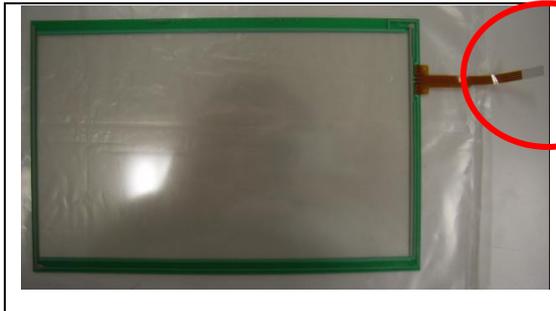
Old parts:
The tip of the electrode is **brown**.

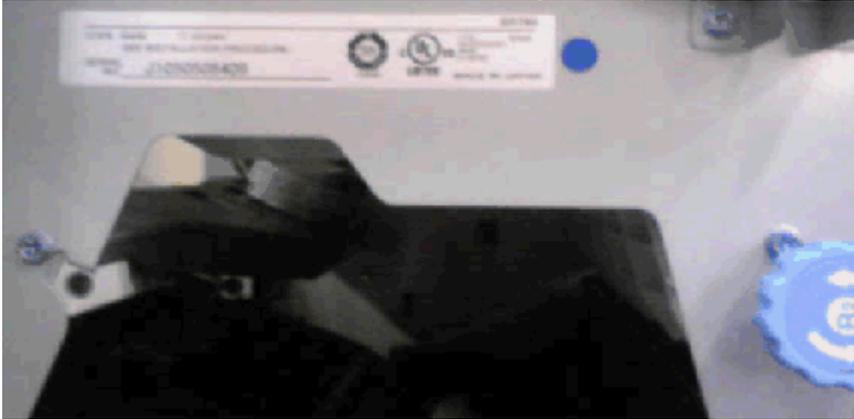
Note: Modified units have a circular blue seal attached as shown below, which is visible when the front door of the SR790 is opened (for two or three production months).

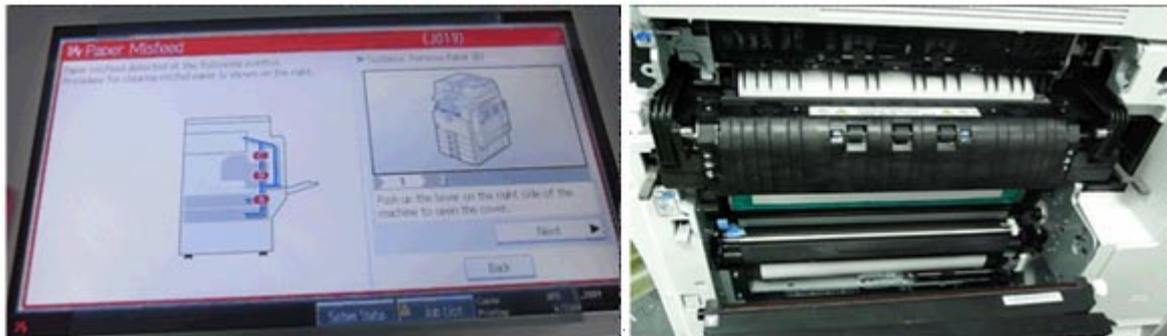
The machine indicates A, B, C Jam all together continually or at two or three paper ejection intervals, but there is no jam (paper is resting inside the machine, but is not jammed).

Note: This symptom does not occur when the machine turns on; it occurs after the machine has been running continuously.

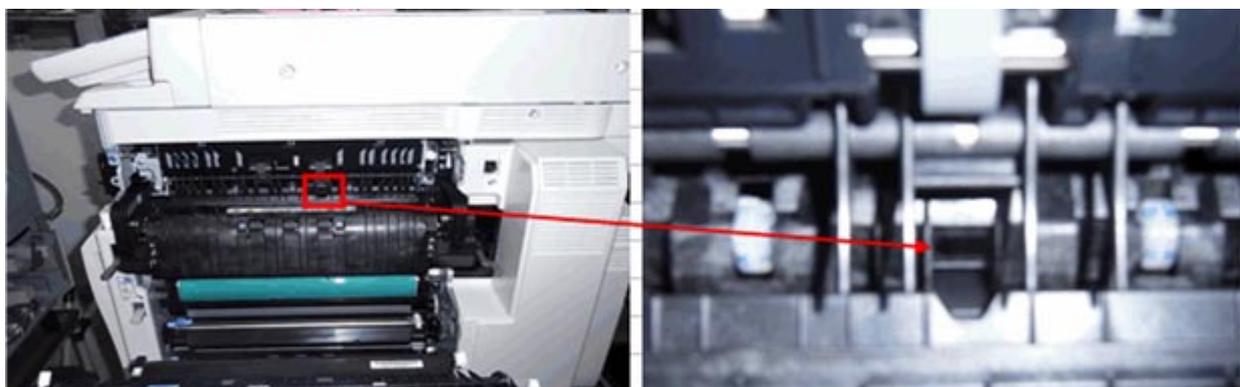
A specific lot of the Paper Exit Sensor is faulty.

As the result of the above, the sensor detects a "No paper" condition continuously even if there is paper in the paper feed path.

Therefore, when the machine expects to detect paper at the sensor (based on the paper feed timing), paper is not detected, and the machine indicates an A, B, and C Jam.

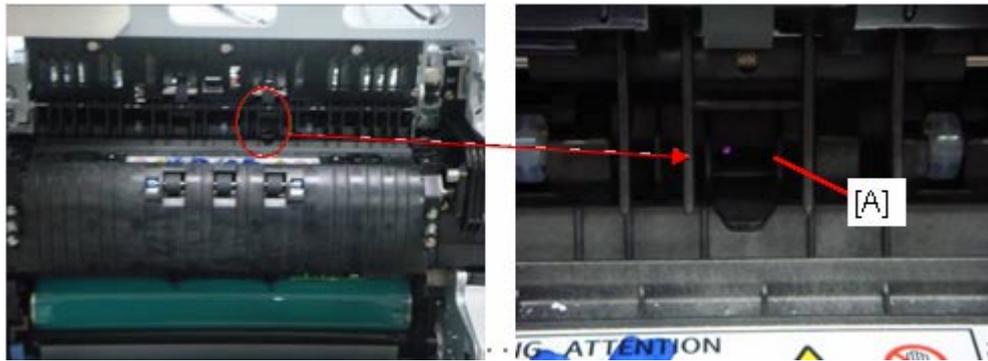
Sensor check condition	SP5803-026 Input Check value	
	Normal Sensor	Faulty Sensor
(a) If the paper exit sensor [A] is covered with paper	00000001	00000000
(b) If the paper exit sensor [A] is not covered with paper	00000000	00000000

4. Replace the paper exit sensor if the value is “**00000000**” in condition (a).

Note: The paper exit sensor is not faulty if the value is “00000001” in condition (a).

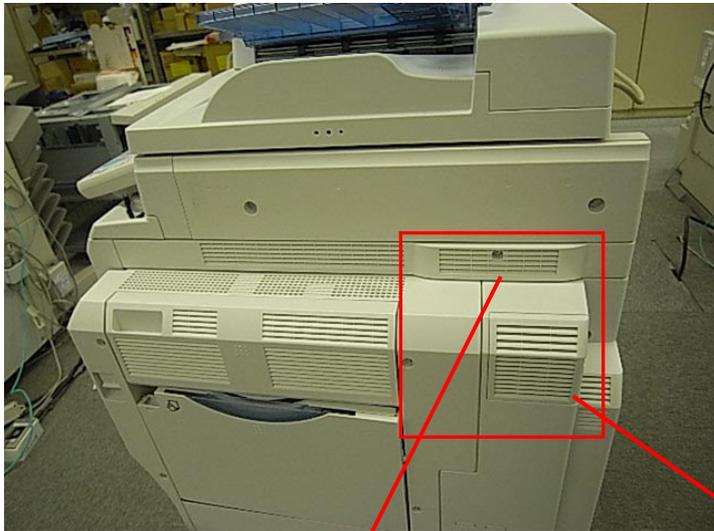
Example

Due to a slight defect with ozone filters from some lots, conditions during the shipping process allowed more powder/dust to exit the machine than usual near the ozone filter (D0291278).

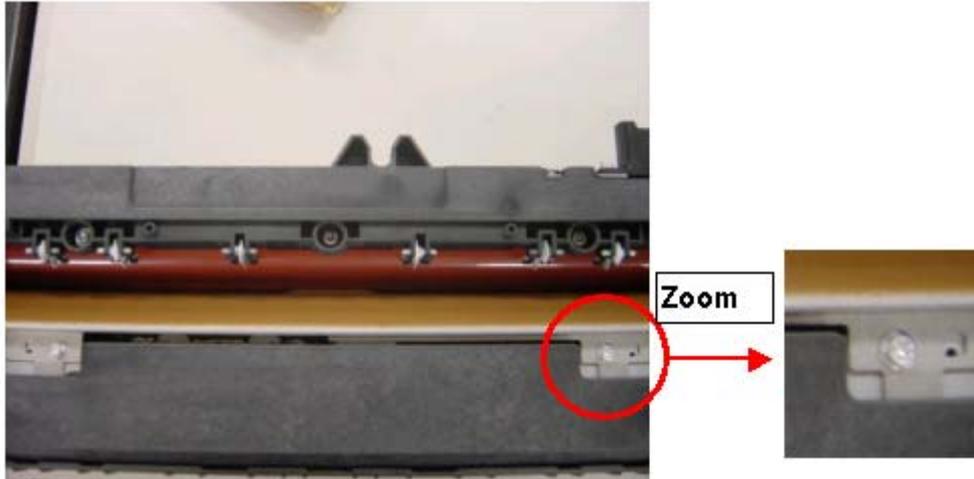
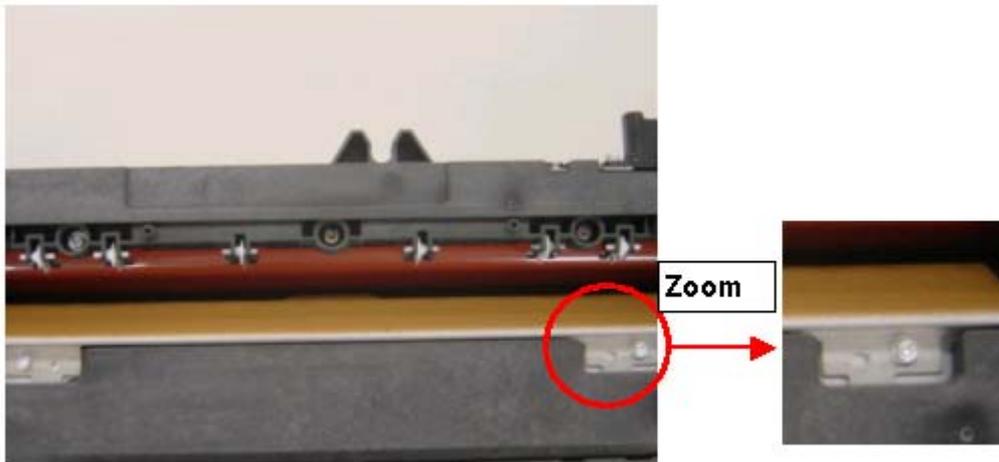
After this screw position is changed, in some cases, earth worms (slight wrinkling) may occur with the first print made of the day.

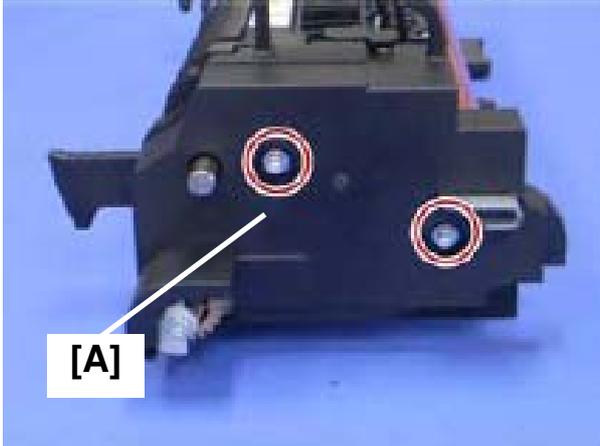
- 2) Excessive load on the fusing unit's rotating parts:
Use **Procedure A** below to check the loads on the fusing unit's rotating parts.
- 3) The fusing unit or rotation detection sensor was not attached correctly
Use **Procedure B** below to check the attachment condition of the fusing lock levers and rotation sensor.

1. Remove the fusing unit.
2. Remove the fusing rear cover [A] on the drive side of the fusing unit.

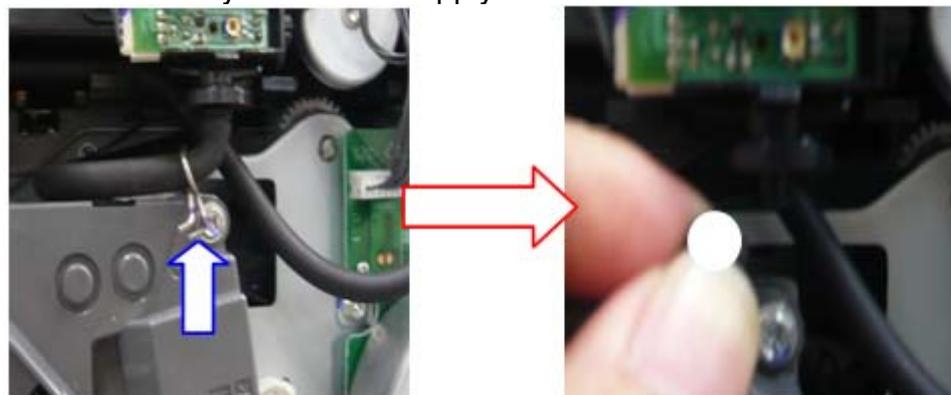
11. Pull out the yellow toner supply tube..

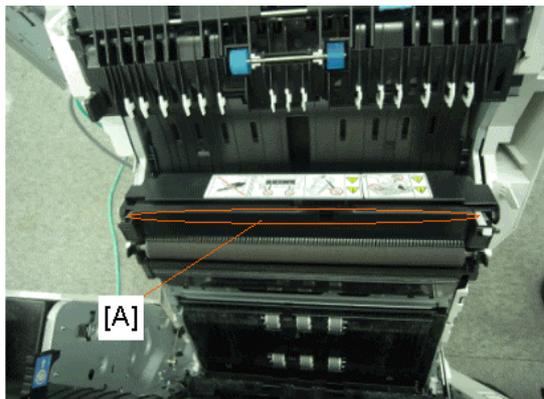
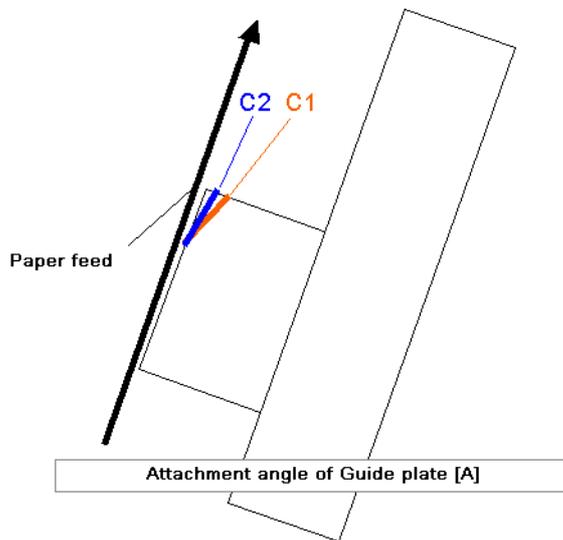
High temperature and a mechanical load cause the fusing entrance guide plate to bend.

- This symptom does not occur on the AP-C1, because the attachment angle of the guide plate is different than on the AP-C2. This is because the guide plate angle was improved from C1 to prevent images from becoming too “grainy”.

Replace the guide plate with the new part shown below.

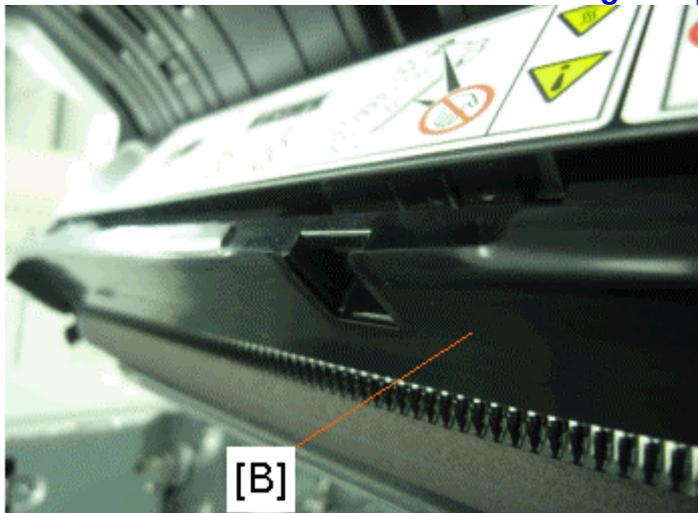
2). Even though removing this decal will minimize the amount of toner that sticks to the guide plate, toner blasting may occur more easily at about 60K-80K. If this happens, replace the guide plate.

2. **Remove the black decal from the guide plate [B].**

Important: 1). *You must remove residual glue on the guide plate after removing the above decal [B].*

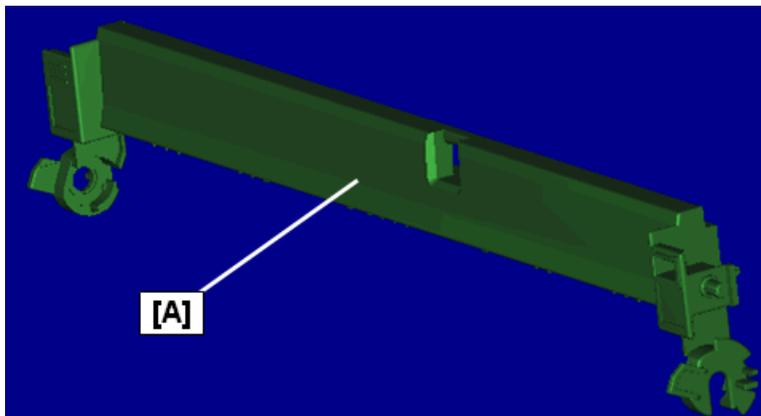
D0896204 (TRANSFER/SEPARATION UNIT:D088/D089:ASS'Y)

Important: DO NOT install this PTR unit on the AT-C2. This is because toner blasting will likely occur due to the difference in fusing process.

Replace the paper transfer roller (PTR) unit with the one shown below.

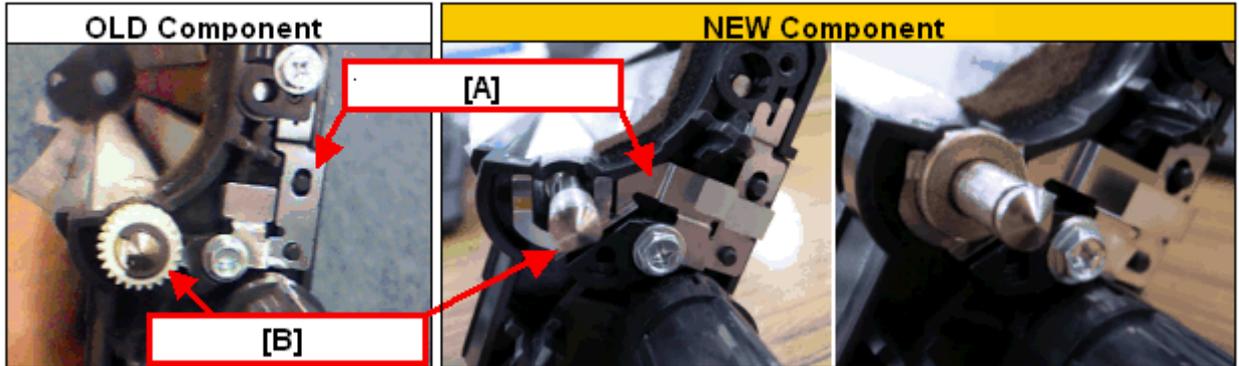
Sometimes, the GND plate at the rear side of the ITB cleaning unit [A] does not touch the lubrication application shaft [B]. As a result, a minor electrical leak occurs, which can trigger electrical noise. Sometimes, this effect appears as lines at 110mm intervals.

- The shape of the GND plate [A] was changed so that there is another contact point between the GND plate and the lubricant application shaft [B].

- If this symptom is reported, replace the ITB cleaning unit or GND plate with the following new parts:

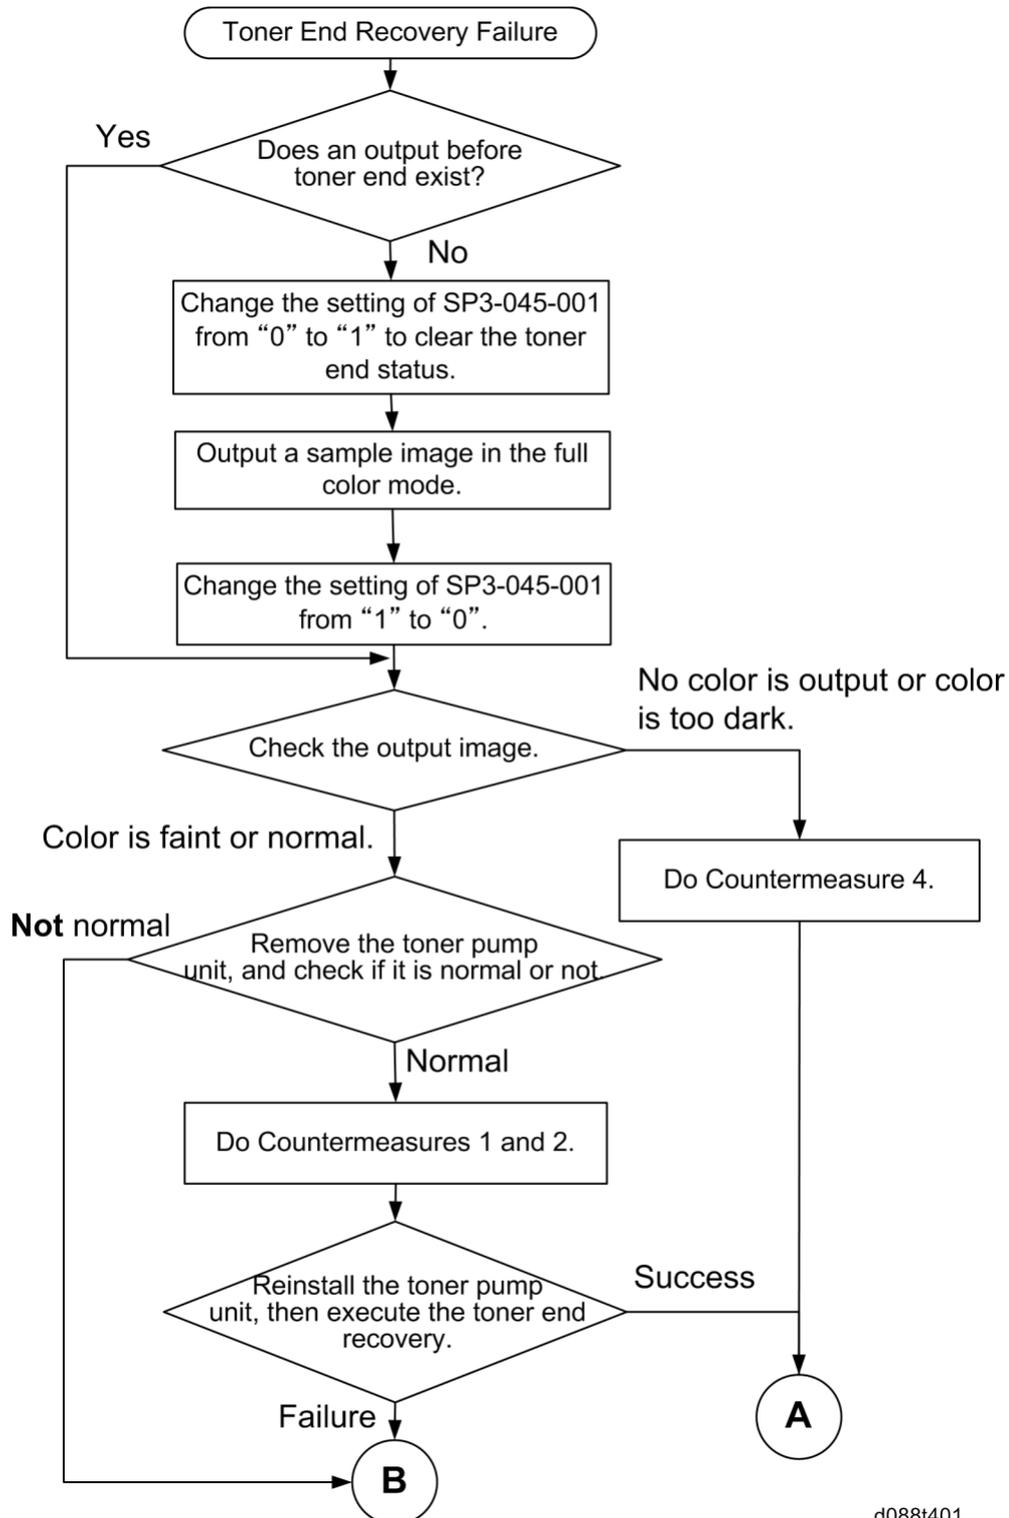
The rotor inside the pump unit moves in an elliptical pattern (instead of straight up and down), as shown in the illustration on the right below. This causes a gap to form between the rotor and stator. As a result, toner is not supplied correctly from the toner bottle to the development unit, and the machine incorrectly detects the Toner End condition.

Follow the flowchart on the next page and take the recommended action.

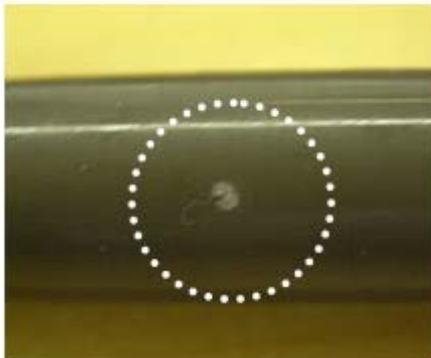
- Be sure to wipe the surface gently. If you wipe it too strongly, parts of the roller's surface layer may peel off (The white layer underneath will be visible).

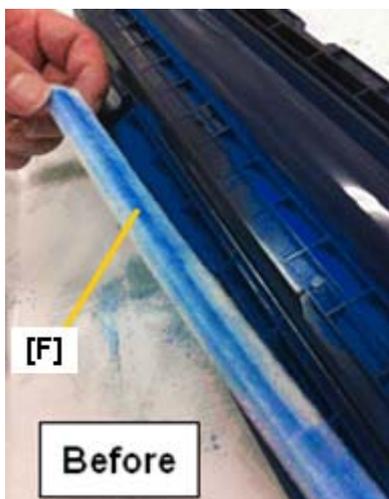
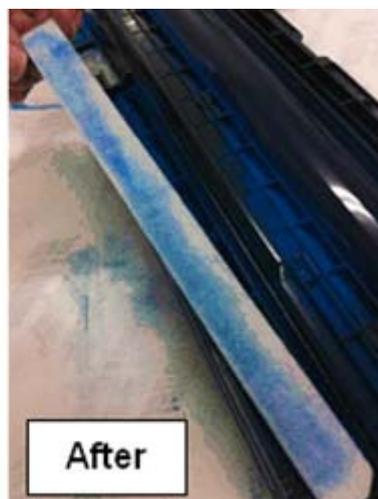
- It is not necessary to clean the filter completely. Clean it until it looks like the filter in the “After” photo below.
- DO NOT tilt the drum unit. If you do, a large amount of toner/developer will adhere to the surface. Under these conditions, the proper air compression cannot be maintained, which will cause toner blasting.

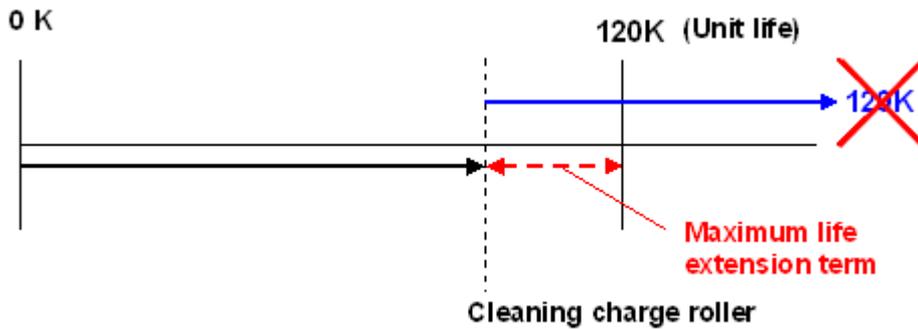
- If the unit is near its lifetime, there will be other parts inside the unit that have already experienced a certain amount of wear (cleaning blade, etc.). Therefore, after cleaning the charge roller surface, the dirtying will occur again sooner that it would with a completely new unit. (See the illustration below). The maximum amount that the unit life could be extended would be the equivalent of **120K** prints.

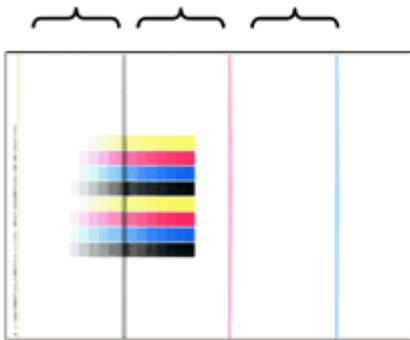
110mm interval vertical line
(Drum unit interval)

Vertical black or colored lines appear at intervals of 110 mm (the pitch of the drum unit).

Sometimes, the GND plate at the rear side of the ITB cleaning unit [A] does not touch the lubrication application shaft [B]. As a result, a minor electrical leak occurs, which can trigger electrical noise. Sometimes, this effect appears as lines at 110 mm intervals.

- If this symptom is reported, replace the ITB cleaning unit or GND plate with the following new parts:

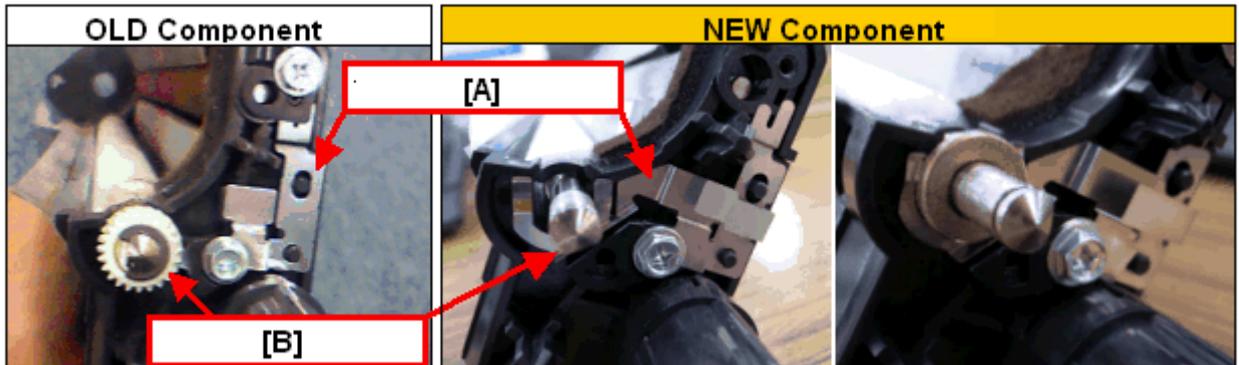
- The shape of the GND plate [A] was changed so that there is another contact point between the GND plate and the lubricant application shaft [B].

Applied from: March 2009 production

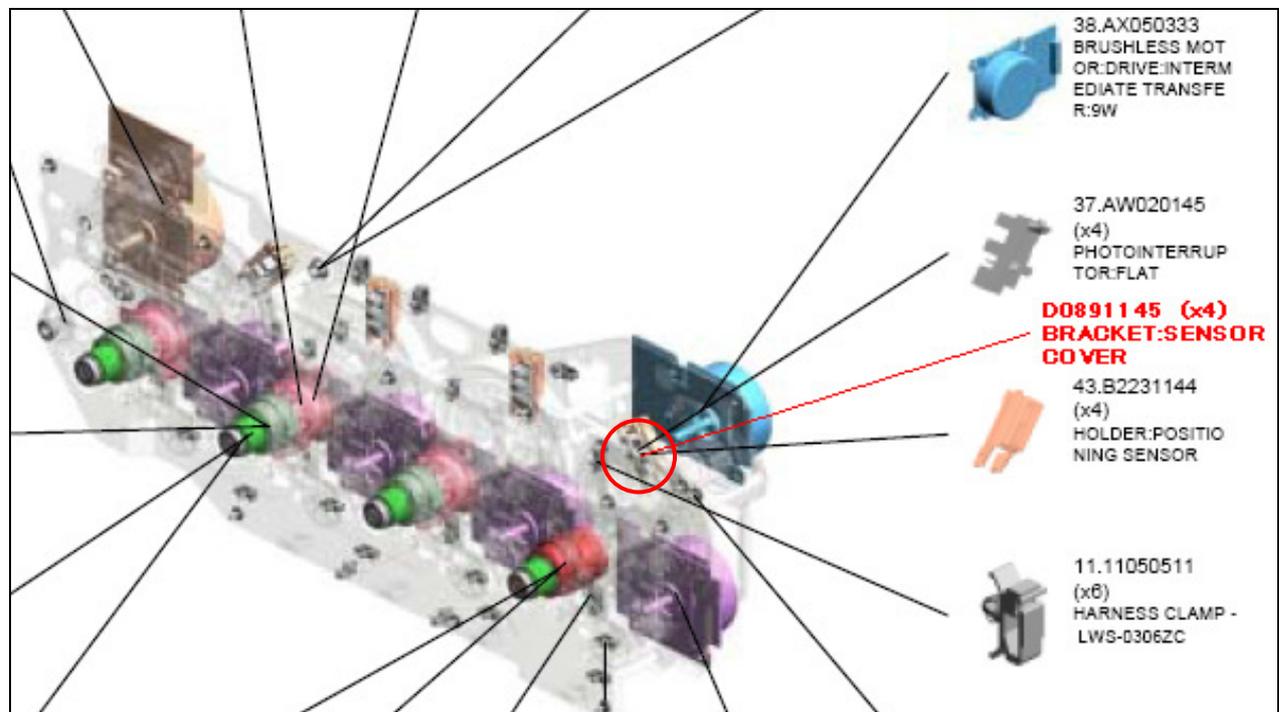
Change: *The phase control positioning sensor ass'y was added as a new part.*
 A sensor cover was added to the phase control positioning sensor.

Reason: To avoid electrostatic influence from drum gear.

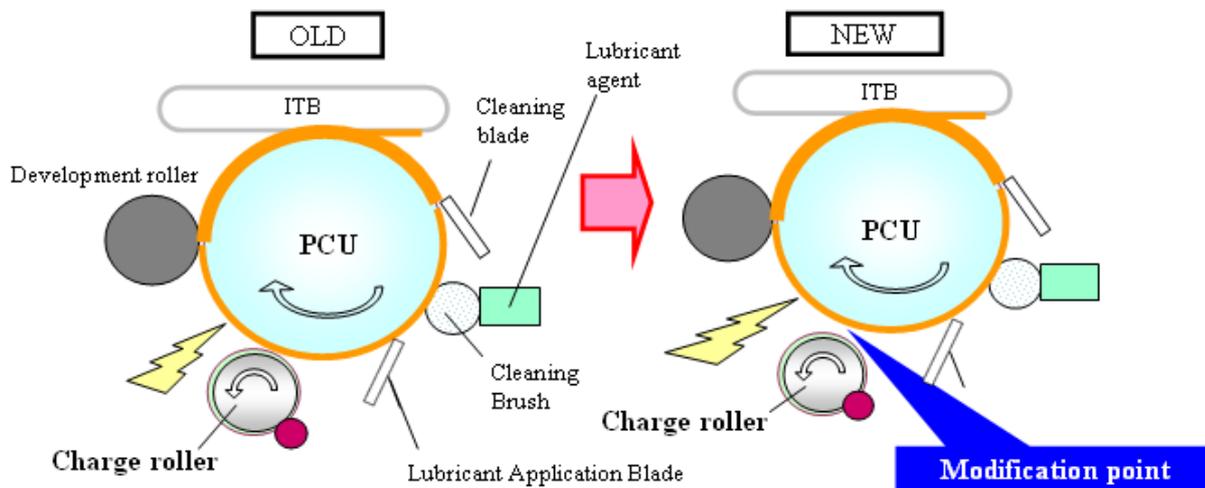
Note: There is no visual difference between the old and new units, since the gap has only been increased by 15µ.

Old part number	New part number	Description	Q'ty	Int	Page	Index
D0292252	D0292256	PCU:BK:UV:ASS'Y	1	O / O

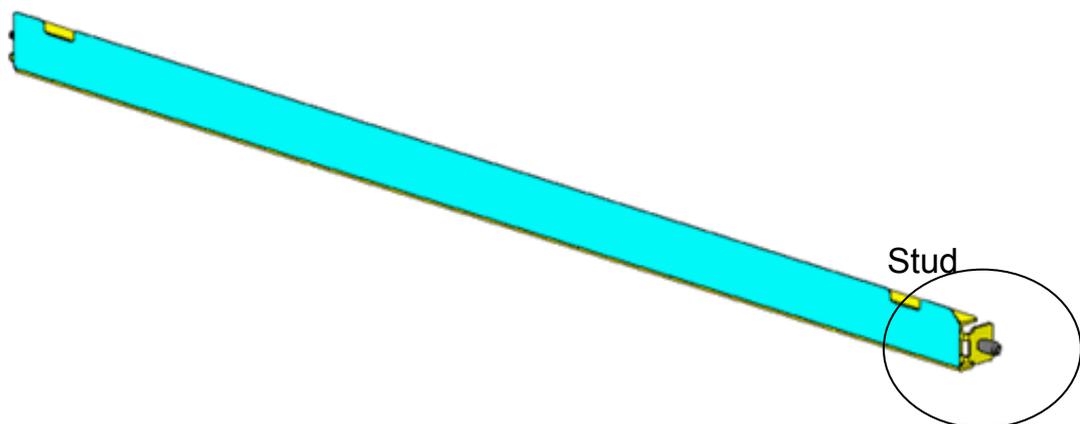
Fig. 1

1. The bracket with a screw hole at the front side of the stay was changed to a stud fixture.
2. The torque specification for the screw (still used at the rear side) was changed from $0.7 \pm 0.1 \text{N/m}$ to $0.5 \pm 0.1 \text{N/m}$.
3. This stay is now included in the service parts assembly shown in the table above (see Fig. 2)

Reason: To prevent paper jams by minimizing the range of motion (twisting) of the stay.
