Model: V-C2	Date: 15-Nov-07	No.: RD014001o
-------------	-----------------	----------------

Subject: Firmware Release Note: Engine		Prepared by: C. Shimaji	
From: 1st Tech Service Sect., MFP/Printer Tech Service Dept			
Classification:	<input type="checkbox"/> Troubleshooting	<input type="checkbox"/> Part information	<input type="checkbox"/> Action required
	<input type="checkbox"/> Mechanical	<input type="checkbox"/> Electrical	<input type="checkbox"/> Service manual revision
	<input type="checkbox"/> Paper path	<input type="checkbox"/> Transmit/receive	<input type="checkbox"/> Retrofit information
	<input checked="" type="checkbox"/> Other ()

This RTB has been issued to announce the firmware release information for the **Engine**.

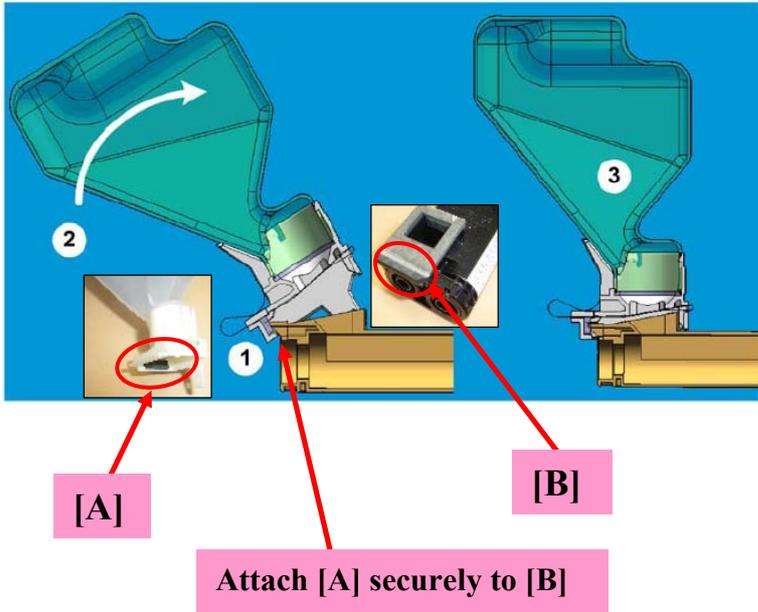
- Attach the bottle in the order shown (1-2-3).
- Make sure to attach [A] securely to [B].

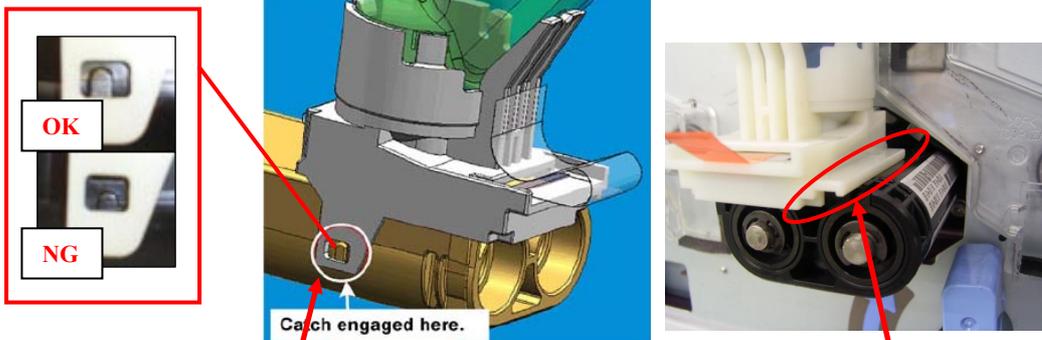
- Check the two items described below.

1) Make sure the neck of each bottle snaps and locks into place

2) Make sure there is no gap between the developer bottle and PCU.

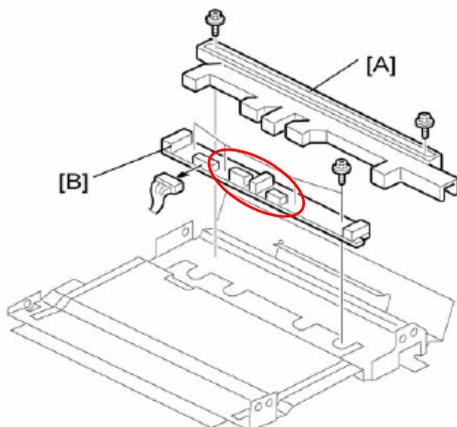
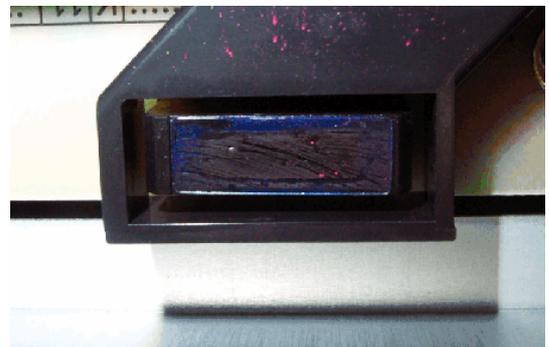
MUSIC and ID Sensors

The ID sensor or MUSIC sensor is wiped with a dry cloth during machine maintenance in the field. As a result, static electricity builds up on the sensor and attracts toner particles.

- **Never** wipe the ID sensor or MUSIC sensor with a **DRY** cloth. If you do, the surface of the sensor will attract toner particles, which triggers one of the above symptoms.
- **Always** make sure to wipe the sensors with a **DAMP** cloth (alcohol), as mentioned in the Service Manual.

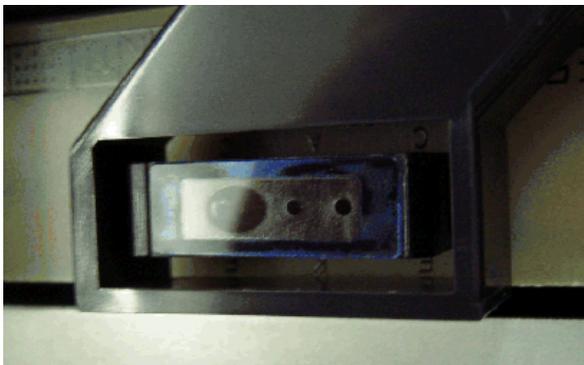
Process control ID sensor

Sensors after cleaning:

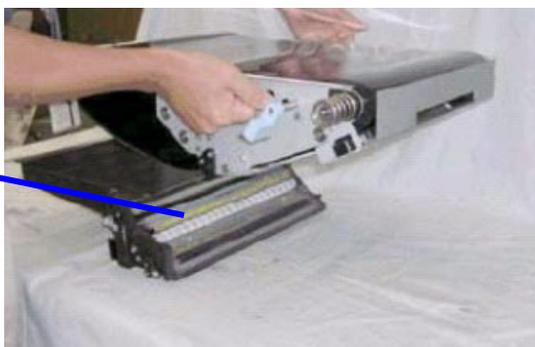
A manufacturing error in the brush scraper [A] causes damage to the ITB cleaning brush [B].

If the symptom is reported on one of the affected machines, replace the ITB cleaning unit [C] with the modified part: P/N **D0149901**.

Note: For the replacement procedure, see the Service Manual.

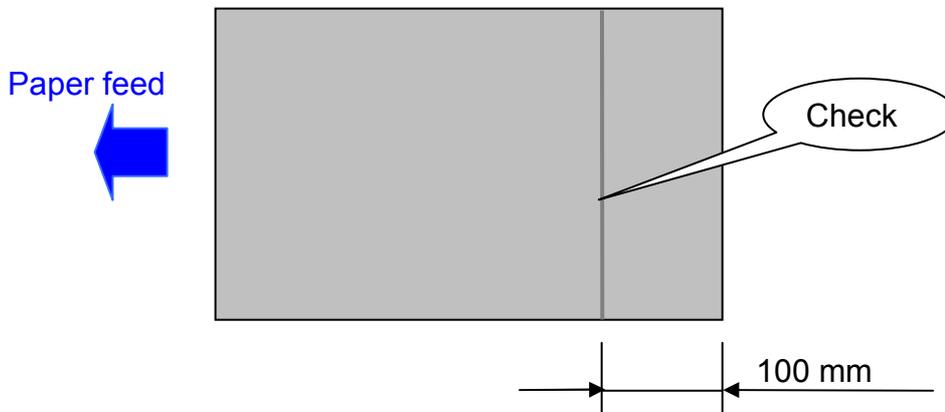
Banding occurs at about 100mm from the trailing edge.

Note: This occurs more easily with thick paper.

The paper vibrates slightly when the trailing edge is released by the registration roller.

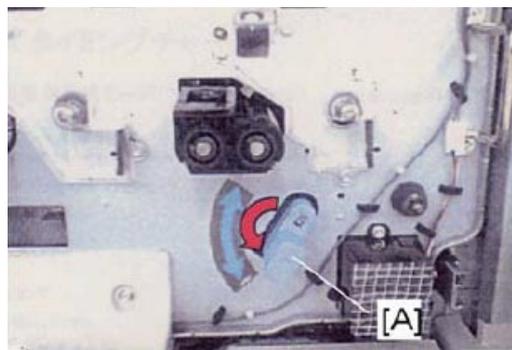
"FAILED" is displayed immediately after hitting the execute button when you try to perform SP3814 (developer fill).

1. The fusing unit has not been warmed up to the Ready condition yet, OR
2. The ITB release lever is set to the upper position.

1. The engine cannot start rotating when the fusing temperature is still low.
2. If SP3814 is executed while this lever is set to the upper position, the machine will refuse the execution and display "FAILED". This is because the ITB contacts the OPC drums when this lever is set to the upper position. If SP3814 is executed under these conditions, the OPC drums will be damaged (there is no developer inside the development unit yet).

1. Execute SP3814 **after the machine beeps twice**. (This means that the fusing temperature has reached Ready condition level).
2. Make sure that the ITB release level [A] is at the **lower position** when you execute SP3814.

Important: After you execute SP3814, set the ITB release lever to the upper position. This is necessary in order to execute SP3811 (developer set up). See the Service Manual, pg. 83, Step 18.

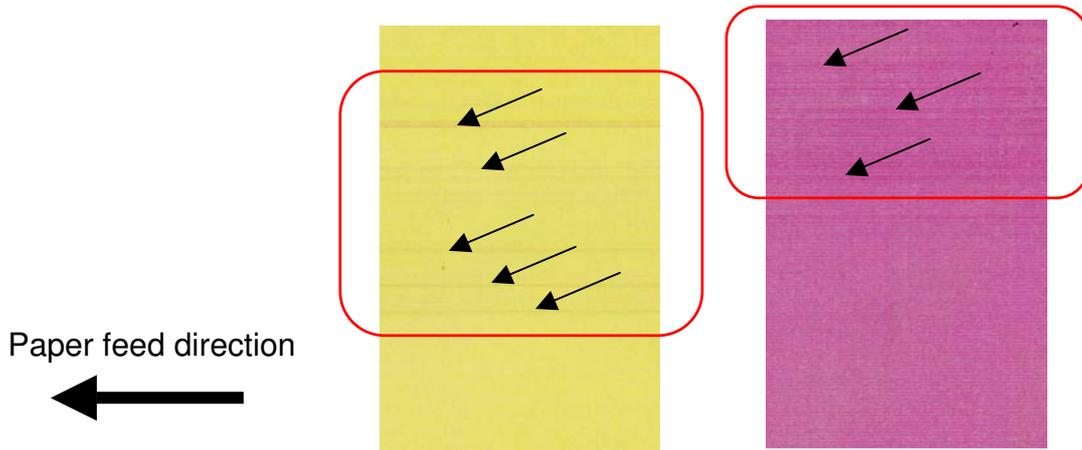
Straight lines appear along the sub-scan direction.

Note: This does not occur with the black PCU.

Under low-temperature/low-humidity conditions, a mixture of lubricant powder and toner leaks out from the lubricant supply blade. As a result, white lines are produced on the surface of the charge roller.

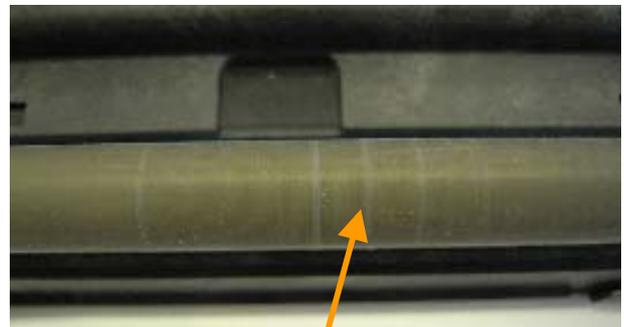
White Lines

Mixture of lubricant powder and toner

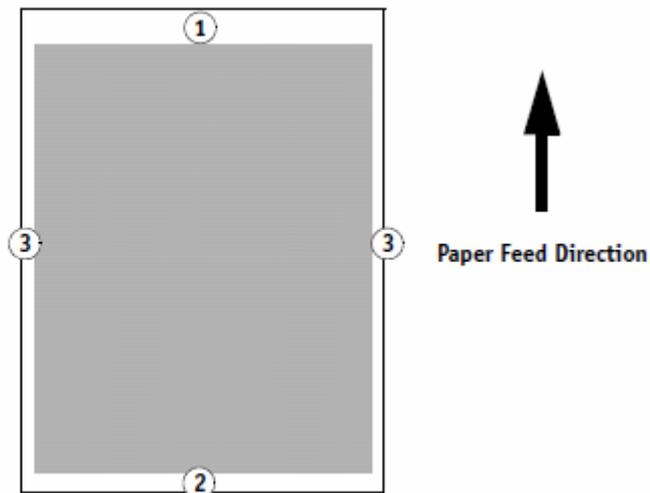
Even when "Full Bleed" is selected in the printer driver for the Color Controller E-7100 or E-8100 as the paper size for printing, margins appear on all four edges of the printout.

- 1 Leading edge: 4.2mm
- 2 Trailing edge: 2.0mm
- 3 Side edge: 1.5mm

When printing out a job from these controllers, by specification, the Erase Margin (SP) setting in the mainframe is given priority over the setting in the printer driver.

2. Explain to the customer that the margin along the leading edge cannot be reduced below 4.2mm. This is because images in this area will cause the paper to wrap around the pressure roller and trigger a jam.

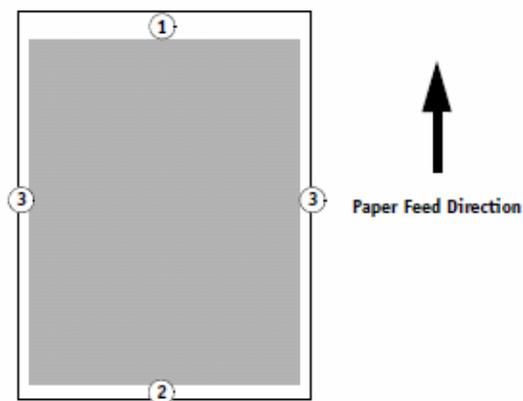
Even when a Full Bleed setting is specified for a job's Paper Size, the output has margins on all four edges of the page.

- 1 Leading edge: 4.2mm
- 2 Trailing edge: 2.0mm
- 3 Side edge: 1.5mm

The margin values for the trailing edge and the side edges can be reduced to 0 mm through a copier adjustment performed by a service technician. To obtain this adjustment for your copier, contact your service representative.

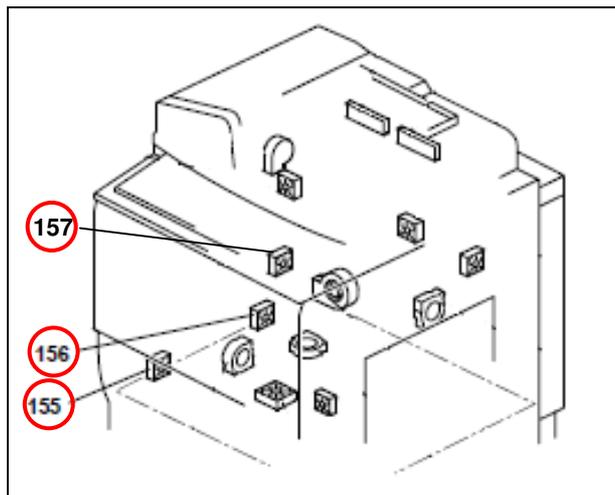
D014/D015 ELECTRICAL COMPONENT LAYOUT (2/3)

SC534	B	Duplex unit fan Error
		<p>The lock signal remained HIGH for 5 sec while the fan that draws air out of the duplex unit was operating.</p> <ul style="list-style-type: none"> • Fan harness disconnected or damaged • Fan blocked by an obstruction • Fan damaged

The fans described in SC534 on S/M pg.417 are ***Paper Exit Fan Motor***, Front Duplex Fan Motor and Rear Duplex Fan Motor (See the diagram below).

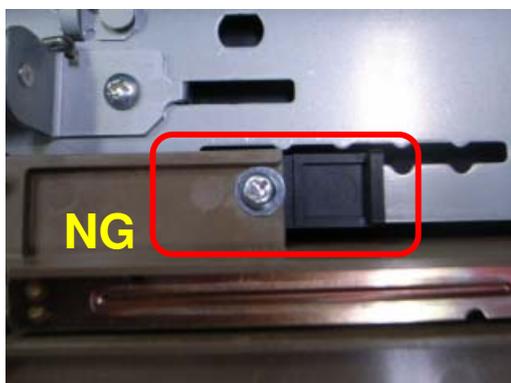
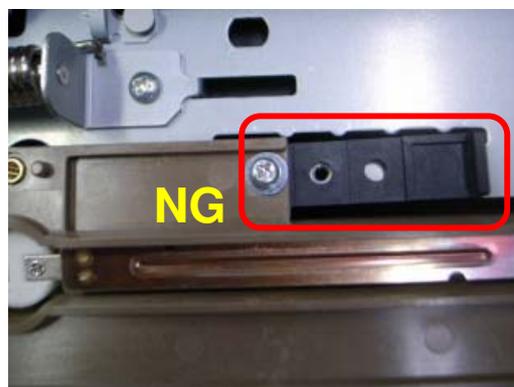
**Incorrect Attachment Position**

A screw is installed in either the left or right position.

The attachment position for **SPACER:HOUSING:THERMOSTAT:FRONT (Pg.123, Index#2)** is decided, so **be sure to attach this part in the correct position** any time in the field.

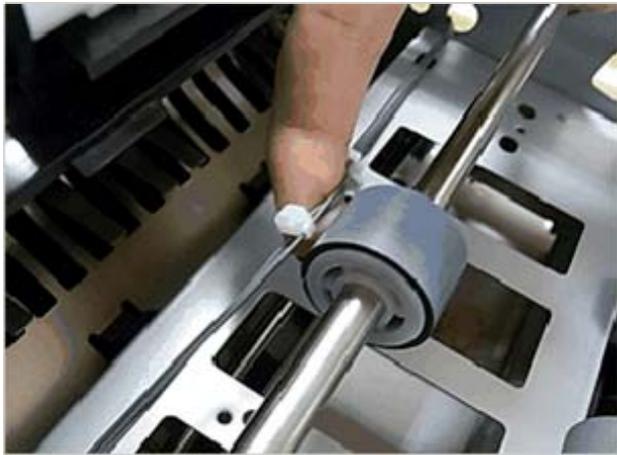
Before Parts Change

Reason: To prevent the harness from touching the roller.

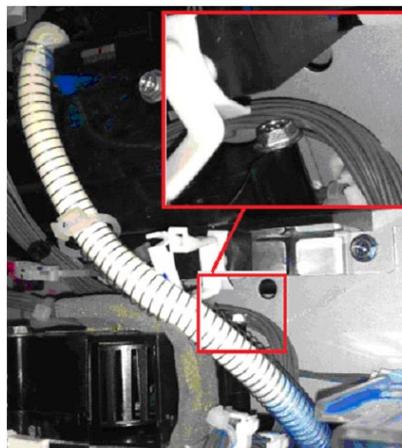
Incorrect

- Make sure to wire the harness **behind** the tube and **in front of** the screw. If you wired the harness around the screw as shown in the "Incorrect" photo, the screw head may damage and short the harness.

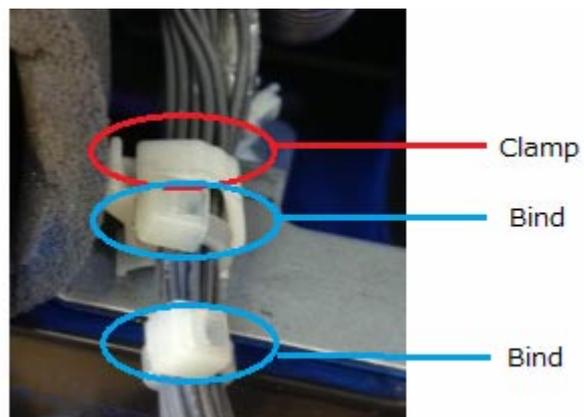
**Incorrect**

Both binds are located below the clamp.

- Close the clamp at the lower end of the cyan toner hopper unit so that the binds are in the positions shown in the photo.

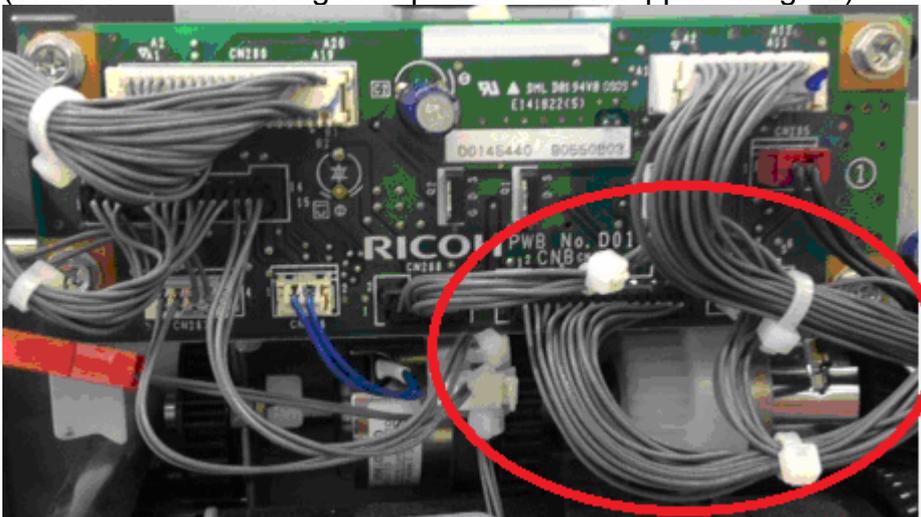
Incorrect

(The harness is resting on top of the toner hopper unit gear)

- Before you attach the bracket, make sure to push the harness up slightly and rest it on top of the CNB board, so that it does not get pinched between the edge of the bracket and another part.

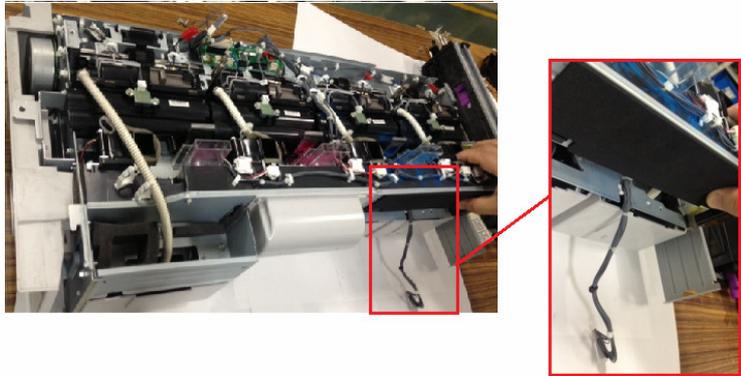
Incorrect

The harness is under the hopper duct, and gets pinched between the hopper duct and toner hopper unit.

IMPORTANT: When you attach the toner hopper duct, always make sure to lay the harness **over the toner hopper duct** and hold it in place as shown. If the harness is under the toner hopper duct, it will get damaged from being pinched.

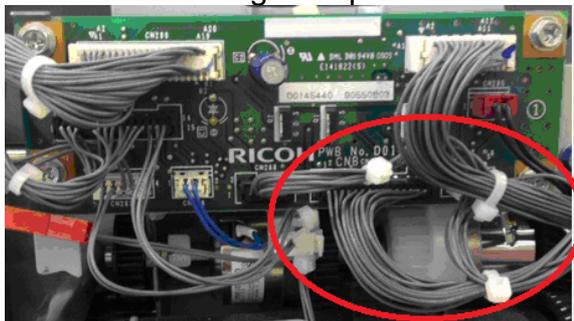
Incorrect

(The harness is resting on top of the toner hopper unit gear)

- Before you attach the bracket, make sure to push the harness up slightly and rest it on top of the CNB board, so that it does not get pinched between the edge of the bracket and another part.

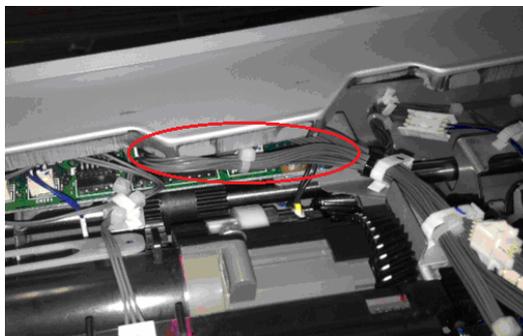
Incorrect

(The harness is pinched between the edge of the bracket and the surrounding part)

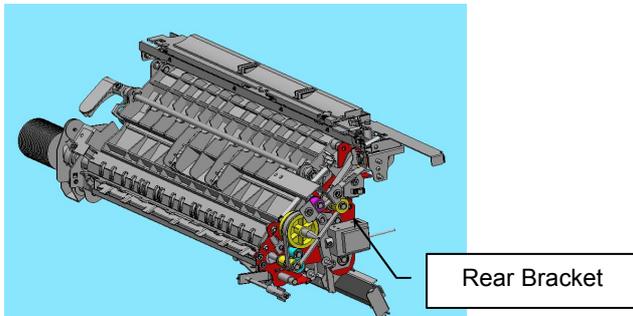
Lower durability in some decurler rollers may damage the ball bearings. As a result, if the machine is used in this condition, the fusing gear (GEAR - 20Z) may also break.

The rear bracket attached to the decurler roller (shown below in red) was also changed, but cannot be replaced individually in the field.

Replace the paper exit unit with the modified part (P/N D0817003).

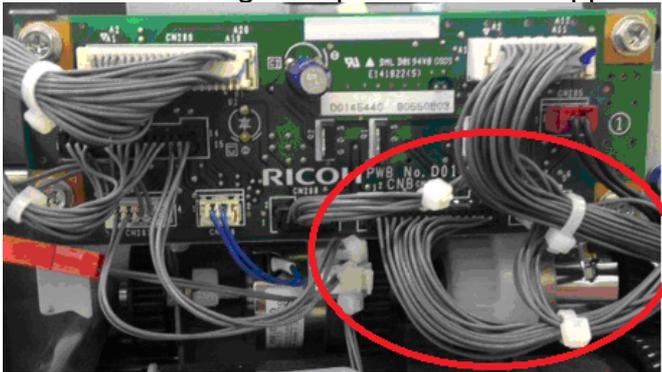
**Incorrect**

The harness is resting on top of the toner hopper unit gear.

- Before you attach the stay, make sure to push the harness up slightly and rest it on top of the CNB board, so that it does not get pinched between the edge of the stay and another part.

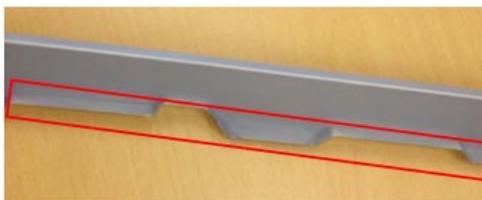
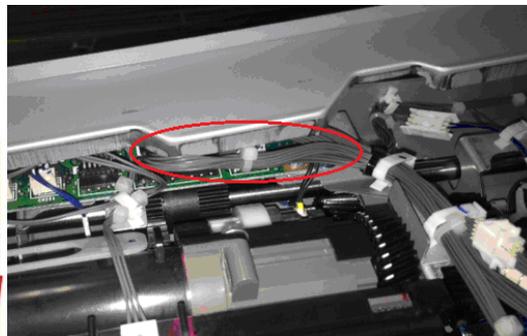
The harness is pinched between the edge of the stay and the surrounding part.

The edge of the stay

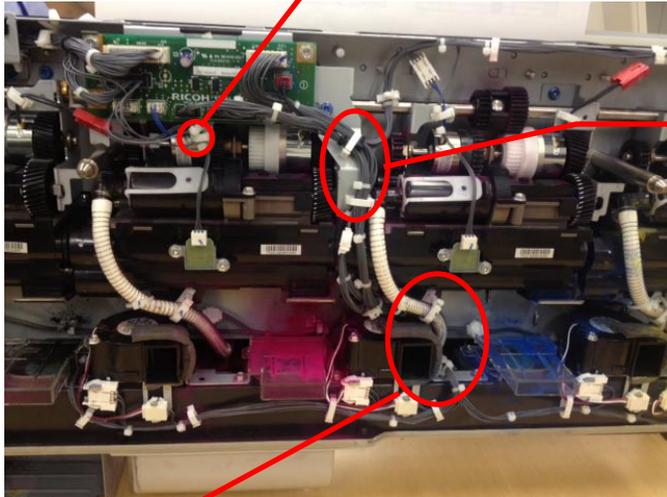
Check points for the wiring position of the harness

Make sure to attach the binds and clamps in the positions shown in this photo.

Correct

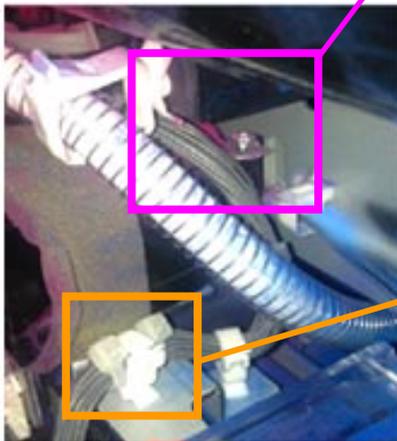
Incorrect

Make sure to wire the harness **behind** the tube and **in front of** the screw. If you wired the harness around the screw as shown in the "Incorrect" photo, the screw head may damage and short the harness.
