Model: V-C3	Date: 11-Dec-09	No.: RD081001c
-------------	-----------------	----------------

Subject: Firmware Release Note: Printer		Prepared by: T. Toriumi	
From: 1st Overseas Tech Support Sec., 1st PQM Dept.			
Classification:	<input type="checkbox"/> Troubleshooting	<input type="checkbox"/> Part information	<input type="checkbox"/> Action required
	<input type="checkbox"/> Mechanical	<input type="checkbox"/> Electrical	<input type="checkbox"/> Service manual revision
	<input type="checkbox"/> Paper path	<input type="checkbox"/> Transmit/receive	<input type="checkbox"/> Retrofit information
	<input type="checkbox"/> Product Safety	<input checked="" type="checkbox"/> Other (Firmware)	<input checked="" type="checkbox"/> Tier 2

This RTB has been issued to announce the firmware release information for the **Printer**.

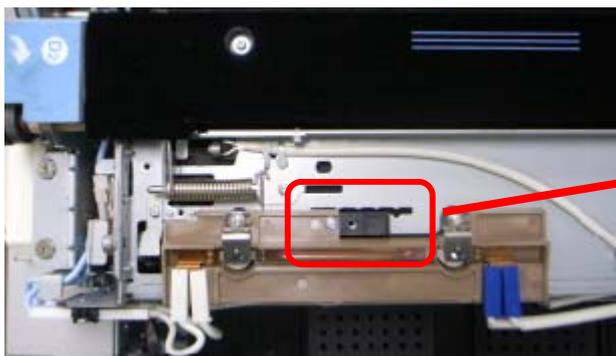
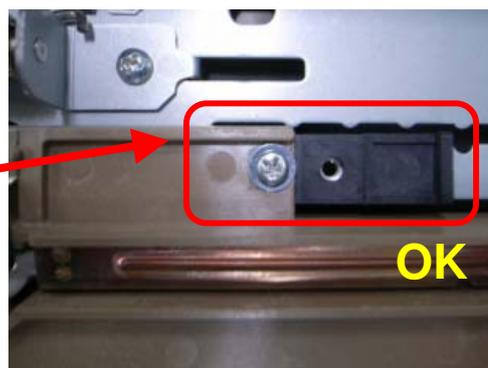
**Correct Attachment Position**

A screw is installed in the center position.

The attachment position for **SPACER:HOUSING:THERMOSTAT:FRONT (Pg.182, Index#165)** is decided, so **be sure to attach this part in the correct position** any time in the field.

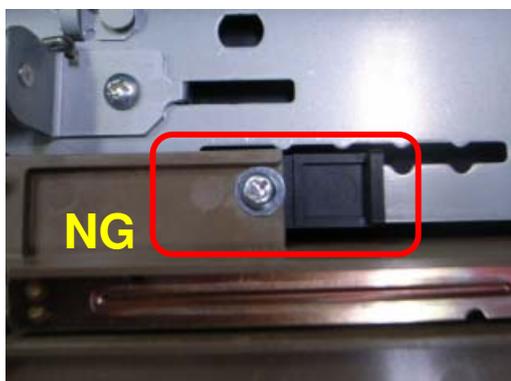
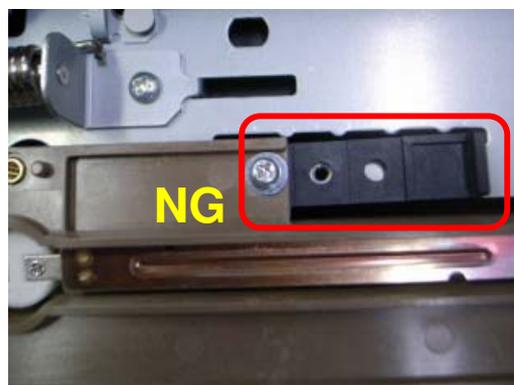
**Incorrect Attachment Position**

A screw is installed in either the left or right position.

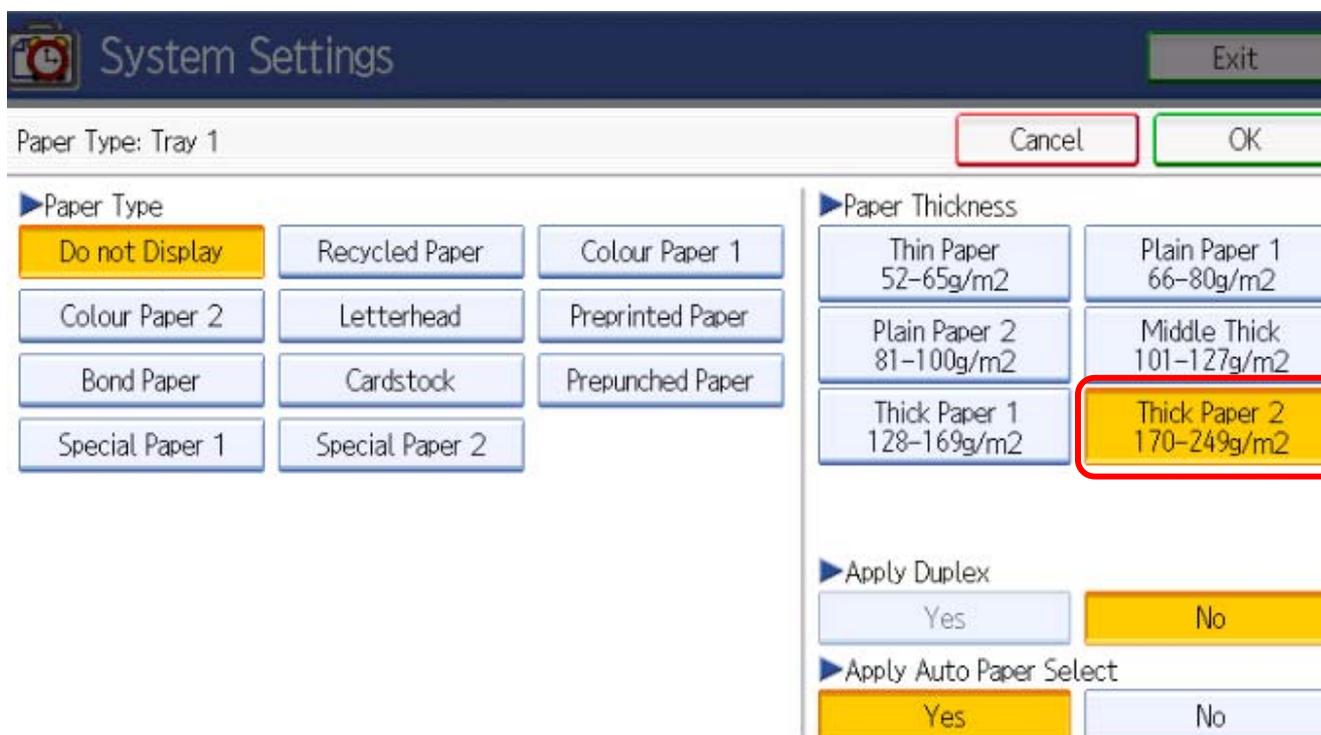
- As shown below, the paper thickness for Tray 1 and 2 is displayed as “170-249g/m<sup>2</sup>”. However, the maximum thickness supported by this model on Tray 1 and 2 is 216g/m<sup>2</sup>.
- Therefore, please advise customers not to load paper with a thickness greater than 216g/m<sup>2</sup> in Tray 1 and 2. Otherwise, a paper jam may occur.

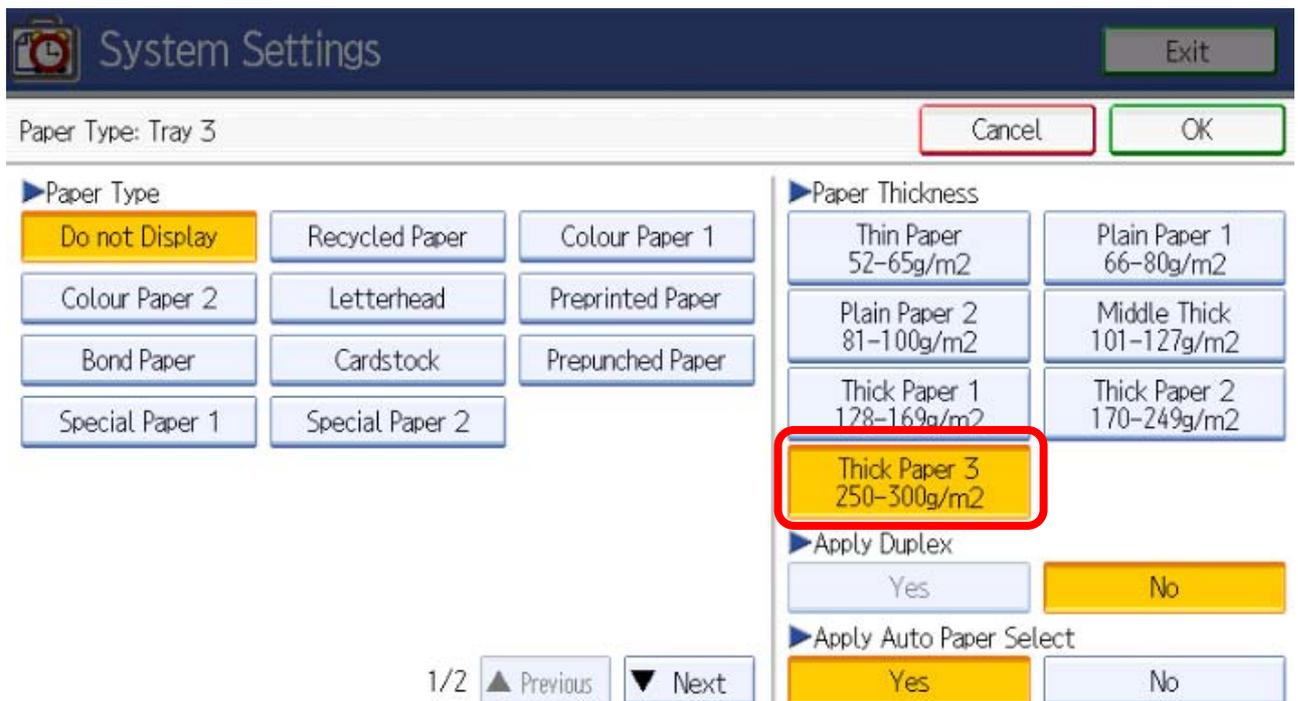
- As shown below, the paper thickness for Tray 3 is displayed as “250-300g/m<sup>2</sup>”. However, the maximum thickness supported by this model on Tray 3 is 256g/m<sup>2</sup>.
- Therefore, please advise customers not to load paper with a thickness greater than 256g/m<sup>2</sup> in Tray 3. Otherwise, a paper jam may occur.

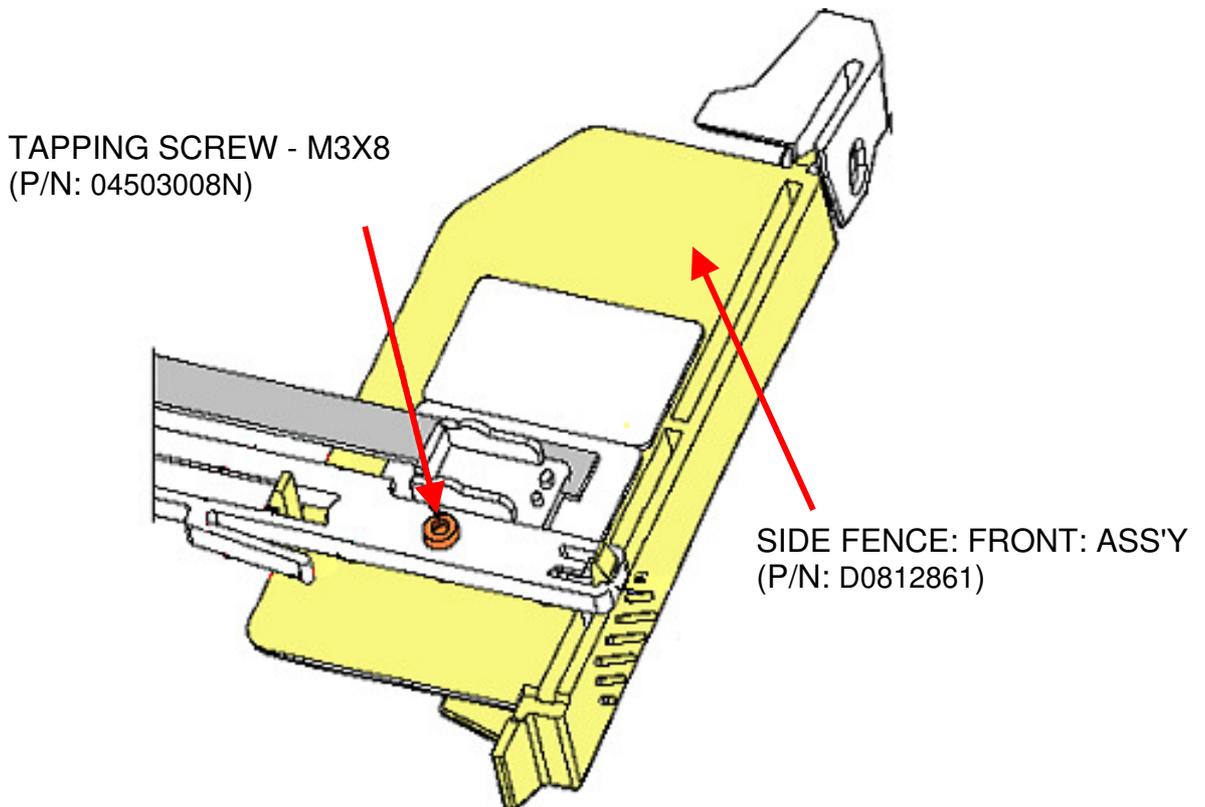
**Reason:** To fix the assembly in place, so that it does not detach from the hook when it is slid.

**Change:** A tapping screw (M3x8) was added to the side fence front assembly.

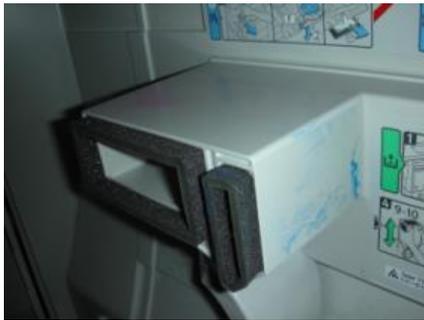
1. Behind the front door

***Following this, toner may scatter inside the machine and stick to the areas shown below if the user continues to use the machine.***

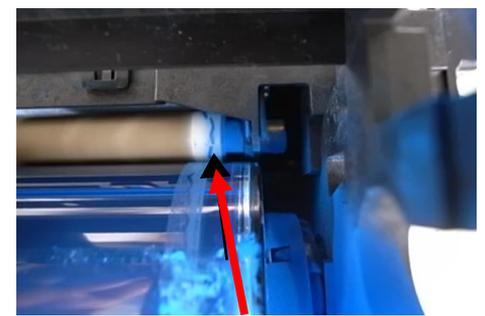
6. Gap between charge roller and drum

Toner builds up between roller and drum

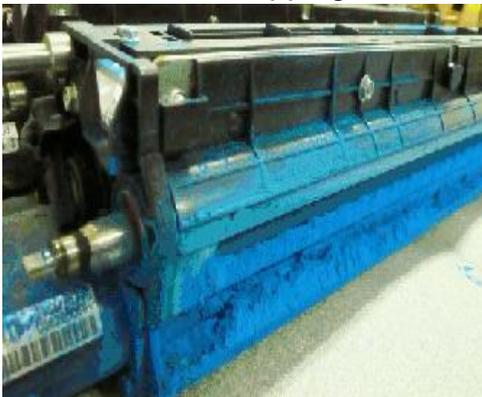
**Toner dropping**

This amount of toner in the trough area indicates that toner dropping (scattering outside the unit) has already occurred.

- For machines with a color APV of 30K or more, clean the development unit every 2 or 3 service visits, i.e. approximately every 75K–100K. This will help prevent the symptom from occurring.
- For the optimum cleaning interval (i.e. every 2 visits or every 3 visits), keep track of the customer's print volume.

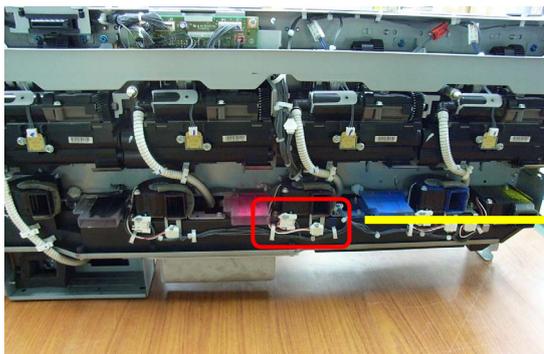
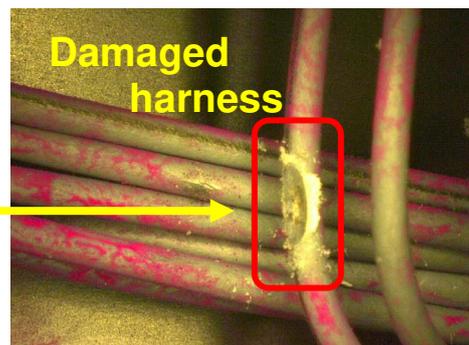
The harness behind the toner hopper unit may be damaged, as shown in the photos below.

If the harness is damaged severely, a short circuit may occur and damage the PCB: CNB (D0145440).

The harness is pinched and ultimately damaged by the positioning pin shown in the photo below.

2. Check the individual cables of the harness [A] for damage (See the photograph on pg. 1). For any cable that is damaged, wrap a piece of Teflon tape twice around the damaged area.

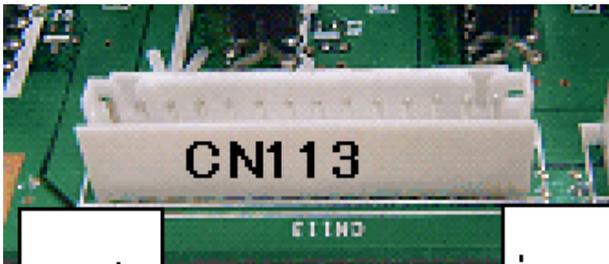
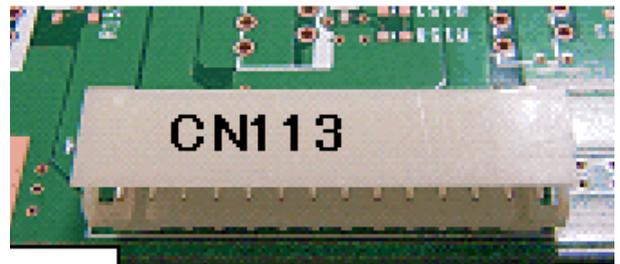
Old Part: D4125500

**Reason:** To further minimize the stress to the insertion slot when the connector is inserted.

New Part: D4125505

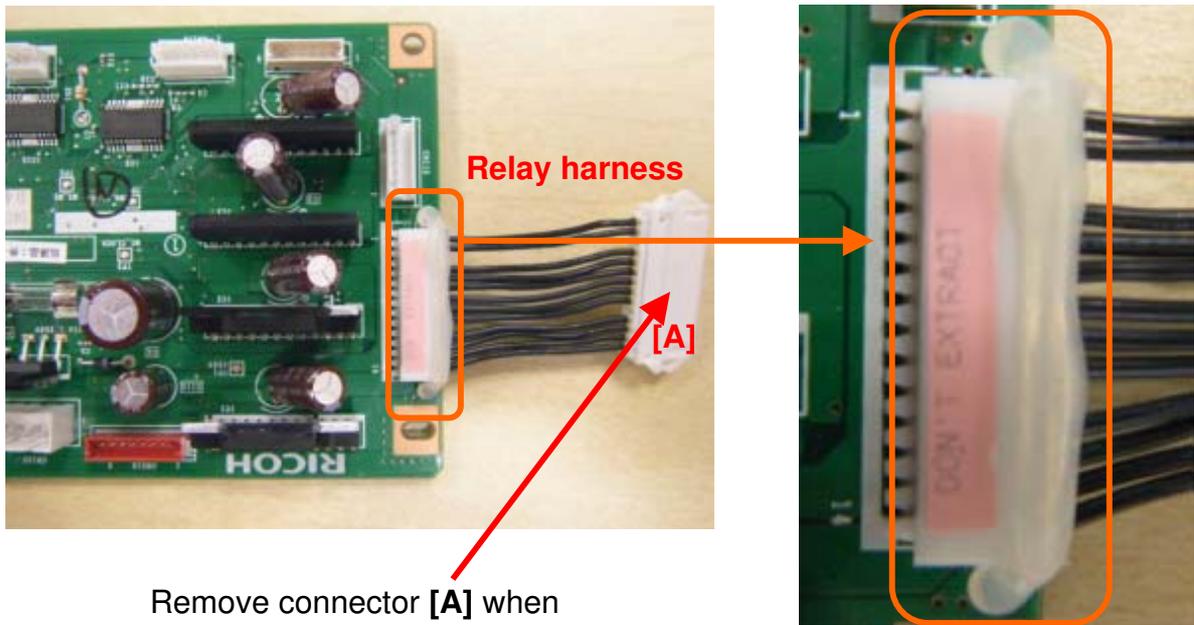
- Before the change is applied to the production line, some machines have a temporary PCB with a relay connector (see the photo and serial numbers below).
- If you replace this temporary PCB in the field, remove connector [A] of the relay harness when removing the board.

Remove connector [A] when replacing this PCB.

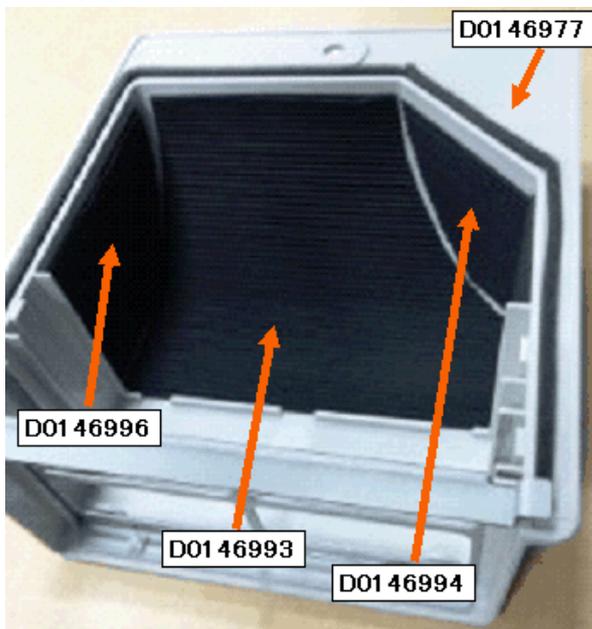
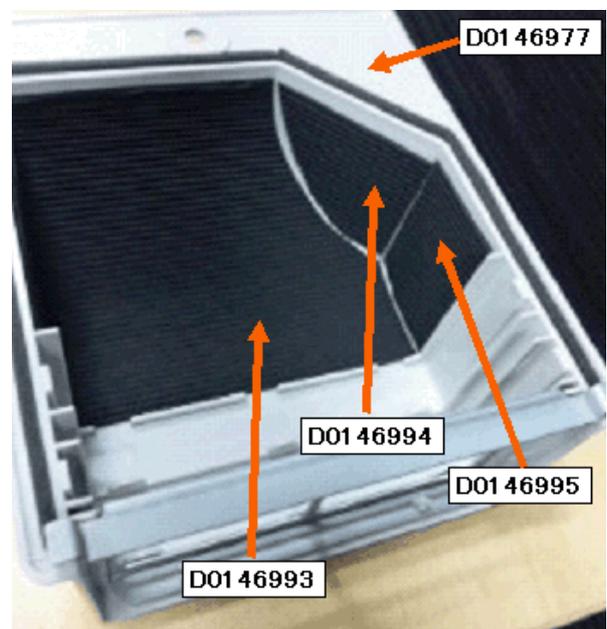
**Change:** Ozone absorption sheets were added inside the main rear duct (P/N: D0146977), as shown below.

**Reason:** To further reduce ozone emission levels and achieve **Blue Angel Mark** certification.

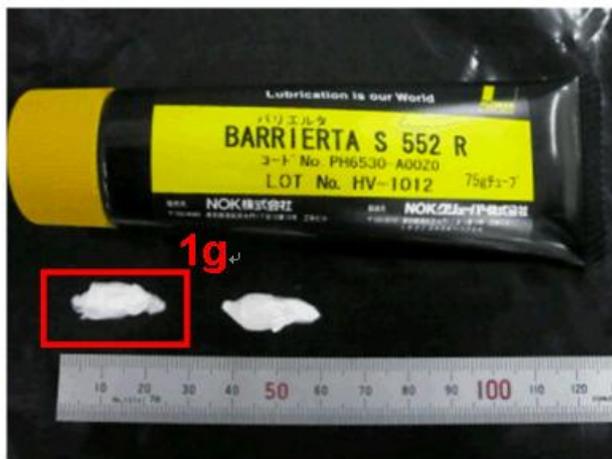
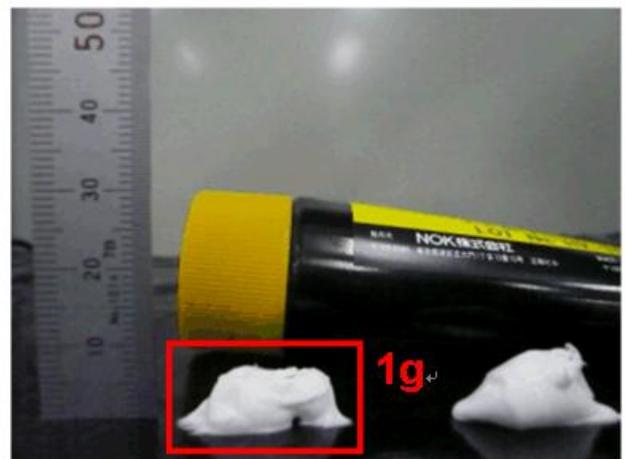
Rust powder from the fusing gears is scattered in the area under the fusing unit.

The fusing gears were not lubricated correctly when they were replaced or at PM. As a result, the friction generates rust powder.

**Apply a total of 2g of Grease Barrierta S552R** to the two gears shown below (AB014322 / GEAR: IDLER: PRESSURE ROLLER, and AB014323 / GEAR: IDLER: DRIVE) whenever you replace the gears or at PM (150K).

Apply **1g** of Grease Barrierta to each gear (**a total of 2g**) as you rotate the gear, making sure that the grease is spread out evenly across the gear surface.

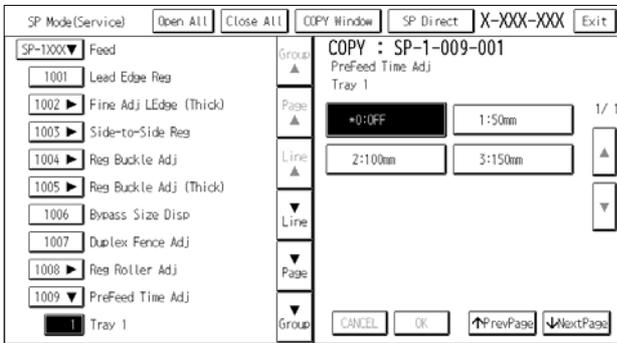
**Fig. 1: Normal display**  
System/Copy v1.01 or earlier

The default value (0) for **SP1009-001** (PreFeed Time Adj\_Tray.1) is not displayed when the machine is using System/Copy Firmware **v1.02 or later**, as shown in Fig. 2 below.

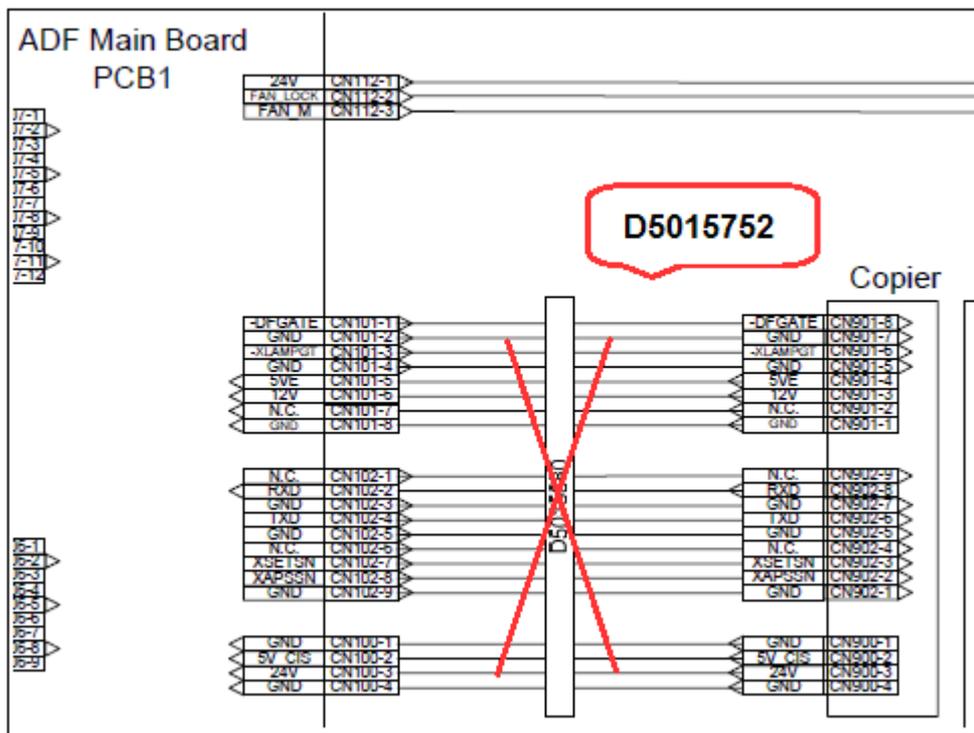
**ADF (FOR D081/D082) Point To Point Diagram (5/5)**

Incorrect P/N	Correct P/N	Name	Page
D5015880	<b>D5015752</b>	HARNES: INTERFACE	5/9

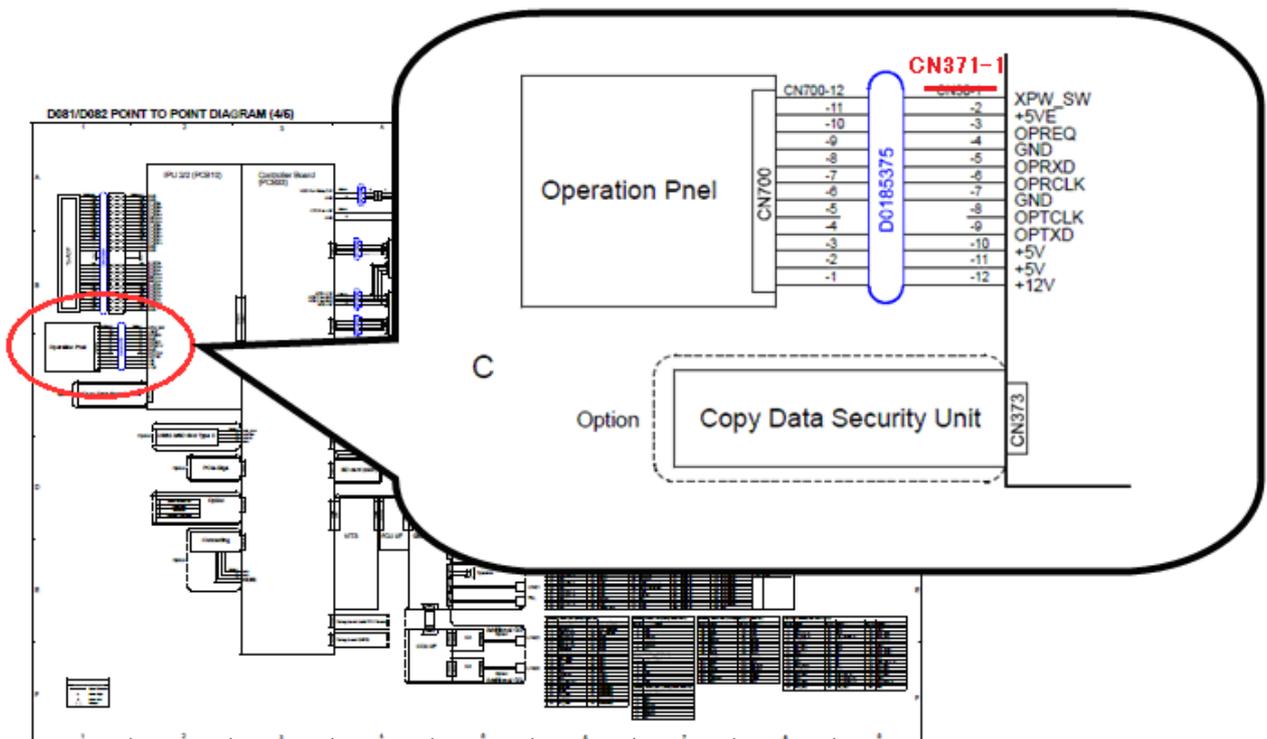
**D081/D082 POINT TO POINT DIAGRAM (4/5)**

Incorrect CN#	Correct CN#
CN30-1	CN371-1

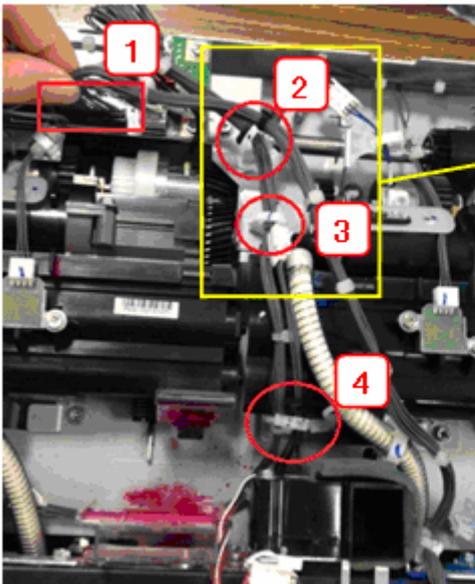
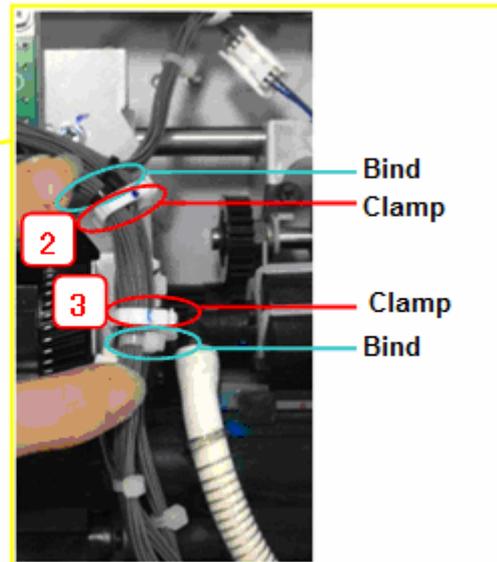
- Make sure to reattach the CNB harness connectors [1] and clamps [2], [3], [4] in the order shown in the photos (#1-4).
- Make sure to fasten clamps [2] and [3] in the positions shown in the photo. Clamp [2] should be below the top bind, and clamp [3] should be above the other bind, as shown.

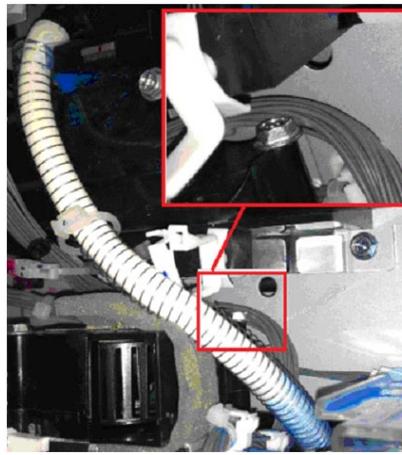
**Incorrect**

- Make sure to wire the harness **behind** the tube and **in front of** the screw. If you wired the harness around the screw as shown in the "Incorrect" photo, the screw head may damage and short the harness.

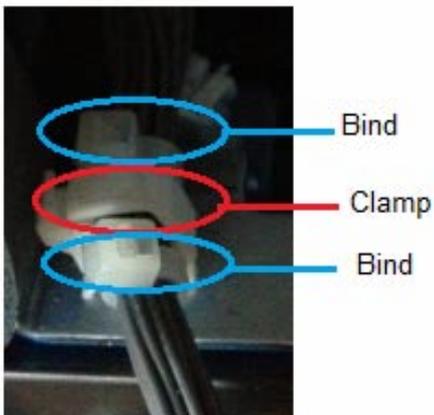
**Correct**

The clamp comes between the binds.

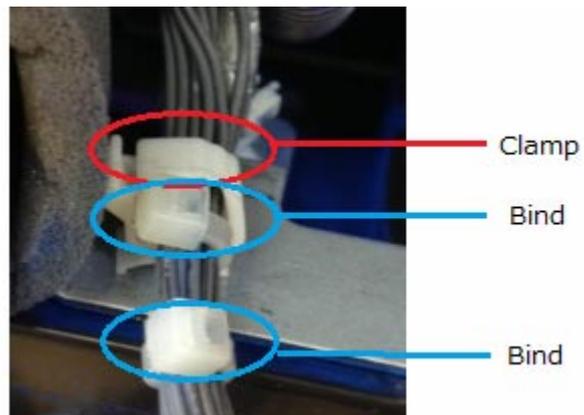
**Incorrect**

Both binds are located below the clamp.

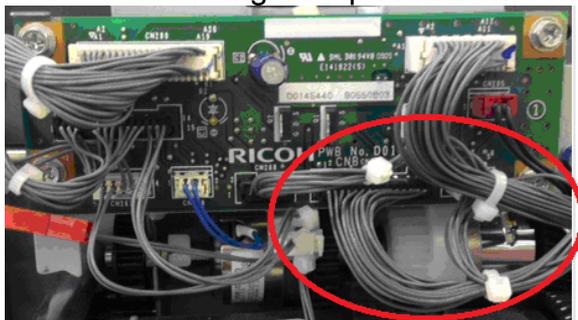
**Incorrect**

(The harness is resting on top of the toner hopper unit gear)

- Before you attach the bracket, make sure to push the harness up slightly and rest it on top of the CNB board, so that it does not get pinched between the edge of the bracket and another part.

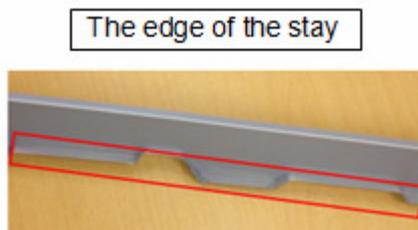
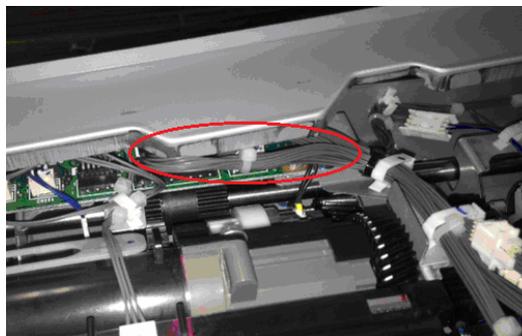
**Incorrect**

(The harness is pinched between the edge of the bracket and the surrounding part)

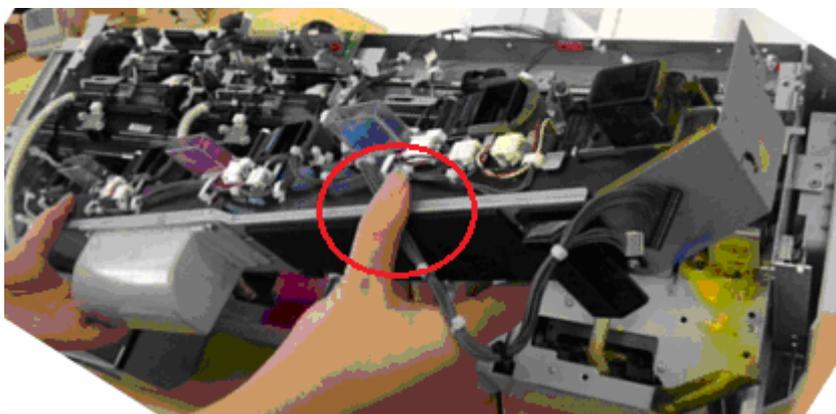
**IMPORTANT:** When you attach the toner hopper duct, always make sure to lay the harness **over the toner hopper duct** and hold it in place as shown. If the harness is under the toner hopper duct, it will get damaged from being pinched.

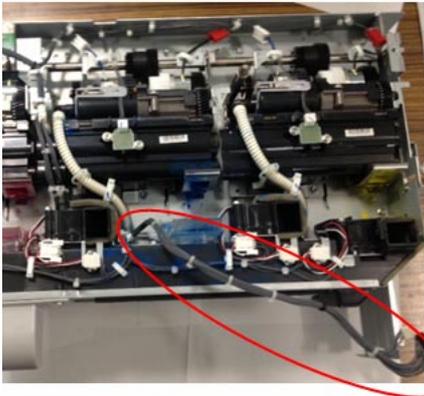
**Correct**

The harness hangs over the hopper duct

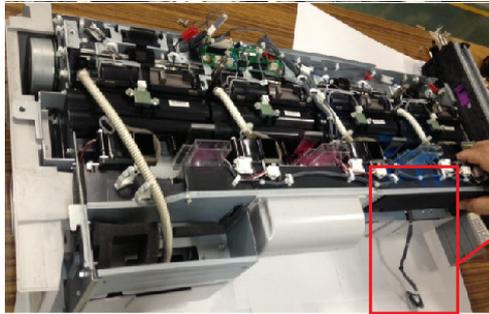
**Incorrect**

The harness is under the hopper duct, and gets pinched between the hopper duct and toner hopper unit.

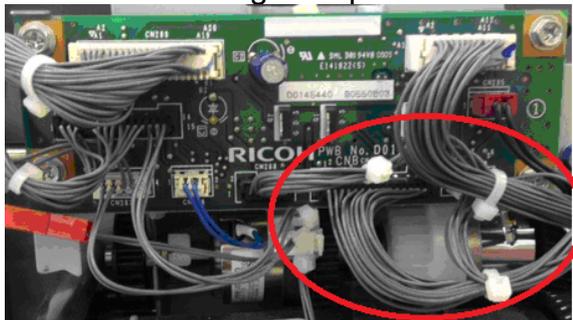
**Incorrect**

(The harness is resting on top of the toner hopper unit gear)

- Before you attach the bracket, make sure to push the harness up slightly and rest it on top of the CNB board, so that it does not get pinched between the edge of the bracket and another part.

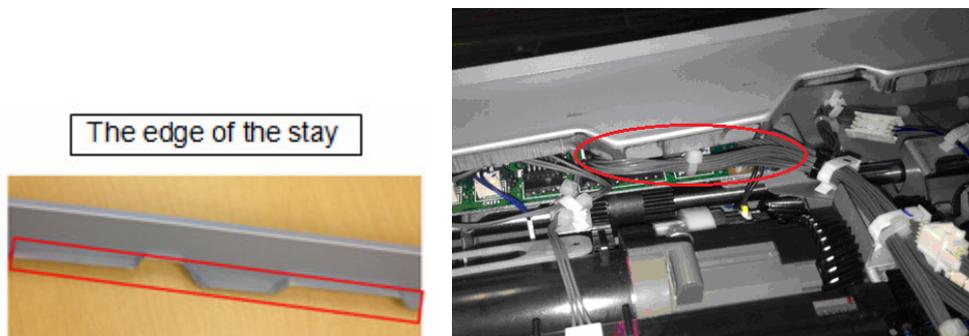
Incorrect

(The harness is pinched between the edge of the bracket and the surrounding part)

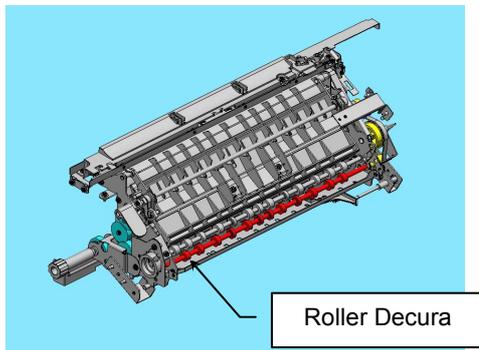
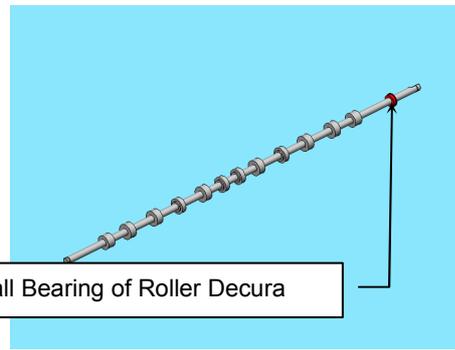
Lower durability in some decurler rollers may damage the ball bearings. As a result, if the machine is used in this condition, the fusing gear (GEAR - 20Z) may also break.

The shape of the ball bearing for the decurler roller was changed to improve the durability of the roller.

Replace the paper exit unit with the modified part (P/N D0817003).

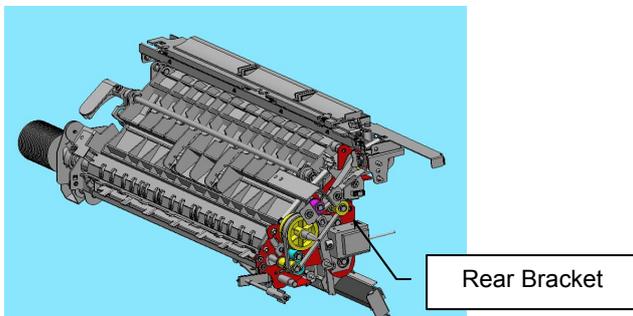
The rear bracket attached to the decurler roller (shown below in red) was also changed, but cannot be replaced individually in the field.

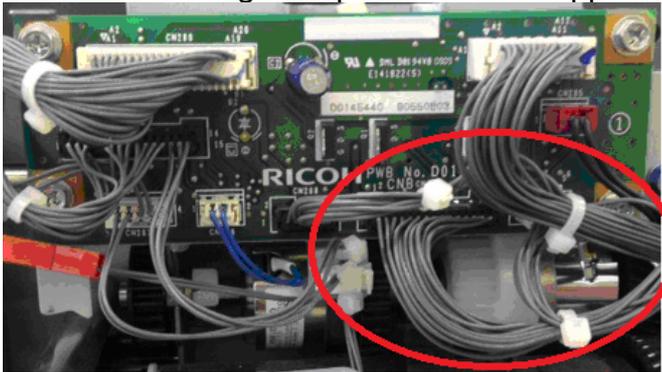
**Incorrect**

The harness is resting on top of the toner hopper unit gear.

- Before you attach the stay, make sure to push the harness up slightly and rest it on top of the CNB board, so that it does not get pinched between the edge of the stay and another part.

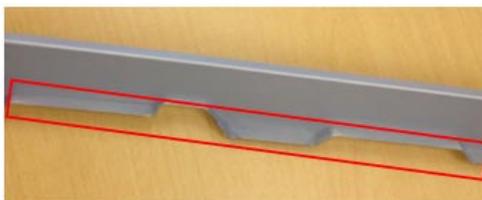
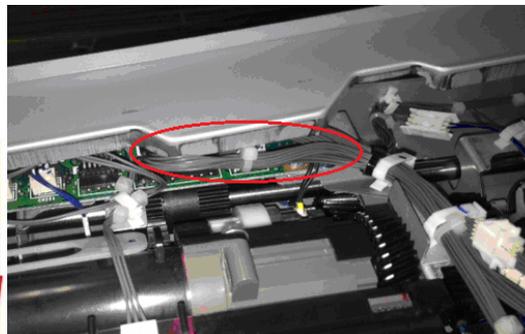
**Incorrect**

The harness is pinched between the edge of the stay and the surrounding part.

The edge of the stay

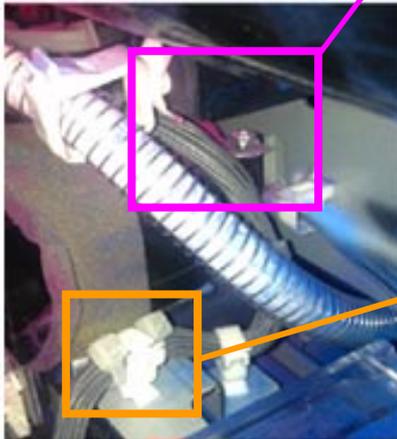
**Incorrect**

The bundled harness [A] for the CNB board is pushed too far inside the machine, and ends up positioned incorrectly (behind the screw [B] on the magenta PCU fan motor). In some cases, the harness covering might be cut. If the exposed area touches the screw head, a short circuit occurs, which damages the CNB board.

Make sure to wire the harness **behind** the tube and **in front of** the screw. If you wired the harness around the screw as shown in the "Incorrect" photo, the screw head may damage and short the harness.

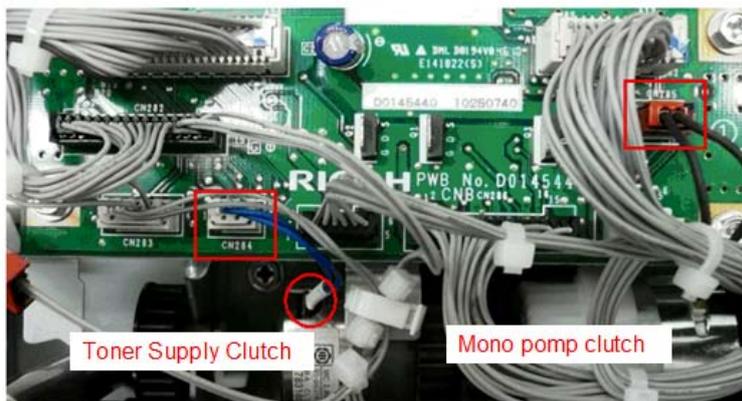
The following may occur just after the PCB: CNB (P/N D0149453) is replaced.

The connector for the magenta supply clutch (sub hopper clutch) is removed from CN284 or CN285 too strongly. As a result, the harness is damaged.

- If the symptom occurs, replace the MAGNETIC CLUTCH: TONER SUPPLY UNIT:ASS'Y (G1783186) or TONER SUPPLY UNIT:ASS'Y (D0143359).
- Always make sure to remove the clutch connectors **gently**.

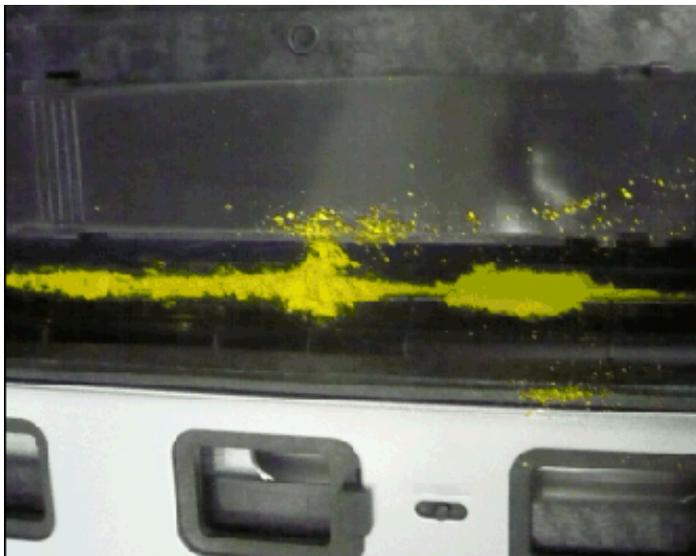
The toner is shipped and/or stored under high-temperature conditions (50C or higher), which melts the additive (wax) in the toner. As a result, the toner tends to stick to the parts along its supply/transport path.

**Note:** The photo below was taken after the PCDU drum was removed, and shows waste toner that had built up inside the cleaning area.

Replace the following parts:
