### Technical Bulletin

Reissued: 02-Nov-15 Model: CH-C1

No.: RD135004c

This RTB has been issued to announce the firmware release information for the Web Uapl.

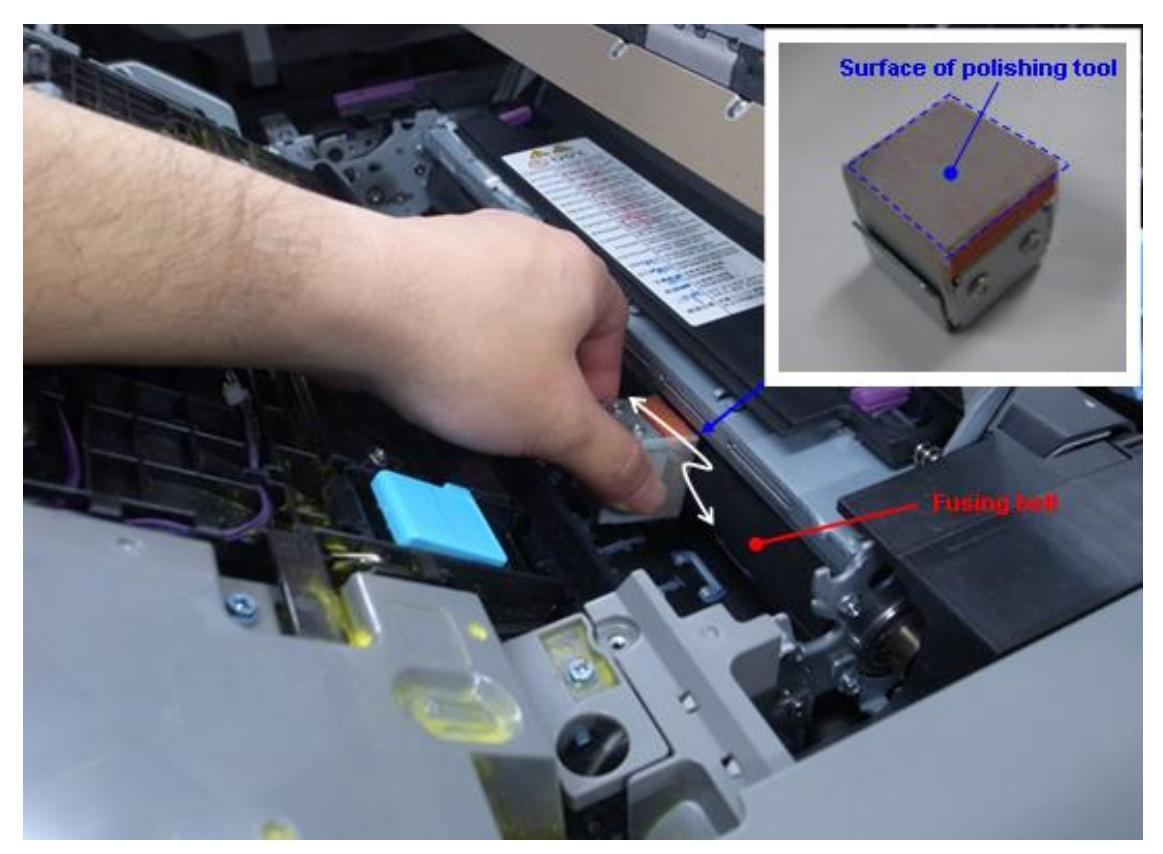
4. Rub the surface of the M0774287 polishing tool (WEB:POLISH:FUSING:ASS'Y) against the surface of the fusing belt.

- F After you finish each section of the fusing belt surface, rotate the fusing gear [A] counterclockwise and do the next section. Repeat this until you have polished the entire surface of the belt.
- Make sure to polish **both the front and rear sides** of the fusing belt. This is because scratches are generated by the front and rear edges of paper.

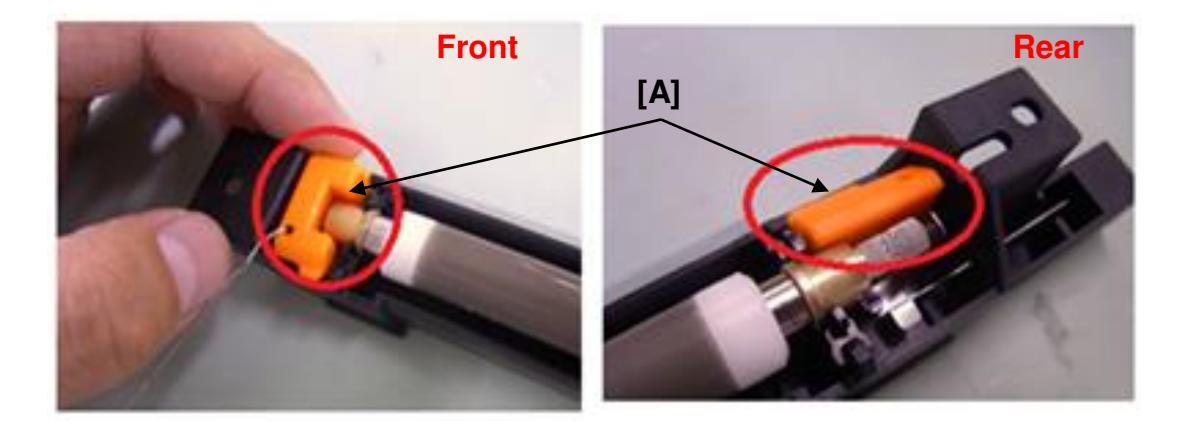
- Shipping retainers **[A]** (circled in red below) were added to both ends of the cyan, magenta, and black charge roller units. This is to prevent any damage to the charge roller cleaning roller during shipping due to high temperature/humidity conditions. (Such damage can cause banding at 5mm intervals in halftone areas).
- A procedure for removing these at installation was added, called "Removing the Retainers of the Charge Roller Units (C, M, K").

**IMPORTANT:** Make sure to **remove the new shipping retainers at machine installation**, before you attach the ITB separation lever. If you do not, image problems will occur.

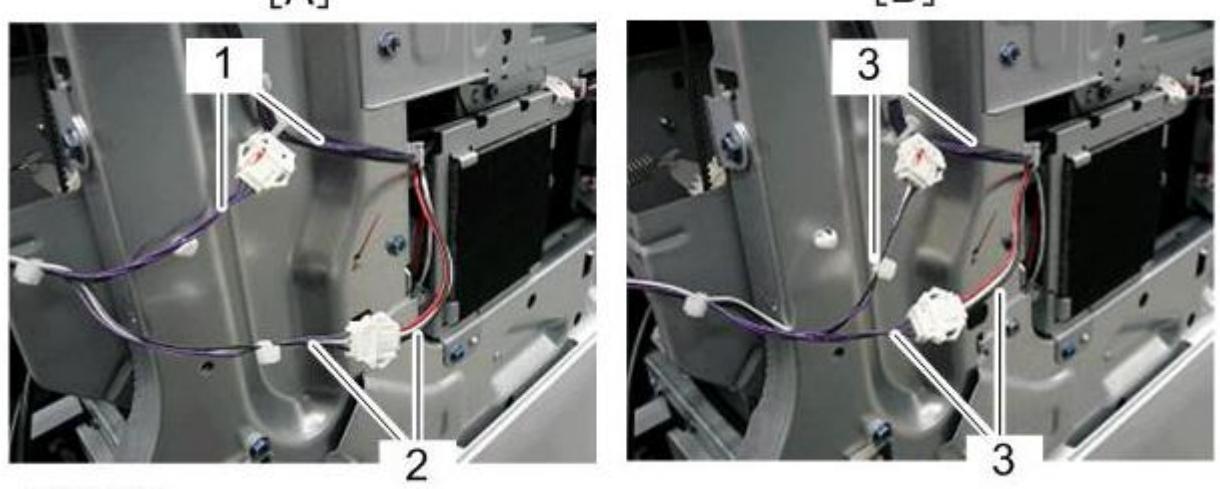
d135a3135

[A]: Correct [B]: Incorrect 1 (OK):Purple harnesses connected to each other 2 (OK): Black/white harnesses connected to each other 3 (NG): Black/white harness connected to purple harness

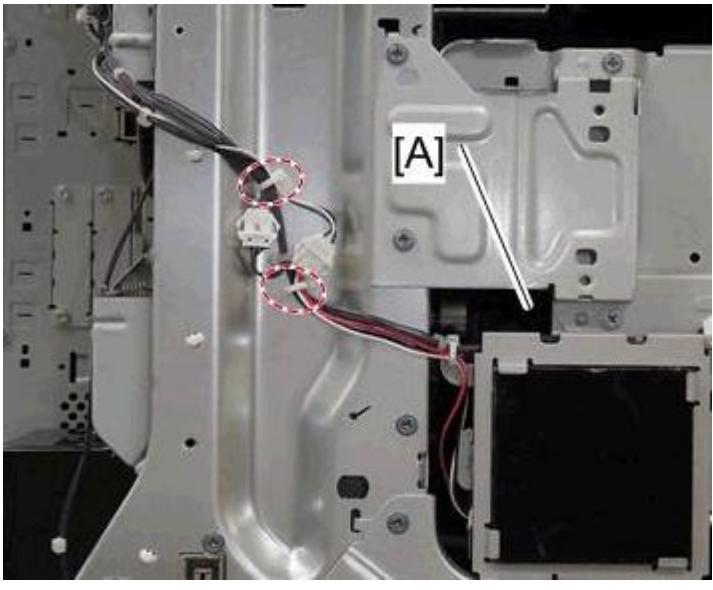
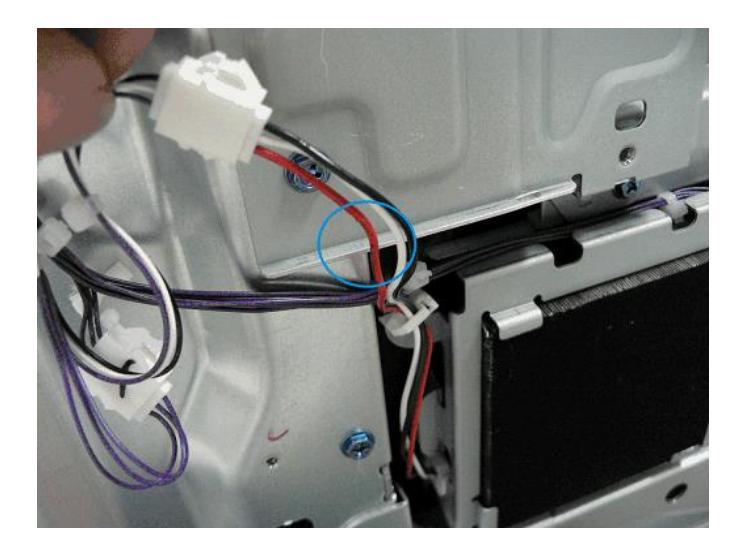
Make sure the harnesses are connected as shown below.

The following symptoms may occur, if the harness is connected incorrectly.

- 1. When turning on the machine power error message "The power cord is pulled out" appears on the operation panel.
- 2. SC547

The above is a result of ground fault, which occurs, if the harnesses are connected incorrectly causing the mainframe and inner cover to pinch the harness of the duplex exit fan (24V).

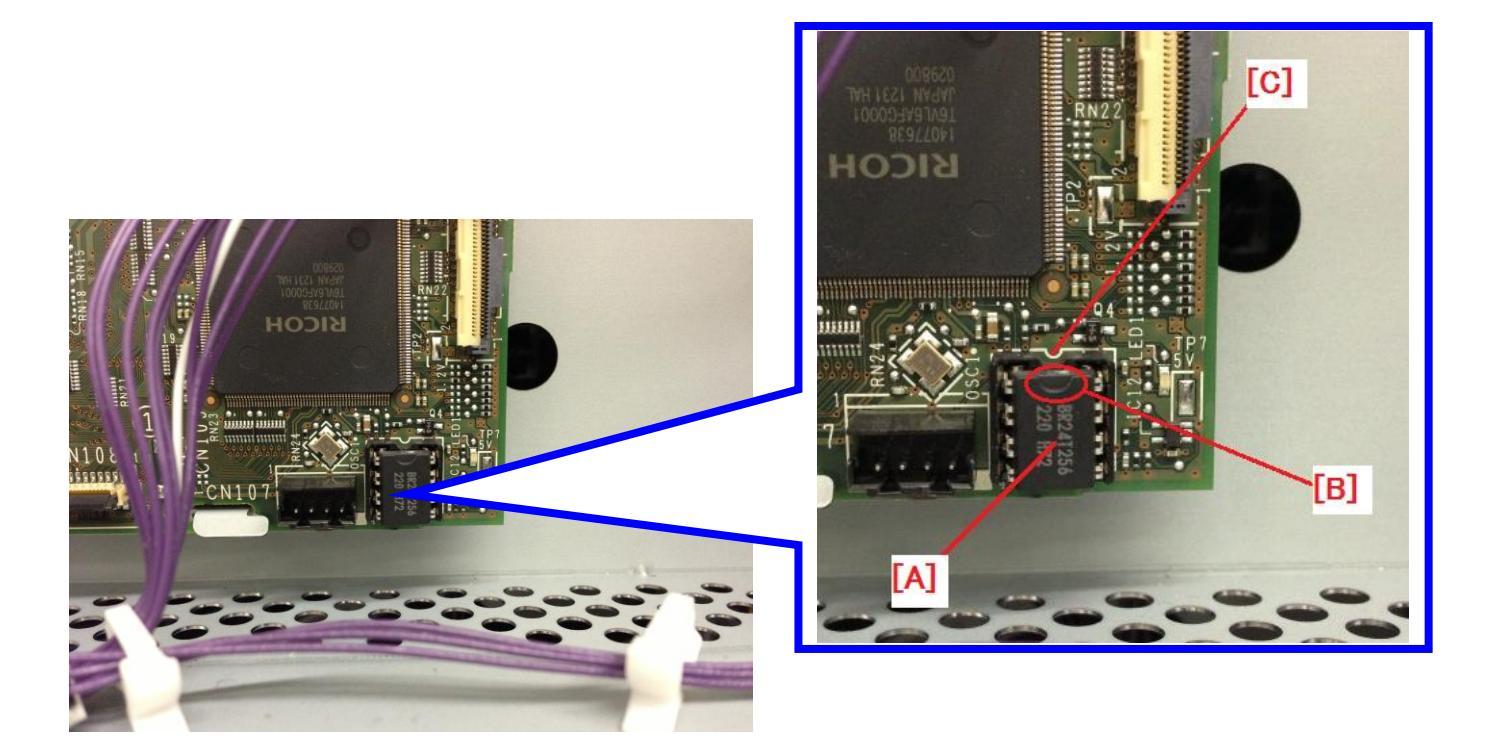
- A BCU procured as a service part does not contain the NVRAM (EEPROM) [A].
- When installing a new BCU procured as a service part, make sure to remove the NVRAM from the old BCU and install it on the new BCU.
- Install so that the indentation [B] on the NVRAM corresponds with the mark [C] printed on the BCU. Incorrect installation of the NVRAM will damage both the BCU and the NVRAM.
- If you forget to install the NVRAM on the new BCU, the machine will not activate and remain in "Please wait" status even with the main power switch turned on.

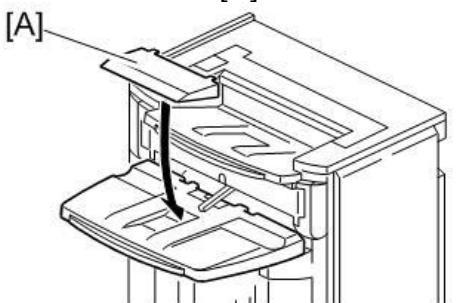
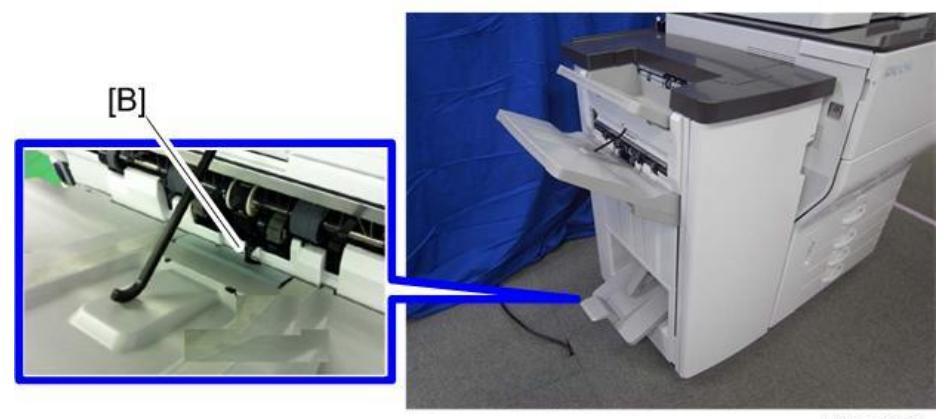
d135a3122

Install the shift auxiliary tray [A] ONLY when the "Multi-Folding Unit FD4000 (D615)" is included in the configuration. Note that the Shift Auxiliary Tray [A] may generate unexpected side effects, for example, paper jams caused by displaced paper height detection feeler [B].

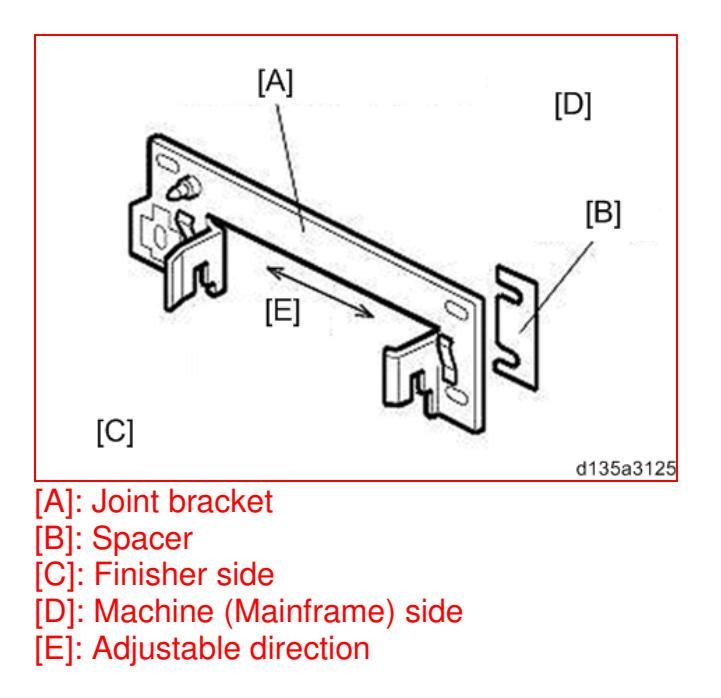
- If the leading edge is skewed about 2mm toward the front (operator) side of the machine, attach a 2mm spacer to the rear side of the joint bracket.
- If the leading edge is skewed about 2mm toward the **rear** (non-operator) side of the machine, attach a 2mm spacer to the **front** side of the joint bracket.

**IMPORTANT:** When you attach the bracket, attach the spacer(s) as follows:

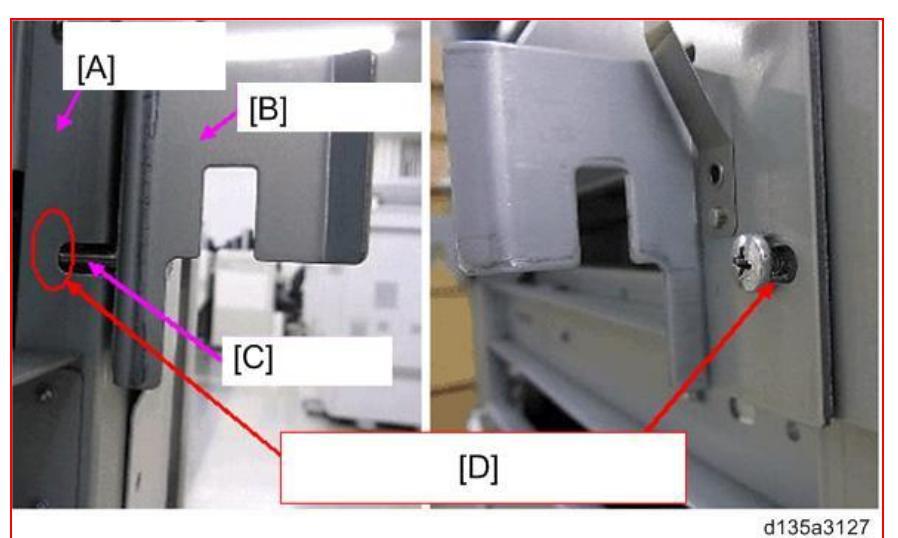
This is because without the spacer, the M4x20 screws are too long and the bracket cannot be fastened in place.

[A]: Folding unit [B]: Joint bracket [C]: Screw (M4x20) [D]: Screw is too long and cannot be fully inserted

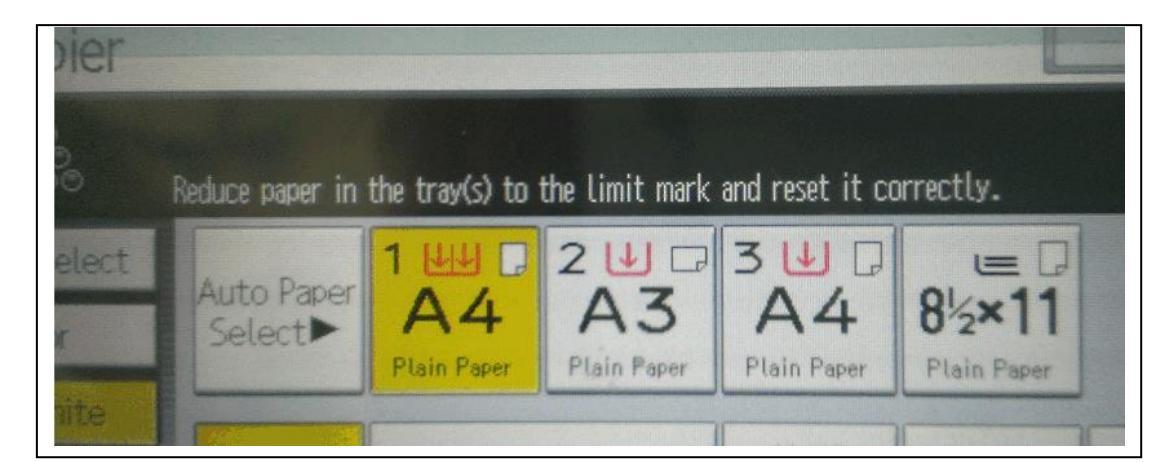
The following message is displayed and the tandem tray does not lift up even after the customer has pushed in the tandem tray, even if the amount of paper in the stack is correct:

"Reduce paper in the tray(s) to the limit mark and reset it correctly."

The right tandem tray is not set far enough into the tray, and the set sensor [A] cannot detect the actuator [B] on the end fence. As a result, the machine detects that the tandem tray is not set properly.

- 1. Pull out the tandem tray.
- 2. Unlock the hook [A] and remove the tray front cover [B]. ( $\mathscr{F}$  x 2)

- 3. Push the right tandem tray into the machine.
- 4. Push the left tray and set the bracket [A] by adjusting the two screws so that the end of the bracket [A] just comes into contact with the right tandem tray when the left tray is fully pushed in.

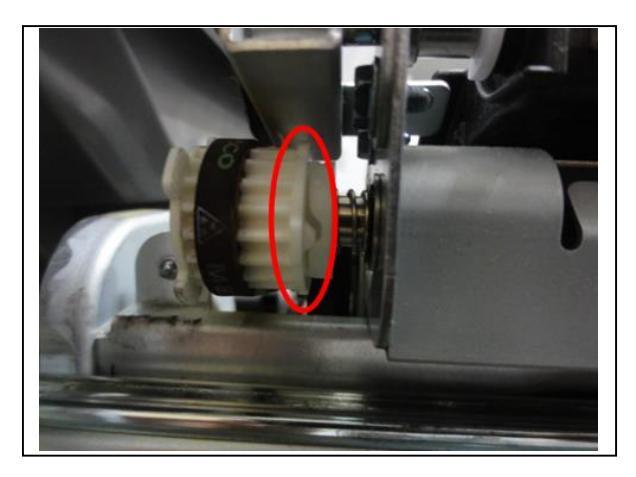
**IMPORTANT:** Make sure to attach the coupling so that it faces **in the correct direction, as shown below.** If the coupling is attached in the wrong direction, Jam 78 may occur when printing onto paper less than 187mm in size.

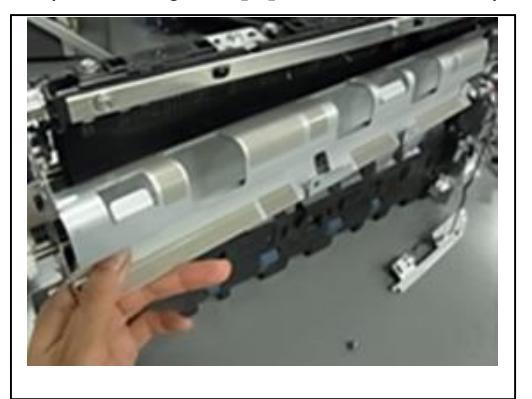
Static electricity causes the paper edge to be attracted to the guide plates (**[A]**, **[B]**). As a result, paper is forcibly stuck in areas [A] and [B] while the paper transfer rollers feed the paper.

Replace guide plate **[A]** with modified guide plate **P/N: D1367110**, and replace guide plate **[B]** with modified guide plate **P/N: D1367100**.

22. Replace the guide [A] with the modified part.

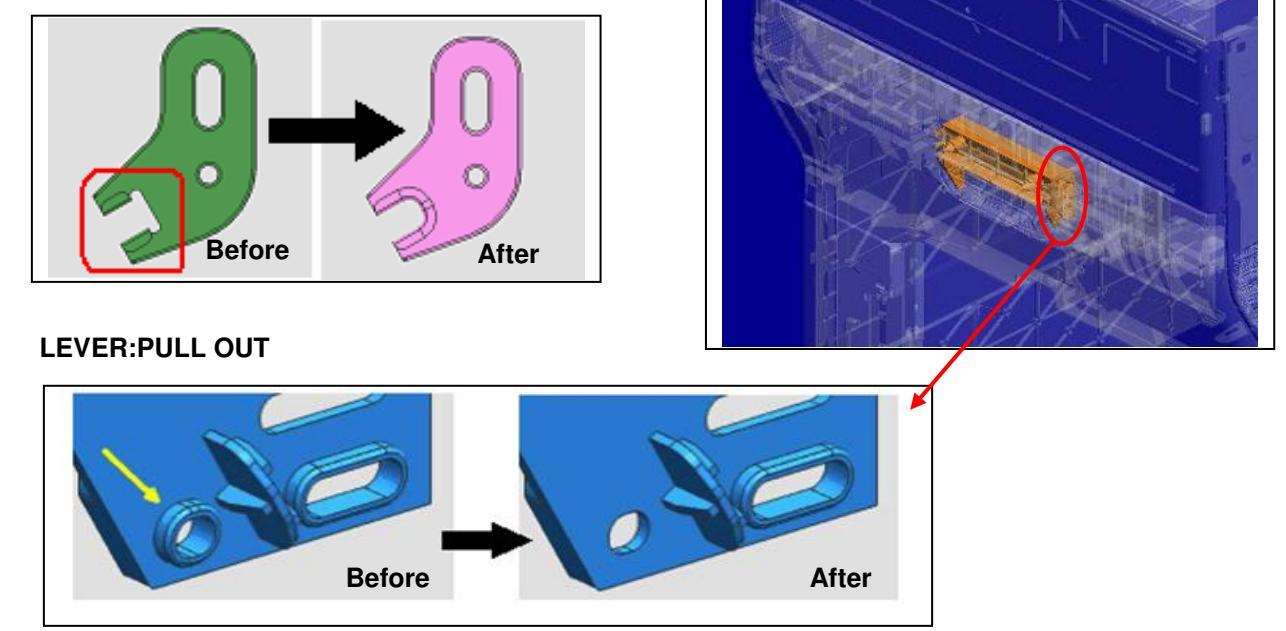
#### LINK:LEVER:PULL OUT

Old part number	New part number	Description	Q'ty	Int	Note
D1381576	D1381581	LINK:LEVER:PULL OUT	1-1	X/O	-
D1381574	D1381579	LEVER:PULL OUT	1-1	X/O	-

Replace the lever with the modified part (P\N: **D1381581**) and the handle with the modified one (P\N: **D1381579**) in accordance with the procedure below.

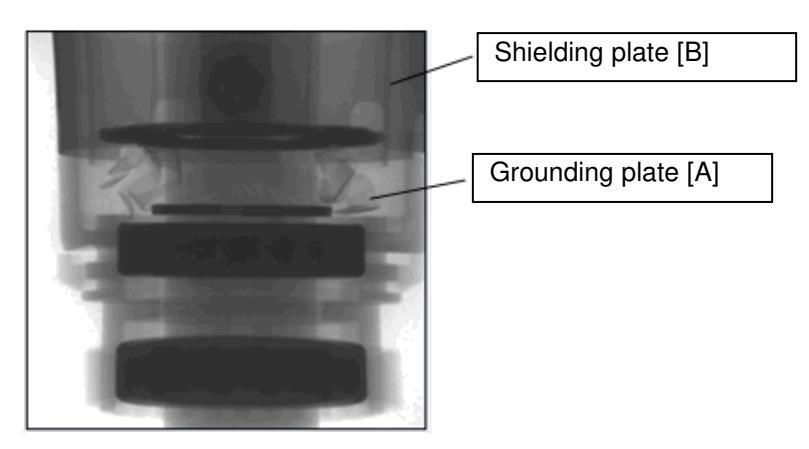
The grounding plate [A] inside the heat roller may not be set in the normal position during factory assembly. The grounding plate moves during operation and may contact shielding plates [B]. As a result, SC548-00 and/or noise occur.

\*This picture shows the inside of the heat roller taken with an X-ray photograph.

Replace the heat roller with the modified one (P/N: D1364184).

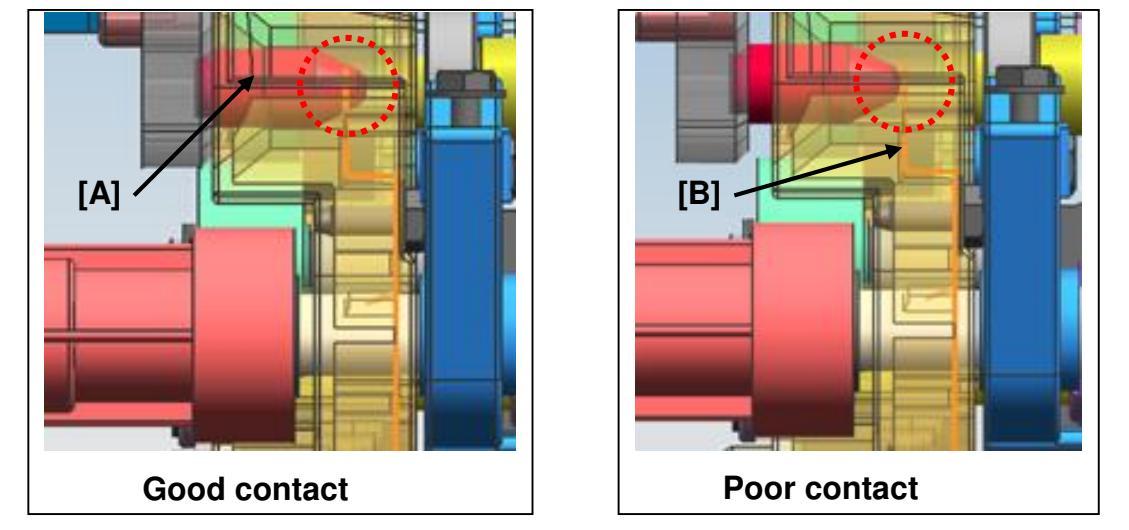
If the operator does not push in the drawer unit all the way, the grounding pin [A] does not touch the grounding plate [B] firmly. As a result, the paper transfer unit is not grounded properly and SC460 is triggered.

Contact between the grounding pin and plate (PTU-mainframe connection at rear of unit):

Note: This symptom occurs on D135-17 (100V) model only. On all other models, the "Drawer unit set orror" message appears if the drawer unit is not pushed into the machine enough. This is because the 200V models have a set detection mechanism.

If SC460 happened many times, please replace **Shaft Lock: Pull Out (P/N: AA140946)** and **Feeler: Pull Out: Lock (P/N: D1351583)** in accordance with the procedure below. If these two parts are replaced, the retraction of the drawer unit increases.

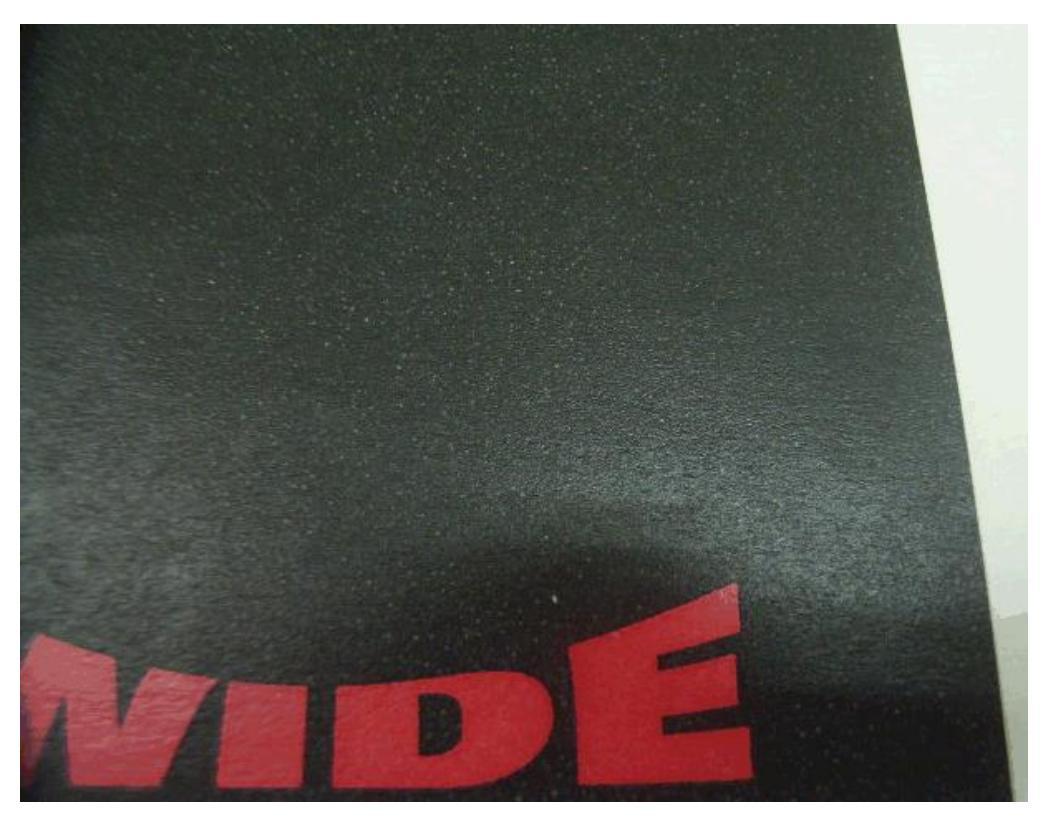
- 1. With paper of weight Plain Paper 2: White spots may appear on the 2<sup>nd</sup> page of duplex printing when using the paper with a rough surface and high electric resistance in an LL environment.
- Higher weight than Middle Thick Paper: White spots may appear on paper with a rough surface and high electric resistance. (See the example image below)

- 1. The electrical resistance increases when the paper goes through the fusing roller and the moisture of the paper evaporates.
- 2. Due to high electrical resistance characteristics of the paper.

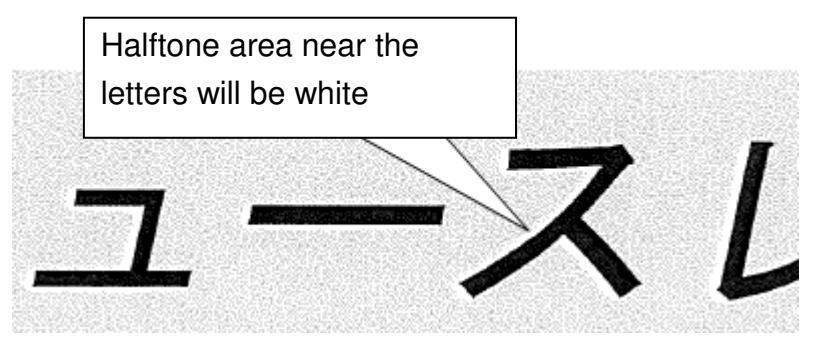
A halo may appear especially in a low-temperature, low-humidity environment .

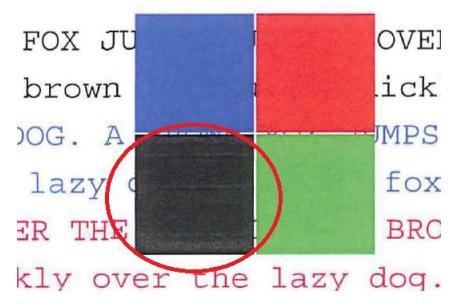
White streaks may appear in the feed direction on small solid black areas (smaller than 3cm x 3cm). (See the example below in the red circle)

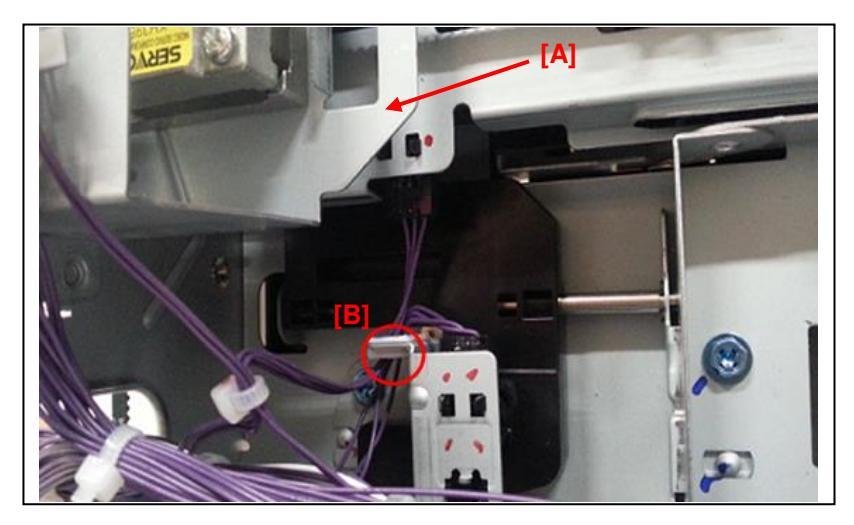
The harness is bound with the clamp [B] so that it does not touch the bracket [A], as shown below.

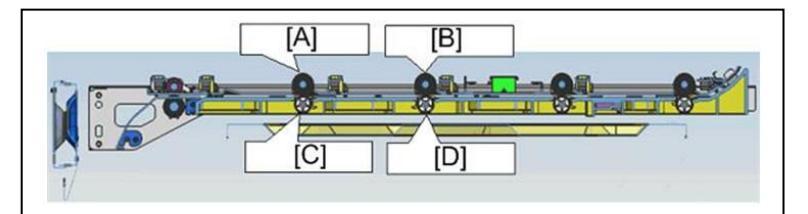
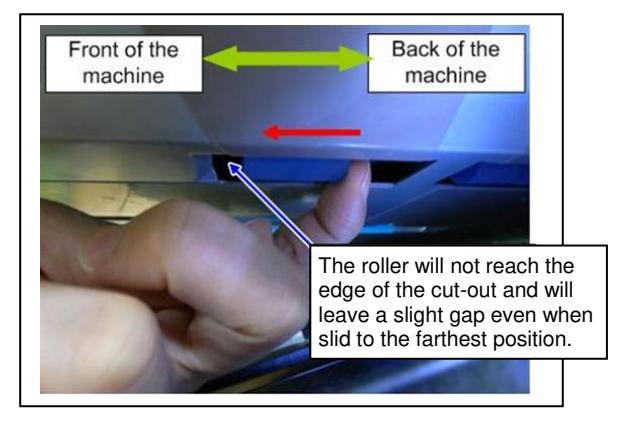
If SC515-01 is observed before the machine reaches 10K since installation, do the following procedure to age the duplex transport roller/duplex exit roller.

- 1. Pull out the drawer unit and open the duplex unit lower guide plate.
- Slide the idle rollers of duplex transport rollers [C] and [D] with your fingers toward the front side of the machine as far as they go.
   Caution: Make sure to grip the edge of the rollers, not the surface.
- Slide the drive rollers of duplex transport rollers [A] and [B] with your fingers toward the front side of the machine as far as they go.

- [A]: Duplex transport roller 2 (drive)
- [B]: Duplex transport roller 3 (drive)
- [C]: Duplex transport roller 2 (idle)
- [D]: Duplex transport roller 3 (idle)

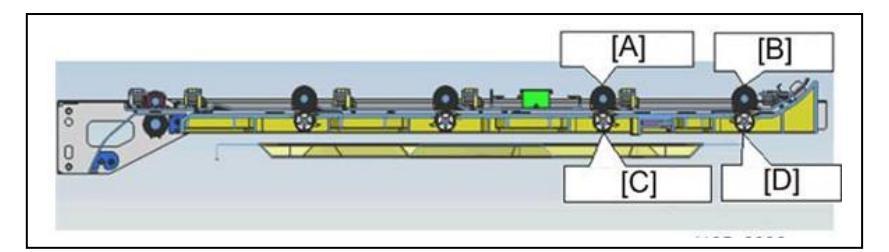
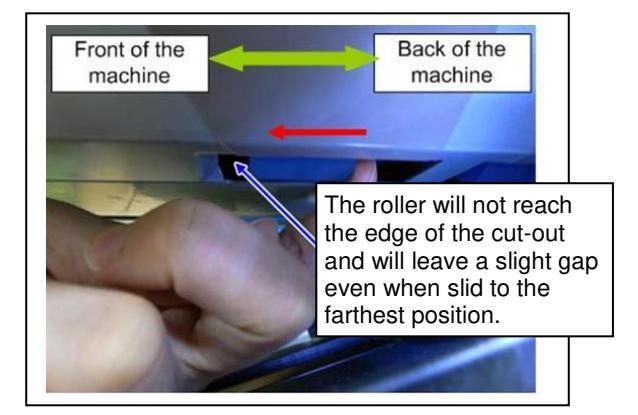
If SC515-02 is observed before the machine reaches 10K since installation, do the following procedure to age the duplex transport roller/duplex exit roller.

- 1. Pull out the drawer unit and open the duplex unit lower guide plate.
- Slide the drive rollers of duplex transport roller [C] and duplex exit roller [D] with your fingers toward the front side of the machine as far as they go.
   Caution: Make sure to grip the edge of the rollers, not the surface.
- Slide the drive rollers of duplex transport roller [A] and duplex exit roller [B] with your fingers toward the front side of the machine as far as they go.

- [A]: Duplex transport roller 4 (drive)
- [B]: Duplex exit roller (drive)
- [C]: Duplex transport roller 4 (idle)
- [D]: Duplex exit roller (idle)

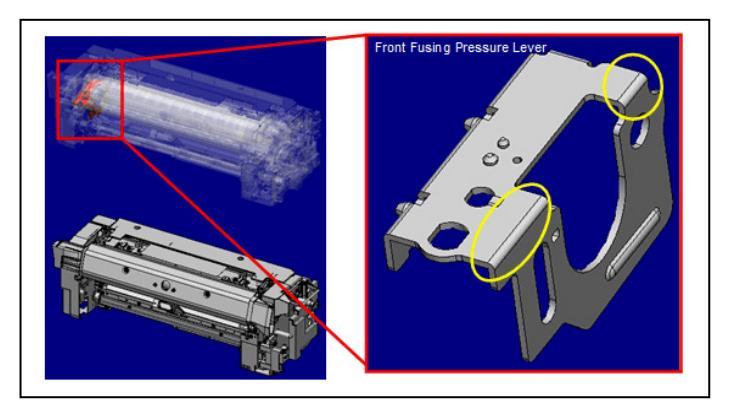
Front:

Due to the poor strength of the levers (portions circled in yellow), the repeated contact and release movement of the lever gives stress, causing the lever to eventually be broken.

Replace the fusing levers with the modified part (LEVER: PRESSURE: OFFICE: ASS'Y; P/N: D1369901) at 600k PM or the next service visit. See PROCEDURE on the next page.

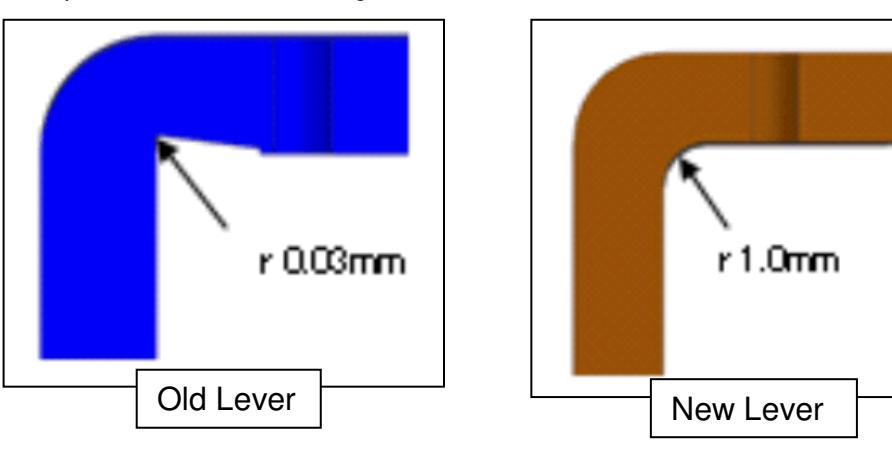
The shape of the lever was changed as shown below, which increases the lever's strength.

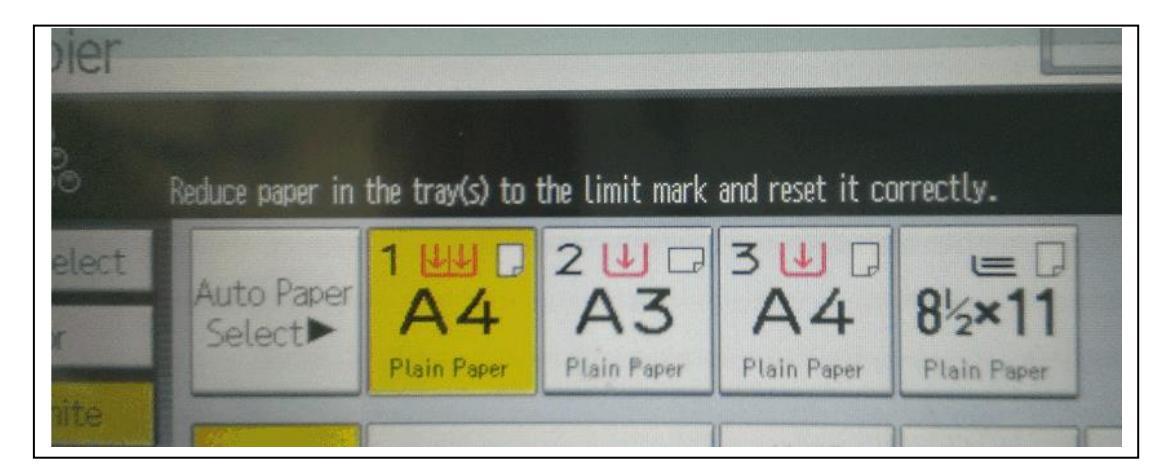
The following message is displayed and the tandem tray does not lift up even after the customer has pushed in the tandem tray, even if the amount of paper in the stack is correct:

The end fence [C] is not positioned correctly. As a result, the tandem tray set sensor [A] cannot detect the actuator [B].

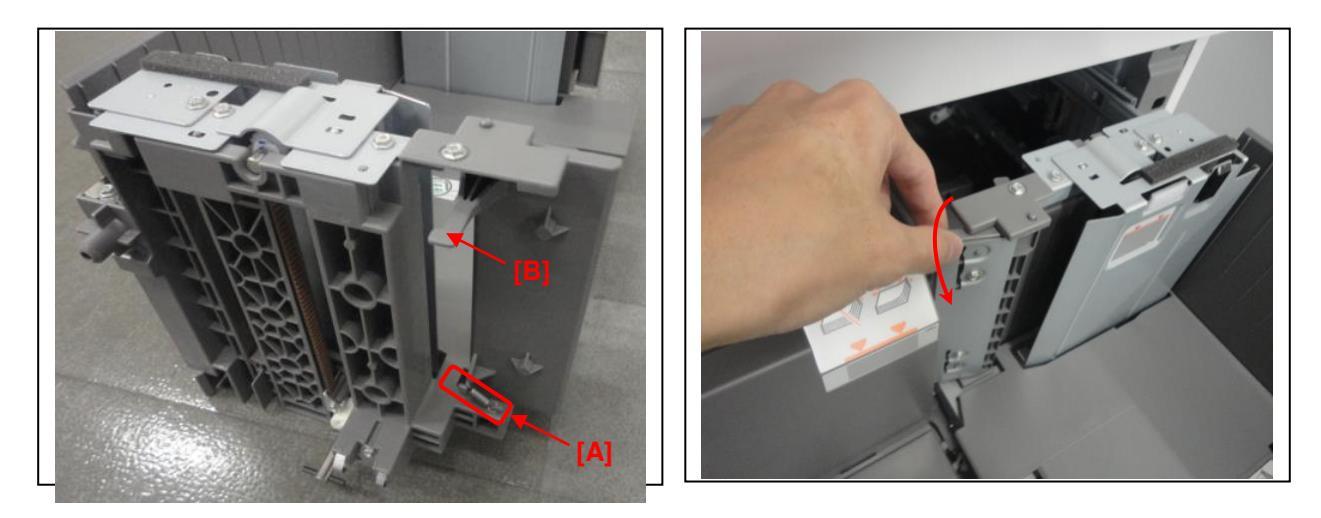
**Note:** If the spring is not attached correctly, the actuator cannot move freely and the machine cannot detect the actuator when the tray is pushed in.

- 1. Check that the spring [A] is attached correctly as shown below.
- 2. Check that the end fence moves freely by the force of the spring in the direction of the red arrow.

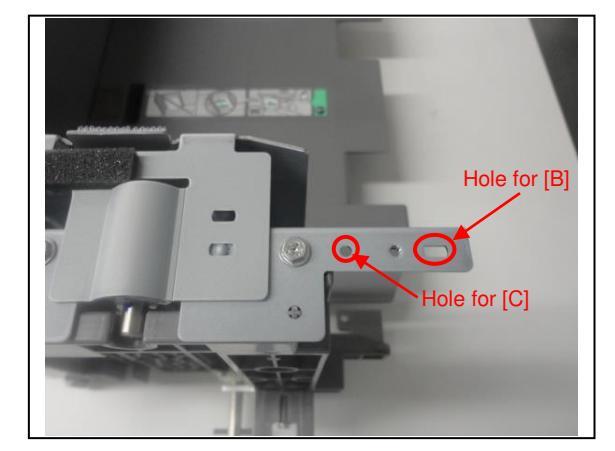
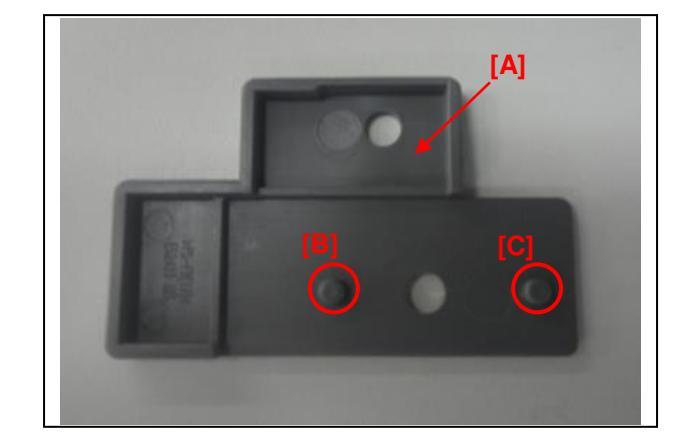
**Note:** If the cover is not attached correctly, the pins may not pass through these holes. As a result, the end fence will not move correctly, even if the spring is attached correctly.

3. Check that pins [B] and [C] are passing through the two holes on the bracket shown.

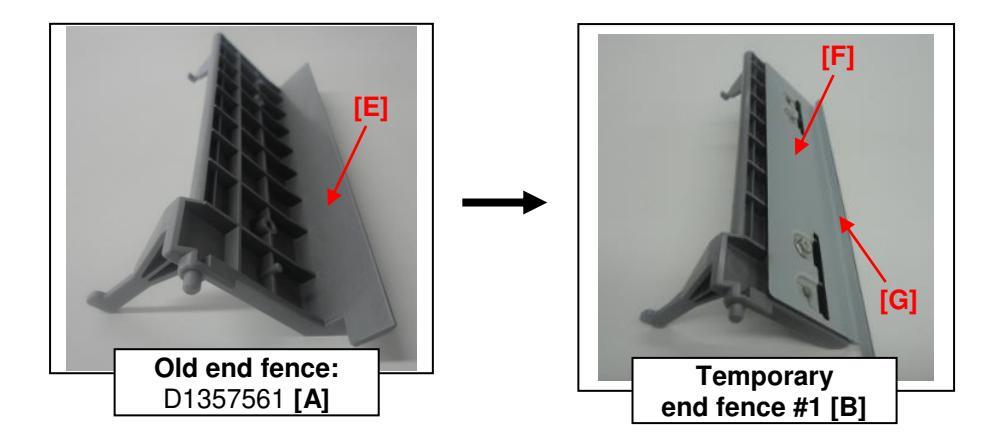
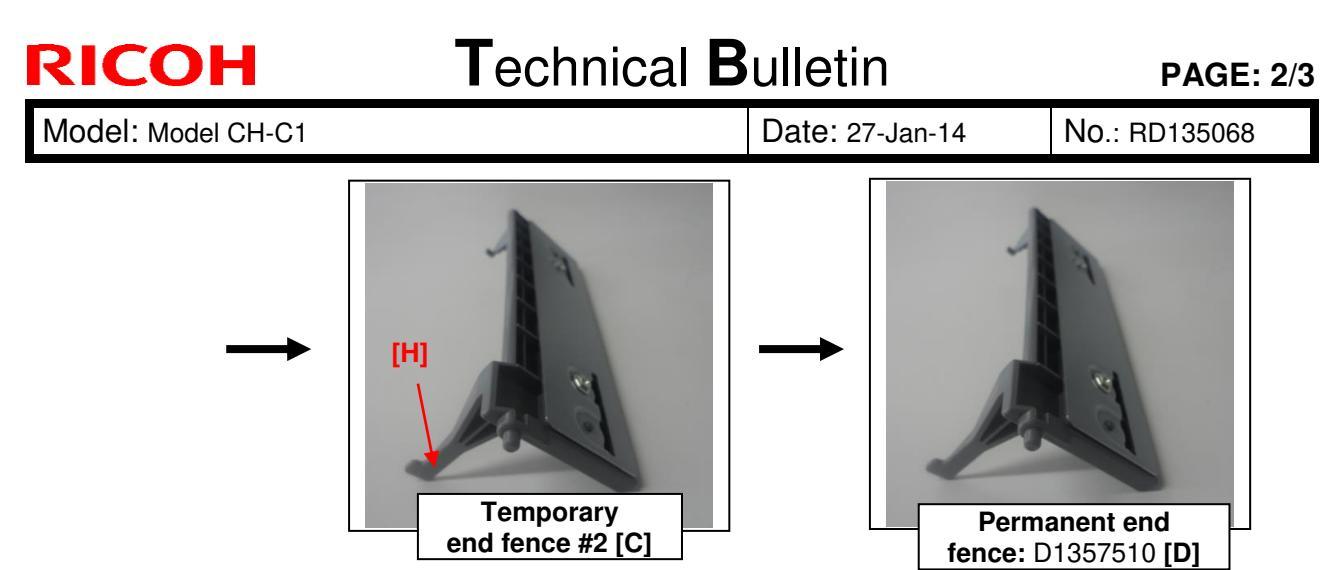
**Reason:** To ensure that the trailing edge of the paper does not hit the end fence guide, which can cause the fence to open and prevent the tray from rising.

- On the D135-29/D136-29, if part [A] is installed, replace it with part [B], [C], or [D].
  - If you are going to install part [B] or [C], you need to add spacers.
    See "Attaching spacers for parts [B]/[C]" below.
- If part [B] or [C] is installed, and you are going to install part [D], remove the spacers.

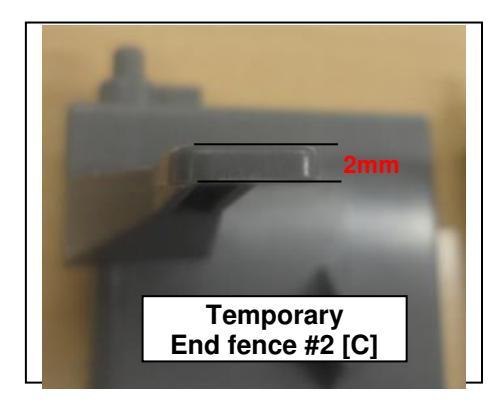
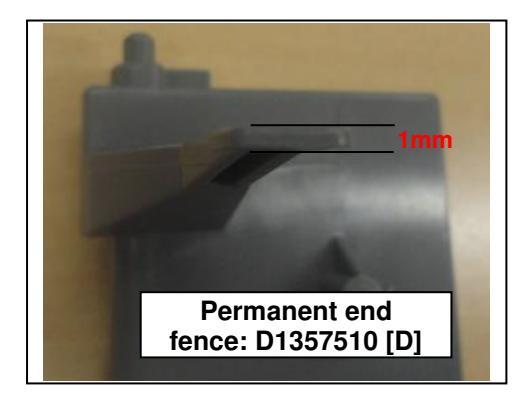
- [A] was modified to [B] to ensure that the trailing edge of the paper does not hit the end fence guide, which can cause the fence to open and prevent the tray from rising. The paper guide was removed and a metal plate [F] was added. Two spacers were added to correct the position of the tray set sensor actuator [H] (See "Attaching spacers for parts [B]/[C]" below).
- **[B]** was modified to **[C]** because portion [G] of the metal plate was unnecessary (and was deleted).
- **[C]** was modified to **[D]** to ensure that the actuator [H] can move correctly into the tray set sensor. To do this, the thickness of the actuator was decreased from 2mm to 1mm. For this reason, the spacers used for parts [B]/[C] are not needed.

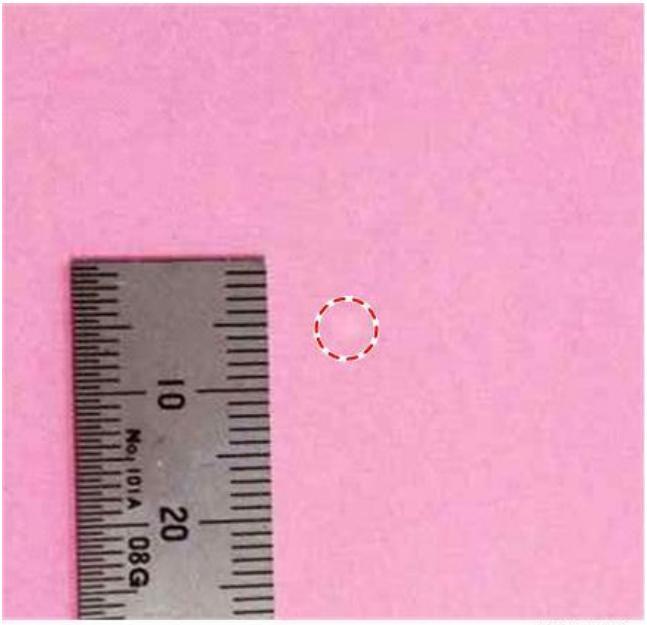
d1352926

White or black spots appear when printing halftone images in low-temperature, lowhumidity environments (10C/15%) immediately after the developer is replaced. **Note:** Black spots occur more frequently when printing onto coated paper.

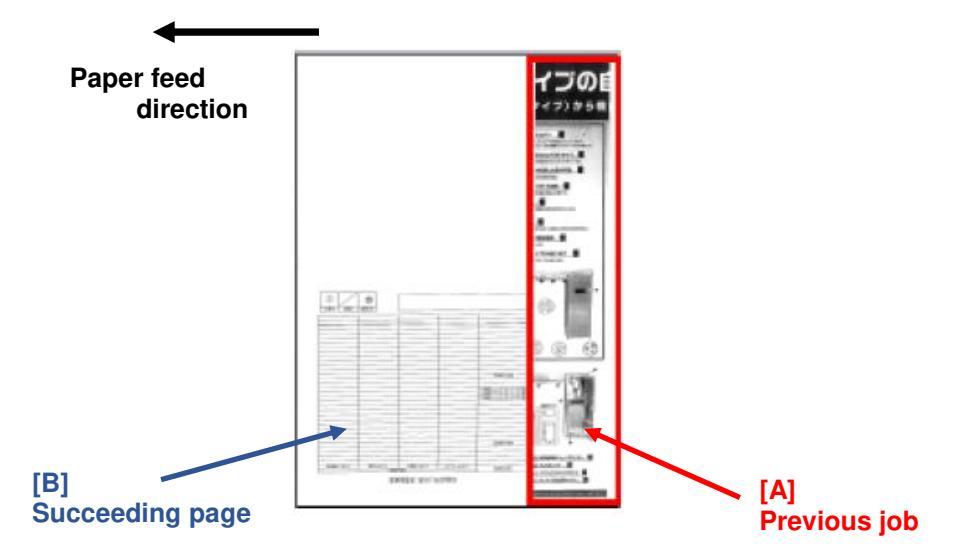
The trailing 5mm of the image printed in the previous job [A] appears on the first page of the following job (superimposed over the image [B])

Note: This occurs on the MP C8002 only.

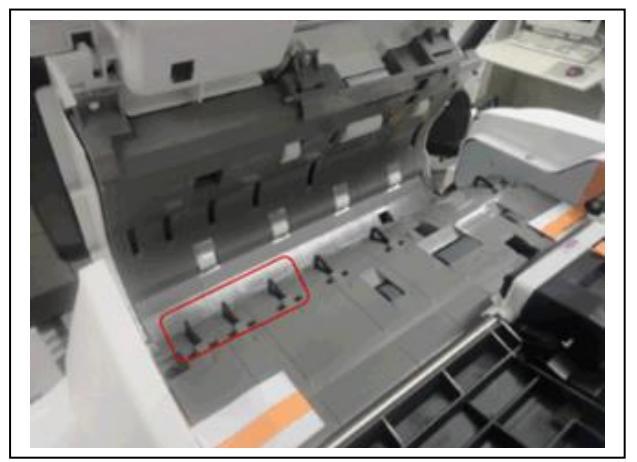
The sensor actuators shown in red below continue to fluctuate/chatter after the original has passed them. Due to the insufficient weight of the actuators, they continue to chatter while the next original is passing their position.

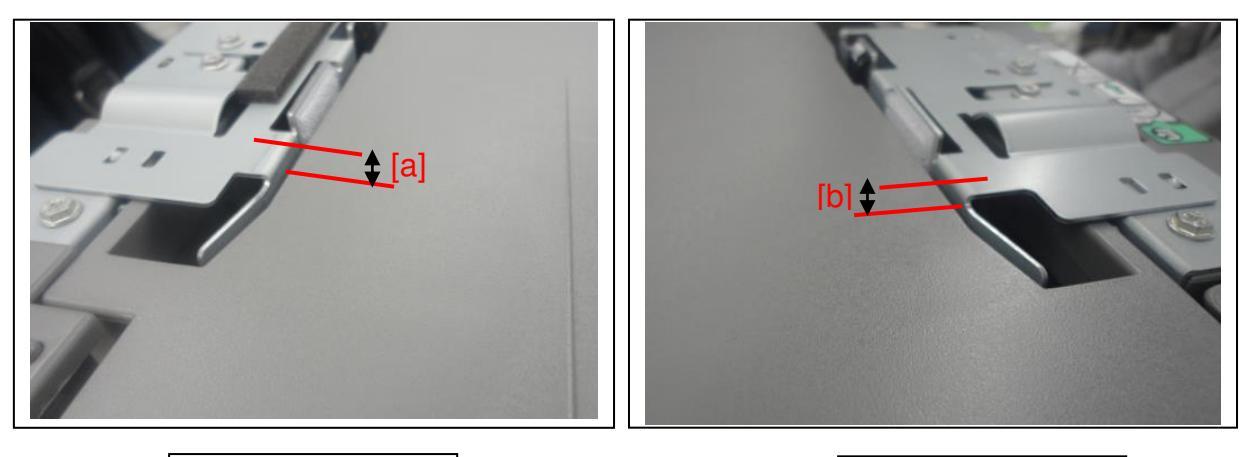
[a]: The top of the side plate to the bottom plate **at the rear** [b]: The top of the side plate to the bottom plate **at the front**

- If the difference between [a] and [b] is **less than 1mm**, you do not need to continue with the procedure. (The bottom plate has been attached correctly.
- If the difference between [a] and [b] is **1mm or more**, do the **Reassembly procedure** below. (The bottom plate has not been attached correctly).

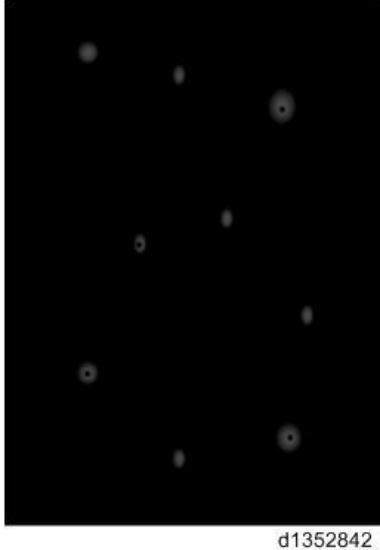
White spots with "toner cores" appear inside solid images/patches when printing under hightemperature conditions.

- The machine is left unused for an extended time, and toner tends to clump inside the development unit. As a result, toner may not be transferred onto the paper correctly.
- The PCDU is subjected to strong vibration or shock. This may cause toner on the wall of the unit to fall inside the developer and form clumps.
- The toner is left outside the moisture bag too long. This may cause toner to form clumps.

- 1. Make a test print and determine the affected color(s).
- 2. Print out 30-200 A3 sheets with solid images of the affected color(s).
- 3. If the symptom still occurs, replace the toner cartridge of the affected color.
- 4. Repeat Step 2.
- 5. If the symptom still occurs, replace the development unit/developer of the affected color.

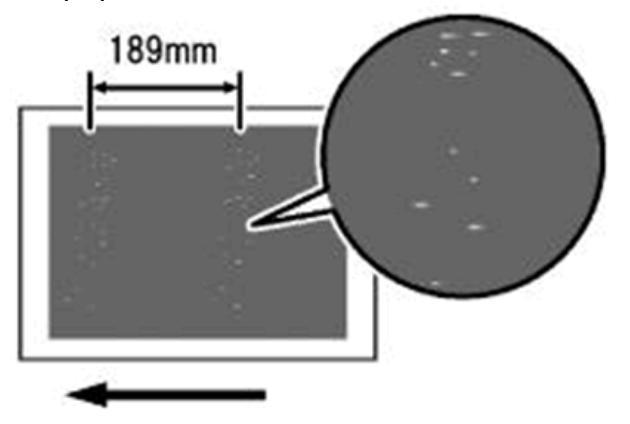
d135a3012

Rows of "Medaka" (small, white, fish-shaped specks) appear in solid image areas along the paper feed direction at 189mm intervals when printing onto A3/SRA3 paper.

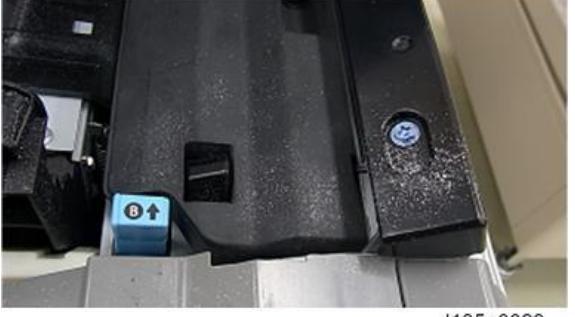
d135a0023

The lubricant in the drum cleaning unit falls into the registration unit and creates smudges on the ITB encoder sensor. As a result, the engine speed cannot be controlled correctly.

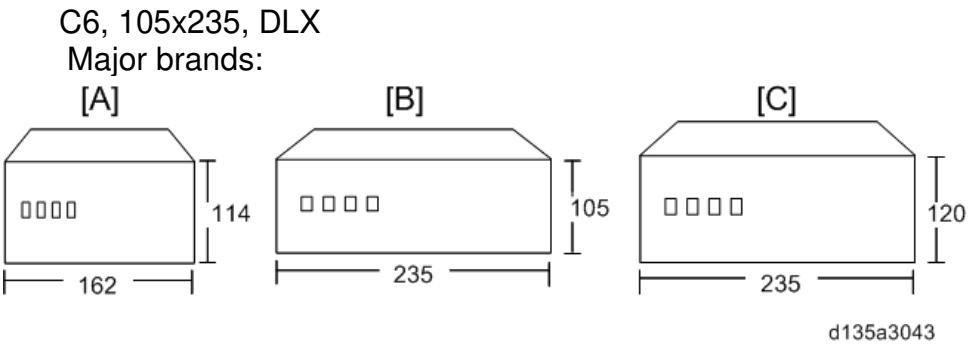
[A]: C6, [B]: 105x235, [C]: DLX

- Wrinkles
- Paper transport issues
- Flaps stick (closed) to the body of the envelope

**Note:** If the envelopes are fed in the SEF direction, they tend to warp in between the PTR unit and fusing unit.

The heat of the fusing process may cause wrinkles to form or the adhesive on the flaps to melt if the flaps are folded.

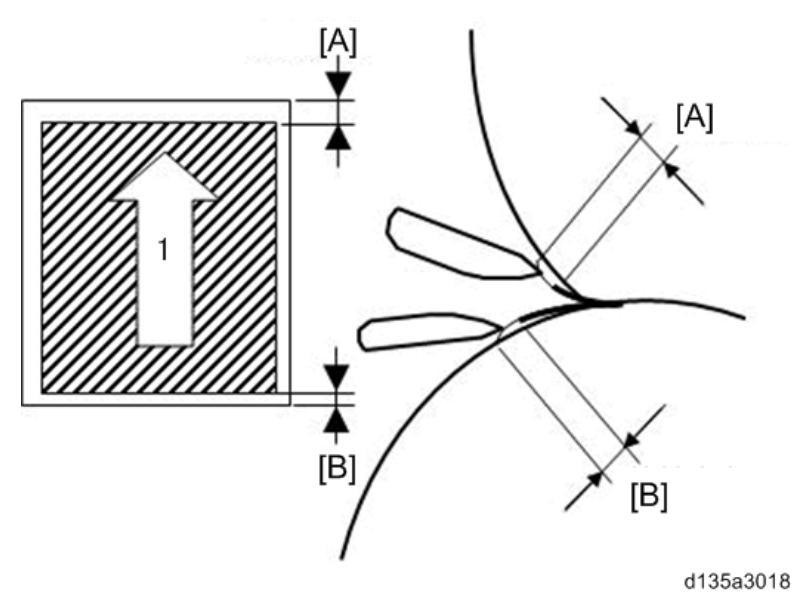
An "accordion jam" may occur under the following conditions:

- Thin, coated paper
- A large amount of toner is needed to develop the images on the leading or trailing edge
- The margins at the leading and trailing edges are relatively narrow

1: Feed direction

[A]: Leading edge margin

The margin at the leading or trailing edge is too narrow, which causes the paper to stick to the pressure roller stripper plate.

- 3. If the symptom still occurs, check the following and replace parts as necessary.
  - If the fusing belt is damaged, replace it.
  - If the gap between the fusing stripper plate and fusing belt is wider than normal, replace the fusing unit.
    - Note: The fusing stripper plate cannot be replaced individually (it can only be attached and precision-adjusted at the factory).
  - If the pressure roller is damaged, replace it.
  - If the gap between the pressure roller stripper plate and pressure roller is wider than normal, replace the pressure roller stripper plate.

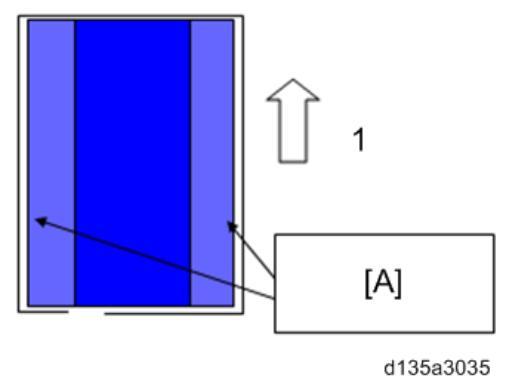
The glossiness is uneven at the sides of the paper (outside the width of the small size paper).

[A]: The 'orange peel' condition gets worse in the area outside the width of small paper and results in uneven glossiness.
