### Technical Bulletin

Reissued: 02-Nov-15 Model: CH-C1

No.: RD135004c

This RTB has been issued to announce the firmware release information for the Web Uapl.

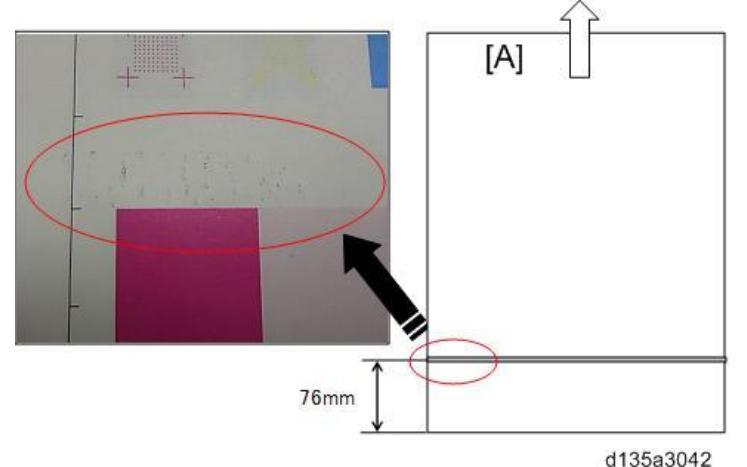
[A]: Feed direction

Stains in the shape of horizontal streaks appear in the area 76mm from the trailing edge when printing high-coverage images onto coated paper.

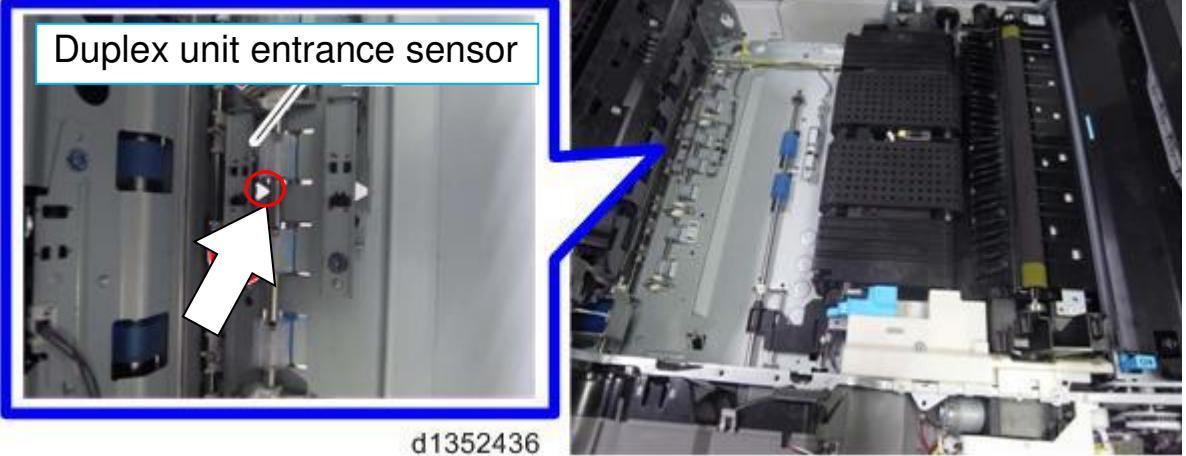
When feeding paper with large curl, the leading edge gets caught in the hole cut out for the duplex entrance sensor located under the duplex horizontal feed path and prevents the sensor from detecting paper.

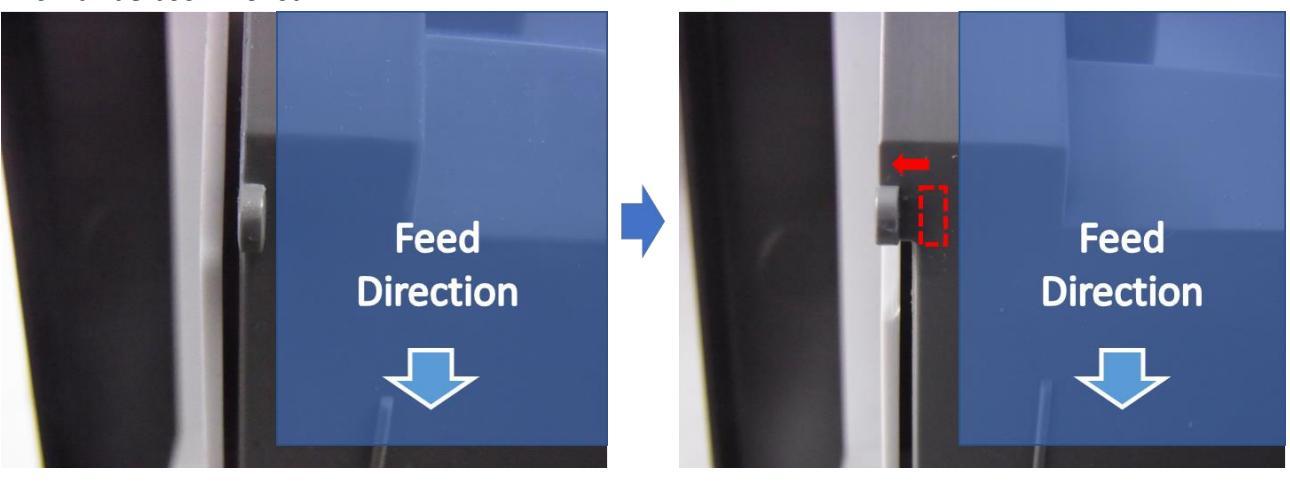
The rib has been moved.

#### Production line: A modified part will be used.

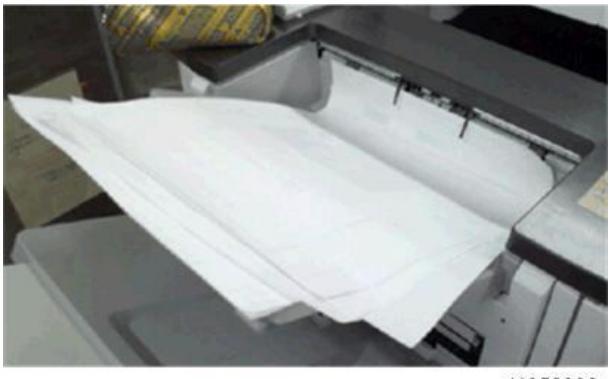
d1352932

The machine detects the tray full condition for the proof tray before the number of sheets in the tray has reached capacity when printing onto large-sized, thin, short-grained paper.

Attach the proof support tray [A] (included with the finisher), as shown below.

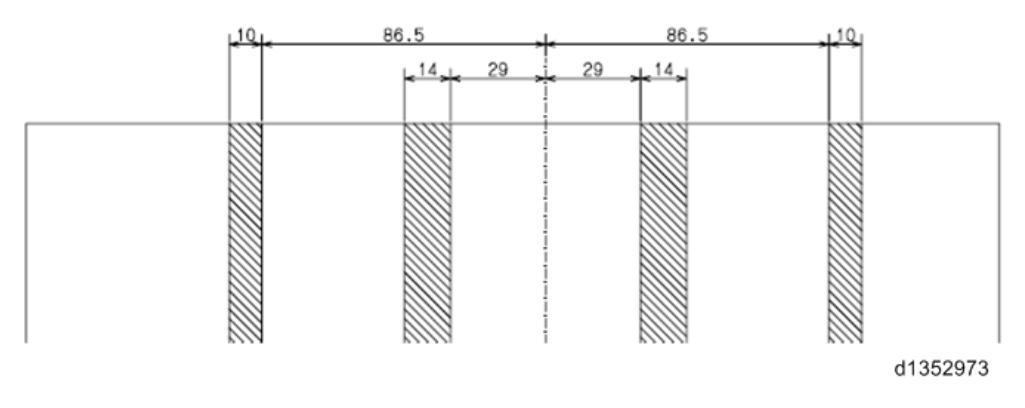
Roller marks appear on the printouts when any of the following conditions are met:

Nip of the drive and idle rollers in the paper path after the fusing unit

Diagram showing the location of the roller marks caused by the **Paper exit relay roller**, **Inverter feed-in roller**, **Inverter exit roller**, **Inverter feed-out roller**:

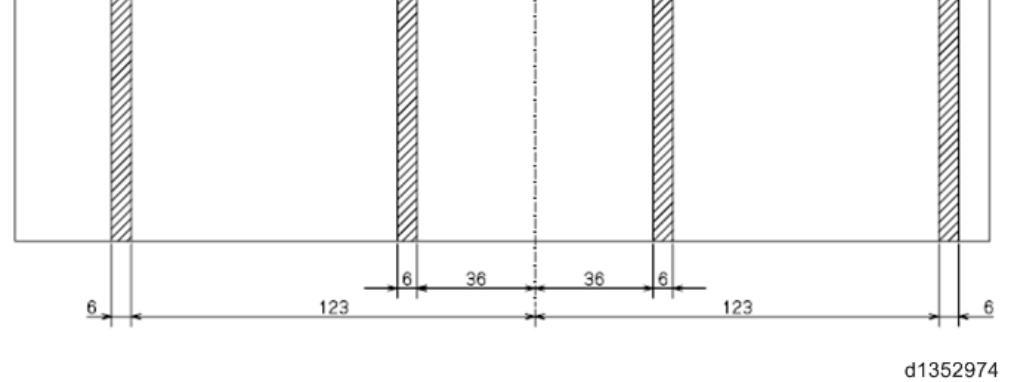
Diagram showing the location of the roller marks caused by the Paper exit roller:

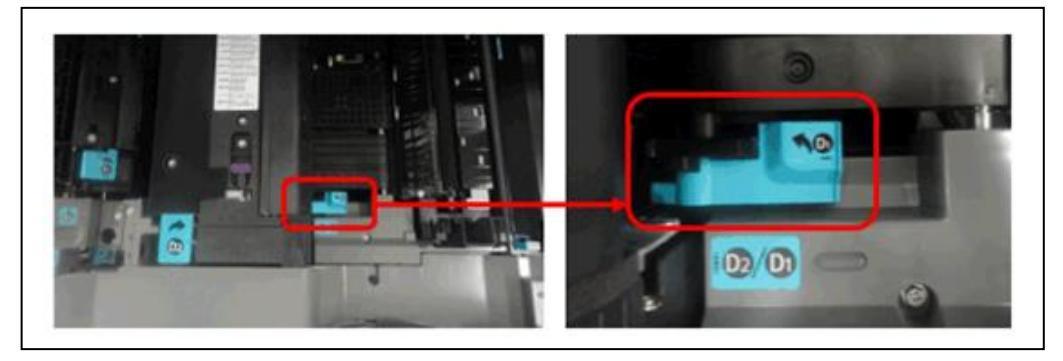
The [**D1**] lever (LEVER: ON-OFF: TRANSPORT BELT UNIT; P/N D1363864; circled in red below) may break if is moved up and down 30+ times.

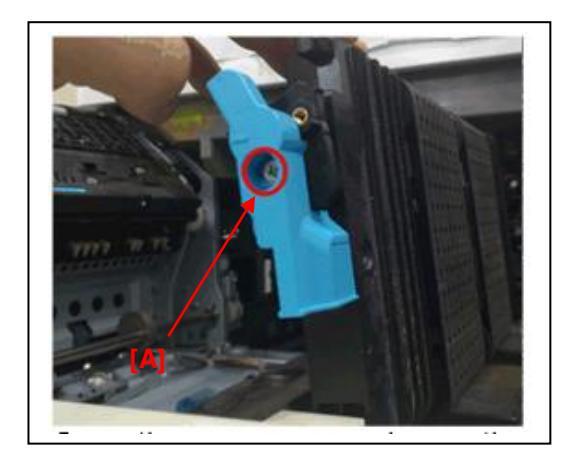
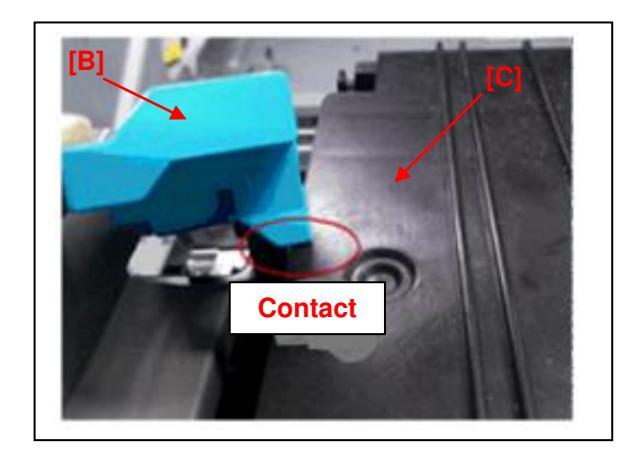
The screw [A] that secures the lever is too short, and cannot provide enough torque to keep the lever [B] in place when the lever is moved many times. As a result, the lever comes loose, contacts the PTB unit [C], and breaks.

Replace the screw (P/N: D1369902\*) in accordance with the procedure below.

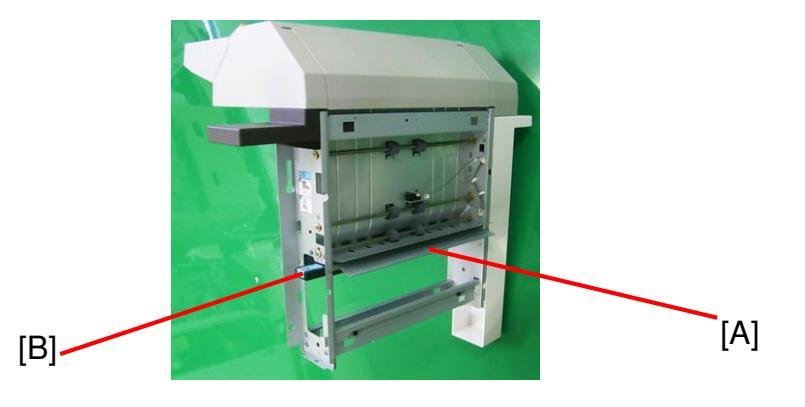
If the "Decurler Unit DU5020 (D727)" or "Buffer Pass Unit Type 5020 (D751)" is included in the configuration, the original guide plate [A] must be replaced with "GUIDE PLATE: CONNECTING: LOWER" (item #19 of the accessories). With the original guide plate [A] installed, lever [B] will catch the optional device if released for jam recovery (\*\*\*).

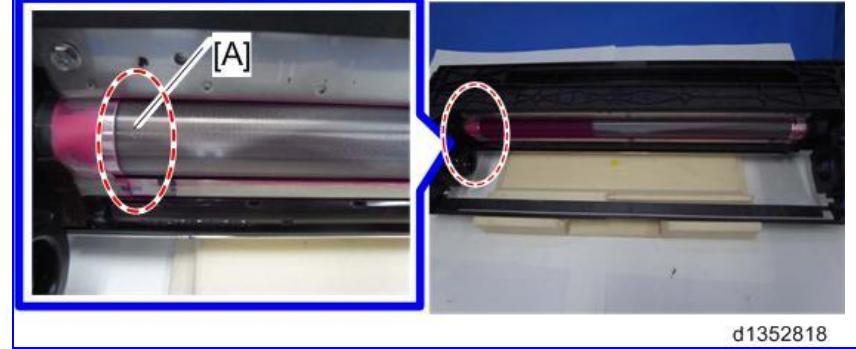
If you are in an environment where use of a vacuum cleaner is not possible, make sure that all old developer is removed from the center of the development roller until about 1cm from the edge [A]. After filling with new developer and there is more old developer than this remaining, a development motor lock may occur.

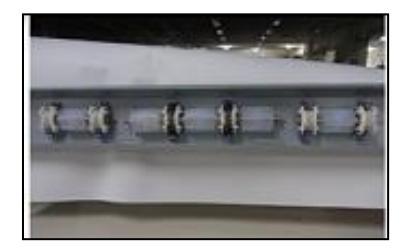
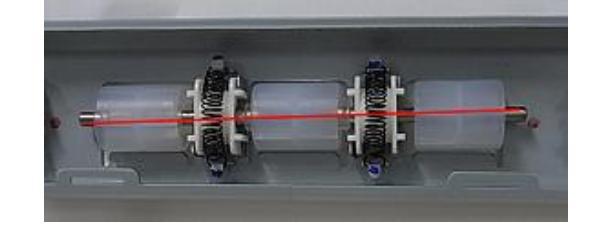
The wrinkles are caused by either or both of the following factors:

- Pressure applied by the 3 idle rollers in the duplex inverter motor unit (see page 4 for the location) causes the drive roller shaft to slightly bend, approximately 0.5mm. As a result, the nip is slanted and squeezes the front (operator) and rear (non-operator) sides of the paper toward the center.
- Backlash of the bearing holder causes misalignment of the 3 idle rollers.

Replace the duplex inverter motor unit.

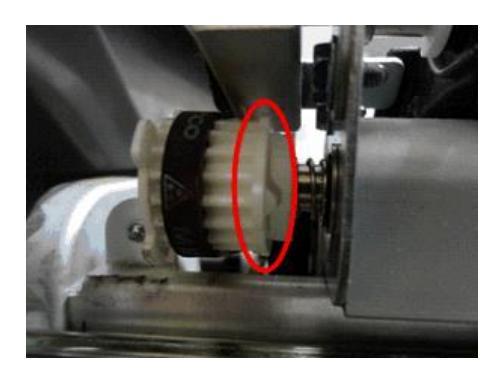
When putting back the unit, make sure to attach the coupling in the correct orientation as shown in the photo. If attached backwards, Jam 78 may occur when printing on 187mm or smaller paper.

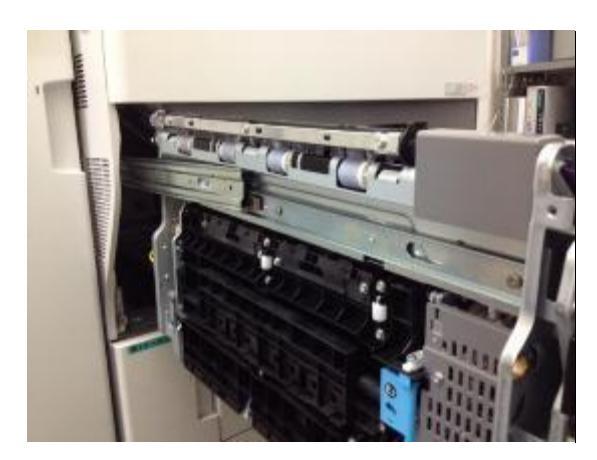
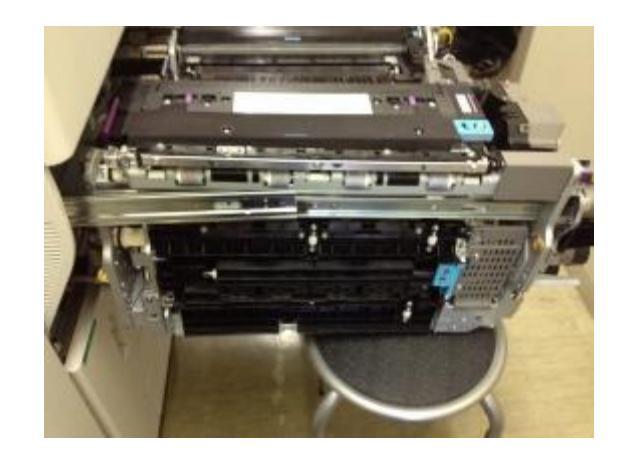
The drawer unit may be derailed off the slide rail and fall out of the machine in the worst case when the unit is pulled out to clear a jam.

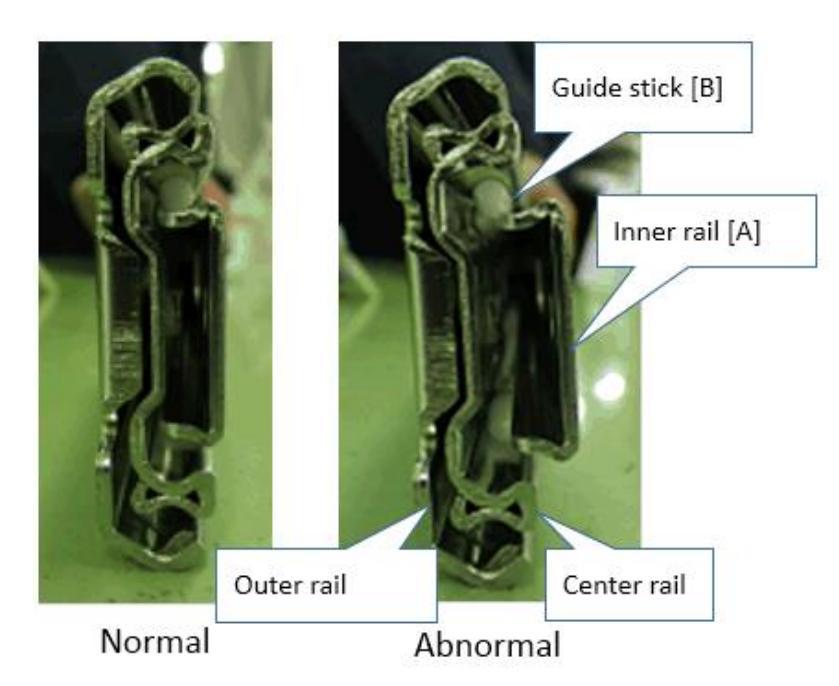
Insufficient clearance between the inner rail [A] and guide stick [B] Due to the insufficient clearance, the inner rail [A] separates from the guide stick [B]. Since the unit

is fixed to the inner rail with screws, when this happens, the drawer unit falls out of the machine.

Replace both right and left slide rails with the modified slide rails included in the following kit (p/n: D1369912 or D1369913).

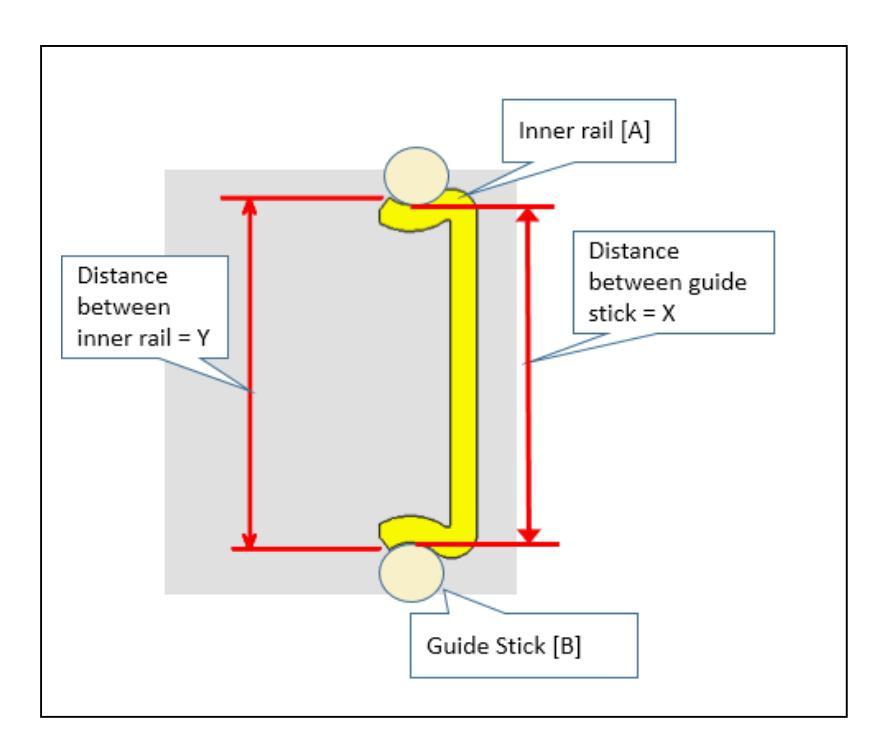
Clearance btw. inner rail and guide stick = Y - X

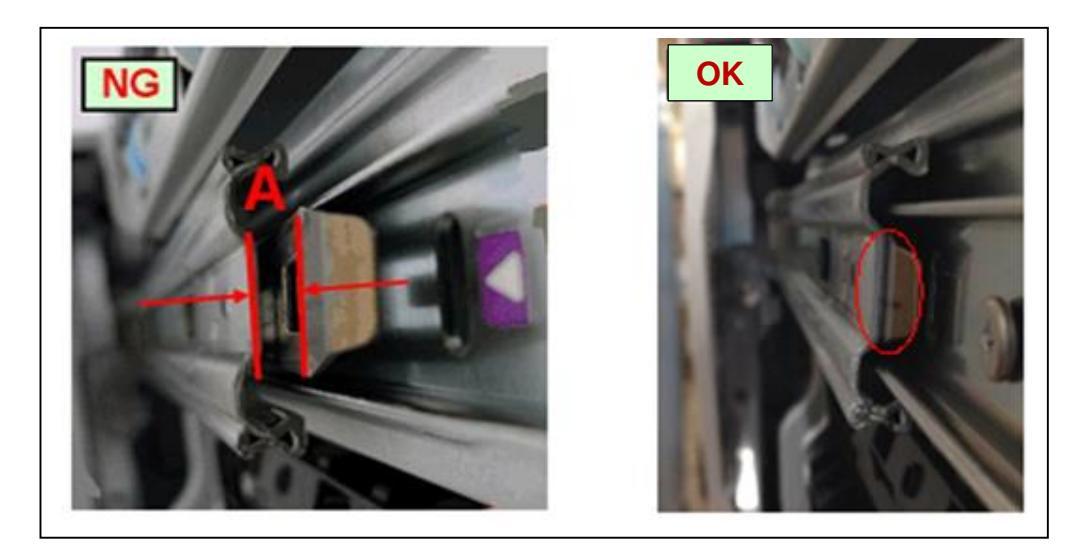
- 5. Check the gap/clearance (marked in red in the photos) between the outer slide and release lever.
  - If there is no gap ("**OK**" **photo** on the right), the drawer unit is correctly mounted on the slide rail. Do the procedure below for **CASE 1**.
  - If there is a noticeable gap ("NG" photo on the left), the drawer unit may derail off the slide rail. Do the procedure below for CASE 2.

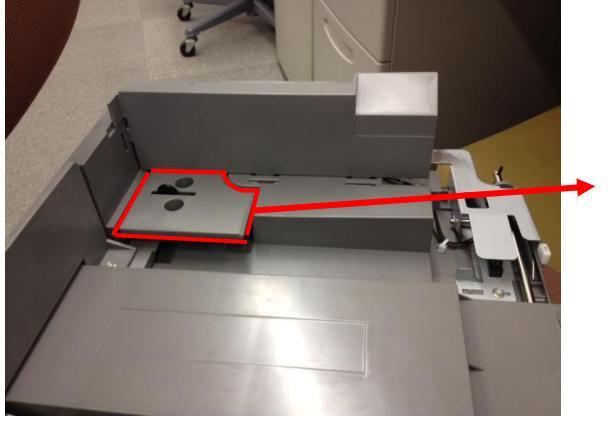
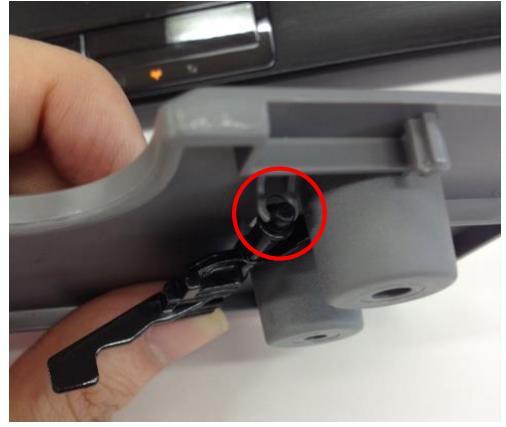
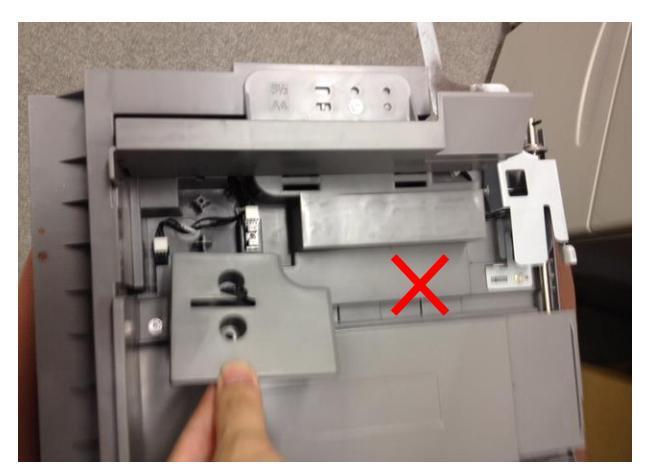
### CAUSE 1

The feeler of the Rear Fence Home Position sensor is stuck and remains pressed down even when there is no paper on the tray, because the shaft of the feeler is detached from the hook. This may happen when the above sensor and the Left Tray Paper sensor are accessed using an incorrect procedure in which where the sensor cover is removed without removing the side fence.

**CAUTION:** Removing the sensor cover without removing the side fence may also break the feeler. Always remove the end fence first, as described in the FSM.

Remove the sensor cover and correct the feeler.

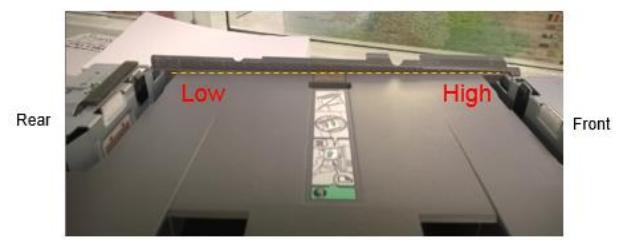
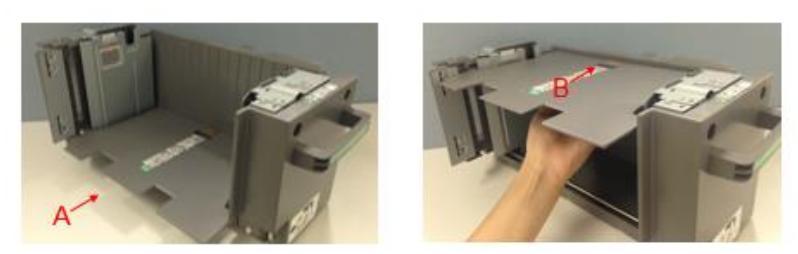
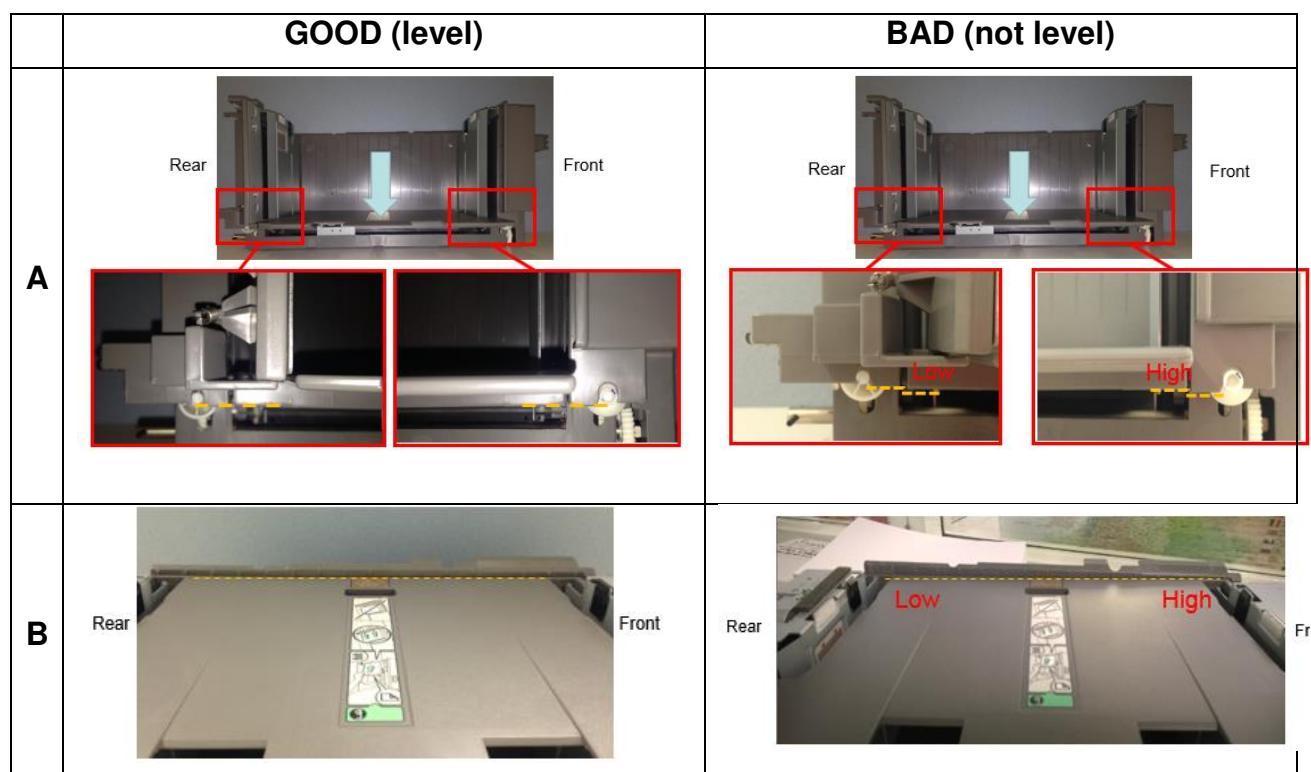
### CAUSE 2

The bottom plate of the right tandem tray is not level, because the belts and pulleys were assembled incorrectly at the factory.

How to check if the bottom plate of the tray is level or not

Look at the plate from A (plate at its lowest position) and B (plate at its highest position).

NOTE: The bottom plate could be slanted in either way; lower at the front (operator side) or lower at the rear (non-operator side).

SOLUTION 2

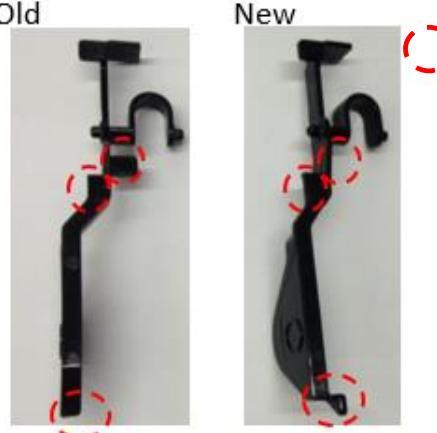
Old

### CAUSE 3

The paper end sensor does not work because the feeler is defective.

Replace the paper set detection feeler with the modified one by following the procedure described on the following pages.

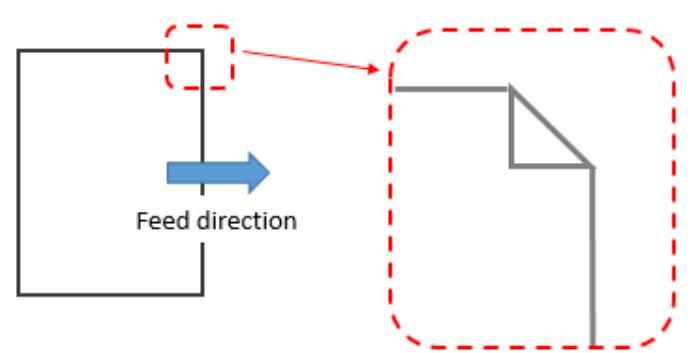
SYMPTOM 4

Jam003: Dog-ear at the leading edge of the non-operator side

### CAUSE 4

Paper interferes with the guide plate of the feed unit.

Replace the set detection feeler with a modified one.

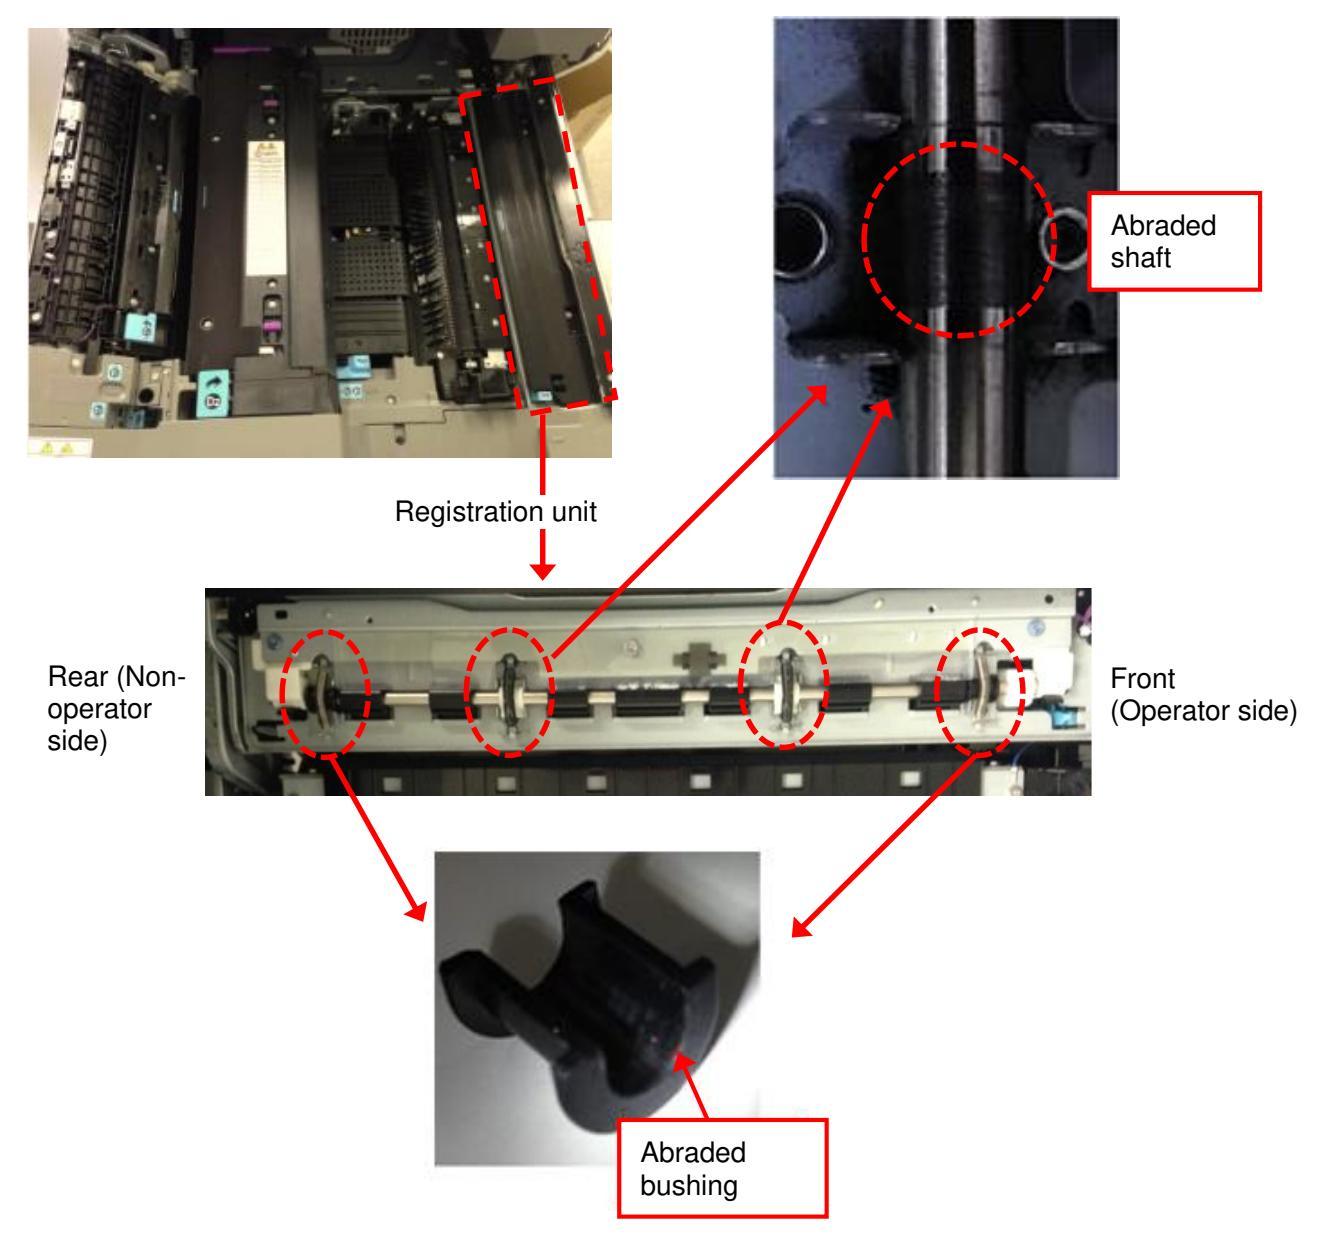
The shaft and/or bushing of the registration roller abrades and the shavings drop and get on the printed image.

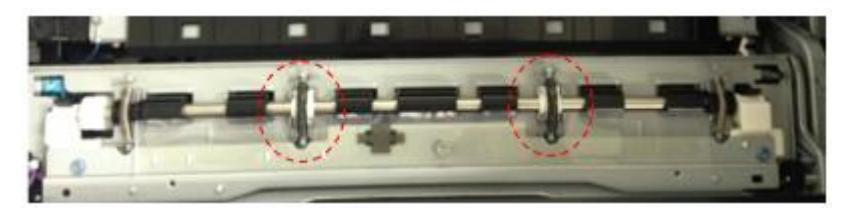
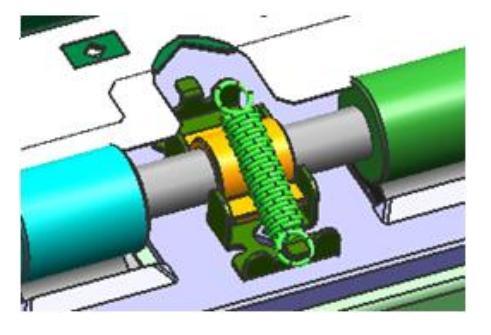
Case 1: Abrasion of the shaft

The spring that secures the shaft holder to the shaft applies too much pressure.

Old Part Number	New Part Number	Description	Q'ty	Int	Note
D1362613	D1362619	COLLAR:REGISTRATION: DRIVEN:INNER	2	X/X	
AA061131	AA061140	TENSION SPRING: REGISTRATION:DRIVEN:16N	2	X/X	Replace as a set.
AA061135	AA061141	TENSION SPRING: REGISTRATION:DRIVEN:1N	2	X/X

Note: Make sure to replace the springs and shaft holders as a set. If they are not replaced as a set, black lines could appear on the printout.

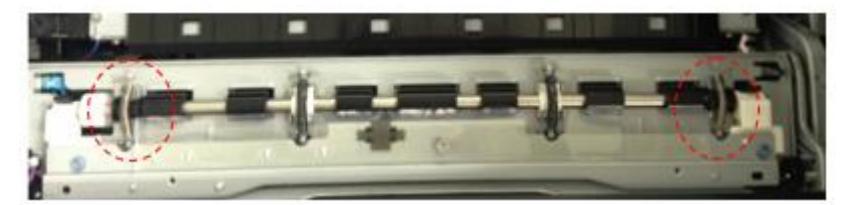
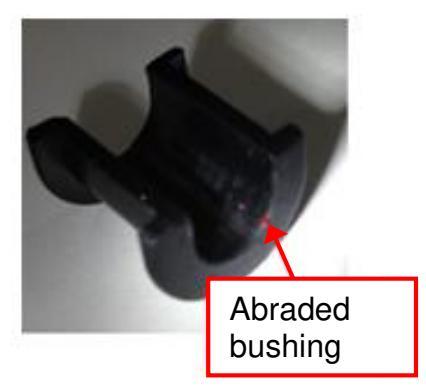
Case 2: Abrasion of the outer two bushings

Thrust of the shaft abrades the bushings.

- A washer was added to both ends of the shaft to avoid contact between the shaft and the bushing.
- New registration roller
- New upper guide plate

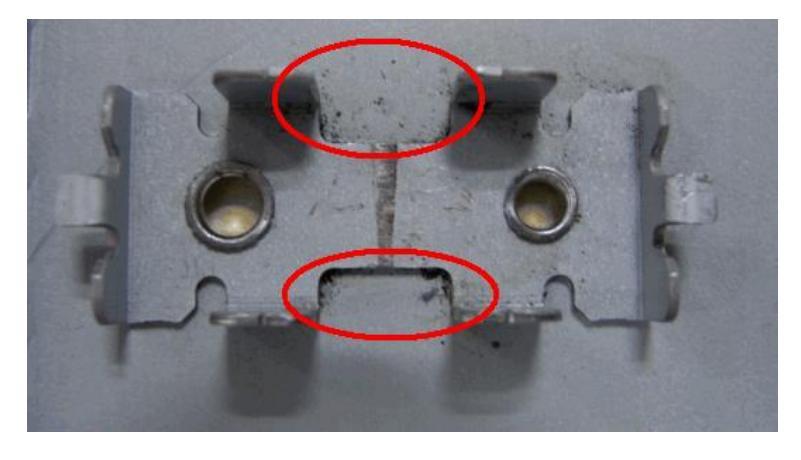
If the abrasion is severe as in the photo below, replace with a new set of springs and shaft holder and apply grease.

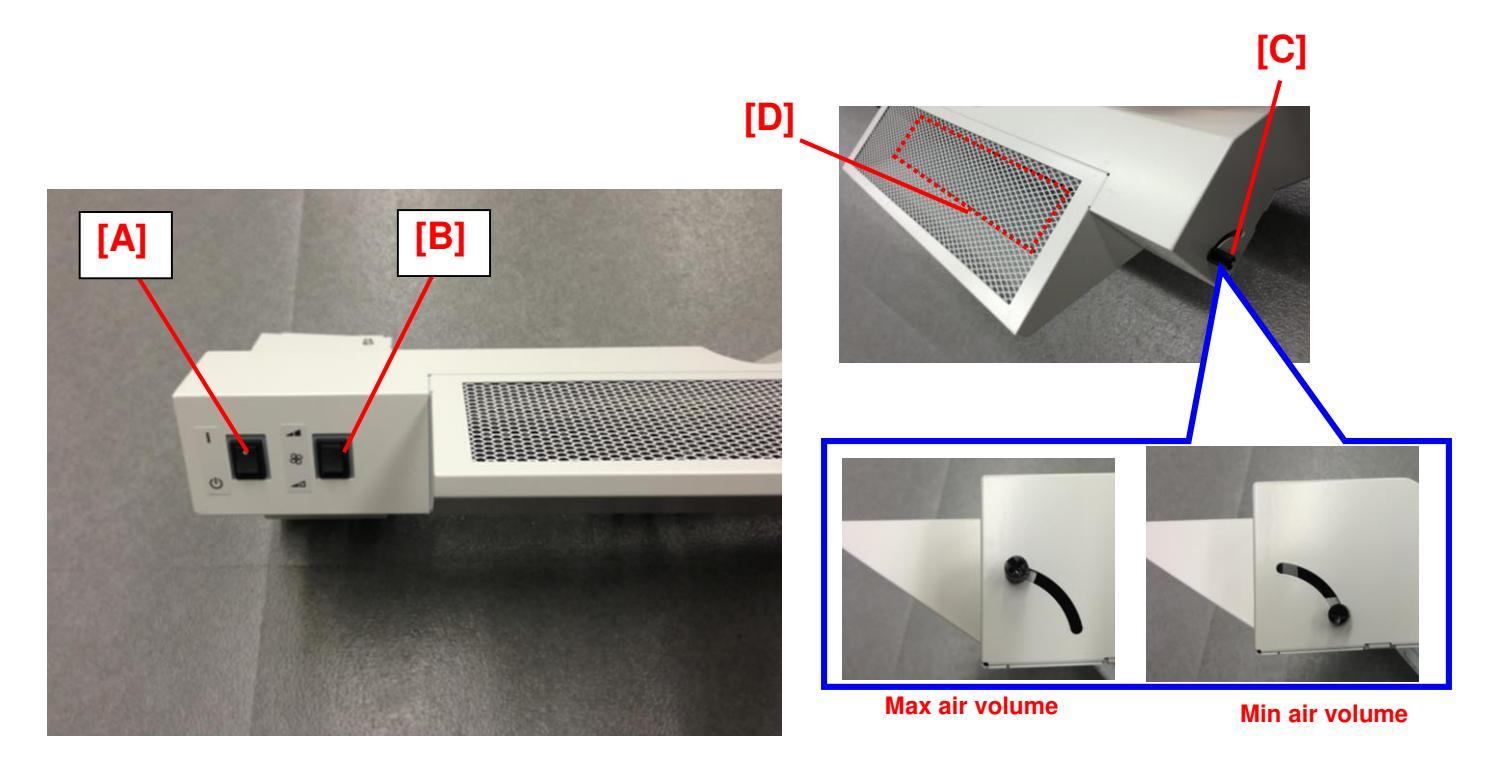
Cooling Fan Unit Type M2 is equipped with a fan power adjustment switch [B]. Fan power can be set to either maximum or minimum. If poor stacking is confirmed as a result of excess air volume, set this switch to minimum.

If the air volume needs to be fine adjusted, rotate the knob screw [C], which will change the position of the air shield [D] inside the unit. The air shield can be fixed at the desired position by tightening the knob screw. (Air shield [D] is located inside the meshed cover.)

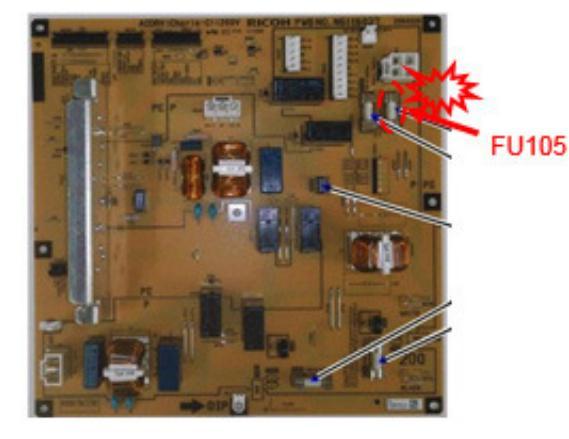
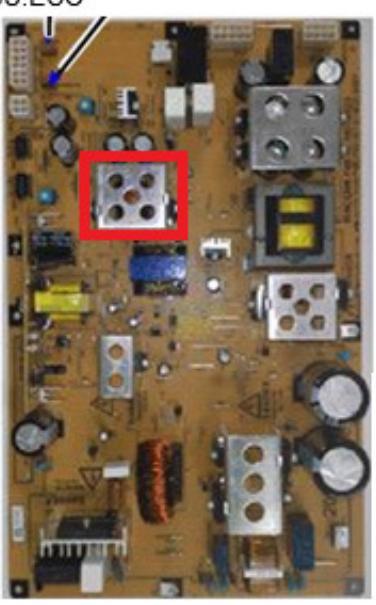
Machine power does not turn on as a result of a damaged PSU-ECO and a blown fuse FU105 on the AC drive board.

AC drive board

PSU:ECO

If the problem occurs, replace the PSU with the PSU of the 2nd modification, *AZ240259* or D1389907, and FU105 (11071344) or AC drive board (D1365465).

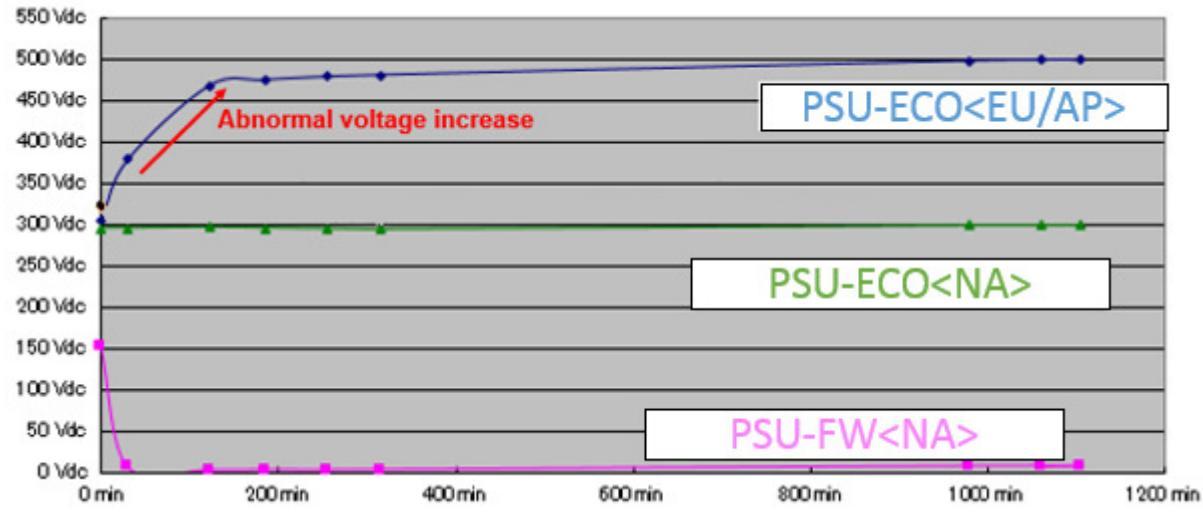
- 1. Internal voltage of the PSU increases abnormally to approximately 500V, while the target is set to 'input voltage x  $\sqrt{2}$ ' (339Vdc at 240Vac input).
- 2. Excess voltage causes the switching circuits Q3 and Q4 on the PSU to activate simultaneously.
- 3. Simultaneous activation of Q3 and Q4 generates an electrical surge and damages Q3, Q4 and the fuse.

Internal voltage of the PSU increases when both of the following conditions are met:

- Voltage supply via delta connection (EU and AP models)
- The machine was left unused with the power cord plugged in for more than 200 min either after entering energy saving mode or after turning off the power with the push switch.

- Internal voltage of the PSU increases abnormally because the PSU does not have a discharge circuit.
- Q3, Q4 and the fuse will be damaged if the surge exceeds 11kw.

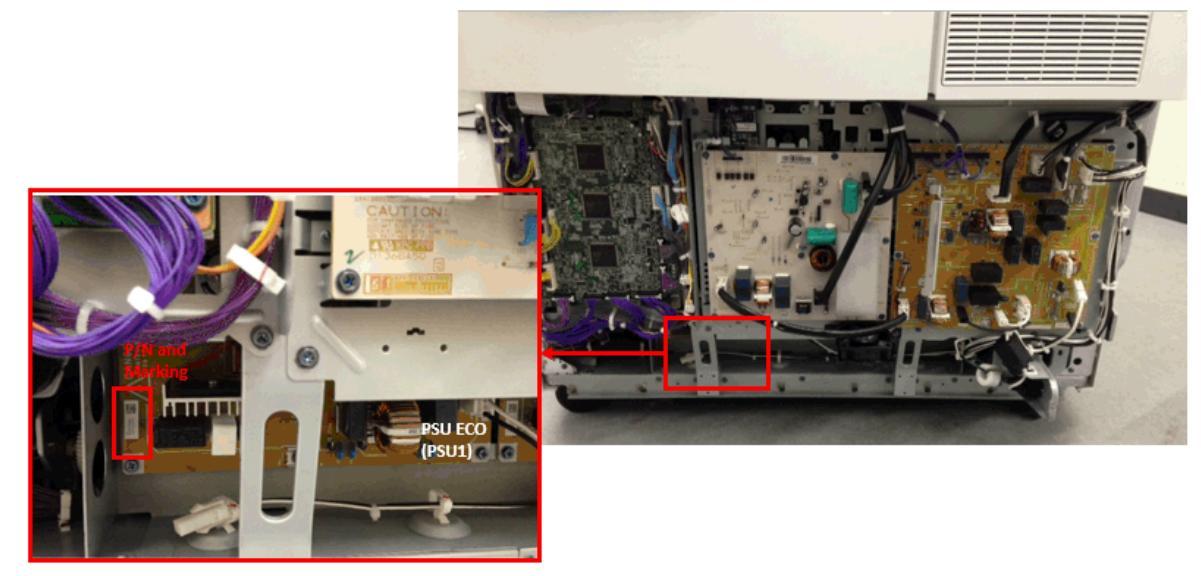
1. Remove the rear cover and look for the p/n and marking on the PSU-ECO in the area squared in red in the photos below.

2. Refer to the chart below and identify the modification level by the combination of the p/n and marking. For example, p/n AZ240228D and blue dot marking indicates a PSU of the "1st modification."

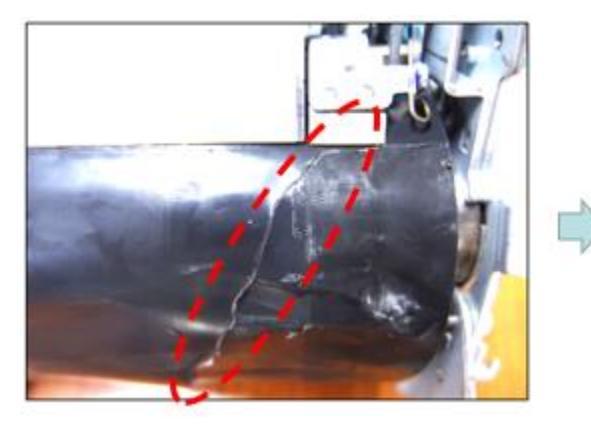
The fusing belt tears apart followed by a machine stop SC548-00.

If the following conditions are met, replace the fusing belt and the heating roller.

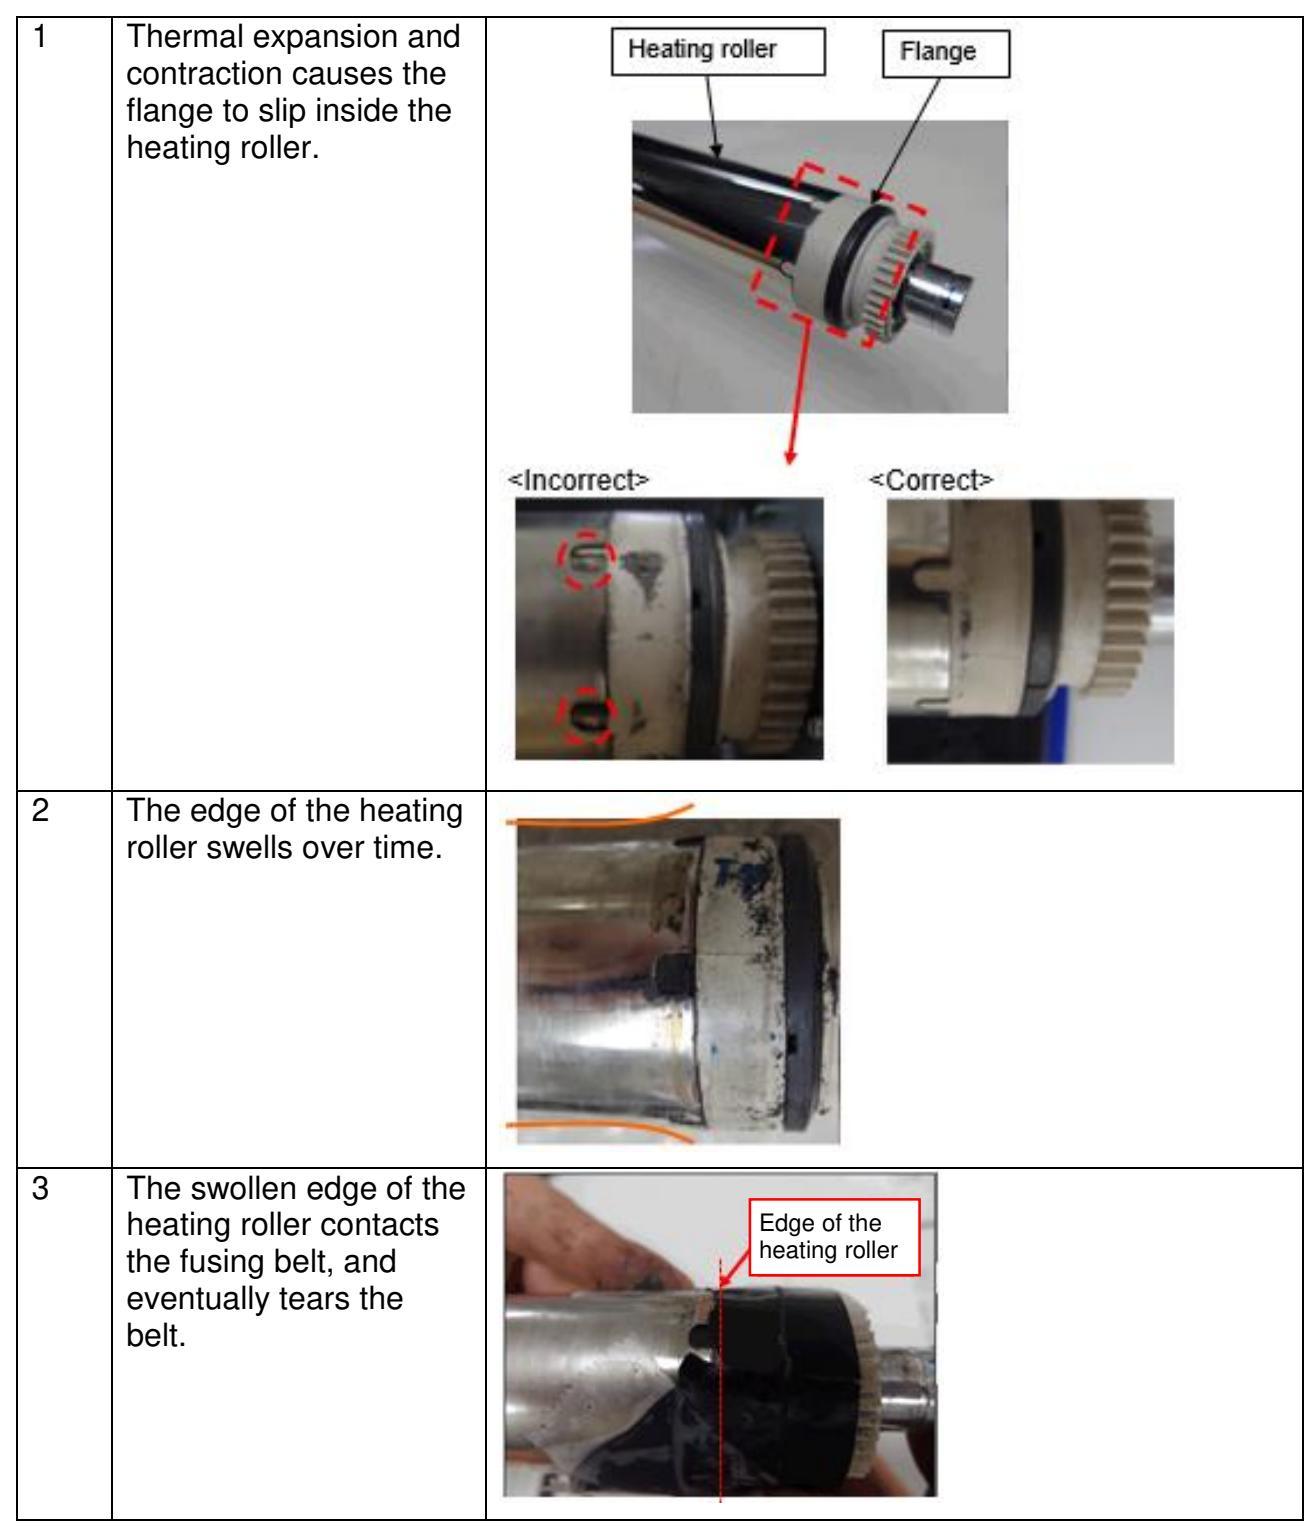
The diameter of the flange attached to the heating roller is smaller than the prescribed specification. The problem occurs in the following sequence:

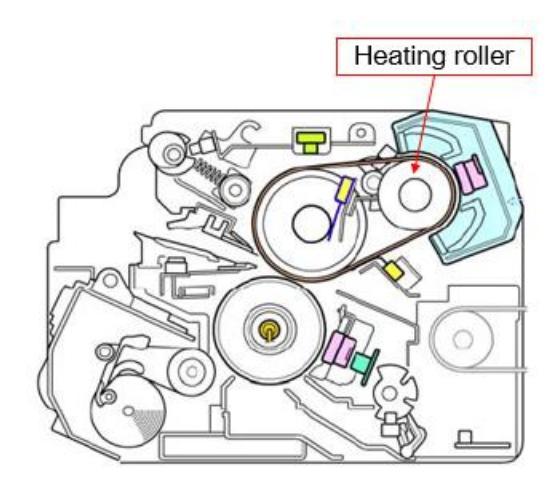
- Step 1. Print a copy.
- Step 2 . Push the "Clear" button after you hear the beep indicating job completion.
- Step 3 . Listen if you can hear the ticking noise while the heating roller rotates for 15 seconds.

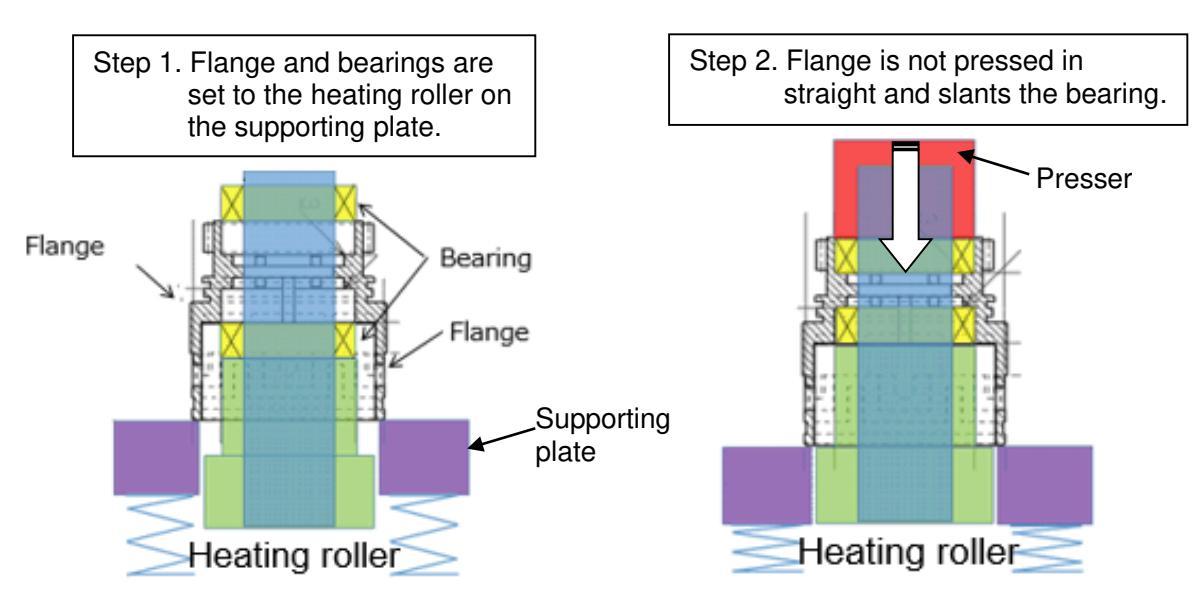
Bearing of the heating roller slants and interferes with the flange due to an inaccurate press process in assembling the components.

If the symptom occurs, replace with the modified heating roller.

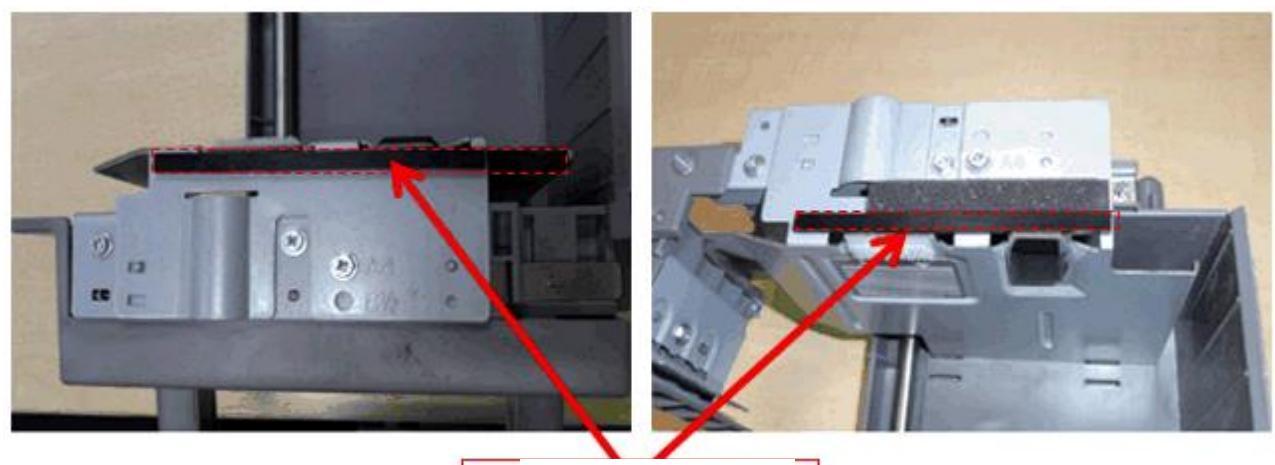
Protective sheet

The edge protective sheet has been attached to prevent burrs on the production line.

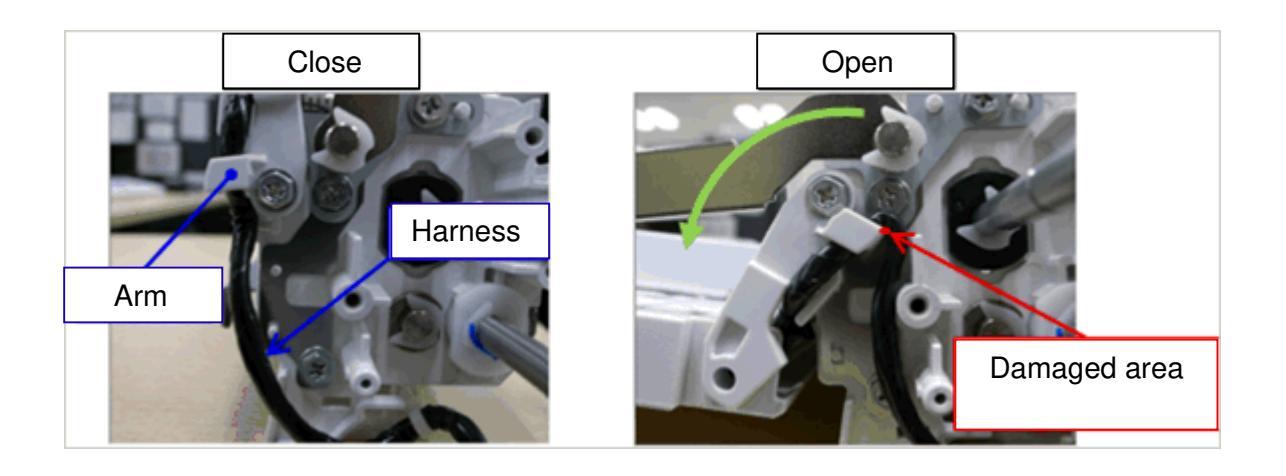
The harness for the paper size detection sensor might be damaged due to repeatedly opening and closing the bypass tray.

Install the following parts.

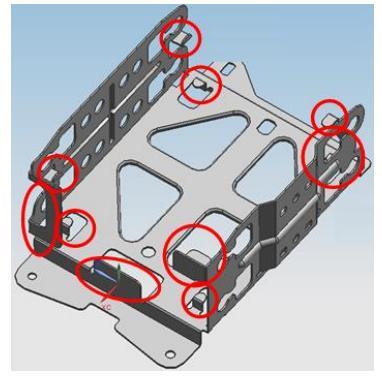
- Some of the projections on the HDD bracket (circled below) can contact the HDD directly.
- The amount that the printing speed is reduced depends on how much vibration is transmitted to the HDD.

- 1. Check whether the following projections on the bracket are contacting the HDD.
- 2. Bend back the projections that are touching the HDD so that they do not touch it anymore.
- 3. Make sure that the gap between the projection(s) and HDD is about 1mm.

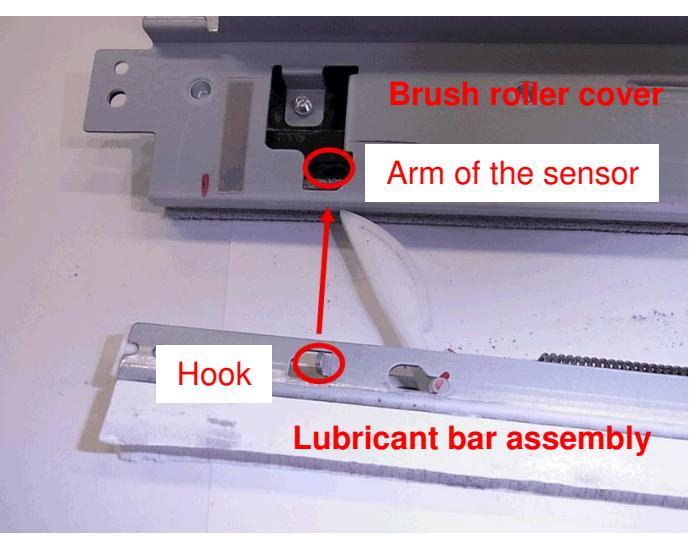
Installing a used lubricant bar may cause the hook (see photo to the right) to jam the arm of the sensor when attaching the lubricant brush roller cover, depending on the remaining amount of lubricant. If the machine is operated in this condition, the hook eventually pushes aside and locks the arm of the sensor. This will not happen with a new lubricant bar, because the width of a new bar secures enough clearance and the hook will not interfere

As a preventive measure, do not install a used lubricant bar. Always replace with a new one.
