### Technical Bulletin

Reissued: 02-Nov-15 Model: CH-C1

No.: RD135004c

This RTB has been issued to announce the firmware release information for the Web Uapl.

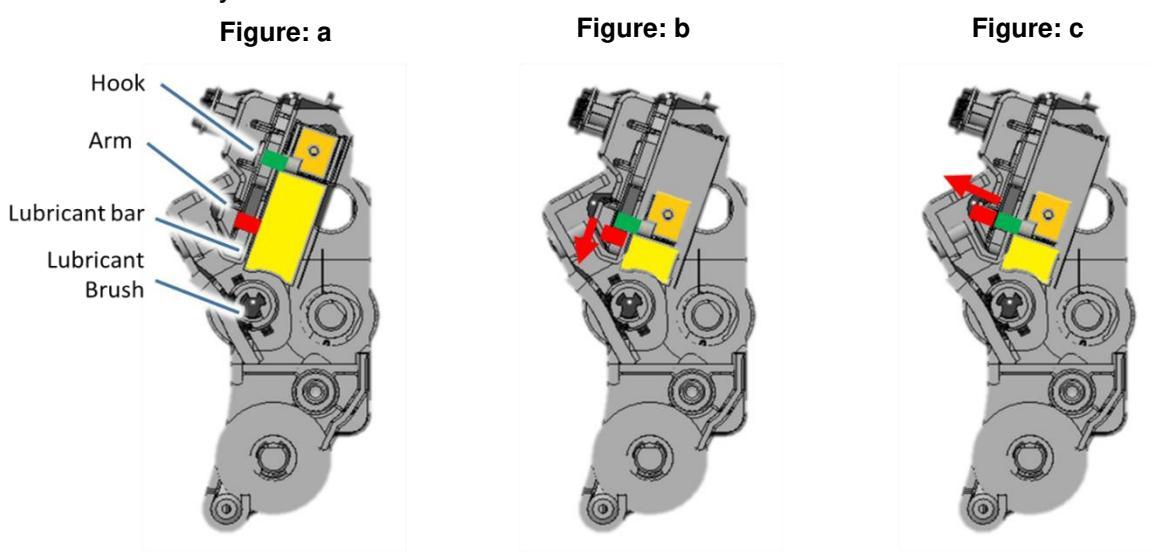
- a) A new lubricant bar is installed. The hook gradually moves toward the brush as the lubricant bar is consumed.
- b) When reaching the point where the hook pushes down the arm, near end is detected.
- c) A used lubricant bar was installed and the hook on its assembly has pushed aside the arm on the sensor. The arm is locked in this condition and the sensor constantly detects near end status.

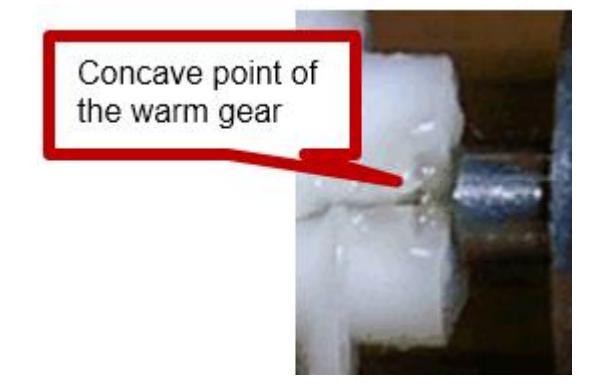
Crack in DC motor worm gear

The worm gear for the DC motor is cracked.

Concave point in gear, where stress was concentrated
Date: 27-Jul-16

Old part number	New part number	Description	I/C
D1361216	D1361212	DC MOTOR:ON-OFF:TRANSFER:ASS'Y	X/O

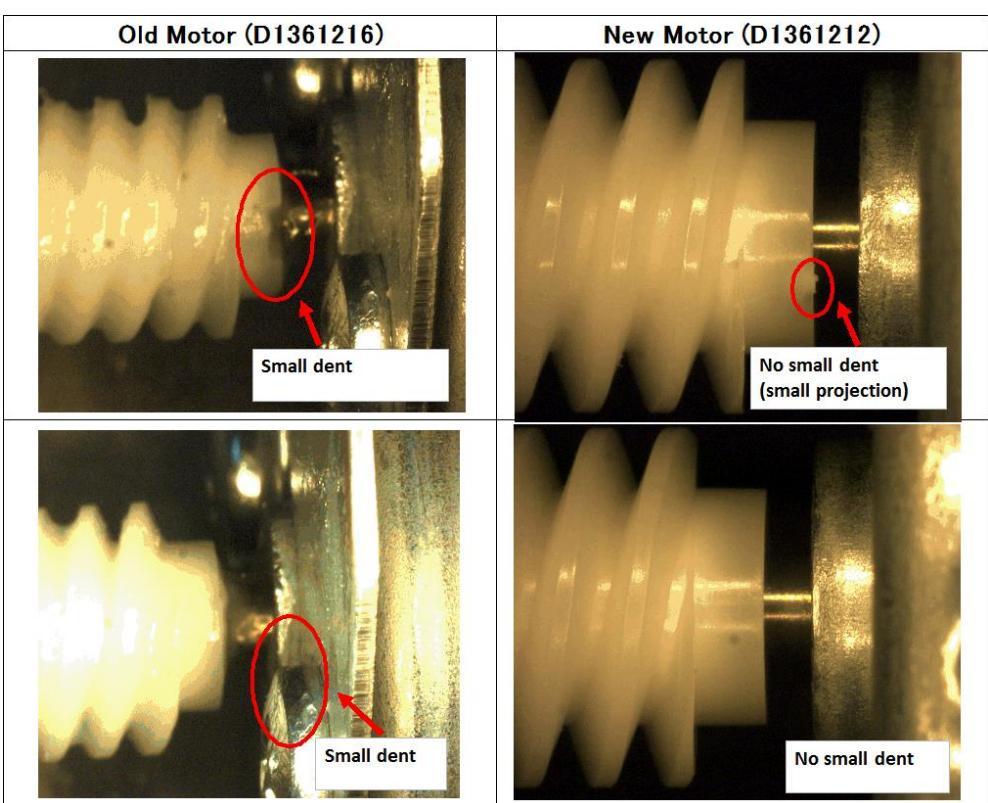
Note: The concave point was removed to prevent stress from concentrating as shown below.

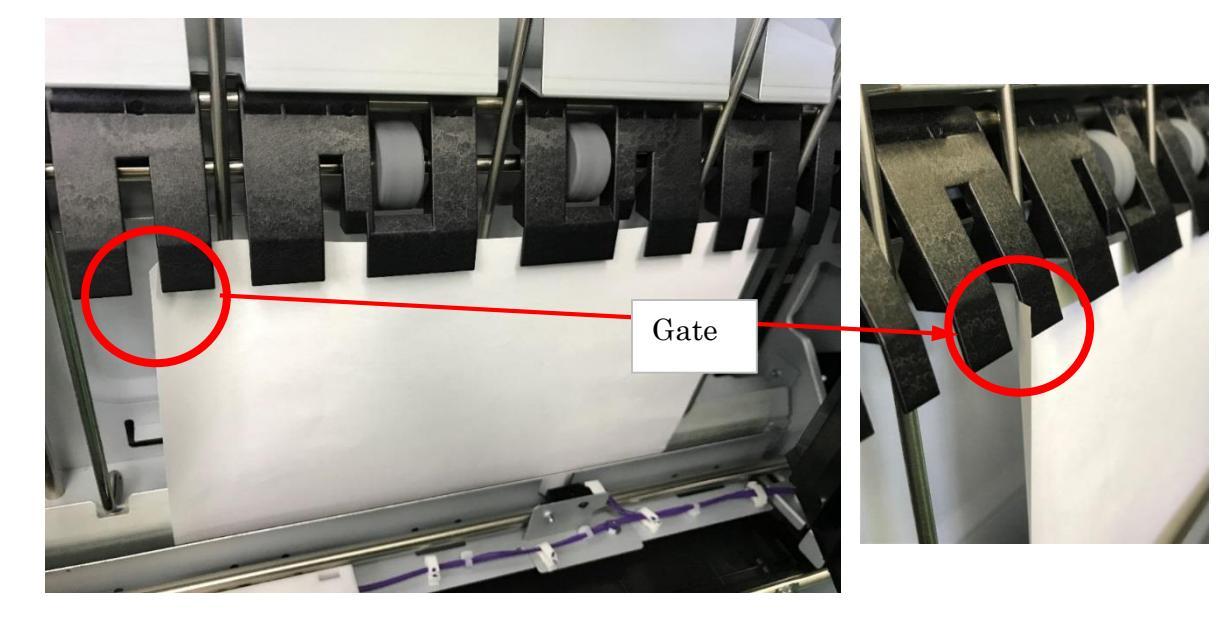
When creating saddle-stitched booklets, the gate holds the stack to prevent the succeeding sheet from colliding with the stack. If the stack has a face-curl, the curled corner can protrude from the slit depending on the paper size as shown in the red circles in Fig1 below. To prevent such instances, paper sizes that have the possibility of the corners to position to these slits are NOT supported.

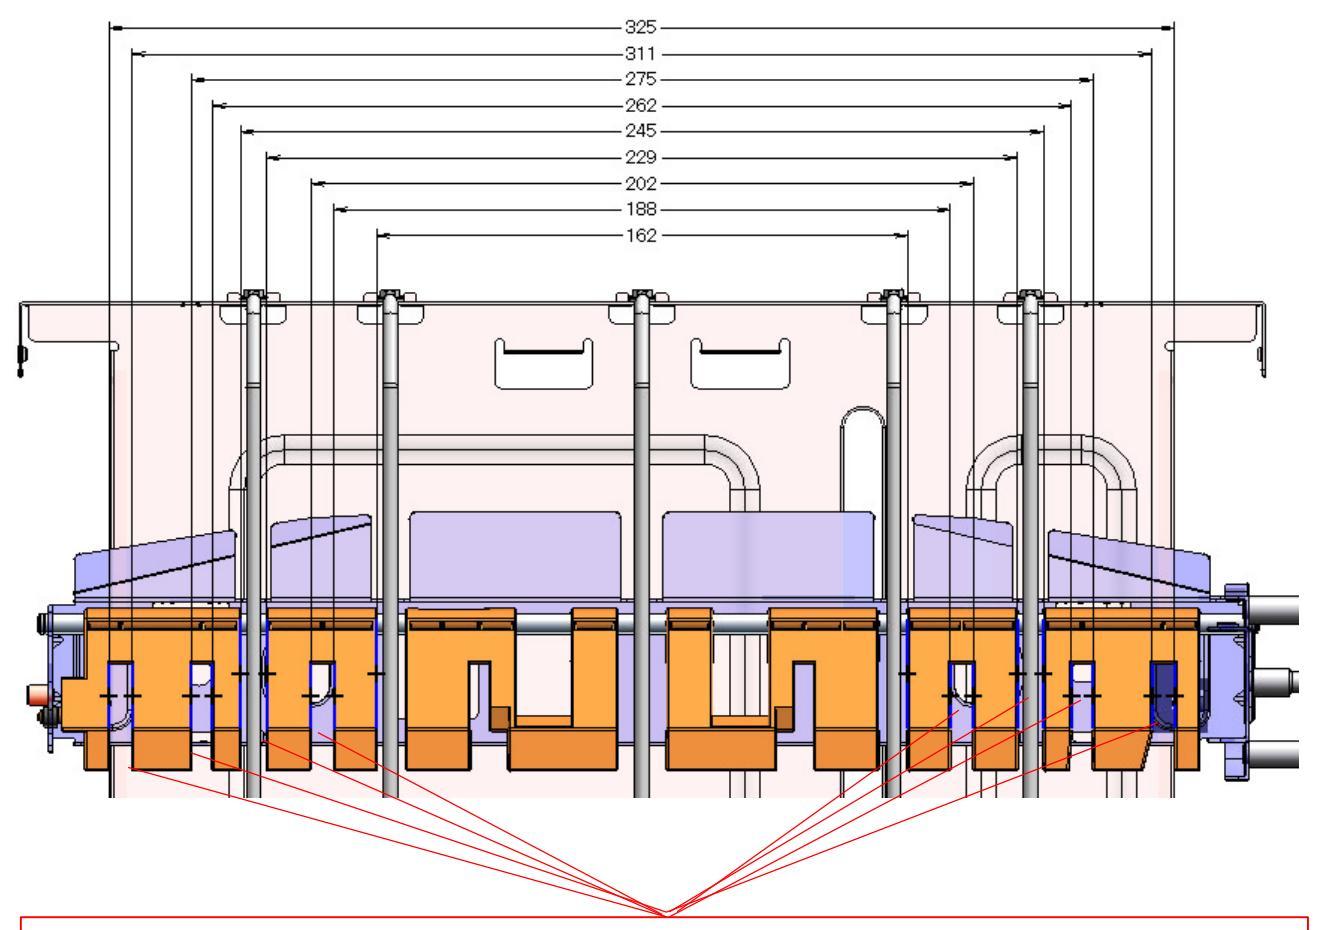
Fig 2

Paper sizes that cause the paper edge to position to these 8 slits on the gate are not supported for saddle-stitching. (Slit area + margin) Saddle-stitch is supported for the following custom paper sizes. Width: 182mm, 207-225mm, 250-257mm, 279.4-306mm, 330-330.2mm Length: 257-467.2mm

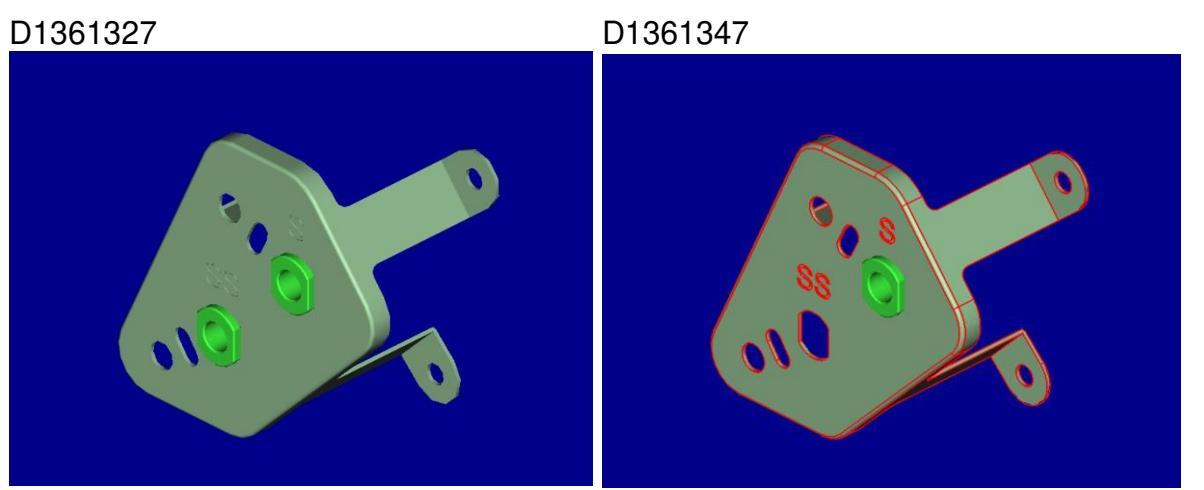
Old: PAPER FEED SUB-UNIT DRUM STAY

There are two types of the old stay; one that has two bearings (p/n: D1361327) and another that only has one bearing (p/n: D1361347). Both types were replaced with the new stay (p/n: D1361328). See the next page for illustrations.

There is no interchangeability (X/X) between the old stay and the new stay. When replacing the old stay, make sure to replace it with the new stay and the bearing **together as a set**.

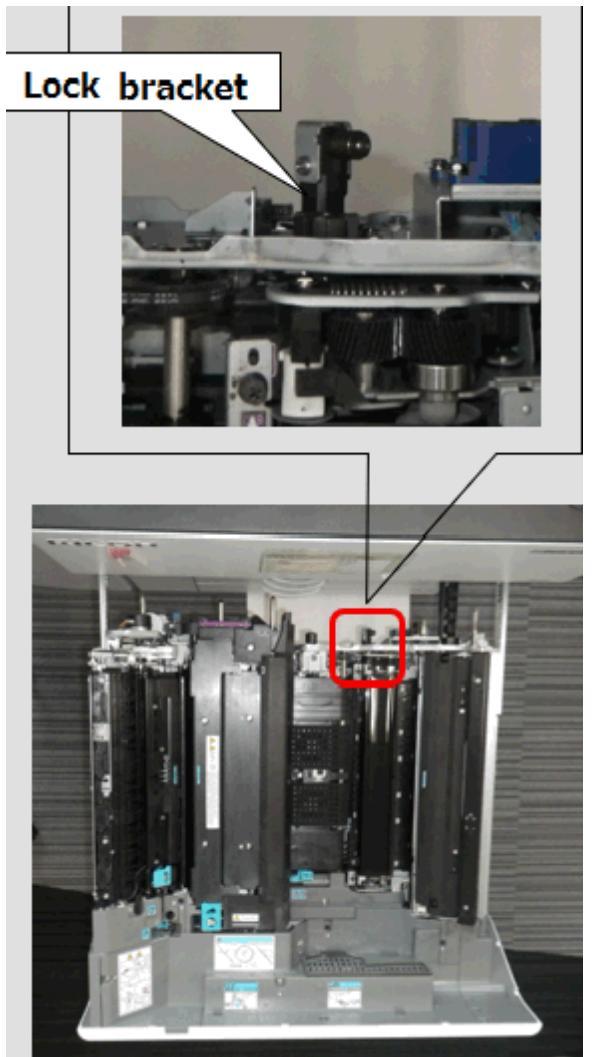
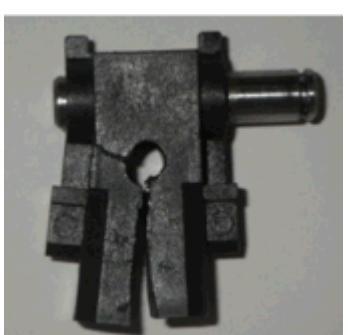
The lock bracket breaks.

Replace the lock bracket with the new part.
