Model: CH-C2/CH-C2 Pro	Date: 14-Oct-16	No.: RD257015a
-------------------------------	-----------------	----------------

Subject: Firmware Release Note: PS3		Prepared by: K. Hamada	
From: 1st Tech Service Sect., MFP/Printer Tech Service Dept.			
Classification:	<input type="checkbox"/> Troubleshooting	<input type="checkbox"/> Part information	<input type="checkbox"/> Action required
	<input type="checkbox"/> Mechanical	<input type="checkbox"/> Electrical	<input type="checkbox"/> Service manual revision
	<input type="checkbox"/> Paper path	<input type="checkbox"/> Transmit/receive	<input type="checkbox"/> Retrofit information
	<input type="checkbox"/> Product Safety	<input checked="" type="checkbox"/> Other (Firmware)	<input checked="" type="checkbox"/> Tier 2

Model: CH-C2a		Date: 30-Nov-16	No.: RD257020
Subject: Part of a FAX image is missing with Memory Unit Type M26		Prepared by: Y.Taniguchi	
From: 1st FQM Sect., 1st FQM Dept.			
Classification:	<input checked="" type="checkbox"/> Troubleshooting	<input type="checkbox"/> Part information	<input type="checkbox"/> Action required
	<input type="checkbox"/> Mechanical	<input type="checkbox"/> Electrical	<input type="checkbox"/> Ser

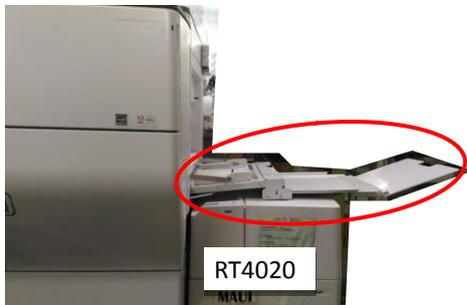
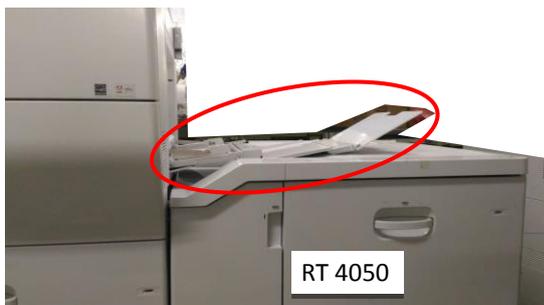
GOOD

With LCIT RT4020

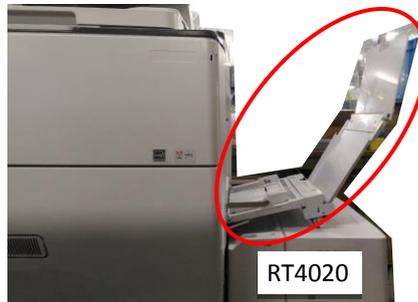
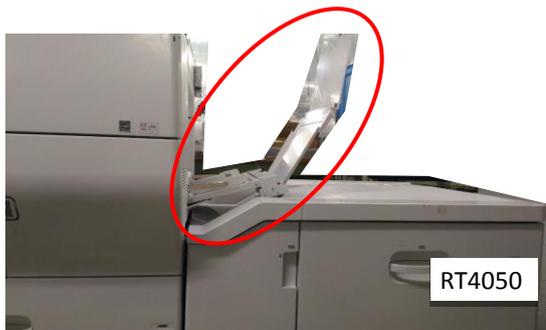
BAD

With LCIT RT4050

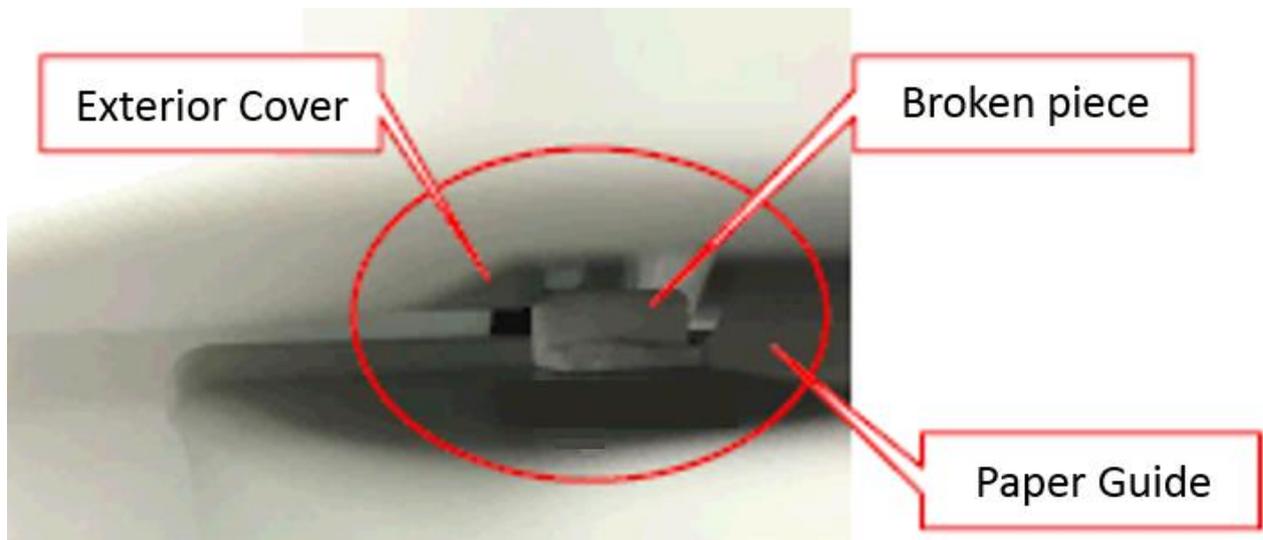
Breakage of the hook of COVER: GUIDE: INNER BACK circled in RED. (Fig.1)

The broken piece drops into the clearance between the paper guide (GUIDE: PAPER: REAR: ASS'Y) and the exterior cover (COVER: PAPER: GUIDE) circled in YELLOW.

See the clearance between the paper guide (GUIDE: PAPER: REAR: ASS'Y) and the exterior cover (COVER: PAPER: GUIDE) to check if there is a broken piece.

RCL are going to modify the guide cover to reinforce the hook of the cover.

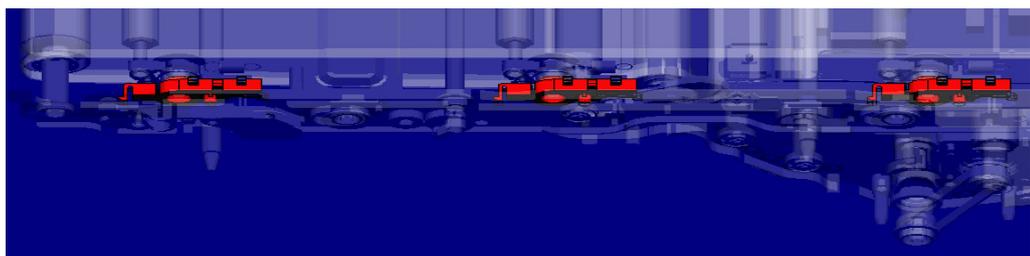
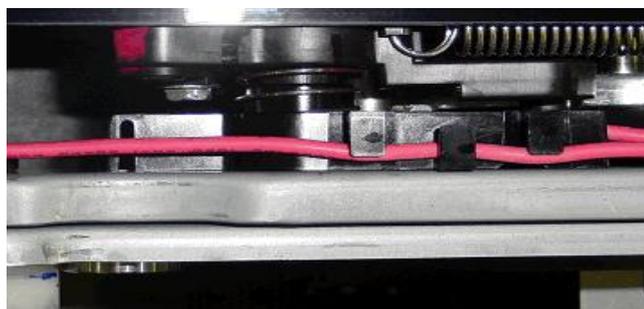
Fig.2

One of the bias brackets (D1366124) **[A]** in the intermediate transfer unit comes loose or out of position when the intermediate transfer unit is installed. As a result, the bracket bumps against the bearing **[B]**, and the intermediate transfer roller **[C]** cannot rotate.

1. If the symptom occurs, return the bias bracket(s) to the correct position.
2. When you install the intermediate transfer unit, make sure to do the following:
 - **Keep the unit level** (flat/horizontal) when you slide it into the machine. If the unit is tilted, the bracket(s) will contact the machine frame and come out of position.
 - Slide the unit into the machine slowly, and if you feel any bumping or other contact, make sure the bracket(s) are securely attached in the correct position.

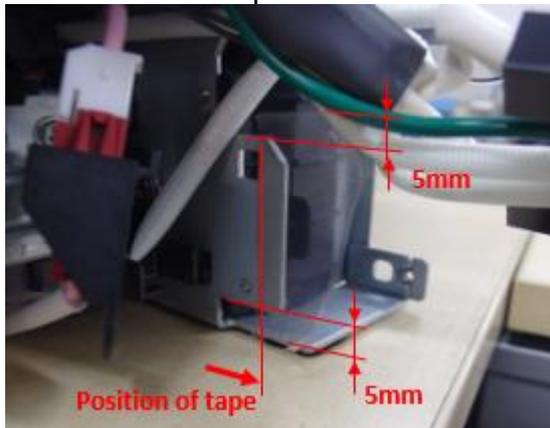
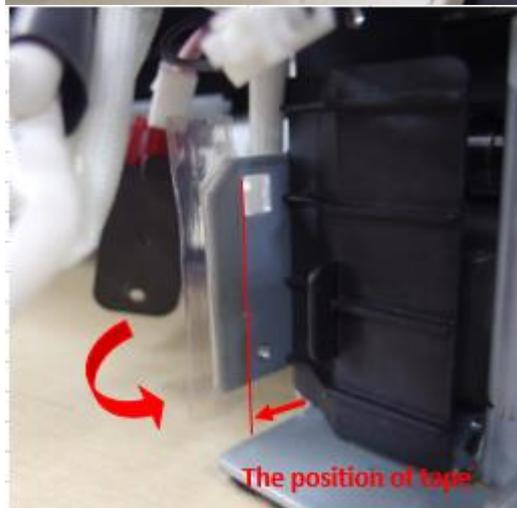
The harness layout was changed when the factory assembly team was changed in January 2017. As a result, the following harness tube in the fusing unit was damaged, causing it to contact the metal plate.

7. Attach the Teflon tape at the following locations on the bracket.

Important: Make sure the tape sticks out 5mm from the top and bottom, as shown in the photos below.

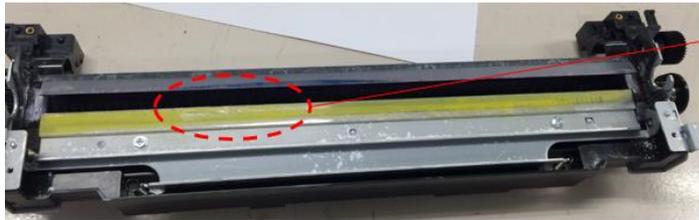
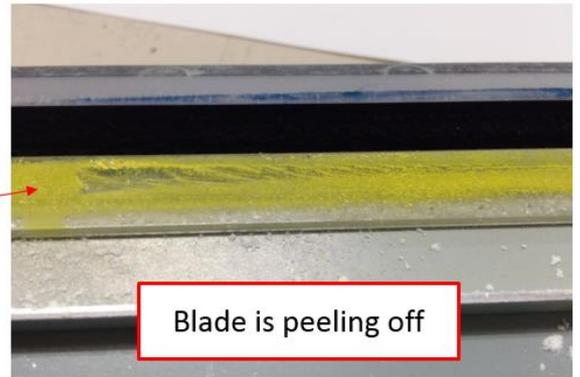
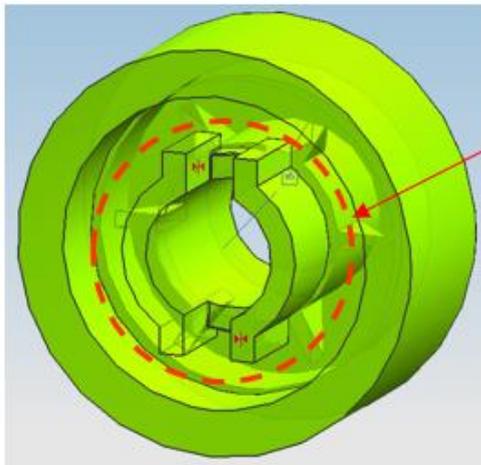
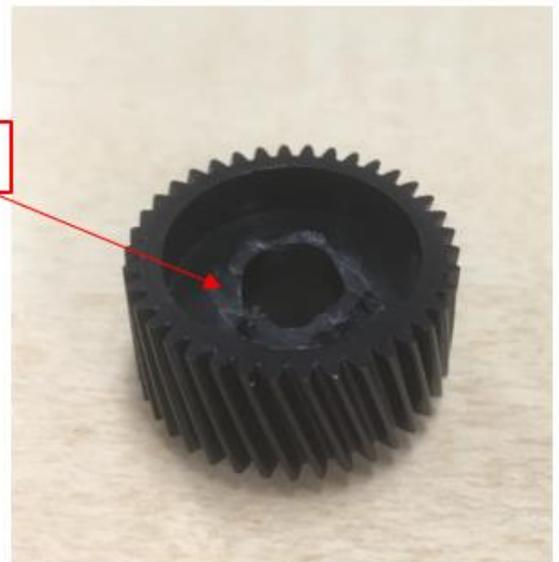
Break

Note: If the toner applied to the blade falls off, the surface layer of the blade may peel off due to the friction between the blade and belt. If this occurs, the friction increases further and may then damage the gear. **See the photos below.**

- Execute **SP2-313-001** (PTR adjustment) at machine **installation, before making any printouts.**
- This is necessary to prevent the following symptoms, which may occur if the toner applied to the cleaning blade falls off during machine transport.
 - Jam 24 (damage to PTB unit gear)
 - Noise (tooth-skipping of PTB unit gear)
 - SC446-03 (ITB motor locks)

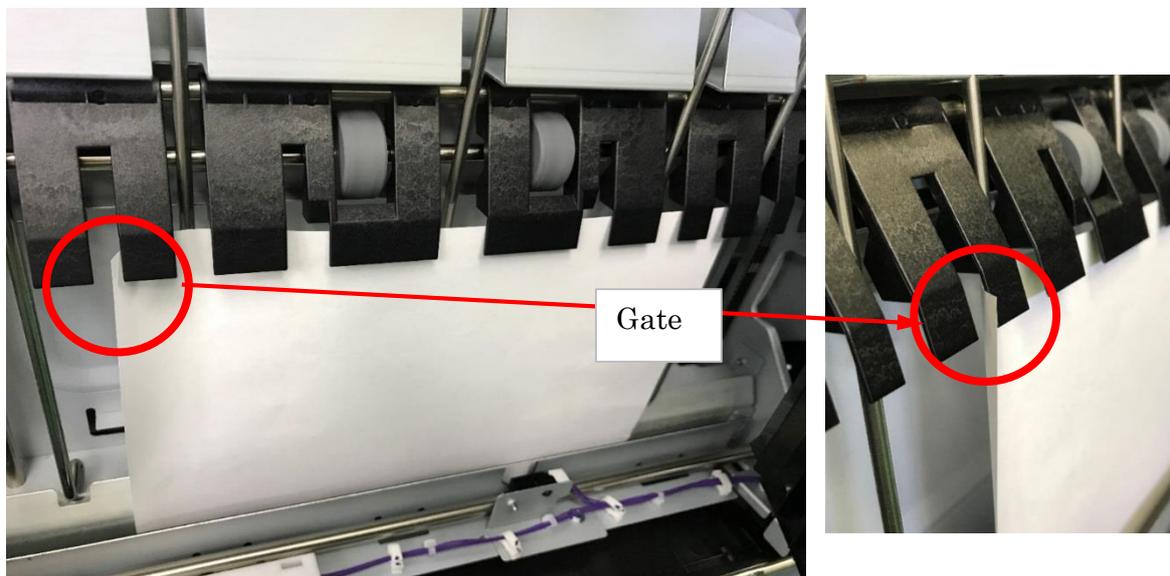
Fig 1

When creating saddle-stitched booklets, the gate holds the stack to prevent the succeeding sheet from colliding with the stack. If the stack has a face-curl, the curled corner can protrude from the slit depending on the paper size as shown in the red circles in Fig1 below. To prevent such instances, paper sizes that have the possibility of the corners to position to these slits are NOT supported.

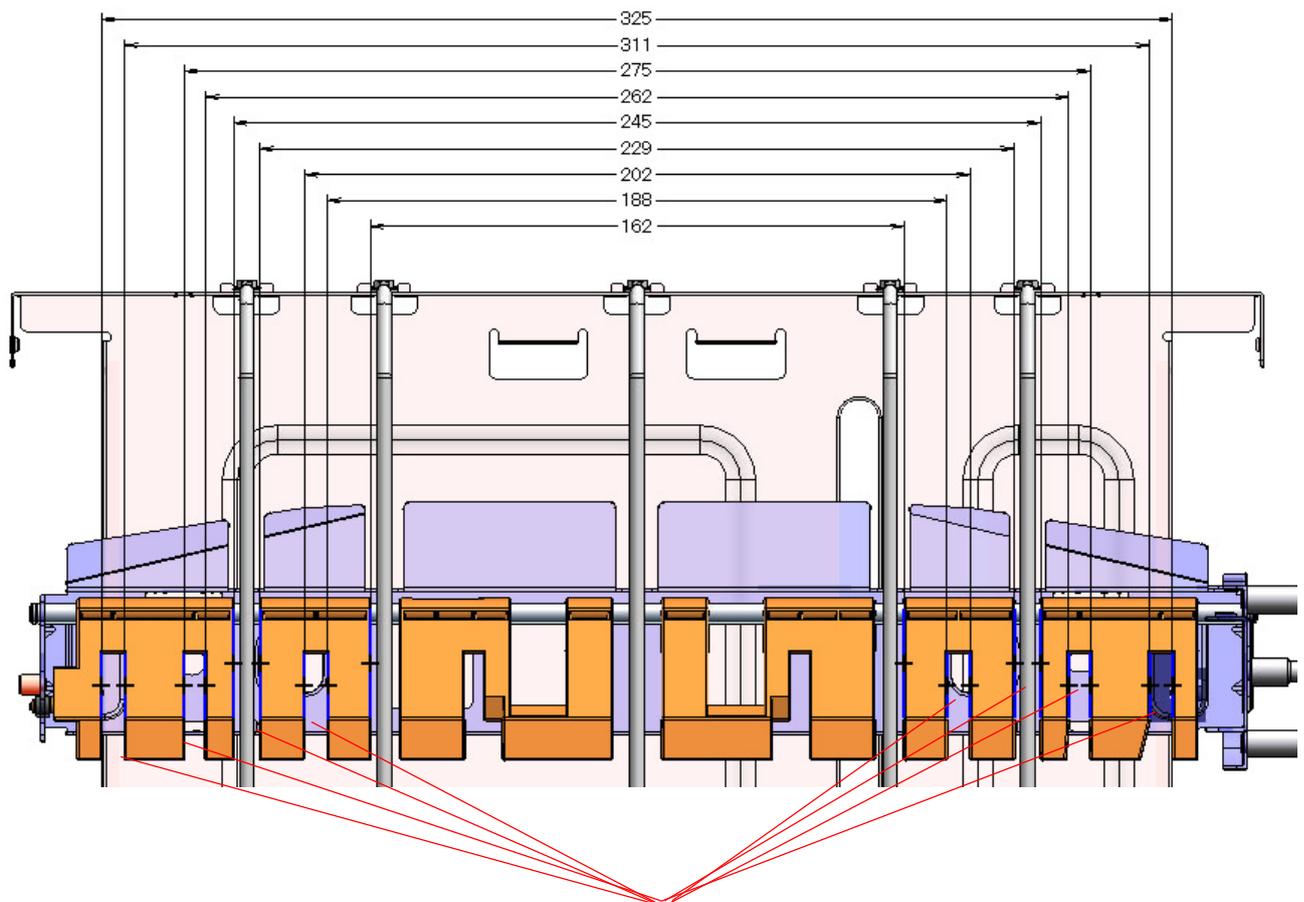
Fig 2

Paper sizes that cause the paper edge to position to these 8 slits on the gate are not supported for saddle-stitching. (Slit area + margin)
 Saddle-stitch is supported for the following custom paper sizes.
Width: 182mm, 207-225mm , 250-257mm, 279.4-306mm, 330-330.2mm
Length: 257-467.2mm

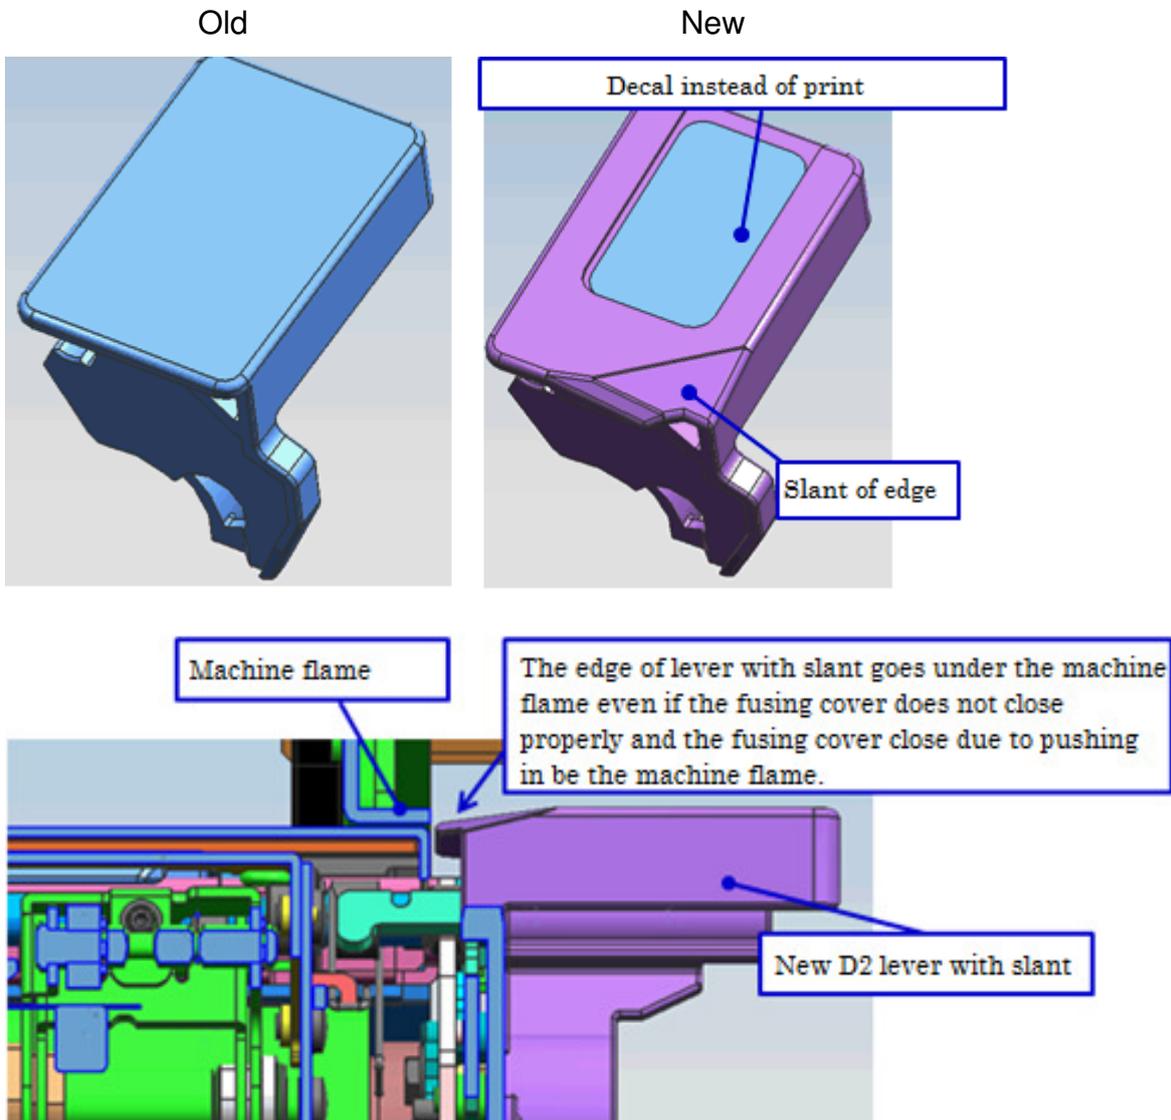
The fusing unit D2 lever is broken and SC583 occurs.

Replace the fusing unit D2 lever with the new part.

Old part number	New part number	Description	Q'ty	Int	Note
D2584359	D2584372	GRIP:SEPARATION:OPEN AND CLOSE:ASS'Y	1	X/O	-

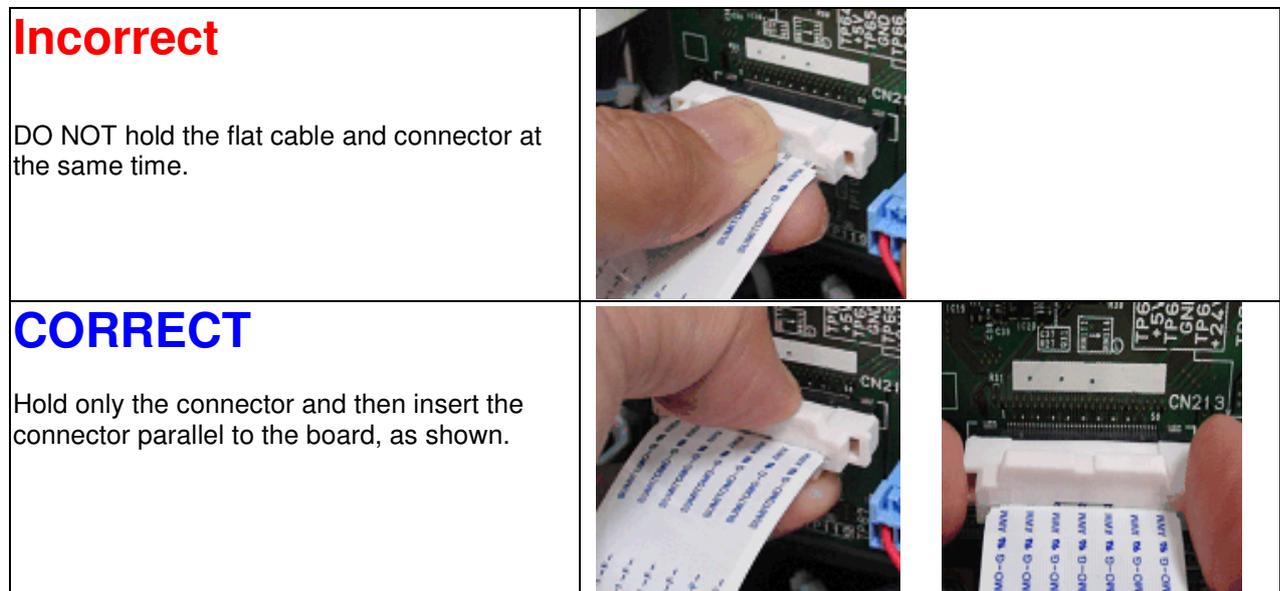
Hold only the connector and insert the connector parallel to the board.

There is some free movement between the connector (boxed in blue in the photo) and the flat cable. As a result, if you hold the connector and cable together, the lines/terminals may become offset from their correct positions.

Replace the flat cable (D2585220) and connect it correctly.

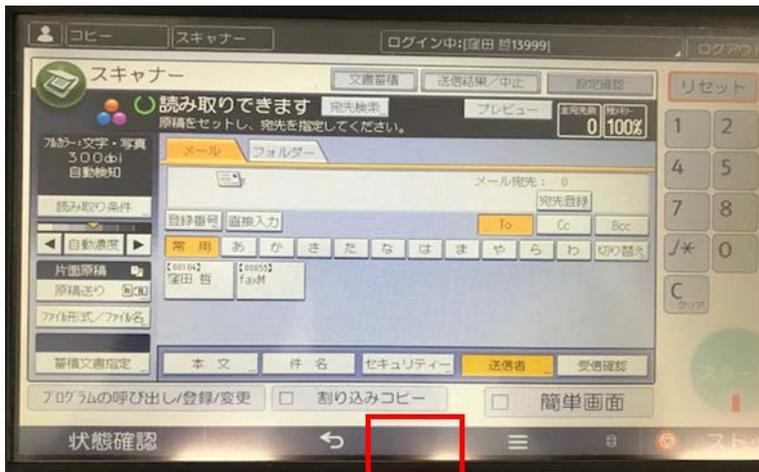
With firmware combination **#3** below, the Home button is not displayed, making it impossible to switch between applications.

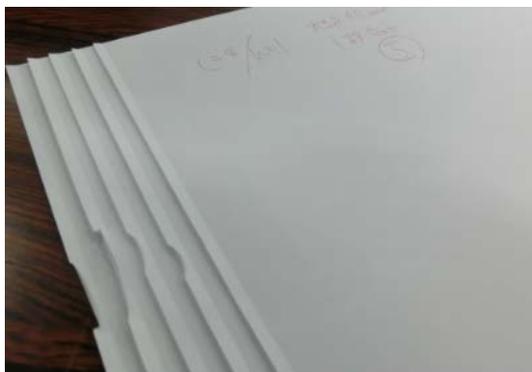
- As a side effect with this separation pad, the leading edge of some paper types may crease when touching the pad, as shown in the photo below.
- Because of this, this pad is only used in cases in which the firmware upgrade is ineffective (It is not installed on machines in mass-production).
