Model: CH-C2 Pro	Date: 20-Dec-16	No.: RD260003
------------------	-----------------	---------------

Model: CH-C2 Pro		Date: 29-Mar-17	No.: RD260017
Subject: Electrical leak from fusing unit		Prepared by: S. Watanabe	
From: PP CS Section, PP FQM Dept., QAC			
Classification:	<input checked="" type="checkbox"/> Troubleshooting	<input type="checkbox"/> Part information	<input type="checkbox"/> Action required
	<input type="checkbox"/> Mechanical	<input checked="" type="checkbox"/> Electrical	<input type="checkbox"/> Service manual revision
	<input type="checkbox"/> Paper path	<input type="checkbox"/> Transmit/receive	<input type="checkbox"/> Retrofit information
	<input type="checkbox"/> Product Safety	<input type="checkbox"/> Other ()	<input checked="" type="checkbox"/> Tier 2

Model: CH-C2 Pro		Date: 28-Jun-17	No.: RD260022
Subject: Troubleshooting Grainy Image		Prepared by: H.K.	
From: PP CS Section, PP FQM Dept.			
Classification:	<input checked="" type="checkbox"/> Troubleshooting	<input type="checkbox"/> Part information	<input type="checkbox"/> Action required
	<input type="checkbox"/> Mechanical	<input type="checkbox"/> Electrical	<input type="checkbox"/> Service manual revis

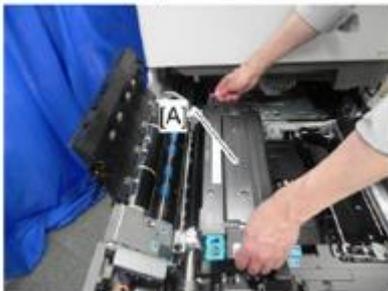
The harness layout was changed when the factory assembly team was changed in January 2017. As a result, the following harness tube in the fusing unit was damaged, causing it to contact the metal plate.

1. Remove the fusing unit.

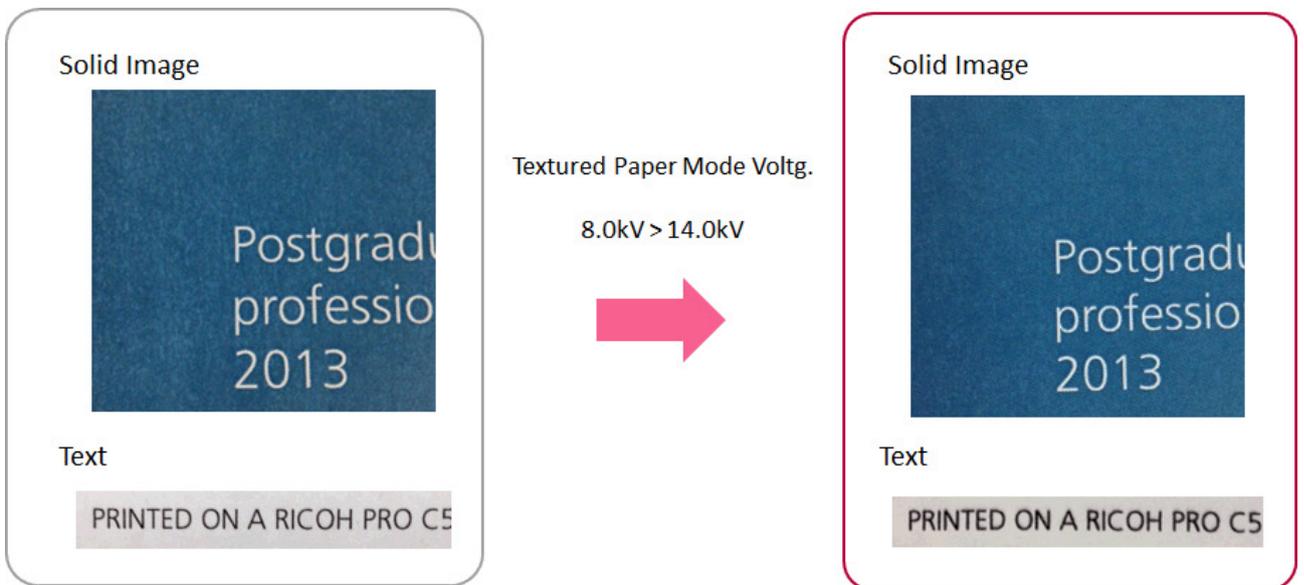
NOTE: Increasing the transfer bias improves Grainy Image, but may cause toner scattering around texts and thin lines.

1. Feed coated stock to verify whether the cause is A or B.
 If graininess is not observed, do step 2. The cause is A.
 If graininess is observed, do step 3. The cause is B.
2. Adjust the AC transfer bias.
 If AC transfer bias adjustment does not work, change the process speed setting.
3. Change the screen settings in the Fiery printer driver.

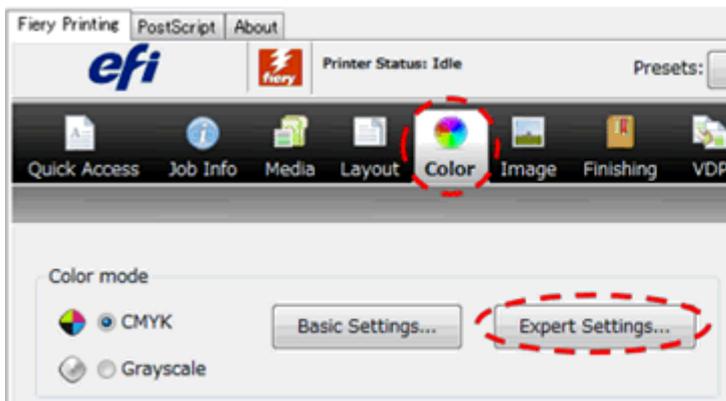
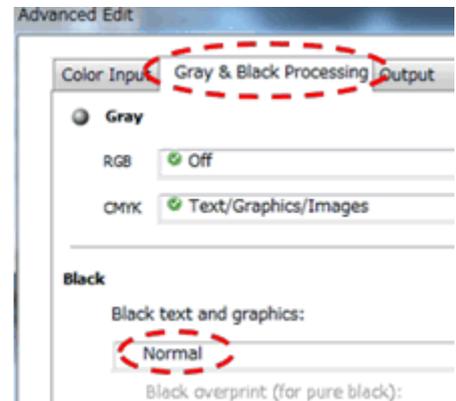
As a side-effect, the density of Bk images will appear lower than expected. If the density is too low, do the following.

1. Apply the maximum toner adhesion amount.
Tray Paper Settings > Change Advanced Sett.
011 | Maximum Image Density: **5** (default: 0)
2. Set the image transfer current to a value between 36 and 41.
016 | Image Transfer Current: FC: K: **36 ~ 41** (default: 31)
3. Set the paper transfer current to a value between -43 and -48.
026, 027 | Paper Transfer Current: FC: **-43 ~ -48** (default: -53)
4. Change the EFI printer driver setting as follows.
Color to Expert Settings > Gray & Black Processing > Black text and graphics: **Normal**

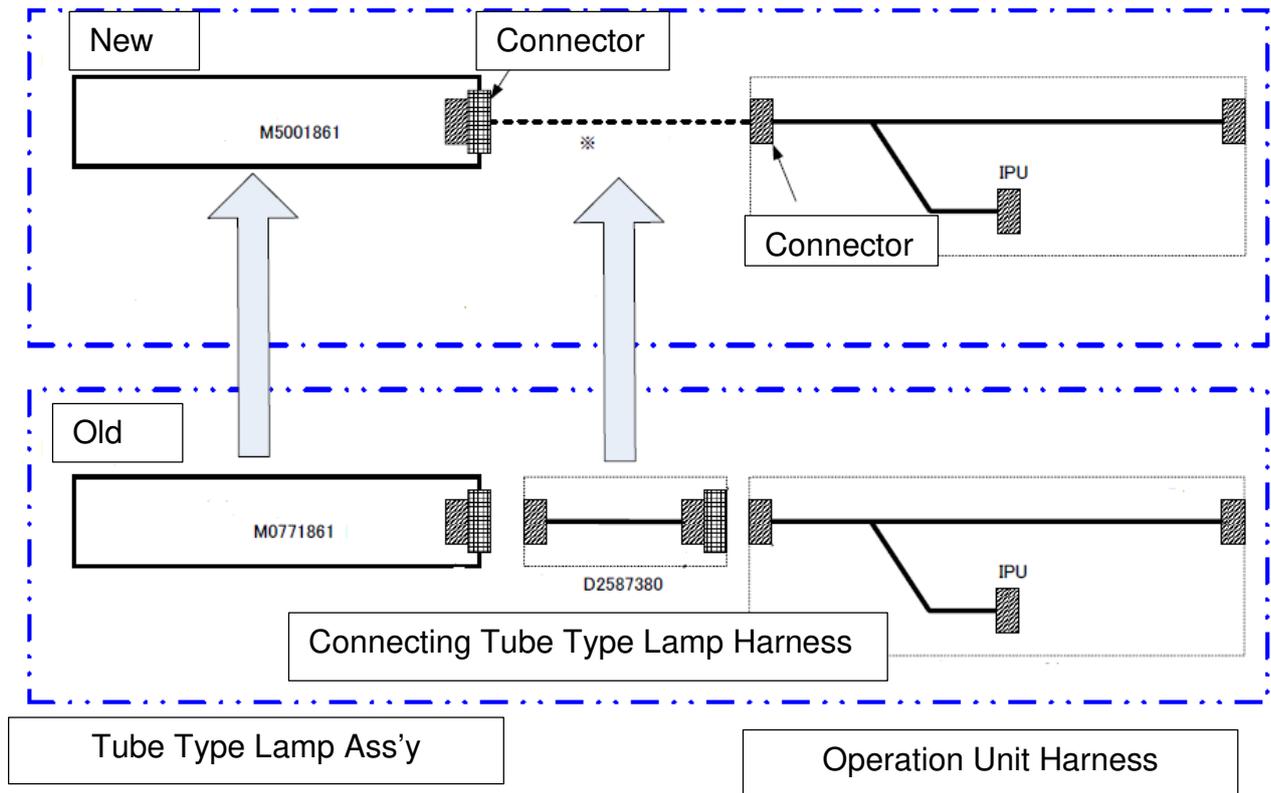
- 1) When the tube type lamp ass'y needs to be replaced, connect the new ass'y directly with the operation unit harness. The connecting tube type lamp harness is unnecessary. Remove and keep it for future use.
- 2) When the connecting tube type lamp harness needs to be replaced, replace it with the new tube type lamp ass'y.

* The diagram on the following page illustrates the connection of these components.

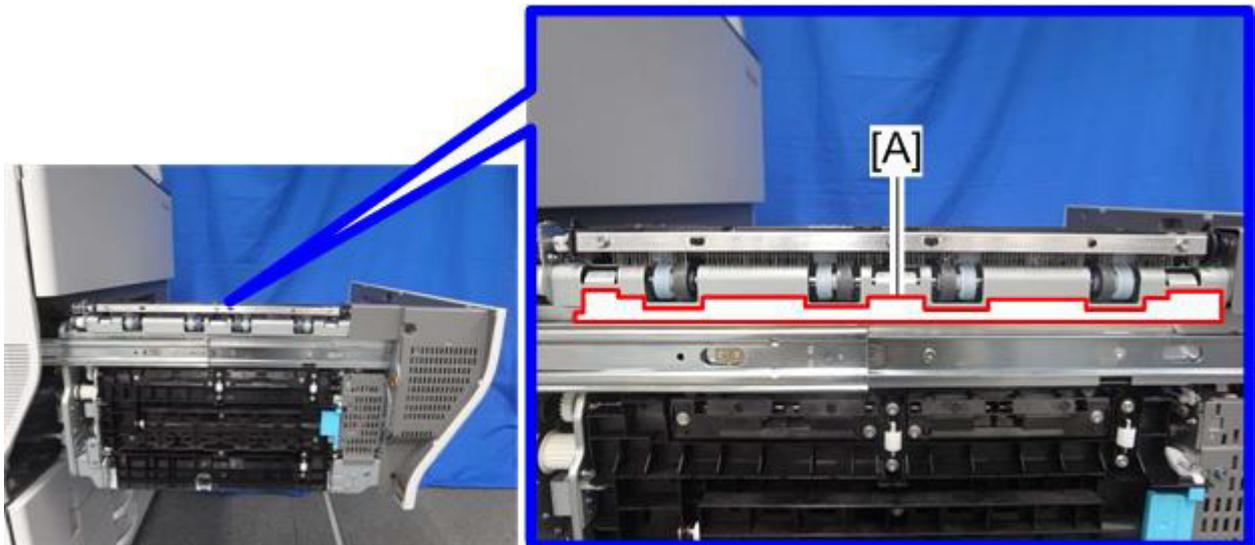
Incorrect

12. Attach the sheet [A] to the left side of the drawer unit.

Step 12 was separated into the following four steps.

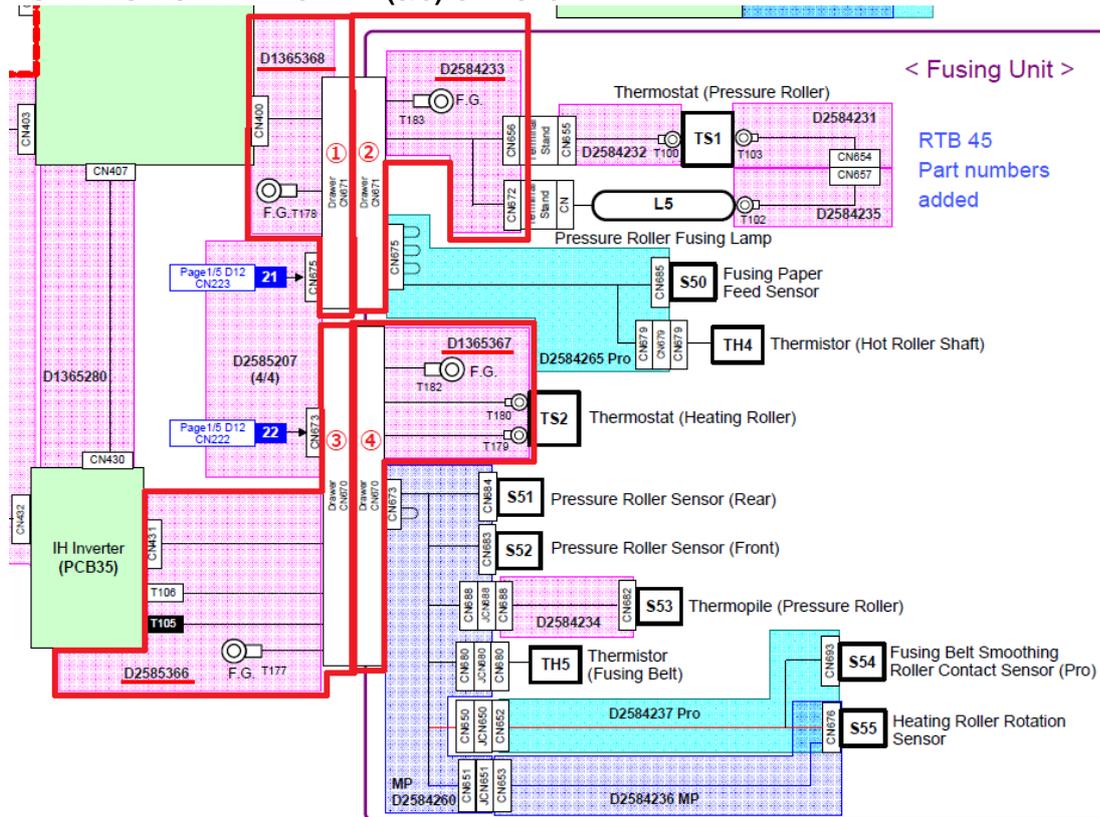
POINT TO POINT DIAGRAM (3/6) G11-J16

- ① The drawer is included in **D1365368** (HARNESS:FUSING:DRAWER:PRESSURE:MAIN)
- ② The drawer is included in **D2584233** (HARNESS:FUSING UNIT:DRAWER:PRESSURE)
- ③ The drawer is included in **D2585366** (HARNESS:IHU:FUSING:DRAWER:THERMOSTAT)
- ④ The drawer is included in **D1365367** (HARNESS:INDUCTION HEATING UNIT:FUSING UNIT:DRAWER)(**Note 1**)

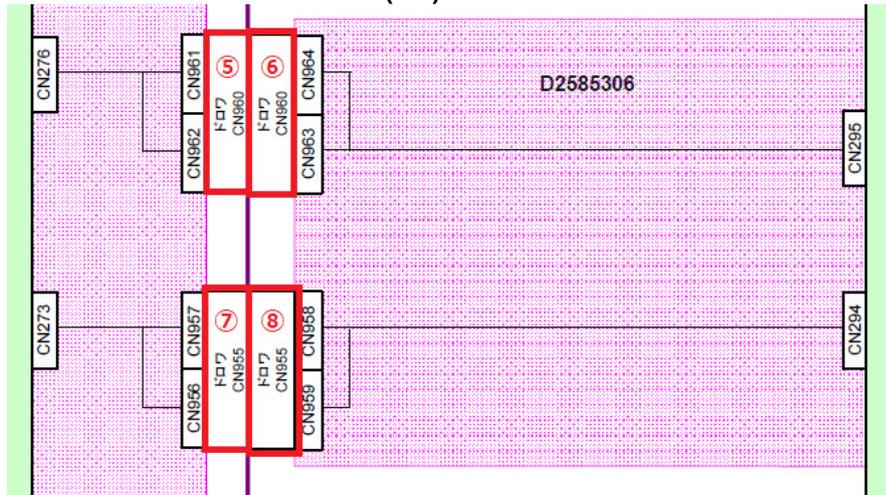
POINT TO POINT DIAGRAM (4/6) F3-G6

- ⑤ 11035841 (CONNECTOR:28W0R-RFC-EGD(LF)(SN))
- ⑥ 11035840 (CONNECTOR:RFCP-28W0-E)
- ⑦ 11035760 (CONNECTOR:36W0R-RFC-EGD(LF)(SN))
- ⑧ 11035758 (CONNECTOR:RFCP-36W0-E)

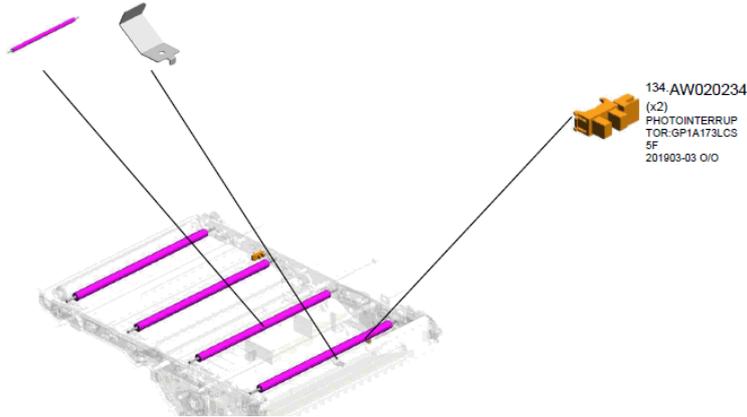
131.D2616005
TRANSFER UNIT:INTERMEDIATE TRANSFER:240V:ASS'Y

134.AW020234
(x2)
PHOTO INTERRUPTOR:GP1A173LCS5F
201903-03 O/O

201904-01	1904 Modification	-	D0746158	ROLLER:INTERMEDIATE TRANSFER:ASS'Y	D2586166	ROLLER:INTERMEDIATE TRANSFER:ASS'Y	U010_S001	135	1	X/O
			D0746158	ROLLER:INTERMEDIATE TRANSFER:ASS'Y	D2586166	ROLLER:INTERMEDIATE TRANSFER:ASS'Y	U010_S001	135	1	X/O
			D0746158	ROLLER:INTERMEDIATE TRANSFER:ASS'Y	D2586166	ROLLER:INTERMEDIATE TRANSFER:ASS'Y	U010_S001	135	1	X/O

For any replacement of the image transfer roller that takes place after July 21, 2019 for Charis-C2 Pro (Pro C5200S/ C5210S), please make sure to replace it with the new roller (p/n: D2586166).

There is no need to make a forced visit to replace with the new roller.
