Model: Mo-C1	Date: 07-Dec-12	No.: RD124001f
--------------	-----------------	----------------

Subject: Firmware Release Note: Engine		Prepared by: Y. Kurohashi	
From: 2nd PP Tech Service Sect., PP Tech Service Dept.			
Classification:	<input type="checkbox"/> Troubleshooting	<input type="checkbox"/> Part information	<input checked="" type="checkbox"/> Action required
	<input type="checkbox"/> Mechanical	<input type="checkbox"/> Electrical	<input type="checkbox"/> Service manual revision
	<input type="checkbox"/> Paper path	<input type="checkbox"/> Transmit/receive	<input type="checkbox"/> Retrofit information
	<input type="checkbox"/> Product Safety	<input checked="" type="checkbox"/> Other (Firmware)	<input checked="" type="checkbox"/> Tier 2

This RTB has been issued to announce the firmware release information for the **Engine**.

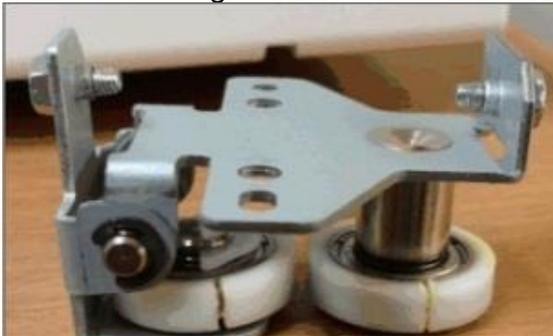
&lt;Slider: Carriage: Unit&gt;

The following occur due to a break/cracks in the bearing's resin coating:

1. Carriage unit (Slider: Carriage: Unit)
  - Rattling noise can be heard when the carriage is moved.
  - Jitter at 63mm intervals along the mainscan direction in halftone images
2. Roll unit (Guide rollers for paper spool)
  - Paper feed jam: The spool of the roll and external area contact one another, which places an excessive load on the spool during paper feed and prevents proper rotation.

Replace the following parts at the next site visit.

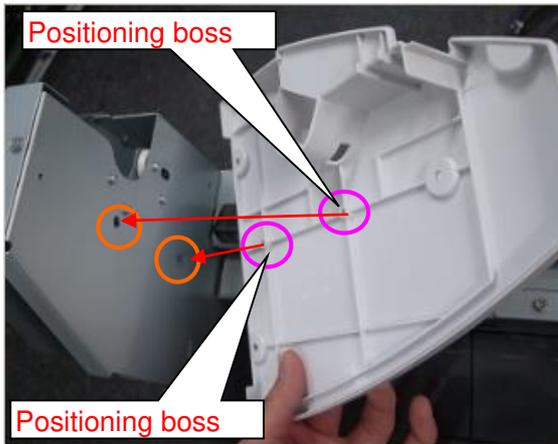
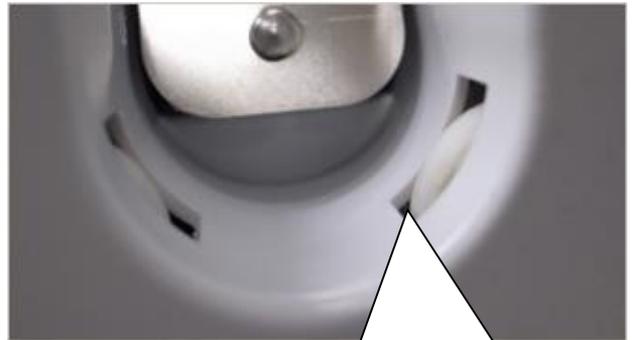
11. Make sure each of the cover's positioning bosses fit into the holes shown.

**NG:**  
If the bosses are not in the correct position, the rollers cannot fit through the holes in the cover, as shown:

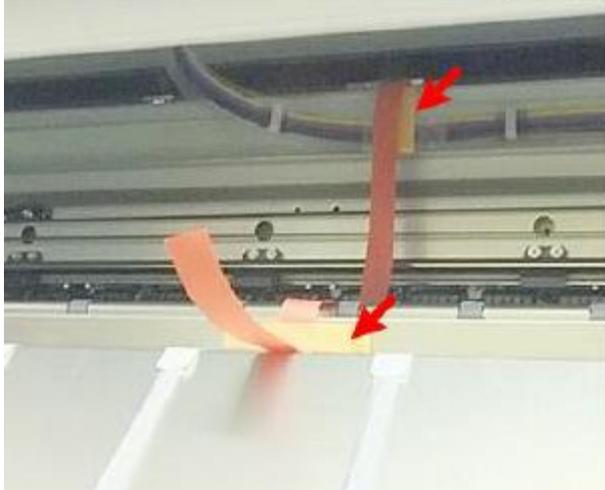
Material 1 (tape, cardboard and strip)

**Note:** Protective shipping materials were added to the area inside the front cover shown below. This was done to further protect the area from any shock or vibration during transport.

4. Remove the following materials (1 and 2).

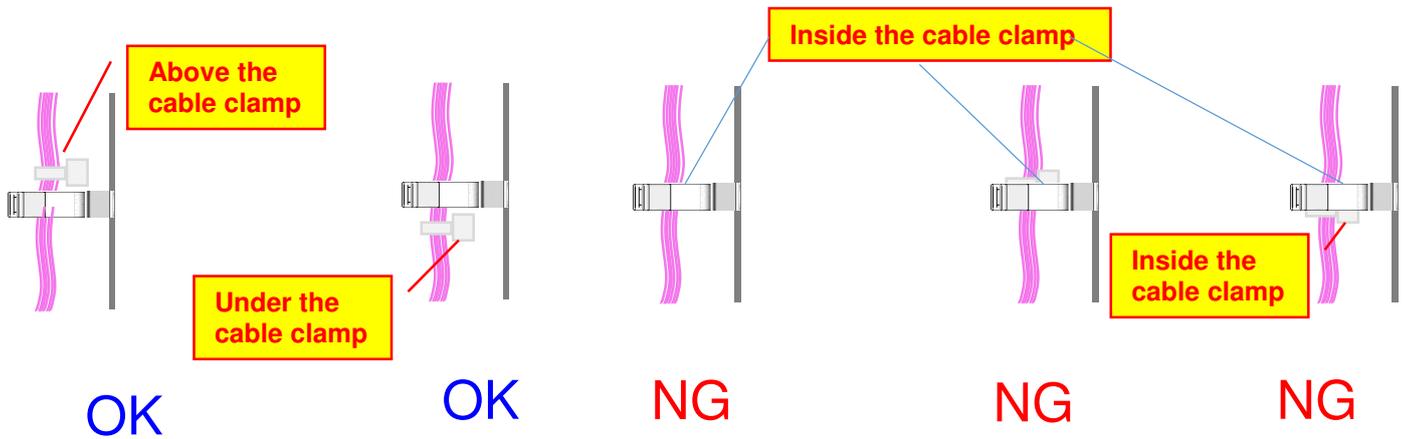
- OK : The binder is positioned either under or above the cable clamp.
- NG : The binder is positioned inside the cable clamp.

If the harness binder position is NG, unlock the cable clamp and shift the position of the harness binder either above or under the clamp

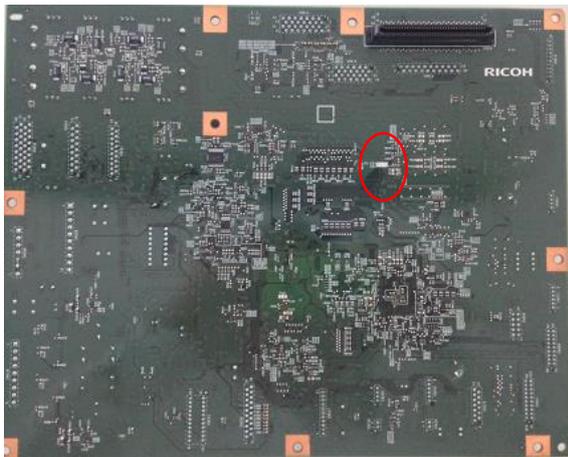
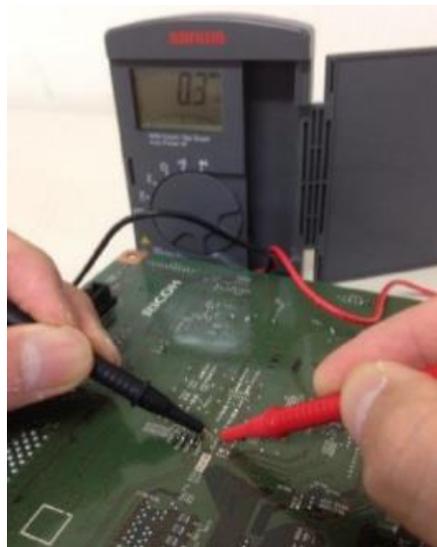
1. **Measure the resistance level to check if fuse FU13 (located on the back side) on the MCU is blown or not.**
  - **Normal range** : 0.1Ω ~ 0.9Ω (Go to step 2)
  - **Abnormal range (fuse blown)** : 1KΩ ~ 1MΩ

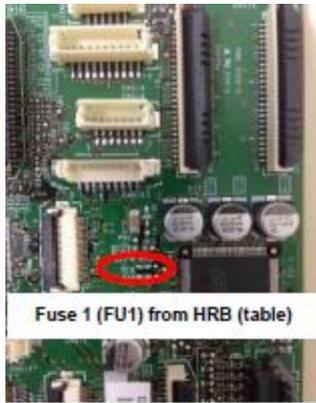
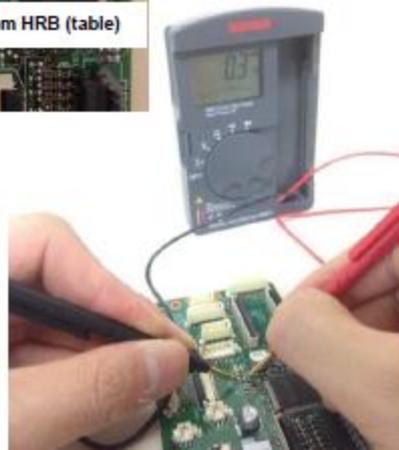
**2. Measure the resistance level to check if fuse FU1 on the HRB is blown or not.**

- **Normal range** :  $0.1\Omega \sim 0.9\Omega$  (Go to step 3)
- **Abnormal range (fuse blown)** :  $1k\Omega \sim 1M\Omega$

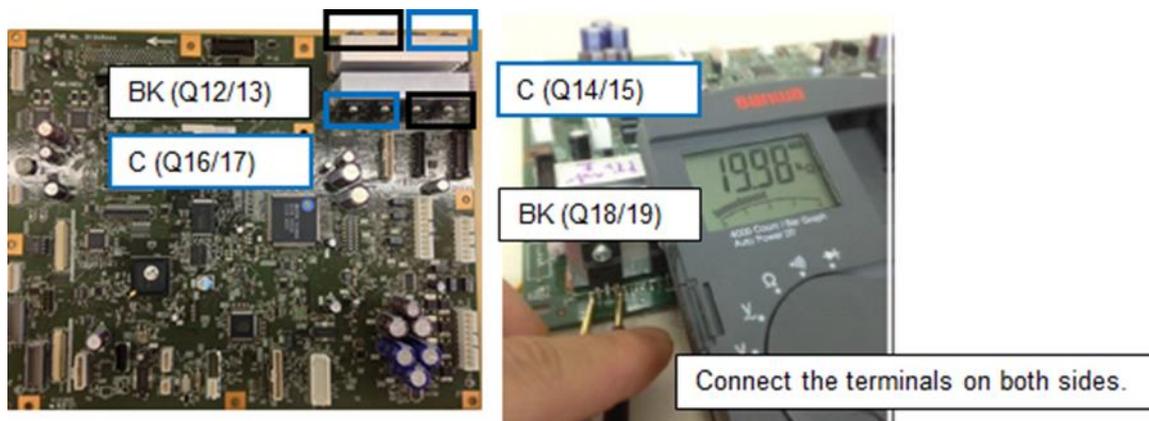
**BK print head does not have to be replaced, if Q12/Q13/Q18/Q19 are all within normal range. (Replace only Color print head.)**

**Color print head does not have to be replaced, if Q14/Q15/Q16/Q17 are all within normal range. (Replace only BK print head.)**

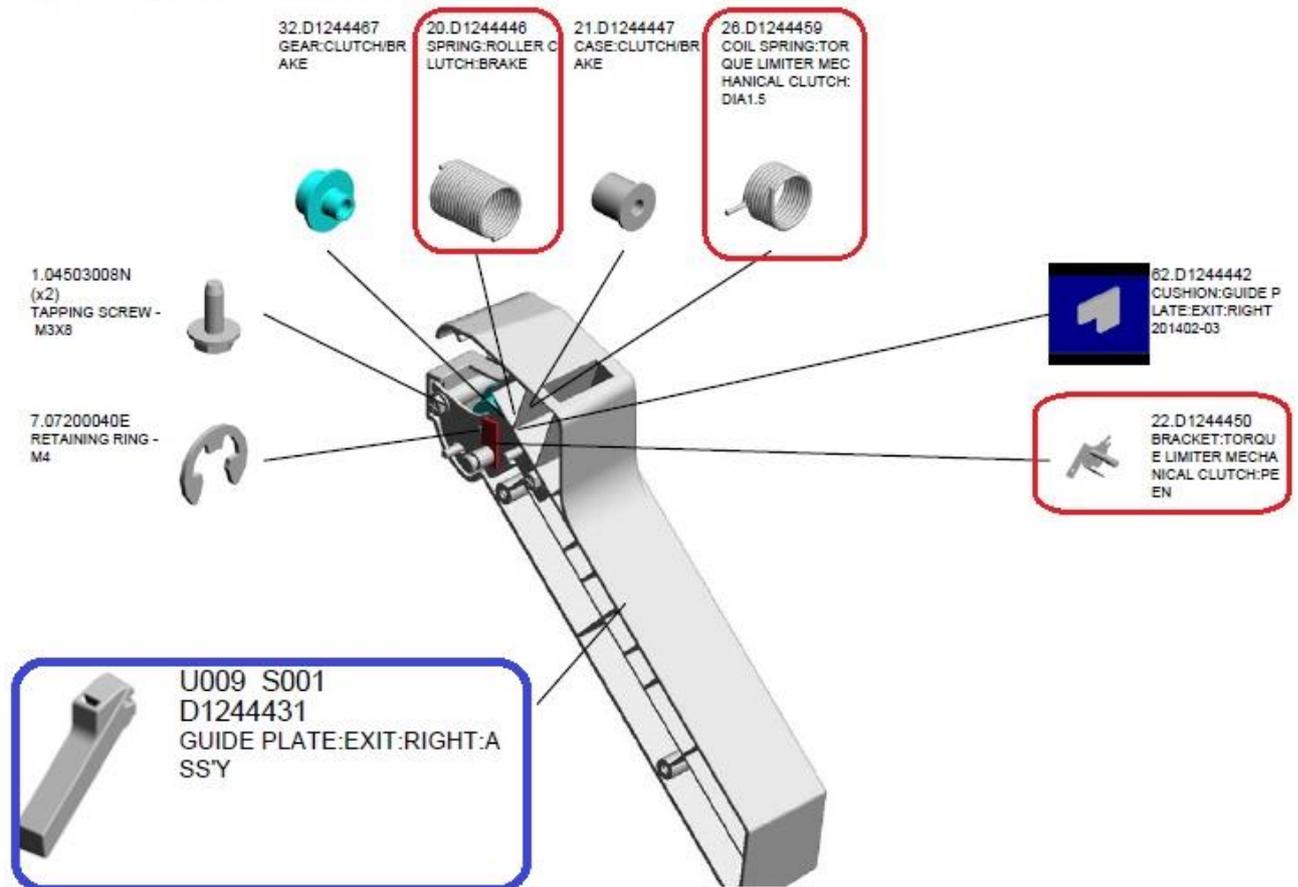
U009\_S001  
GUIDE PLATE:EXIT:RIGHT:ASS'Y

Parts outlined in **red** were deleted from the parts catalog.  
Outlined in **blue** is the new service part registered as an assembly unit.

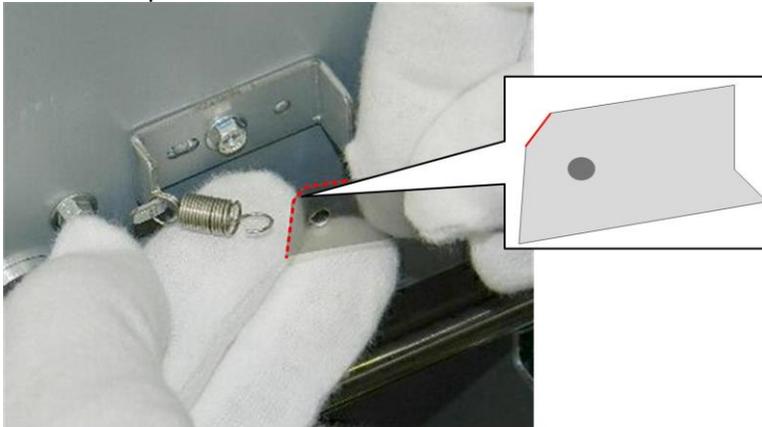
d124r377

- Never use a cotton ball, cotton swab, or tissue paper to clean the surface of the encoder strip.

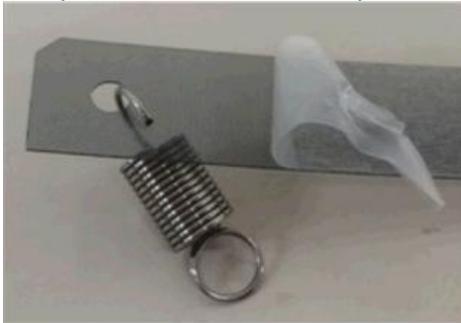
d1249700

- Horizontal encoder strip procured as a service part is attached with a transparent sheet for protection. Peel off the protection sheet before installing the encoder strip.

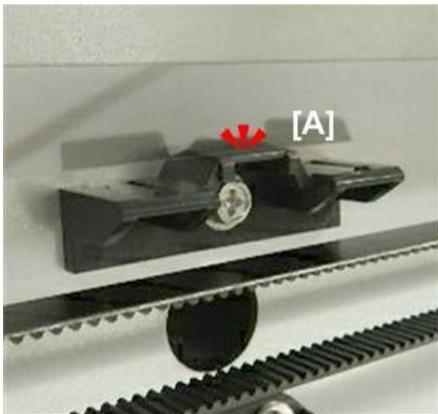
Incorrect

- Before you turn the machine on, check the position of the horizontal encoder strip.
  - If the encoder strip is up on the bracket as shown at [A], pull it forward and down so it is in front of the bracket as shown at [B].
  - If the machine is turned on with the strip positioned as shown at [A], the movement of the carriage unit may scratch the surface of the encoder strip.
