Technical Bulletin

Model: Mo-C2

Subject: Firmware Release Note: PowerSaving Sys			Prepared by: Y. Kurohashi
From: 1st PP Tech Service Sect., PP Tech Service Dept.			
Classification:	Troubleshooting	Part information	n 🛛 Action required
	🗌 Mechanical	Electrical	Service manual revision
	Paper path	Transmit/receiv	e Retrofit information
	Product Safety	Other (Firmwar	e) 🛛 Tier 2

Model: Mo-C2		Date: 22-Jan-17		17	No.: RD262044	
Subject: Troubleshooting for SC665-01 and SC666-01			Prepared	d by: A. S	Shigeta	
From: Tech. Supp	ort Sec., Product Marketing Dep	ot.				
Classification:	☑ Troubleshooting [☑ Mechanical [☑ Paper path [☑ Product Safety [☐ Part inf ⊠ Electric ☐ Transm ☐ Other (al		Servio	n required ce manual revision fit information

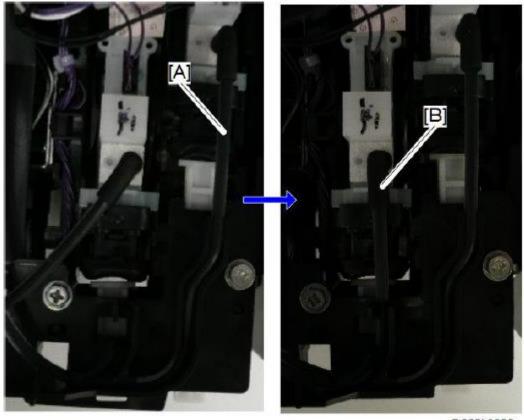
D262k3088

Place the ink tube (K2) [A] on the path of the print head first.

Then place the ink tube (K1) [B] upon the ink tube (K2) on the path of the print head.

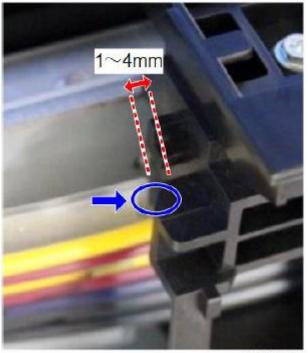
Before attaching the bracket to secure the ink tubes, check the followings:

- Place the ink tube so that the cutout of the ink tube guide is placed 1 to 4 mm apart from the side of the carriage unit.
- Check that there is the space between the ink tube guide and the carriage unit.

If the ink tube falls down, the ink tube is loosely attached on the left of the carriage unit.
 Remove the bracket to secure the ink tubes and pull the ink tube from the left of the carriage unit as possible to remove the looseness.

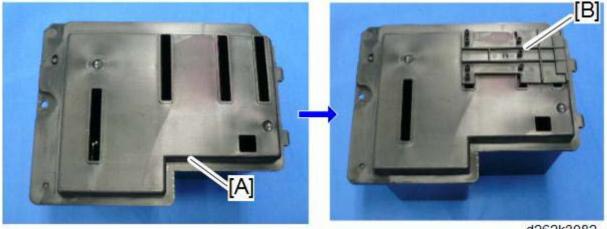
- 4. Reattach the ink cartridge cover.
- 5. Reconnect the FFCs (\blacksquare x4) to the carriage unit.
- 6. Close the front cover if it is up.
- 7. Make sure that the paper exit guide is down.
- 8. Set the service ink cartridges in the new ink supply unit.
- 9. The dummy tank [A] is provided with a nozzle plate [B].

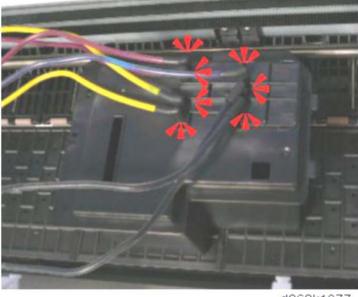
d262k1077

- 10. Snap the nozzle plate onto the top of the dummy tank.
- 11. Set the dummy tank on the platen.
