Model: Neptune-C2	Date: 31-May-07	No.: RB286001b
--------------------------	-----------------	----------------

Subject: Firmware Release Note: Engine		Prepared by: F.Noguchi	
From: 2nd Tech. Support Sec. Service Support Dept.			
Classification:	<input type="checkbox"/> Troubleshooting	<input type="checkbox"/> Part information	<input type="checkbox"/> Action required
	<input type="checkbox"/> Mechanical	<input type="checkbox"/> Electrical	<input type="checkbox"/> Service manual revision
	<input type="checkbox"/> Paper path	<input type="checkbox"/> Transmit/receive	<input type="checkbox"/> Retrofit information
	<input checked="" type="checkbox"/> Other ()

This RTB has been issued to announce the firmware release information for the **Engine**.

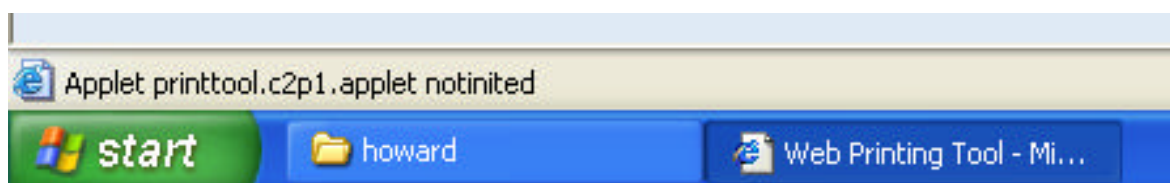
"Applet printtool.c2pl applet notinited" (error message) is displayed if WebPrint is used together with Java 6 Update 2, Version 1.6.0_2.

Note: This does not occur if Java 6 Update 2, Version 1.6.0_1 or earlier is installed.

The default setting for "Temporary Internet Files" in the Java Control Panel was changed from Java 6 Update 2, Version 1.6.0_2.

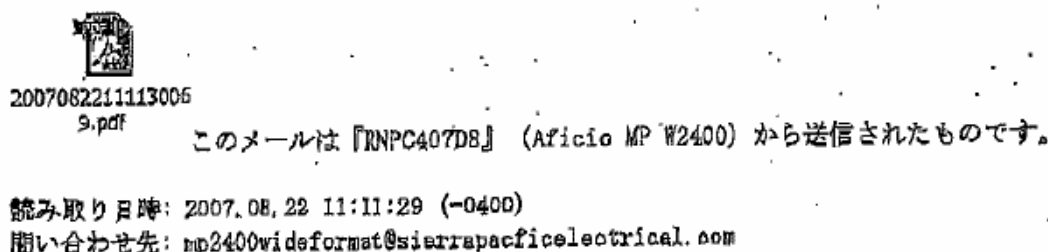
When scanning to e-mail on the N-C2, the body message displays either Japanese characters or square boxes.

Note: The file attachment (scanned file) is not affected.

Scanner system limitation

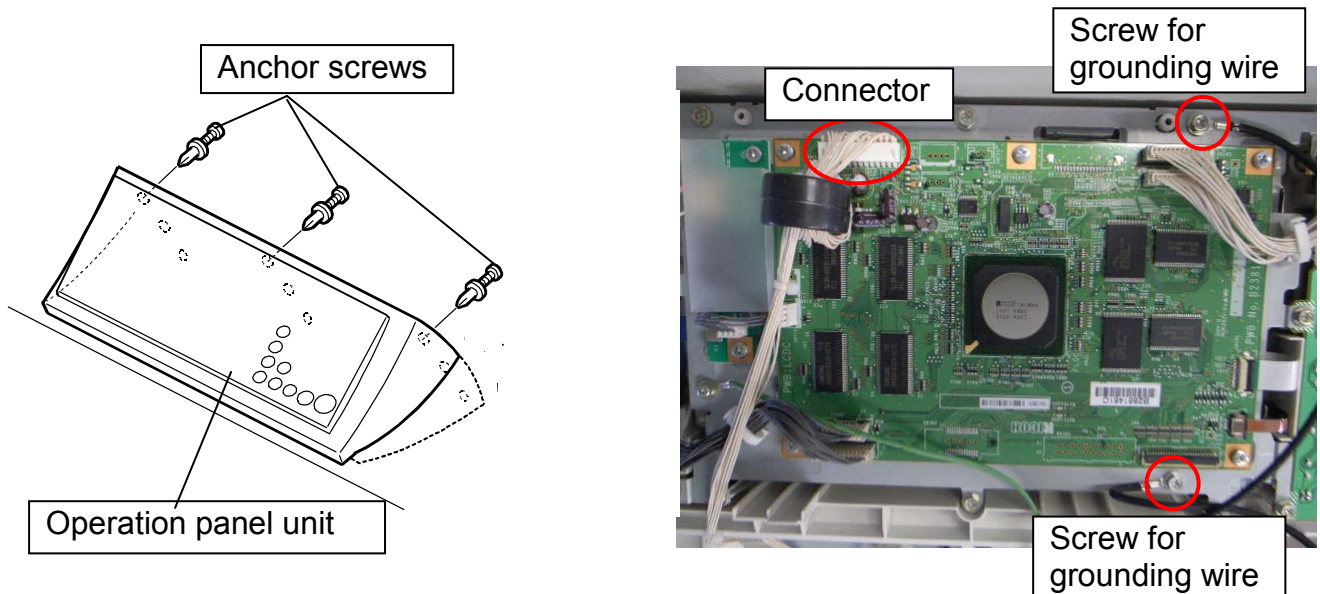
The adhesive that binds electrodes to the touch panel surface contains a polymer that tends to expand under normal office environmental conditions.

1. Open and remove the operation panel unit (anchor screw x 3, screw x 2, connector x 1).

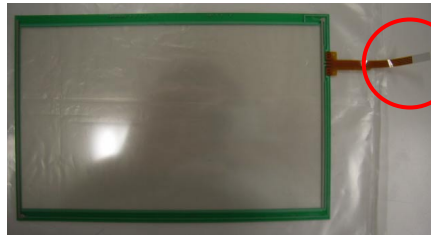
How to distinguish the new parts from the old parts

Old parts:

The tip of the electrode is **brown**.

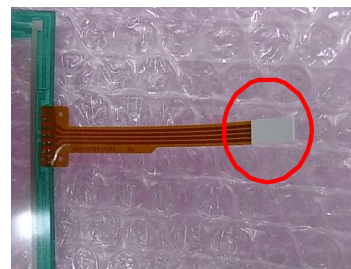
New parts:

The tip of the electrode is **white**.

Service parts: The adhesive was changed to one that will not expand under conditions of standard office environments.

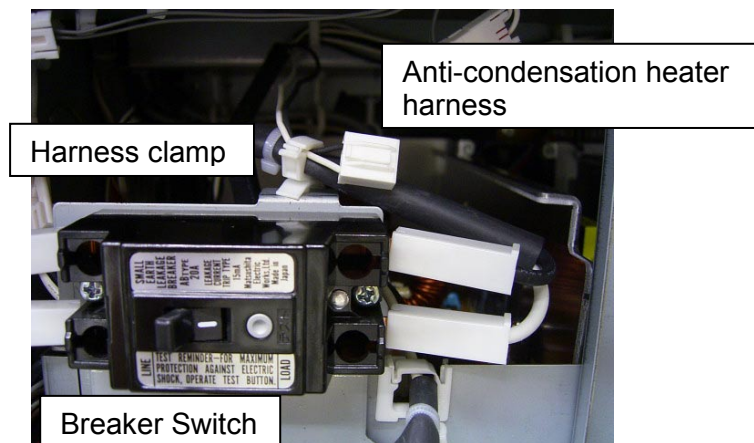
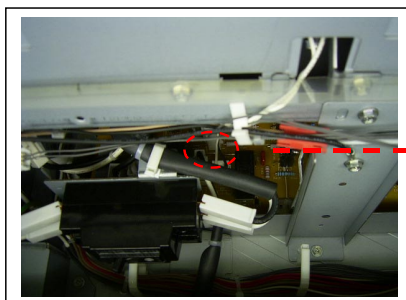
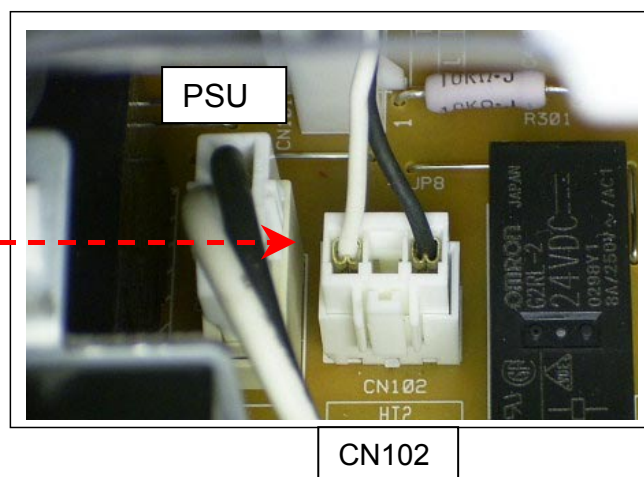
- When the machine is running with the heater connected, the additional power consumed is approximately 26W.
 - You do not need to change the Energy Star decals if you connect the heater.
 - In cases where the heater is not connected, if the machine is left OFF for a while under low-temperature conditions (10C or lower) and then turned ON, condensation tends to form on the drum surface. This is especially true during winter months and first thing in the morning. This can cause smeared images or other image problems to occur.
- In cases where condensation has already formed on the drum, make about 10 copies onto A1 paper (LEF). This should restore the images to normal. Then, to prevent these image problems from recurring, connect the harness for the anti-condensation heater to the PSU.

1. Remove the rear cover (screws x 2).
2. Open the harness clamp.
3. Remove the anti-condensation heater harness from the harness clamp.
Important: Leave the harness with the black tube inside the clamp.
4. Close the harness clamp.
5. Connect the anti-condensation heater harness to **CN102** on the PSU.

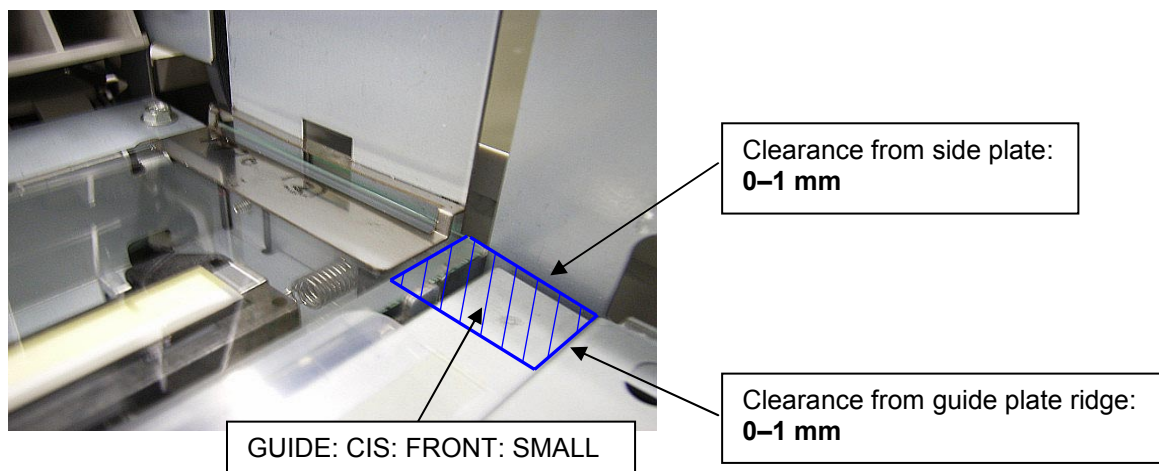
Reason: To further protect the operator-side edge of the exposure glass.

Note: The Mylar shown in the photo is attached to the right corner, operator side. There is also one more attached to the left corner.

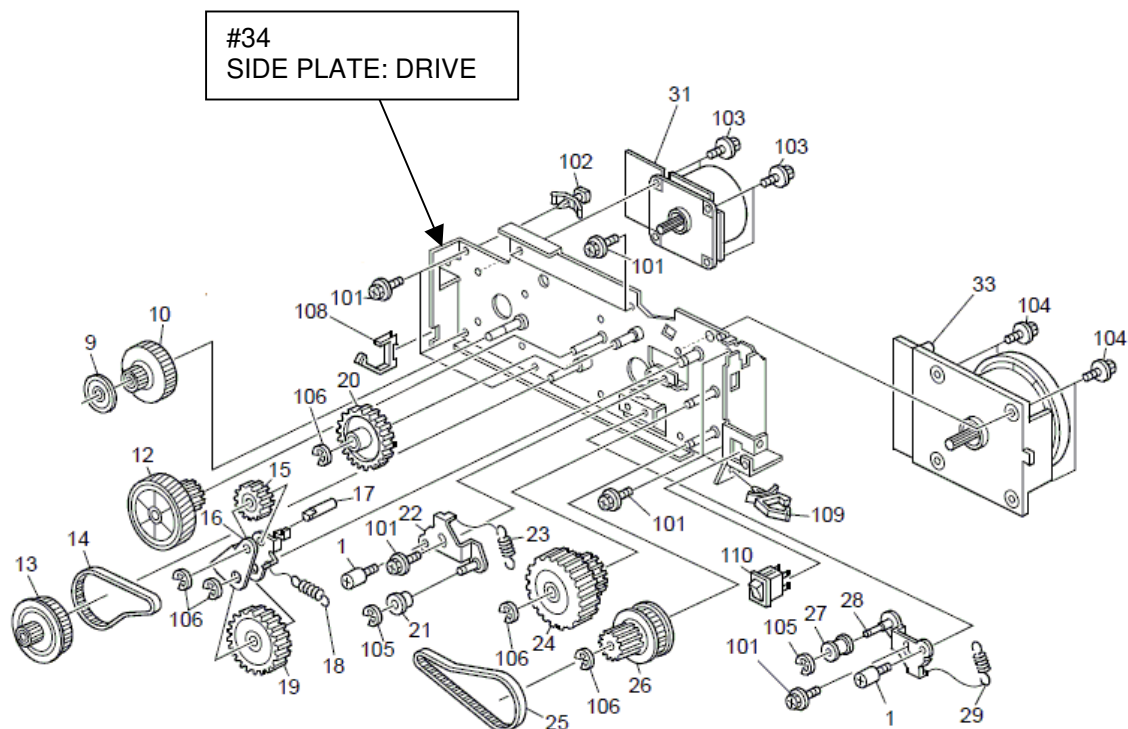
Change: The side plate was added.

Reason: In accordance with requests from the field.

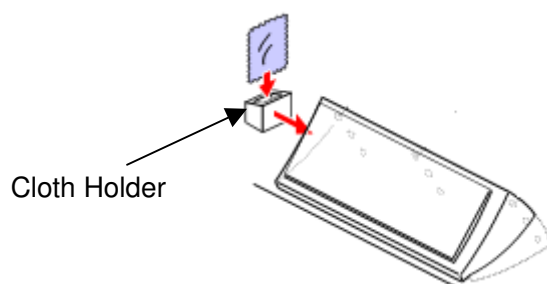
Change: The cloth holder is now bundled at the factory from May 2010 production.

Reason: In accordance with requests from the field.
