Model: N-C3		Date: 10-Dec-10	No.: RD093001
Subject: Service Manual Correction		Prepared by: F.Noguchi	
From: 2nd Overseas Tech Support Sec. 2nd PQM Dept			
Classification:	<input type="checkbox"/> Troubleshooting	<input type="checkbox"/> Part information	<input type="checkbox"/> Action required
	<input type="checkbox"/> Mechanical	<input type="checkbox"/> Electrical	<input checked="" type="checkbox"/> Service manual revision
	<input type="checkbox"/> Paper path	<input type="checkbox"/> Transmit/receive	<input type="checkbox"/> Retrofit information
	<input type="checkbox"/> Product Safety	<input type="checkbox"/> Other ()	<input type="checkbox"/> Tier 2

Revisions made to the N-C3 Field Service Manual (FSM) and Technical Training Package (TTP)

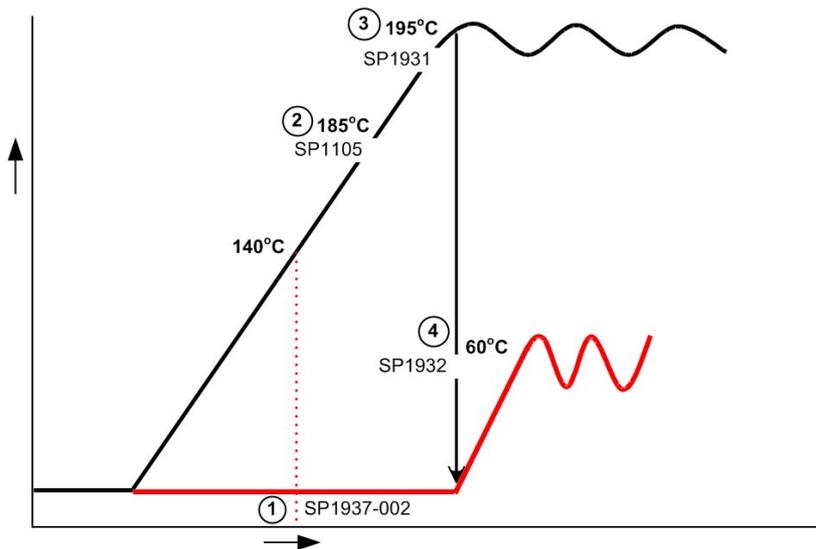
FUSING > Fusing Warm-up 1

- First, the machine detects how long it takes for the hot roller to get to 140°C.
 - ◆ If it takes more than **85 seconds**, the procedure will be different, as we shall see later.

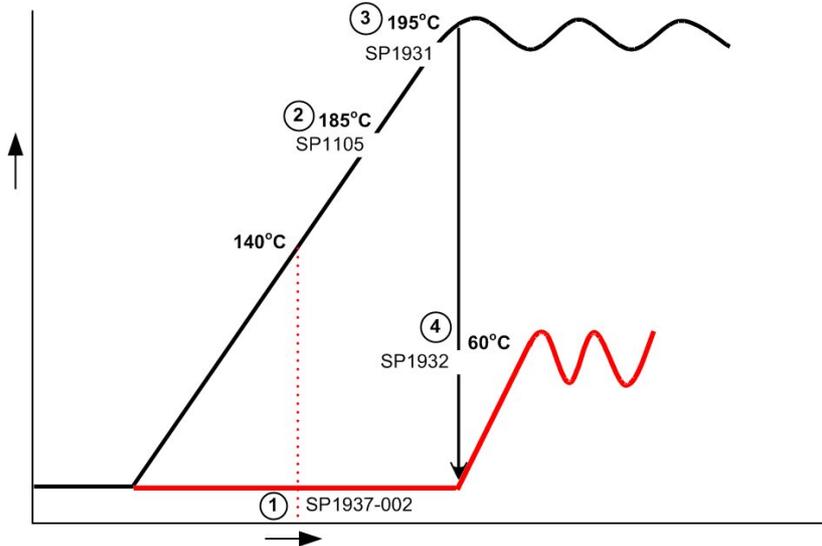
FUSING > Fusing Warm-up 2

- ❑ If it took less than **85 seconds** for the hot roller to get to **140°C**, then copying can start when the hot roller gets to 185°C (this is 10°C less than the copy start temperature).

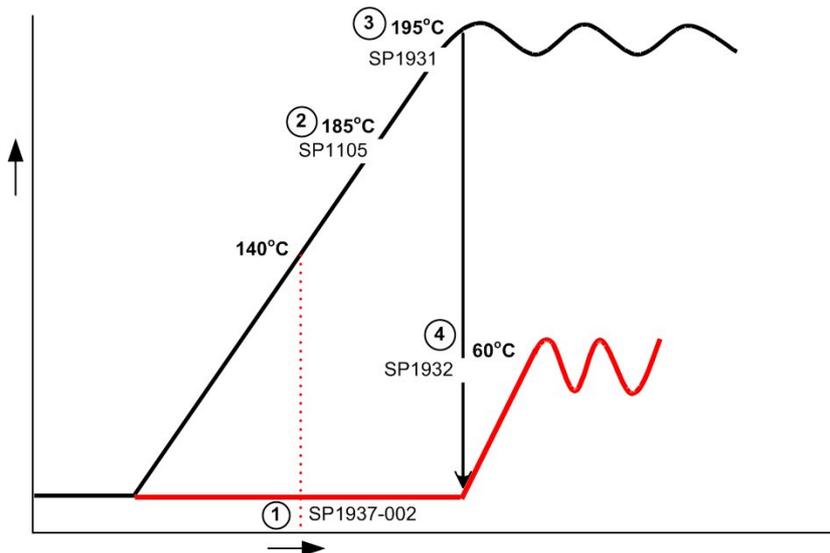
FUSING > Fusing Warm-up 3

- ❑ When the hot roller temperature gets to its target (195°C), the fusing unit idles until the pressure roller gets to its target temperature (60°C).
- ❑ If it took longer than **85 s** for the hot roller to get to **140°C**, copying cannot start until the hot roller gets to its target temperature.

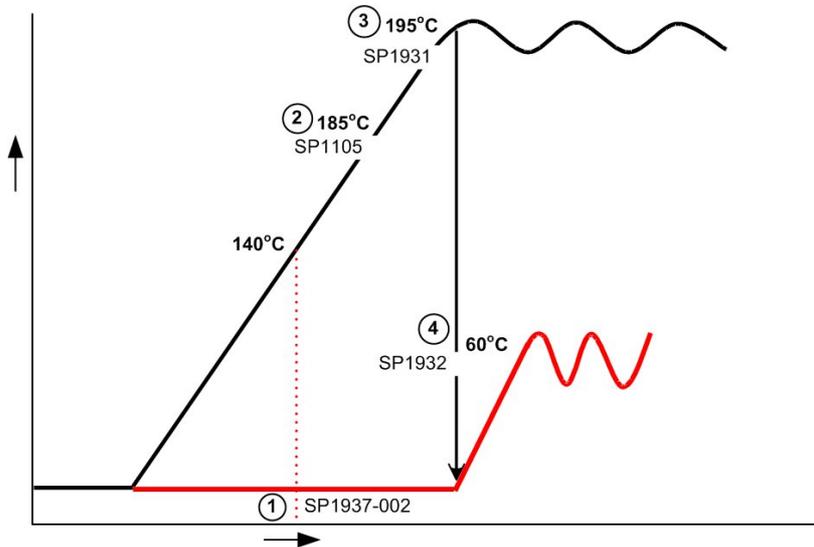
FUSING > Fusing Warm-up 3

- During standby mode, the hot roller and pressure rollers are kept within $\pm 5^{\circ}\text{C}$ of their target temperatures.
 - ◆ Hot roller: 195°C
 - ◆ Pressure roller: 60°C

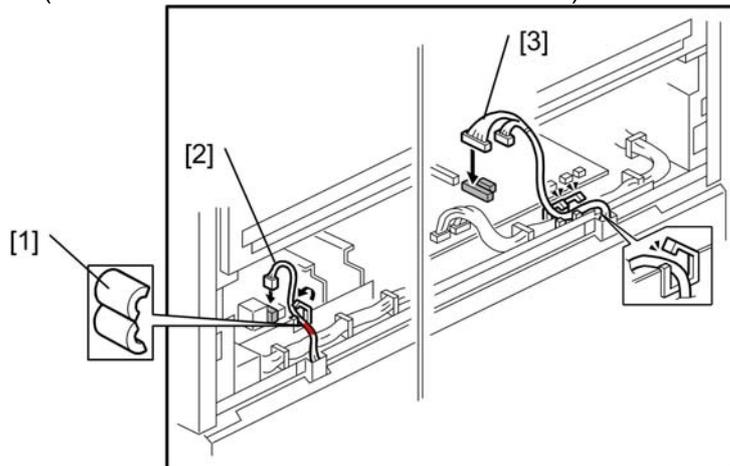
d334i010

Change: The ferrite core was added as a service part for the mainframe. (It is attached to the power supply cord from the beginning of mass-production).

9. Attach ferrite core [1] **(for the -17 and -27 models only)**

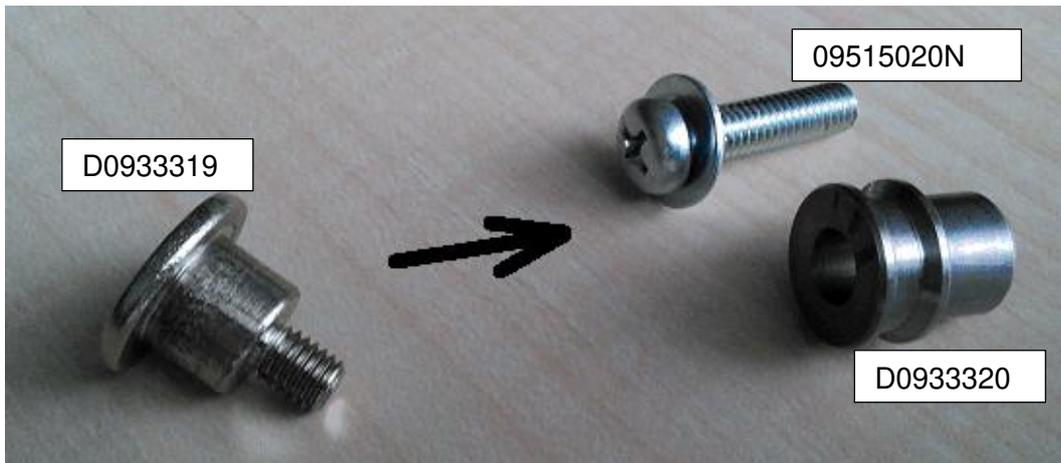
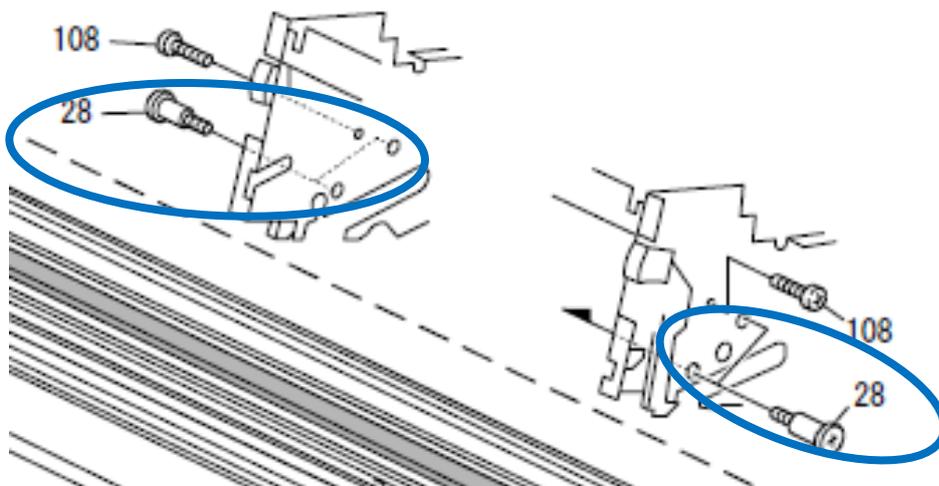
Old P/N	New P/N	Description	Q'ty	Page	Index
D0933319	D0933320	COLLAR:DEVELOPMENT UNIT	4	27	28
	09515020N	SCREW:POLISHED ROUND:M5X20	4

NOTE: When replacing the above screws, replace both types of screws as a set.

Replacement Procedure

(The example shown below is the procedure for the left hand side. The procedure is the same for the right hand side.)
