Model: Be-C1	Date: 19-Sep-08	No.: RD046002f
--------------	-----------------	----------------

Subject: Firmware Release Note: Engine		Prepared by: F.Noguchi	
From: 2nd PP Tech Service Sect., PP Tech Service Dept.			
Classification:	<input type="checkbox"/> Troubleshooting	<input type="checkbox"/> Part information	<input type="checkbox"/> Action required
	<input type="checkbox"/> Mechanical	<input type="checkbox"/> Electrical	<input type="checkbox"/> Service manual revision
	<input type="checkbox"/> Paper path	<input type="checkbox"/> Transmit/receive	<input type="checkbox"/> Retrofit information
	<input type="checkbox"/> Product Safety	<input checked="" type="checkbox"/> Other (Firmware)	<input checked="" type="checkbox"/> Tier 2

This RTB has been issued to announce the firmware release information for the **Engine**.

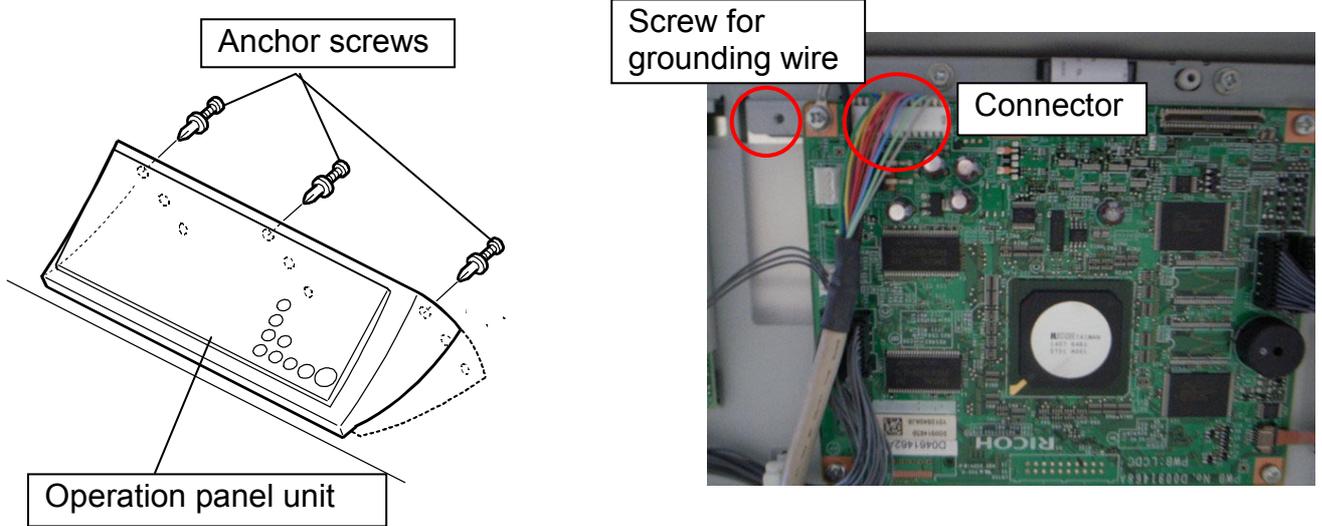
CAUSE

The adhesive that binds electrodes to the touch panel surface contains a polymer that tends to expand under normal office environmental conditions.

In the field: Replace the touch panel (**see the procedure below**).

1. Open and remove the operation panel unit (anchor screw x 3, screw x 1, connector x 1).

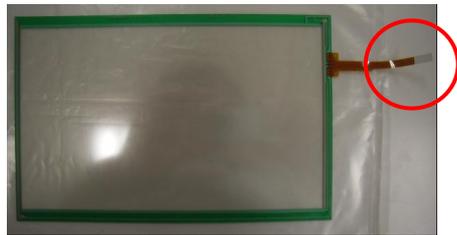
How to distinguish the new parts from the old parts

Old parts:
The tip of the electrode is **brown**.
