Model: <b>Be-C2</b>	Date: 01-Sep-15	No.: RD211005
---------------------	-----------------	---------------

Subject: Firmware Release Note: Web Uapl		Prepared by: Y. Kurohashi	
From: 1st PP Tech Service Sect., PP Tech Service Dept.			
Classification:	<input type="checkbox"/> Troubleshooting <input type="checkbox"/> Mechanical <input type="checkbox"/> Paper path <input type="checkbox"/> Product Safety	<input type="checkbox"/> Part information <input type="checkbox"/> Electrical <input type="checkbox"/> Transmit/receive <input checked="" type="checkbox"/> Other (Firmware)	<input type="checkbox"/> Action required <input type="checkbox"/> Service manual revision <input type="checkbox"/> Retrofit information <input checked="" type="checkbox"/> Tier 2

This RTB has been issued to announce the firmware release information for the **Web Uapl**.

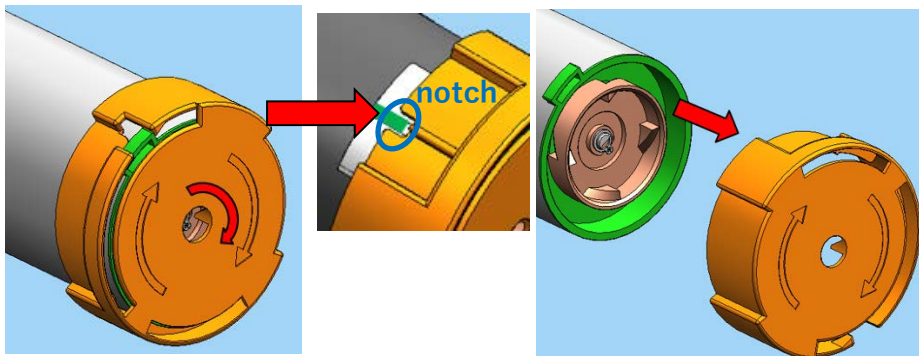
- *Show the customer how to prepare a toner cartridge for installation.*
- *A toner cartridge should never be put on its end or stored vertically.*
- *Do not remove the tape from new toner cartridge at this time.*
- *Rotate that knob in the direction marked on it until the green line appears in the notch area. Once the green line appears, pull the knob out.*

**20\*. Install the new toner cartridge[A]. (You can refer to the decal attached to the left side of the machine.)**

- *Peel off the green tape [B] from right to left to expose the perforated clear tape (these are the toner supply holes). (This clear tape is not removed.)*
- *Rotate the knob [C] until it stops.*
