SUBJECT: Additional information to TD check

FROM: Copier Technical Support Section

PDC-1E

SUBJECT: Discolored spots on color background

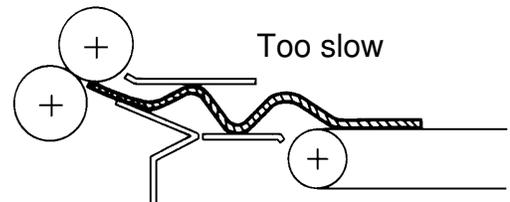
Fig. 3

3. Observe the paper condition when the paper is pulled by the fusing rollers. If the paper is pulled strongly by the fusing rollers (figure 2), lower the speed of the fusing rollers by choosing a lower setting for SPD#720. If the paper buckles (figure 3), increase the speed of the fusing rollers by choosing a higher setting for SPD#720.

NOTE: In the case of figure 3, the copy image is scraped by the upper paper guide.
