Model: Katana-P1 (Bellini-P1)	Date: 09-Feb-09	No.: RM002001g
-------------------------------	-----------------	----------------

Subject: Firmware Release Note: Engine		Prepared by: Y. Tanimoto	
From: 1st PP Tech Service Sect., PP Tech Service Dept.			
Classification:	<input type="checkbox"/> Troubleshooting <input type="checkbox"/> Mechanical <input type="checkbox"/> Paper path <input type="checkbox"/> Product Safety	<input type="checkbox"/> Part information <input type="checkbox"/> Electrical <input type="checkbox"/> Transmit/receive <input checked="" type="checkbox"/> Other ()	<input type="checkbox"/> Action required <input type="checkbox"/> Service manual revision <input type="checkbox"/> Retrofit information <input type="checkbox"/> Tier 2

This RTB has been issued to announce the firmware release information for the **Engine**.

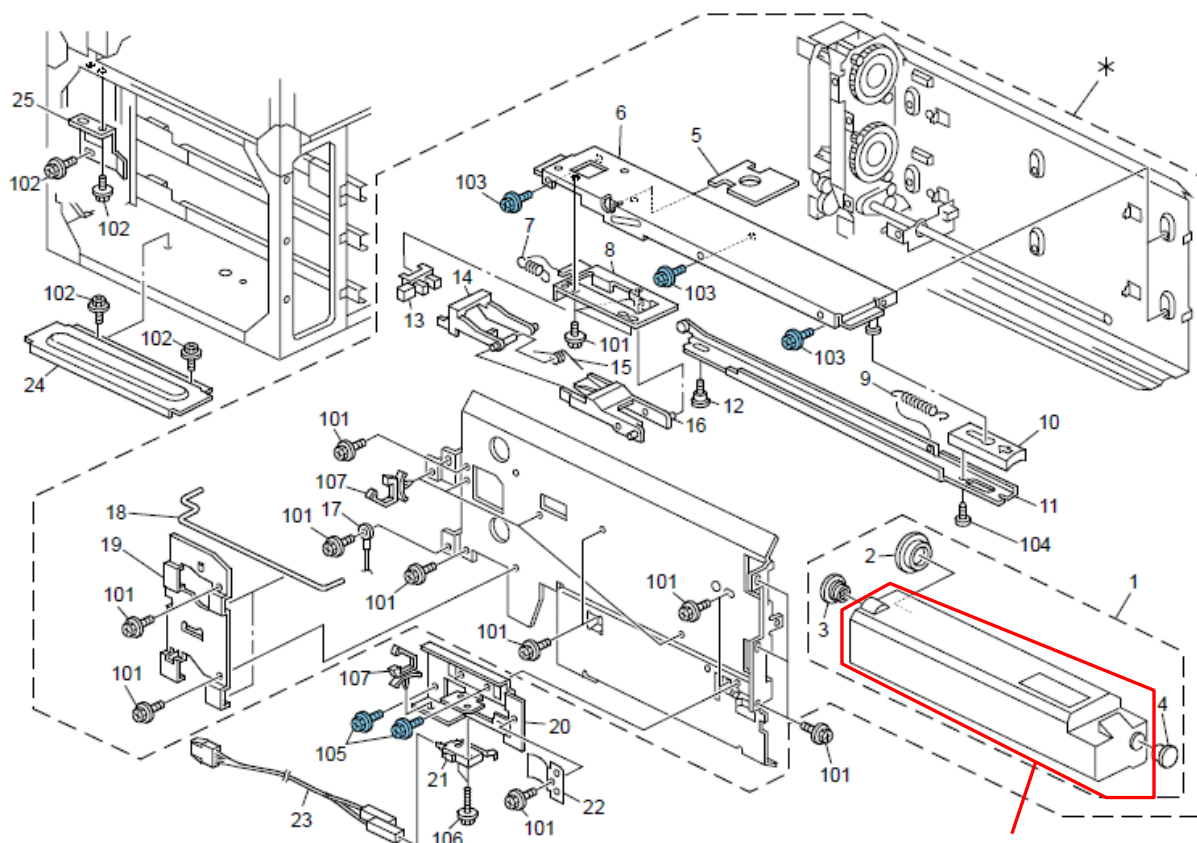
23.Toner Bank Unit 1 (M002/M003/M004)

Change: A new service part has been added.

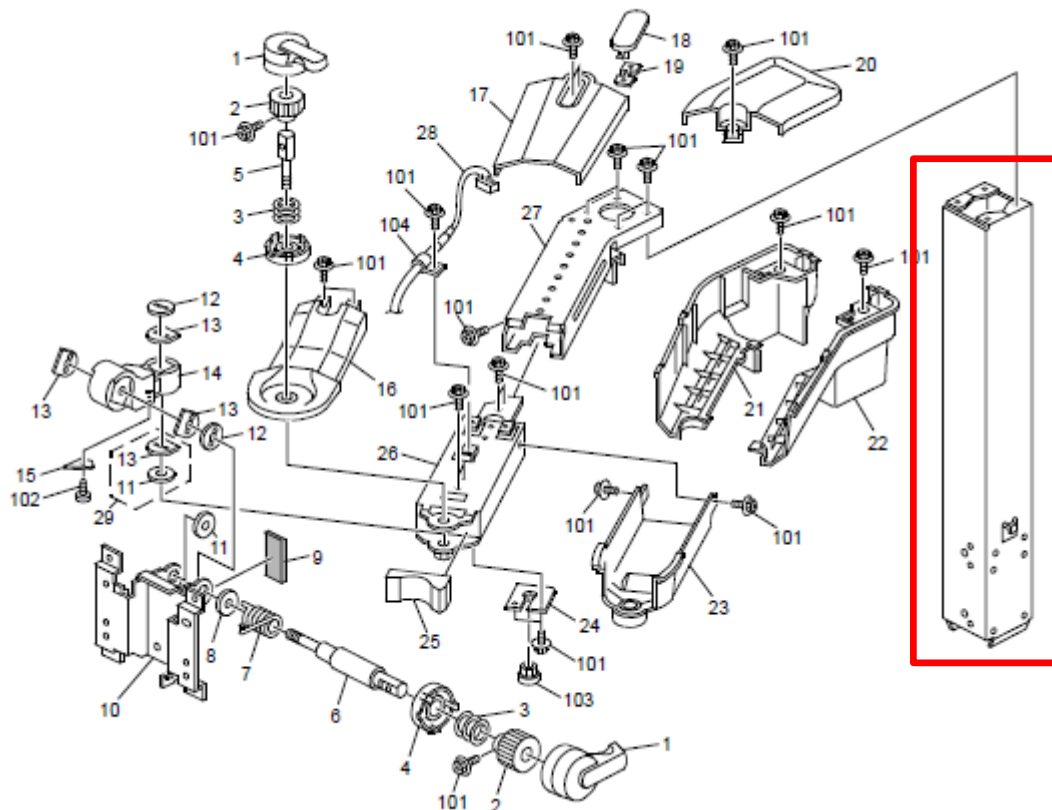
8.Operation Panel 4 (M002/M003/M004)

Change: Parts Catalog Correction

New Part Number	Description	Q'ty	Page	Index	Note
M0021433	FRAME:ARM:OPERATION SUB-UNIT	1	31	30	Add

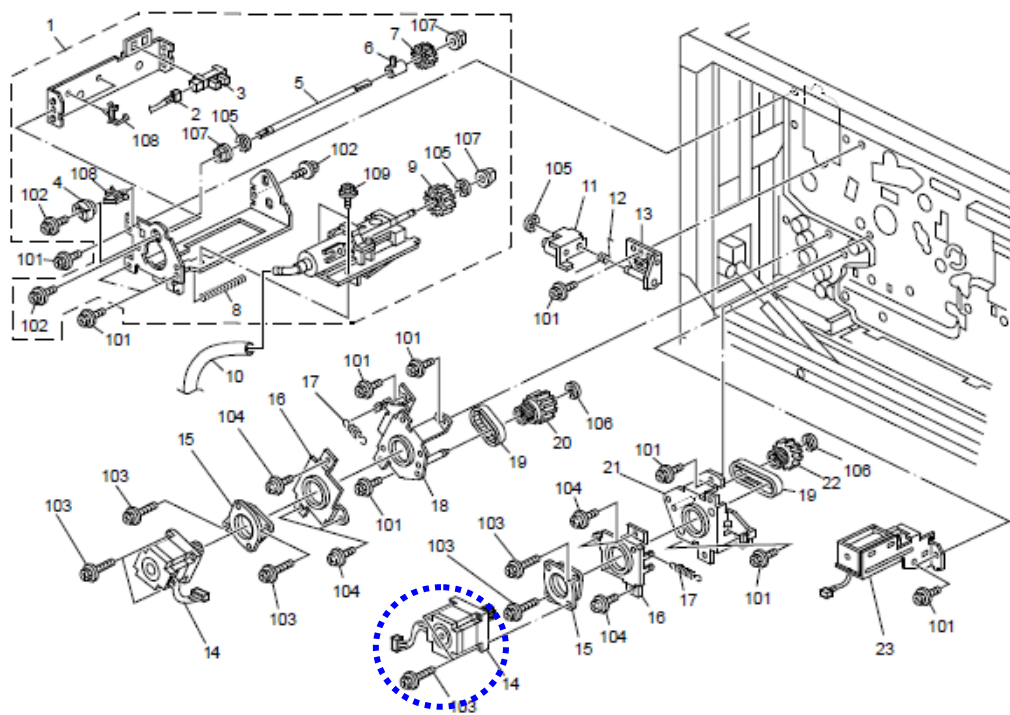
56.Drive Section 5 (M002/M003/M004)

Change: a) Orientation of the DC Stepper Motor; 90 degrees counterclockwise
 b) Addition of a clamp (in accordance with the change in the motor orientation)

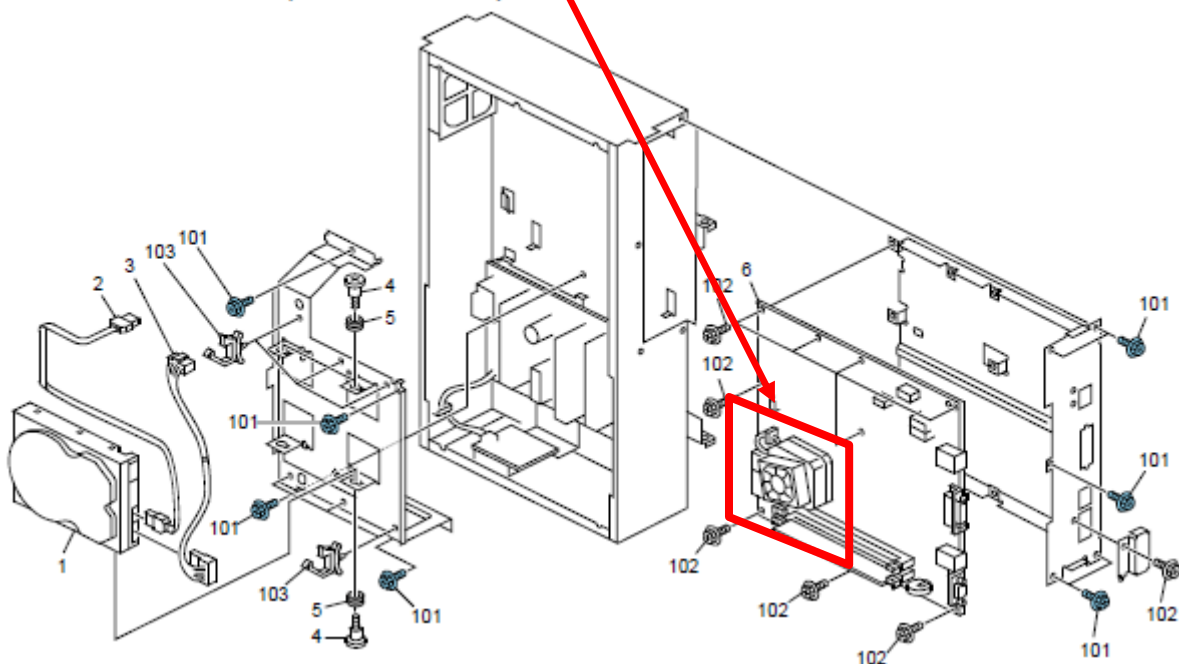
64.Electrical Section 6 (M002/M003/M004)

Change: Parts Catalog Correction

New Part Number	Description	Q'ty	Page	Index	Note
M0025708	IC:DDR2:1GB	1	143	7	Add

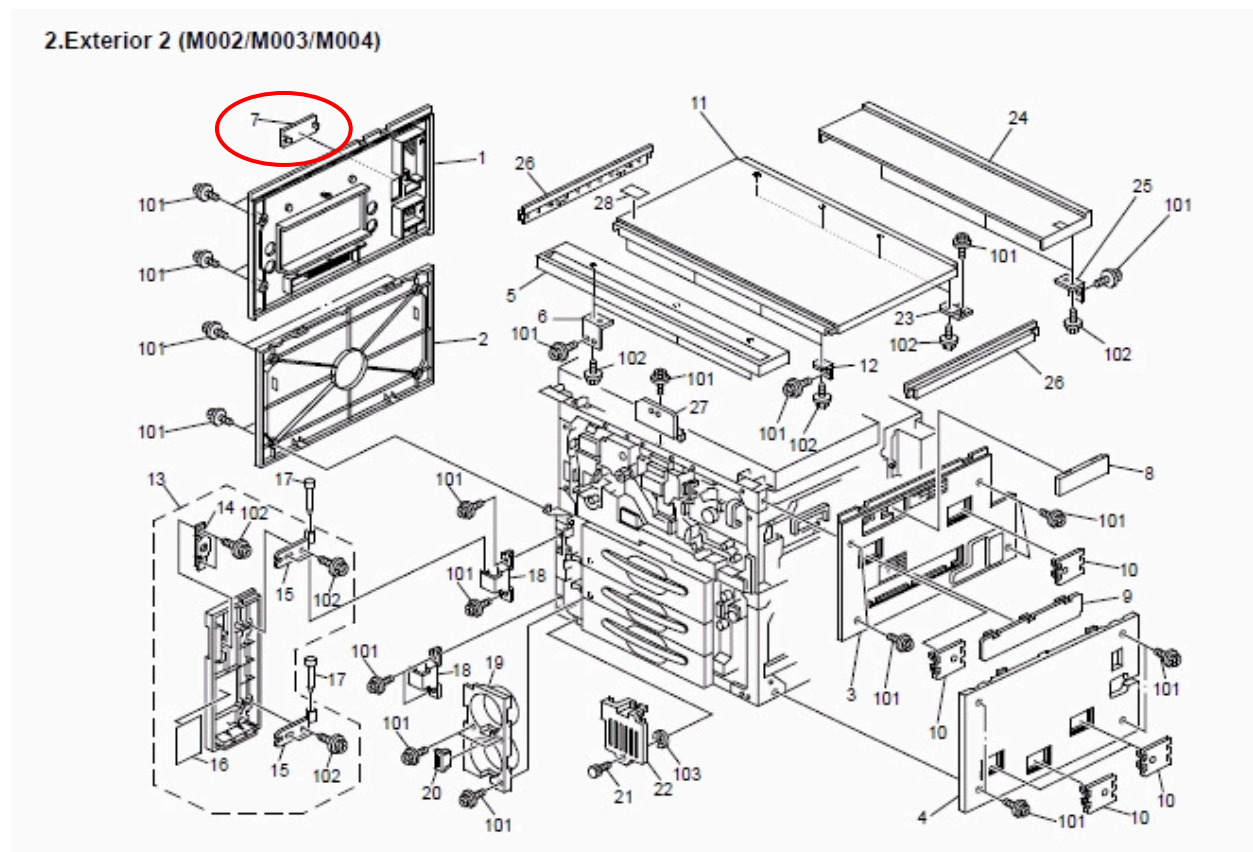
Please delete the following part from your Katana-P1 parts catalog.

Old Part Number	New Part Number	Description	Q'ty	Int	Page	Index	Note
B2341341	-	CAP:CONNECTOR	1	-	19	7	-

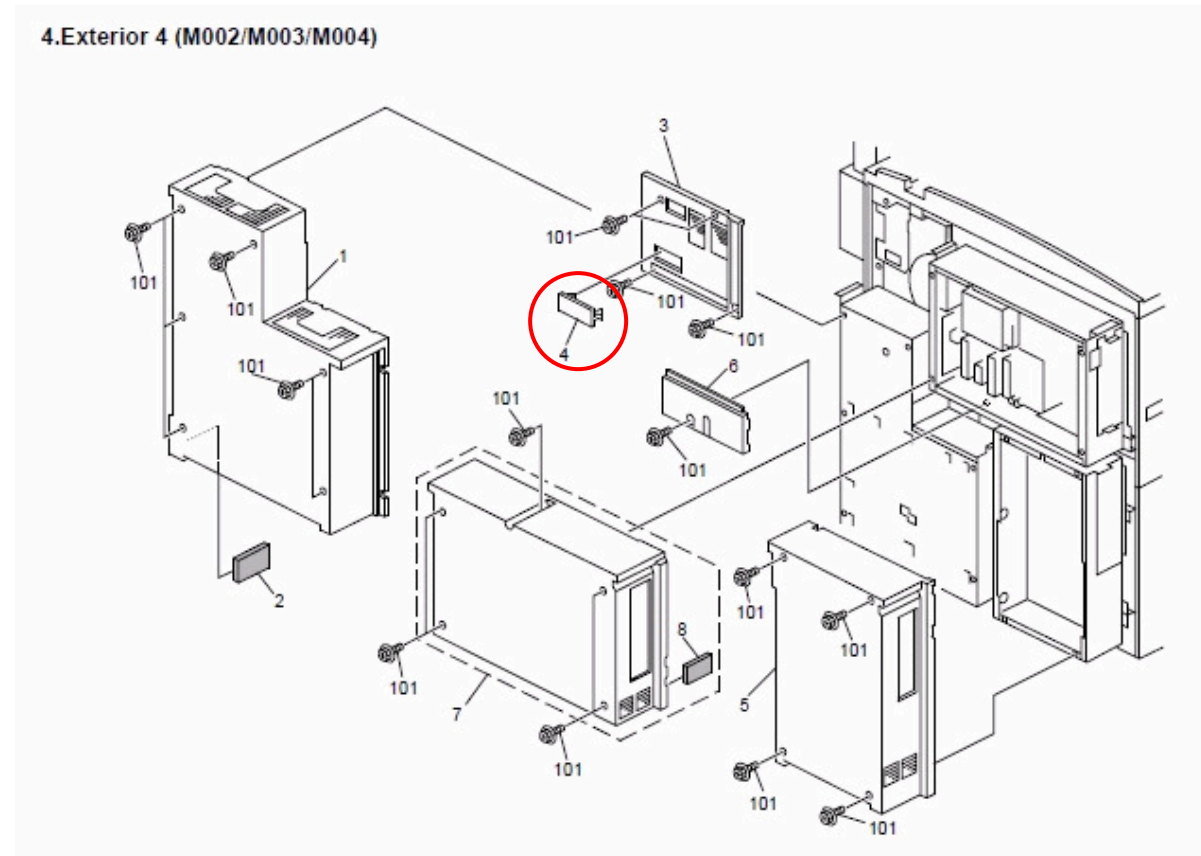
4.Exterior 4 (M002/M003/M004)

Old Part Number	New Part Number	Description	Q'ty	Int	Page	Index	Note
B2341341	-	CAP:CONNECTOR	1	-	23	4	-

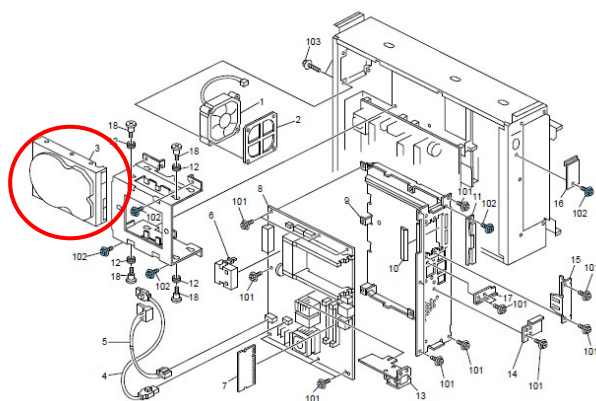
62.Electrical Section 4 (M002/M003/M004)

Old Part Number	New Part Number	Description	Q'ty	Int	Page	Index	Note
D0895765	D0295792	HDD:WD:160GB:63N9A0	1	X/O	139	3	-
D0895765	D0295792 <i>M0026868</i>	HDD:WD:160GB:63N9A0 <i>HDD:PROGRAM:IPDS:INNER ASSEMBLY:EXP</i>	1	X/O	143	1	-

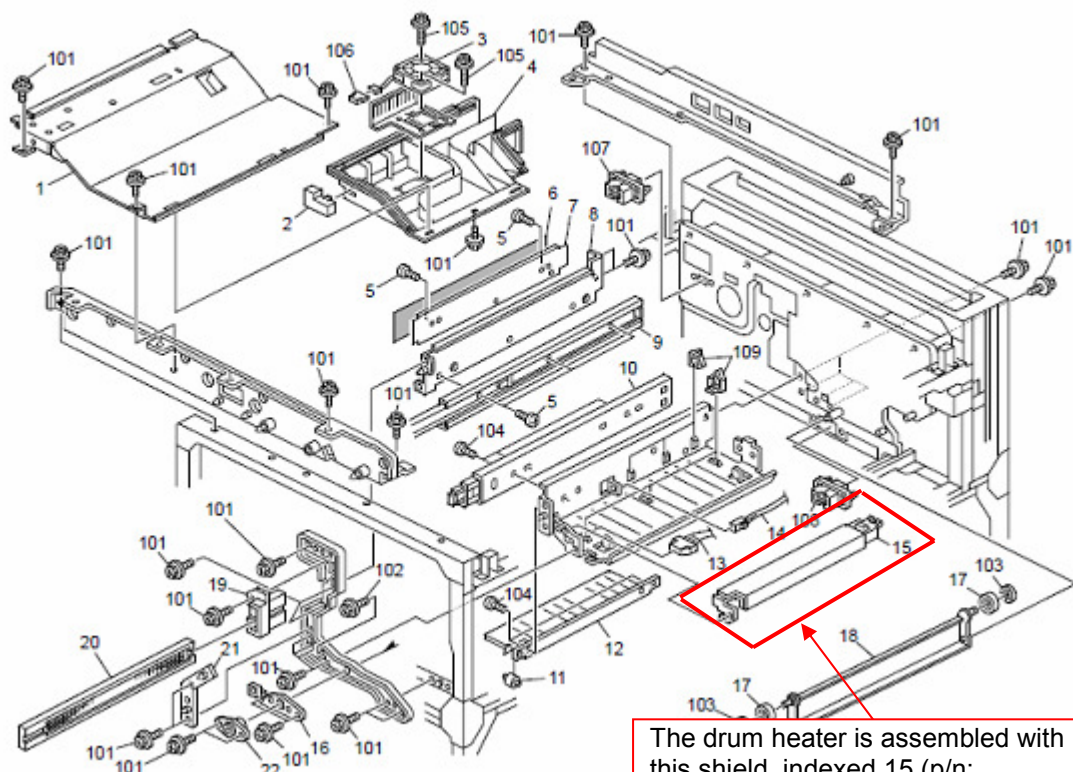
73.Frame Section 3 (M002/M003/M004)

Old Part Number	New Part Number	Description	Q'ty	Int	Page	Index	Note
-	AX400198	HEATER - 240V/9W	1	-	161	23	Add

The drum heater is assembled with this shield, indexed 15 (p/n: B2343871) in the parts catalog.

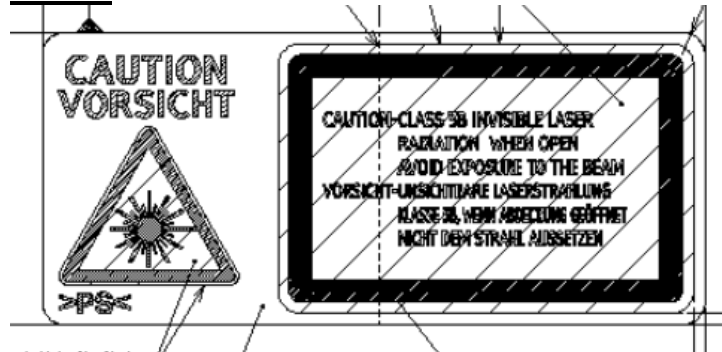
Before

This change has been applied to the mass production machines since July 2014.

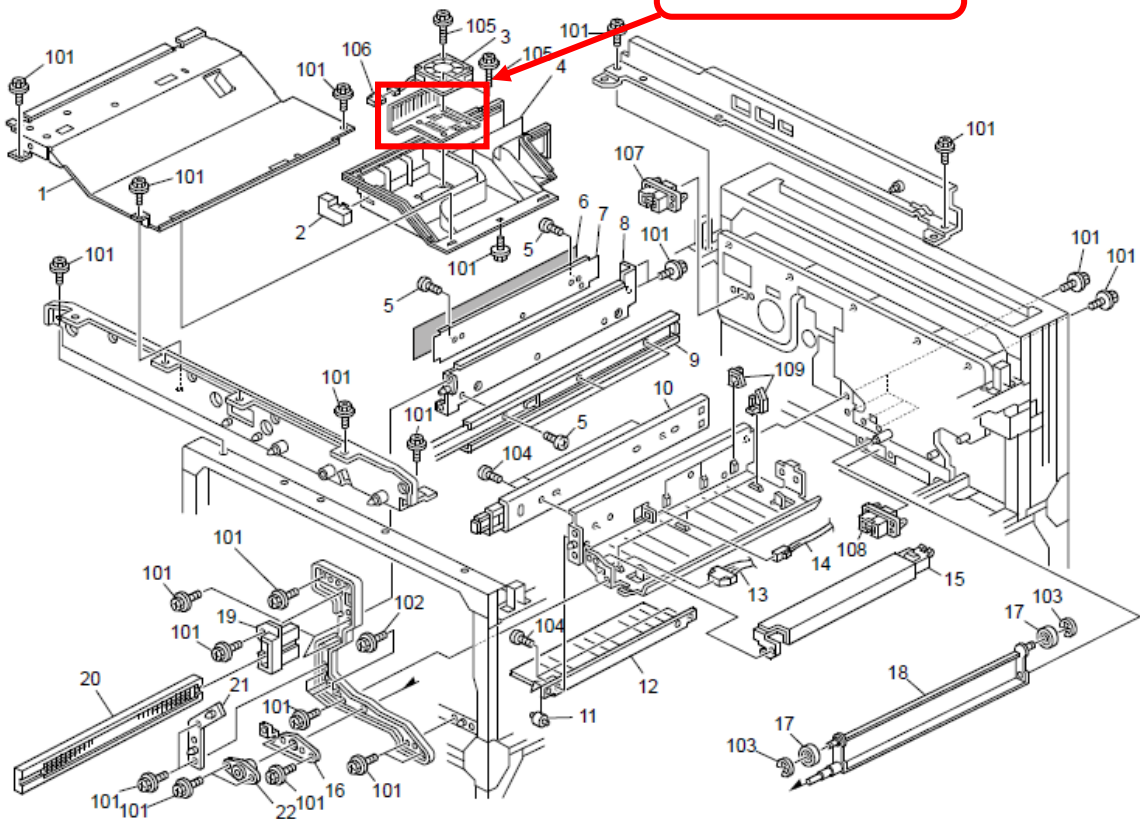
84.Frame Section 3 (D059/D060/D061)

The following part was registered as service part to meet requests received from the field.

#24 p/n : D0594384
GUARD:FAN:MM60

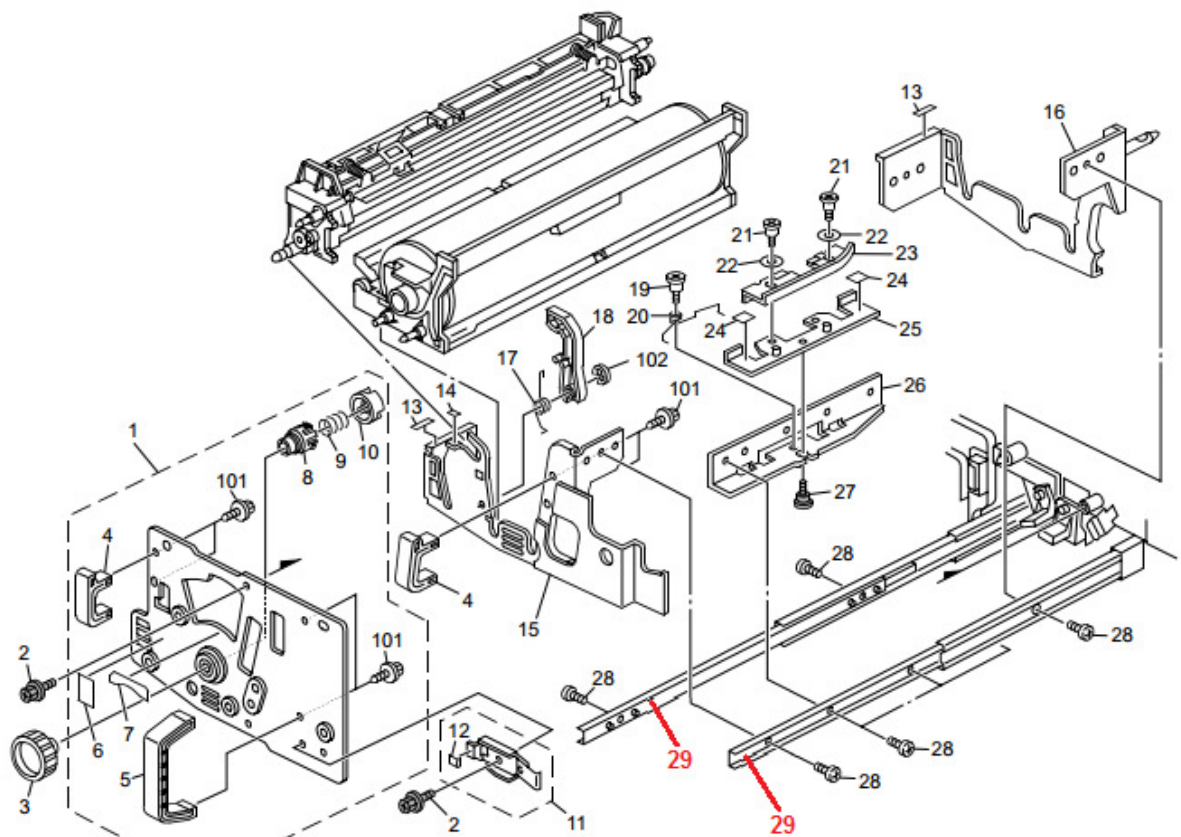
30.PCU 1 (M002/M003/M004)

New p/n	Description	Q'ty	Int	Page	Index	Note
B2342485	SLIDE RAIL:TRAY UNIT:AROUND THE PHOTOCONDUCTOR	2	-	75	29	Add
