Model: B-C4	Date: 04-Feb-09	No.: RD059002h
-------------	-----------------	----------------

Subject: Firmware Release Note: Printer		Prepared by: J.Ohno	
From: 1st PP Tech Service Sect., PP Tech Service Dept.			
Classification:	<input type="checkbox"/> Troubleshooting <input type="checkbox"/> Mechanical <input type="checkbox"/> Paper path <input type="checkbox"/> Product Safety	<input type="checkbox"/> Part information <input type="checkbox"/> Electrical <input type="checkbox"/> Transmit/receive <input checked="" type="checkbox"/> Other (     )	<input type="checkbox"/> Action required <input type="checkbox"/> Service manual revision <input type="checkbox"/> Retrofit information <input type="checkbox"/> Tier 2

This RTB has been issued to announce the firmware release information for the **Printer**.

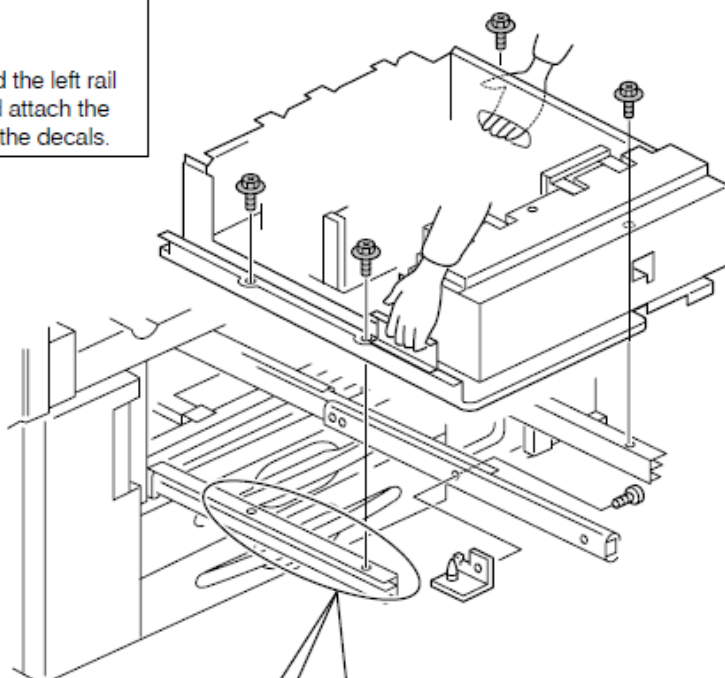
When installing the kit, be sure to fully extend the left rail so that the three screw holes are visible, and attach the two M3 screws in the positions indicated by the decals.

穴が3ヶ所見えた位置にレールを合わせる。

Align all three screw holes with those along the left rail.

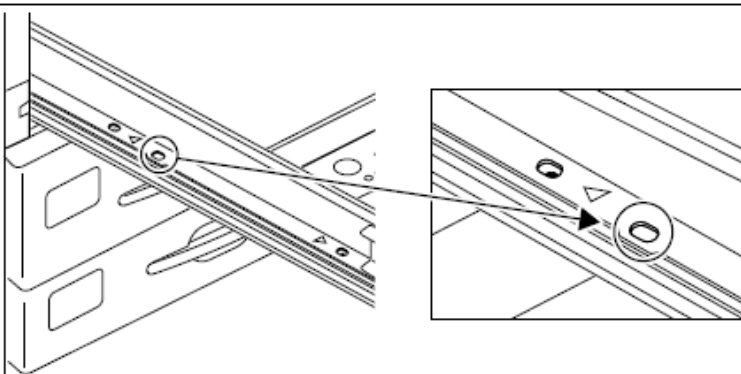
1ヶ所穴が見えていない。

If one screw hole is not visible, the kit is not properly aligned with the rail.

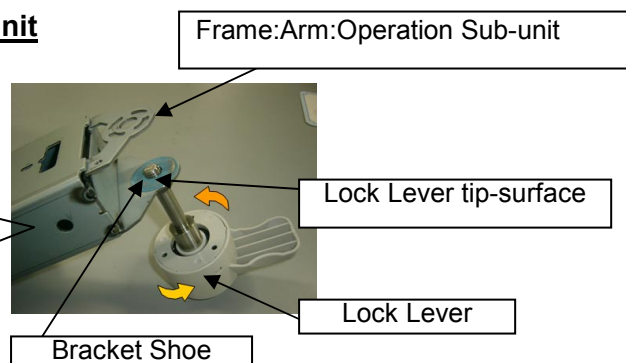
Screw in the Lock Lever from the opposite end (nut side). Check the rotation load when the tip-surface of the Lock Lever screws into the bracket hole.

**TIPS**  
If the rotation load is extraordinarily heavy, do NOT forcibly screw in. Remove and follow the adjustment procedure to prevent screw threads from stripping.

**GOOD**  
The lever is screwed all the way in using only one finger. If so, move on to "7 Checking Coaxiality".

**BAD**  
If the "rotation load is heavy" or "stops halfway", do NOT remove the lever yet, move on to "5 Adjusting the Bracket Shoe".

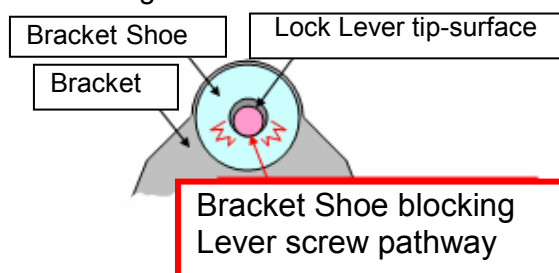
Check the part where the Bracket Shoe and Lever screw are interfering. Then remove the lever.

In most cases, interference occurs in the location shown above.

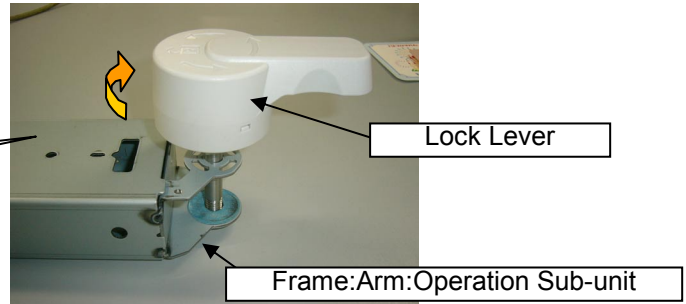
Screw in the Lock Lever from the same direction as in the regular procedure. Check the rotation load when it enters the nut and the rotation load as it screws into the nut.

If rotation load is extraordinarily heavy, do NOT forcibly screw in. Remove and follow the adjustment procedure to prevent screw threads from stripping.

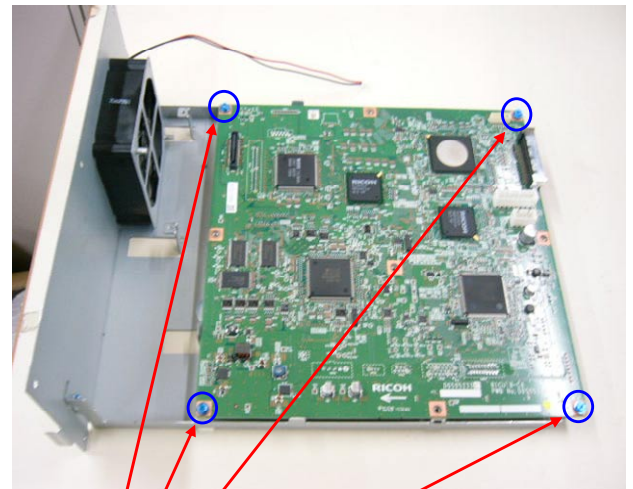
Do NOT fasten screws completely. Fasten halfway so that the board has room to move. Screw head should appear above the board.

7. After changing the BICU board, fasten the screws (x4) halfway.

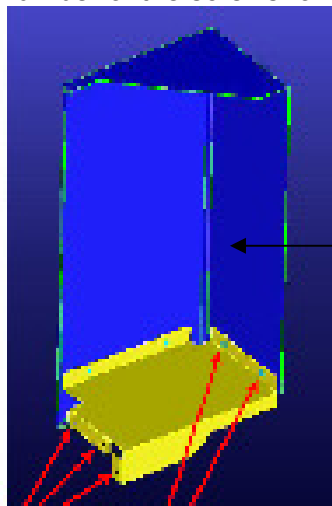
Picture of the modified cover.  
When installing it, use the same 5 screws and locations of screws as the original cover.

2) When installing the transfer unit, use the modified one you obtained. The location and the number of the screws for tightening are the same as the original ones.

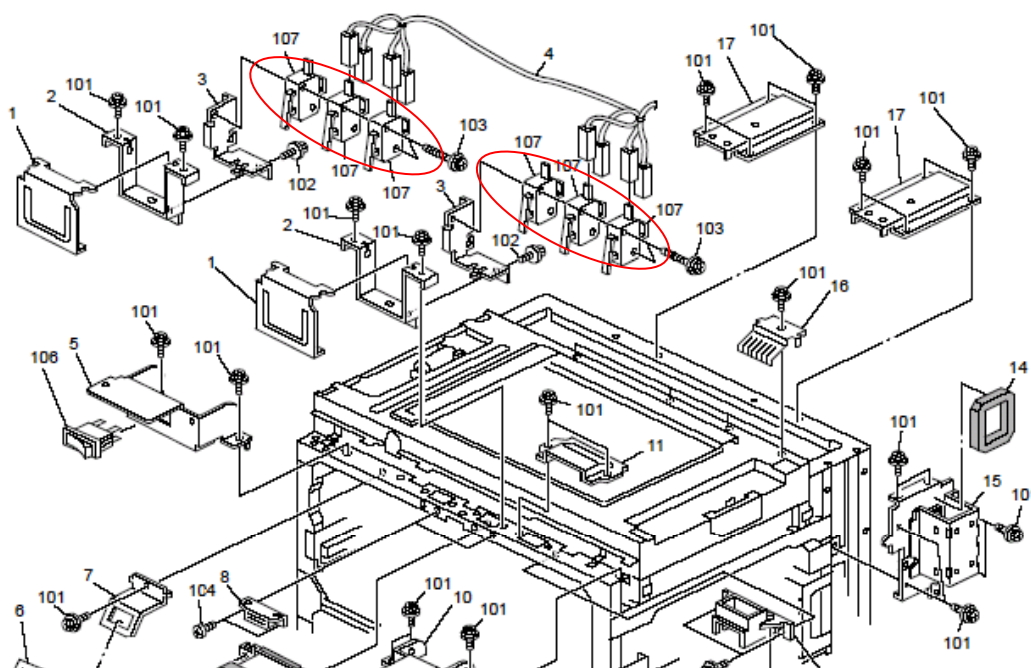
## 81.Electrical Section 10 (D059/D060/D061)

Part number "12042521" is assigned for the Front Door Safety Switch indexed with number 107 in the following diagram.

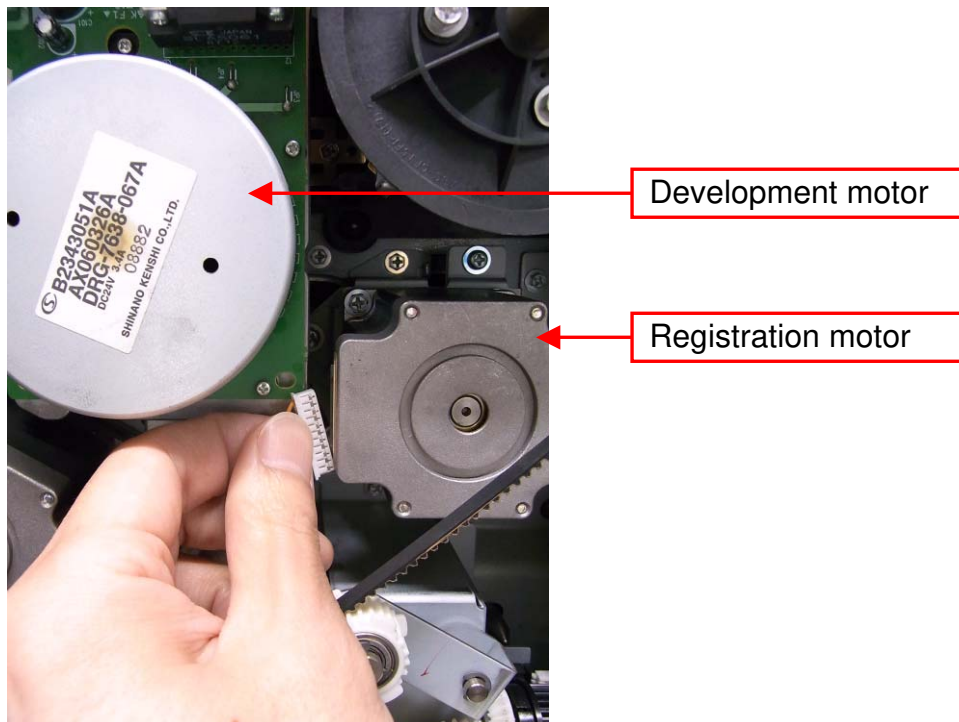
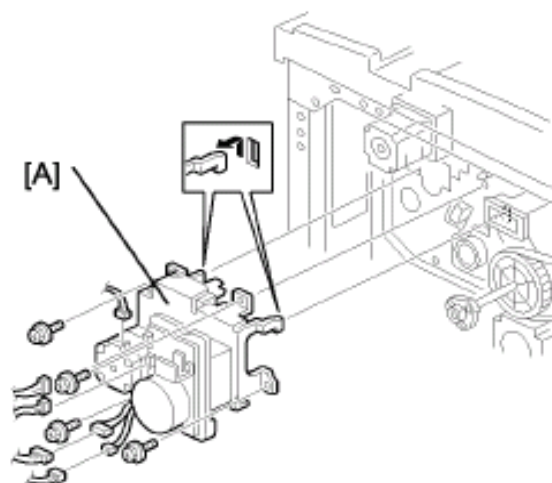
b234r919b

The above SCs could occur due to damage to the harnesses when removing/replacing the development motor unit.

2. Disconnect the harness from the registration motor.  
(This step has been newly included in the procedure.)

3. Remove development motor unit [A] (⚙ x4, 🛠 x5, 🗑 x1)

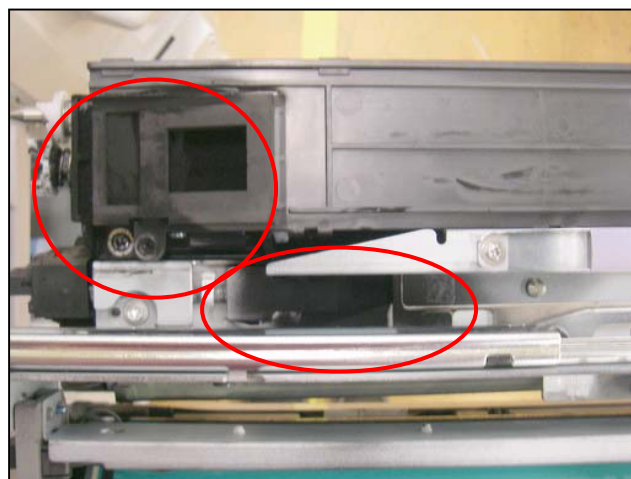
Affected unit

Charge leak originating in toner leaks from the toner pump.

\*Deflection of the spring causes the shutter to slant, leaving a gap causing toner leakage

If both areas are scattered with toner, the toner pump should be replaced with the modified special registered Toner Pump.

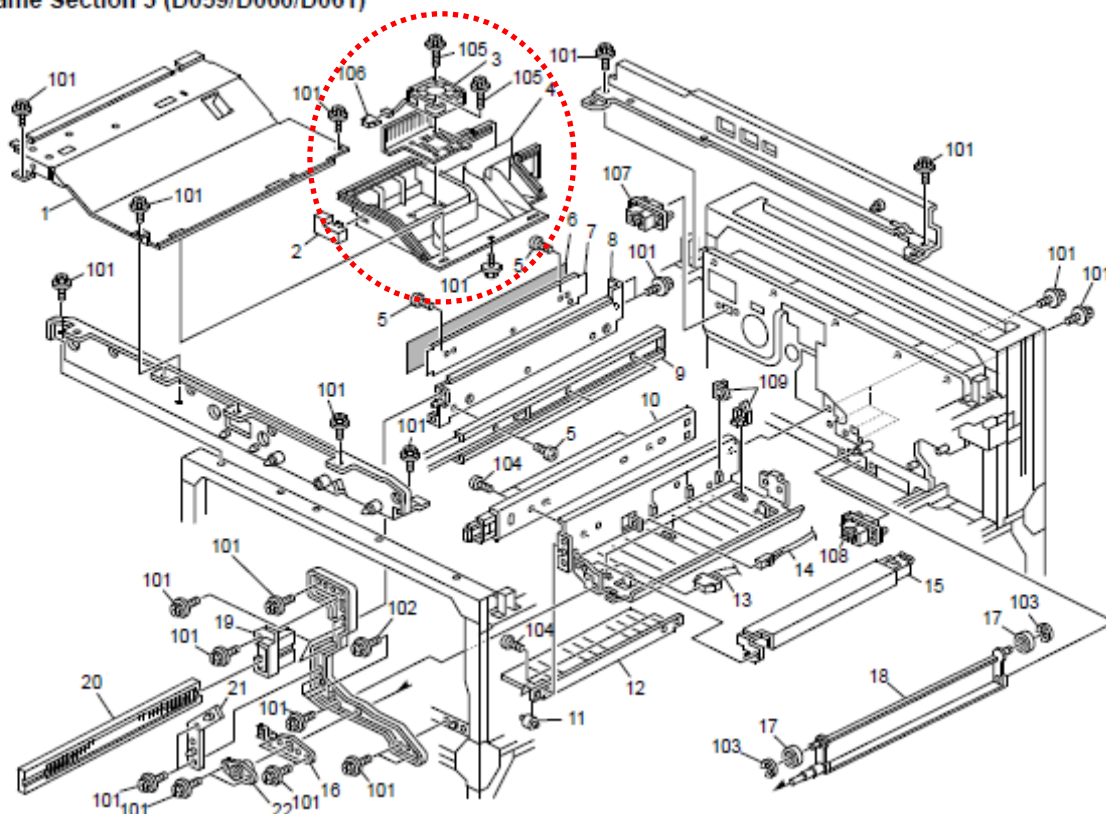
#### 84.Frame Section 3 (D059/D060/D061)

A screw hole of the duct (indexed 4 below) had cracked in the manufacturing process when assembling the fan motor (indexed 3 below). To prevent this breakage, the duct has been modified to apply longer screws which will allow better engagement of the screw and the screw hole.

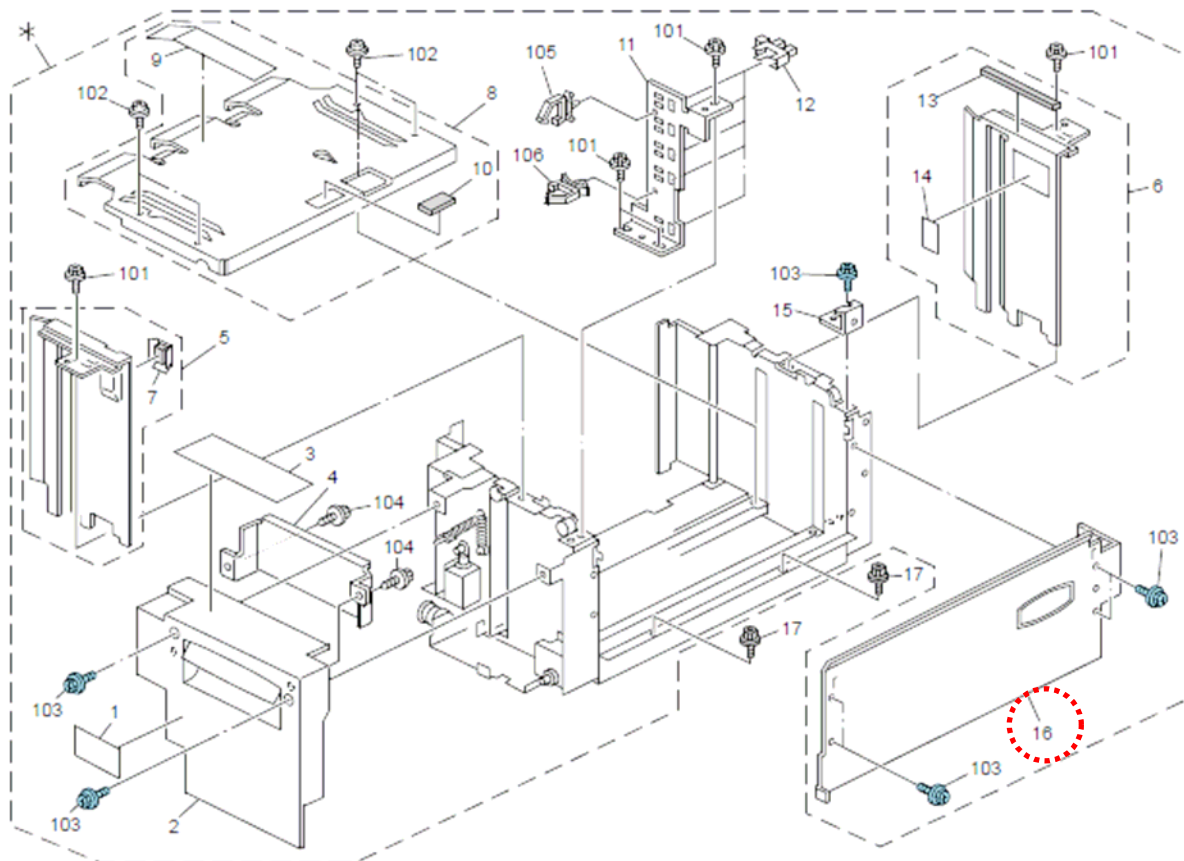
## 25.Tandem Tray 2 (D059/D060/D061)

The leading edge of the sheets beneath the topmost sheet could be damaged or creased from directly contacting with the reverse roller. To prevent the leading edge from contacting the reverse roller, Mylar (D0596664) has been added to the modified side plate (D0596668) which is marked with a groove to indicate the location for attaching the mylar.

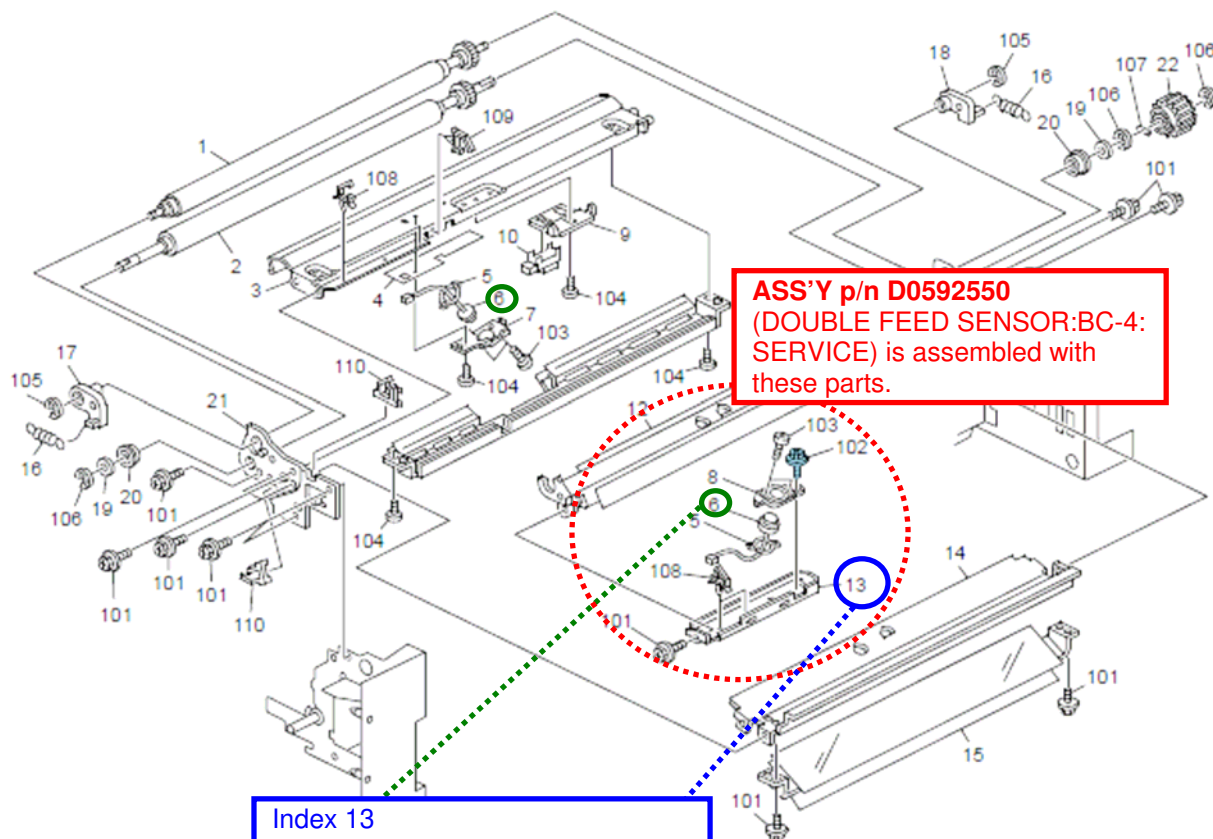
### 33.Paper Registration 2 (D059/D060/D061)

**ASS'Y p/n D0592550**  
(DOUBLE FEED SENSOR:BC-4:  
SERVICE) is assembled with  
these parts.

Index 13  
D0592636 → **D0592634**  
BRACKET:LED:GASKET:ASS'Y

**D0592639**  
COVER:HARNESS:SENSOR

Index 6  
D0592559 → **D0592691**  
DOUBLE FEED SENSOR:BC-4

1. If a replacement is required for a URB registered with the p/n D0595750, D0595752 or D0595753, it must be replaced with D0595755 as a set either by ordering the relative parts (D0592691, D0592639, and D0592634) or by ordering an assembly part D0592550 which includes all the necessary components; URB, sensor, cables, clamps, and screws.
2. This modification is reflected in the production starting from September 2010.
3. This modification also applies to the Bellini-P1 (Katana-P1, M002/M003/M004).

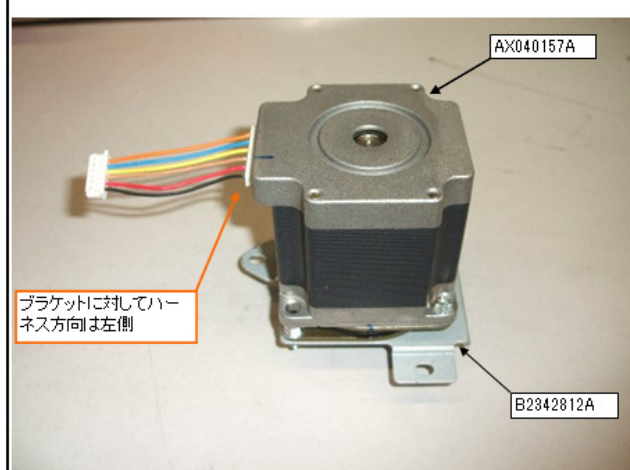
B2342811(DC Stopper Motor:Registration:Ass'y)

**Reason:** To prevent possible damage to the registration motor harnesses

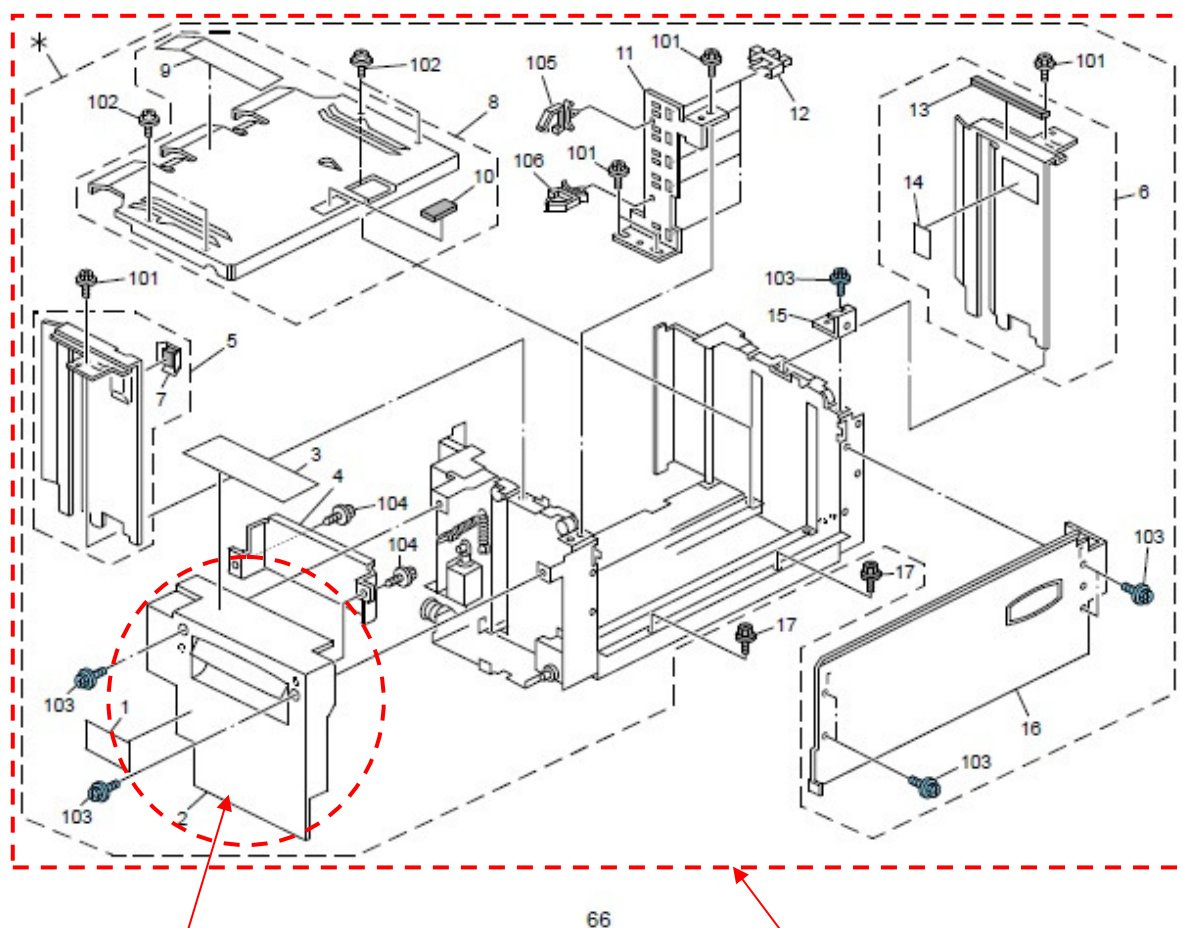
### 25.Tandem Tray 2 (D059/D060/D061)

**Reason:** When closing the tray, the tip of the white plastic stopper (p/n: D0596702) could interfere with the tandem ray inner cover and damage the fulcrum of the stopper, disabling proper setting of the tray.

D0596698 → **D0596712** (Change)  
INNER COVER: TANDEM LCT

D0596619 → **D0596613** (Change)  
TANDEM LCT: RIGHT: NA: ASS'Y  
D0596618 → **D0596612** (Change)  
TANDEM LCT: RIGHT: DOM: ASS'Y

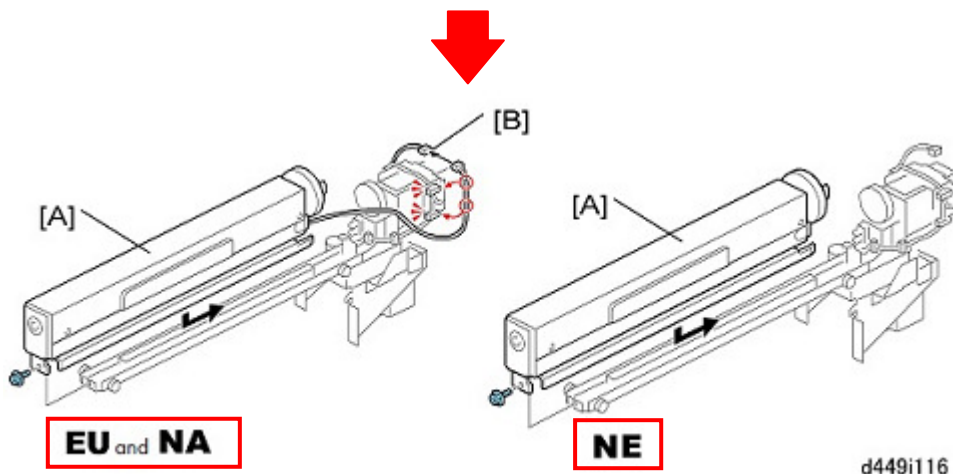
2. Attach the punch mechanism [A] to the rails of the punch unit (⚙ x1).
  - If you are installing the punch unit for Europe, connect the harness [B] (⚙ x1, ⚙ x2).
  - The punch unit for North America has no punch switching motor, so this harness is not required.

2. Attach the punch mechanism [A] to the rails of the punch unit (⚙ x1).
  - If you are installing the punch unit for **Europe and North America**, connect the harness [B] (⚙ x1, ⚙ x2).
  - The punch unit for **North Europe** has no punch switching motor, so this harness is not required.

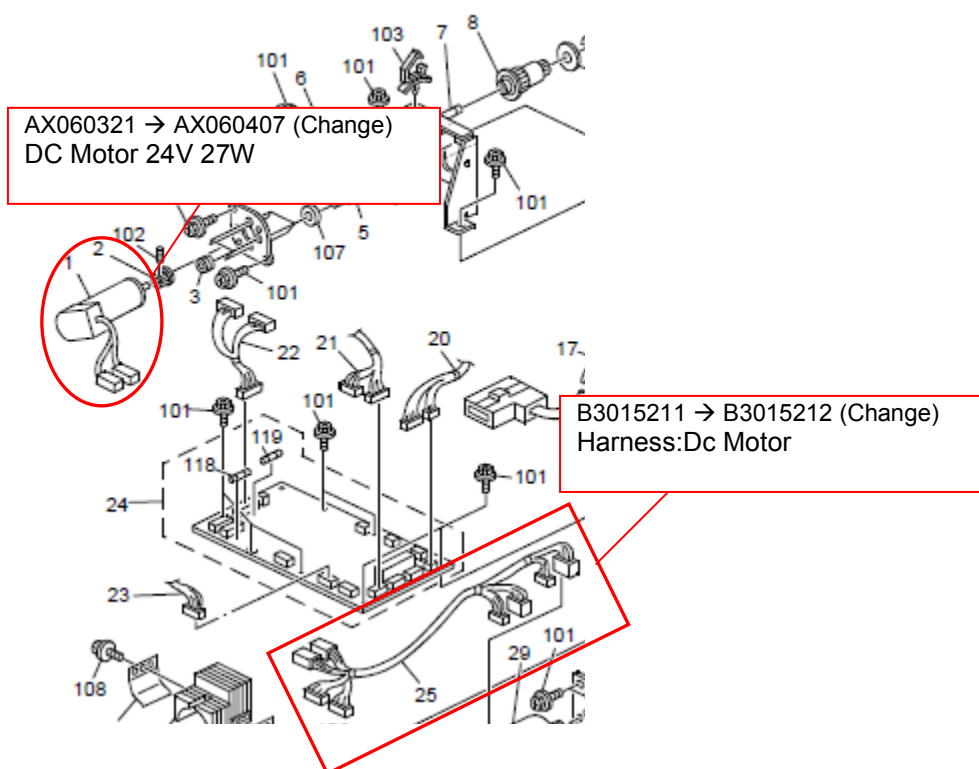
## 114.ADF 9 (D095)

**Reason:** The factory of the motor has changed; the harness connecting the motor needs to be replaced together with the motor.

NOTE: Motor and Harness need to be replaced as a set.

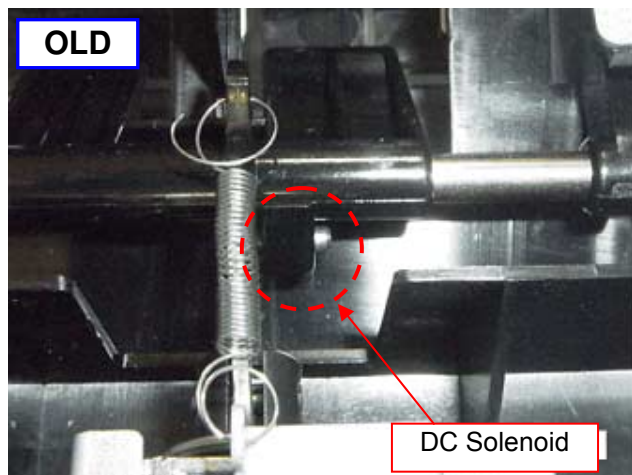
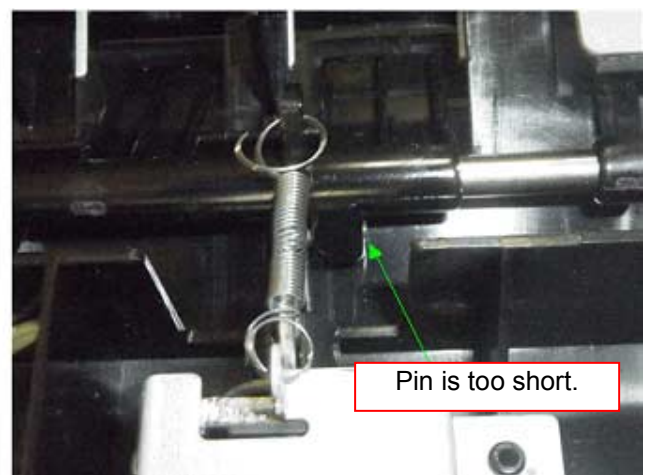
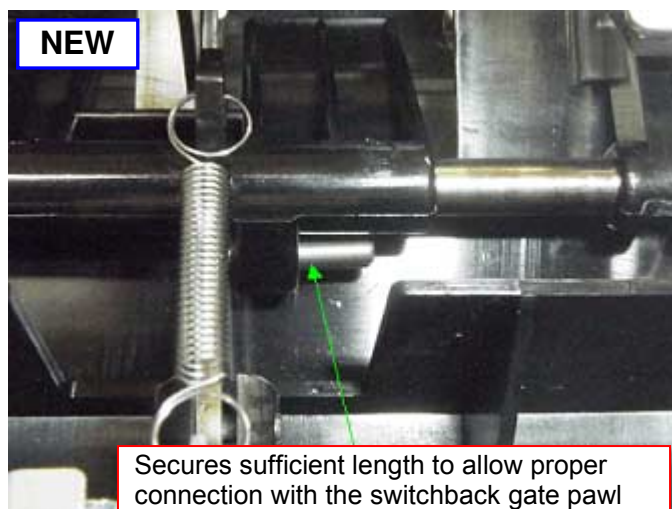
The pin protruding from the DC solenoid connects to the switchback gate pawl. (See the photos below and the p/c diagram shown on the next page.) However, due to the insufficient length of this pin on the original DC solenoid, the pin could be inserted oblique to the hole on the switchback gate pawl, causing friction in the switchback gate pawl operation that could result in paper jams. To prevent this, the length of the pin was extended 5.0mm on the modified DC solenoid.

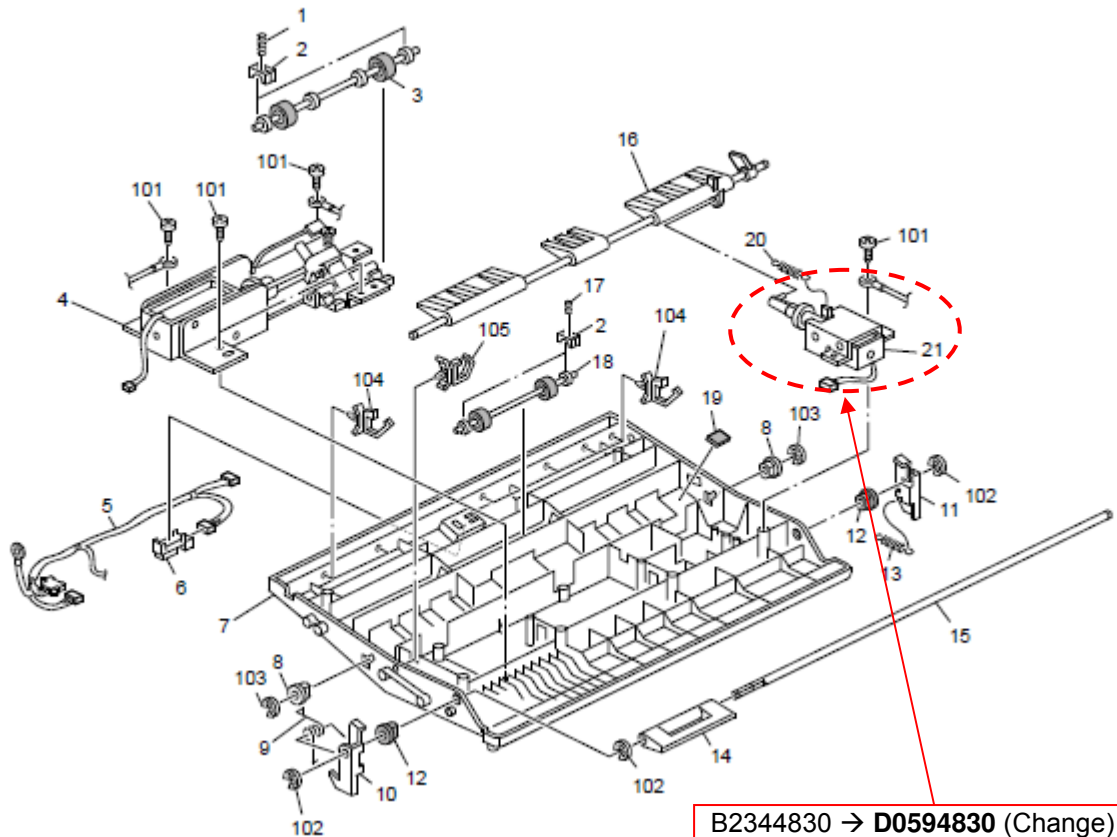
### 60.Duplex Unit 3 (D059/D060/D061)

B2344830 → **D0594830** (Change)  
DC SOLENOID: GATE PAWL:  
SWITCHBACK: ASS'Y

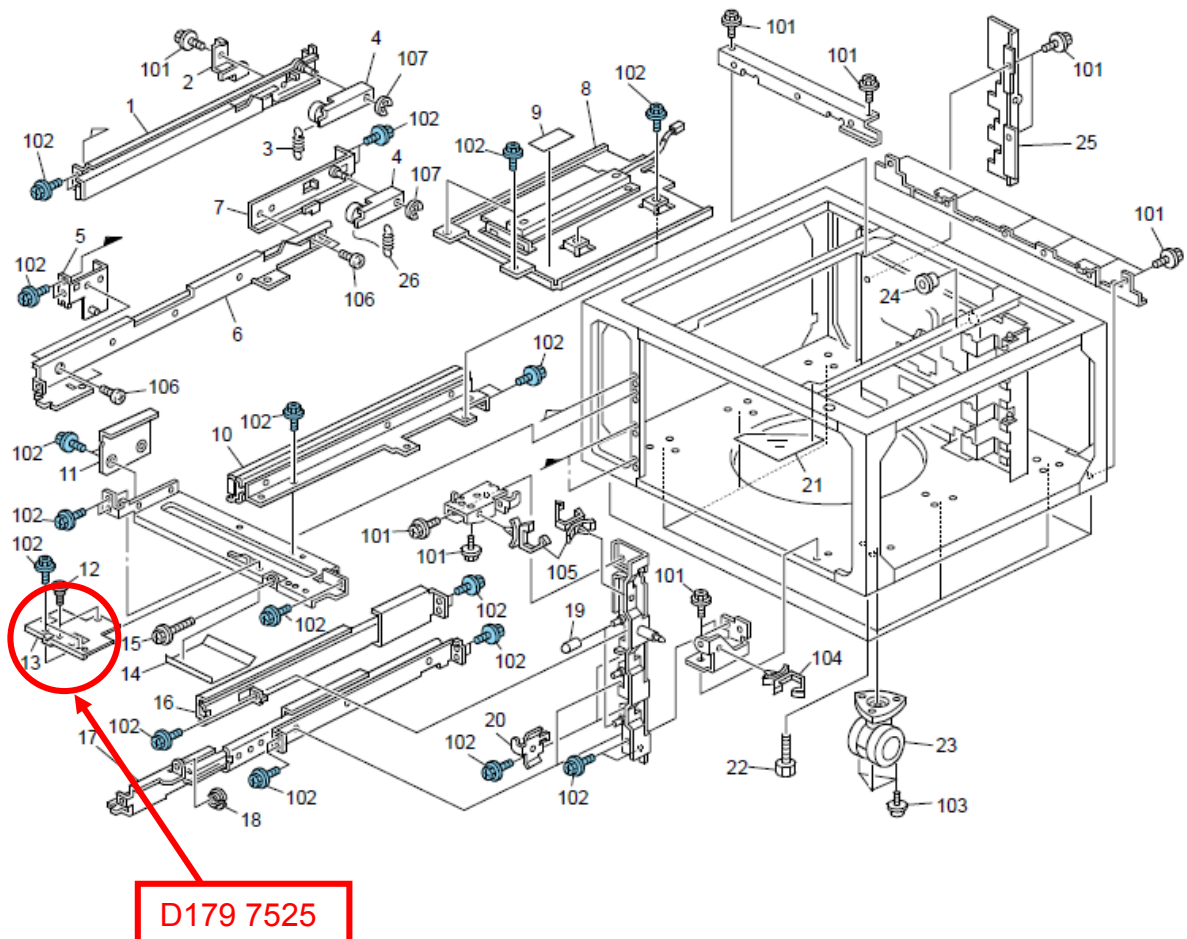
## 86.Frame Section 5 (D059/D060/D061)

Old p/n	New p/n	Description	Q'ty	page	index	Int	Note
D0596859	D1797525	STOPPER:REGISTRATION:TANDEM LCT: ASS'Y	1	189	13	X/O	Change

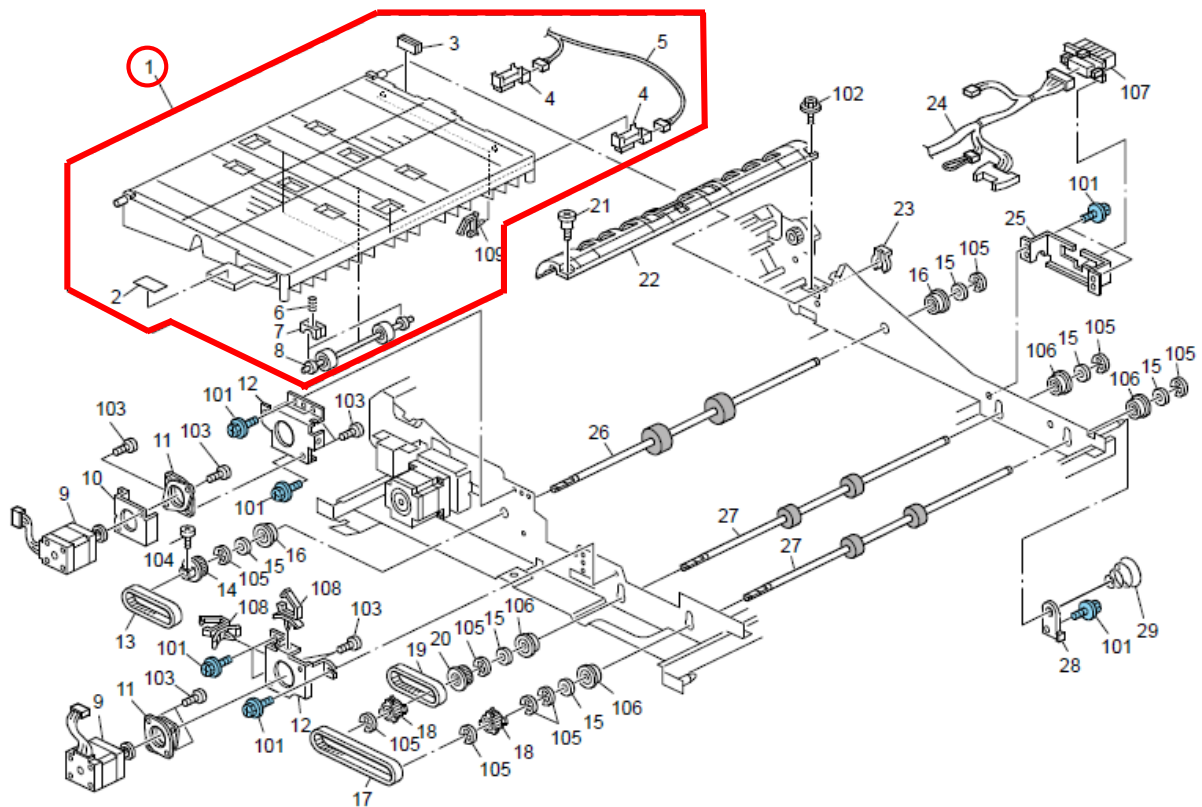
## 61.Duplex Unit 4 (D059/D060/D061)

Old p/n	New p/n	Description	Q'ty	Int	Page	Index	Note
-	D0594850	GUIDE PLATE:OPEN AND CLOSE: DUPLEX:LEFT:SUB-ASS'Y	1	-	139	1	Add

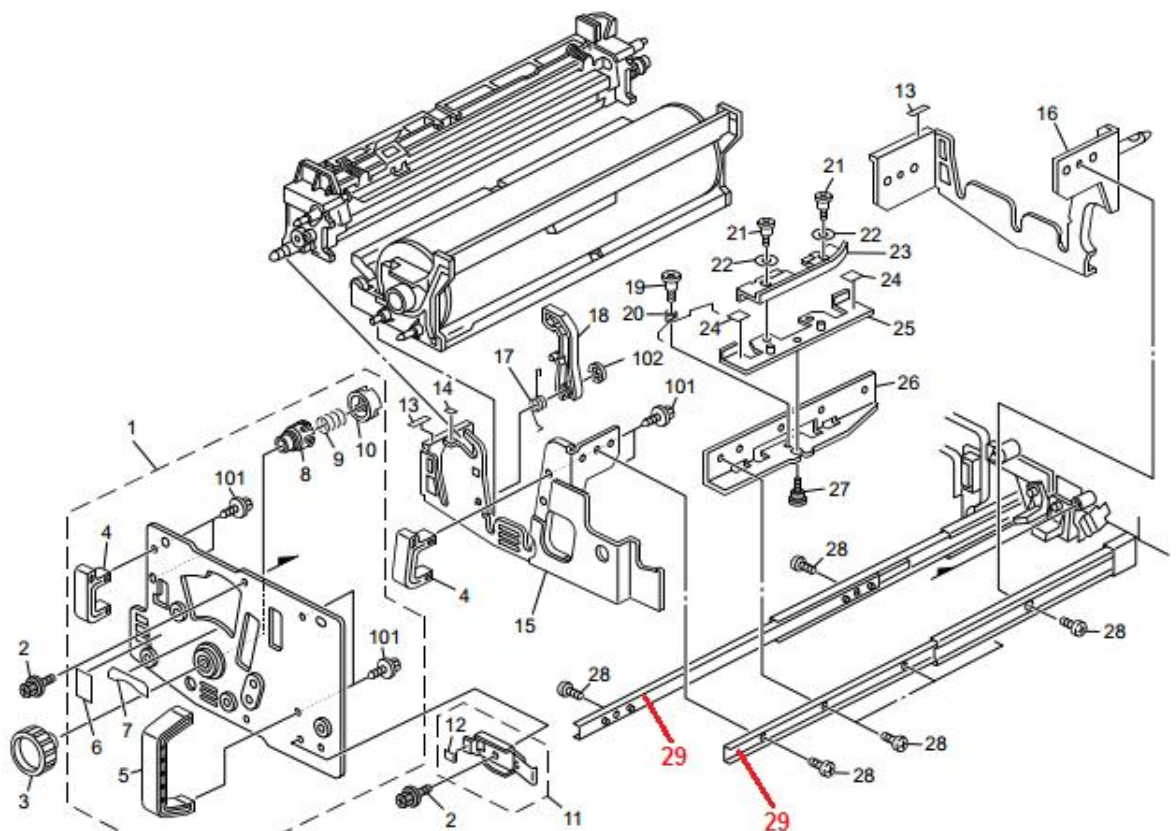
## 43.PCU 1 (D059/D060/D061)

New p/n	Description	Q'ty	Int	Page	Index	Note
B2342485	SLIDE RAIL:TRAY UNIT:AROUND THE PHOTOCONDUCTOR	2	-	103	29	Add
