**Model BR-C1/P1
Machine Code:
D179/D180/D181
M263/M264
Troubleshooting**

May 2015

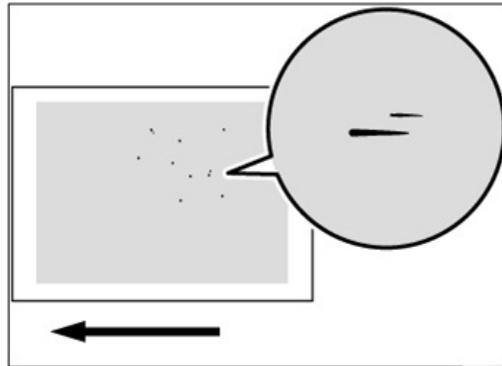
d1798002

Paper Is Spotted with Toner

Paper is soiled with toner spots of 0.5–1 mm (0.02–0.04 inches) in diameter.

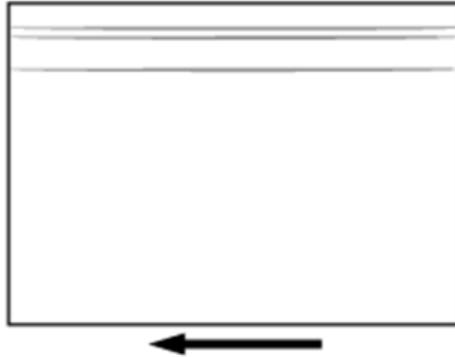
d1798004

Streaks (1)

Streaks parallel to the paper feed direction appear.

- The charger is dirty.
- The cleaning unit for PCU has worn out.
- The drum surface is scratched.

3. Replace the charge wire and cleaning pads.

Dirty:	Replace the cleaning unit for PCDU.
--------	-------------------------------------

Scratched:	Replace the drum.
Neither:	Consult key operators.

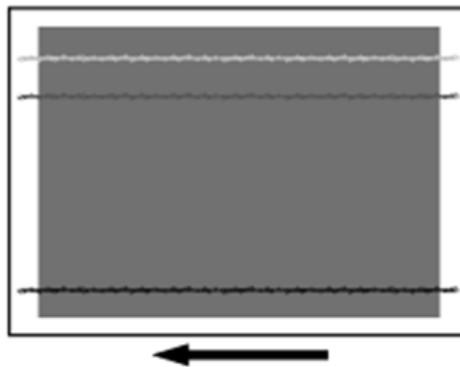
d1798005

Streaks (2)

Extended, blurred streaks parallel to the paper feed direction appear. The streaks also appear randomly in the margins.

If the temperature or humidity is low, remaining toner might be missed by the cleaning blade of the cleaning unit for intermediate transfer belt or transfer unit, causing streaks to appear sporadically.

- Replace the cleaning unit for intermediate transfer belt.
- If the problem persists after you have replaced the cleaning unit for intermediate transfer belt, consult key operators.

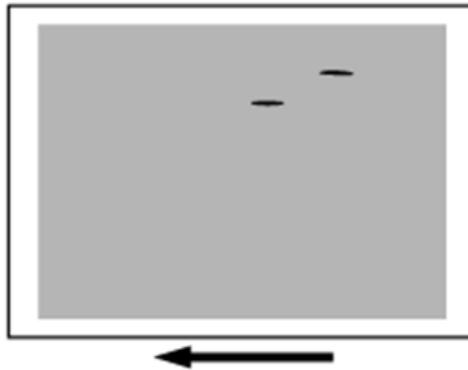
d1798006

Streaks (3)

Streaks appear in solid-filled areas.

This problem may occur if the machine is left unattended for a long period or the toner bottle is kept out of its moisture-proof bag for a long period.

Yes	Finished!
No	Replace the toner bottle.

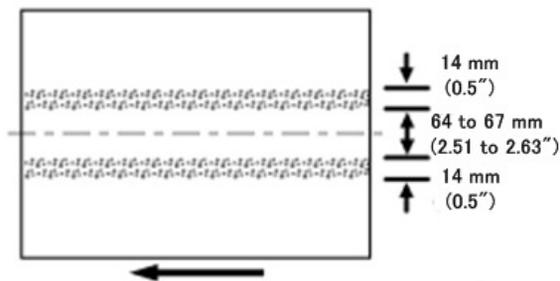
d1798011

Two 14-mm Wide Streaks

Two 14-mm wide streaks parallel to the paper feed direction appear.

Clean the rollers, sensors, and guide boards in the drawer.

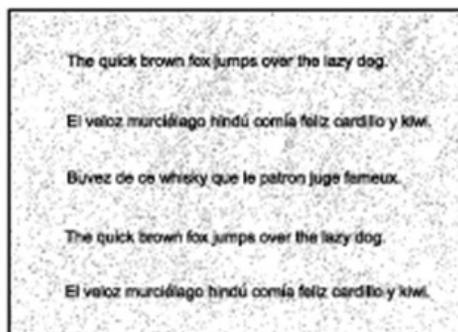
d1798015

Completely stained background

This may occur because of wearing of the developer, drum unit, or drum charge unit.

1. If a message prompting replacement of a unit has appeared, replace the unit.
2. In the Machine: Image Quality group on the Adjustment Settings for Skilled Operators menu, select Adjust Image Density and execute Image Density Adjustment: Manual Execute. (SP3-011-002: Manual ProCon :Ex Density Adjustment)
3. Print the image. Is the problem resolved?

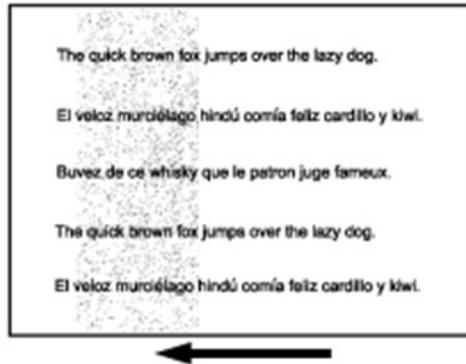
d1798016

Partially stained background

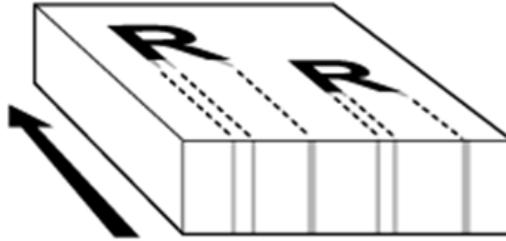
d1798018

Scatched Images and Stained Paper Edges

Scatched images or soiled paper edges appear.

When a relatively stiff, thick paper is delivered, the entrance guide board for the transfer unit is warped toward the intermediate transfer belt due to the stiffness of the paper. The edge of the entrance guide board comes into contact with the toner on the belt to cause images to be scratched and paper edges to be soiled.

- When storing paper at low humidity, wrap the paper in coated paper or a plastic sheet.

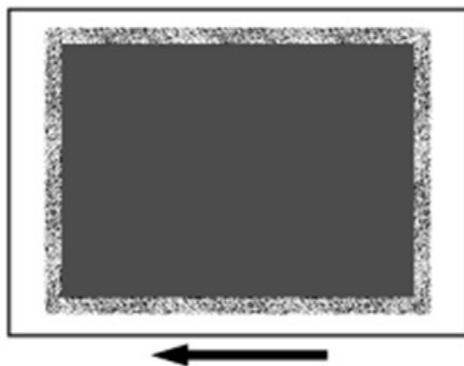
d1798019

Toner Scatter (1)

Toner is scattered around a solid-fill print.

This may occur if printed at low temperature or humidity.

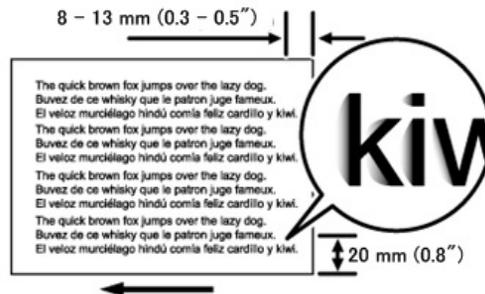
d1798021

Toner Scatter (3)

Parts of a line or character exhibit splatter. This may occur in a line or character that is 8 to 13 mm (0.3 to 0.5 inches) from the trailing edge and 20 mm (0.8 inches) or less from the left edge facing the paper feed direction.

Shock jitter occurs when the trailing edge of the paper leaves the paper guide during paper transfer and causes toner scattering. This may occur if paper with a thickness equivalent to Paper Weight 4 or higher is used.

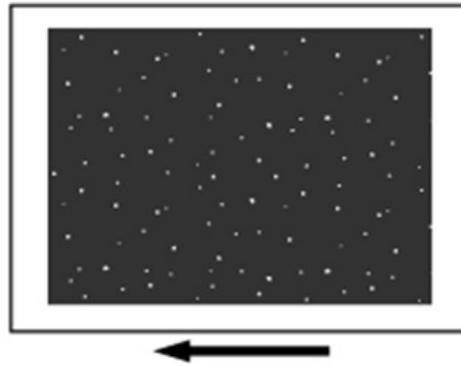
d1798022

White Spots 1

White spots of 0.2–0.3 mm (0.008–0.01 inches) in diameter appear.

This may occur if printed at low temperature or humidity.

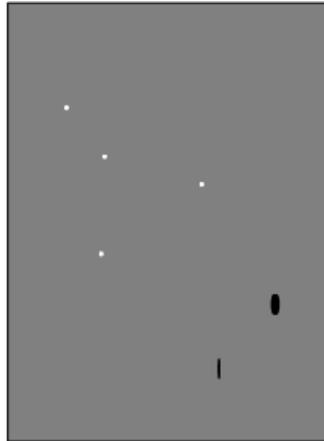
d1808005

Firefly, Comet Patterns

White spots in firefly patterns, or black comet streaking patterns appear.

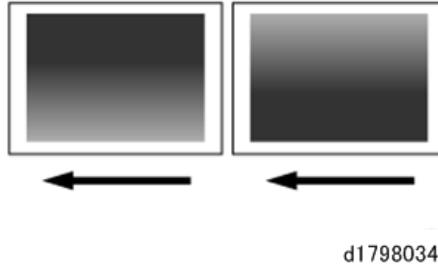
Uneven Density from Top to Bottom

The density is uneven from top to bottom.

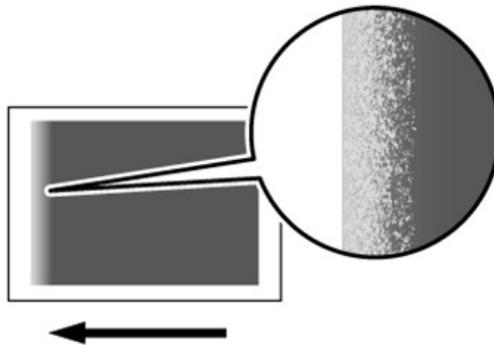
d1798035

Fainter Leading Edge

The leading edge is fainter.

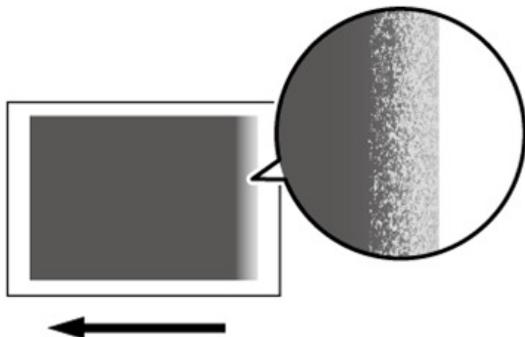
d1798036

Fainter Trailing Edge

The trailing edge is fainter.

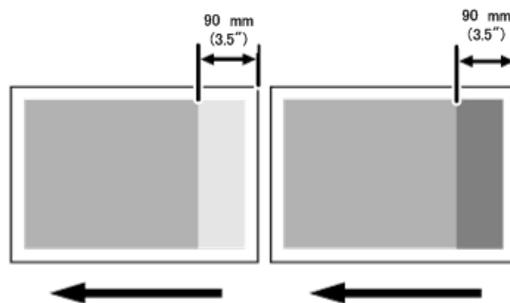
d1798037

Uneven Density within 90 mm (3.5 in.) of the Trailing Edge

Printing in the area extending approximately 90 mm (3.5 inches) from the trailing edge is fainter or denser.

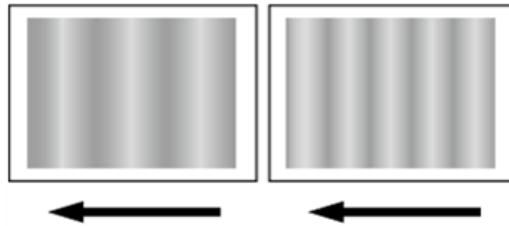
d1798038

Periodic Density Fluctuation

The vertical density fluctuates periodically.

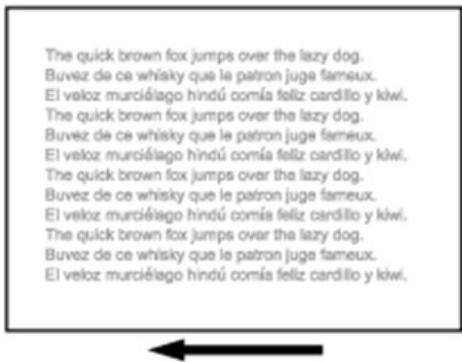
d1798039

Entire Image Faint

The entire image is fainter than normal.

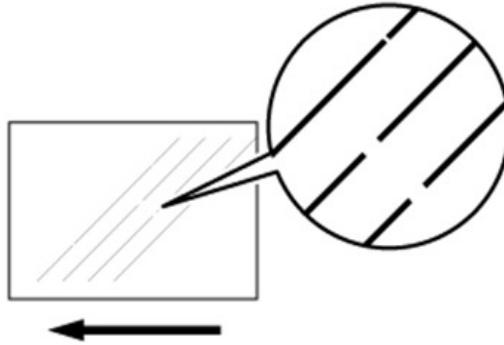
d1798041

Broken Thin Lines

Thin lines (1 dot lines in 1200 dpi images) break.

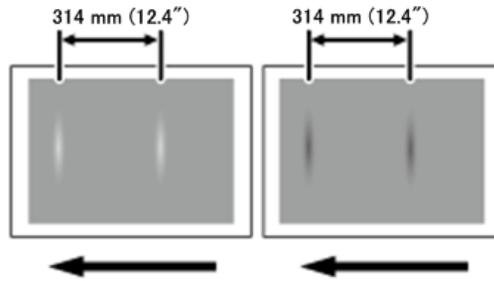
d1798042

Blurred Images (Lens Shaped)

Lens-shaped blurred images appear at 314 mm (12.4 inches) intervals.

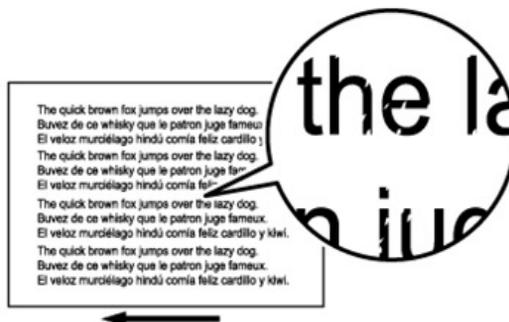
d1798043

Dropouts (Characters Broken)

Dropouts (character voids) occur when characters or lines are printed.

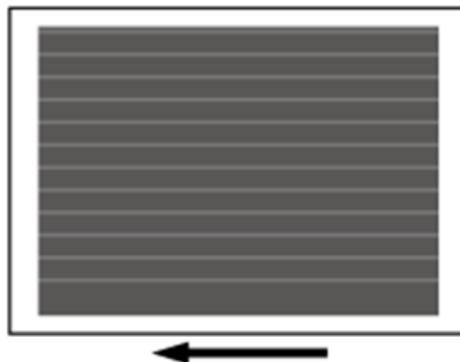
d1798044

After Images

An afterimage of the image printed just before the intended image appears.

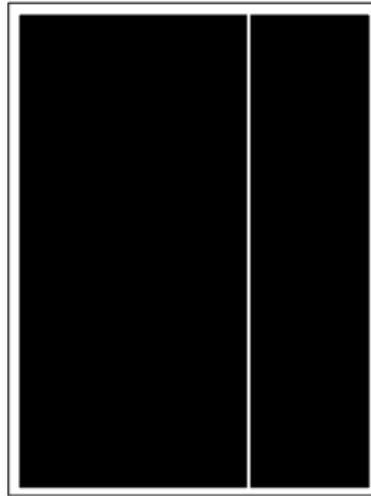
d1808010

Vertical White Lines

These are vertical white lines that appear on the paper in the direction of paper feed.

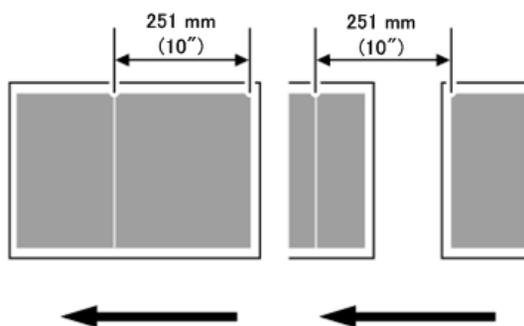
d1798046

Vertical Glossy Lines

Glossy lines perpendicular to the paper feed direction appear.

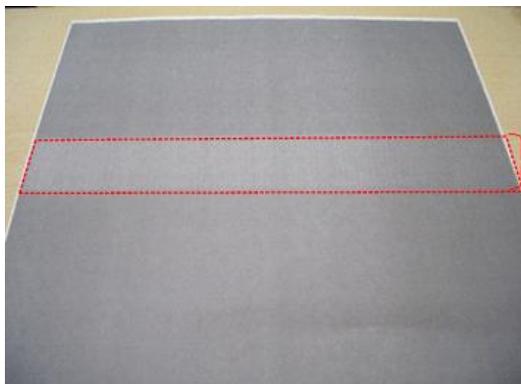
d179b4001

Halftone and text images appear light (low in density) or blurry at intervals within bands that are equal to the circumference of the drum.

Low Density in Shaded Area

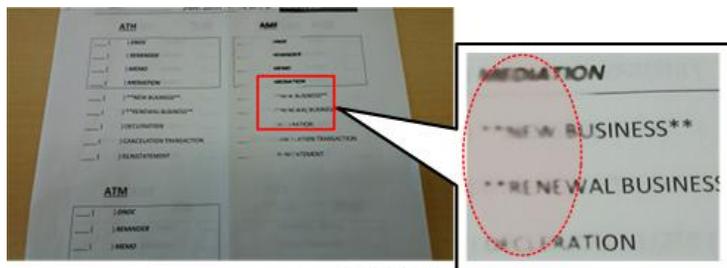
d179b4002

Blurry Text

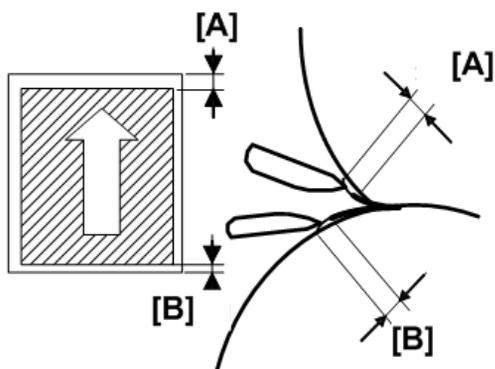
d1808101

Fusing Unit Separation Plate Accordion Jams

Accordion jams can occur at the fusing unit separation plate with paper where there is insufficient white space at the leading edge of paper.

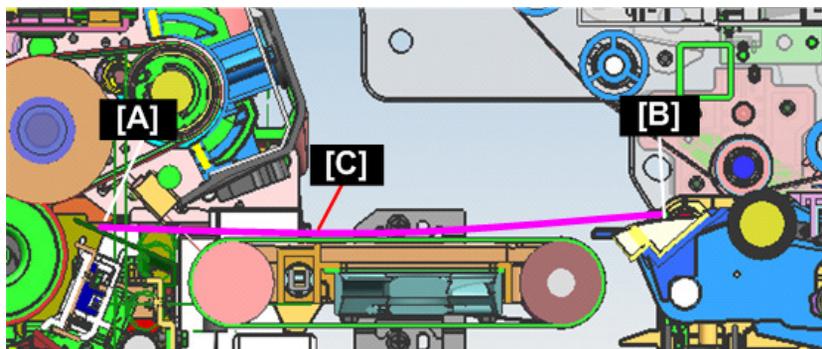
d1808102

If J082 Appears

This code signals a jam with paper above Thickness 6.

With paper thicker than Thickness 6, when the leading edge of the paper on the fusing guide plate [A] and the trailing edge is on the transfer exit guide [B] both ends of the paper rest on the guide plates, and due to the rigidity of the paper the surface of the paper loses contact with the paper transport belt below

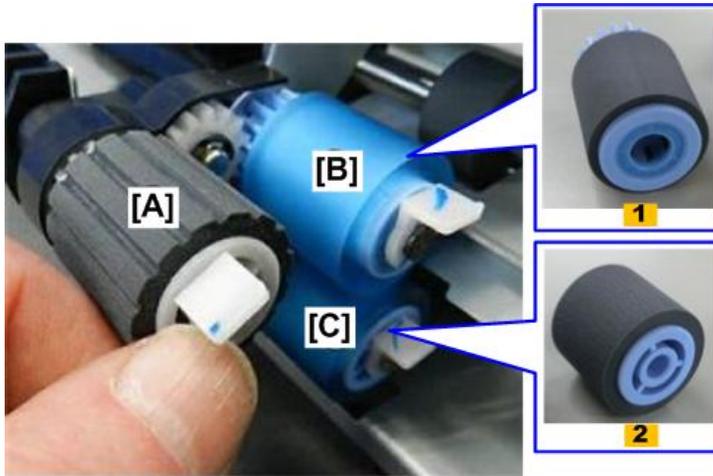
m263b4003

Paper dust adheres to the surfaces of the rollers in the paper feed units of the main machine, the rollers become smooth, and then slip on the surface of the paper. The paper fails to feed out of the paper tray.

The photo shows the configuration of the rollers in each paper feed unit. Only two of the three rollers need to be replaced.

No.	Roller	Comment
[A]	Pick-up roller	Do not replace
[B]	Feed roller	Replace with EPDM Roller [1]
[C]	Reverse (separation) roller	Replace with EPDM Roller [2]

Two rollers can be replaced with EPDM rollers to improve feed performance. If the customer is using paper with a high ash content, replace the feed and reverse rollers in the paper feed units.

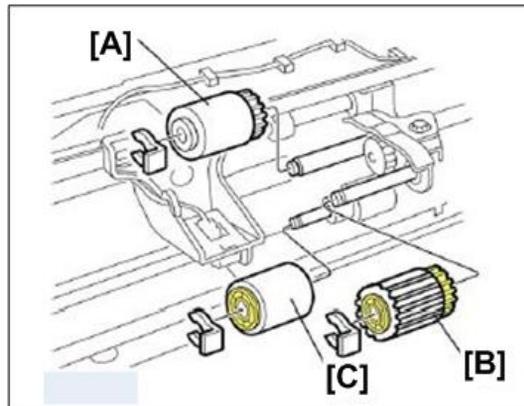
m263b4007

Paper dust adheres to the surfaces of the rollers in the LCIT paper feed units, the rollers become smooth, and then slip on the surface of the paper. The paper fails to feed out of the paper tray.

The photo shows the configuration of the rollers in each paper feed unit. Three rollers need to be replaced:

No.	Roller	Comment
[A]	Pick-up roller	Replace with EPDM pick-up roller
[B]	Feed roller	Replace with EPDM feed roller
[C]	Reverse (separation) roller	Replace with EPDM separation roller

Three rollers can be replaced with EPDM rollers to improve feed performance. If the customer is using paper with a high ash content, replace the pick-up roller, feed roller, and separation roller in the paper feed units.

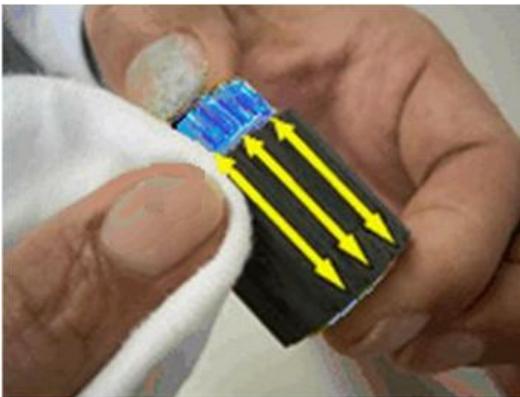
m263b4005

If no-feed jams start to occur before the EPDM rollers have reached the end of their service life, clean the rollers.

1. Remove the three rollers (pick-up, feed, and separation roller).
2. Moisten a clean cloth with some water.
3. Slowly wipe the surface of each roller in the direction of the arrows as shown to remove the paper dust.

4. Allow the rollers to dry completely before you re-install them in the machine.

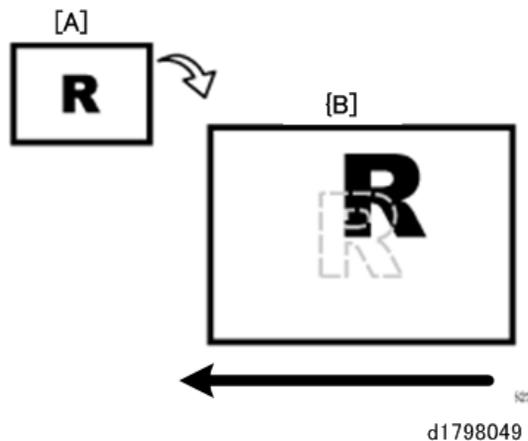
The Image Is Positioned Incorrectly

[A]	Original
[B]	Output

1. On the machine operation panel: group on the Adjustment Settings for Skilled Operators > Image Position > Adjust the image position.
 - To adjust the position horizontally, change the value in Adjust Image Position With Feed Direction. (SP1-001-001 to 008: Lead Edge Reg Thick <number>)
 - To adjust the position vertically, change the value in Adjust Image Position Across Feed Direction. (SP1-003-001 to 008: Side-to-Side Reg Tray <number>)
 - If the problem persists even though you have adjusted the setting to its maximum and minimum values, consult key operators.

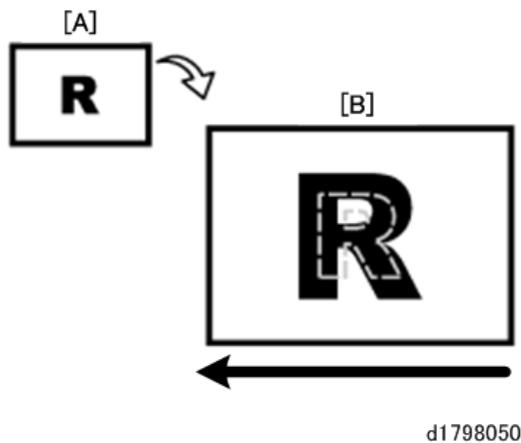
Image Scaling Error on the Side 1 of Paper

[A]	Original
[B]	Output

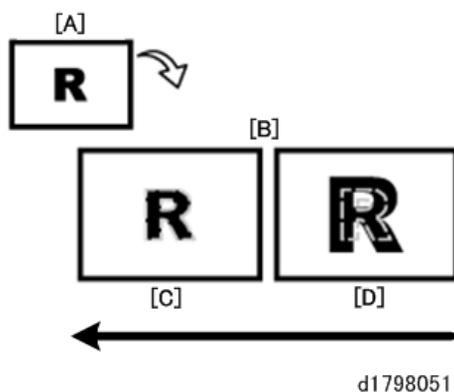
Image Scaling Error on the Side 2 of Paper

[A]	Original
[B]	Output
[C]	Side 1
[D]	Side 2

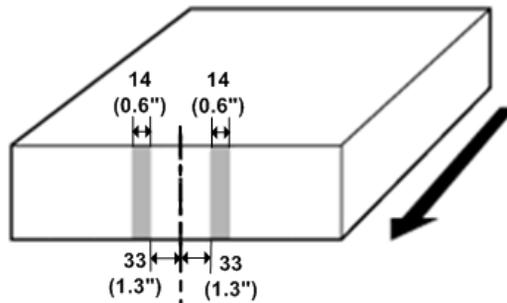
d1798052

Paper Edges Are Dirty (1)

Clean the exit rollers in the drawer.

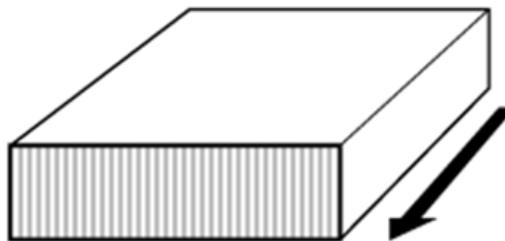
d1798053

Paper Edges Are Dirty (2)

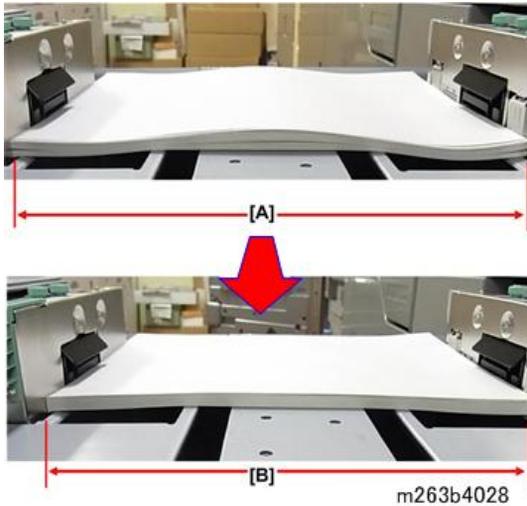
Cause: Side Fence, Rear Fence Set Incorrectly

Paper with excessive buckle [A] can cause double-feeding, so adjust the fences to the correct positions so the paper lies flat [B].

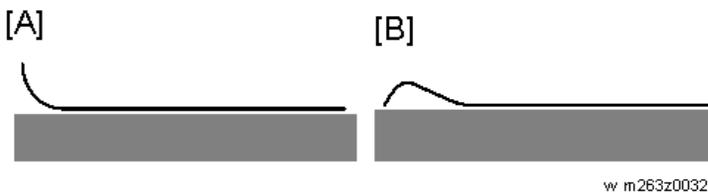
Cause: Paper Curling

[A]	Concave curl. Paper exits with curve down.
[B]	Convex curl. Paper exits with curve up.

In either case if the curl is excessive (not within specification), this can cause double-feeding.

Solution: Measure and correct curl.

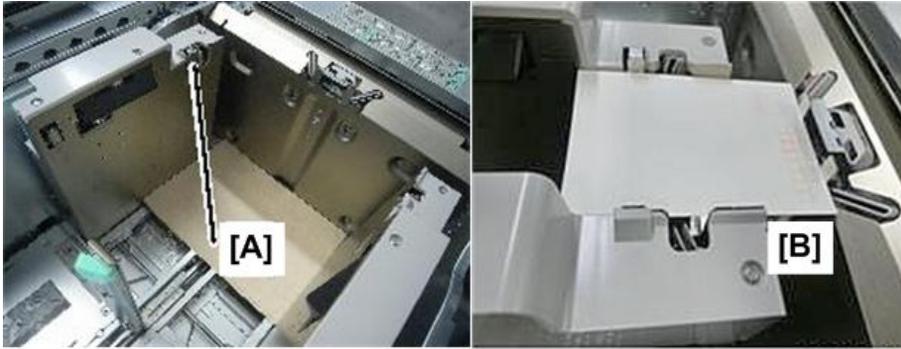
m263b4031

Paper Remains Up after Tray Opened

With paper in in the tray and the bottom plate up with the stack at the paper feed position, when the tray is opened, the pressure of the spring [A] on the skew correction plate is stuck between the side fence so the stack [B] remains up even after the plate is lowered.

This problem occurs only when the operator opens the tray. This does not occur during paper feed because the bottom plate does not operate.

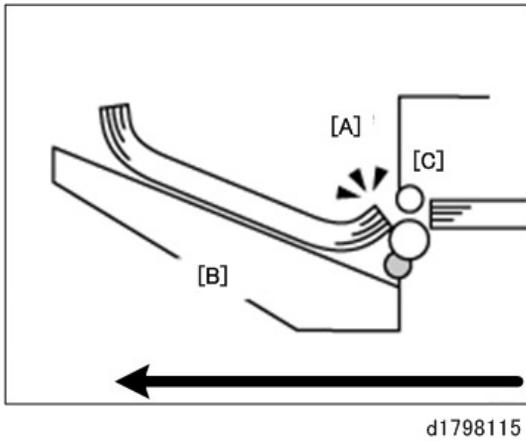
[A]	Trailing Edges
[B]	Output Tray
[C]	Paper Exit

- There is a tight curl on a delivered set of stapled sheets.
- Limp paper such as thin or recycled paper is used.

In the illustration the trailing edges of the stack [A] on the output tray [B] are too close to the paper exit [C]

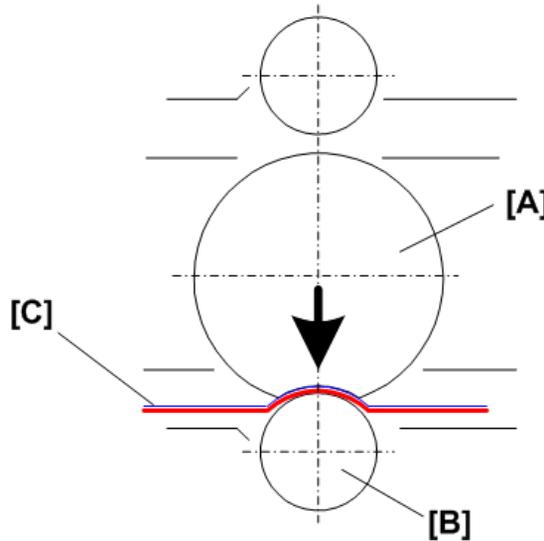
d1808104

Streaks Appear 4 mm Apart on the Leading Edge of the Stacked Paper

During back-curl correction the paper is compressed in the nip of the sponge roller [A] above and the decurl roller [B], so the sponger roller can press down to correct paper curl. When the image on the paper [C] is facing up when the sponge roller presses down, this can cause toner from the image to detach and foul the anti-static brush which then transfers this loose toner to the leading edge of each sheet.

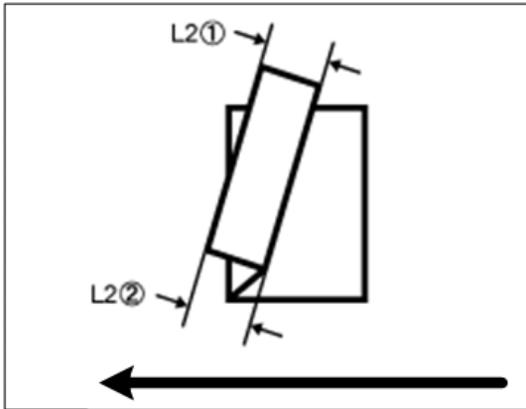
d1798116

- A deviation may appear if the edge dimensions of the parts between folds are different.
- For example, in the following illustration, the dimensional difference between the top (L2[2]) and bottom (L2[1]) edges is a deviation.

<Folding deviation sample of L2 for Z-fold>

Adjust the deviation.

The multi-folding unit has three adjusting screws (L1, L2, and L3) to adjust deviation.

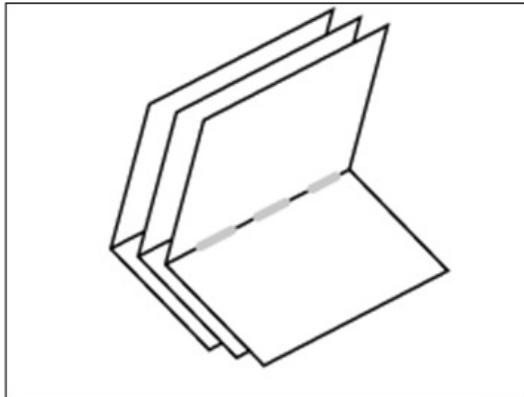
d1798128

If multi-sheet folding is performed after a large number of Z-folds have been performed, the tip of the blade used for the multi-sheet folding may be soiled, resulting in soiled paper.

This will produce paper soil of 1-3 cm (0.4-1.2 inches) in width (equal to the width of the blade) in the fold in the center of paper.

Clean the blade.

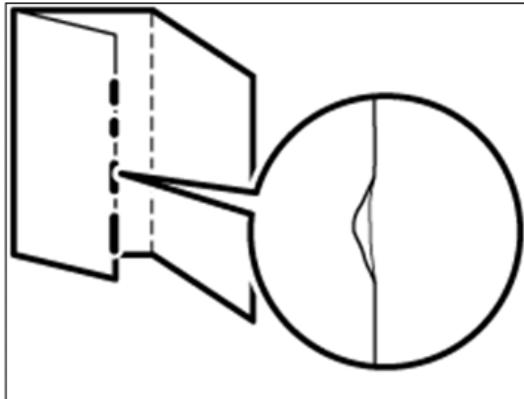
d1798132

Edges of Letter Fold Bent

When letter folding is applied, the edge of the inner flap may become bent.

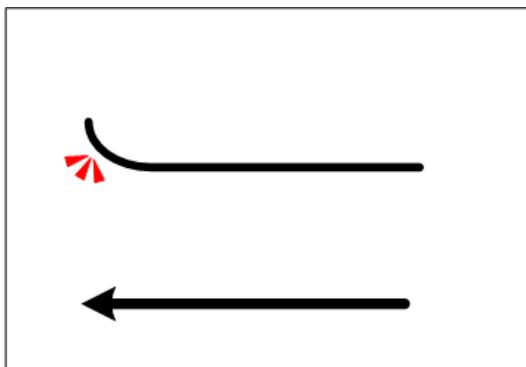
d1798133

Z-Folding Is Not Performed Correctly

The delivered paper has an upward curl with a arc of 4 cm (1.6") or less at leading edge.

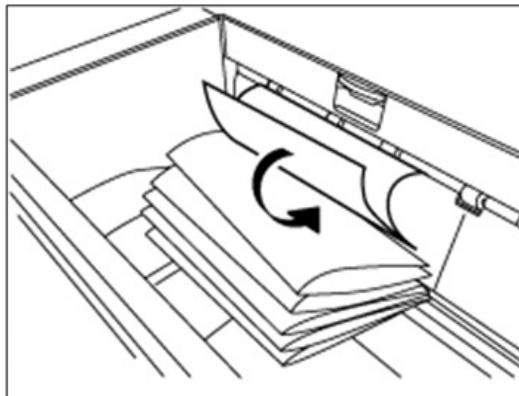
d1798134

If a large number of half-folded multi-sheet is delivered, the edge of the sheets may bulge and some part of the edge will be swollen. If this happens, other sheets loaded on the bulged paper may turn over in the output tray. This is likely to occur if thick, relatively stiff paper is used.

As a bundle is delivered, its folded edge may droop and catch on the stacked bundles, causing the delivered bundle to flip over.

Use the Z-fold support tray for multi-folding unit. This will reduce the angle of stacked bundles and prevent bundles flipping over as they are delivered.

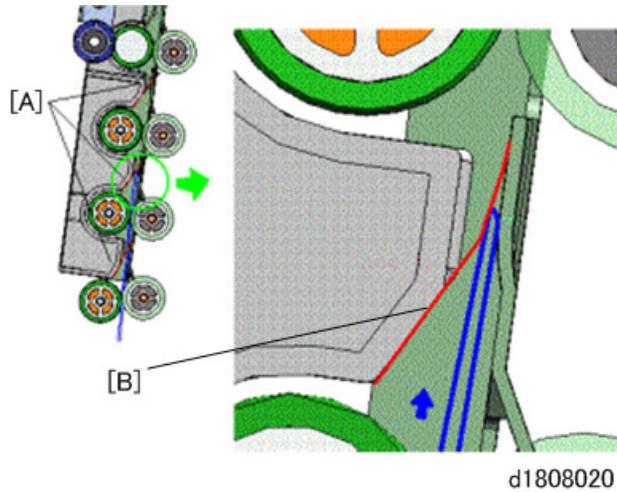
The surface of matte finish paper shows scratches after folding.

When the folded paper is transported to the fold crease unit, the leading edge (creased edge) enters the fold nip prepared level for the press guide, and then is pressed by the on the paper transport guide. The press guide is provided with three press rollers [A]. The friction between the press guide and press guide plate as the paper is fed can scratch or mark the matte finish of the paper.

3. Take a piece of paper and gently rub the surface of the metal plate to smooth it, and then do another test. Is the problem solved?

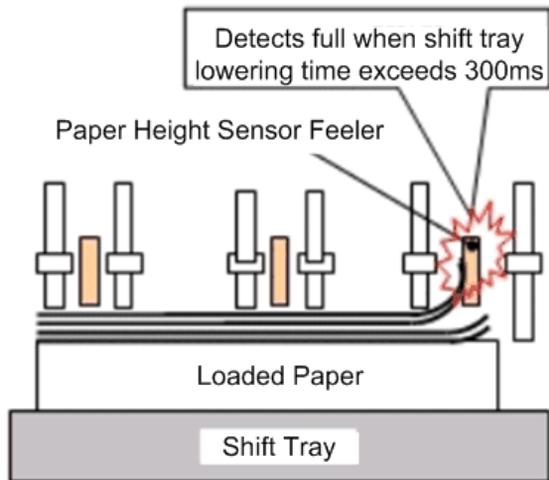
w_d194e6186a

When paper that is about as wide as the paper height sensor feeler is discharged to the shift tray, if it has side face curl, the edge of the paper may fail to go under the paper height sensor feeler and ride up on the feeler; alternatively, by coming in contact with the paper height sensor feeler, it may ride up and press against the feeler and the load from this may hinder the movement of the feeler. In this case, even if the shift tray lowers down, the paper height sensor feeler fails to turn OFF, and the lowering time of the shift tray ends up exceeding 300ms, and the unit ends up sensing it is full.

This is likely to occur if paper of a certain width is output to the shift tray, the unit may detect being full prematurely. (Paper between roughly 191 mm to 261 mm wide)

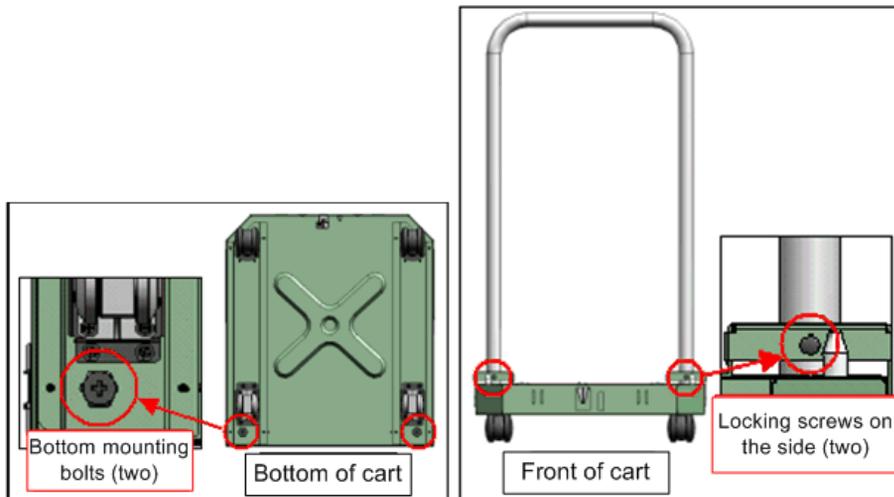
w_d194e6191a

There have been cases of screws [A] to the handle of the cart loosening.

The torque on the mounting bolt of the handle on the bottom of the cart is too low, so when the cart is loaded with paper and it is pushed/pulled repeatedly, the mounting bolt may get loose. This is likely to occur if the torque on the mounting bolt of the handle is less than 18Nm.

If the cart's handle starts to rattle, or if the paper holder fails to be effective because of loosening, re-tighten the mounting bolt on the bottom of the handle.

Also, if the locking screws on the side of the handle get loose, re-tighten them.

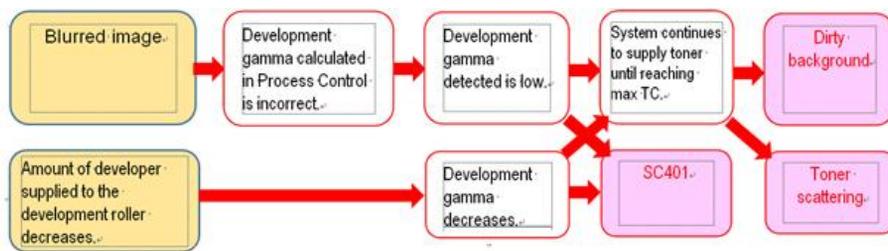
d179b4020

1. Process control fails. The development gamma detected in process control was lower than 3.0 because the ID sensor pattern created on the drum was blurred. (page 62)
2. Due to the degradation of toner over time, and the adhesion of toner on the doctor blade, the amount of developer supplied to the development roller decreased and development gamma becomes lower than 3.0.

- In addition to SC401, toner scatter and dirty backgrounds could also occur because the system supplies too much toner to compensate for reduced development gamma.

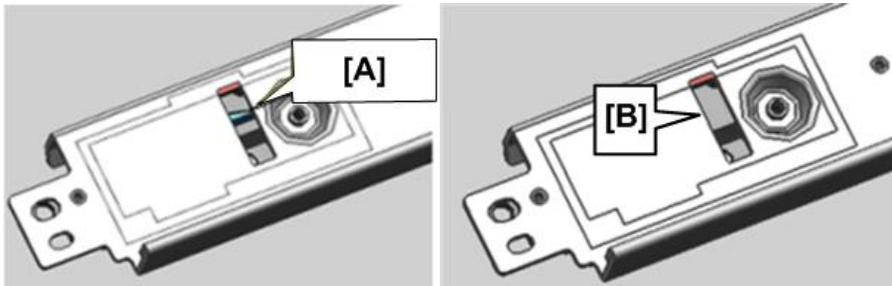
d179b4027

A jammed feeler can cause the machine to issue a false drum lubricant near-end alert.

The feeler that detects lubricant near-end is stuck and caused the system to constantly issue a false drum lubricant near-end alert. This can be caused by removing the drum lubricant components in the incorrect order. Removing the brush roller before the lubricant bar can cause the lubricant bar to pop up and lock the feeler.

1. Confirm that the setting of SP3-810-021 is not "0: Normal" (because the system is notifying a near-end status).
2. Remove the lubricant blade with the bracket attached and the two lubricant near-end sensors.
3. Place the bracket bottom-side-up on a table and check if the feeler is visible [A]. The feeler is not visible [B] if it is stuck out of position.

If the feeler is stuck, correct its position.

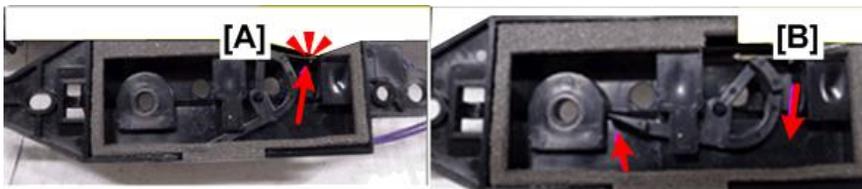
d179b4028

- The feeler is up at [A]. This is the wrong position because the contact causes the near-end alert.
- The feeler is down at [B]. This is the correct position because there is no contact.

4. Reassemble the unit and confirm the setting of SP3-810-021 is "0". If the value is "1" or "2", repeat step 2.
