Model: BR-C1 (D179)		Date: 20-Aug-13	No.: RD179001
Subject: FSM Correction (Notes on main power switch status check / ITB unit removal procedure)		Prepared by: Kazuya Tsutsui	
From: 1st PP Tech Service Sec., PP Tech Service Dept.,			
Classification:	<input type="checkbox"/> Troubleshooting <input type="checkbox"/> Mechanical <input type="checkbox"/> Paper path <input type="checkbox"/> Product Safety	<input type="checkbox"/> Part information <input type="checkbox"/> Electrical <input type="checkbox"/> Transmit/receive <input type="checkbox"/> Other ()	<input type="checkbox"/> Action required <input checked="" type="checkbox"/> Service manual revision <input type="checkbox"/> Retrofit information <input type="checkbox"/> Tier 2

Subject: Firmware Release Note: NetworkDocBox		Prepared by: J.Ohno	
From: 1st PP Tech Service Sect., PP Tech Service Dept.			
Classification:	<input type="checkbox"/> Troubleshooting <input type="checkbox"/> Mechanical <input type="checkbox"/> Paper path <input type="checkbox"/> Product Safety	<input type="checkbox"/> Part information <input type="checkbox"/> Electrical <input type="checkbox"/> Transmit/receive <input checked="" type="checkbox"/> Other (Firmw

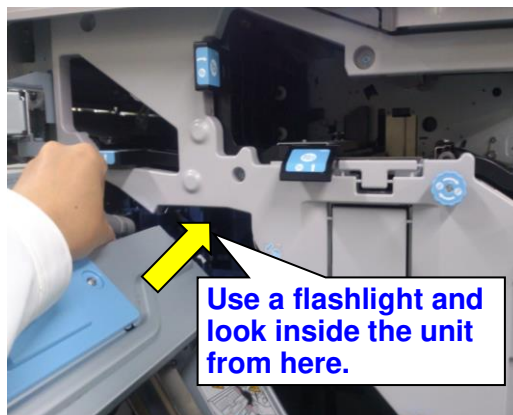
2. Use a flashlight and check the harnesses position from the direction indicated with the yellow arrow in the photo below.

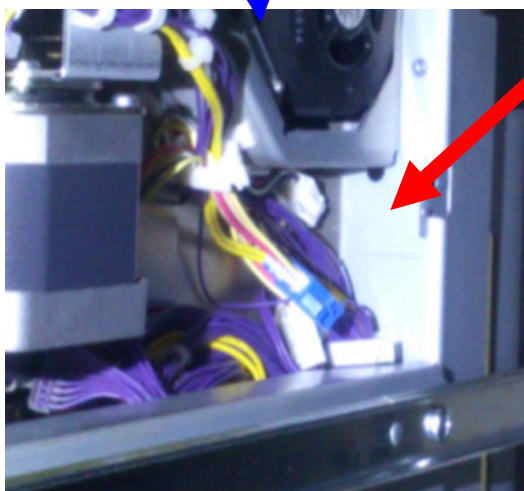
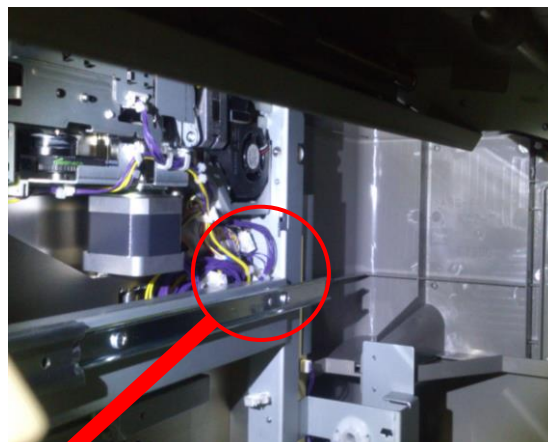
**NOT GOOD**

The bundle of purple harnesses behind the drag roller unit, which are supposed to be to the left of the slide rail in the open space, are falsely positioned above the slide rail. The harnesses are caught when pulling out and pushing in the stapler unit, resulting in loose connection or damage.

If the bundle of harnesses is not in the correct position (above the slide rail), shift them so that they are to the left of the slide rail in the open space, behind the motor.

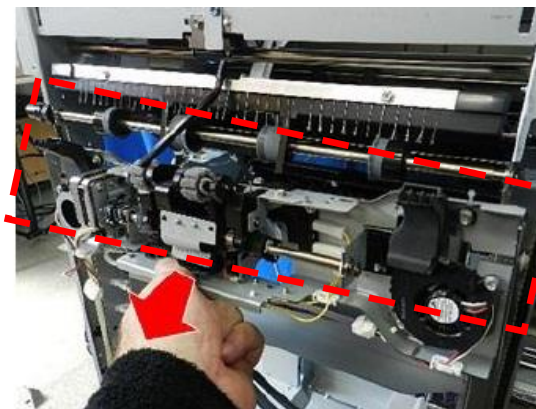
This slight arch prevents the cam from stopping at its home position and causes the TE (trailing edge) press-down levers and the cam to contact in the wrong position.

As a result, the TE press-down levers do not function properly and the sheets are fed on top of the levers instead of below the levers, generating Jam122 followed by SC720-75.

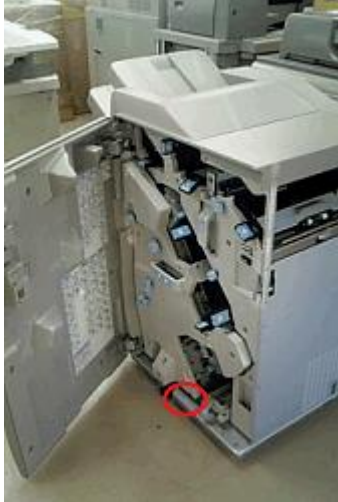
The s/n of the finisher is shown on a label attached to the location indicated by the red circle in the photo below.

The 6th figure from the left (indicated in red) represents the production month. In this example, the unit is of June production. "7" would indicate July production.

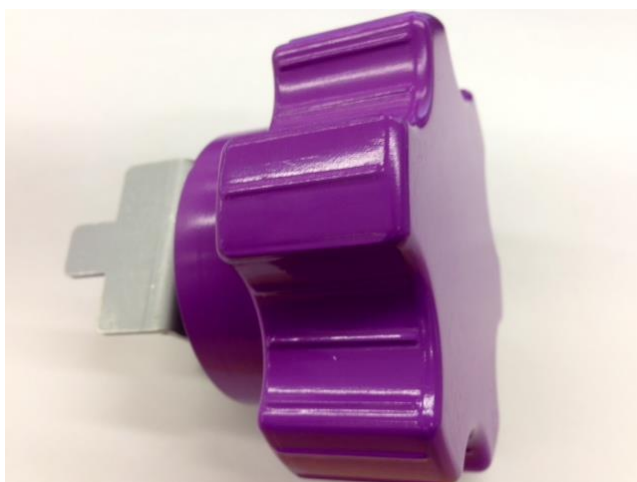
Reason: To prevent drum scratching caused by narrower PG.

Fastening the drum knob incompletely will cause the drum cleaning unit to apply pressure to the drum and narrow the PG at the front side. Then, developer piled up on the Mag roller will scratch the drum.

This tool assists with the tightening drum knob completely, because the drum knob might be incompletely tightened when it is done without the tool.

Add D1792445

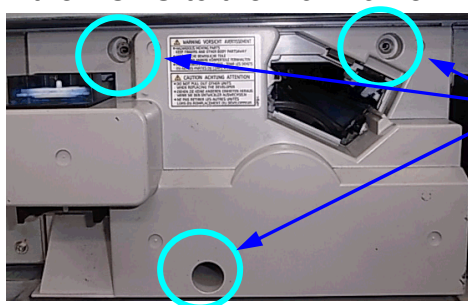
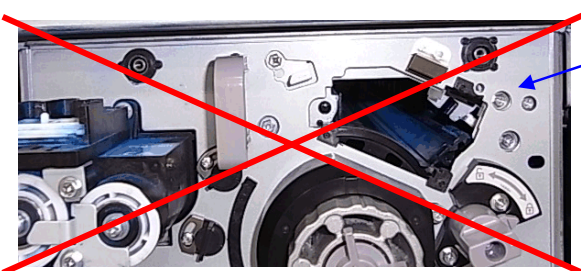
The Inner Cover must always be fastened with the 3 screws circled in blue in the photo below when in operation. Note that these screws not only function to hold the cover but fix the PCDU to the mainframe.

Confirm complete fastening of the 3 screws.

The development unit will be positioned incorrectly when operated without the Inner Cover and the screws, causing scratches on the drum surface and uneven image density.

Never operate the machine without the Inner Cover or the screws.

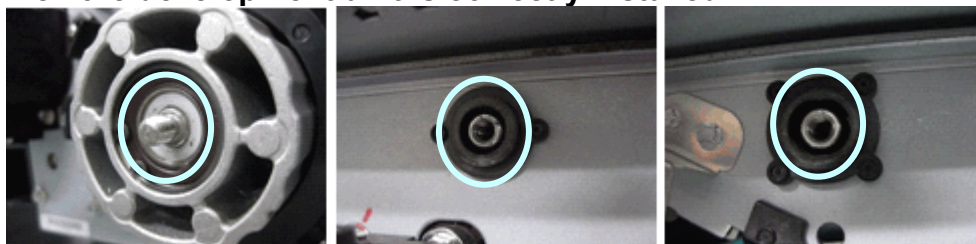
When the development unit is correctly installed...

The surface of the knob and the adjacent area (black-colored) is almost flush, as shown in the left photo. Also, the screw holes for attaching the inner cover should be clearly visible as shown in the center and right photos.

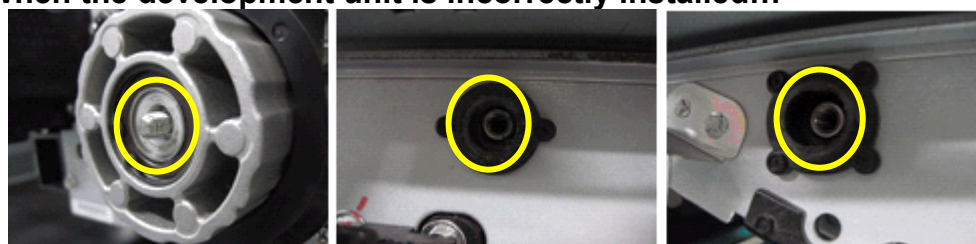
When the development unit is incorrectly installed...

The surface of the knob is clearly protruding against the adjacent area (black-colored) and the screw holes are sunk in and are not clearly visible, as shown in the photos above. In this case, the unit is bounced back towards the front side because the drum internal and drum drive external gears are not properly engaged as shown below.

If the development unit is not correctly installed, pull out the PCDU and slightly reposition the drum so that the internal and external gears are engaged properly.

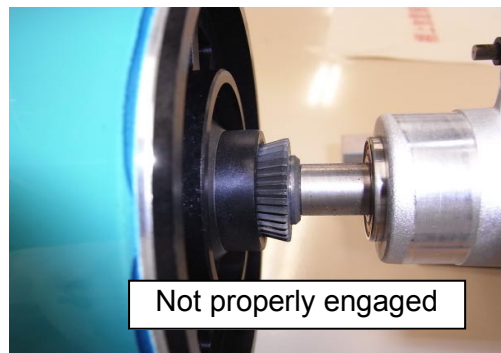
Not properly engaged

When the gears are not engaged properly, the drum cleaning unit pushes the drum towards the direction in which the PG is narrowed. Printing in this condition will cause toner to adhere to the development rollers and generate scratches on the drum surface.

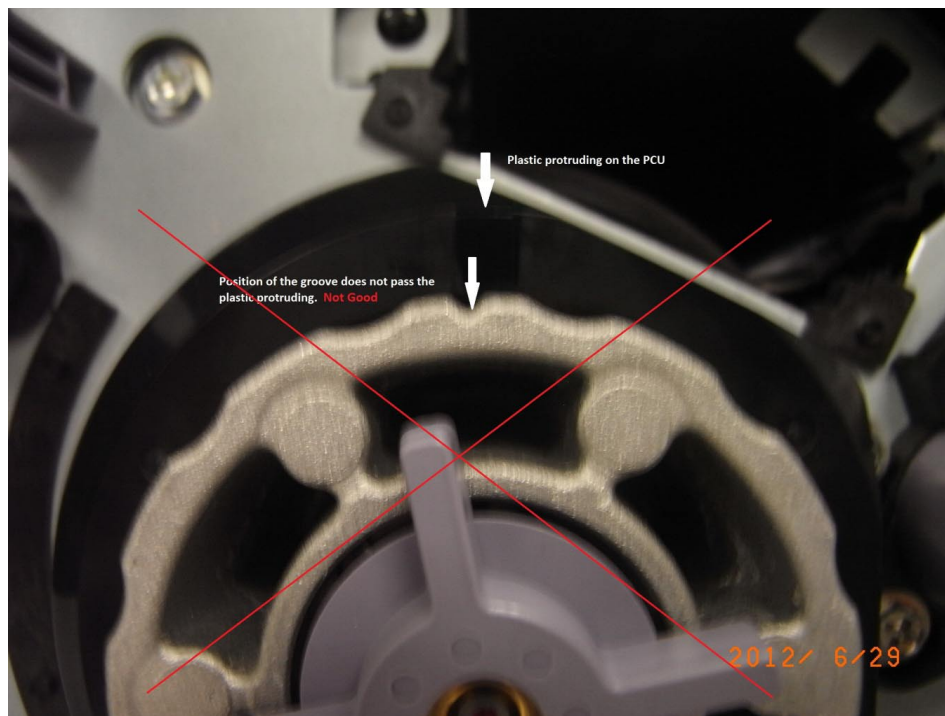
Incorrect Drum Knob Position

If the drum knob is not tightened completely, the PG will be narrower. As a result, drum scratching occurs. With toner adhered on the Mg sleeve, do the following procedure to repair the Mg sleeve so that you are able to use the development unit.

Tighten the Drum Knob so that the groove on the Drum Knob goes past the plastic protrusion on the PCDU as shown in the photo below.

Note: Turn the drum knob until it stops and cannot be further tightened.

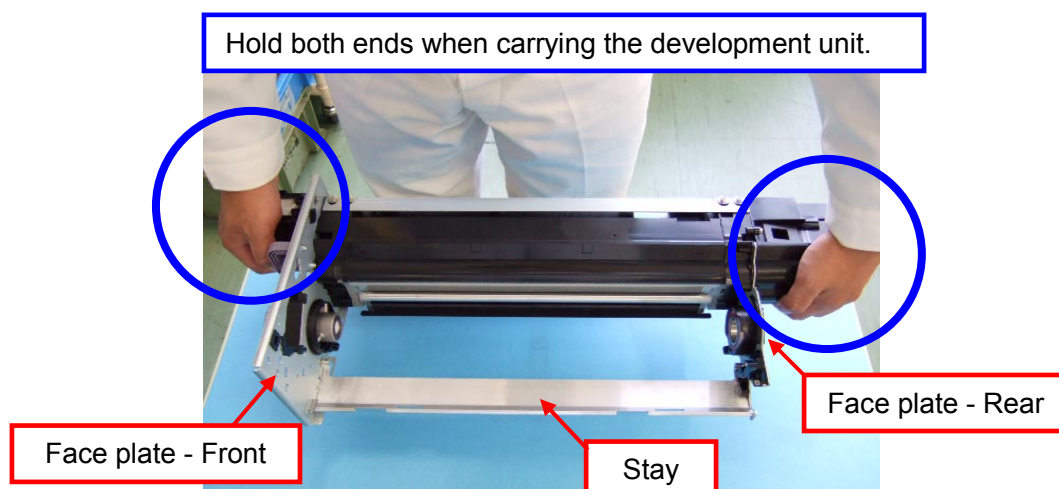
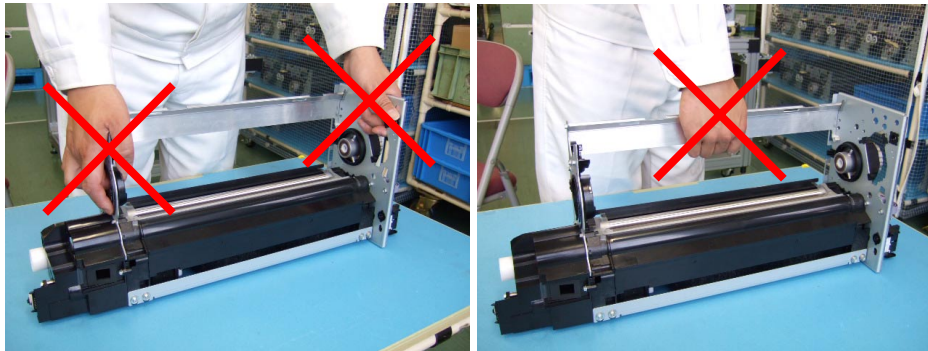
Do not grip the face plates or the stay.

Applying external pressure will deform the front and rear plates in vertical and horizontal directions, resulting in fluctuation of the PG.

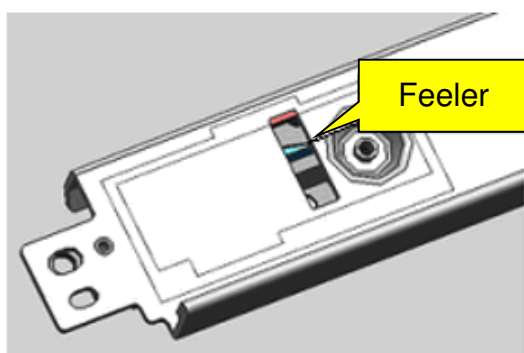
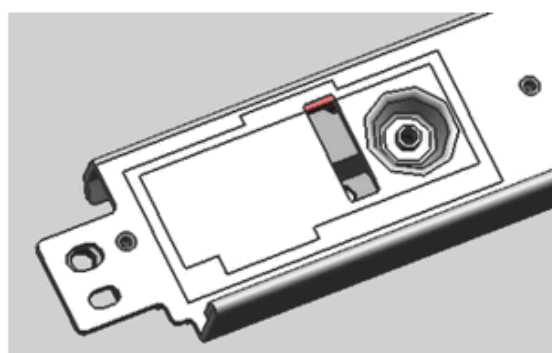
The feeler that detects lubricant near-end is stuck and causes the system to constantly detect and alert near-end status. This may happen if the drum lubrication components are removed in the wrong order. Removing the brush roller before the lubricant bar causes the lubricant bar to pop up and lock the feeler.

1. Confirm the value in SP3-810-021 is NOT "0: Normal" (because the system is notifying a near-end status).
2. Remove the lubricant blade and the bracket attached with the two lubricant near-end sensors.
3. Place the bracket bottom-side-up on a table and check if the feeler is visible.
(The feeler is not visible, if stuck.)

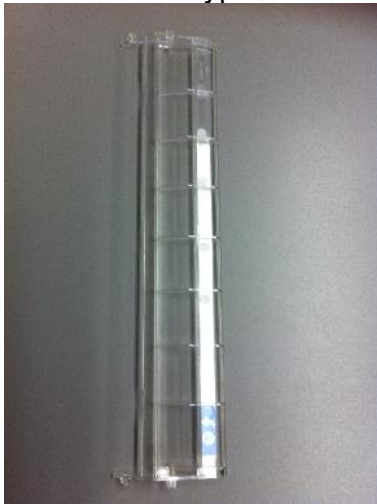
Plastic cover type **A**: 7 ribs on the top

In addition to the aforementioned CAUSE, Jam 80 also occurs when static electricity causes the paper to adhere to the upper plastic cover of the registration unit.
In this case, do the following.

- 1) If the plastic cover is of type 'A', replace with type 'B' (p/n: D1792663).

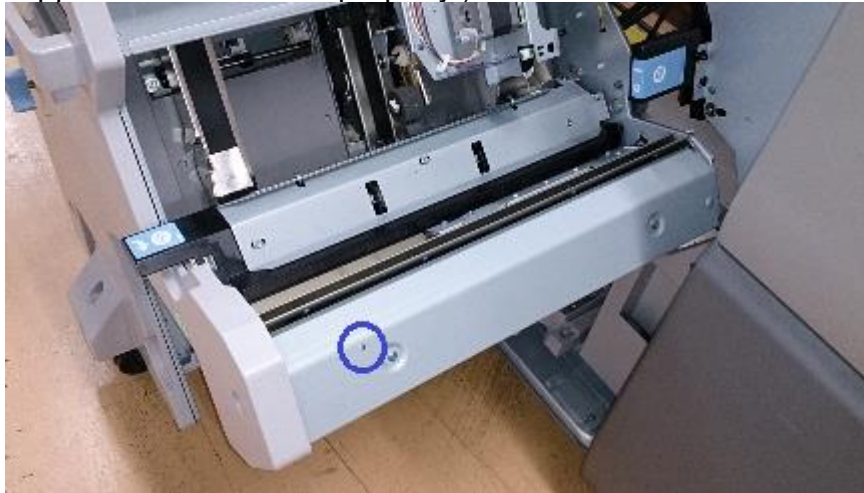
1. Pull out the stack/staple unit and check that the screw hole circled in blue in the photo below has no screw. (This screw should be removed at installation. Running the machine with this screw fastened will cause SC720-35, because the trailing edge stopper will not function properly.)

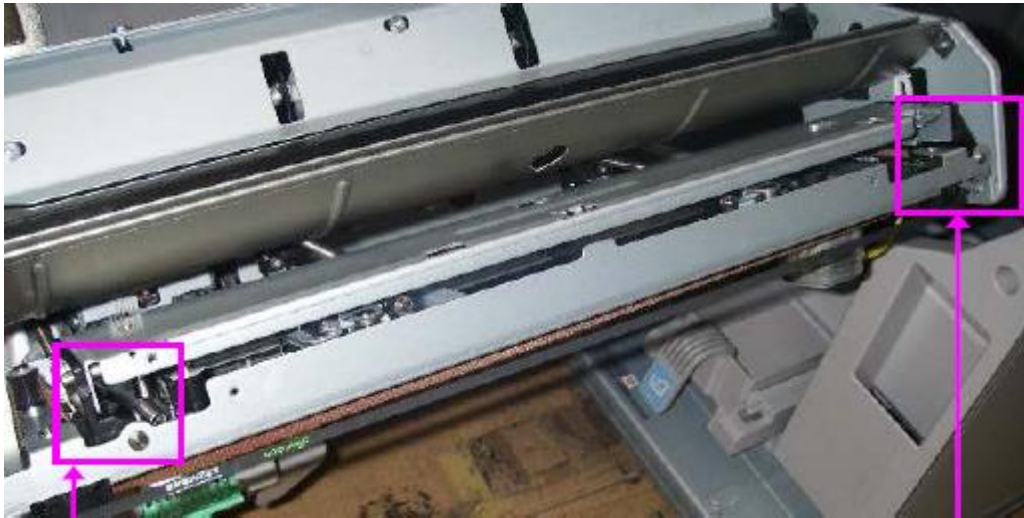
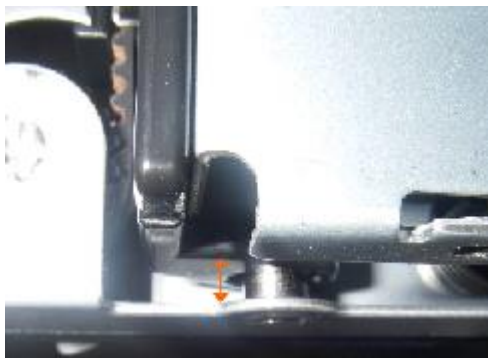
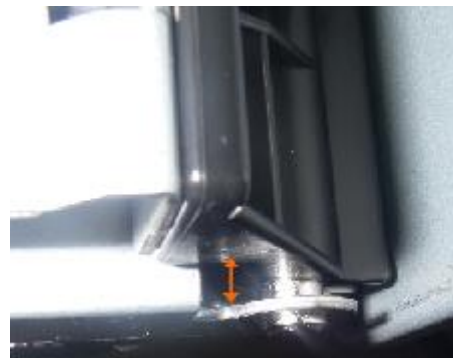
1. Measure the gap between the top piece of the corner stapler stack unit and its supporting plate at both front and rear sides with a scale.
The gap should be approximately 2.6mm +/- 0.8mm at both Front and Rear sides.

If ***the measured gap difference between front and rear is larger than 2.0 mm***, excess load could be put on the corner stapler stack unit, causing the SC.

Do 'Adjustment A', ***when the gap at the front is larger than at the rear***. if the difference between the front and rear measurements is 2mm or less.

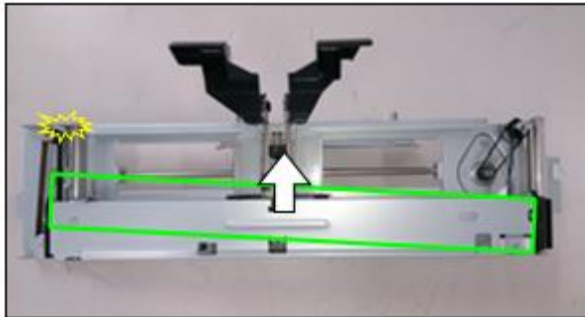
A: Larger gap at the front

- **Larger gap at the front:** A moving part collides with the frame during operation, and it causes the motor overload.
- **Larger gap at the rear:** A moving part collides with the frame when returning to home position, and it causes the motor overload.

Adjustment A: If the gap at the front is larger than at the rear. Difference between the front and rear measurements is 2mm or less

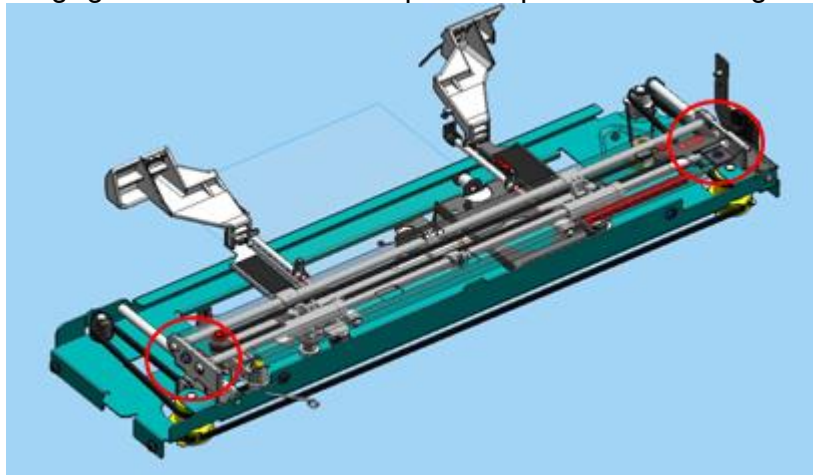
- B-1. Remove the corner stapler stack unit. (See 'Adjustment A' above for the procedure.)
- B-2. The timing belt could be fixed in the wrong groove at either of the 2 locations circled in red, causing an uneven tension. If so, slide the timing belt so that its engagement with the black piece slips to a different groove on the belt.

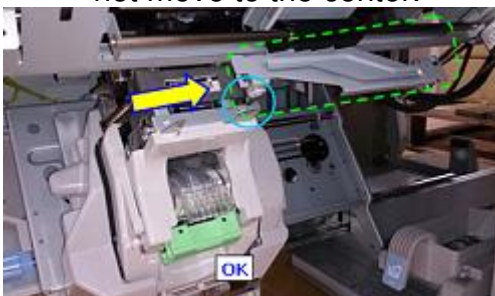
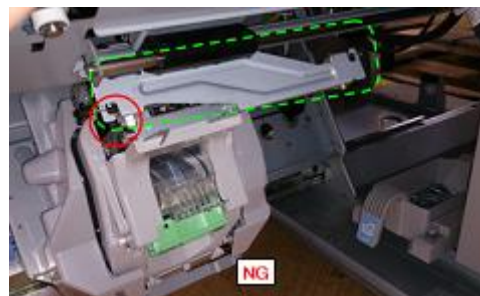
Good: The corner stapler stack unit follows the corner stapler unit and moves to the center.

Bad: The corner stapler stack unit does not follow the corner stapler unit and does not move to the center.

2. If the corner stapler stack unit moves together with the stapler unit, complete the procedure.

If the corner stapler stack unit does not move together with the stapler unit, do the next step.

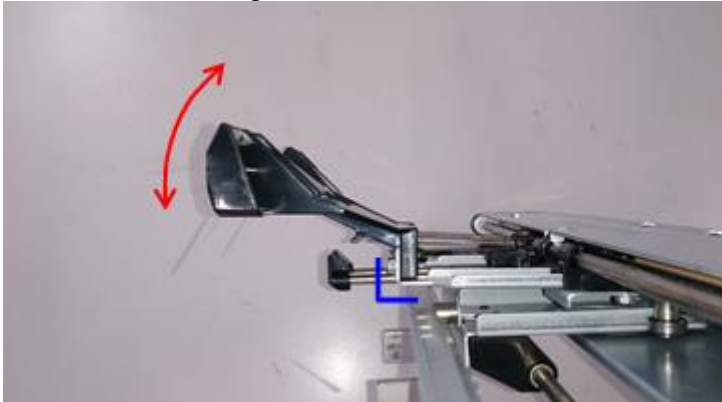
5. Confirm no damages or deformation of the two black arms.

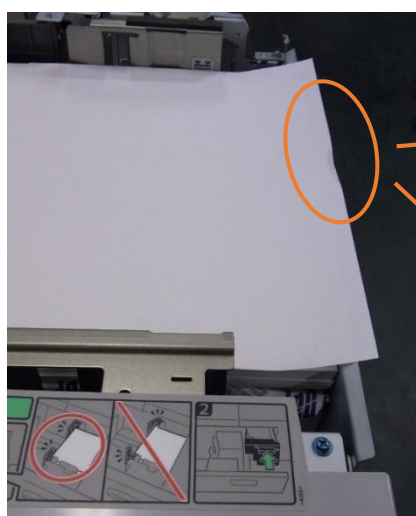
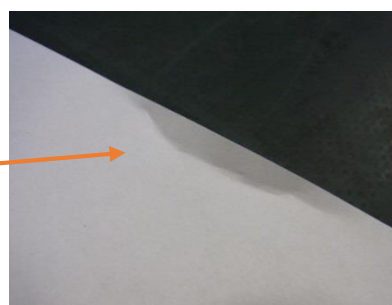
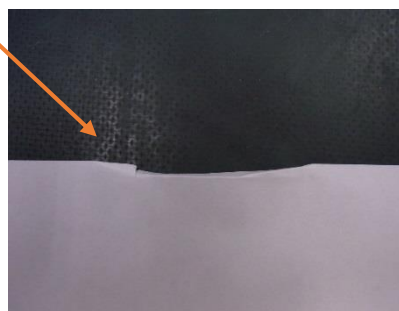
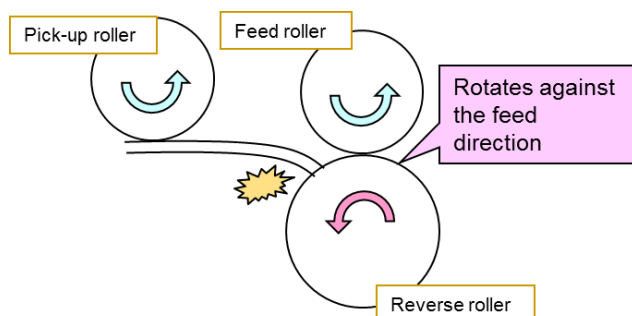
Using paper with high ash content (calcium carbonate) causes frequent no-feed jams, and the feed and reverse rollers need to be replaced before reaching end of life.

- No-feed jams start to occur at approximately 50K.
- The rollers are not abraded and have not reached end of life.
- Paper dust is powder-like, not grainy.
- Damage to the leading edge of paper as shown below

The torque limiter in the reverse roller does not function because the rollers are slippery with paper dust. This causes the reverse roller to rotate against the feed direction and the leading edge of the paper to hit the reverse roller.

If the paper in use by your customer is high in ash content and the machine is experiencing frequent no-feed jams, replace the feed and reverse rollers in the mainframe paper feed unit with these rollers.

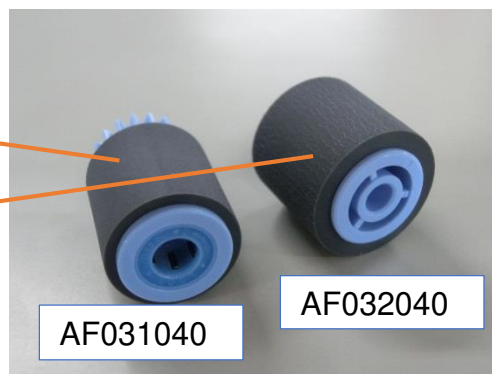
Life of the EPDM rollers is 300K and is shorter than the default urethane rollers (1000K).
Replace with the EPDM rollers ONLY if the jams are critical.

- Pick-up roller [1] → No need to replace
- Feed roller [2] → Replace with **AF031040**
- Reverse roller [3] → Replace with **AF032040**

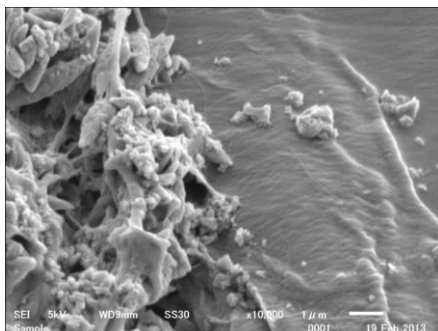
Standard paper

Photomicrographs below show how the ash particles are formed on the paper surface. The photo to the right shows a paper typical of this problem. This paper is not only high in ash content, but the ashes are formed in miniscule particles. Due to the miniscule size of the particles, the particles tend to easily come off and adhere to the rollers.

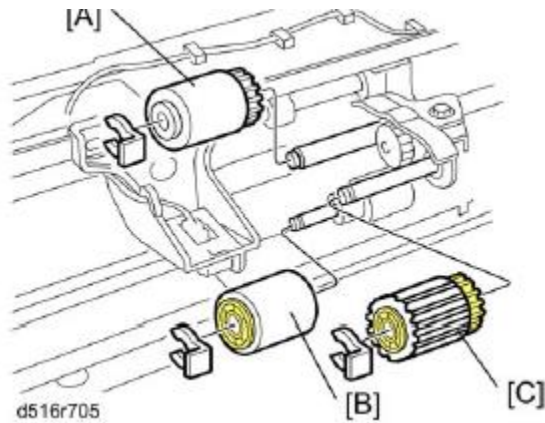
The pick-up roller [A] also needs to be replaced for the LCT.

- Replace pick-up roller [A] with EPDM roller p/n: **AF030071**.
- Replace feed roller [C] with EPDM roller p/n: **AF031071**.
- Replace reverse roller [B] with EPDM roller p/n: **AF032041**.

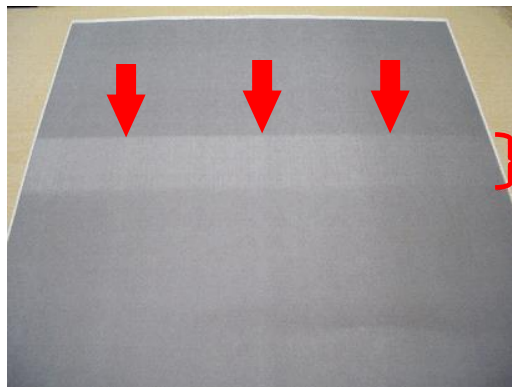
Halftone and text images appear low in density or blurred. The symptom is observed across the width of the drum charge unit in intervals corresponding to the drum circumference.

Low density

Width of the drum charge unit

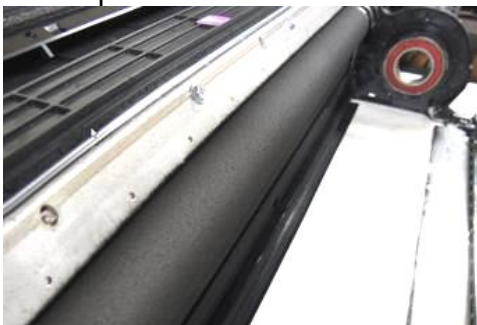
- Before cleaning the doctor gap, ensure old developer is not remaining on the development roller as shown in the photo below.

- After cleaning the doctor gap with the cleaning tool (p/n: D1793420), use a vacuum cleaner to completely remove the toner particles.

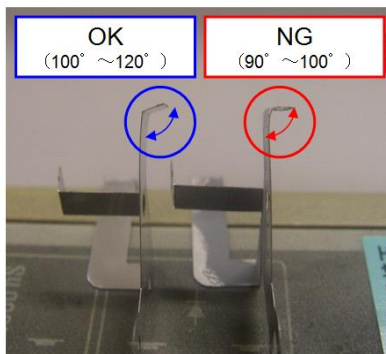
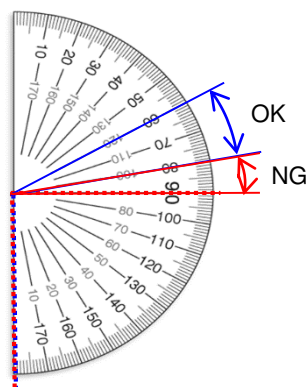
Remove the grounding plates (p/n: D1793669) from the unit and check the angles.

Clean, if dirty with toner or grease, and replace with new grounding plates, if deformed or have poor contact.

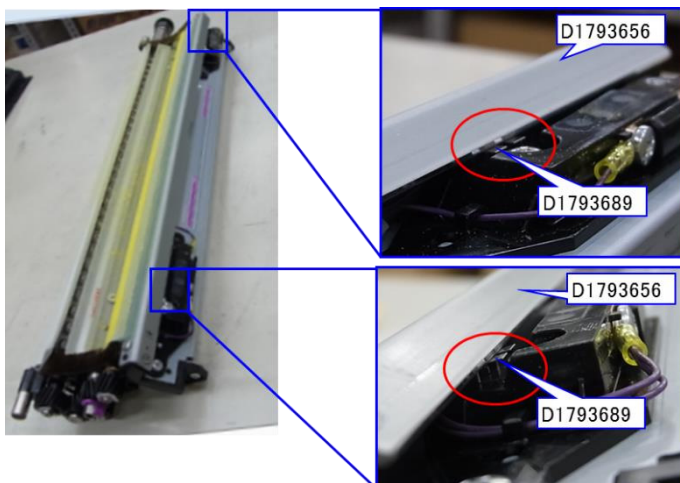
● No. 2 D1793689 GROUND PLATE:COVER:APPLY

Check the connection of the grounding plates (p/n: D1793689 x2) with the frame (p/n: D1793656) of the cleaning blade assembly at two points, front and rear.

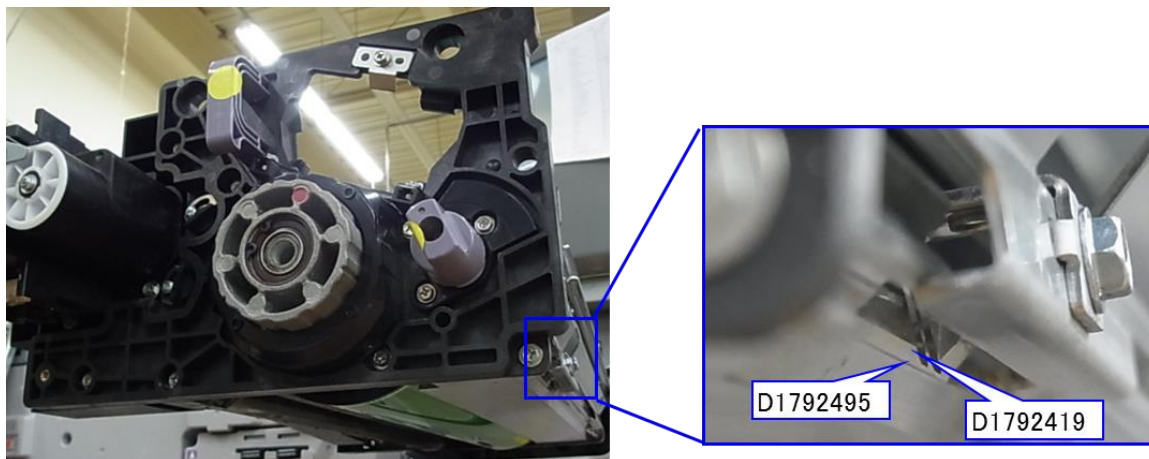
- No. 3 D1792419 STOPPER:SLIDE RAIL:PCU:PEEN

Check the connection of the grounding plate (p/n: D1792419) with the stay (p/n: D1792495).

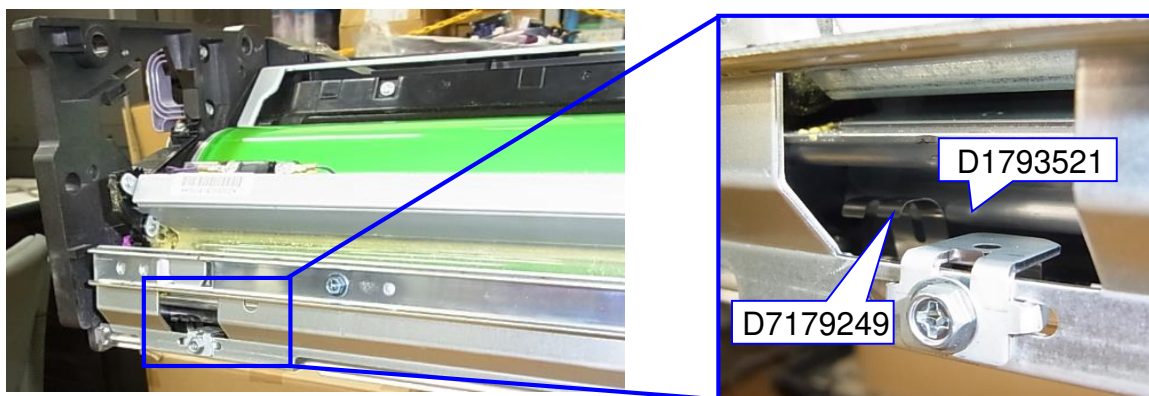
- No. 4 D1792494 GROUND PLATE:STAY:PCU

Check the connection of the grounding plate (p/n: D1792494) with the frame (p/n: D1793521).

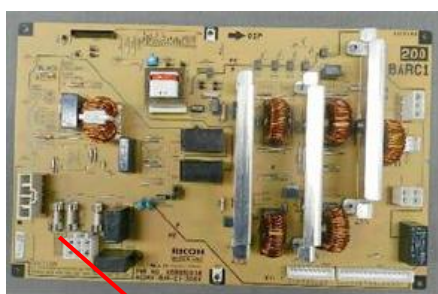
AC Drive Board

Machine power does not turn on as a result of a damaged PSU-A (PSU-ECO) and a blown fuse FU401 on the AC drive board.

Fu401

If the problem occurs, replace the PSU with the PSU of the 2nd modification, AZ240259 or D1389907, and ~~FU401, D1795445 or 11071344~~ **FU401, 11071344 mounted on the AC drive board (p/n: D1795445).**

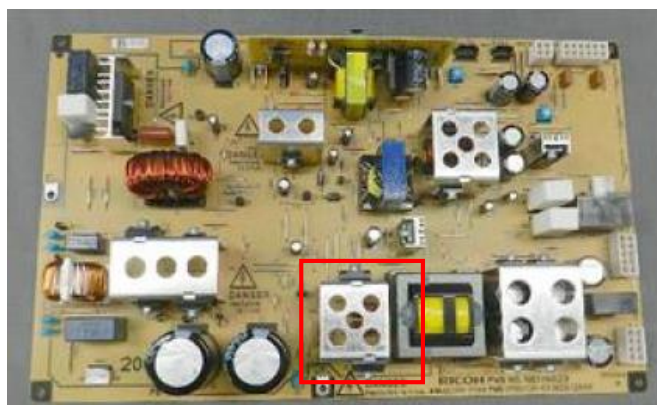
PSU-A (PSU-ECO)

Q3, Q4

1. Internal voltage of the PSU increases abnormally to approximately 500V, while the target is set to 'input voltage x $\sqrt{2}$ ' (339Vdc at 240Vac input).
2. Excess voltage causes the switching circuits Q3 and Q4 on the PSU to activate simultaneously.
3. Simultaneous activation of Q3 and Q4 generates electrical surge and damages Q3, Q4 and the fuse.

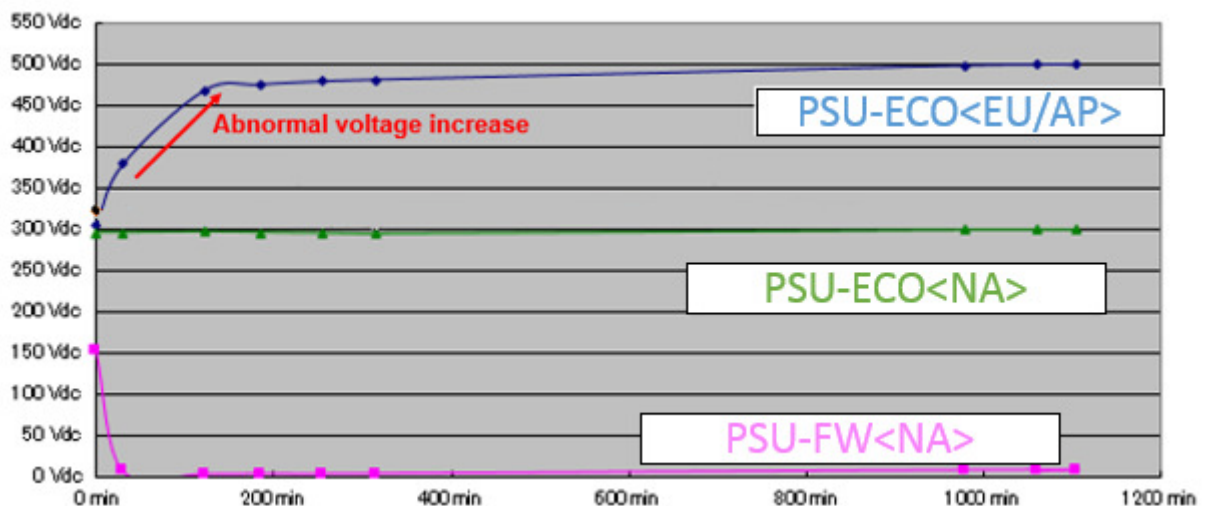
Internal voltage of the PSU increases when both of the following conditions are met:

- Voltage supply via delta connection (EU and AP models)
- Machine was left unused with the power cord plugged in for more than 200 min either after entering energy saving mode or after turning off the power with the push switch.

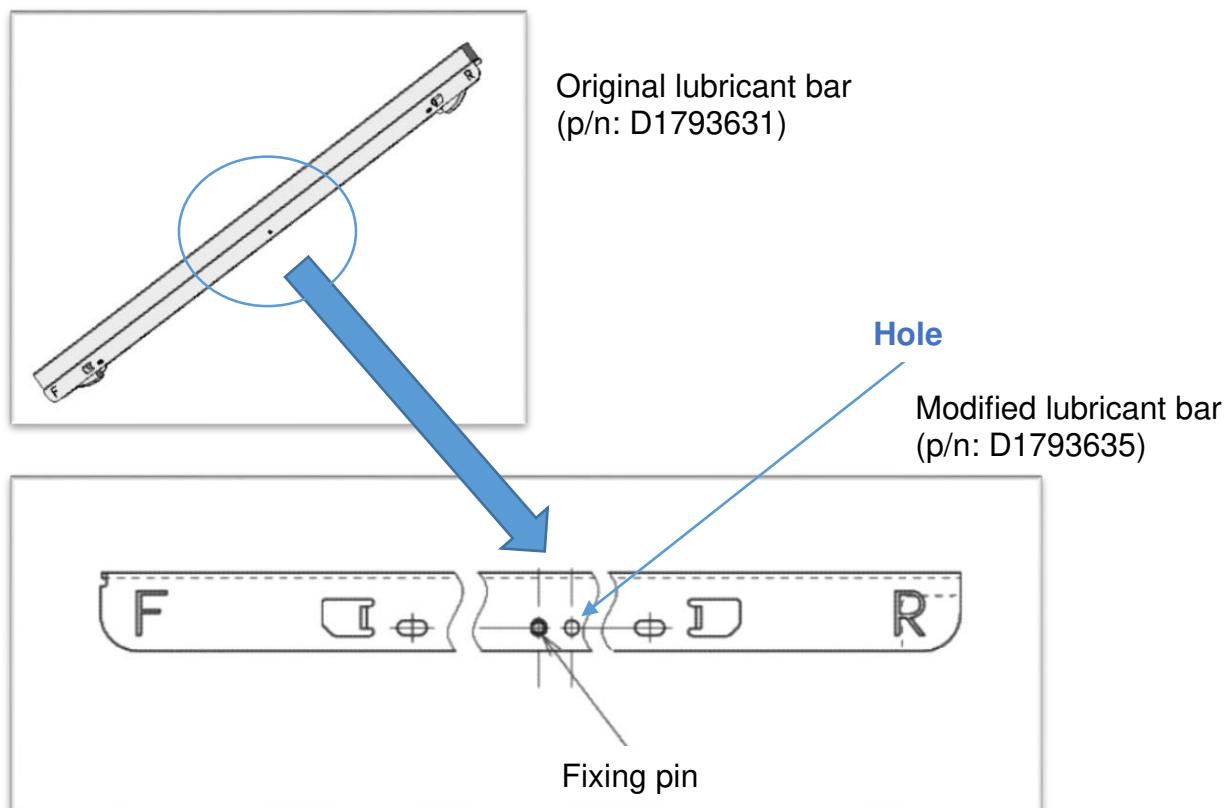
Reason: The original drum lubricant bar could not last the prescribed 600k yield depending upon the machine usage conditions.

On the modified lubricant bar, there is a hole next to the fixing pin.

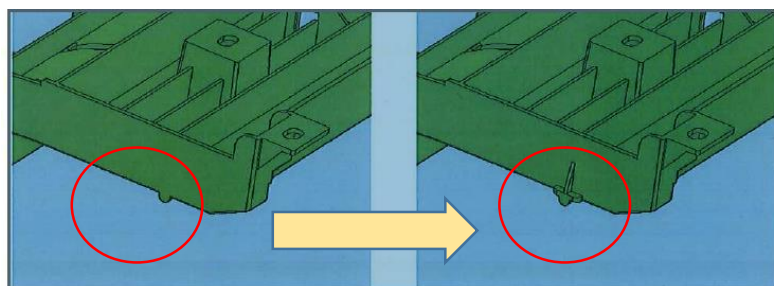
Detail of the modification

Originals fed through the ADF may interfere with the projection (circled in red) located on the edge of the guide plate and result in jams, especially when the side fence is stretched to the maximum width. To prevent this, the projection was shifted (2.7mm) toward the outside, allowing wider path for the original.

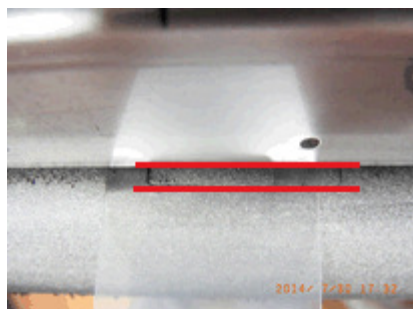
Good: 3.0mm

- The width of the cut-out should be approximately 3mm while cleaning.

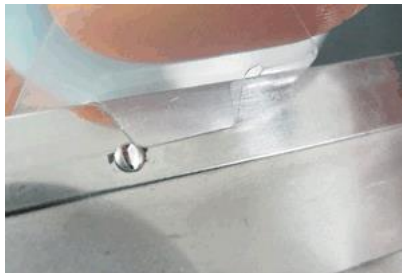
- Pulling the jig too hard may cause the following adverse effects:
 - Damage, quick wear of the jig
 - Stress on the doctor blade
 - Interference of the flap on the jig with the rivet on the rear side of the blade
(Do not attempt to clean the rivet with the flap. Developer adhered to this rivet will not affect the image.)

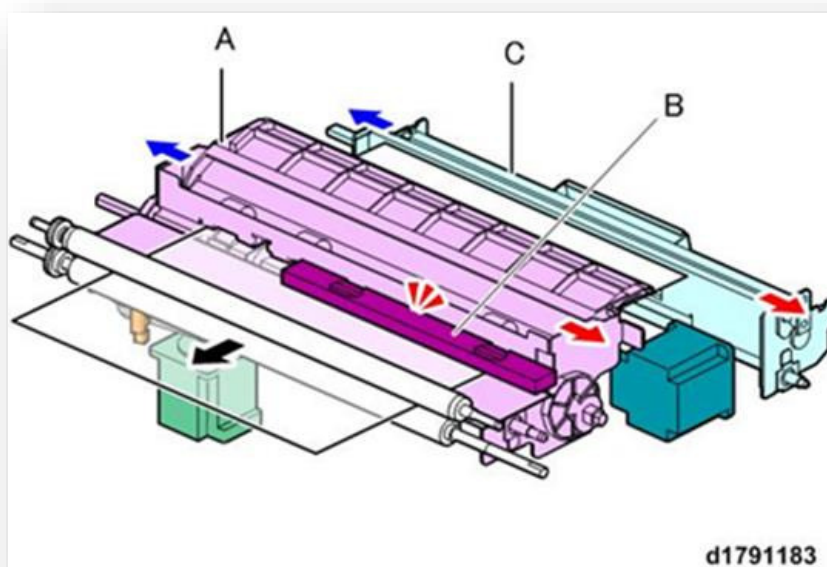
The LE (leading edge) shift unit is equipped with a CIS (Contact Image Sensor) [B] that detects the leading edge of the paper by detecting the reflection from the paper. Since the strength of the reflection depends upon the color of the paper, specifying the wrong color in Tray Paper Settings will cause incorrect CIS readings and result in jams.

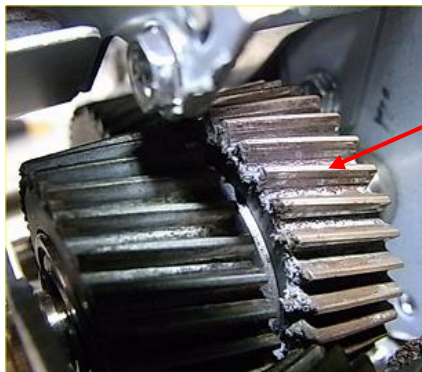
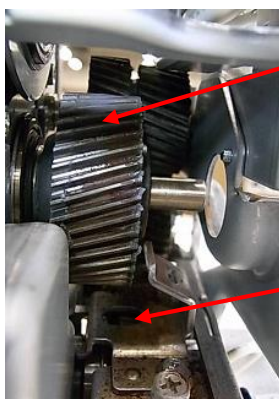
The fusing drive gear is worn and rusted. Rust particles may be observed on the idle gear and around the unit.

Check if the teeth of the fusing drive gear are worn and rusted.

Check if rust particles are adhered to the idle gear.

To prevent abrasion/corrosion of the fusing drive gear, inspect the gear on your next service visit and take actions according to the condition of the gear as described below.

If the teeth of the gear are severely worn, replace with a new gear (p/n: AB014285). Similarly, clean with a dry cloth before applying grease when installing the new gear.

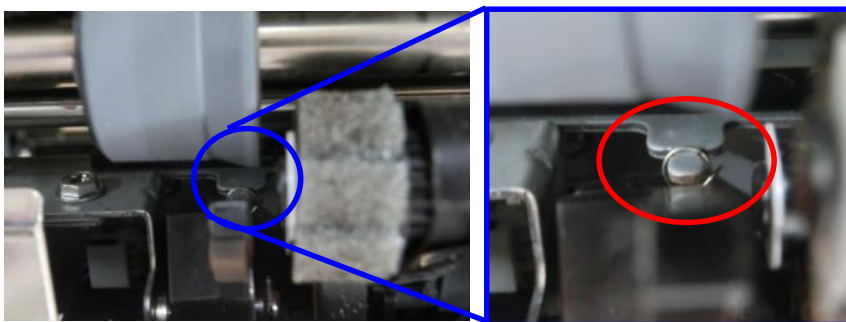
Jam109 or SC720-17 or SC720-75 occurs as a result of a broken spring attached to the TE (trailing edge) press-down lever.

Since the modification of the spring in Apr 2014 (p/n: D734 6349 → p/n: D734 6251), a biased load is put on the spring, depending on the direction in which the spring is attached to the TE press-down lever, and eventually causes the breakage.

3. Check whether the edge of the spring is facing to the left or to the right hand side.

Facing LEFT: ~~BAD~~
→ **GOOD**

If the end of the spring faces to the ~~LEFT~~ **RIGHT**, reattach the spring in the opposite orientation by following the procedure below.

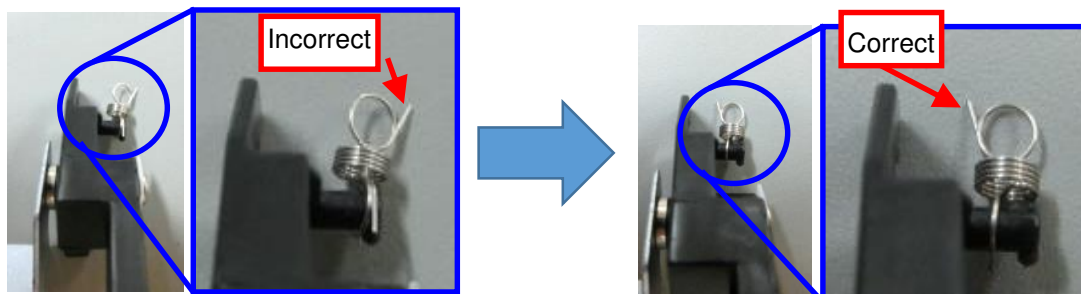
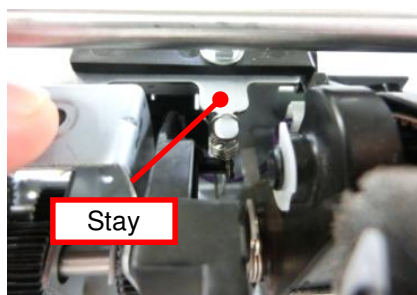
Make sure the edge of the spring faces to the left hand side.

- Detach the spring and reattach it in the opposite orientation so that the edge of the spring faces the direction as shown in the correct example below.

- Hook the spring to the stay and reconfirm correct orientation of the spring.

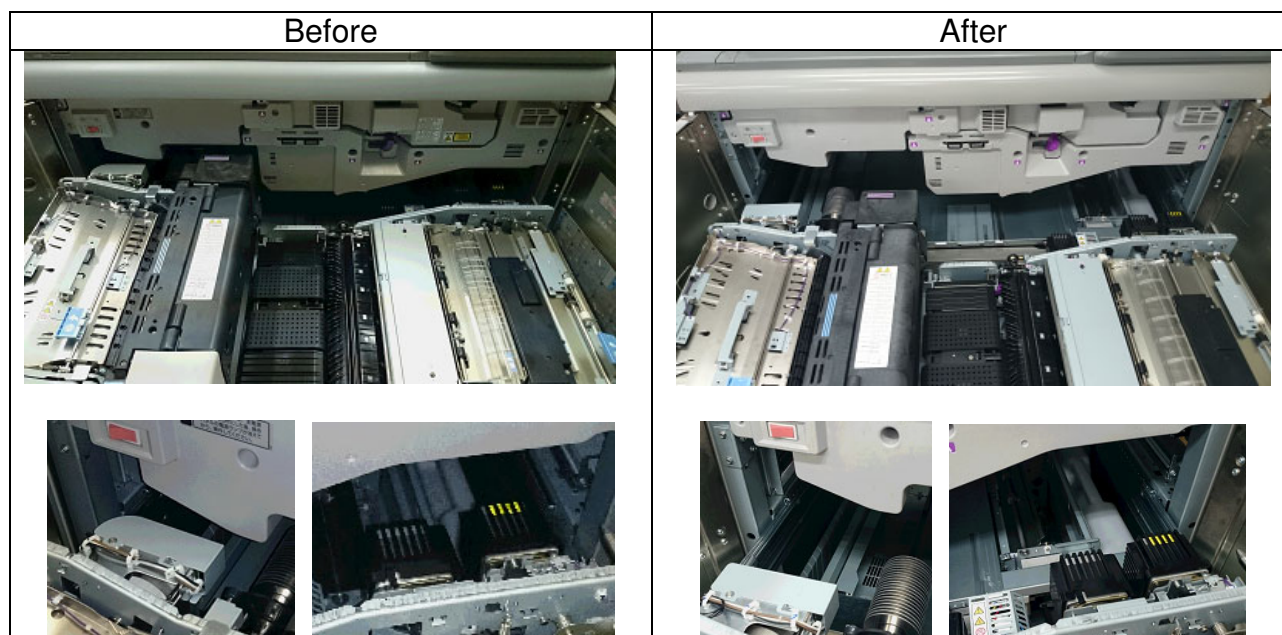
Reason: The slide rails of the drawer unit were extended 100mm for better reach inside the unit. The wider gap created between the unit and the frame enables easier jam removal.

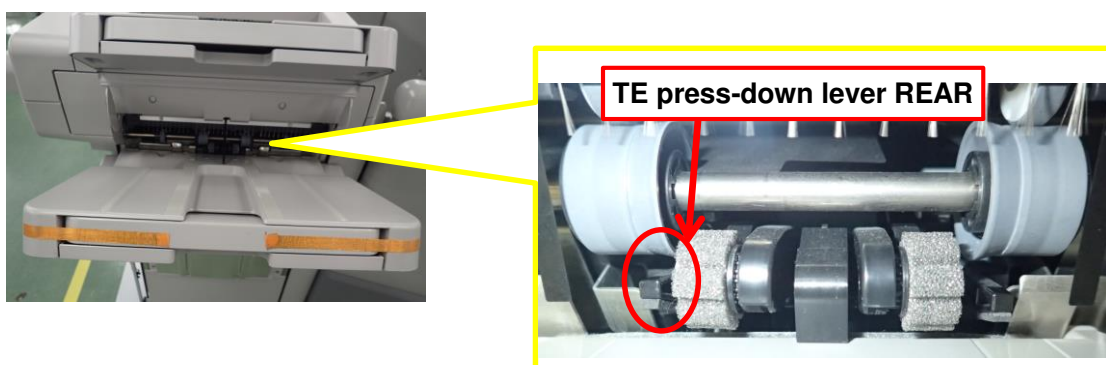
RTB Reissue

A component of the bracket (p/n: D734 6334) of the TE press-down lever was inaccurate in its dimensions, preventing the cam of the lever from stopping at the correct position.

NOTE: The TE press-down lever is installed at the front and rear sides respectively. The problematic bracket is the bracket at the **REAR** side.

To see if the TE press-down lever is functioning properly, do the check procedure on the following page on your next service visit or if the jam or SC occurs. Replace the drag roller unit, if necessary.

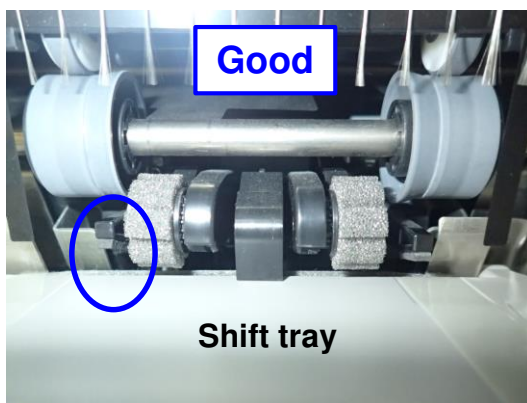
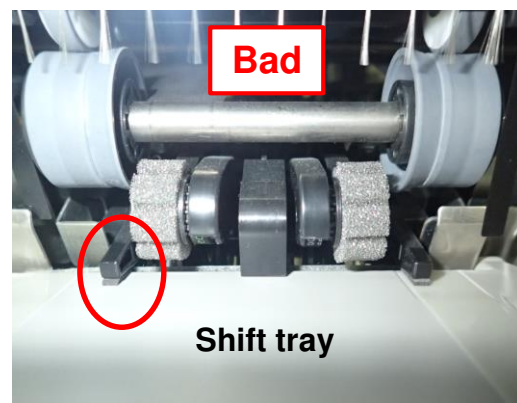
1. Power cycle or open and close the front door of the finisher to run the initialization process.
2. Press the rear TE press-down lever with your finger with moderate pressure. The lever should not move on a properly working unit. However, if the lever sinks and touches the shift tray, the unit is defective.
3. Run 2 copies of a 2-sheet booklet; 2 center staples on A4/LT paper. The job should result in SC720-70, if the unit is defected.
4. Repeat Step 2.

5. If the lever sinks and touches the shift tray in Steps 2 and 4, replace with a new drag roller unit (p/n: D179 9003).

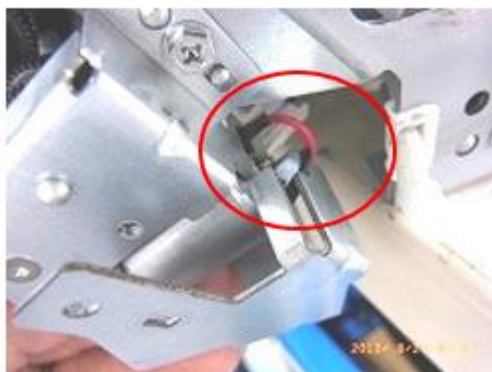
Bad

This photo shows a bad example of the wire sticking out.

Route the wires so that they do not interfere with the bracket.

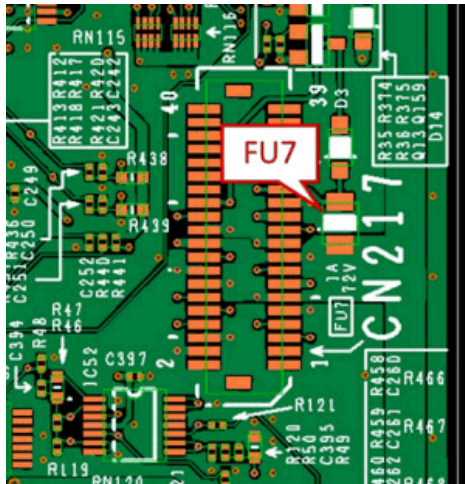
If the fusing web motor does not function properly even after replacing with the modified one, disconnection of the fuse (FU7) on the IOB might be the problem. Check the IOB with the following procedure.

- FU7 is located beside CN217, at the right edge of the IOB slightly below the center.

- Power off the machine and use a tester to measure the resistance between the electrodes of FU7.
 - If the resistance is around 0 Ohms, the IOB is not defective.
 - If the resistance is 100 Ohms or higher, the IOB is defective.

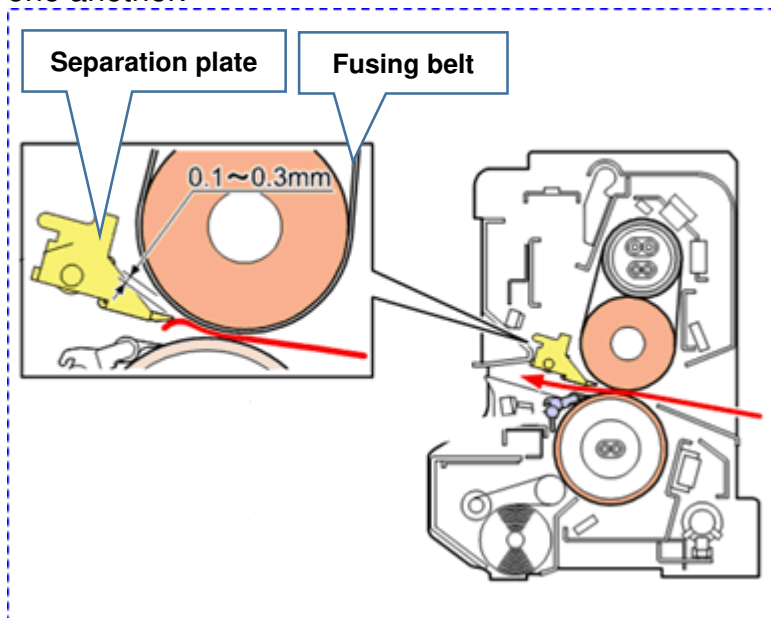
Positioning of the fusing separation plate and fusing belt

The 2 stoppers (p/n: D1794153) that are supposed to be attached to the fusing separation plate are missing due to incorrect assembly at the factory. Without these stoppers, the fusing separation plate contacts the fusing belt and scratches the belt.

With the stoppers attached, a gap of 0.1~0.3 mm is secured between the fusing separation plate and the fusing belt, whereas without the stoppers the two components interfere with one another.

If the symptom is reported by your customer, check the fusing unit by following the check procedure on the next page, and replace the fusing unit with a new one if the stoppers (p/n: D1794153) are missing.

NOTE: Fusing units found with missing stoppers can continue to be used by replacing the fusing belt and attaching the stoppers.

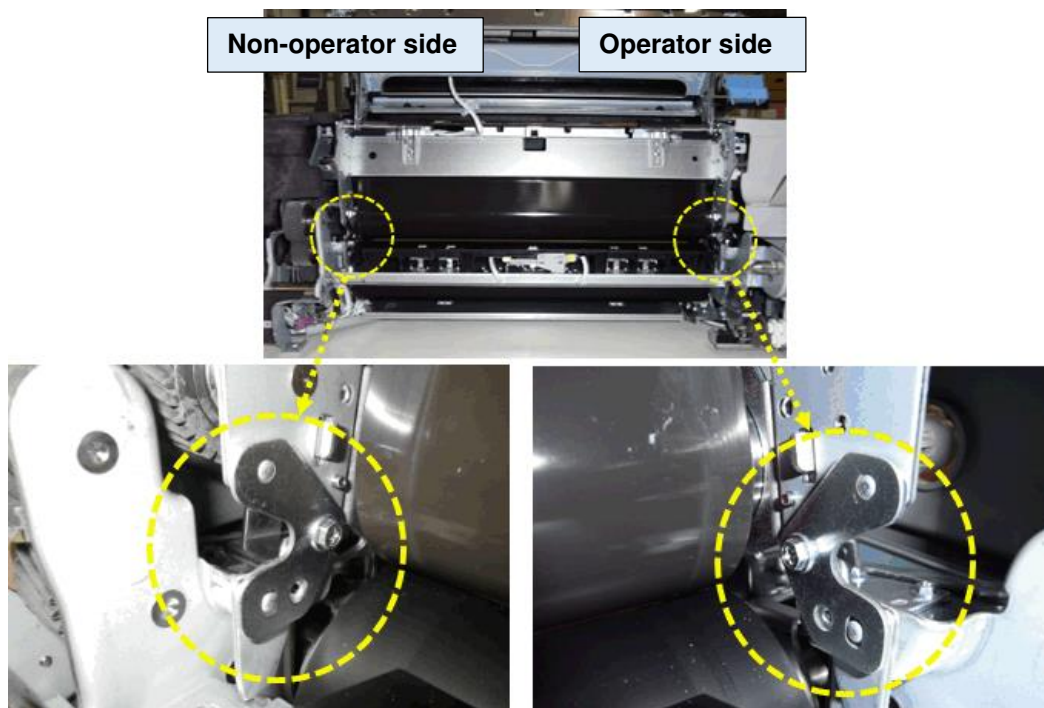
2. Check if the stopper is attached (one each to the operator side and non-operator side).

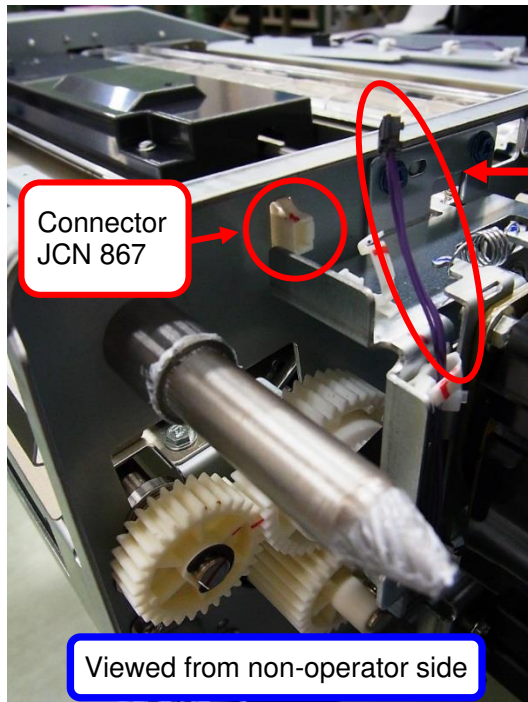
Connector
JCN 867

p/n: D1795363

5. Disconnect the harness (p/n: D1795363) connected to the rear side of the drawer unit from connector JCN 867 mounted on the drawer unit frame.
