Model: BR-C1 (D179)		Date: 20-Aug-13	No.: RD179001
Subject: FSM Correction (Notes on main power switch status check / ITB unit removal procedure)		Prepared by: Kazuya Tsutsui	
From: 1st PP Tech Service Sec., PP Tech Service Dept.,			
Classification:	<input type="checkbox"/> Troubleshooting <input type="checkbox"/> Mechanical <input type="checkbox"/> Paper path <input type="checkbox"/> Product Safety	<input type="checkbox"/> Part information <input type="checkbox"/> Electrical <input type="checkbox"/> Transmit/receive <input type="checkbox"/> Other ()	<input type="checkbox"/> Action required <input checked="" type="checkbox"/> Service manual revision <input type="checkbox"/> Retrofit information <input type="checkbox"/> Tier 2

Subject: Firmware Release Note: NetworkDocBox		Prepared by: J.Ohno	
From: 1st PP Tech Service Sect., PP Tech Service Dept.			
Classification:	<input type="checkbox"/> Troubleshooting <input type="checkbox"/> Mechanical <input type="checkbox"/> Paper path <input type="checkbox"/> Product Safety	<input type="checkbox"/> Part information <input type="checkbox"/> Electrical <input type="checkbox"/> Transmit/receive <input checked="" type="checkbox"/> Other (Firmw

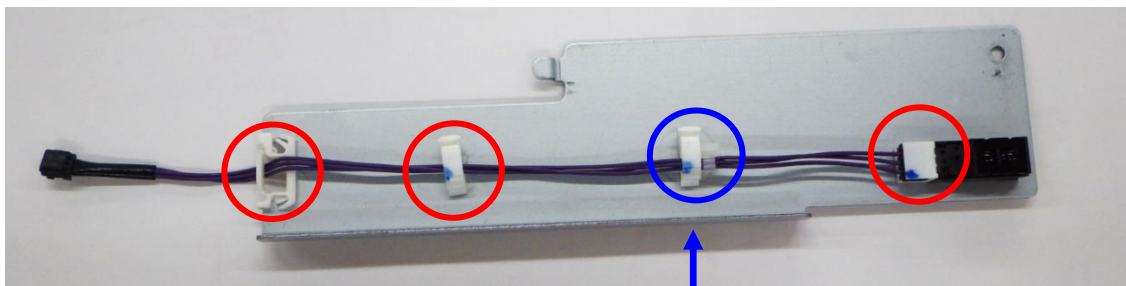
Binder is to the **RIGHT** hand side of this clamp.

IMPORTANT: Make sure the binder is to the right side of the clamp circled in blue.

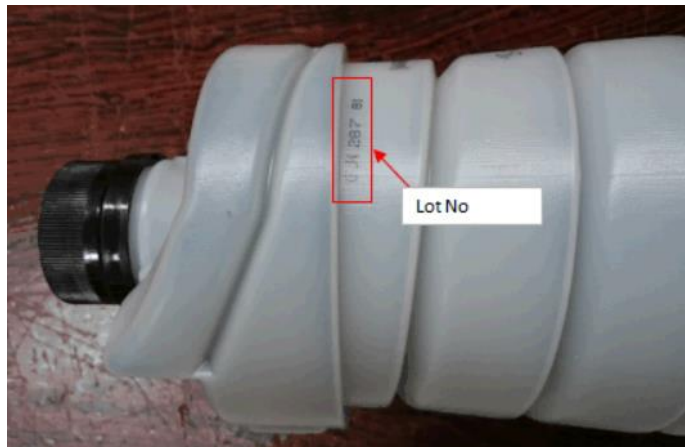
The lot number is indicated here:

Cut-in Lot Number: 6J4 299 82 or later

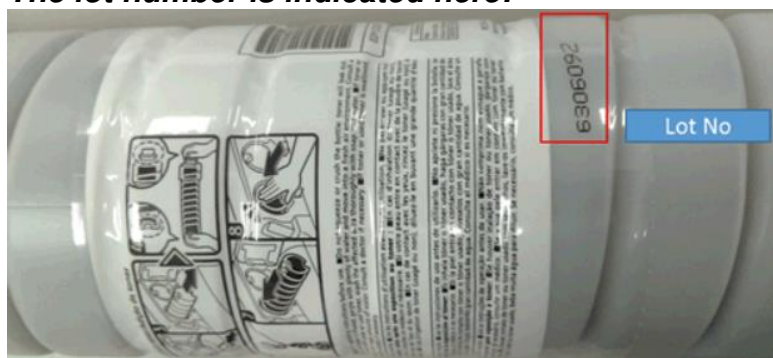
The lot number is indicated here:

Cut-in Lot Number: 6279091 or later

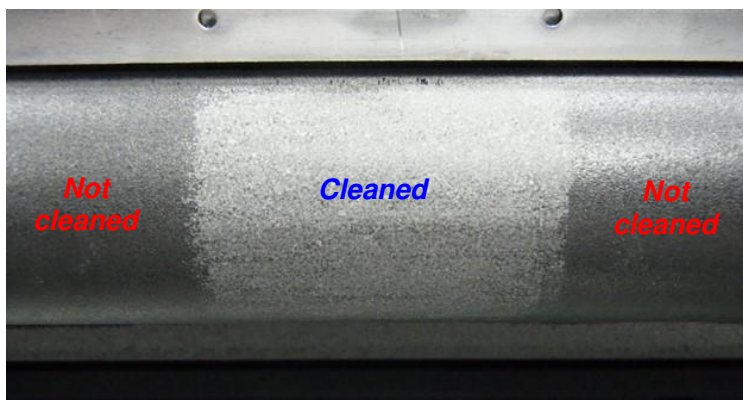
For reference, the photo below shows the cleaning effect. The light colored area is the surface cleaned with the cleaning tape.

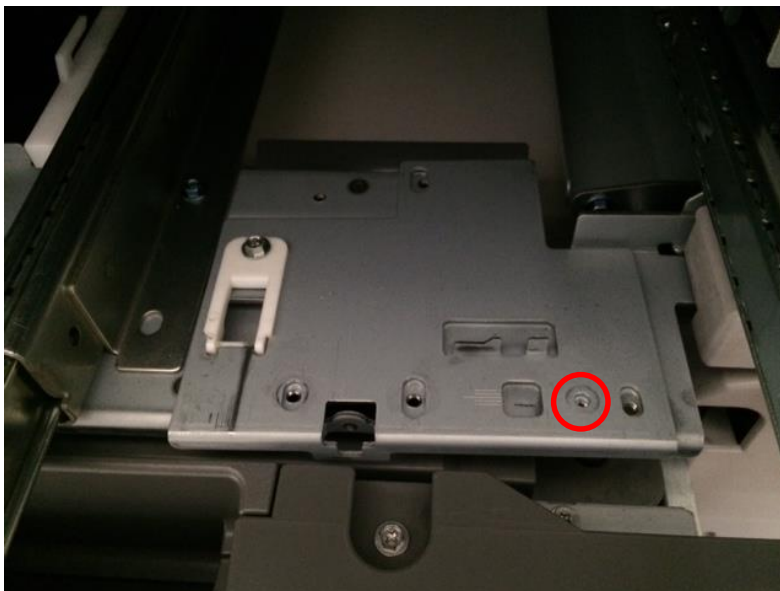
First fasten the screw to the reference screw hole circled in the photo below.

4. Attach the new stopper to the tandem tray with the four screws removed in the previous step.

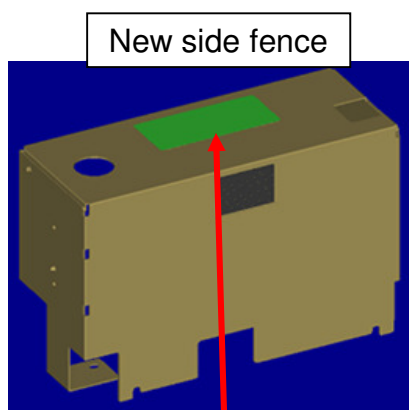
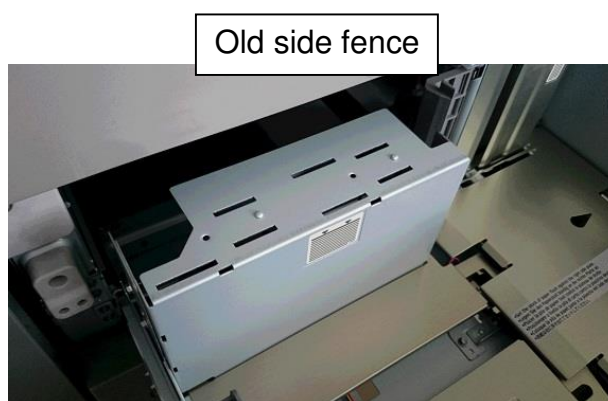
There was a safety issue reported where the operator forcefully stuck in his/her hand through the top corner of the side fence of the tandem tray to remove jammed paper and got his/her arm stuck inside.

Procure the caution decal (p/n: AA000313) and attach it to the old side fence.

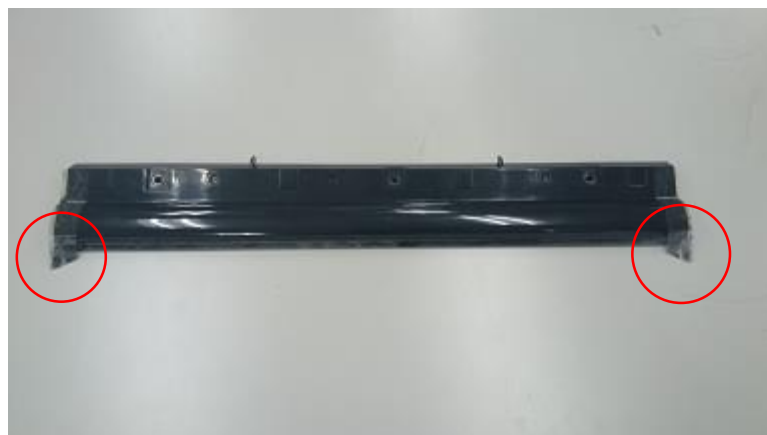
NOTE: Work carefully to prevent the seals at both ends from curling inward when installing the development roller cover.

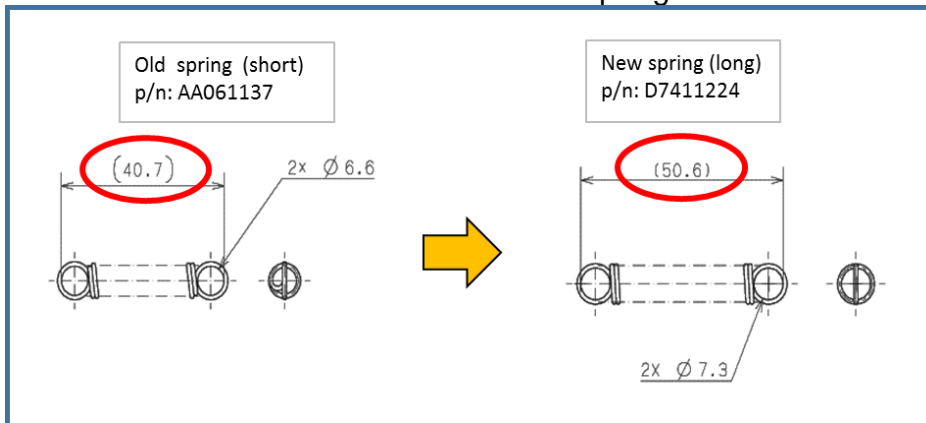
The difference between the old and new springs.

13. Install 2 new springs.

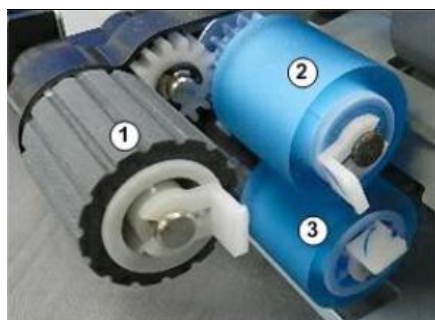
Reason: For higher reliability against no-feed jams caused by paper dust and calcium carbonate adhesion to the roller surface

- [1] Pick-up roller → No change
- [2] Feed roller → New p/n: AF031098
- [3] Separation roller → New p/n: AF032098

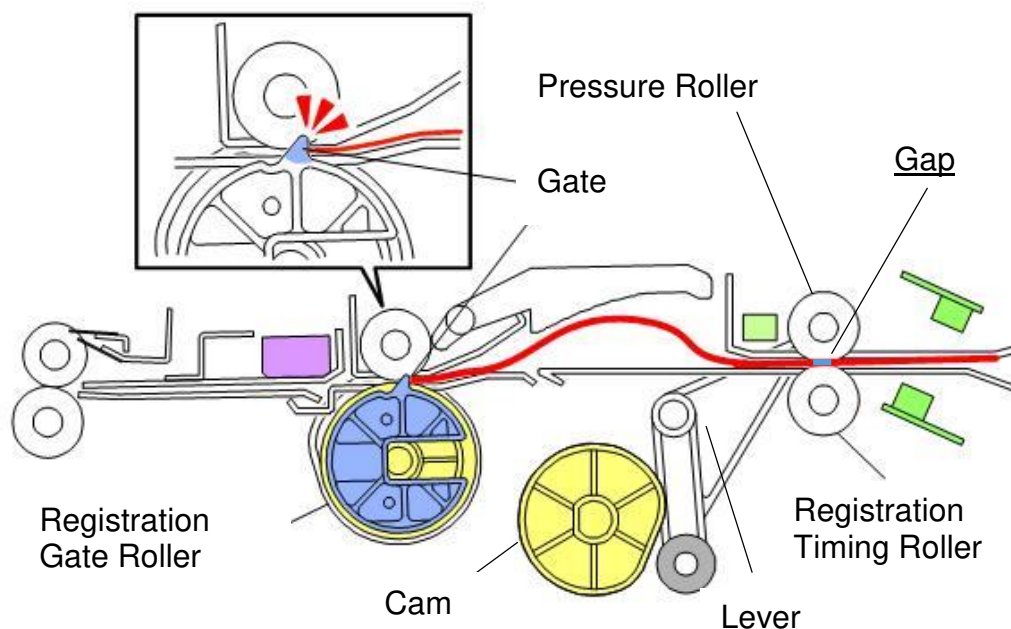
The clearance between the lever hole and its shaft is too large, resulting in an insufficient gap between the registration timing roller and the pressure roller.

Note: During main-scan registration, the paper is shifted after the pressure roller and registration timing roller are separated. If the gap between these rollers is insufficient, the paper will skew when the trailing edge is pushed forward.

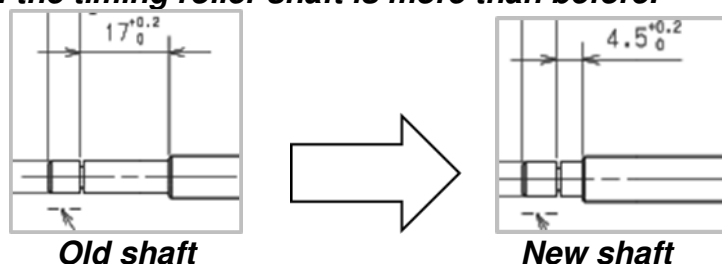
- *The diameter of the timing roller shaft is more than before.*

1. *The new shaft can make a suitable gap between the registration timing roller and pressure roller without the spacers.*
2. *The spacer slips and causes the skew.*

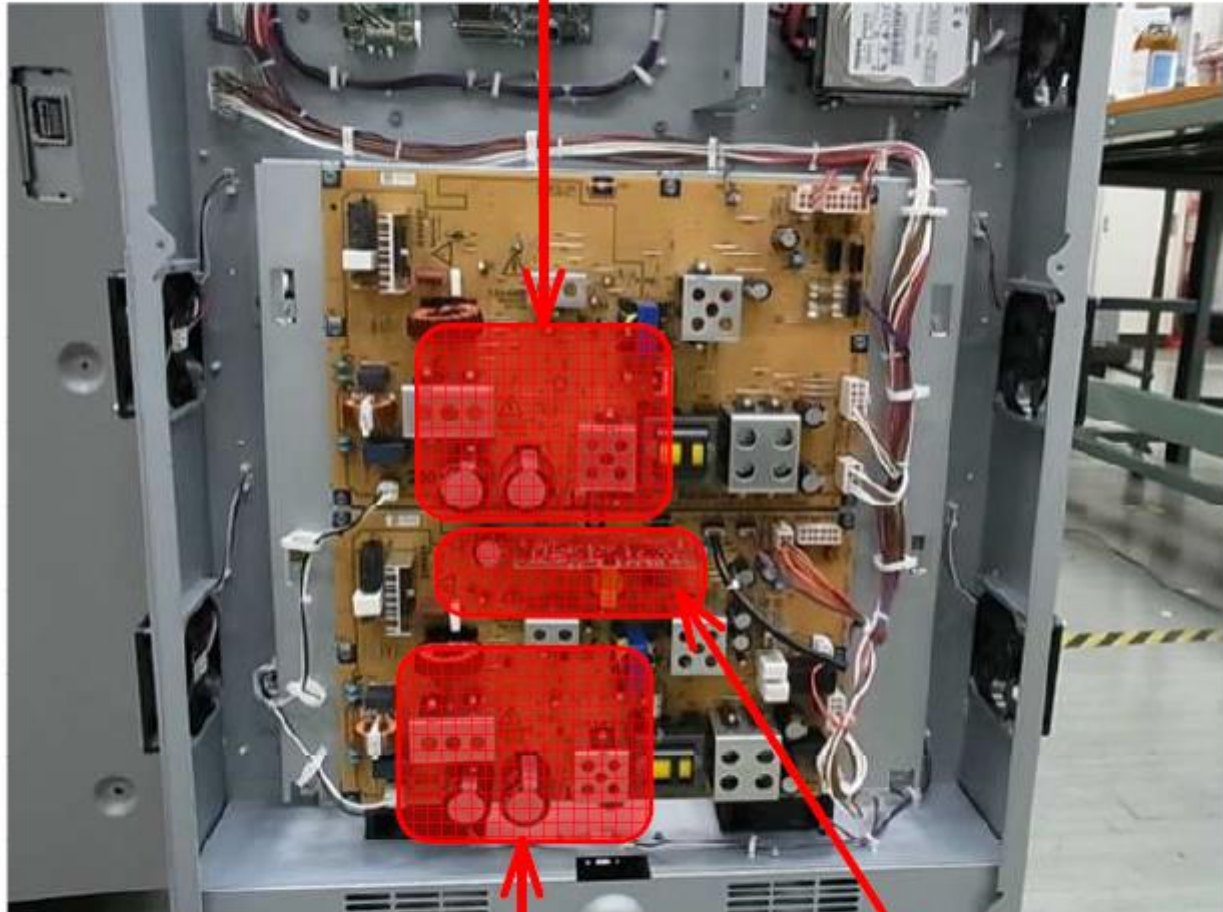
AZ240232
PSU-B C9,C75

NEVER touch the areas outlined in red in the photos below, to prevent electric shock caused by residual charge.

The procedure to discharge residual charge from the machine by unplugging the power cord from the AC wall outlet and pressing the main power switch works only for the DC circuits on this board. Residual charge remains in the AC circuits.

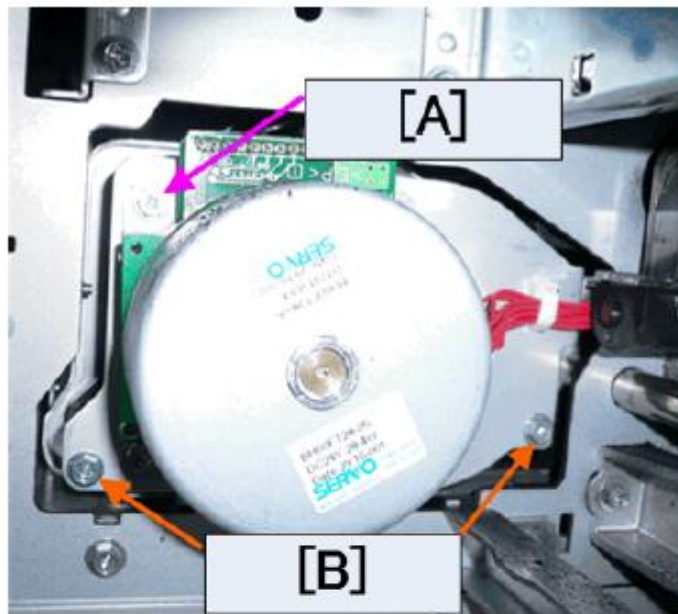
d1808023

- This step is required the correct the positions of these screws [A] and [B] because adjustment of the right steering plate can cause these screws slip out of position between the ITB unit and the ITB/PTR motor.

11. Loosen the three screws of the ITB/PTR motor bracket, and then tighten them.

- Recommended torque for screw [A]: $0.9 \pm 0.1 \text{ N m}$
- Recommended torque for screws [B]: $0.7 \pm 0.1 \text{ N m}$
- Screws [B] are made of resin-based material, so do not apply to much force when loosening and tightening them.

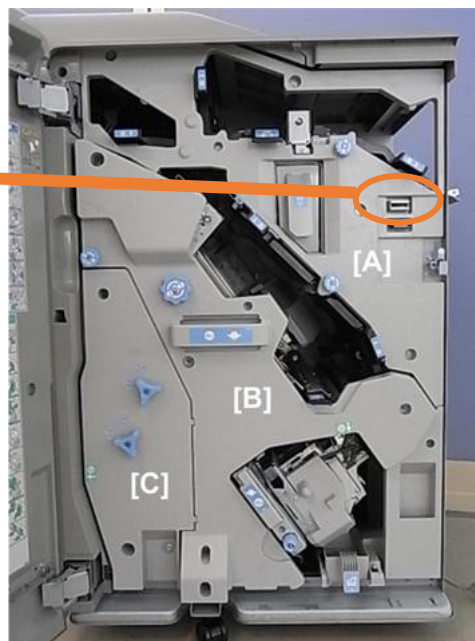
d512r103

The contact surfaces of the interlock switch on the finisher door were covered in small particles of insulating impurities during the plating process. As a result, a contact failure may occur in the switch.

Replace the interlock switch using the **PROCEDURE** on the next page, **if:**

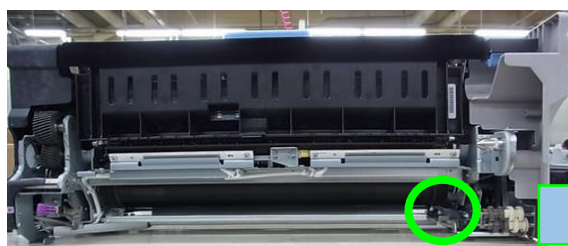
There is insufficient clearance between the wire for the pressure roller thermistor and the metal plate (see photo). The pressure roller is lifted repeatedly over time, and as a result, the wire covering is cut and the core wire contacts the metal plate, or the wire is broken in two.

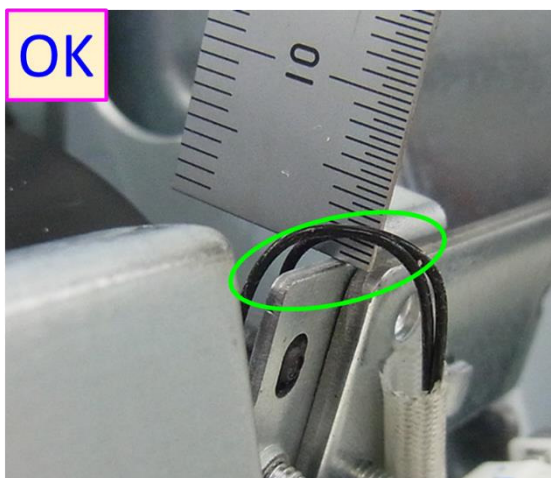
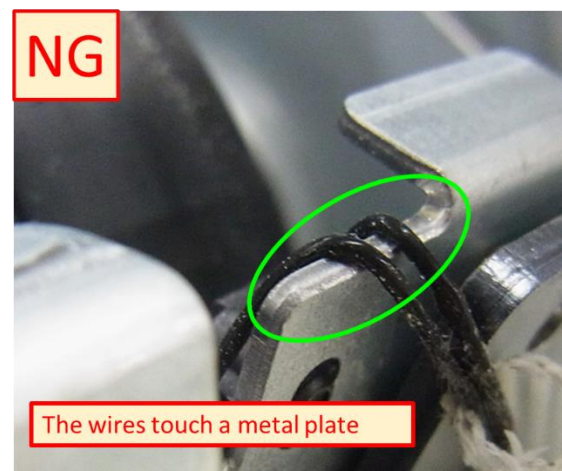
1. Check the SMC sheet to see if SC558 has occurred in the past.
 - If it **has** occurred in the past, **replace with a new part** (D1795385, see note on Page 2/6), referring to the **TEMPORARY SOLUTION**.
 - If it **has not** occurred in the past, go to **step 2**.
2. Remove the fusing unit.
3. Remove the web unit from the fusing unit.
4. Measure the gap between the sensor wire and the metal plate, as shown below.
5. If the gap is **less than 1mm**, do the **TEMPORARY SOLUTION** below.

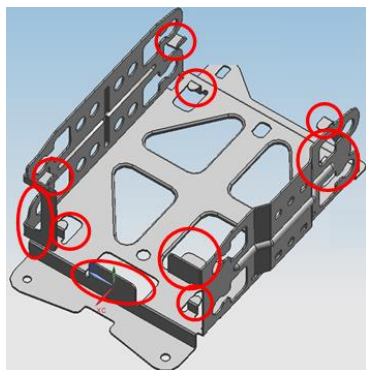
- Some of the projections on the HDD bracket (circled below) can contact the HDD directly.
- The amount that the printing speed is reduced depends on how much vibration is transmitted to the HDD.

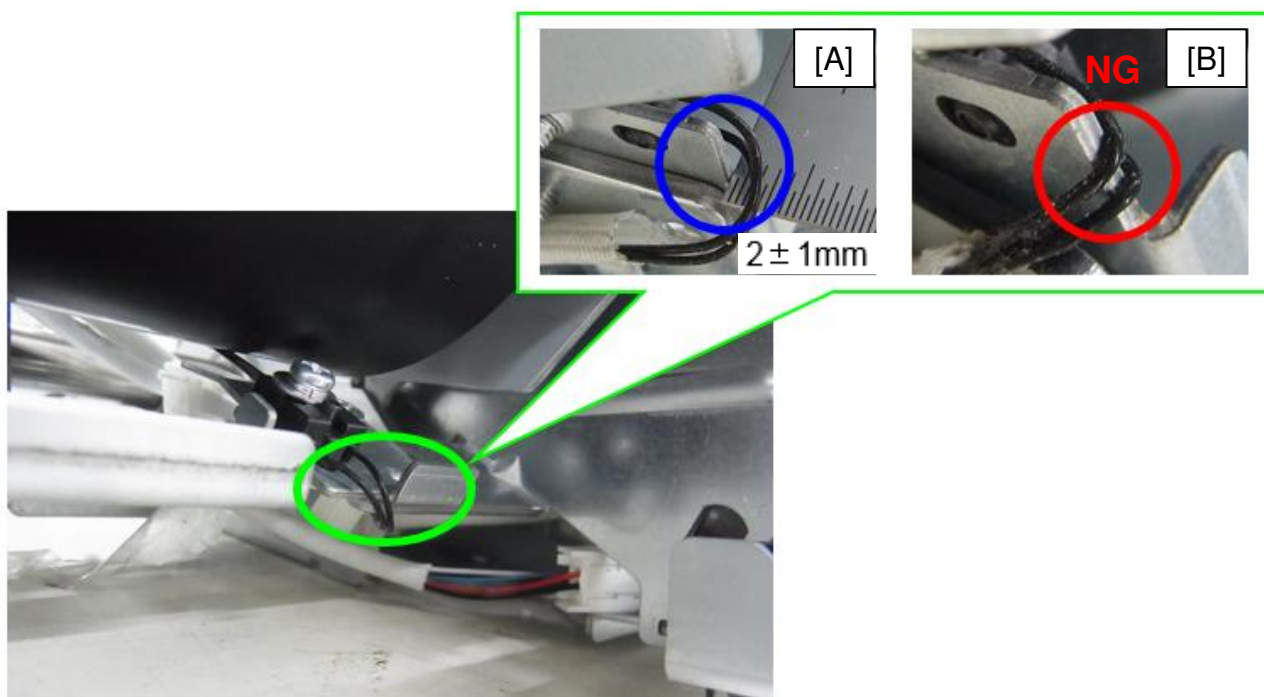
SC558 will occur if these cables are damaged. Check these cables if the machine is frequently experiencing SC558.

- Give enough room for the cables as shown in [A].
- The cables should not be touching the bracket as shown in [B].

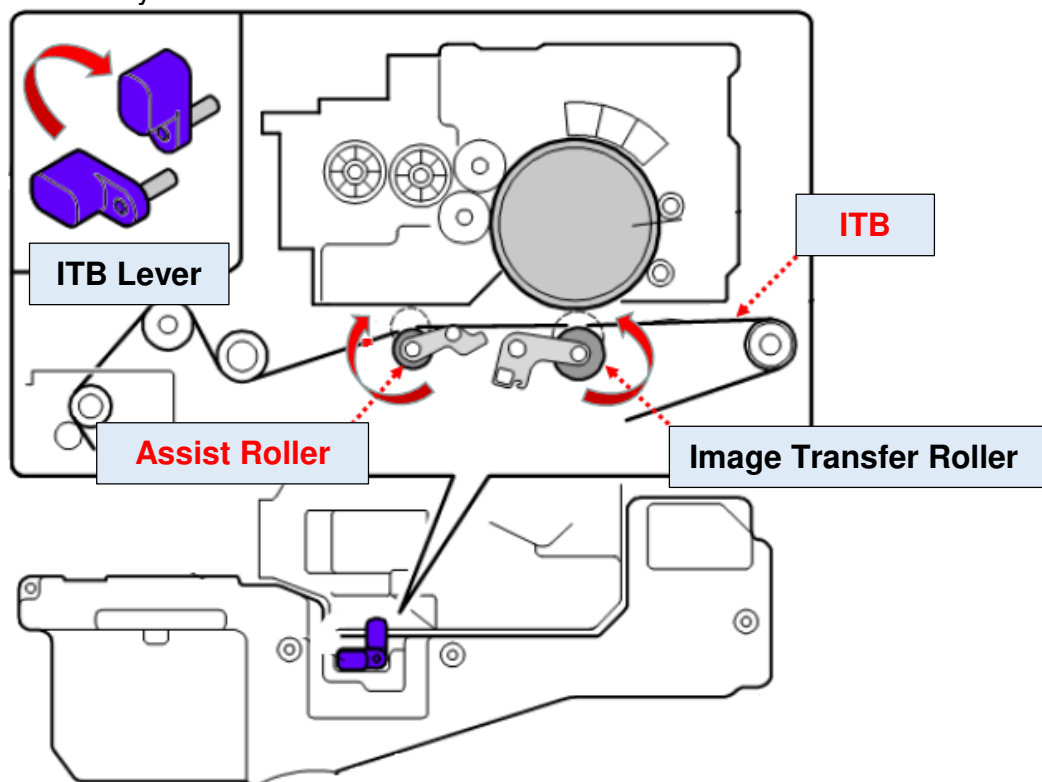
ITB unit layout:

In rare cases, this can cause the edge of the link to touch the frame (circled in red) when the ITB lever is raised. As a result, the movement of the link is inhibited and the assist roller and image transfer roller do not move to the correct position.

Apply the recommended grease (Grease Barrierta-S552R, P/N: A2579300) to the edge of the link in the area that may touch the ITB frame.

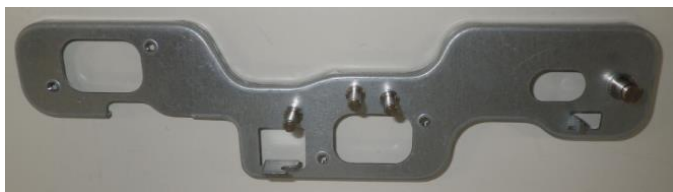
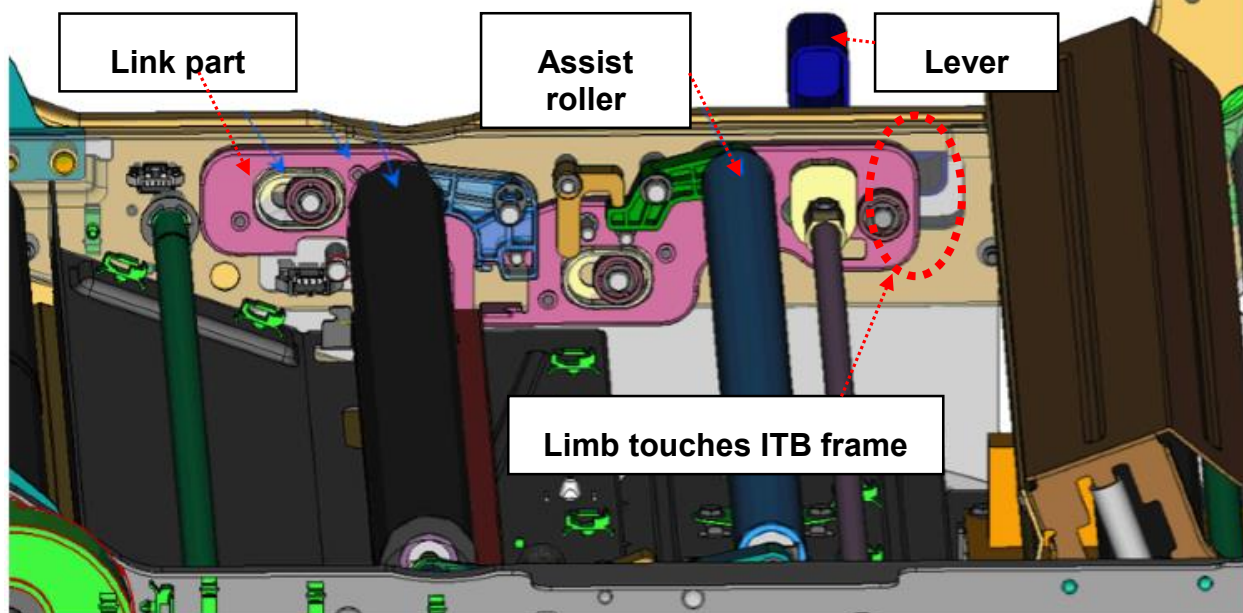
Metal link:

Note: There is another link attached to the rear side, but the shape is different.

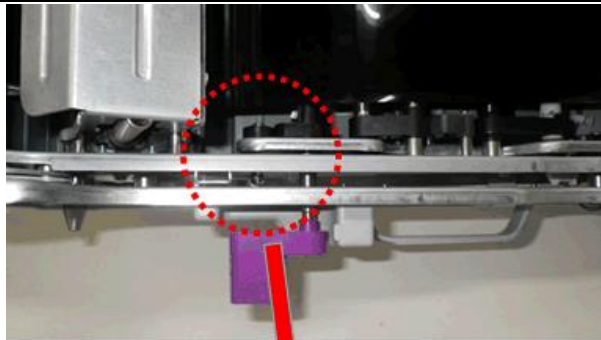
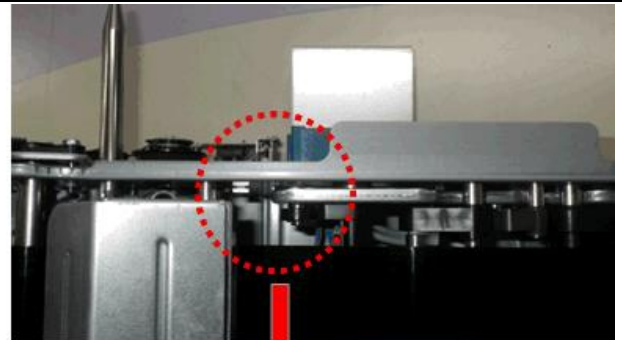
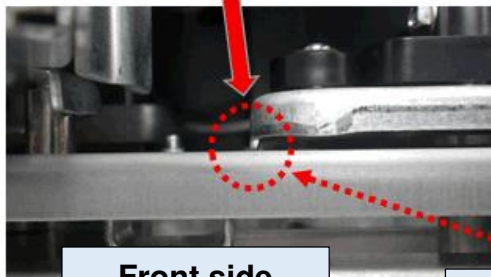
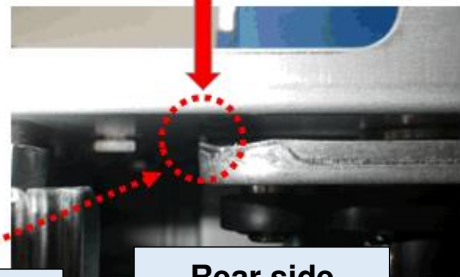
Apply grease
here

3. Apply the grease to the edge of the both the front and rear links.

IMPORTANT: The amount to apply is about the size of a pea.

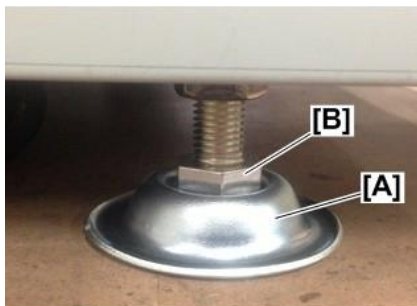
d194e9107a

<- Check the gap between leveling bolt and shoe

- 1. Slide one of the leveling shoes [A] by hand to check whether it can be moved.***
- 2. If there is an air gap and the leveling shoe can be moved, adjust the leveling bolt [B] and make sure it stops against the leveling shoe [A] completely without an air gap.***

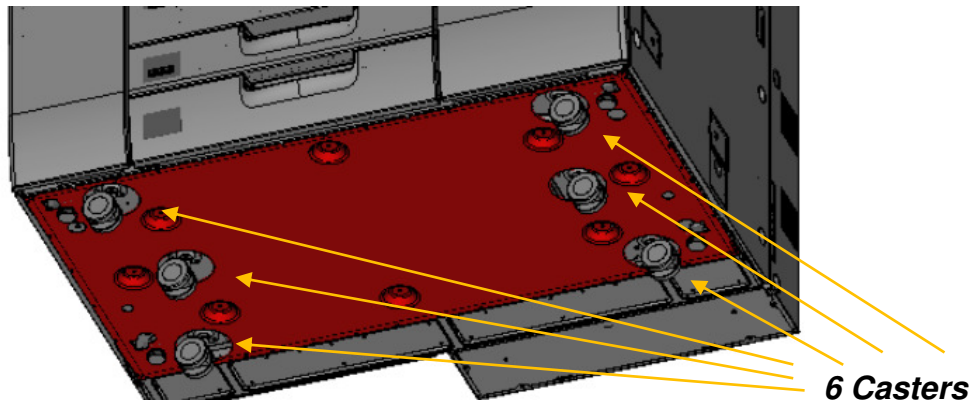
If the leveling bolts and leveling shoes are not used for installation, one of the six casters may not contact the floor, and this can lead to machine deformation.

Make sure leveling bolts and leveling shoes are used correctly at installation. Otherwise, SC471-** may occur due to machine frame deformation.

If SC 471-** occurs, the control parameter must be reset with Lubricant Application Mode.

Refer to “ITB Centering: SC471-03, -04, -05, -06 (ITB Position Errors)”, Other Problems in Troubleshooting Manual, and perform Lubricant Application Mode, after checking the causes and setting the ITB to the correct position.

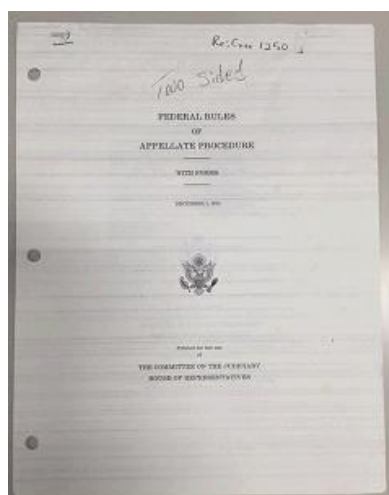
Black streaks occur under the following conditions.

- The machine is used for the first time in a long while, or first thing in the morning.
- The Low Power Mode Timer is set to a value longer than 1 hour.
- The average monthly copy volume is less than 30,000 pages

Note: The streaks disappear after a few sheets have been printed.

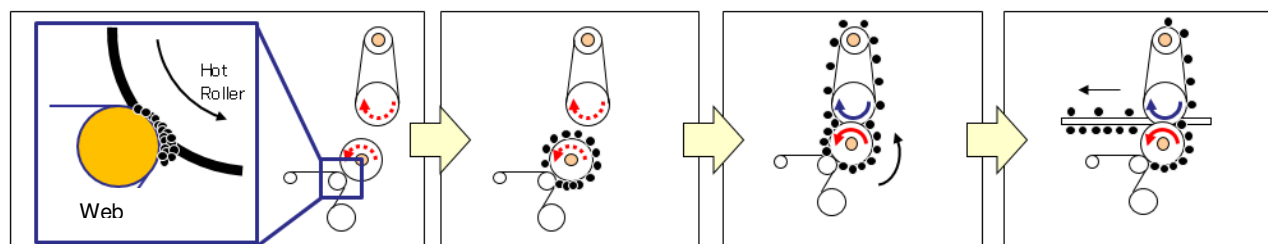
Under the conditions described above, a larger amount of shavings than normal from the pressure roller build up on the web roller.

Note: While the machine is in the Ready (stand-by) condition, the web roller is stationary while the pressure roller is rotated. A certain amount of shavings from the pressure roller are transferred to the web roller, but this is normally not visible.

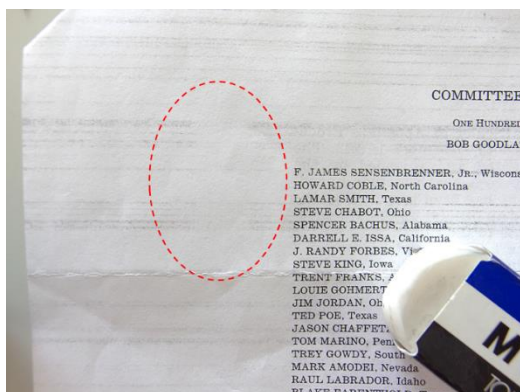
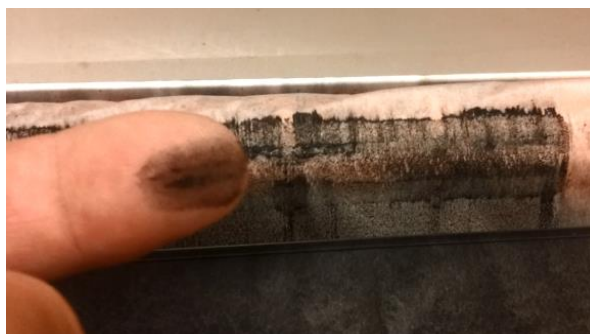
Note: If the streaks can be wiped off easily with an eraser, they are caused by the CAUSE explained above (as the streaks are not toner). The roller shavings will also rub off easily onto your finger. If not, the cause is different.

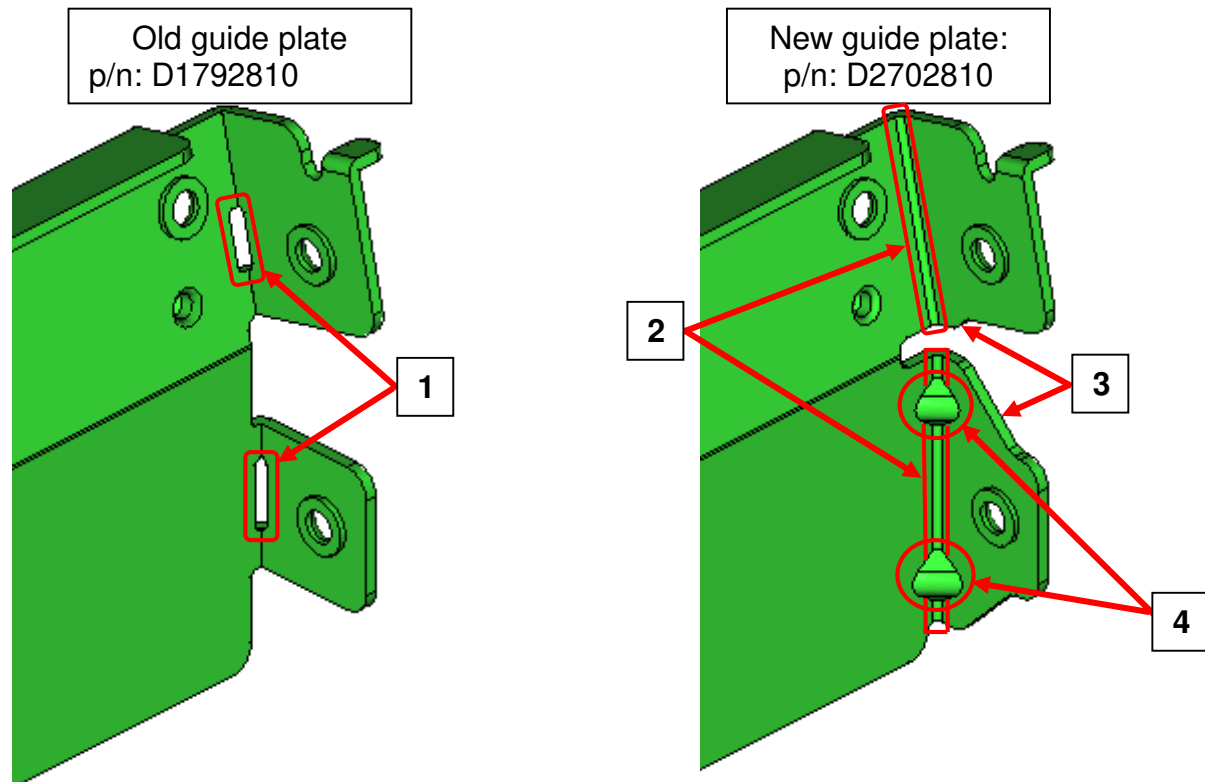
The following modifications were applied to the corner joints of the guide plate, to prevent breakage.

1. Eliminated the hole in the joint.
2. Optimized the angle of the joints.
3. Enlarged the joints.
4. Added a V-shaped wedge to the joints.

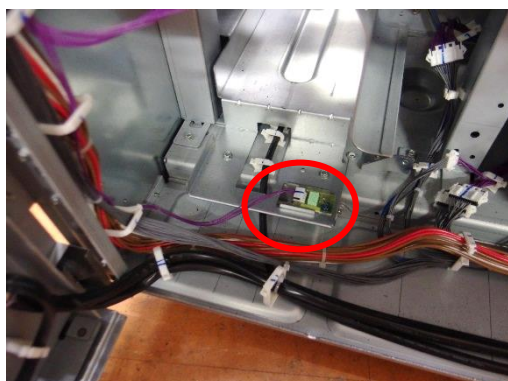
Temperature/Humidity detection sensor
(View with the waste toner bottle removed)

The PCB that contains the temperature/humidity detection sensor is touching the metal plate (near the waste toner bottle), causing a short circuit.

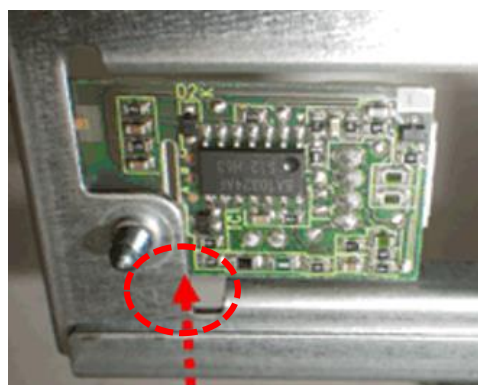
PCB with the sensor
(View from bottom of the sensor)

Short circuit is caused by contact between the PCB and metal plate at this point.

- Verify that there is a gap between the screw and the outline of the imprint “54AG” and refasten the screw. With this gap secured, the PCB should not touch the metal plate.

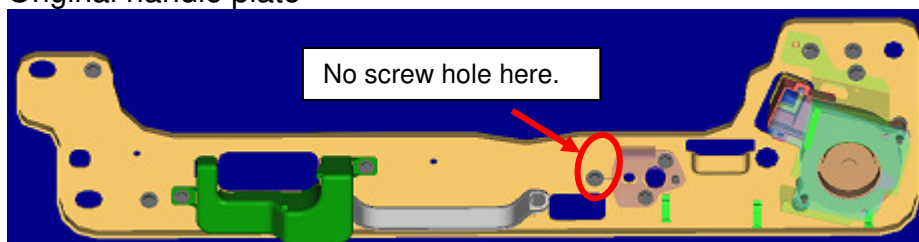
Original handle plate

Reason: To prevent SC741 caused by interference between the positioning pin of the ITB unit and the handle plate of the ITB unit.

When replacing with the new ITB unit (p/n: D1796100), make sure to replace the handle plate with the new one (p/n: D1796169) together as a set, because the original handle plate does not fit with the new ITB unit.

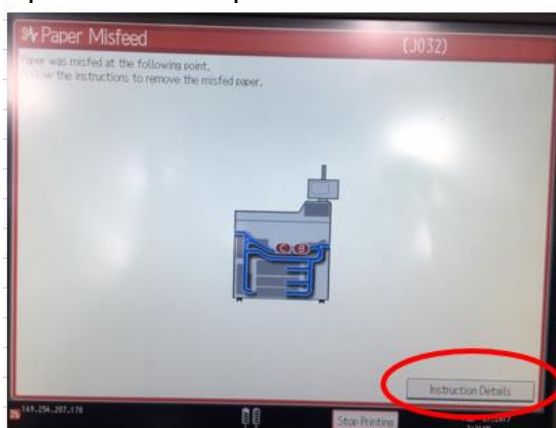
- Before D1795760V
Operators must press "Instruction Details" (circle in red) to see the jam animation.

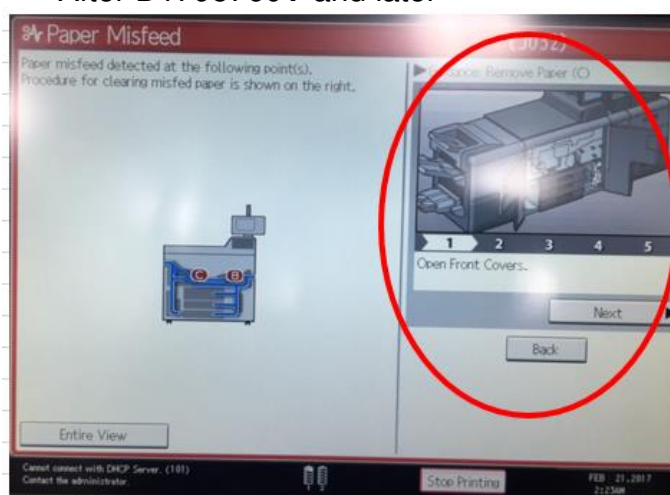
- After D1795760V and later

Jam animation starts immediately with no "Instruction Details" button.

From this, operators can clearly see the jam animation

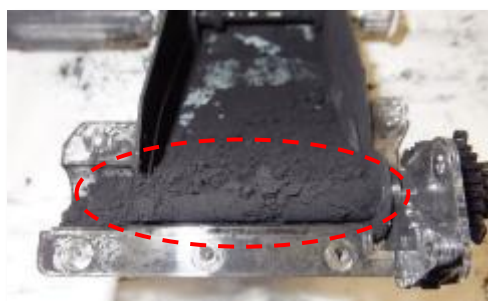
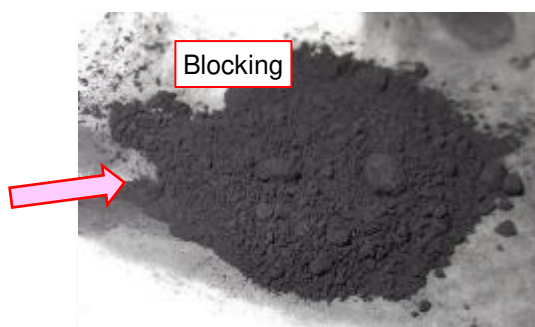
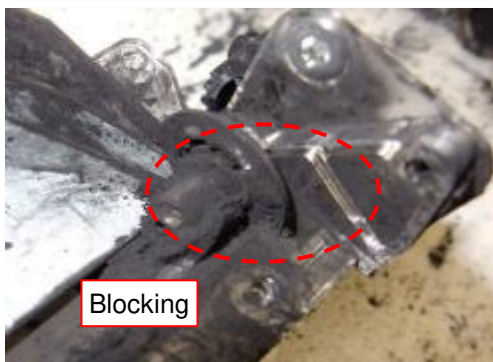
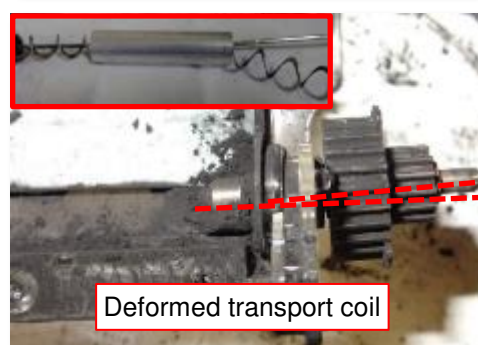
SC488 (used toner transport blockage) and broken waste toner transport coil

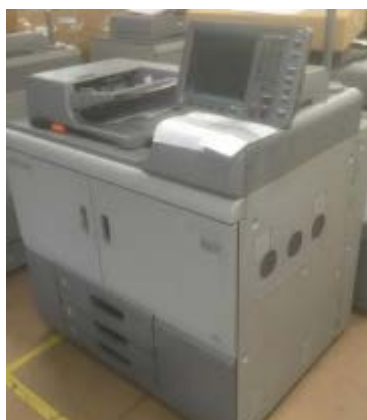
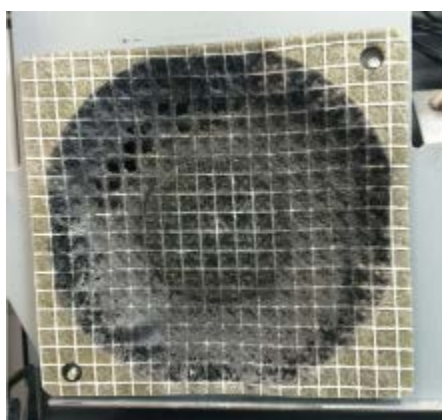
Clogged filter

The right cover air intake filters of the main frame are clogged with dust / paper dust and increases the internal temperature of the ITB cleaning unit. This causes waste toner collected from the ITB to melt and eventually clog the waste toner path.

- Clean the intake filters at **600K** interval to prevent clogging of the filters.
NOTE: The cleaning interval should be shortened if the paper in use contains considerable amount of paper dust.
- Replace with the following fan bracket assembly, which allows cleaning without having to disconnect the LCIT and remove the right cover. With this assembly, the filters can be cleaned by just opening the LCIT jam removal cover and sliding out the fan bracket assembly. See the following pages for the bracket assembly installation procedure.

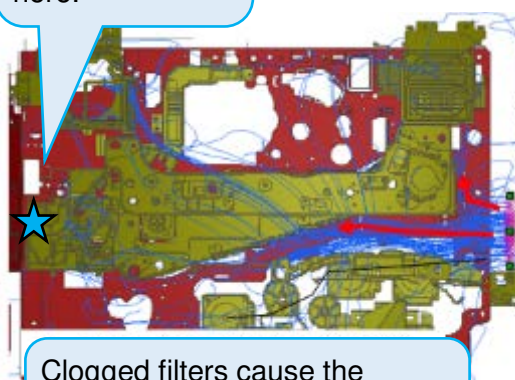
Viewed from Front

Clogged filters cause the machine internal temperature to increase.

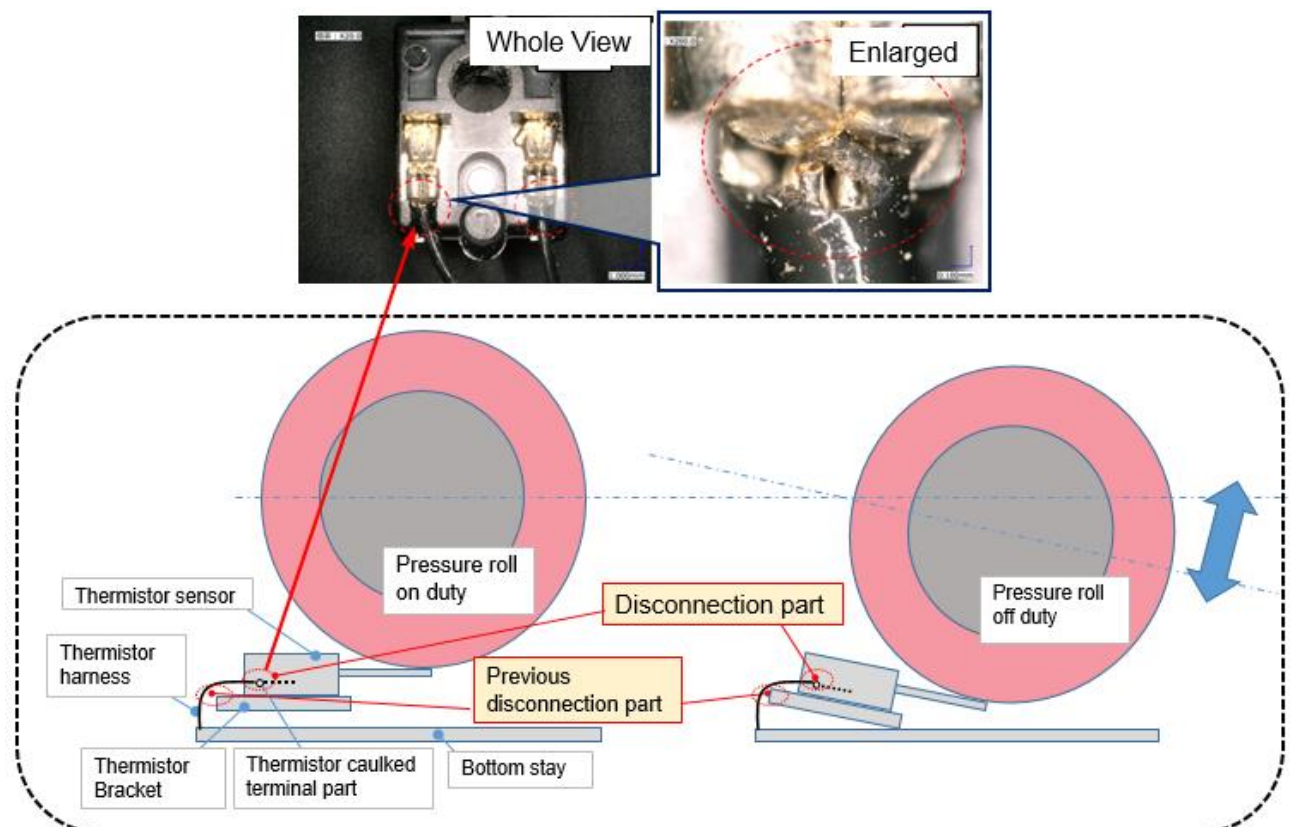
Repeated stress from a certain angle broke the caulked terminal part of the pressure roller thermistor (see the photo below).

1. Apply the engine firmware to mask the SC558-00.

2. Cut the thermistor harness to avoid accidental short-circuit with the broken part of the caulked terminal.

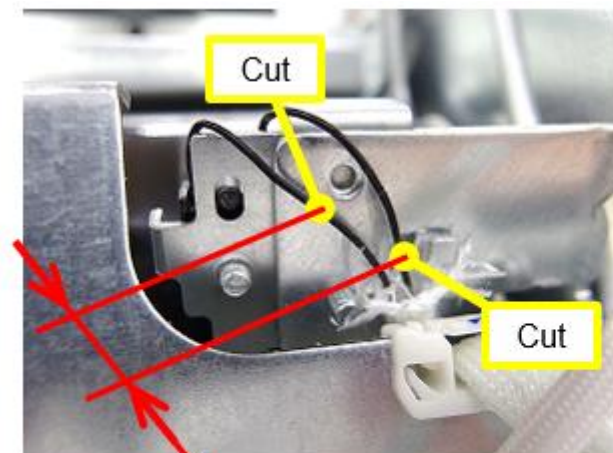
Cut each harness at a position shifted by 10 mm or more

Note: The reason for cutting at a distance of 10 mm or more is to prevent a short circuit due to contact between the two cut wires.

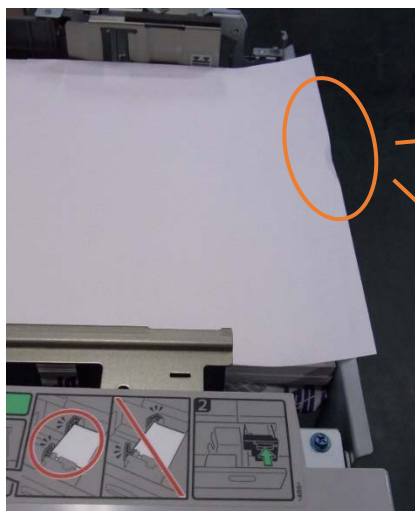
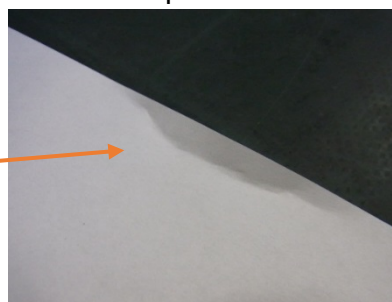
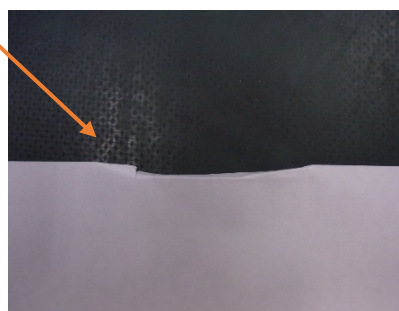
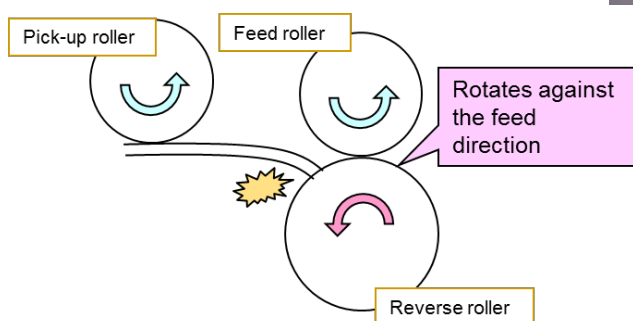
- No-feed jams start to occur at approximately 50K.
- The rollers are not abraded and have not reached life.
- Paper dust is powder-like, not grainy.
- Damages to the leading edge of paper as shown in photos below

Torque limiter in the reverse roller does not function because the rollers are slippery with paper dust. This causes the reverse roller to rotate against the feed direction and the leading edge of the paper to hit the reverse roller.

If the paper in use by your customer is high in ash content and the machine is experiencing frequent no-feed jams, replace the existing spring with this service part below.

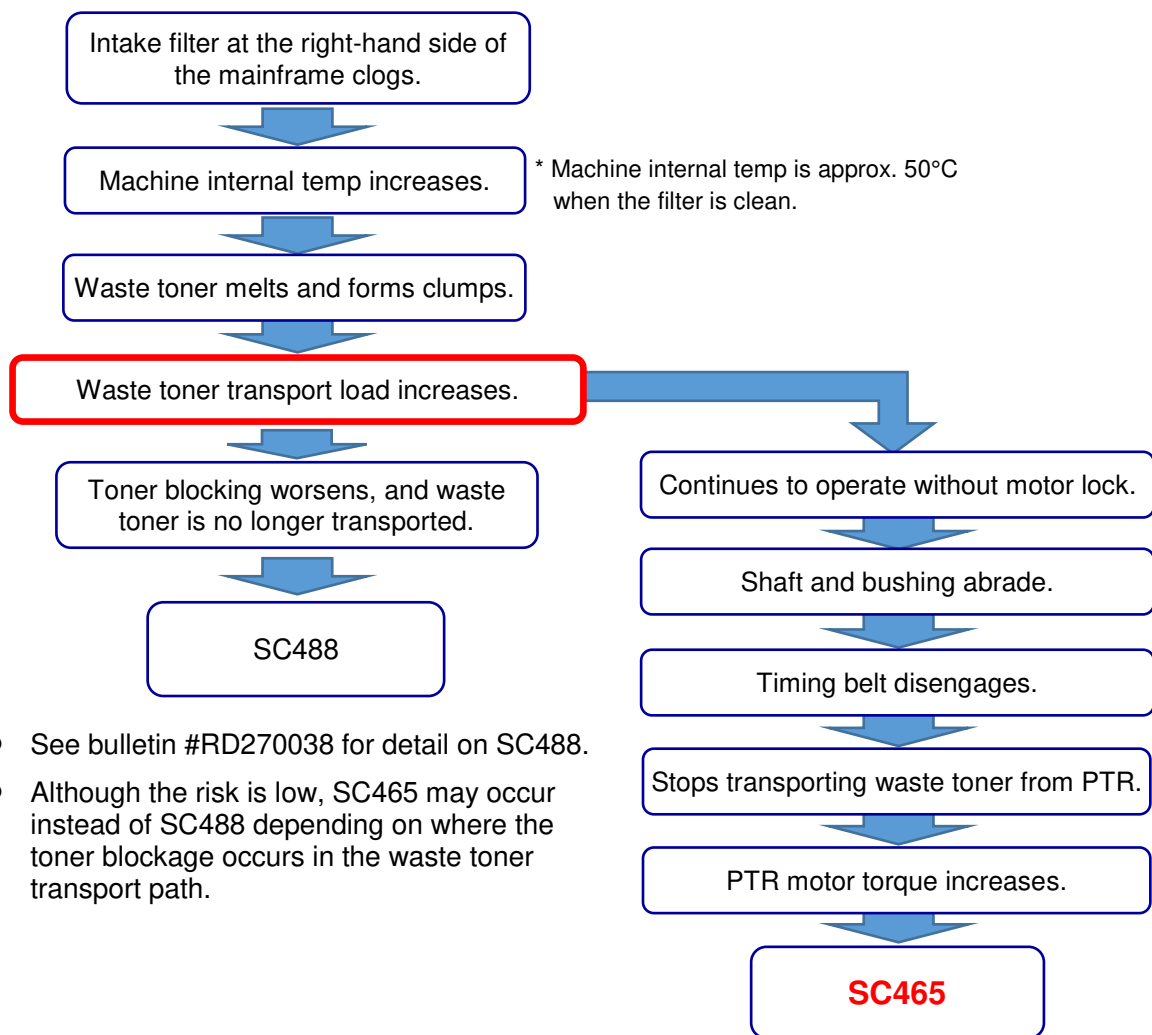
SC465 (PTR motor error)

CAUSE

- See bulletin #RD270038 for detail on SC488.
- Although the risk is low, SC465 may occur instead of SC488 depending on where the toner blockage occurs in the waste toner transport path.

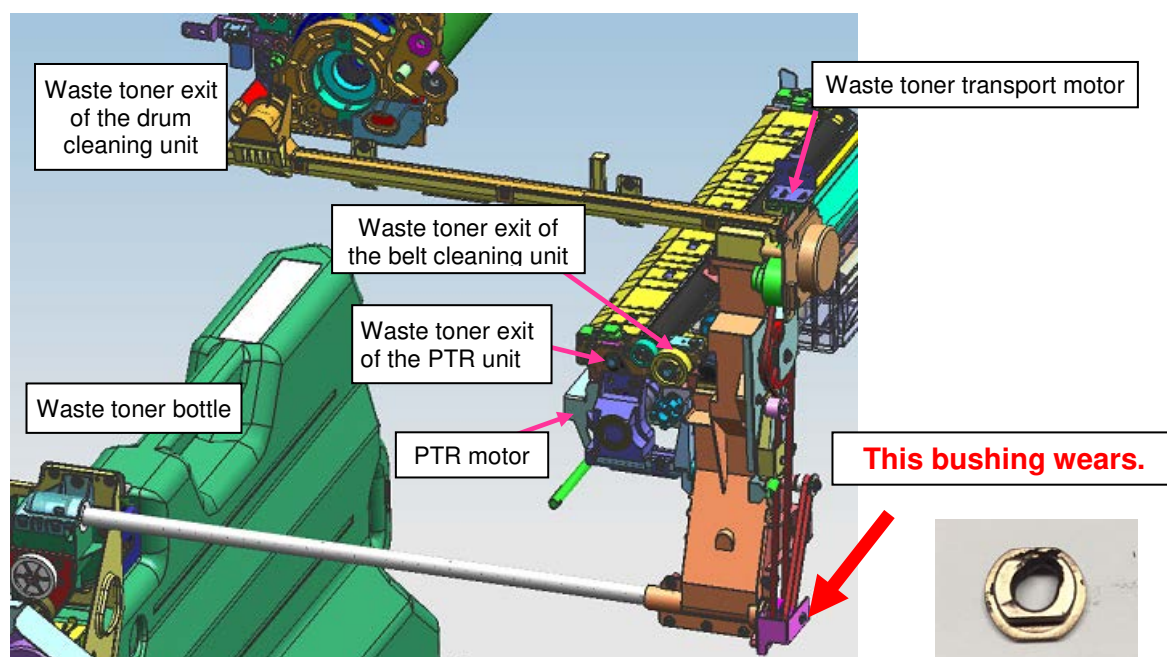
The following conditions increase the risk of the symptom:

- High room temperature
- The machine is installed close to the wall with hardly any or no space at all.
- The machine generates high print volume.
- Intake filter at the right-hand side of the mainframe is clogged.
- The machine experienced SC488 in the past. The waste toner transport unit and bushing were not replaced at that time.

- Check the above bushing (p/n: B1202063). If it is abraded and requires replacement, replace it together with the waste toner unit (p/n: D1796528).

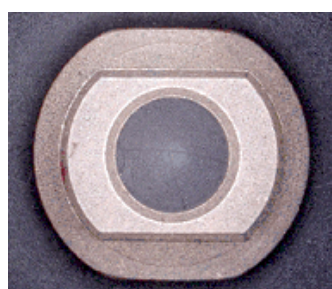
Brand new

Reference: The photos below show bushings at various stages for reference.

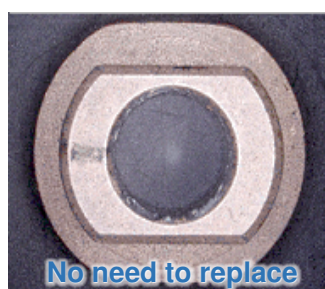
After approx. 20,000k
(normal transport load)

No need to replace

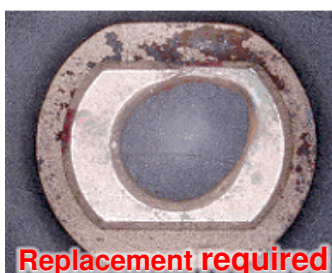
After approx.
20,000k (high
transport load)

Replacement required

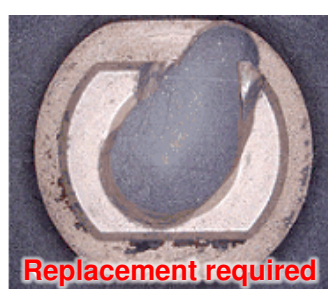
After approx. 30,000k
(SC465 confirmed)

Replacement required
