Model: BR-P1	Date: 27-May-15	No.: RM263005a
--------------	-----------------	----------------

Subject: Firmware Release Note: PDF		Prepared by: J. Ohno	
From: 1st PP Tech Service Sect., PP Tech Service Dept.			
Classification:	<input type="checkbox"/> Troubleshooting <input type="checkbox"/> Mechanical <input type="checkbox"/> Paper path <input type="checkbox"/> Product Safety	<input type="checkbox"/> Part information <input type="checkbox"/> Electrical <input type="checkbox"/> Transmit/receive <input checked="" type="checkbox"/> Other (Firmware)	<input type="checkbox"/> Action required <input type="checkbox"/> Service manual revision <input type="checkbox"/> Retrofit information <input checked="" type="checkbox"/> Tier 2

Model: BR-C1/Leo-C1/Leo-P1/Andromeda-P1/ BR-P1	Date: 23-Aug-13	No.: RD179017k
---	-----------------	----------------

Model:BR-P1		Date: 16-Oct-17	No.: RM263029
Subject: Parts information - Development Unit		Prepared by: Rie Shohda	
From: Sales Strategy Sect., 1st CP Business Dept.			
Classification:	<input type="checkbox"/> Troubleshooting <input type="checkbox"/> Mechanical <input type="checkbox"/> Paper path <input type="checkbox"/> Product Safety	<input chec

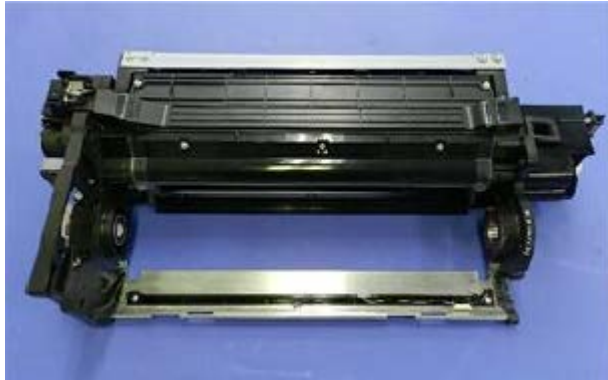
If the sensor is not in the correct position, the distance between the sensor and the developer contained in the development unit will fluctuate and hinder proper toner density detection, which may cause problems like toner scattering.

1. Remove the development unit. (FSM: page 912)

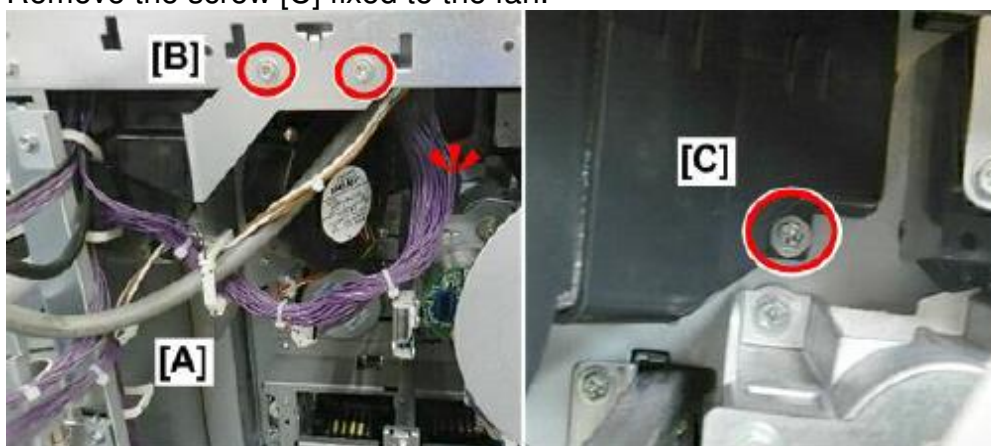
NOx (nitrogen oxides) generated in the drum charging process combine with the lubricant powder (zinc stearate) and this absorbs moisture, which adheres to the drum surface, if the machine is left unused for an extended period, causing poor drum charge in the affected area.

How to attach the Mylar sheet:

1. Open the controller box.
2. At the bottom right (viewed from the rear), release the purple harnesses [A].
3. Remove the bracket [B].
4. Remove the screw [C] fixed to the fan.
