Model: <b>BR-C2</b>	Date: 10-Nov-16	No.: RD270004
---------------------	-----------------	---------------

Subject: Firmware Release Note: PowerSaving Sys		Prepared by: J.Ohno	
From: 1st PP Tech Service Sect., PP Tech Service Dept.			
Classification:	<input type="checkbox"/> Troubleshooting	<input type="checkbox"/> Part information	<input type="checkbox"/> Action required
	<input type="checkbox"/> Mechanical	<input type="checkbox"/> Electrical	<input type="checkbox"/> Service manual revision
	<input type="checkbox"/> Paper path	<input type="checkbox"/> Transmit/receive	<input type="checkbox"/> Retrofit information
	<input type="checkbox"/> Product Safety	<input checked="" type="checkbox"/> Other (Firmware)	<input checked="" type="checkbox"/> Tier 2

Model: BR-C2		Date: 8-Nov-16	No.: RD270011
Subject: Request for Firmware Update at new site install (Baron-C2)		Prepared by: J. Ohno	
From: 1st PP Tech Service Sec., PP Tech Service Dept.,			
Classification:	<input type="checkbox"/> Troubleshooting	<input type="checkbox"/> Part information	<input checked="" type="checkbox"/> Action required
	<input type="checkbox"/> Mechanical	<input type="checkbox"/> Electrical	<input type="checkbox"/>

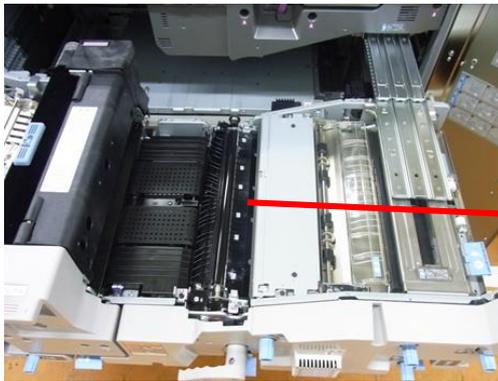
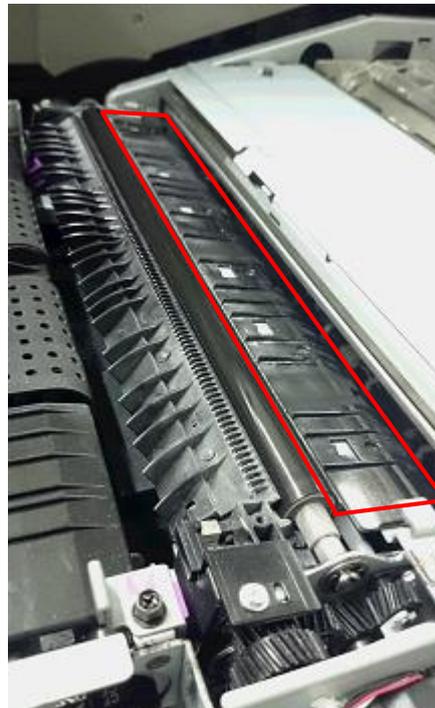
**Black streaks on back side of the page****SYMPTOM**

Toner adhered to the entrance guide plate of the PTR unit offsets to the back side of the page.

Advise the operator to clean the ribs of the PTR unit every day before running the first job. (Cleaning is recommended every 20K pages.)

- The entrance guide plate of the PTR unit can be cleaned by users.
- Wipe the ribs using a dry piece of cloth. No alcohol needed.

Clean the following location:

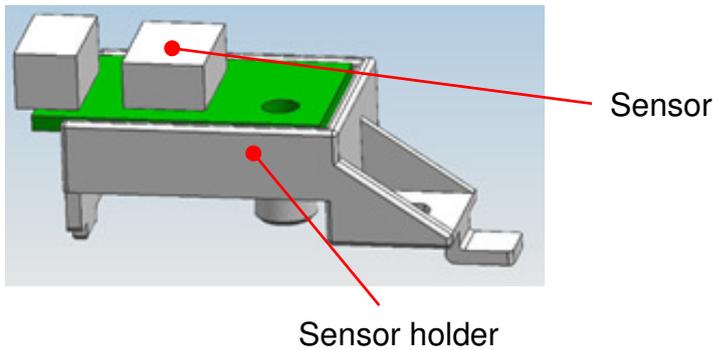
The PCB that mounts the temperature/humidity detection sensor is touching the metal plate (near the waste toner bottle), causing a short circuit.

Short circuit is caused by contact between the PCB and metal plate at this point.

A sensor holder will be added to prevent the PCB from contacting the metal plate.

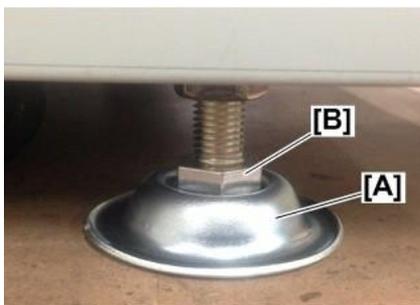
<- Check the gap between leveling bolt and shoe

If the leveling bolts and leveling shoes are not used for installation, one of the six casters may not contact the floor, and this can lead to machine deformation.

1. Slide one of the leveling shoes [A] by hand to check whether it can be moved.
2. If there is an air gap and the leveling shoe can be moved, adjust the leveling bolt [B] and make sure it stops against the leveling shoe [A] completely without an air gap.

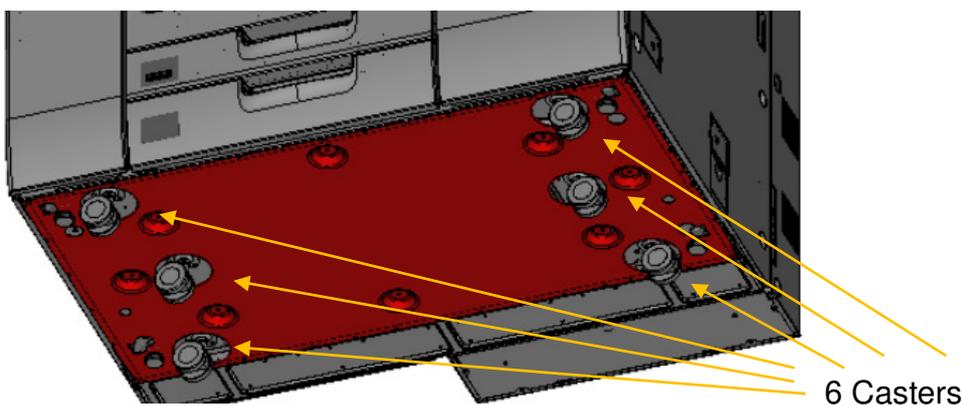
Make sure leveling bolts and leveling shoes are used correctly at installation. Otherwise, SC471-\*\* may occur due to machine frame deformation.

If SC 471-\*\* occurs, the control parameter must be reset with Lubricant Application Mode. Refer to “ITB Centering: SC471-03, -04, -05, -06 (ITB Position Errors)”, Other Problems in Troubleshooting Manual, and perform Lubricant Application Mode, after checking the causes and setting the ITB to the correct position.

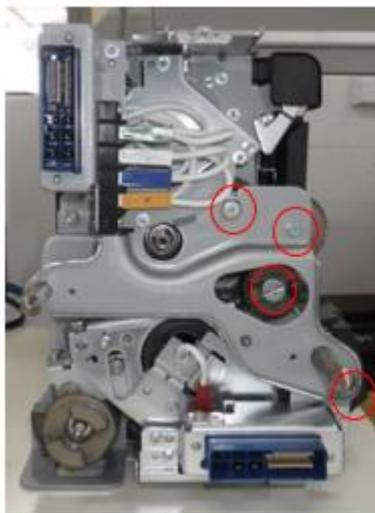
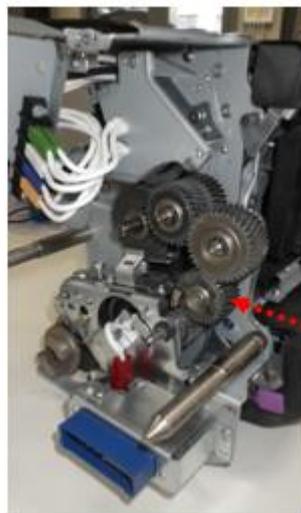
Drive gear  
(P/N: BB013037)

The drive gear in the Fuser Unit is broken and jams at the PTB Unit occur because the fuser rollers cannot rotate.

Damaged drive gear

The 2 joints of the drive gear do not have enough mechanical strength and might be broken during printing.

Replace the affected drive gear with a new one and apply the required grease to it. Please see the following replacement procedure.

8. Remove the drive gear and replace with a new one. (1 screw)

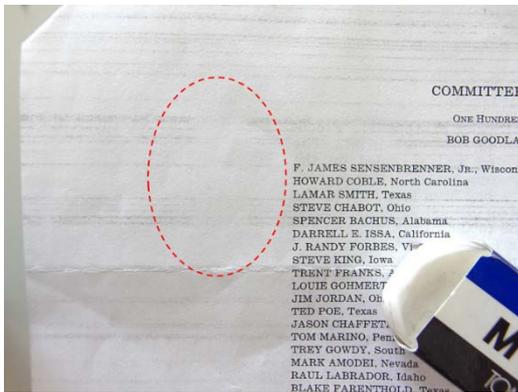
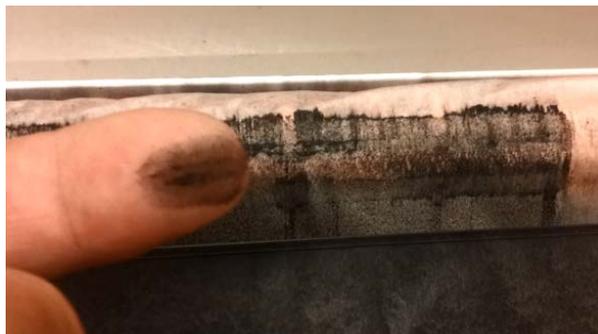
Under the conditions described below, the surface layer of the pressure roller rubs against the web and is scraped. And the abrasive powder passes through the web, accumulates on the pressure roller, and is transferred to the sheet.

**Note 3:** If the streaks can be wiped off easily with an eraser, they are caused by the CAUSE explained above (as the streaks are not toner). The roller shavings will also rub off easily onto your finger. If not, the cause is different.

1. Set the Low Power Mode Timer to a value of less than 60 minutes.

Default setting (= 15 minutes ) is recommended.

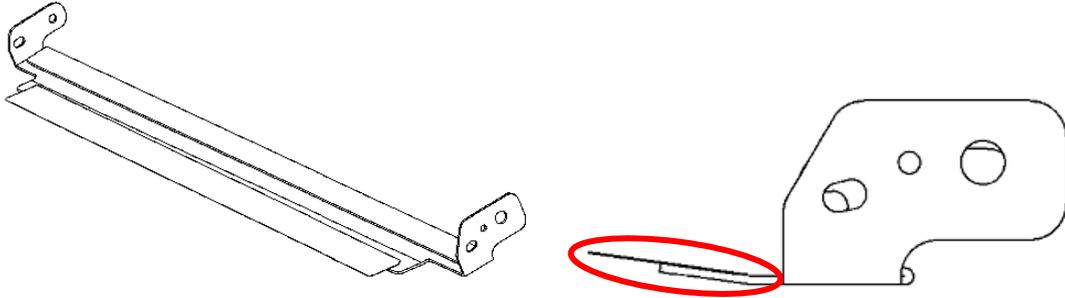
**CAUSE:** Toner on the ITB scatters when the trailing edge approaches the PTR. This happens because the trailing edge flicks the belt immediately after it passes the guide plate before entering the PTR nip.

- For thickness 4~7, use the guide plate registered with the p/n: D2706128. Compared to the default guide plate, this guide plate has a shorter guide, which is compensated with a lengthened Mylar, to reduce the flick when the trailing edge passes through the guide plate.

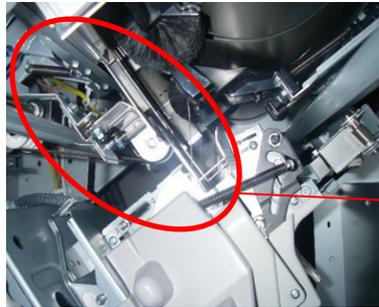
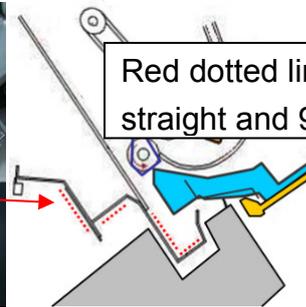
**Bottom Fence**

Red dotted lines should be straight and 90 degrees.

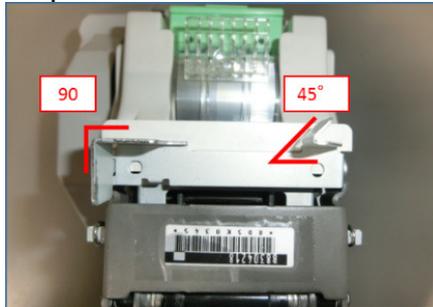
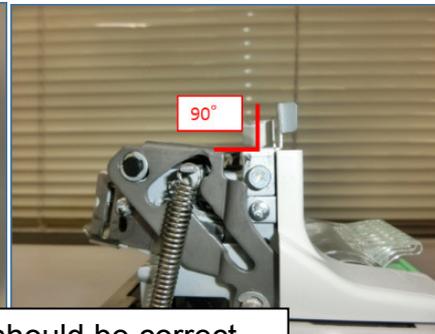
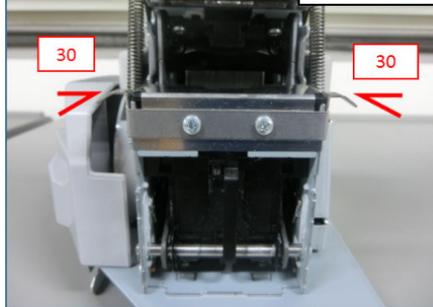
**Staple Unit**

Angles should be correct.

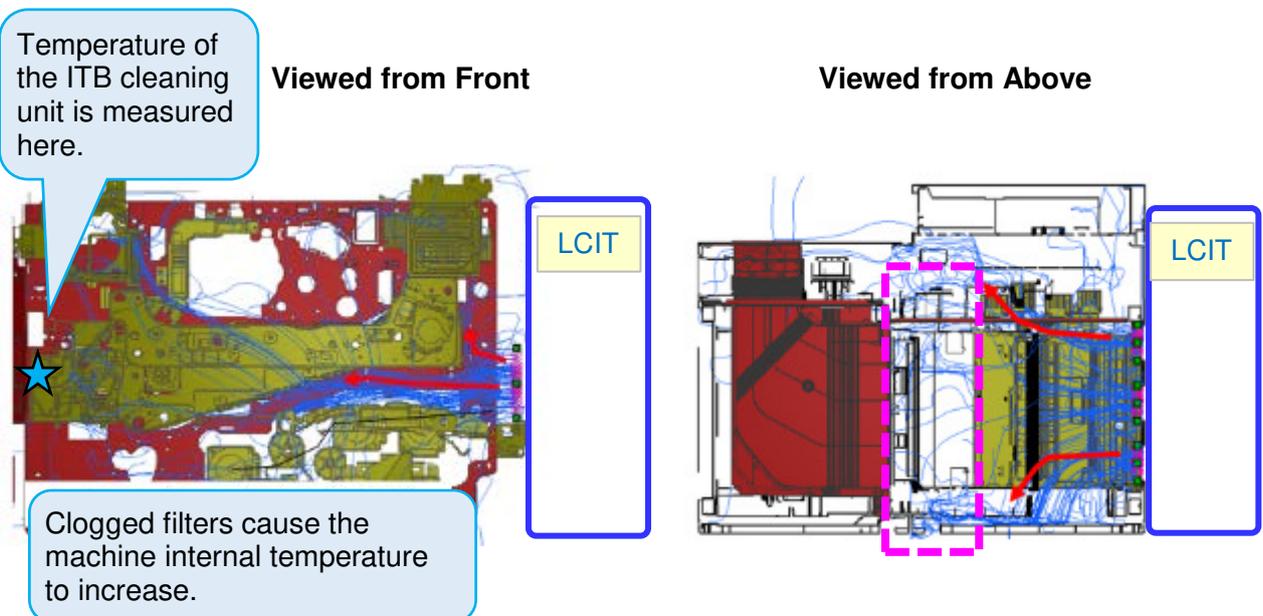
**Airflow to cool the ITB cleaning unit**

The right cover air intake filters of the main frame are clogged with dust / paper dust and increases the internal temperature of the ITB cleaning unit. This causes waste toner collected from the ITB to melt and eventually clog the waste toner path.

\* The risk of clogging is higher with systems consisted of the LCIT.

- Clean the intake filters at **600K** interval to prevent clogging of the filters.  
 NOTE: The cleaning interval should be shortened if the paper in use contains considerable amount of paper dust.
- Replace with the following fan bracket assembly, which allows cleaning without having to disconnect the LCIT and remove the right cover. With this assembly, the filters can be cleaned by just opening the LCIT jam removal cover and sliding out the fan bracket assembly. See the following pages for the bracket assembly installation procedure.

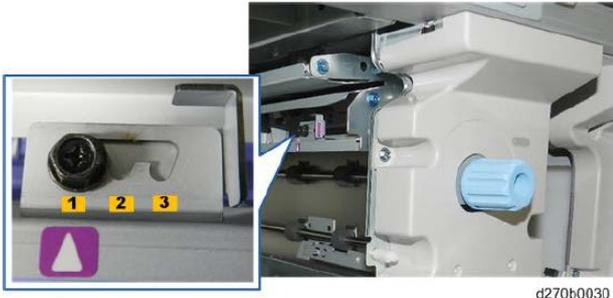
Paper feed unit in mainframe:

Refer to the service manual and adjust a notch adjustment mechanism shown below.

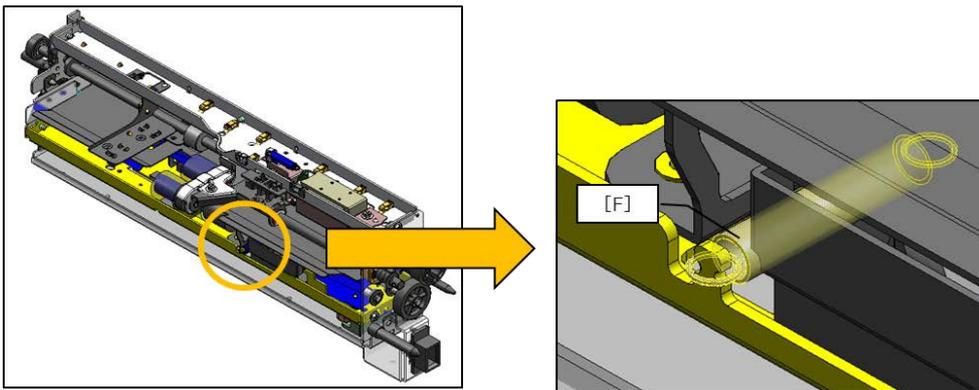
Using paper with high ash content (calcium carbonate) causes frequent no-feed jams, and the feed and reverse rollers need to be replaced before reaching life.

Torque limiter in the reverse roller does not function because the rollers are slippery with paper dust. This causes the reverse roller to rotate against the feed direction and the leading edge of the paper to hit the reverse roller.

8. Change the existing spring [F] with the service part.

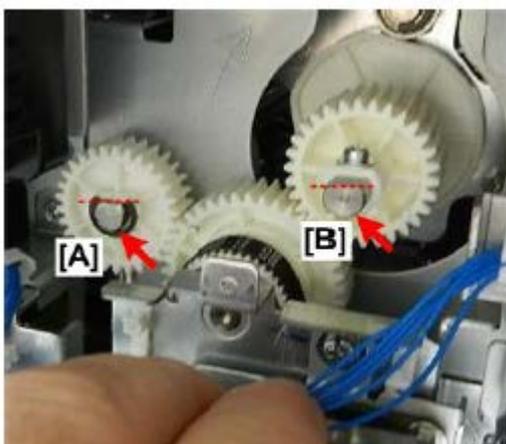
The drive gear of the Registration Gate Roller wears, and jam J031 occurs because of a backrush.

After printing over 15,000K pages, this drive gear might wear.

6. Replace Gear [A] (AB014243) and Gear [B] (BB013040) with new ones (E ring x1 screw x1).

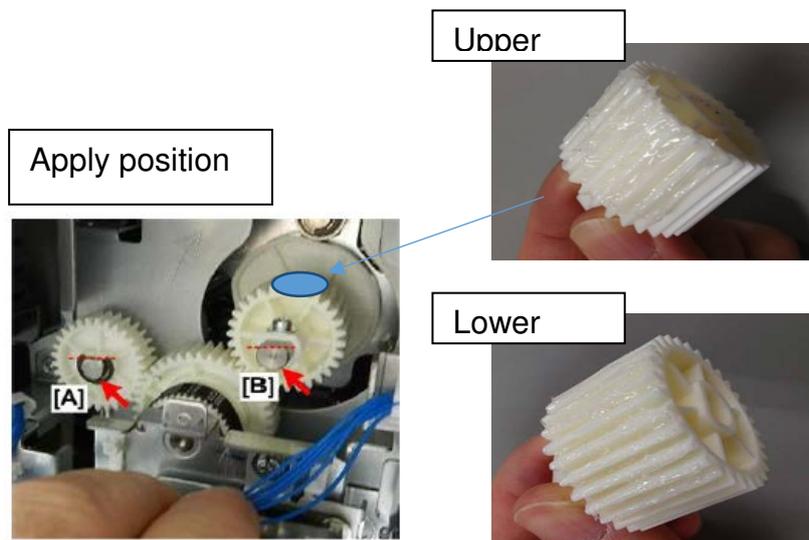
When re-attaching the motor bracket to the mainframe, make sure that the both flat side [A] and [B] of two shafts are up and level with one other. Then, apply silicone grease G-501 (0.55g) to the gear [B] referencing the picture below.

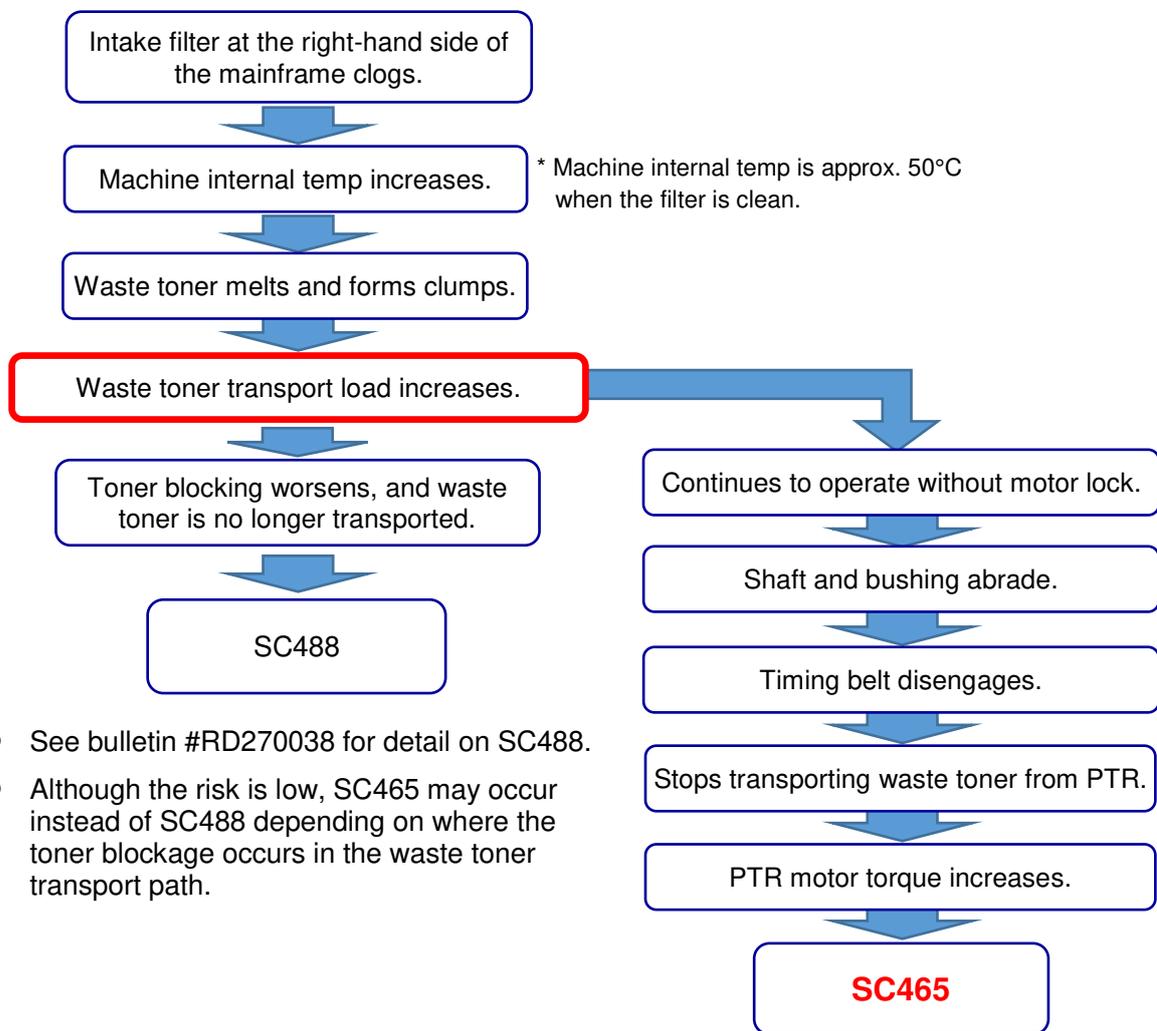
SC465 (PTR motor error)

- See bulletin #RD270038 for detail on SC488.
- Although the risk is low, SC465 may occur instead of SC488 depending on where the toner blockage occurs in the waste toner transport path.

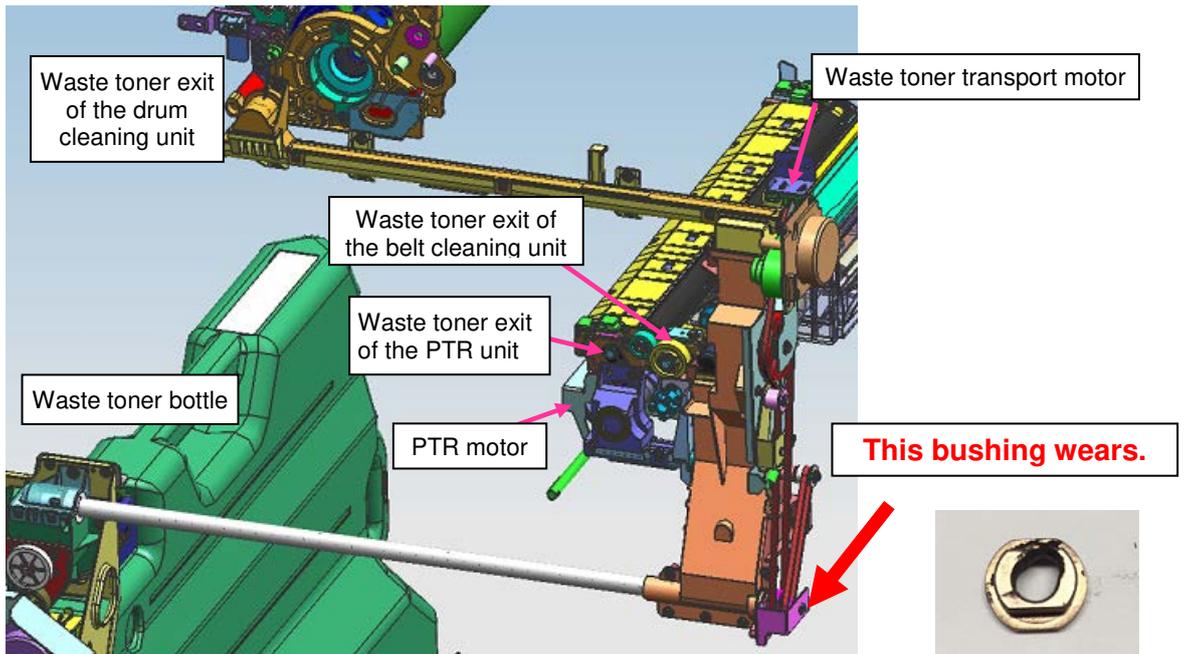
The following conditions increase the risk of the symptom:

- High room temperature
- The machine is installed close to the wall with hardly any or no space at all.
- The machine generates high print volume.
- Intake filter at the right-hand side of the mainframe is clogged.
- The machine experienced SC488 in the past. The waste toner transport unit and bushing were not replaced at that time.

- Check the above bushing (p/n: B1202063). If it is abraded and requires replacement, replace it together with the waste toner unit (p/n: D1796528).

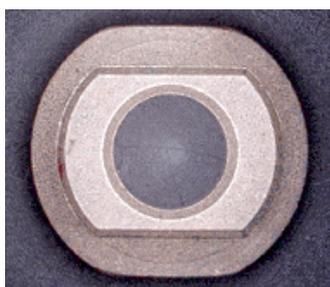
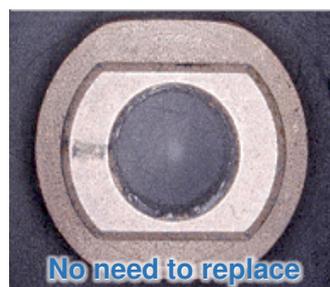
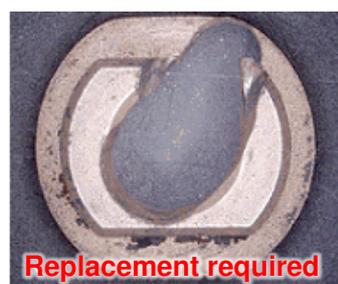
**Reference:** The photos below show bushings at various stages for reference.

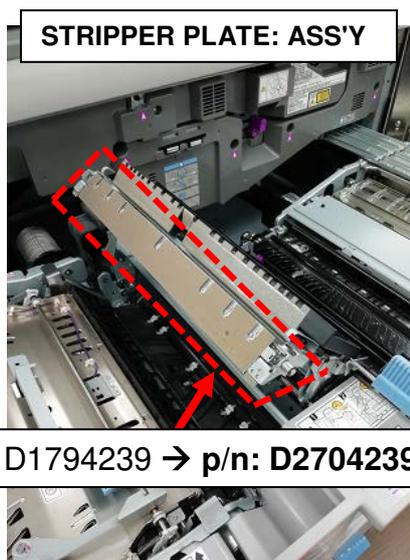
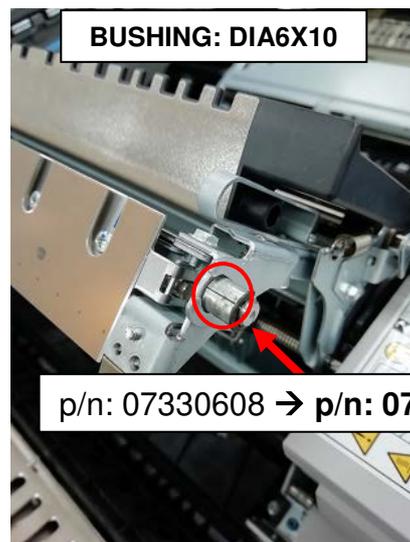
**Important note when replacing the Fusing Stripper Plate**

- When replacing with the new stripper plate, replace with the new bushing together as a set.
- Using the new stripper plate with the old bushing causes the plate to scratch the fusing belt.

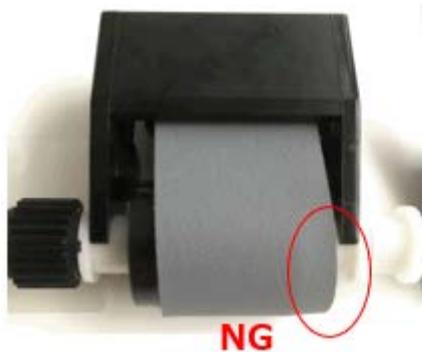
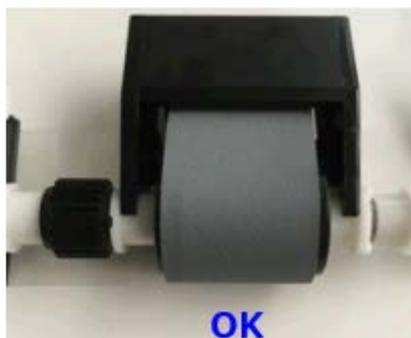
Notes: When replacing the Feed Belt, the Feed Belt may run on the flange under the following conditions and has a damaged belt edge as a result, so install it in the correct position.

- 3) The belt position on the drive roller is misaligned. (the belt should not protrude from the drive roller).

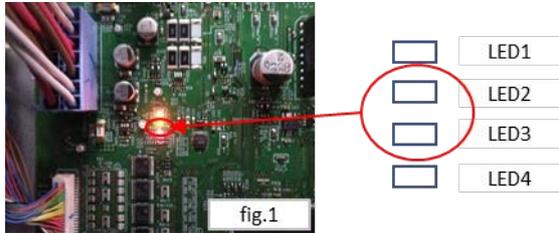
Steps	Possible cause	Troubleshooting procedure
1	<p>IOB, BCU and IPU do not activate because AC power is not supplied from PSU-B.</p> <ul style="list-style-type: none"> <li>• Poor harness connection between PSU-B and IOB/BCU/IPU</li> <li>• PSU-B board failure</li> </ul>	<p>Check the LED status of the three boards.</p> <ul style="list-style-type: none"> <li>• IOB LED2 (+5VL), LED3 (+5V)</li> </ul>
