Model: Baron-P3/C3	Date: 22-Mar-19	No.: RD0BX001a
--------------------	-----------------	----------------

Subject: Production delay of the Feed Rollers		Prepared by: S. Katoh	
From: Sales Strategy Section, 1st CP Business Dep.			
Classification:	<input type="checkbox"/> Troubleshooting	<input checked="" type="checkbox"/> Part information	<input type="checkbox"/> Action required
	<input type="checkbox"/> Mechanical	<input type="checkbox"/> Electrical	<input type="checkbox"/> Service manual revision
	<input type="checkbox"/> Paper path	<input type="checkbox"/> Transmit/receive	<input type="checkbox"/> Retrofit information
	<input type="checkbox"/> Product Safety	<input type="checkbox"/> Other ( )	<input checked="" type="checkbox"/> Tier 2

**Notice Regarding the New Paper Feed Roller**

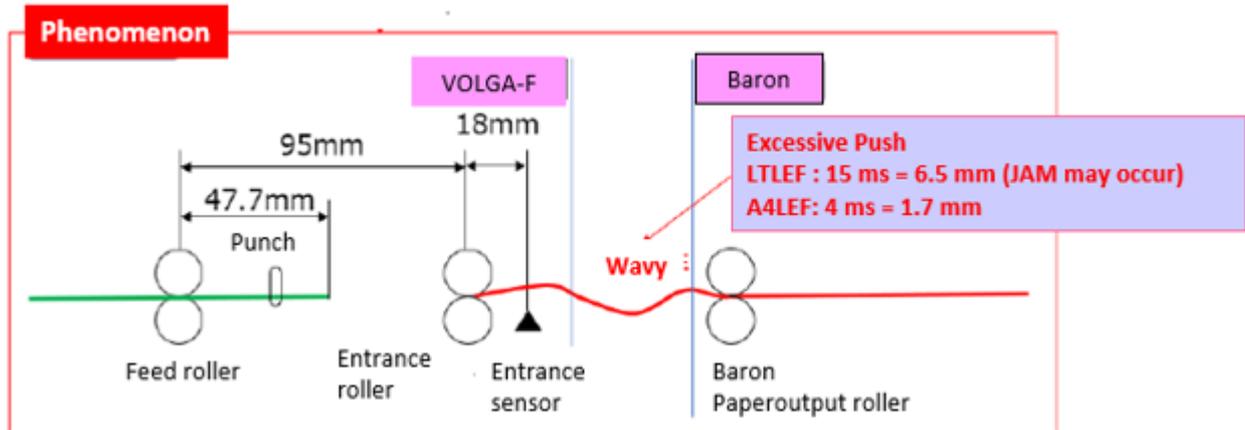
Fig.2

Firmware change to ensure the margin of 29 m sec (12.5 mm) against the condition where 15 m sec (6.5 mm) control can not be made in time. As a result, the same productivity (90.5 ppm) as shift tray punch mode.

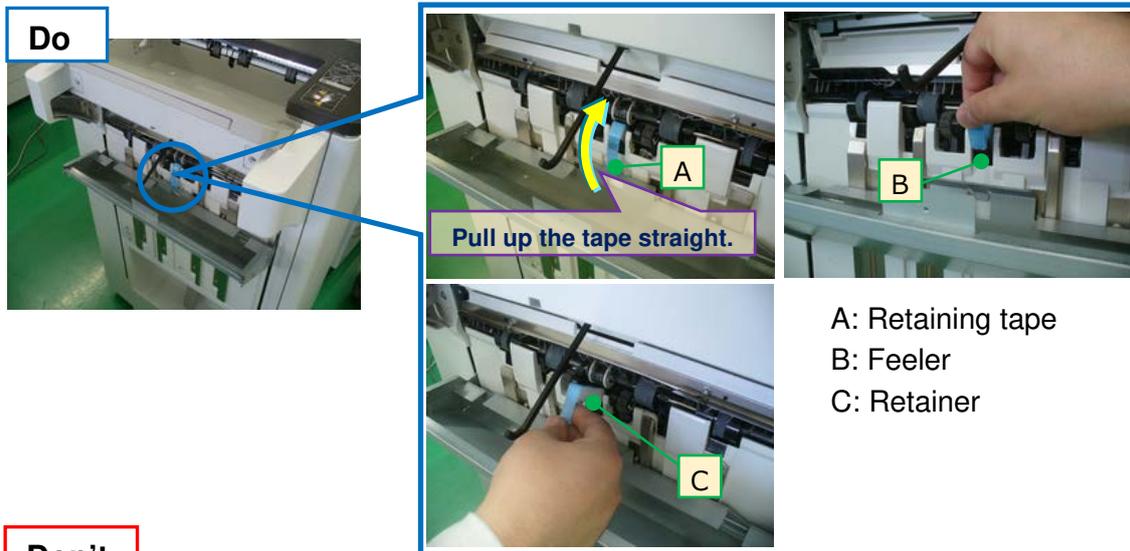
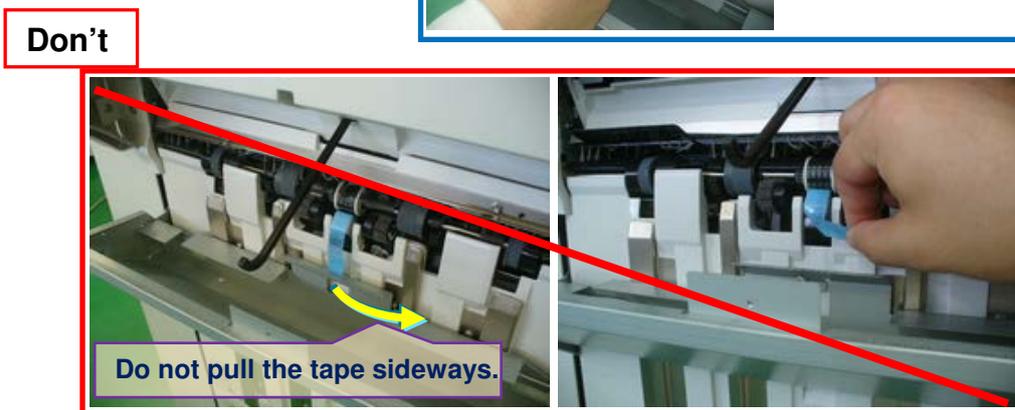
***Turning On the machine power with the feeler detached causes the shift tray to descend to the lowest position followed by J493 (Tray Lift Motor Jam). Power cycling Off/On in this condition will display the message 'Remove the paper from Finisher Shift Tray' on the operation panel.***

Temporary solution

Do not remove the retaining tape side by pulling it sideways. Instead, pull it up straight.

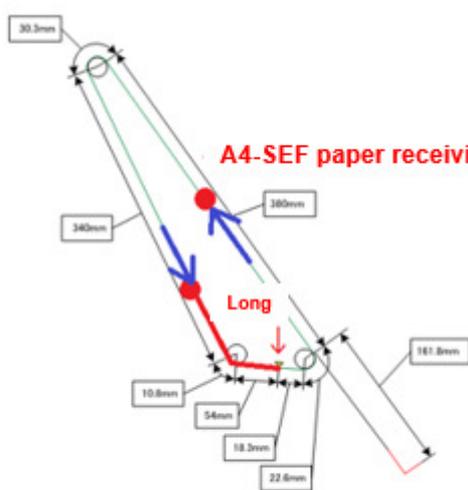
Fig.1 A4-SEF (Normal)

A soft bug caused by the fact that the homing sequence of the tip stopper did not consider reaching the HP sensor during motor start up.

When the leading end stopper is moved to the DLT size paper receiving position, the distance between the leading end stopper and the leading end stopper HP sensor decreases. In the subsequent homing process, the HP sensor is reached during motor start-up, and the homing process is not completed at the target timing, leading to a timeout (J132).

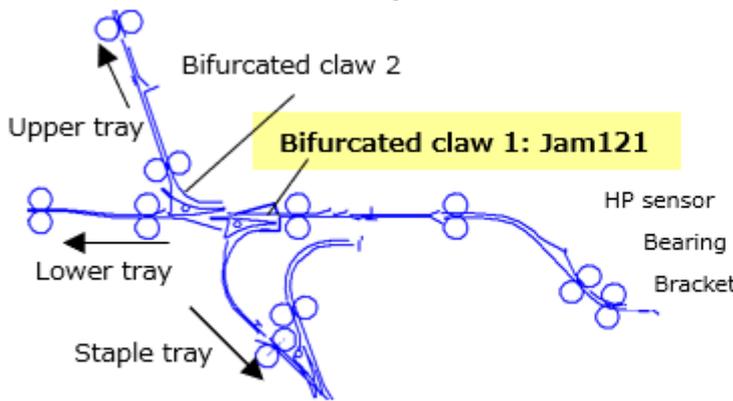
Fig.1 IGUAZU paper path

When the bearing that holds the Bifurcated claws is removed from the bracket, the Bifurcated claws can not operate normally, causing JAM 121.

Inadequate "amount of hooked bearings" due to design error and Parts failure.

Replace with the Bearing that has sufficient amount of "hooked bearings".

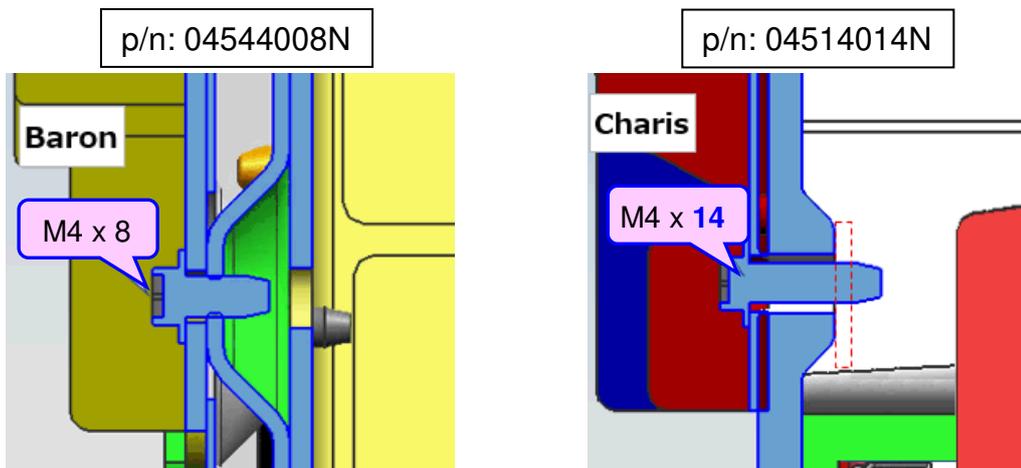
**Reason:** Cover Interposer Tray CI5040 will also be supported by the successor model to the Pro C52xx series, which will have a thicker exterior cover. To compensate for the thicker cover, the 8mm screw was replaced with the 14mm screw.

**Note:** DO NOT use the 14mm screw for models other than the successor to the Pro C52xx, because the screw will stick out.

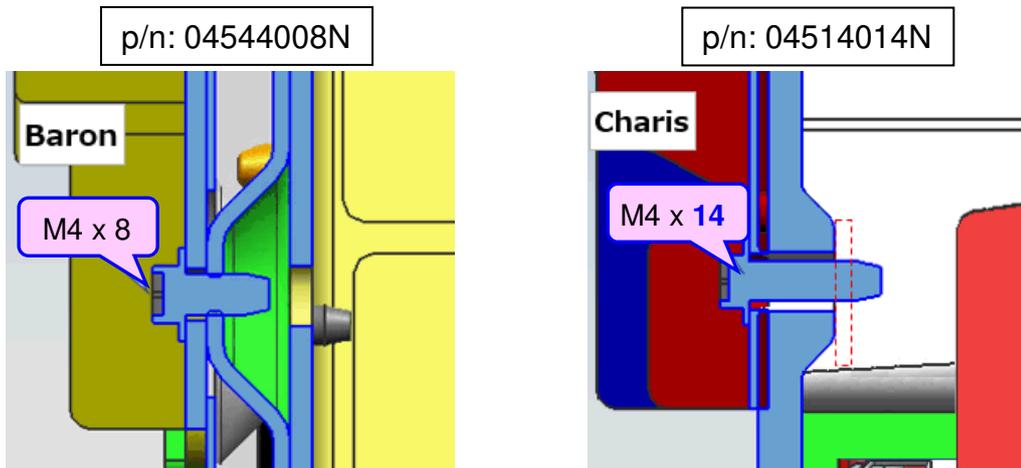
**Reason:** Cover Interposer Tray CI5040 will also be supported by the successor model to the Pro C52xx series, which will have a thicker exterior cover. To compensate for the thicker cover, the 8mm screw was replaced with the 14mm screw.

**Note:** DO NOT use the 14mm screw for models other than the successor to the Pro C52xx, because the screw will stick out.

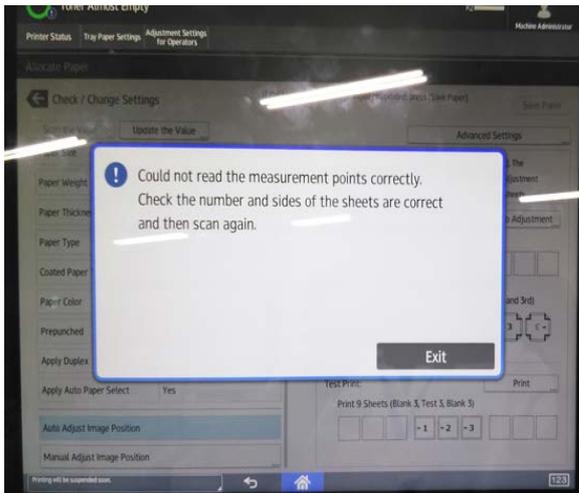
Scanning the test charts in the wrong order will display the error message shown to the left.

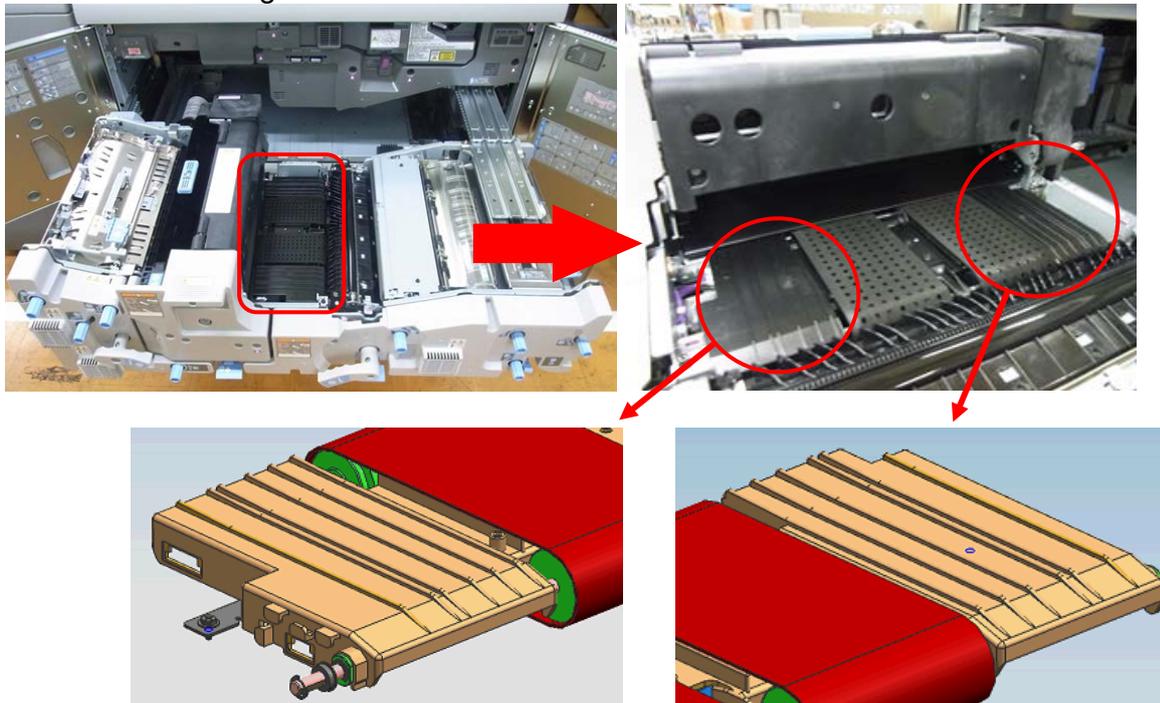
It is recommended to take good account of the information provided in this guide, as it should be beneficial in preventing the following image quality issues that may occur with carbonless copy paper:

- Ribs of the PTB unit can be cleaned by users.
- Wipe the ribs using a dry piece of cloth. No alcohol needed.

Clean the following locations:

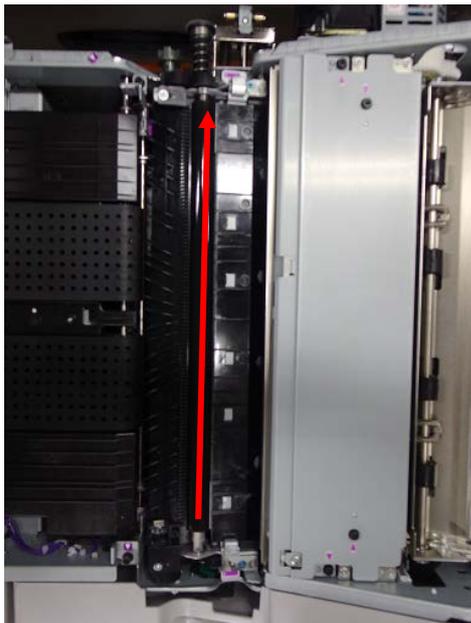
Pressure applied by the paper feed/transport rollers causes the chemical substance contained in the carbonless copy paper to seep to the surface and adhere to the PTR, which offsets to the back side of the page and appear as black roller marks.

1. Open both front doors and pull out the drawer unit.
2. Clean the surface of the PTR in one-way direction as shown with the arrow, from the front side to the rear side of the machine. **DO NOT** wipe in the opposite direction.

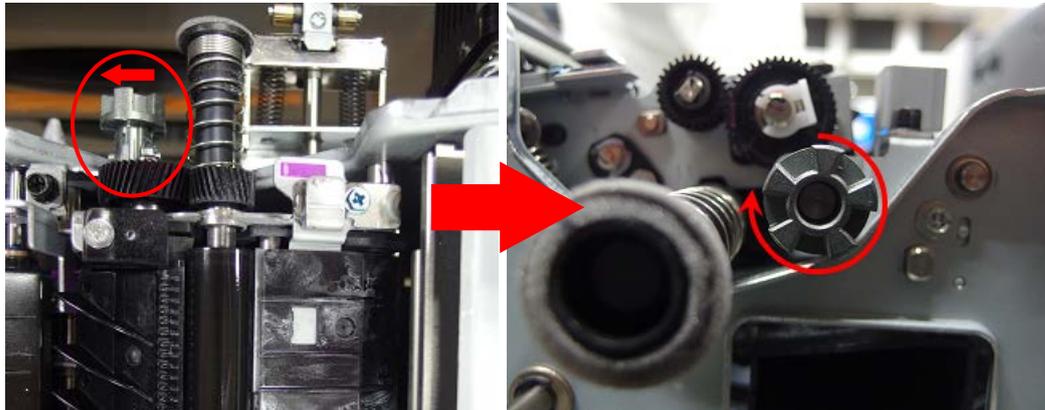
- DO NOT turn the shaft in the opposite direction (against feed direction). Doing so may bend the cleaning blade and cause image quality problems and jams.

3. At the rear side, turn the drive shaft of the PTR in the direction that feeds paper, to clean the entire surface of the roller.

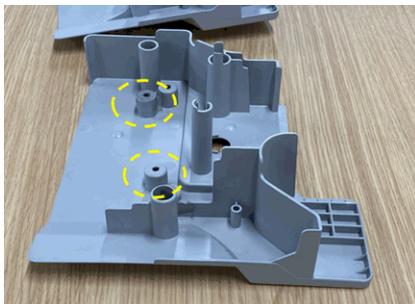
The front cover of the fusing unit breaks at the screw holes (circled in yellow) when the drawer unit or fusing unit is pulled out by gripping the wrong area (top left corner of the fusing unit cover circled in red).

Production: The front cover of the fusing unit will be modified for higher durability.

In the field: Grip the locations as described in the FSM when pulling out the drawer and fusing units. This applies also for units with the modified cover.

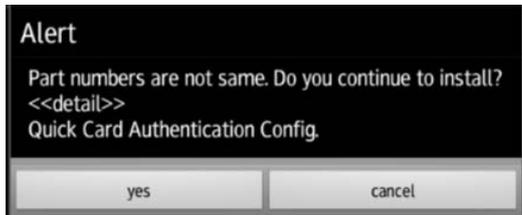
Because the p/n of the applications uploaded on the eDC server has changed, attempting to update the existing eDC applications via the eDC server will cause a mismatch and fail as shown below. To prevent this, update the existing applications with an SD card using the following procedure. This will change the product ID contained in the app installed on the machine and allow update via the eDC server in the standard procedure thereafter.

\*Shown to the left is an example of a mismatch error when attempted to update the Quick Card Authentication Config.

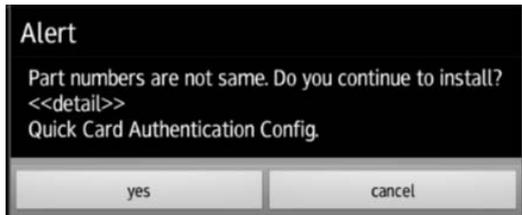
Because the p/n of the applications uploaded on the eDC server has changed, attempting to update the existing eDC applications via the eDC server will cause a mismatch and fail as shown below. To prevent this, update the existing applications with an SD card using the following procedure. This will change the product ID contained in the app installed on the machine and allow update via the eDC server in the standard procedure thereafter.

\*Shown to the left is an example of a mismatch error when attempted to update the Quick Card Authentication Config.

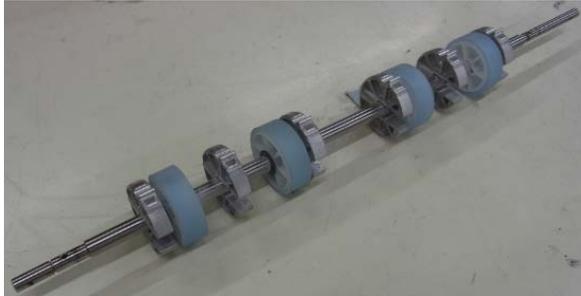
**Old**

The rubber rollers are translucent blue.

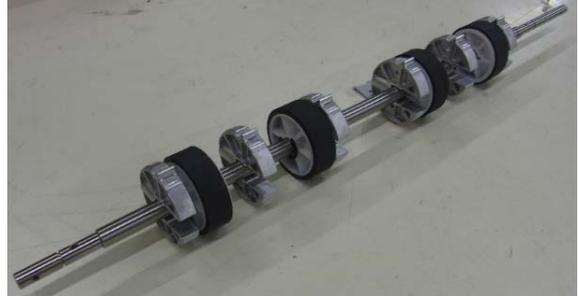
**New**

The rubber rollers are dark gray.

Replace with the modified roller.

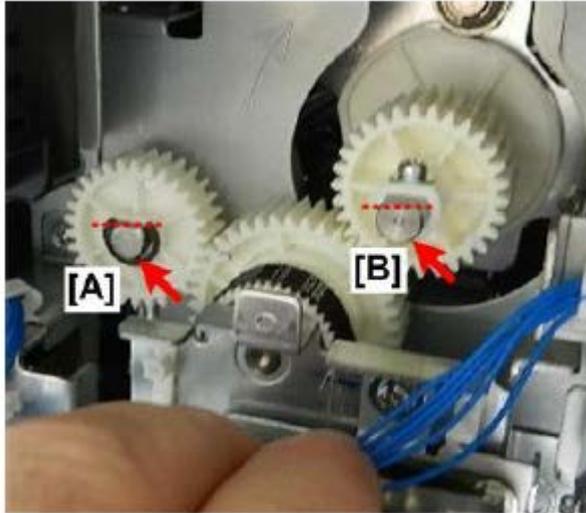
- Turn either gear so that the flat edge faces up. Ensure the flat edges are both facing up after setting the motor.
- If they are not facing up and parallel, the gears will be out of alignment, which may cause paper jams in the registration unit.

Before you re-attach the Registration Gate Roller Motor, make sure that the D-cut flat edges [A] and [B] on both shafts face up and are parallel.

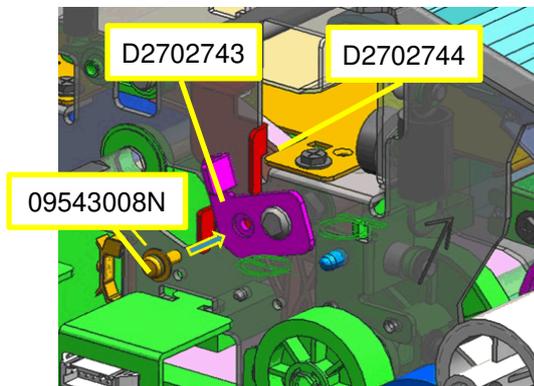
The gap between the registration timing roller and its idle roller is too small for the leading edge of the paper to pass through. This happens because the radial load generated by the registration timing roller wears the keyhole-shaped slot on the side plate to which the roller is fixed, causing a loose shaft. The wear occurs over time at approximately 50,000K.

Added a holder and bracket, to firmly support the timing roller in the slot.

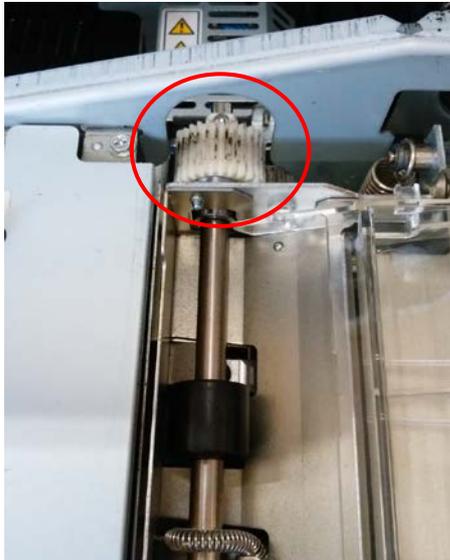
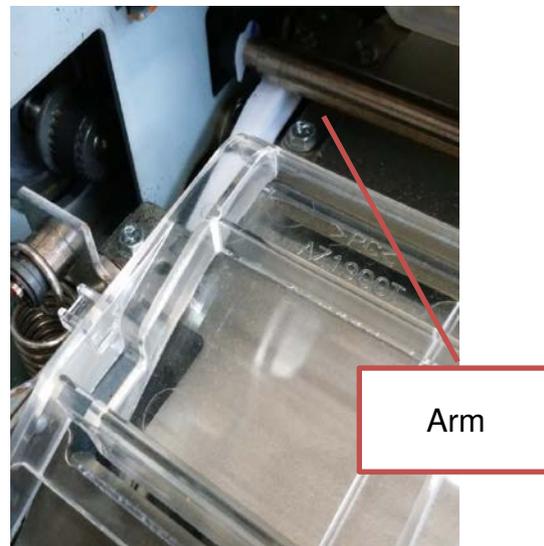
1. Pull out the drawer unit and turn the gear circled in red with your fingers until the arm reaches the highest position.

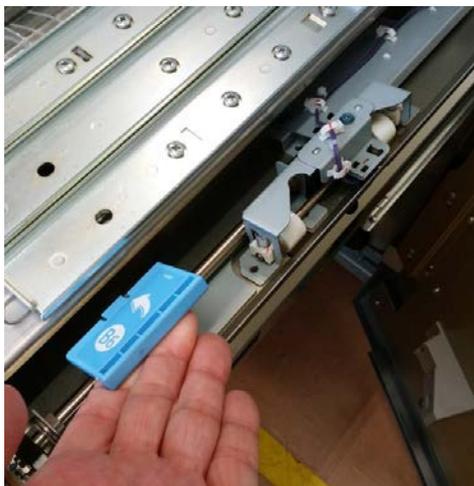
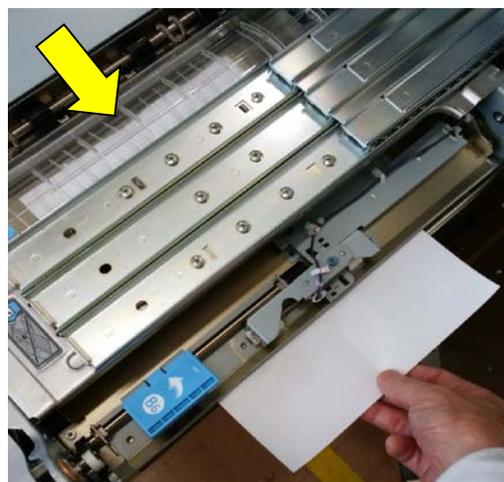
2. Lift up the B6 lever and insert a plain sheet of paper in between the guide plate.

If the paper comes through the transparent cover smoothly:

- ➔ No problem. The jams are not caused by a loose timing roller.

- ➔ The keyhole is worn. Do the modification described on the following pages.

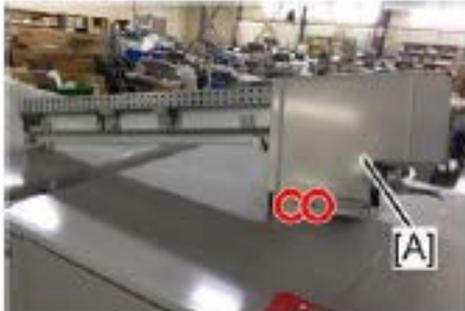
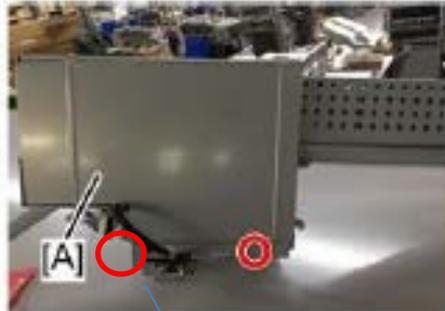
8. Remove the punch unit cover [A].

Added a red circle and corrected the number of screws from 3 to 4.

3 → 4

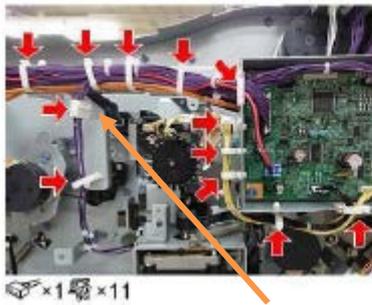
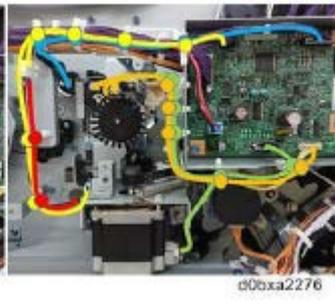
20. Route the harnesses between the punch unit and punch unit PCB as shown below.

Added the orange arrow to clarify the connector position.

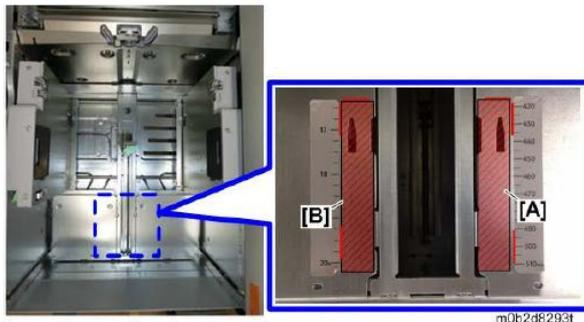
No. 35.

2. Installation > Vacuum Feed Banner Sheet Tray > Before  
Changed the instruction and photo.

Attach the scale decals [A] and [B] by referring to the red markings.

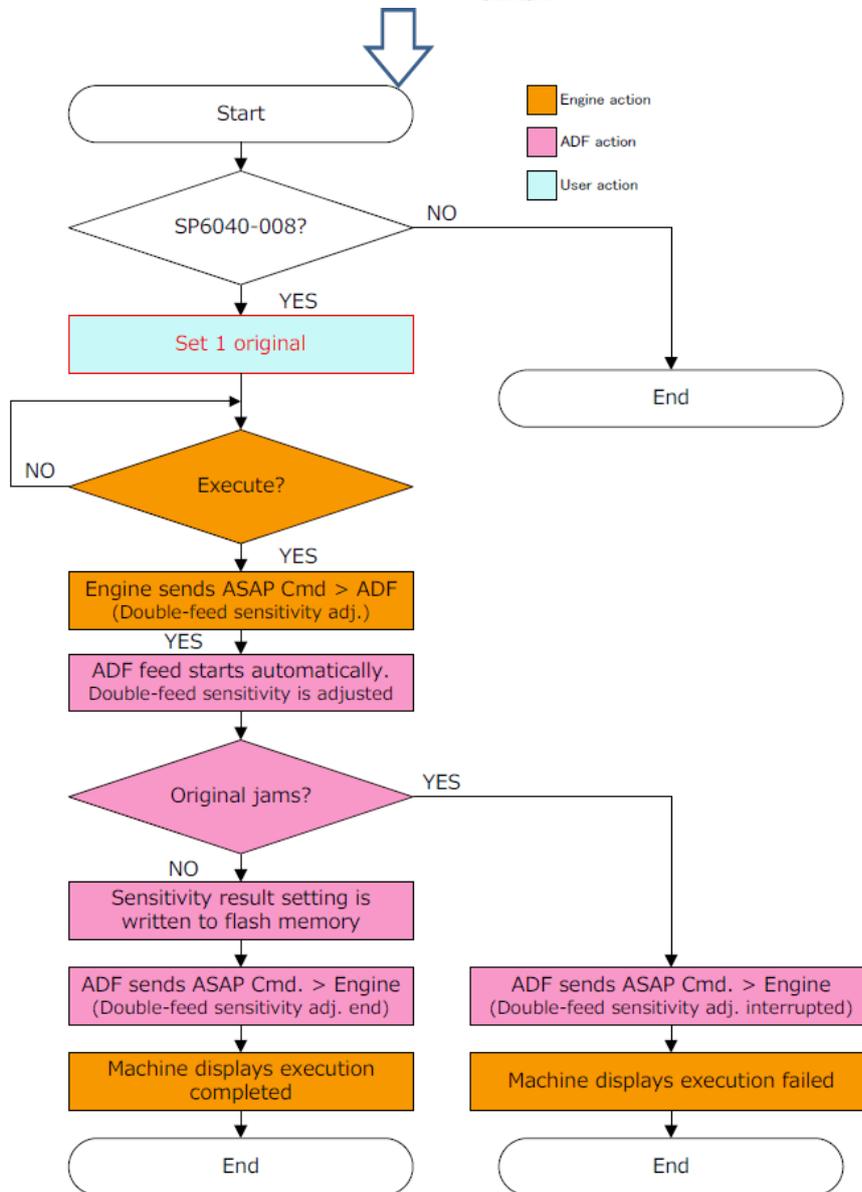
Correction 4-3

Replaced the flow chart.
