Model: Leo-C1

No.: RD194004

Subject: Firmware Release Note: NetworkDocBox			Prepared	d by: Y.Yamada
From: 1st PP Tech Service Sect., PP Tech Service Dept.				
Classification:	Troubleshooting	Part informat	ion	Action required
	Mechanical	Electrical		Service manual revision
	Paper path	Transmit/rec	eive	Retrofit information
	Product Safety	🛛 Other (Firmv	vare)	🛛 Tier 2

# This RTB has been issued to announce the firmware release information for the **NetworkDocBox.**

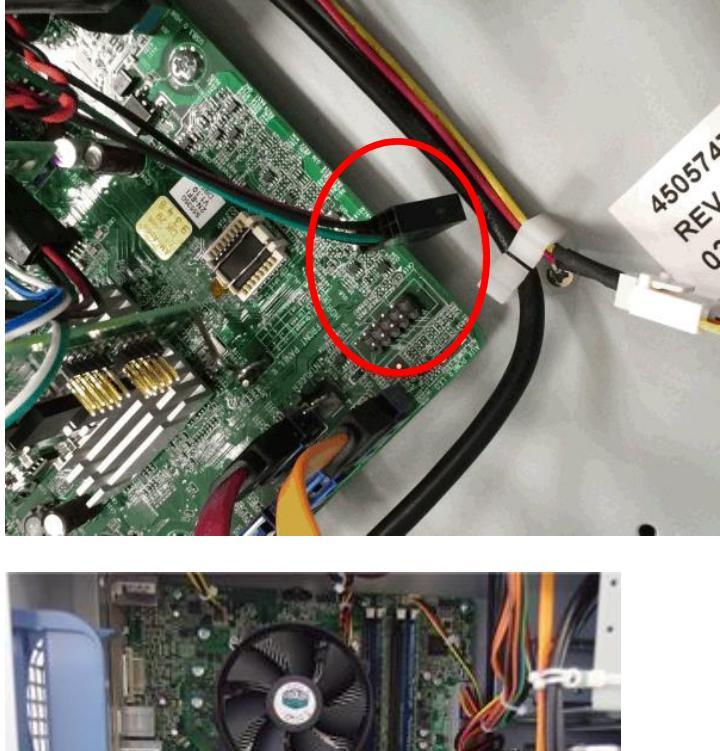
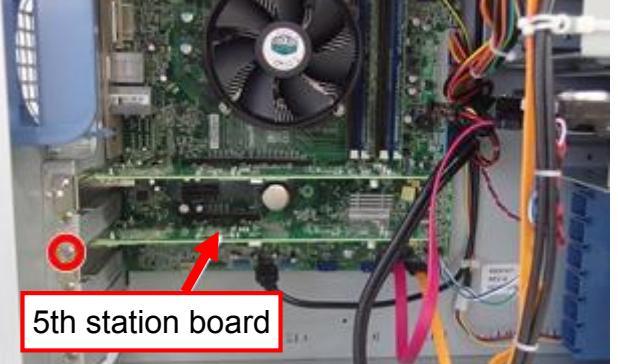
- If the controller does not activate even after turning on the power at new site install, check the mother board. The cable connecting the mother board and video card may be disconnected on the mother board side.
- When installing the 5th station kit, work carefully to avoid contact with the above connector to prevent its disconnection from the mother board, especially on the E-43A. (E-83A is larger and provides enough space.)

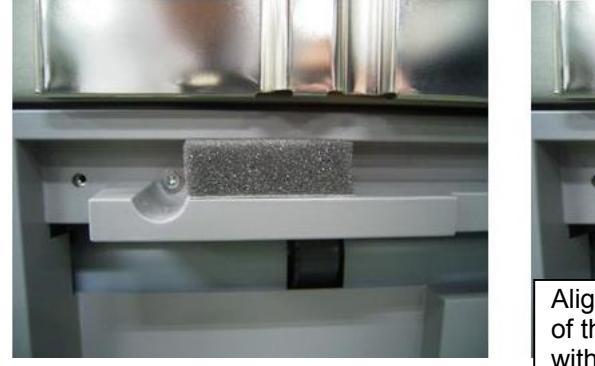
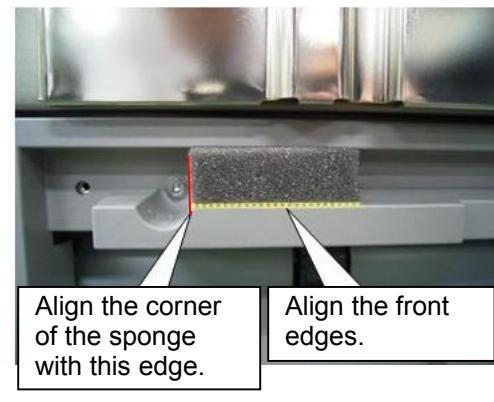
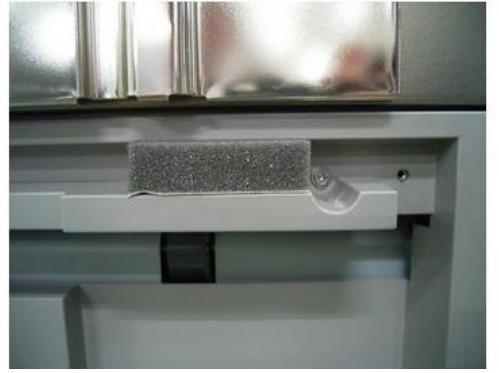
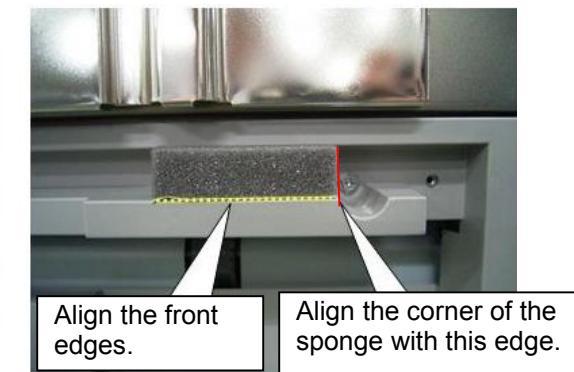
Sponges 1 and 2 were attached to the wrong position in the illustration. Replace the illustration with the photos below.

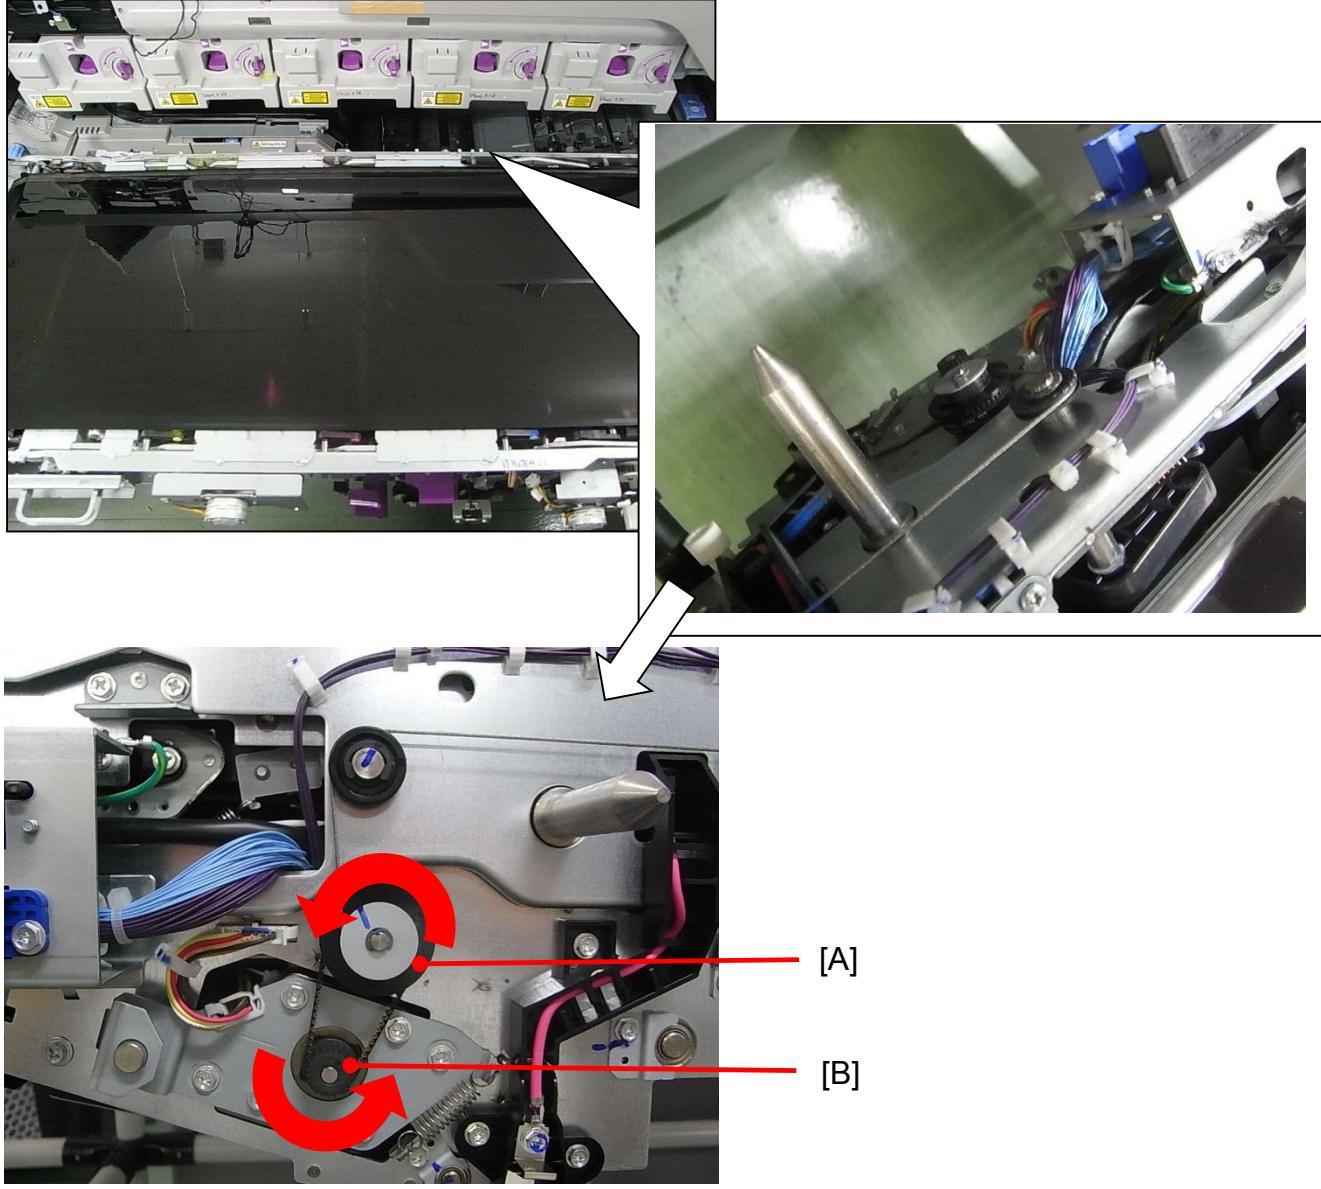
(View from the non-operator side)

The steering control arm at the back of the ITB unit is not in home position when the machine power is turned on, which is caused by shock from transportation. The SC is detected before the arm retrieves its home position during initialization, because the SC detection is too strict.

Rotate the gears [A] and [B] counterclockwise to align the arm with the bracket, if you experience SC472 at new site installs.

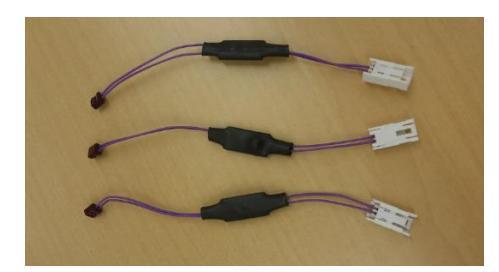
Static electricity built up inside the machine damages the fan(s) in the Paper Transport Belt Unit, which then damages the IOB.

Add fuses to the fan circuits. These fuses will blow to protect the IOB when the fan breaks down. An SC will not be issued.

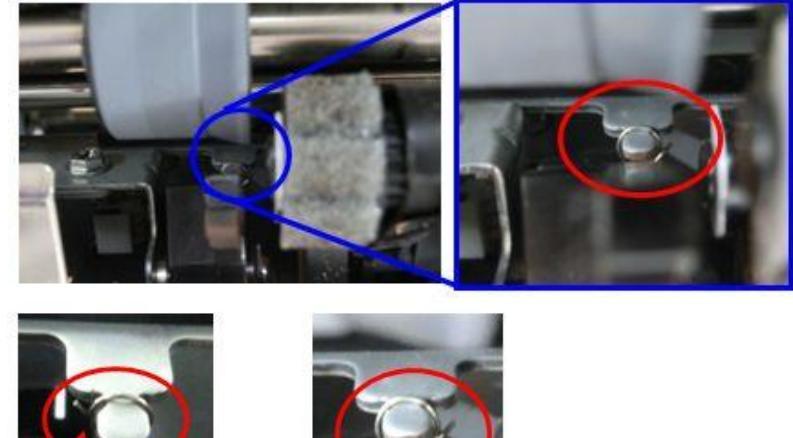
3. Check whether the end of the spring is facing to the left or to the right hand side.

Facing left: GOOD

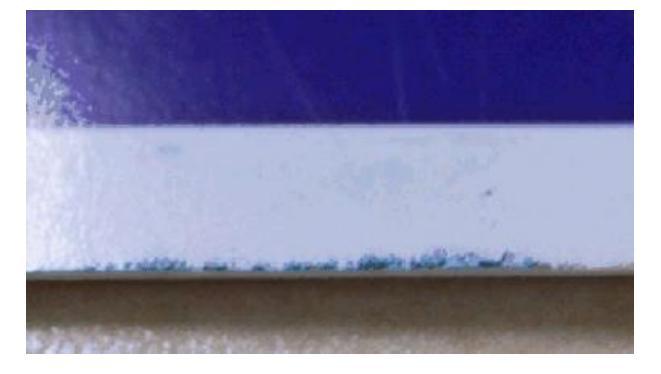
The trailing edge is stained with toner when printing on thick paper.

Feeding thick paper causes its trailing edge to catch the toner accumulated on the ITB guide plate.

## Procedure

Remove the ITB guide plate. (screw x 3) To avoid damage, slide it out slowly. Do not drop.

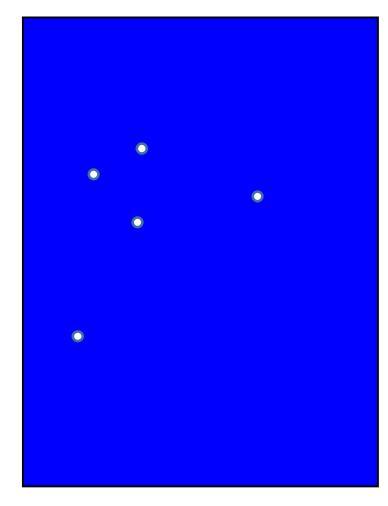
#### White spots

Both of the above symptoms are caused by caked toner.

- The machine is left unused for an extended period in a high temp/humidity environment.
- Toner adhered to the housing of the development unit cakes up and falls into the mixture when the PCDU or toner supply unit is given an intense shock.
- Toner bottle is not stored in a plastic bag in a high temp/humidity environment.
- The air cooling system is defective and causes the internal temperature of the development unit to increase.

Replace the toner bottle of the affected color and print 300 copies of solid fills on A3/DLT. Caked toner in the toner hopper or development unit can be removed with this method.

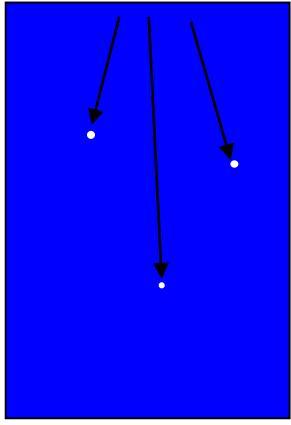
The symptom is noticeable on 4x4 and 2x2 test patterns.

Wavy lines: Condensation on the fusing exit guide plate affects the print AFTER fusing White spots: Condensation on the fusing exit guide plate affects the print BEFORE fusing

- Apply good paper storage conditions and plastic bags to prevent paper from absorbing moisture.
- Turn on the tray heater.
- Apply the following settings so that the machine is fully warmed up when running jobs:
  - Turn ON the machine 30 min before running the first job. Timer setting is convenient.
  - > Set SP1-101-007 (Rotation time: Cold) to 500 sec.
  - > Set SP1-121-001: Time: After Reload) to 900 sec.
- Print 30 sheets of A3/DLT in duplex before running jobs

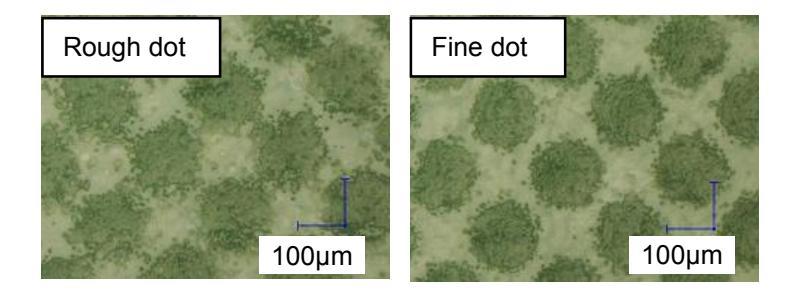
Toner deteriorates and does not transfer to the paper as expected.

As the toner deteriorates, dots become rough and gloss uneven (because the height of the dots are uneven).

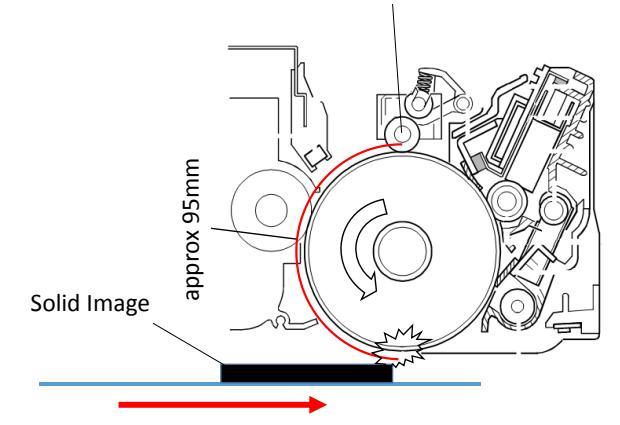
Charge Roller

The solid image is composed of toner piled up high on the ITB, which causes a shock when it enters and leaves the nip between the drum and the image transfer roller(s). Vibration from the shock transfers to the charge roller via the drum and affects the charging process.

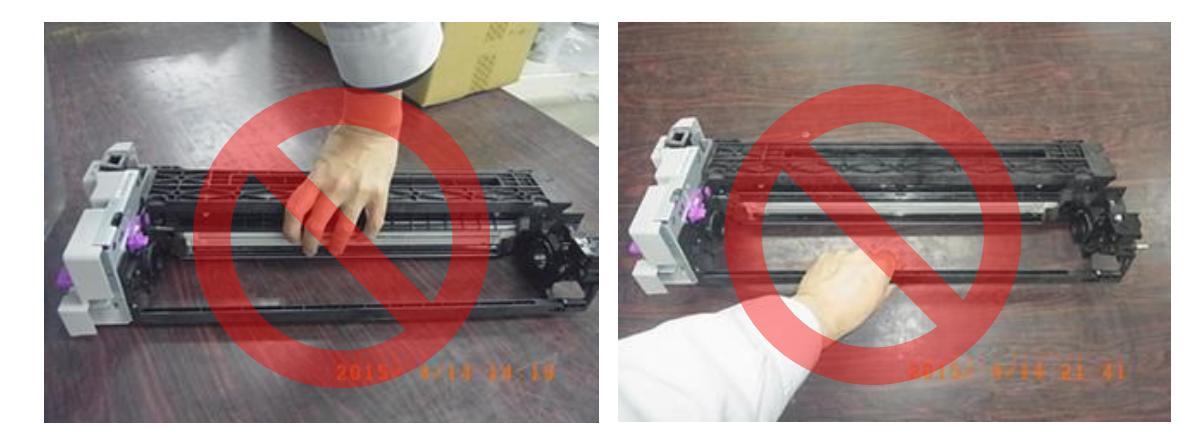
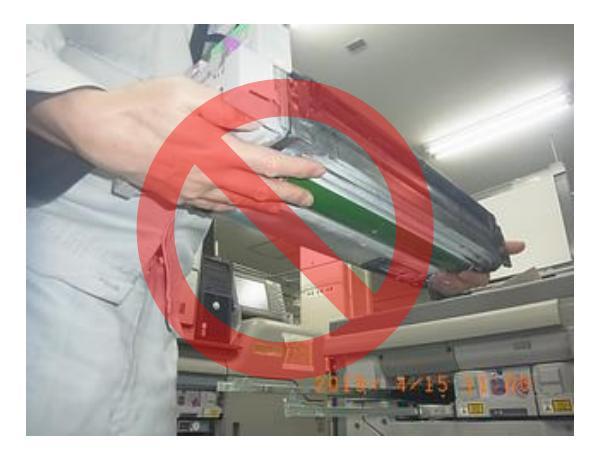
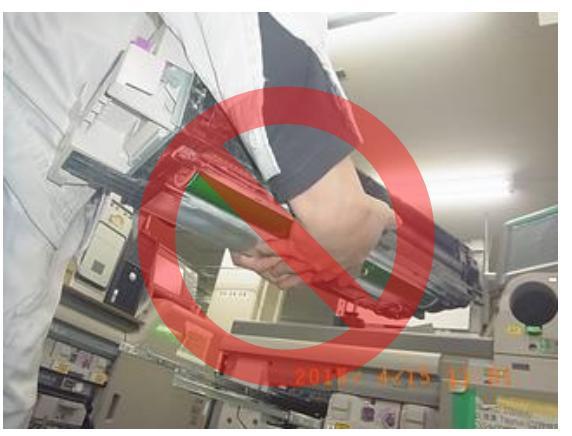
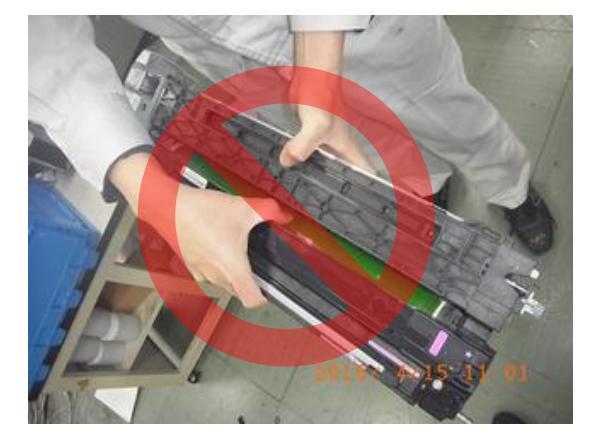
There have been cases reported from the field where the toner shield glass was frequently dirty with toner. According to our investigations, the operator had deformed the development unit entrance seal when performing special color replacement, causing toner to spill.

**DO NOT** hold the development unit and PCDU as shown below.

The locations indicated are fragile. **DO NOT** hold the development unit at these locations.

When providing instructions to machine operators on Special Color Replacement, please make sure to advise them where to hold and where not to hold the development unit to avoid damage. The "Replacement Guide" will be updated to add this infromation.

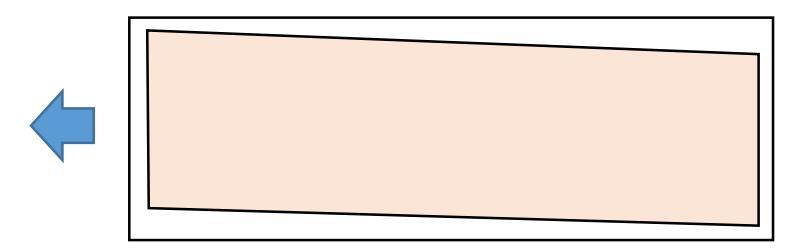
Image skew occurs when banner sheets are fed from the Vacuum Feed LCIT RT5100 (D777).

The trailing edge of the banner is not moved (it is held by the transport roller in the LCIT) during side-to-side registration.

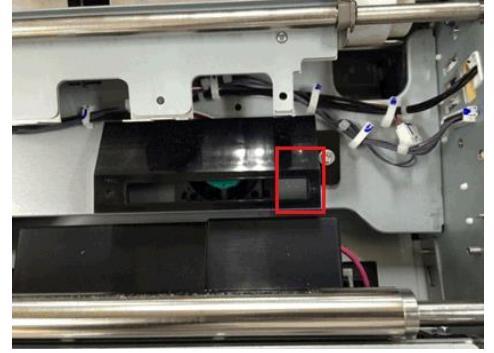
The CIS mistakenly detects the fan duct of the registration unit as the paper's edge when applying maximum light power, which is when printing on black paper or colored paper.

#### Failure rate: Approximately 20%.

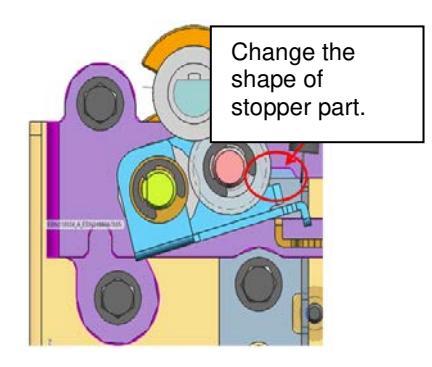
#### Stopper bracket:

Changed the shape of the stopper bracket for better engagement of the gears. This has been applied from '15 July mass productions. (p/n: D1944268)

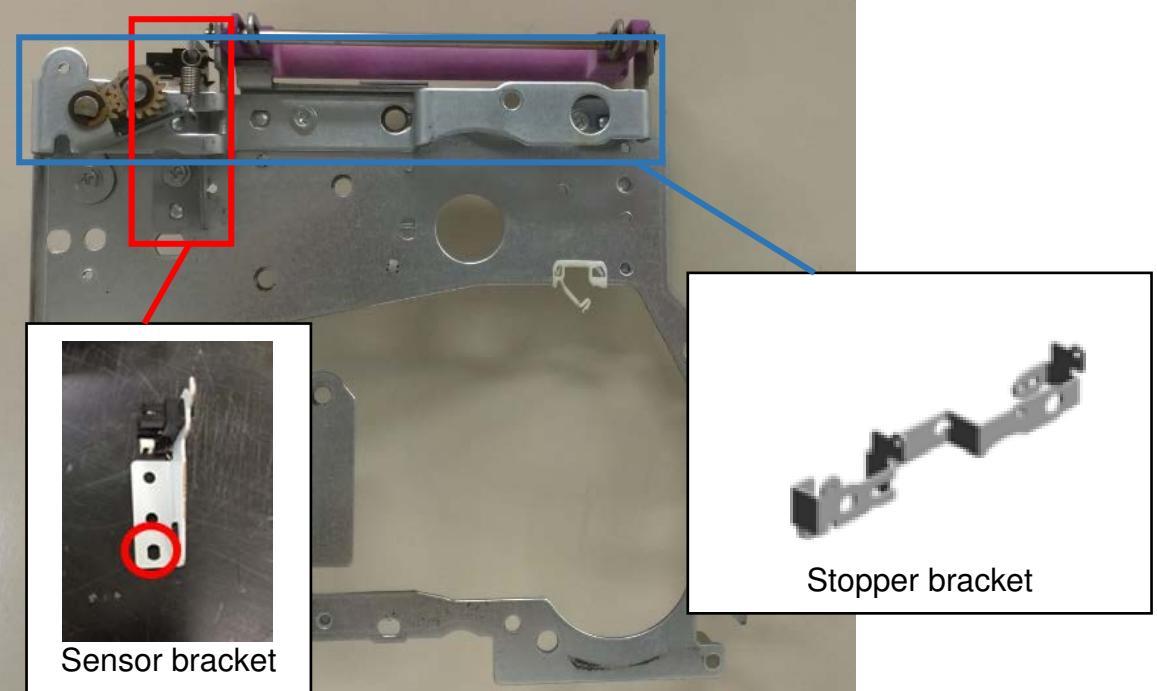
Note: The sensor bracket and stopper bracket (P/N D1944268) are attached to the inner face of the rear frame.

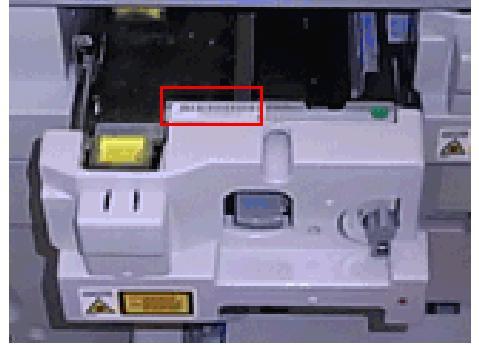
The wrong development unit was included in fourteen 5<sup>th</sup> Station Replacement Kits manufactured in December 2014 (the kits were configured for BK development units).

- The development unit inside each replacement kit contains a chip that stores the color information. This chip is normally blank when the kit is shipped out, and the machine writes the information to the chip at installation ("White" or "Clear").
- For these fourteen units, "Black" was written to the chip.

1. Check the serial number on the top of the PCDU front panel (boxed in red in the photo) to check if the development unit is an affected unit.

2. If it the development unit is an affected unit, replace it with the **Service parts** development unit and report the serial number of the affected unit to your supervisor.

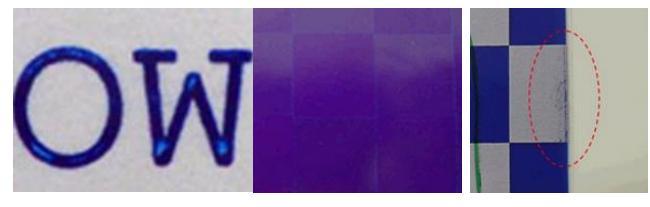
Image Quality Problem: Full Page > Unprinted> Worm Holes: Text or Edge of an Image

Worm Holes: When Using the Clear Toner Unprinted: When Using a Transparent Film

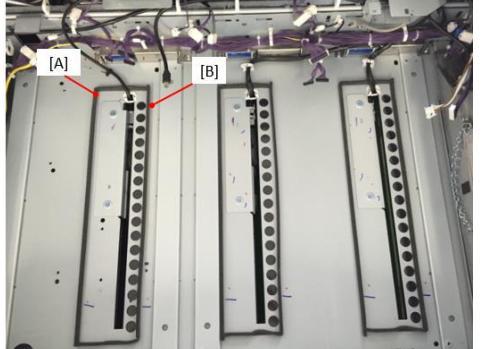
**Note:** Some machines in the field do not have the circular holes shown in the photo above (some have square-shaped holes and some have no holes). This does not affect this procedure.

7. Remove the sponge with double sided tape [A] and [B].

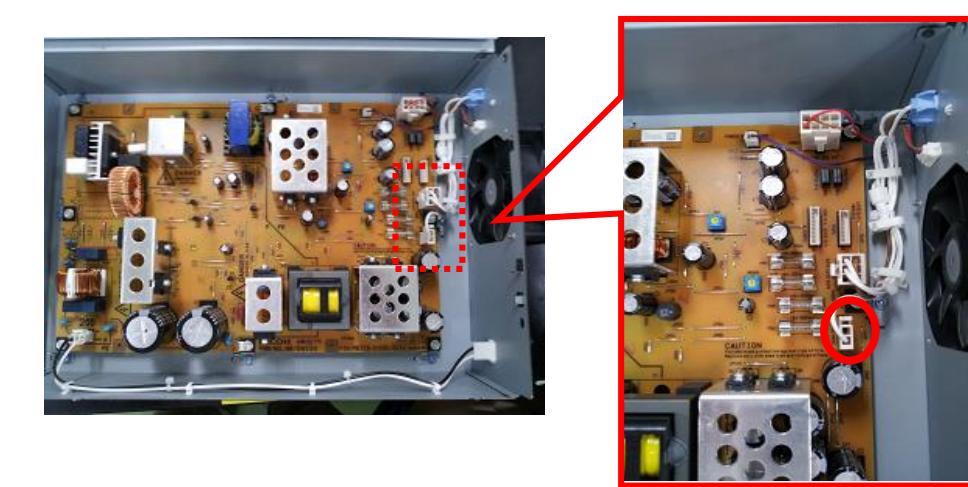
- **Note:** There are two types (levels of mass production), one with no harness and another with the harness attached.
- 37. Replace the harness with the harness (D1945294) provided as a Service part and attach it to PSU 5.

**36.** If the harness is connected to the board connector circled in red in the photo, go to Step **36.** If not, go to Step **35.**

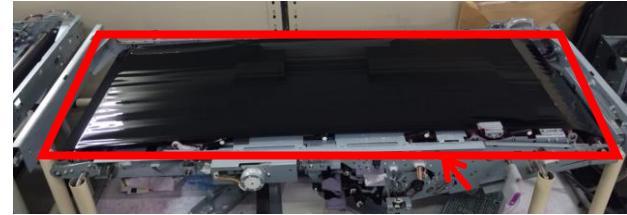
NOTE: If SC446 persists, manually lubricate the ITB instead of executing SP2-301-1 (Force Lubricant - Belt Cleaning).

Apply lubricant powder (p/n: B1329700) evenly across the ITB by manually rotating the ITB drive motor.

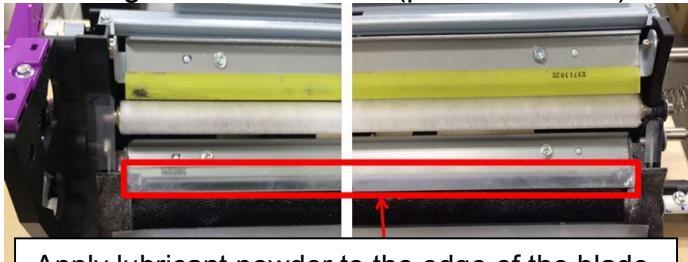
Apply lubricant powder to the edge of the blade.

1. Apply lubricant (p/n: D0159501) to the edge of the cleaning blade of the new cleaning unit using the blower brush (p/n: D0747960).

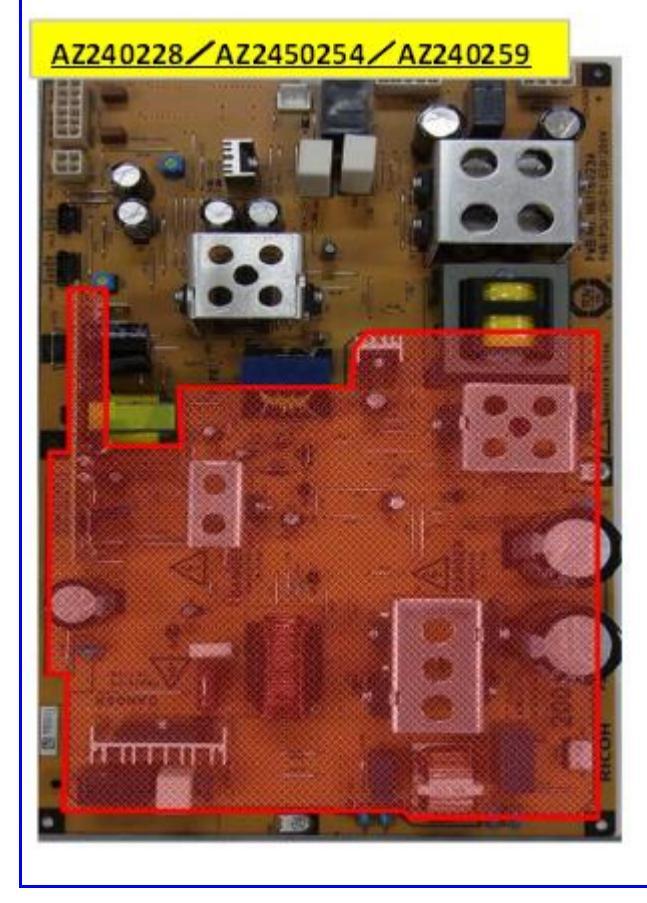
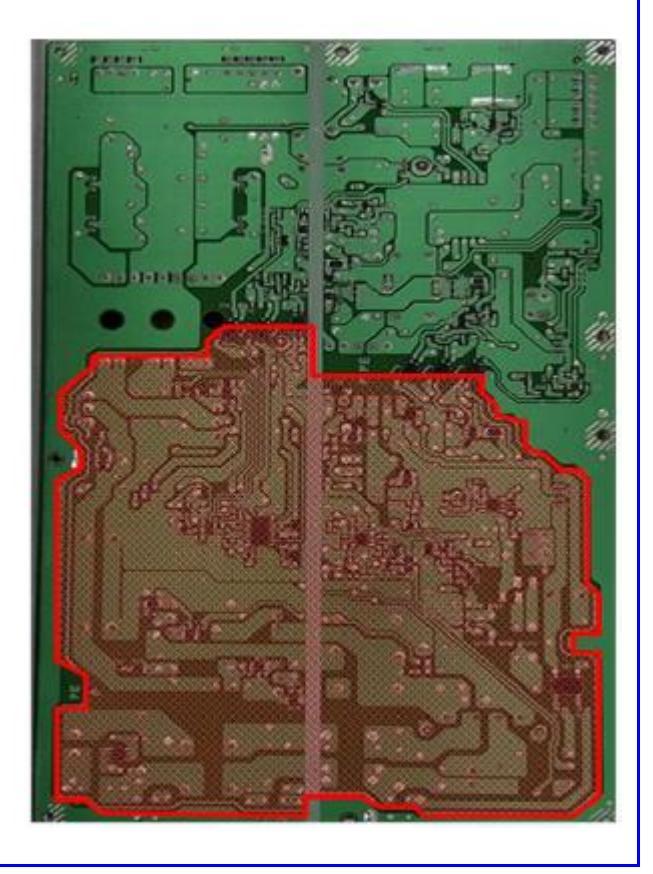
**NEVER touch** the areas outlined in red in the photos below, to prevent electric shock caused by residual charge.

Residual charge of about 100V-400V remains in the AC circuits on the PSU board for several months even when the board has been removed from the machine after turning off the machine power and unplugging the power cord.

The procedure to discharge residual charge from the machine by unplugging the power cord from the AC wall outlet and pressing the main power switch works only for the DC circuits on this board. Residual charge remains in the AC circuits.

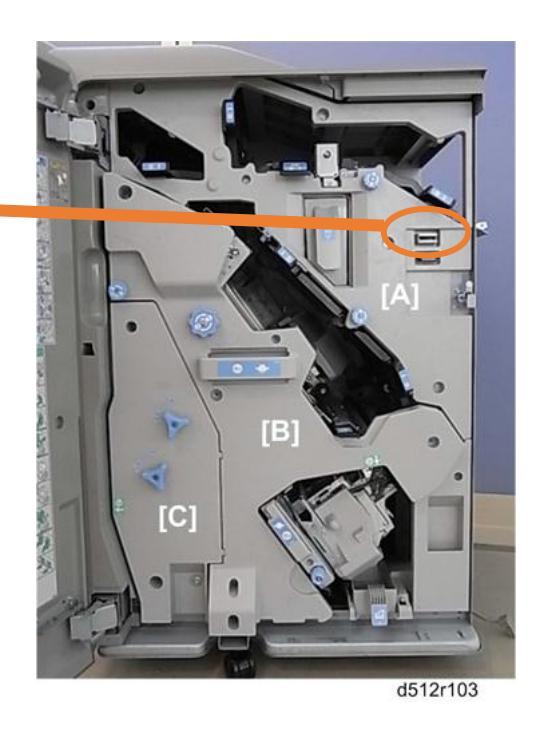
The contact surfaces of the interlock switch on the finisher door were covered in small particles of insulating impurities during the plating process. As a result, a contact failure may occur in the switch.

**Note:** The impurities are very small. As a result, the symptom only occurs on a small percentage of affected machines.

Replace the interlock switch using the **PROCEDURE** on the next page, if:

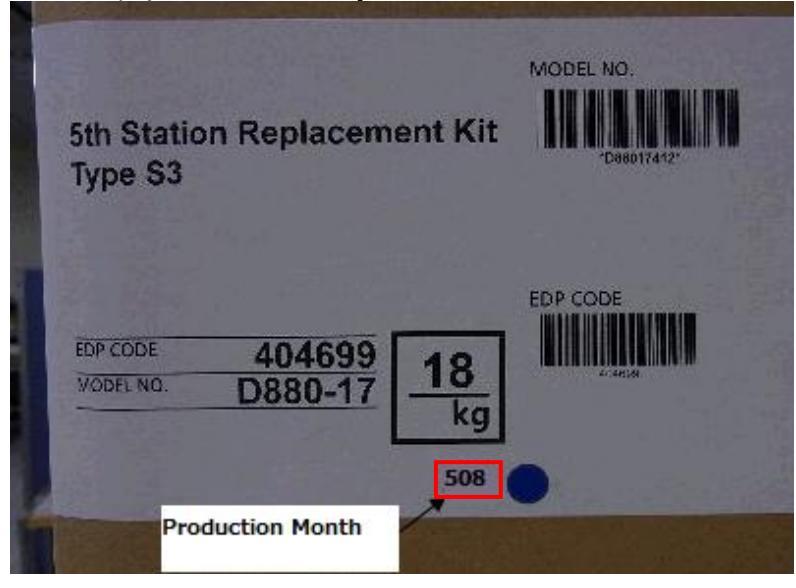
- Do the following when you install the 5<sup>th</sup> Station Replacement Kit.
- This is necessary because some development units produced in August 2015 have a misshaped groove.
- This **does not** apply to individual development units already installed in the machine or to service parts inventory.

Check the see whether the kit was produced in August 2015. If the number "508" appears on the bottom of the label (boxed in red in the photo below), proceed to Step 2.

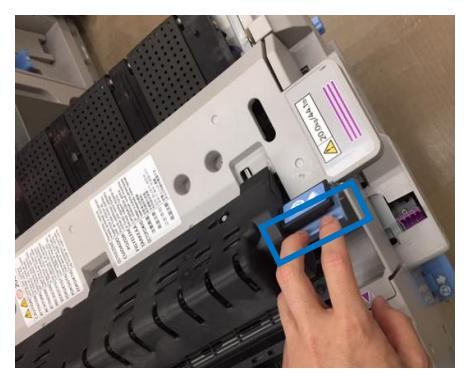
The operator pushes the blue grip (see photo) with excessive force when closing the fusing guide unit.

Replace the broken grip plate (B1324168).

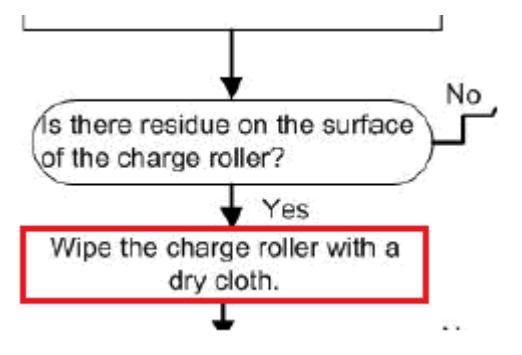
- Stains on the rollers
- Stains on the guide plate ribs
- Stains on the charge roller
- Aging of the drum cleaning unit
- Scratched drum
- Aging of the ITB cleaning unit
- Aging of the PTR unit.

Wipe the charge roller with damp cloth and then with dry cloth.

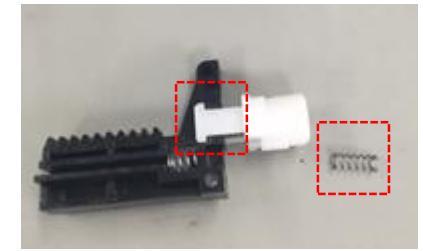
The machine cannot recover from the Toner End or Near End condition after the toner bottle is replaced.

The user turns the toner bottle while the chuck is in the process of pulling the cap to open the bottle. As a result, the chuck and spring (see the photo) break, and cannot pull the cap to open the bottle.

The following reinforcement bracket (P/N: TBA) will be added. This will protect the chuck so that it is not broken even if the user turns the bottle as described above.

a. Replace the broken parts with the toner bank unit (p/n: D1943554) which includes the broken chuck and spring inside. (Estimated working time: 30min) ,

b. Replace the broken parts with the individual parts, chuck (p/n: B2343356) and spring (p/n: D1943724). (Estimated working time: 40 min)

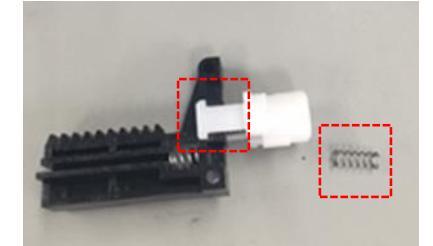
The machine cannot recover from the Toner End or Near End condition after the toner bottle is replaced.

The user turns the toner bottle while the chuck is in the process of pulling the cap to open the bottle. As a result, the chuck and spring (see the photo) break, and cannot pull the cap to open the bottle.

A reinforcement bracket (P/N: D1943713) has been added. This will protect the chuck so that it is not broken even if the user turns the bottle as described above.

Attach the reinforcement brackets at all color stations except the 5<sup>th</sup> station at the next service visit.

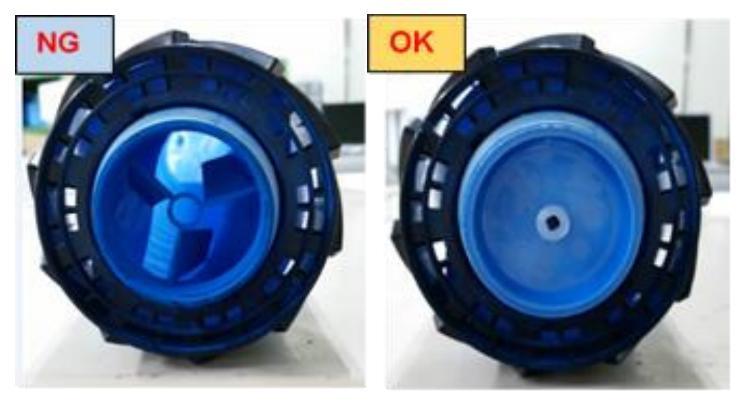
- Note: Each modification kit (P/N D1949921) includes four reinforcement brackets, i.e. one kit is needed per machine.
- 1. Check whether the white cap is attached correctly to the removed toner bottle, as shown in the "OK" photo.
  - ➢ If it is (OK), go to Step 2.
  - If the white cap is NOT attached, check the toner hopper at the rear side of the machine. The cap may still be inside the machine.

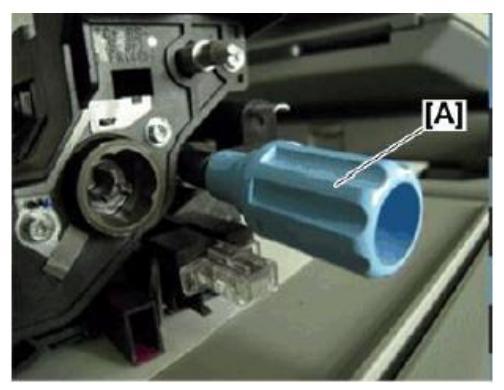
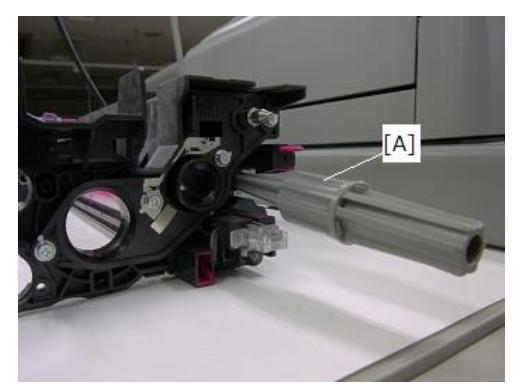
Please replace the photo of the jig with the correct photo below in the following section of your field service manual.

4. Replacement Adjustments > Photoconductor Development Unit (PCDU) > Replacing Developer > Removing Old Developer > Step 10

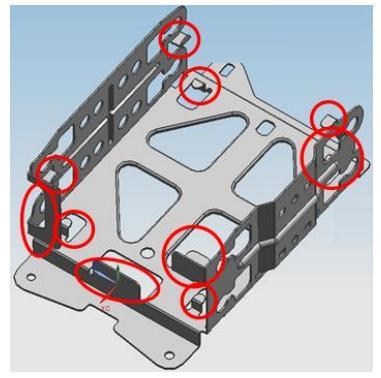
- Some of the projections on the HDD bracket (circled below) can contact the HDD directly.
- The amount that the printing speed is reduced depends on how much vibration is transmitted to the HDD.

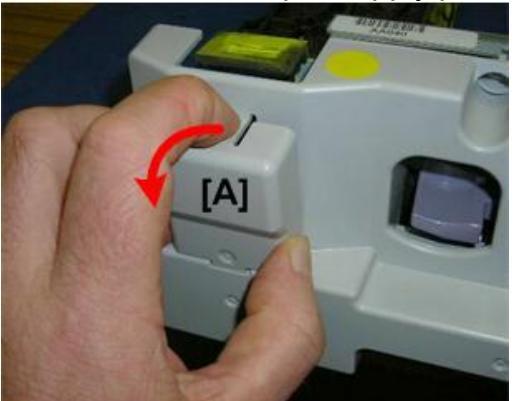
This is because following the current procedure may contaminate the bearing of the development roller and cause the image quality issue known as 'banding'.

- 1. Pull out the Development unit.
- 2. Remove the Developer supply port cover [A].

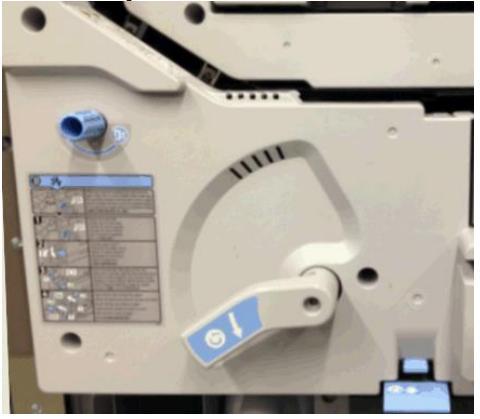
### **Correct** position

- 1) The left drawer lever (C1 lever) is loose (Photo 1) or,
- 2) The lever is locked in the incorrect position (Photo 2)

The lock mechanism engages incorrectly or is disengaged.

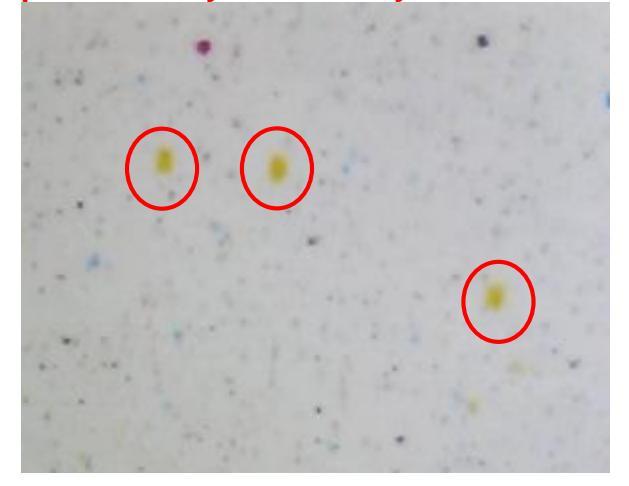
Туре	Sample (magnified)	CAUSE
A Small dots	<u>Dot size:</u> Approx. 5μm	Insufficiently charged developer Charge level of the developer is low due to either or both of the following:
		<ul> <li>High TC (toner concentration) in the development unit</li> </ul>
		<ul> <li>Degradation of the developer</li> </ul>
	She was a set of the set of the set of the	High humidity
		High humidity reduces the charge level of the developer.
		Coated paper (surface coating)
	The entire background appears dirty with very fine toner particles.	Some coatings may cause excess toner to be transferred to the paper.
В	Dot size: Approx.0.1-0.3mm	OPC deterioration
Large dots	О • • О	The electrostatic potential on the drum surface decreases due to deterioration.
	the second s	High humidity
		High humidity reduces the charge level of the developer.
	0	
	and the second sec	Coated paper (surface coating)
	0	Some coatings may cause excess toner to be transferred to the paper.

Note: The large yellow dots in the example below are not part of the symptom. These are embedded into the image by the machine, as part of a tracking pattern. They are virtually invisible to the naked eye.

- Check the counter values of the PM parts in the PCDU and replace any that have exceeded target yield.
- Make sure to calibrate the color with DFE after you complete the adjustments.
- Make a test print after you perform each action/step. If enough improvement is made, stop the procedure.
- 1. Print out test charts in **SP2109** using the following settings. SP2109 test chart print parameters

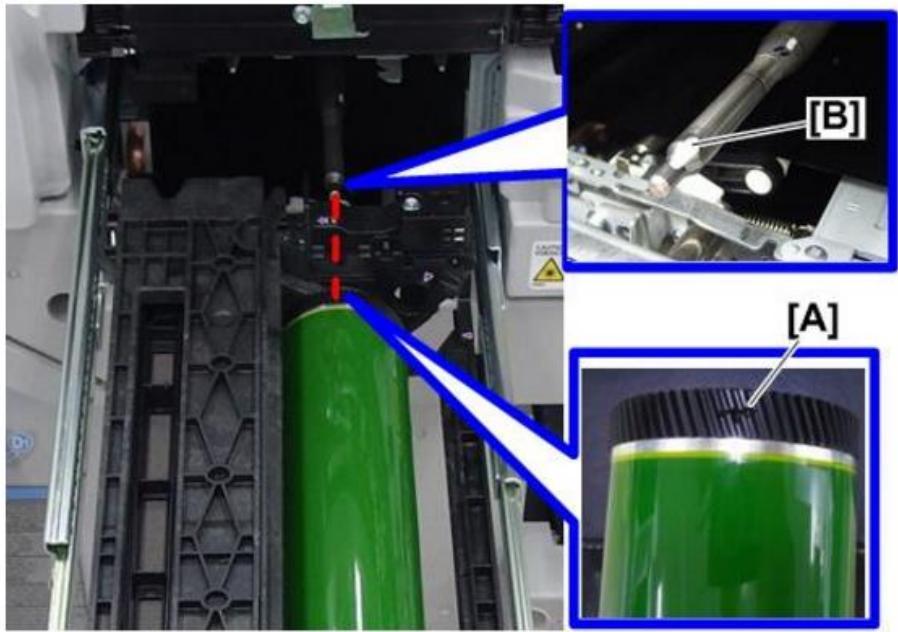
#### 189mm

- 1. Refresh the toner (See Appendix 1 for procedure).
- 2. Execute [DEMS] in "0201 [Adjust Image Density/DEMS]" in the Adjustment Settings (or SP3-040-001).
- 3. Align the drum shaft.
  - Align the white mark [B] on the drum shaft with the notch mark [A] on the top of the drum gear.

- 4. Execute [DEMS] again, and then check the image.
- 5. If there is no improvement, execute DEMS up to 3 times (check the image quality after each time).
- 6. If you executed DEMS 3 times, refresh the toner again.

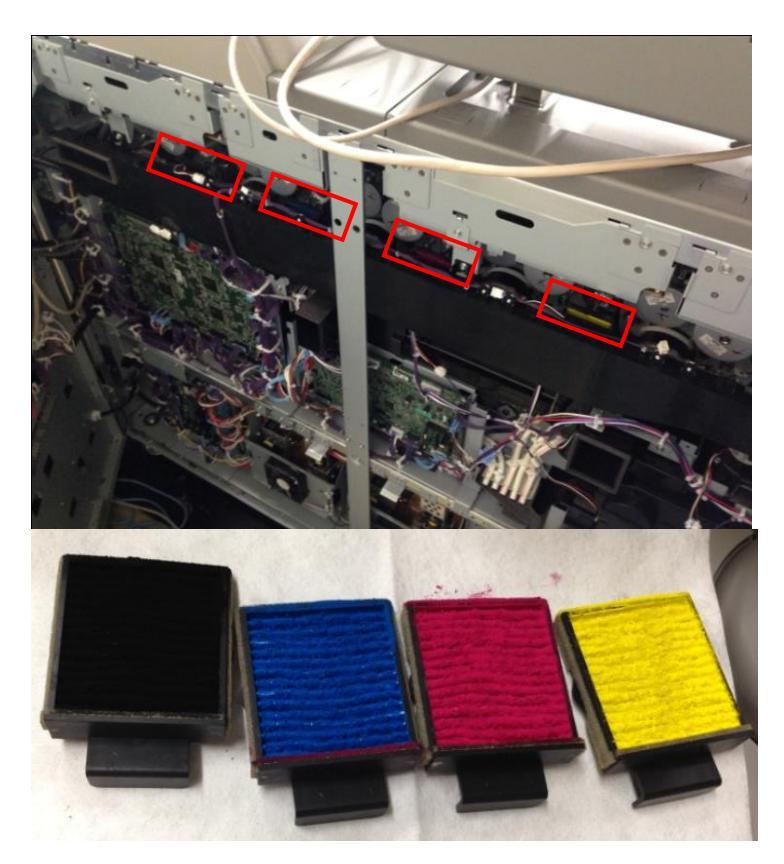
- Make sure to **replace the dust filters** (P/N D1947153) in the horizontal duct at **400KP** intervals. If you do not, this can cause toner scattering.
- These filters have already been announced as PM parts, but data from the field shows that the filters are rarely replaced.
- Order 4 pcs or 5 pcs, depending on how many filters the model has (There is one filter per color).

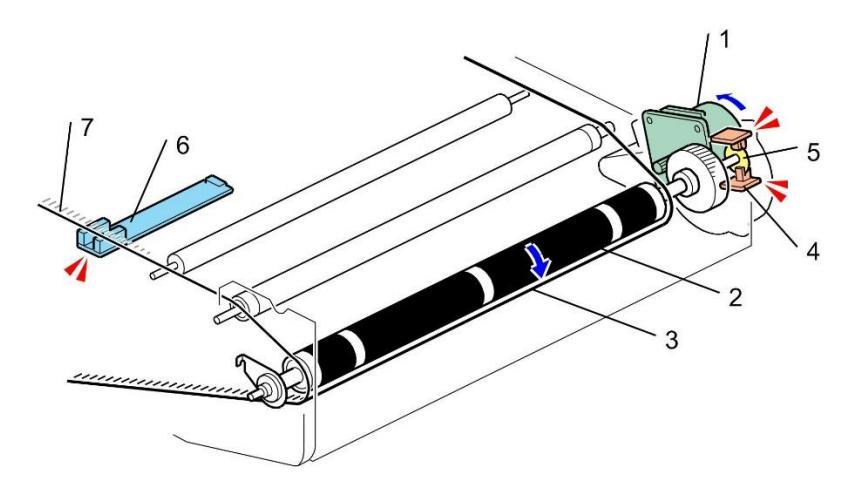
Difference in ITB speed control

To control the rotational speed of the ITB, the machine uses a feedback sensor (#6 below) for full-color mode, and an encoder (#5) in S-only mode.

Set SP2915-001 (Encoder Sn Ctrl Condition: Scale FB Control Enable) to "0."

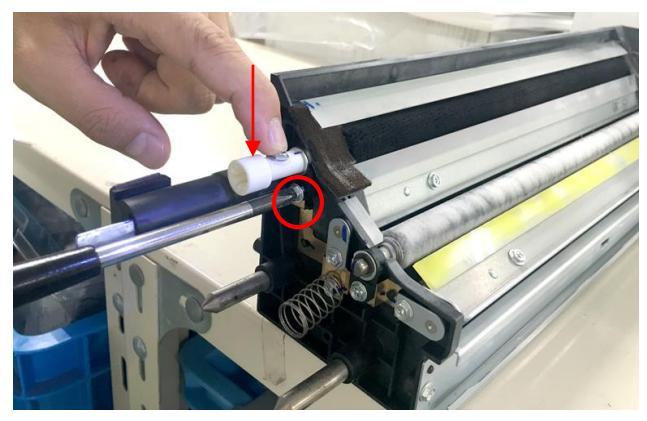
In very rare cases, due to variations in the manufacturing process, the ITB cleaning unit coupling and its drive gear in the mainframe do not engage completely. This can cause banding at an interval of about 5-6mm.

- When you install a new ITB cleaning unit (service part), adjust the coupling as shown below.
  - 1. Loosen the screw circled in red.
  - 2. Push down the coupling gently.
  - 3. While pushing down, tighten the screw.
  - **Note:** You do not have to push it down strongly. It is only necessary to fix it in place (so that it does not rattle loosely).

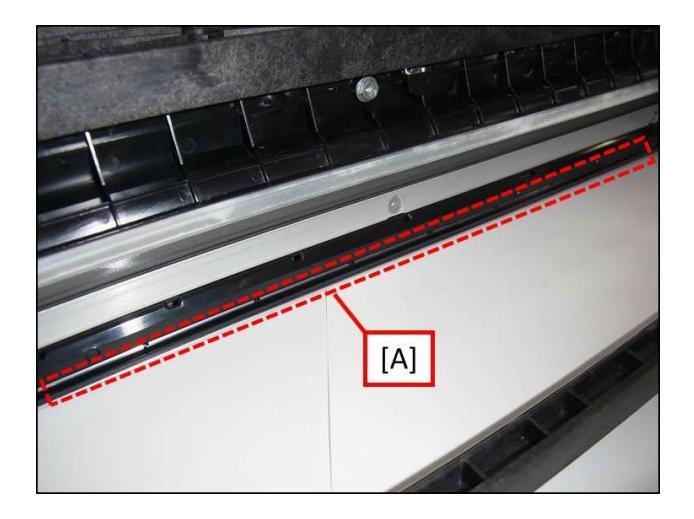
- Make sure to wipe off the toner that has collected on the toner receptacle [A] with a dry cloth **every 400KP.**
- If you do not, this can cause toner scattering.

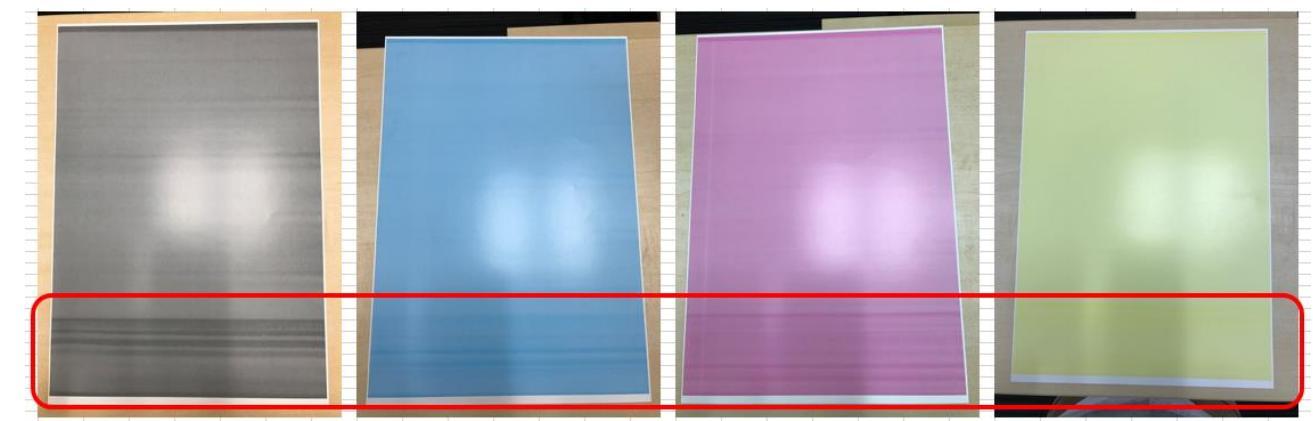
Rusting of the PTR coupling gear:

- Jam 032
- Jam 033
- Jam 082
- Jam 083
- Banding within 100mm from the leading edge or trailing edge

- The image is reduced in size
- Paper creasing

The machine is used under high-temperature, high-humidity conditions. This can cause the joints of the coupling gear mentioned above to rust. As a result, the gears may not engage properly.

- 1. Check whether each coupling gear rotates smoothly.
  - If it does not, apply "Moly High Temp Grease: 50G" (P/N: VSSG9001) to the area shown in the diagrams below.
  - Do this for each of the coupling gears mentioned below.
- 2. If the gear still does not rotate smoothly, replace the gear. **Important:** If no grease has been applied to the service part gear, apply the grease.

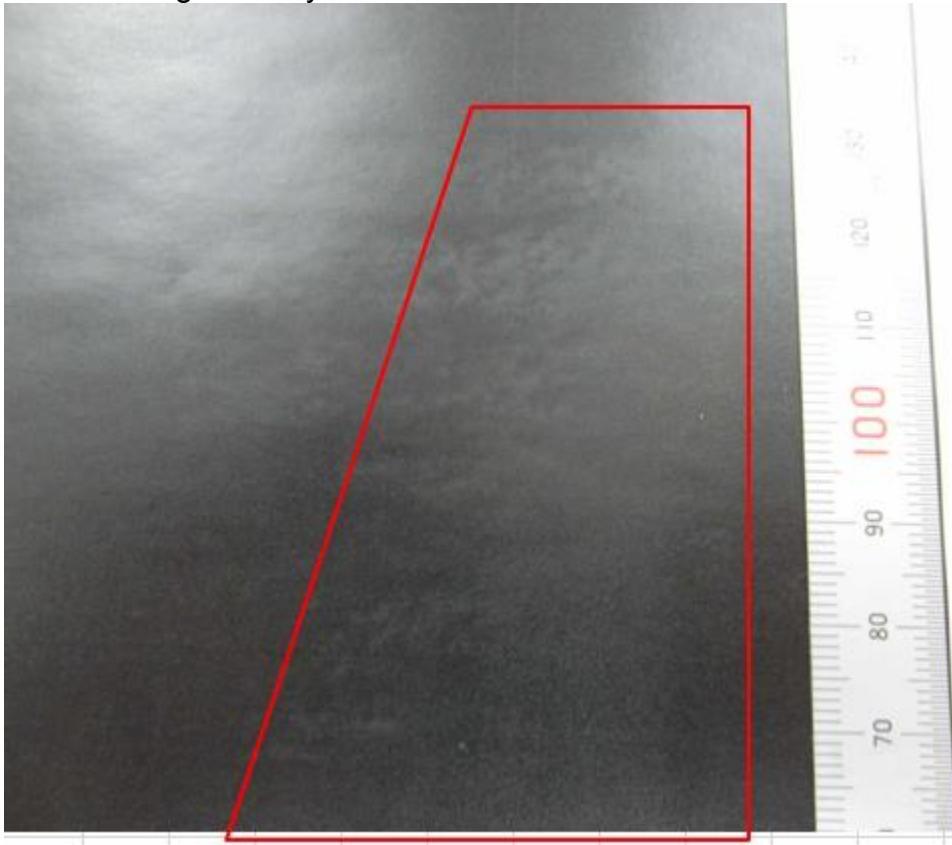
RICOH	Technical <b>B</b> u	PAGE: 2/7	
Model: Leo-C1/P1		Date: 2-Jun-17	No.: RD194160
Rusting of the PTB unit coup - Jam 033 - Jam 083 - Uneven image density	ling gear:

- Paper creasing

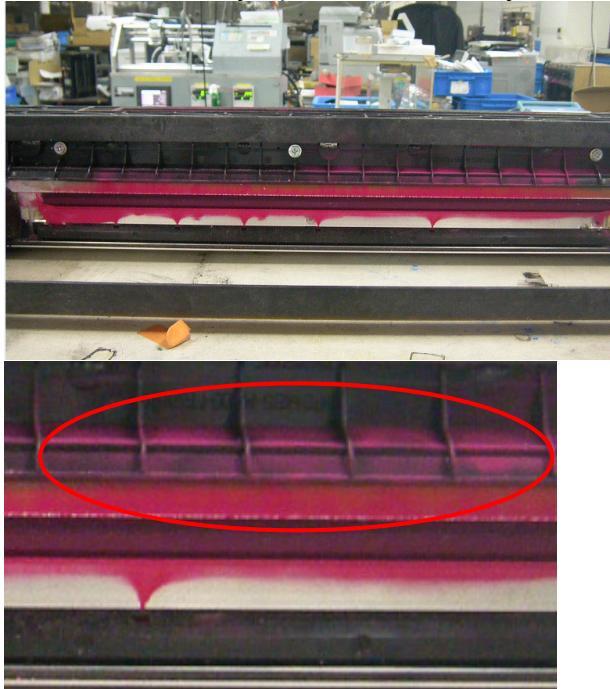
Toner leaks from the development unit entrance seal at 4k or shorter intervals. **Note:**

- This often dirties the laser glass shield.
- The symptom occurs only with the CMY stations.

Toner is shown having leaked onto the upper seal and bracket.

**Note:** The toner leaks in an upward direction due to the pressure inside the development unit.

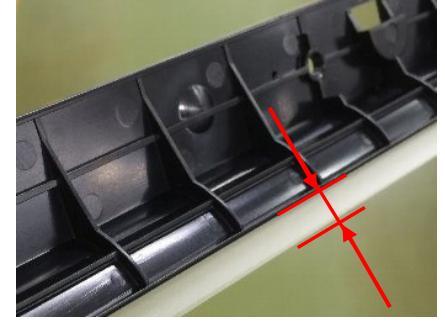
The seal on some development units is too long. As a result, the seal can sometimes physically interfere with the developer on the roller surface. In addition, the seal does not contain/seal the entrance to the unit properly.

Replace the entrance seal with the modified one (see **PROCEDURE**).

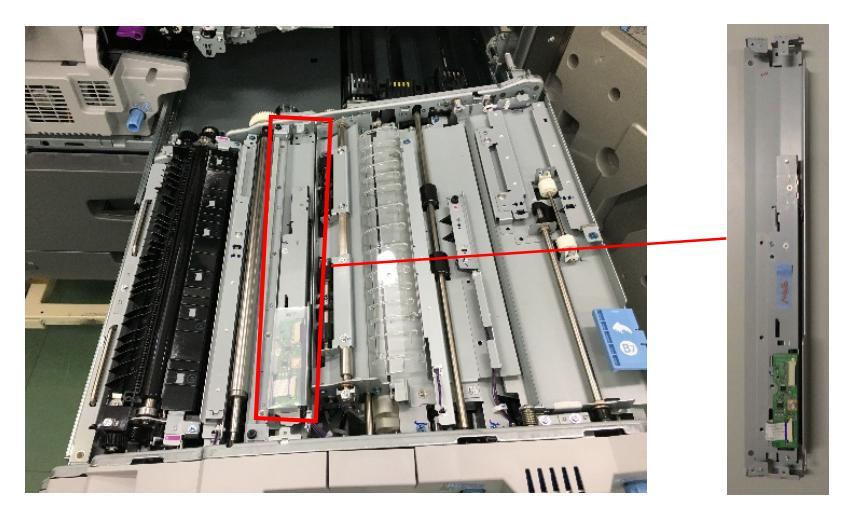
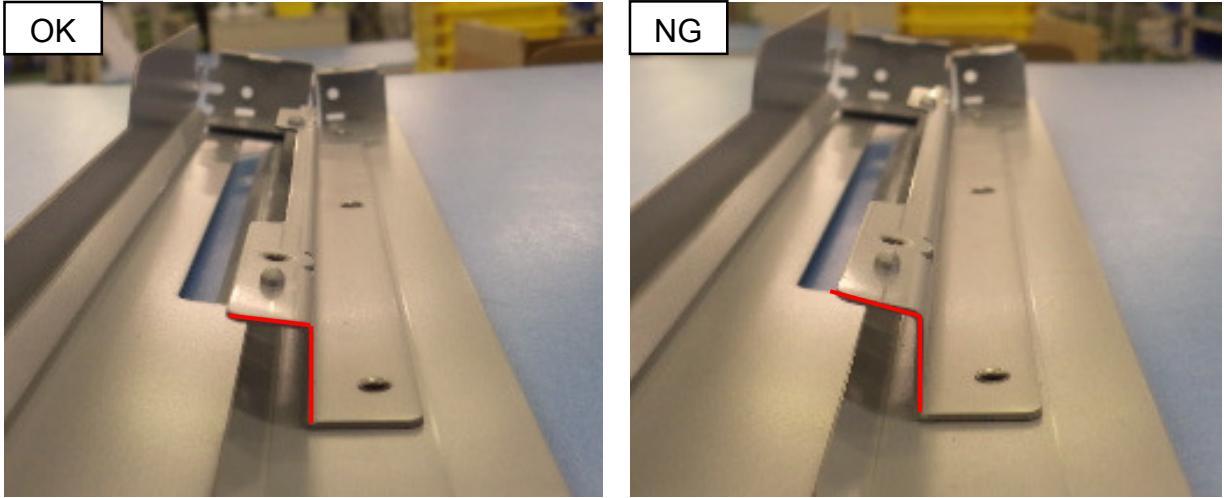
The bending angle in some CIS brackets is slightly large, causing thin paper types to contact the bracket during paper transport.

**Note:** The difference in angle is very slight but visible.

Replace the CIS bracket with the modified one (see **PROCEDURE** below). P/N D1942960 GUIDE PLATE: REGISTRATION: PEEN
