Model: Leo-C1

No.: RD194004

Subject: Firmware Release Note: NetworkDocBox			Prepared	d by: Y.Yamada
From: 1st PP Tech Service Sect., PP Tech Service Dept.				
Classification:	Troubleshooting	Part informat	ion	Action required
	Mechanical	Electrical		Service manual revision
	Paper path	Transmit/rec	eive	Retrofit information
	Product Safety	🛛 Other (Firmv	vare)	🛛 Tier 2

# This RTB has been issued to announce the firmware release information for the **NetworkDocBox.**

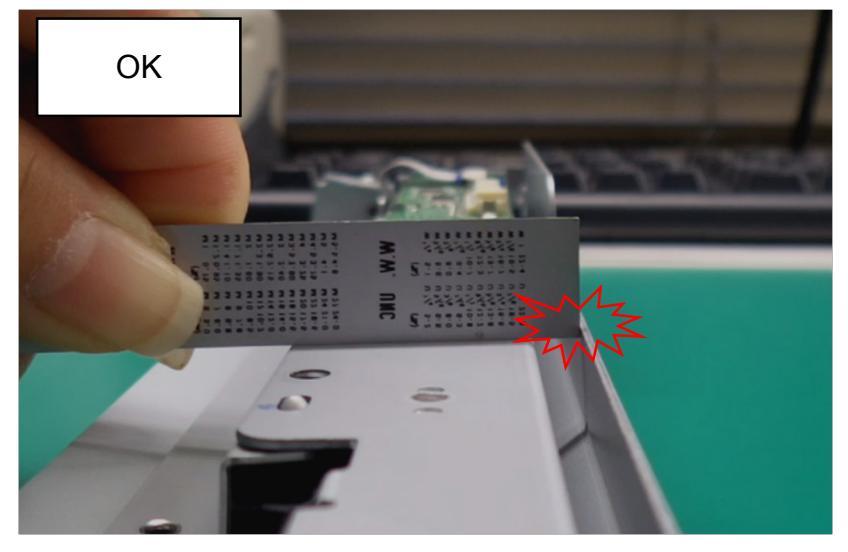
**<u>Normal</u>** (no action needed): The leading edge of the scale bumps into the bracket as shown.

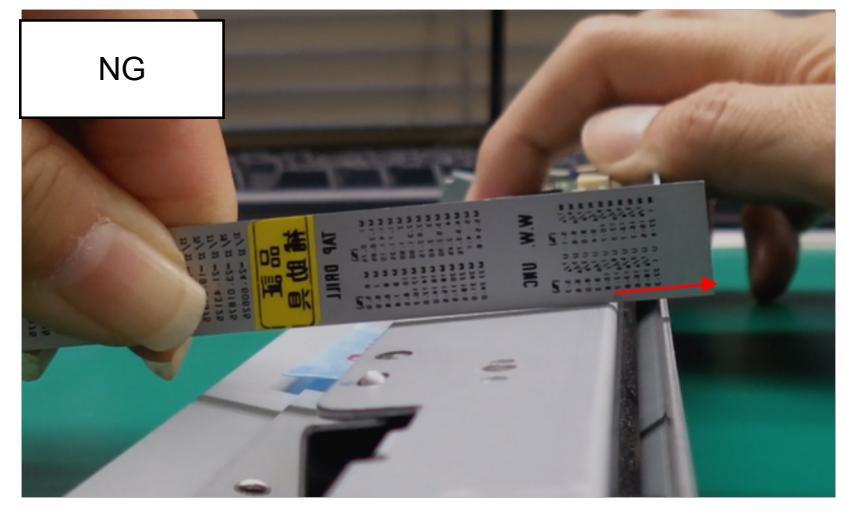
NOT normal (Do the action in Step 6 onward): The scale does **not** bump into the bracket as shown.

6. Remove the inner cover of the right drawer.

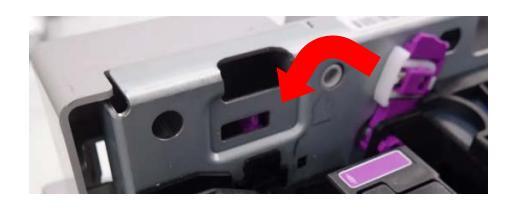
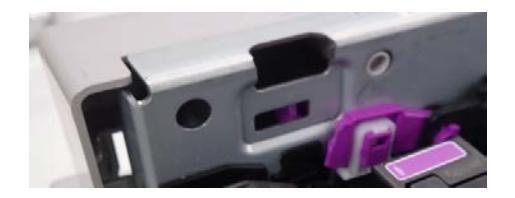
The Charge Roller Lever becomes damaged, requiring the replacement of the entire PCDU assembly.

- 1. Pull out the affected PCDU
- 2. Turn the broken lever to the close position

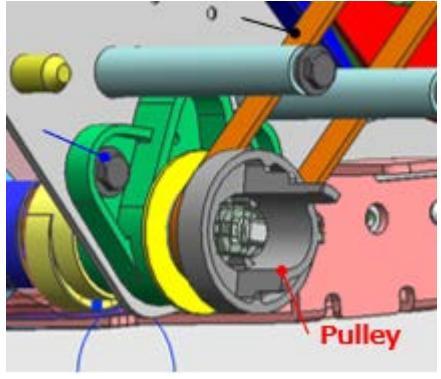
Arcing around the ITB pulley due to high voltage leak damages the pulley.

- 1. SC450-001 displayed due to a failure to the DC Power Supply
- 2. High resistance occurs around the PTR section due to low temperature/humidity conditions and feeding high resistance paper. High voltage leaks from the opposed roller to the ITB timing belt generates arcing and damages the ITB pulley.

7. Remove the Pulley and replace it with the modified part.

Install the pulley so the design outlined in the red circle faces the front cover, as shown below.

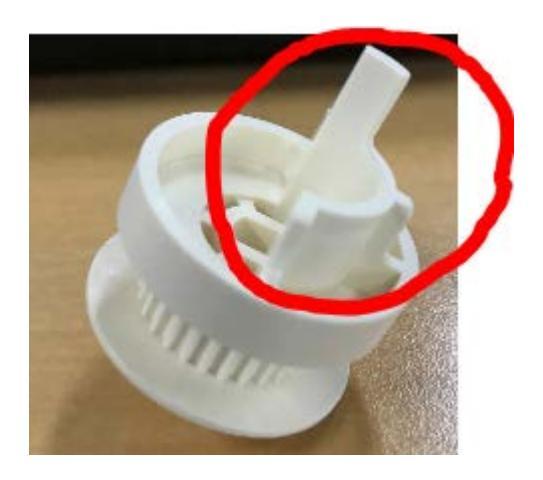
Original pulley is black. Modified pulley is white.

The modified pulley material has improved flame retardant, and shape was modified to have greater creepage distance.

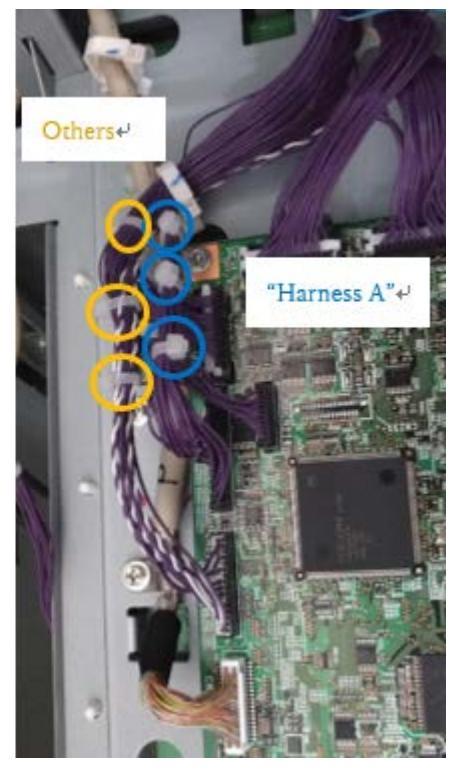
After: Band No4-6

1. Open tie band No 1 to separate "Harness A" from others. Tie up "Harness A and others separately using tie bands.

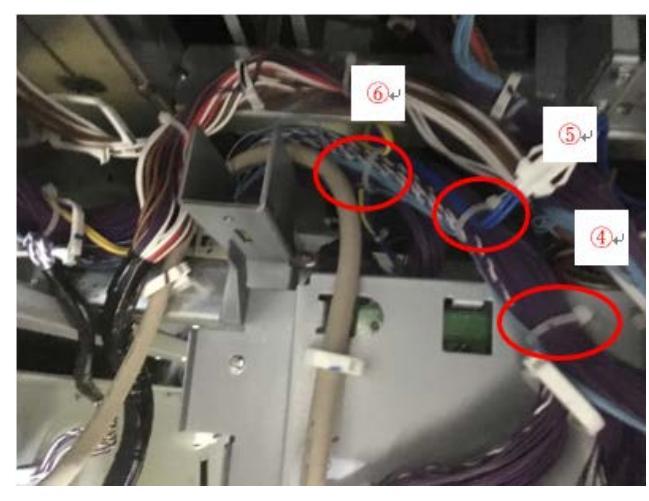
Before: Band No4-6

2. Open tie band No 2 and separate "Harness A" from the others. Tie up "Harness A and others separately using tie bands.

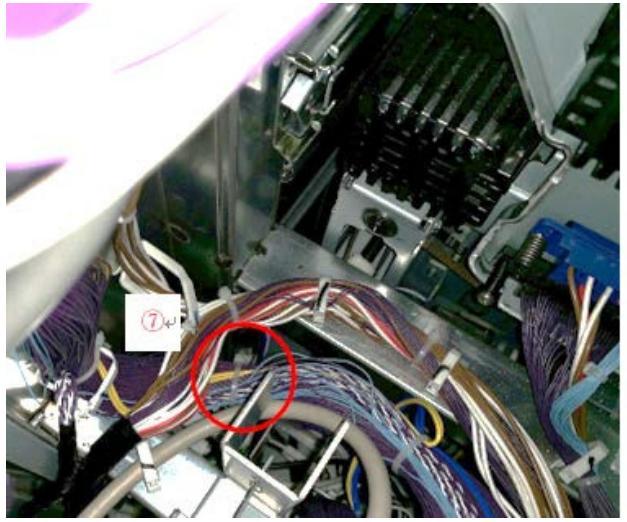
Before: Band No7

Repeat the same process for bands No 3 to 10.
