Model: Taurus-C1a/C1b	Date: 20-Jun-11	No.: RD074001d
-----------------------	-----------------	----------------

Subject: Firmware Release Note: OpePanel.EXP		Prepared by: S. Sasaki	
From: 1st PP Tech Service Sect., PP Tech Service Dept.			
Classification:	<input type="checkbox"/> Troubleshooting	<input type="checkbox"/> Part information	<input type="checkbox"/> Action required
	<input type="checkbox"/> Mechanical	<input type="checkbox"/> Electrical	<input type="checkbox"/> Service manual revision
	<input type="checkbox"/> Paper path	<input type="checkbox"/> Transmit/receive	<input type="checkbox"/> Retrofit information
	<input type="checkbox"/> Product Safety	<input checked="" type="checkbox"/> Other (Firmware)	<input checked="" type="checkbox"/> Tier 2

This RTB has been issued to announce the firmware release information for the **OpePanel.EXP**.

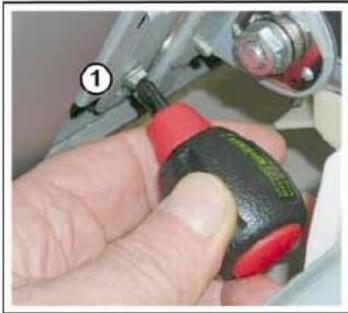
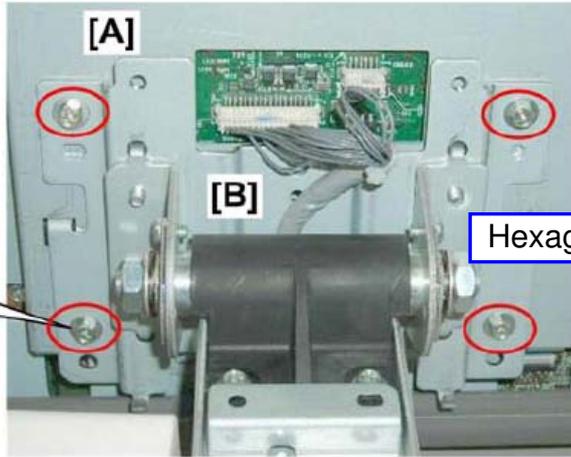
INCORRECT

IMPORTANT: Screws longer than 6mm could damage the PCB

Hexagonal screws; M4x8

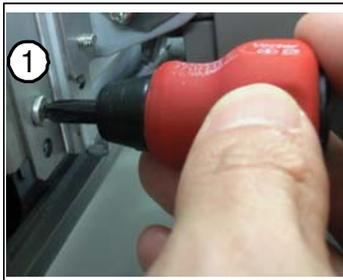
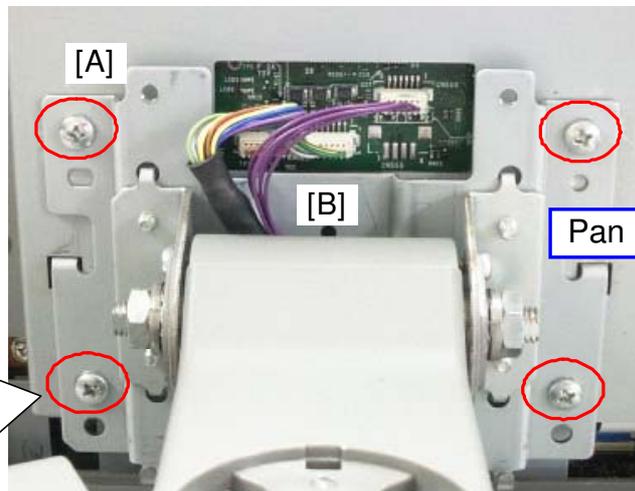
CORRECT

Pan head screws; M4x6

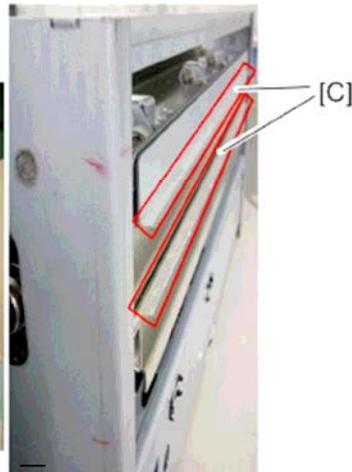
Do not lay the Decurler Unit on the floor with the entrance gate of the decurler unit facing downward. Otherwise, the mylars [C] on the entrance gate may be bent or folded.

1. Prepare a place to lay the Decurler Unit [A].
2. Lay the Decurler Unit [A] on the carton box [B] as shown above so that the entrance gate of the decurler unit does not touch any object or the floor.
 - Keep this position before attaching this unit to the main machine.

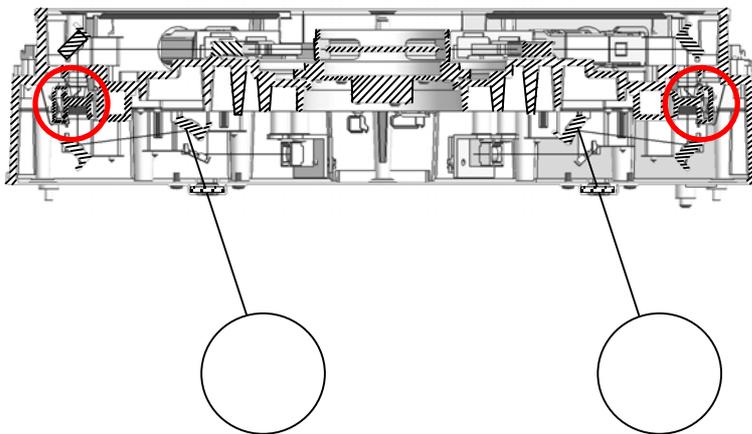
Lens assembly unit is slightly off-position, possibly because of shock generated during transportation.

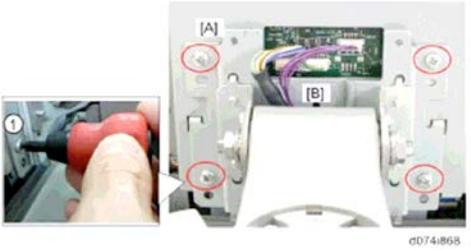
<p>13. Fasten the back of the operation panel [A] to the mounting bracket [B] (⌀ x4 M4x6). You will need a short screwdriver to attach the screw at ①.</p> <p>Important</p> <ul style="list-style-type: none"> You must use the M4x6 screws to fasten the operation panel at this step. If you use the longer screws (M4x8) they could touch and damage the operation panel board.

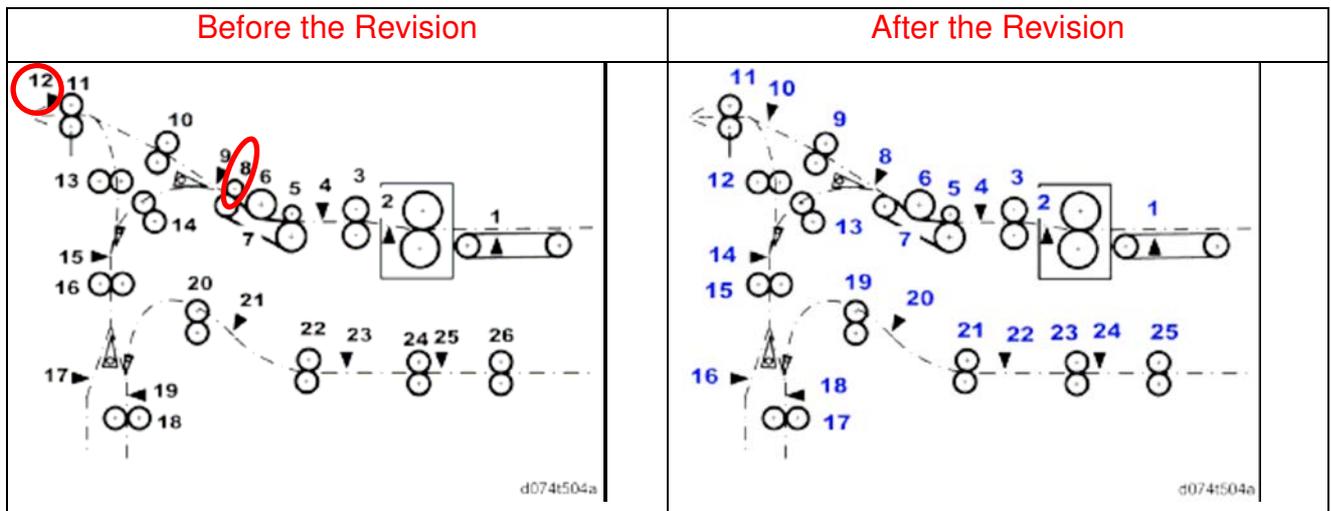
The "Cooling Belt Idle Rollers" that were assembled in the pre-mass production unit were eliminated in the mass production. These rollers were deleted from the illustration accordingly.

Also, a correction was made for the "Exit Sensor" that was illustrated in the incorrect position.

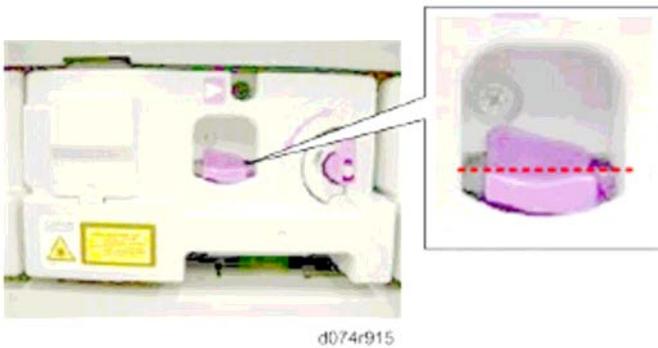
d074r915

- When the PCDU is locked correctly, the top of the lock lever is straight as shown above.

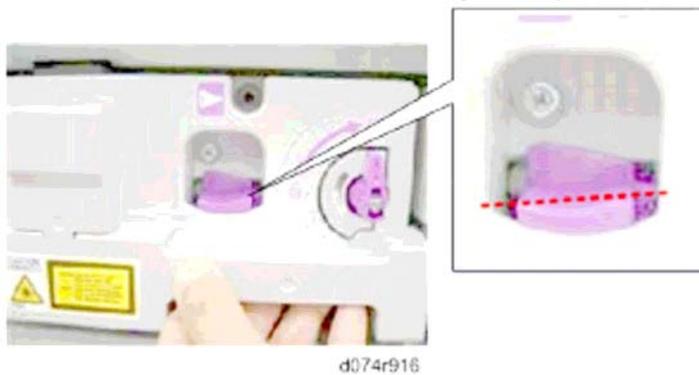
d074r916

- If the PCDU is not locked correctly, the top of the lock lever is slanted slightly down to the left as shown above.

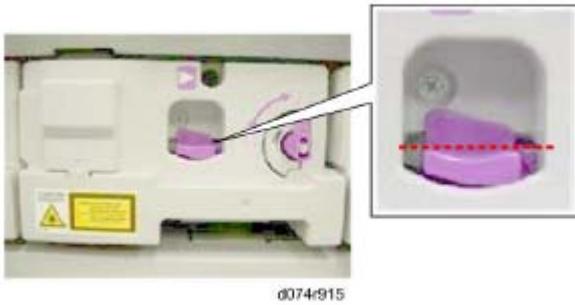
- When the PCDU is locked correctly, the top of the lock lever is straight as shown above.

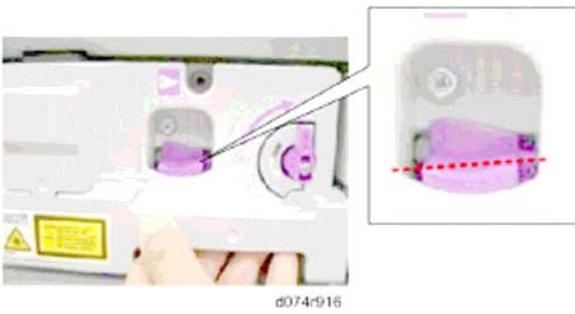
- If the PCDU is not locked correctly, the top of the lock lever is slanted slightly down to the left as shown above.

4. If the PCDU lock lever is not locked correctly, pull the PCDU out about 30 mm (1.5 in.) and push it in again so the top of the lock lever is level.

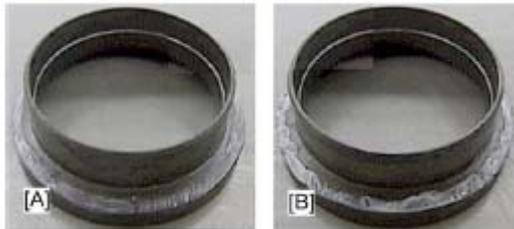
d074r543

· Apply an appropriate amount of FLUOTRIBO MG Grease to the flange referring to the pictures above. The left picture above [A] shows the minimum amount and right picture above [B] shows the maximum amount.

- If applied grease is not enough comparing with the left picture [A], the fusing belt may shift on the flange rib and cause the fusing belt a malfunction finally.
- If applied grease is much more comparing with the right picture [B], the hot roller may get excessive grease and cause the hot roller a malfunction finally.

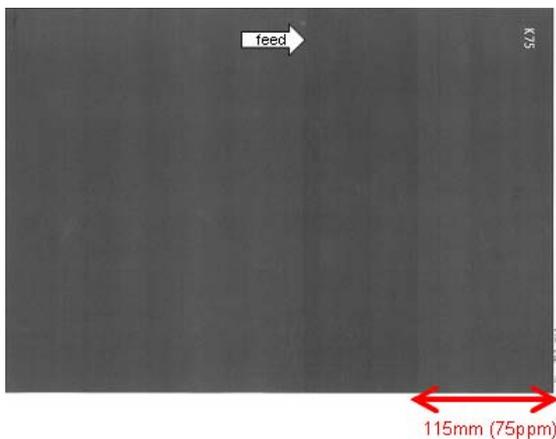
- a) Image density is fainter in the area 115mm in width from the leading edge when printing a halftone image immediately after printing a solid image on the 75ppm model. On the 65ppm model, the faint density appears in the area 65mm in width from the leading edge.

NOTE: 115mm corresponds to the paper interval distance

Symptoms “a” and “b” are both caused by the same mechanism.

- ✓ When printing halftone image immediately after printing a solid image
- ✓ Low temperature and low humidity
- ✓ Black images; the symptoms tends to occur with Black OPC drum
- ✓ When applying fresh developer

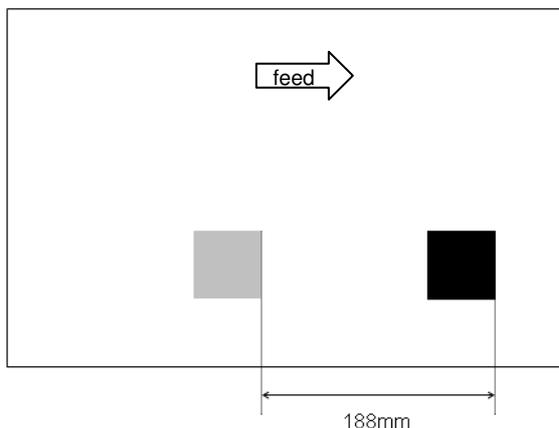
- b) After printing a bold image, the image appears as a residual image positioning 188mm behind the bold image.

NOTE: 188mm corresponds to the circumference of the OPC drum.

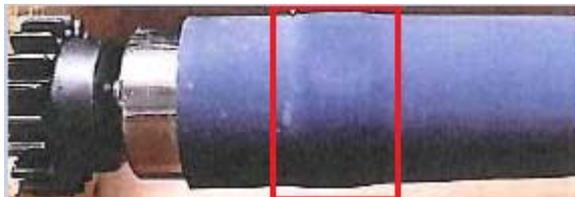
Chemicals applied to carbonless copy paper causes the edges of the feed roller to swell as shown in the photo below.

Please instruct your customers to avoid usage of carbonless copy papers.

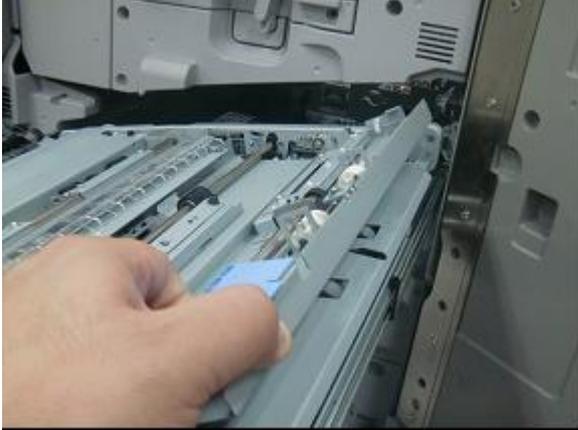
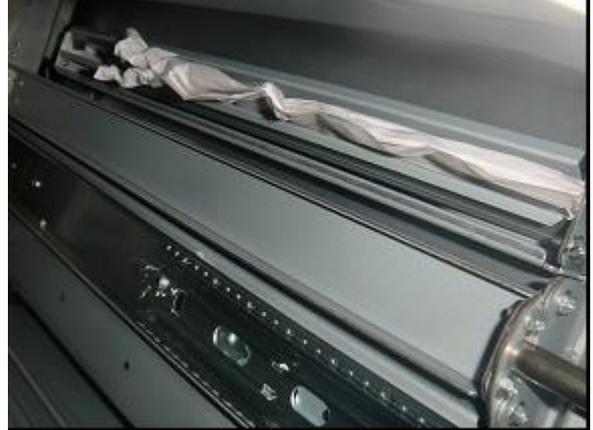
Jam 27: Location of jammed paper

The right-drawer unit should be clear;
no jammed paper.

Jammed paper should be found at the
entrance of the mainframe.

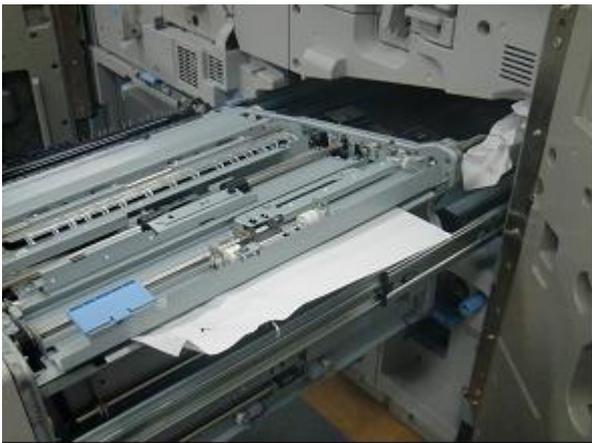
Jam 29: Location of jammed paper

Jammed paper should be found in the right
drawer unit.

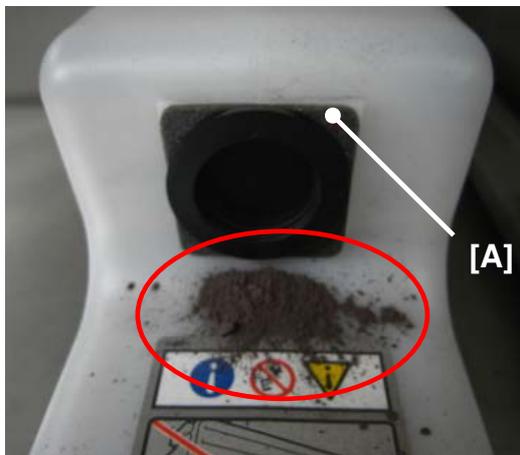
Toner leaks from the aperture of a used waste toner bottle when the bottle is full and pulled out from the mainframe.

1. The entrance seal [A] attached to the old bottle (D0746670 or older) is slightly oversized and does not completely seal the aperture.
2. The entrance seal [A] was damaged when pulling out the waste toner bottle.

Always replace with a new entrance seal [A] (D0746684) when reusing the waste toner bottle regardless of the bottle type, before or after the modification, to prevent toner leakage caused by a worn entrance seal.

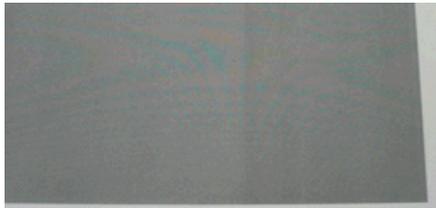
Uneven density at TE in 90mm width

The side effects a) and b) are caused by the difference in the “contact surface area” between the paper and the ITB. As shown in the diagrams below, the contact surface area is small when the leading edge enters the PTR nip, whereas the contact surface area is large when the trailing edge passes the transfer guide plate.

To prevent these side effects, the special guide plate D0743810 was added with a PET mylar (indicated in orange) as shown below to absorb the shock when stiff paper contacts the mylar.

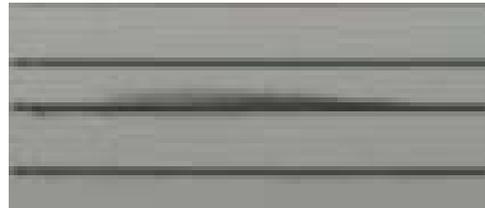
Scattered line image

The side effects c), d), and e) occur when the toner on the ITB is wiped off. This happens when feeding very stiff paper that pushes the mylar upwards against the ITB or when the paper contacts the ITB immediately after the trailing edge passes the guide plate.

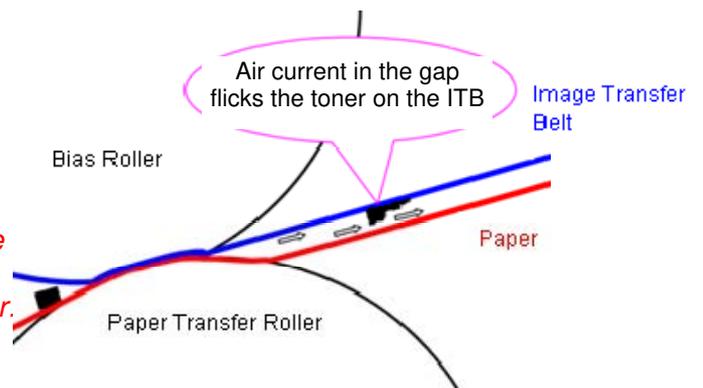
Note that "scattered line images" are more likely to occur with the special guide plate when in use with coated paper. Due to the smaller gap between the paper and the ITB in comparison to the original guide plate, air in the gap is left with no escape route and is pressurized. Toner on the ITB is flicked by this air current, which is enhanced by the smooth surface of coated paper.

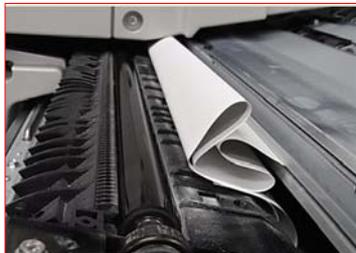
Paper jams at PTR entrance

Among the 3 Mylars attached to the PTR entrance guide plate, the bottom Mylar wears over time. The leading edge of the paper interferes with the damaged area of this bottom Mylar, resulting in paper jams. (Please see the following page for details.)

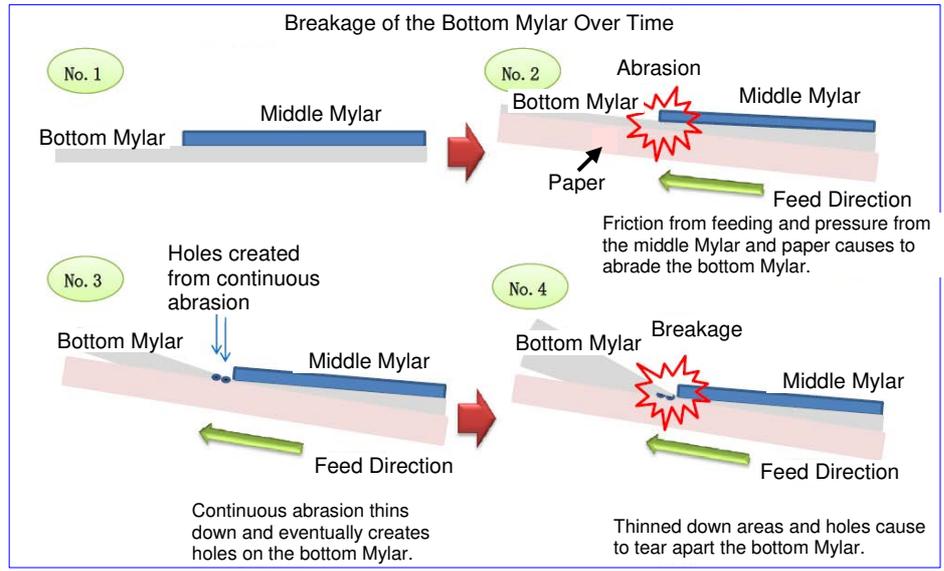
The bottom Mylar wears out in the location where it is in contact with the corner of the middle Mylar, positioned immediately above. The bottom Mylar is squeezed between the corner of the middle Mylar and the paper passing beneath, and this pressure and abrasion damages and thins down the bottom Mylar.

Damage to the bottom Mylar is prominent when fed “Heavy” and “Large Sized” paper stocks. Paper of “Weight 4” or heavier will tear away the bottom Mylar.

While the PTR entrance guide plate is planned for a modification, RCL requests you to peel off the bottom Mylar from the guide plate for machines having already been installed in the field. RCL is now investigating the serial numbers of the affected units, which will be announced in the revised version of this bulletin. Until then, we sincerely apologize for the inconveniences caused by the extra work, but would appreciate your cooperation in peeling off the Mylar by checking the ITB unit for each unit.

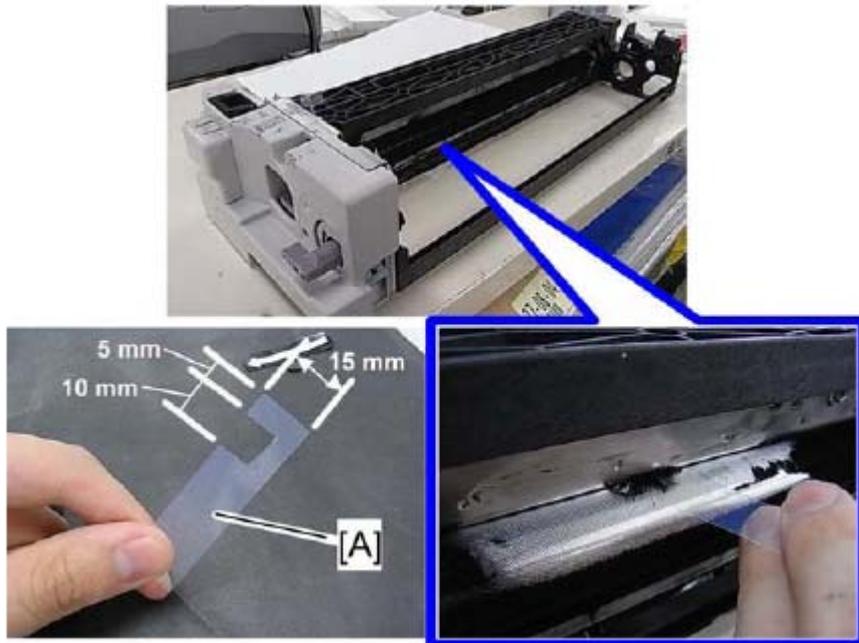
A foreign substance stuck in the doctor gap of the development unit causes inconsistency in developer supply.

2. Clean the doctor gap of the affected color.

- Cut out an OHP transparency [A] or a plastic sheet as shown below.
- Clean the doctor gap using the sheet and then vacuum the remaining developer.

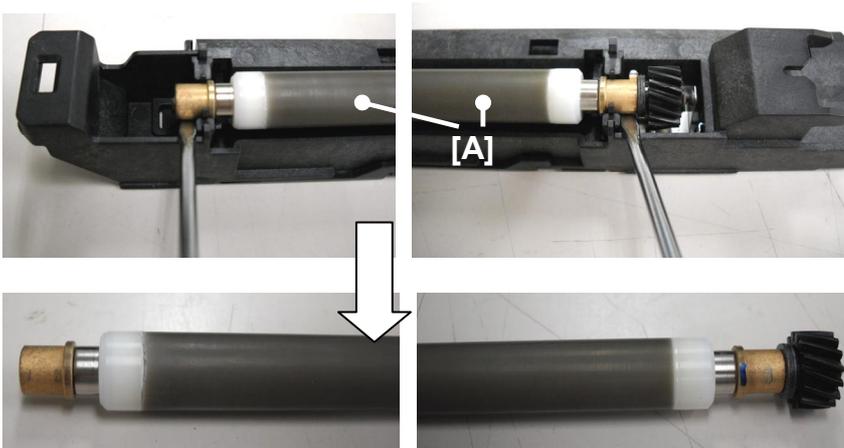
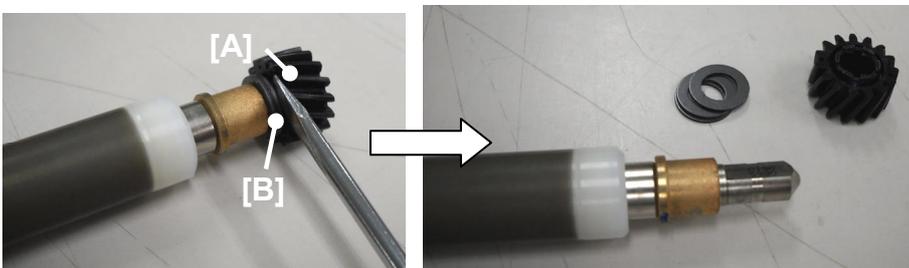
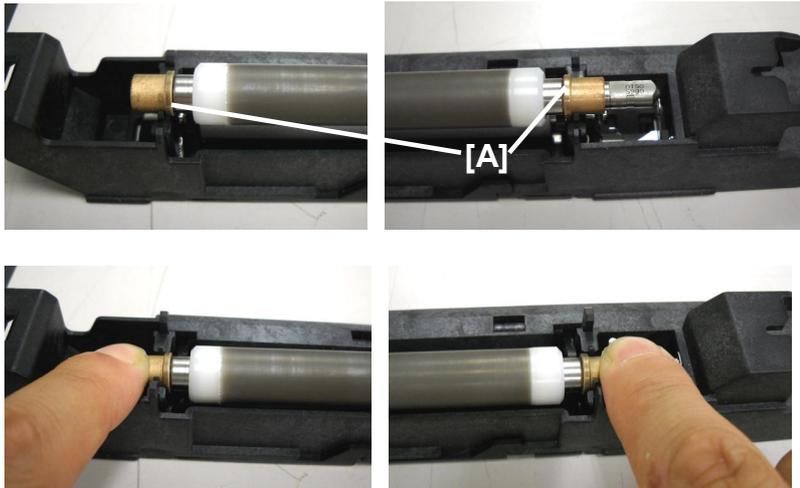
Incomplete engagement of the drum charge roller gear causes the OPC drum to vibrate.

When replacing the drum charge unit (D0742195) at its PM cycle, check if the new drum charge unit to be replaced with is installed with the gear, and if installed, it is recommended to remove the gear.

1. Remove the drum charge unit from the PCDU and locate the gear.

2. Remove the drum charge roller [A] from its case.

3. Remove the drum charge roller gear [A] (and the two washers [B]).

- There are two types of drum charge units; one with washers [B] and one without washers.
- If you find any grease adhered to the drum charge roller, wipe it off with a clean wet cloth and wait until the surface dries naturally. DO NOT use ethanol or organic solvent to clean the charge roller. Doing so will damage the charge roller.

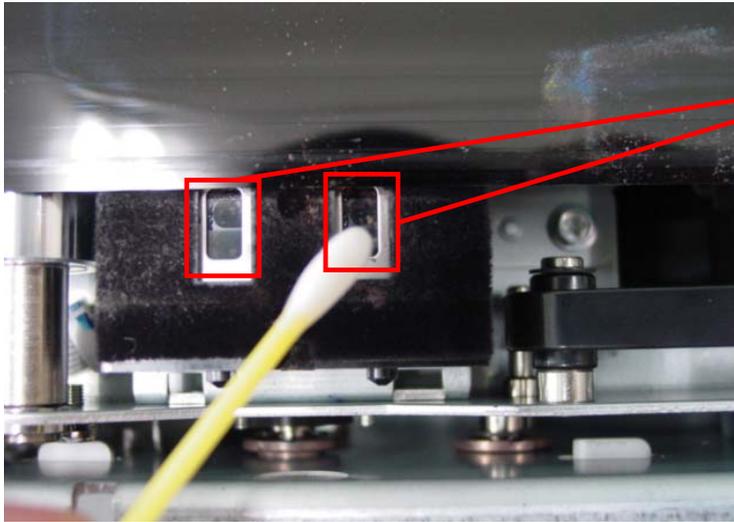
Cleaning of the Transfer Belt Speed Sensor is prescribed at 300K as part of PM but it is recommended to be cleaned more frequently to prevent SC499 caused by a dirty sensor.

**[A]****7. Clean the sensors [A].**

- Use a vacuum cleaner or an air blower to remove dust.
- Wipe the sensor with a wet cotton swab. If a cotton swab is not at hand, wipe the sensor with a wet cloth. Use water if necessary, but **DO NOT** use any solvent (ethanol, etc).

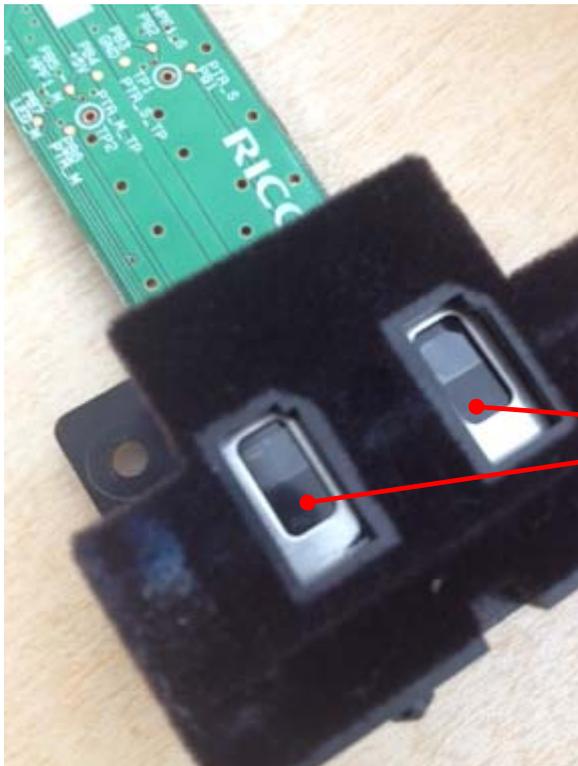
DO NOT attempt to wipe off the "black prints" on the sensors. These black prints are NOT dust/dirt but are components of the sensor.

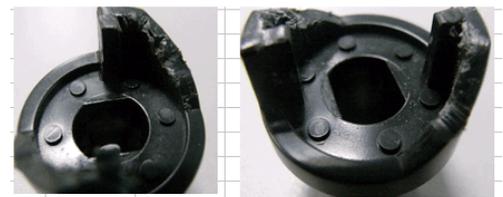
Frequent occurrences of JAM20 are caused by either a breakage of the molded coupling [C], or an incorrect engagement of the molded coupling [C] and the metal coupling [D] (see the next page) which stops the registration roller from functioning properly.

Broken molded coupling

Check the condition of the molded coupling on your next service visit and apply grease to both couplings, molded and metal.

If the molded coupling [C] is already damaged or broken, replace it with a new one and apply grease to both couplings.

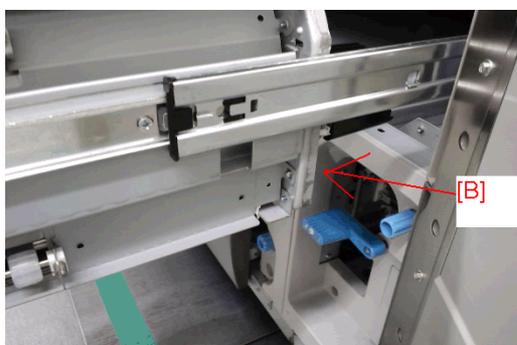
View from an angle [B] to check the condition of the molded coupling [C].

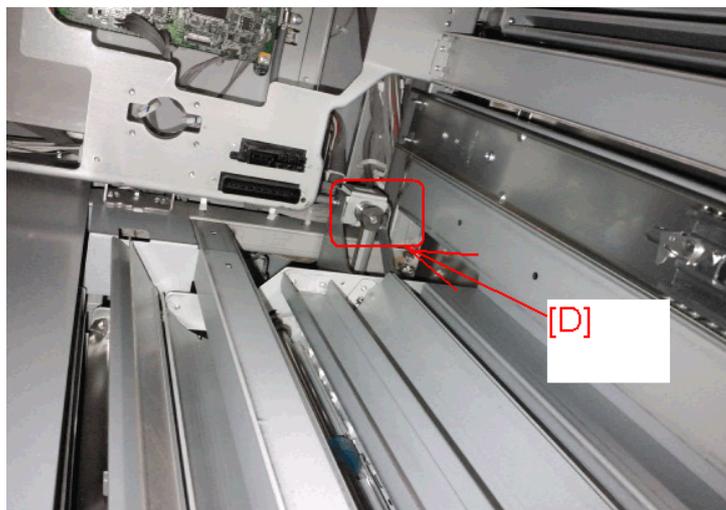
Metal coupling [D] interlocks with the molded coupling [C] when the Right Drawer Unit is set in the mainframe. However, if the couplings are not engaged properly, the metal coupling cannot retract (in the direction indicated with the arrow in the photo above right) and absorb the pressure when the drawer is pushed in, causing damage to the molded coupling.

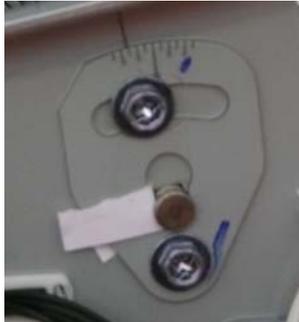
(a) Skew Variation

1. Confirm secure fastening of the 2 screws to prevent the adjustor plate from loosening.

If fastening the screws cannot securely fix the plate, insert a material, for instance an OHP transparency to stabilize the plate.

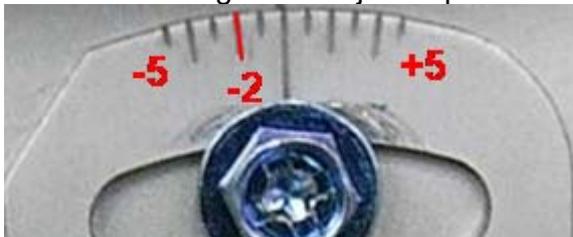
Do the following if the adjustor plate is currently set to a value smaller than “- 2”.

Jam97 is caused by interference between the registration gate and the shaft of the shift roller, which occurs if the adjustor plate is set to a value smaller than -2 and the unit is installed with an ‘unmodified shift roller’.

1. Set the adjustor plate to a value between - 2 and +5.
2. Replace the shift roller with the modified one, D0742760. (See the next page.)

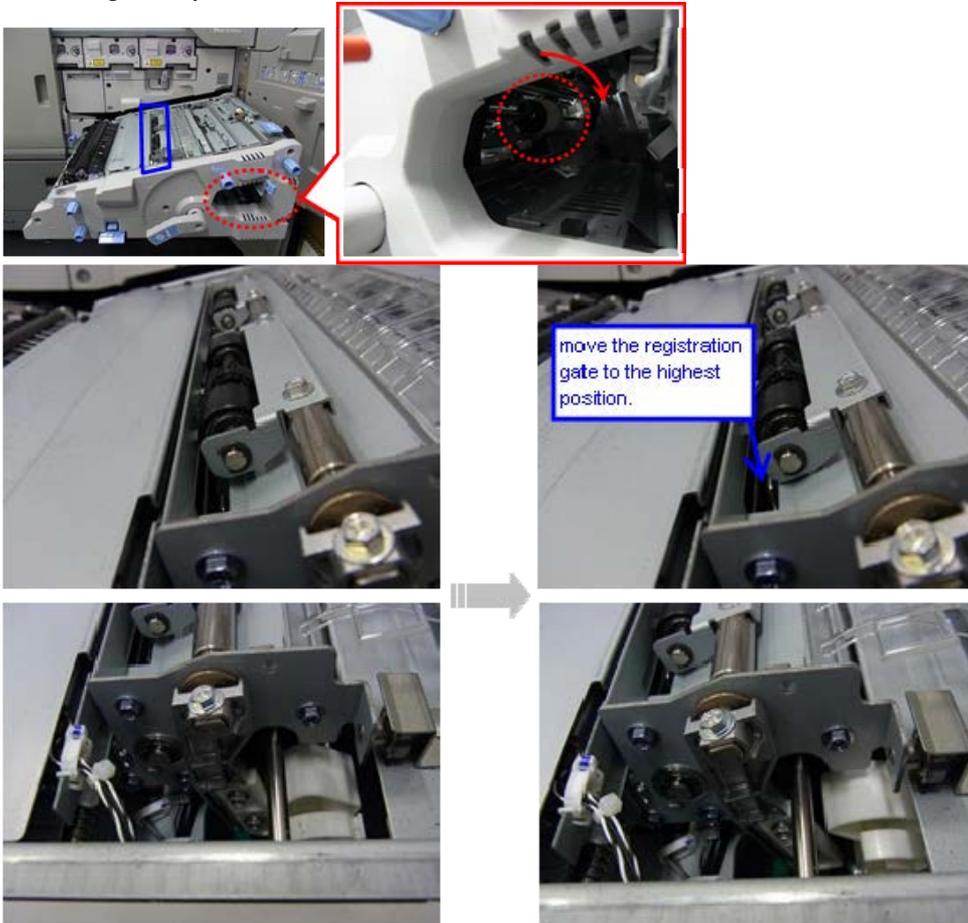
How to check whether the unit is installed with the modified shift roller or the unmodified shift roller

1. Insert your hand in the opening indicated with the red circle in the photo below and turn the cam clockwise until the shift roller separates and the registration gate moves to its highest position.

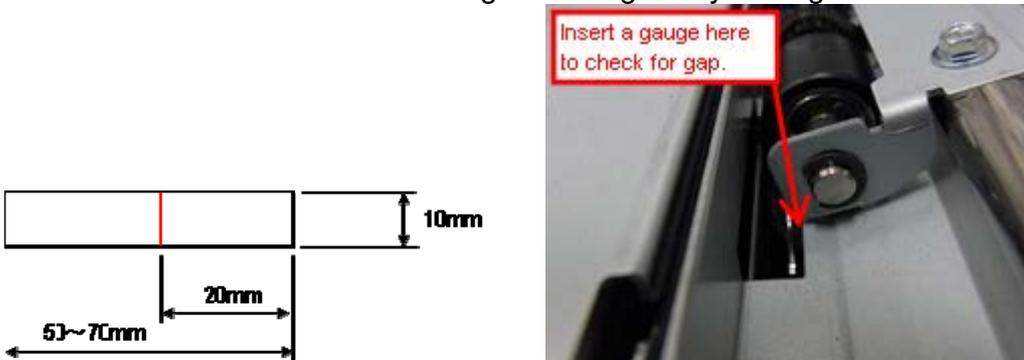
3. If there is no gap, the unit is installed with the unmodified shift roller and therefore should be replaced with the modified one.

2. Prepare a gauge using an OHP transparency of thickness between 0.05mm and 0.12mm and draw a reference line at 20mm from the edge. Insert the gauge in between the shift roller and the registration gate by sliding it in from the front side.

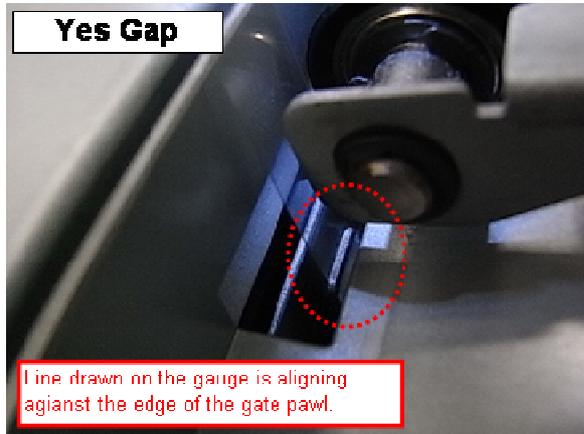
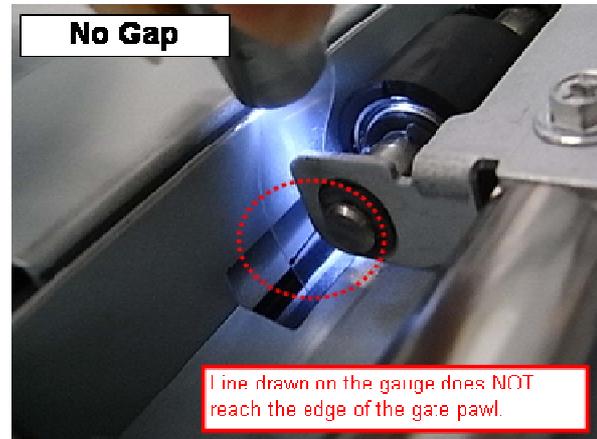
If a gap is confirmed, the unit is installed with the modified shift roller.

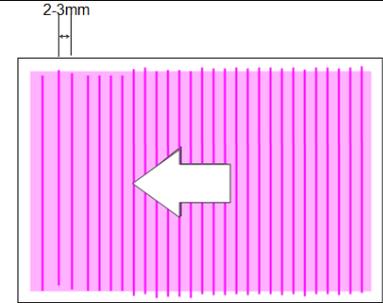
Symptom	2-3mm pitch banding
Cause	Vibration caused by the drum charge roller gear
Action	Remove the drum charge roller gear, if installed. Note: Newer machines/PCDU contain the modification and the gear is not installed.
Image	<p>The image contains two parts. The top part is a schematic diagram showing a series of vertical pink lines representing a banding pattern. A double-headed arrow above the lines is labeled '2-3mm'. A white arrow points from the center of the lines towards the left. The bottom part is a photograph of a dark, textured surface showing a similar banding pattern. A double-headed arrow above the photograph is also labeled '2-3mm'.</p>
RTB #	RD074041 or newer

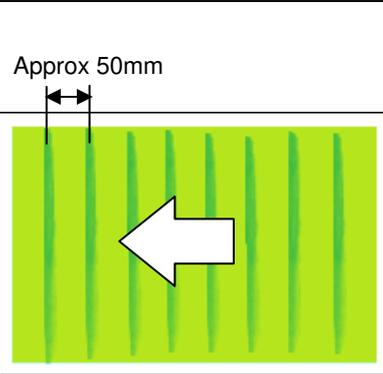
Symptom	50mm pitch banding
Cause	Incorrect engagement of the development unit gear and the mainframe gear causes uneven revolution of the development roller.
Action	Align the mark on the development unit gear with the mark on the mainframe gear.
Image	<p>The image shows a series of vertical green lines on a light green background, representing a 50mm pitch banding pattern. A double-headed arrow above the lines indicates the pitch, labeled 'Approx 50mm'. A large white arrow points to the left, indicating the direction of the countermeasure.</p>
RTB#	RD074019 or newer

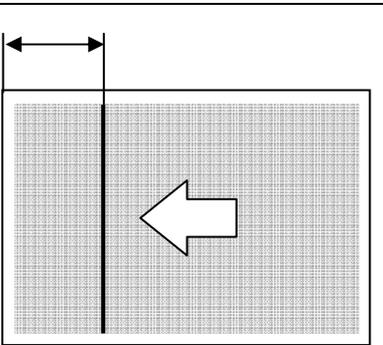
Symptom	Shock jitter on thick paper
Cause	<p>Vibration of the ITB caused by either of the following:</p> <ol style="list-style-type: none"> Shock generated when the leading edge enters the nip of the ITB and the PTR Shock generated when the trailing edge exits the nip of the ITB and the PTR
Action	<p>Depending on the two different causes, the following actions will reduce the chances of shock jitters:</p> <ol style="list-style-type: none"> Enlarge the gap between the ITB and the PTR by specifying “Small Gap” for “Custom Paper Advanced Settings: 43 Adjust Gap of Paper Transfer:” Shorten PTR release timing interval by changing SP1022-002 "Fine Adj LEdge: Thick2" Default : <u>-70 to -120</u>. <p>Note: The default value of SP1022-002 was modified in the following Engine firmware versions: Copier: Version 1.60:04 (D0745404G) Printer: Version 1.60:04 (M0445404E)</p>
Image	<p>The diagram illustrates the adjustment of the gap between the ITB and the PTR. It shows a rectangular area representing the paper path. A vertical line is drawn across the width of the paper. Above the line, a horizontal double-headed arrow indicates the width of the gap. A large white arrow points from the right side of the paper towards the vertical line, indicating the direction of adjustment.</p>

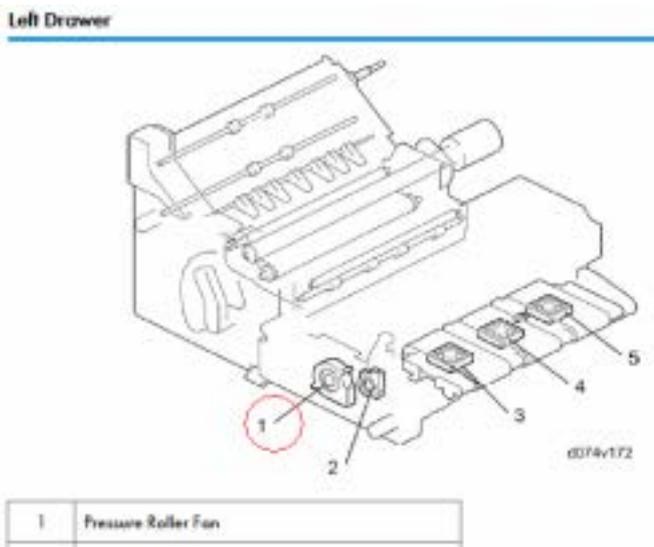
The Pressure Roller Fan was installed incorrectly with its harness(es) jammed, resulting in a short circuit

NOTE: Danger of fire as a result of the short circuit is prevented by the safety circuit.

The photo on the right shows the harness color coded in red protruding from the groove.

Check the harness routing of the Pressure Roller Fan. If the harnesses are not routed correctly, replace with a new fan. Carefully replace the fan so that the harnesses stay within the groove. You may also cover the harnesses with an insulation tape as shown in the photo below.

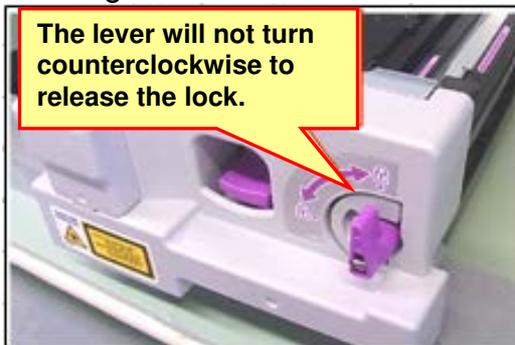
The drum cleaning unit lock lever could be stuck, making it impossible to remove the drum cleaning unit from the PCDU.

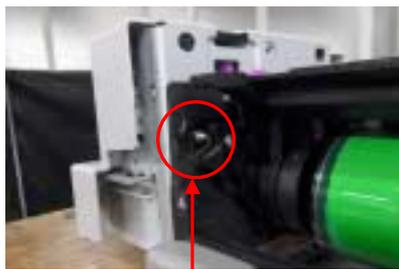
Pin on the development unit

The drum cleaning unit is set in the PCDU by turning the lock lever clockwise, which fixes the pin that protrudes from the development unit with the hollow shaft on the drum cleaning unit. However, the tip of the hollow shaft could be rough on its surface and this disables the release of the pin on some units.

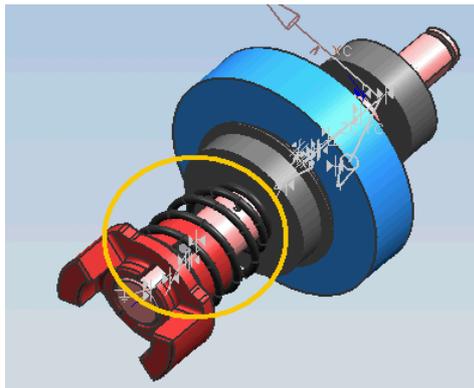
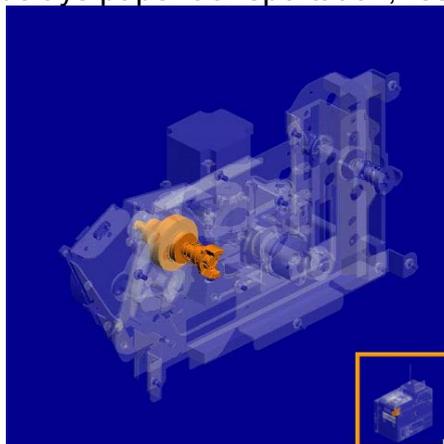
The spring installed in the shaft assembly (D074 1405) to drive the fusing unit is not strong enough and causes to the coupling separate momentarily, which temporarily slows down the rotation of the fusing unit and delays paper transportation, resulting in Jam 033.

The occurrence rate is approximately 20%, which is a calculation based on units that exhibited Jam 033 twice or more according to the @Remote data.

Replace with the modified shaft assembly. Serial numbers of the affected units and the replacement procedures are on the following pages.

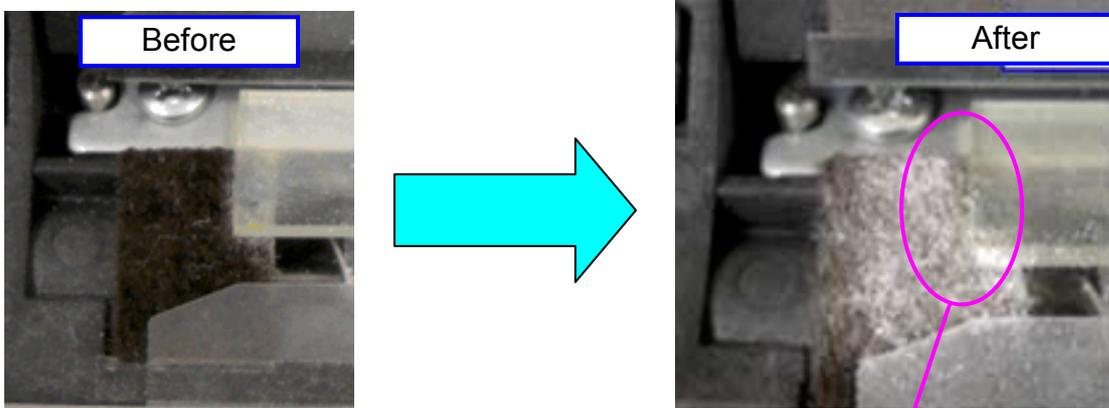
Make sure the powder covers this corner

3. Use your fingers to apply the Zinc Stearate Powder on the front cleaning blade edge and seal [C] AND rear cleaning blade edge and seal [B]. Especially, powder should be applied on the edge of cleaning blade [D] (indicated with the circle in the above photo.)

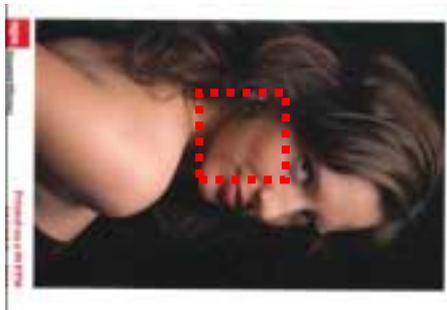
High frequency banding (2.5-2.7mm pitch banding)

When the drum cleaning unit reaches half of its yield, which is approximately 67,500m, equivalent to 150kP (* see the note below), the lubricant brush roller begins to rotate slightly faster to maintain sufficient lubrication on the drum surface. However, this high speed rotation of the lubricant brush roller causes the PCDU to vibrate, resulting in high-pitch banding as shown in the photo above.

1. **Make a service visit for ALL field machines to check the PM counter current value of drum cleaning unit for all stations.**

b) If the current counter is over 67500 (150kP), replace the brush roller (lubricant roller/D0742454), coating bar (lubricant bar/D0742466) **and joint (D0742459)**, clear the PM counter of “#Cleaning Unit” and then change the SP settings (PM alert).

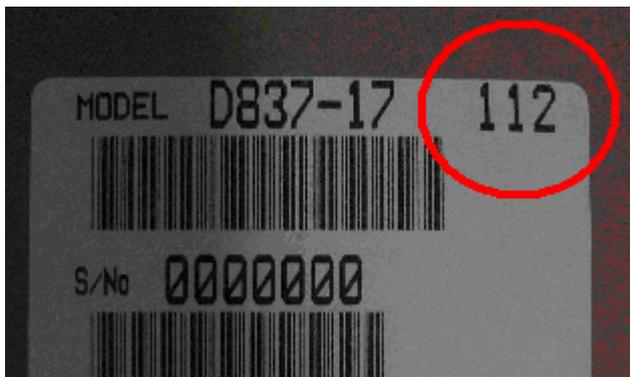
Affected TCRU Set A (D83717/D83729)*Manufactured before February, 2012*

To identify the affected TCRU Set A, refer to the number on the seal attached to the packaging box circled in red in the photo above. If the number is equal to or greater than “202” which indicates that the TCRU kit was manufactured in 2012 February (02), the kit includes the modification and does NOT require the rework.

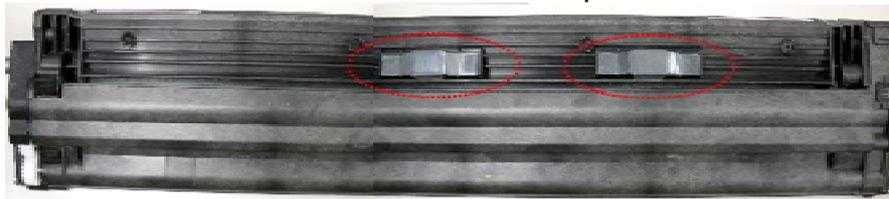
To identify whether or not the drum cleaning unit includes the modification by visual appearance, check for the 2 “cushions” on the back side.

If attached, the modification has been implemented.

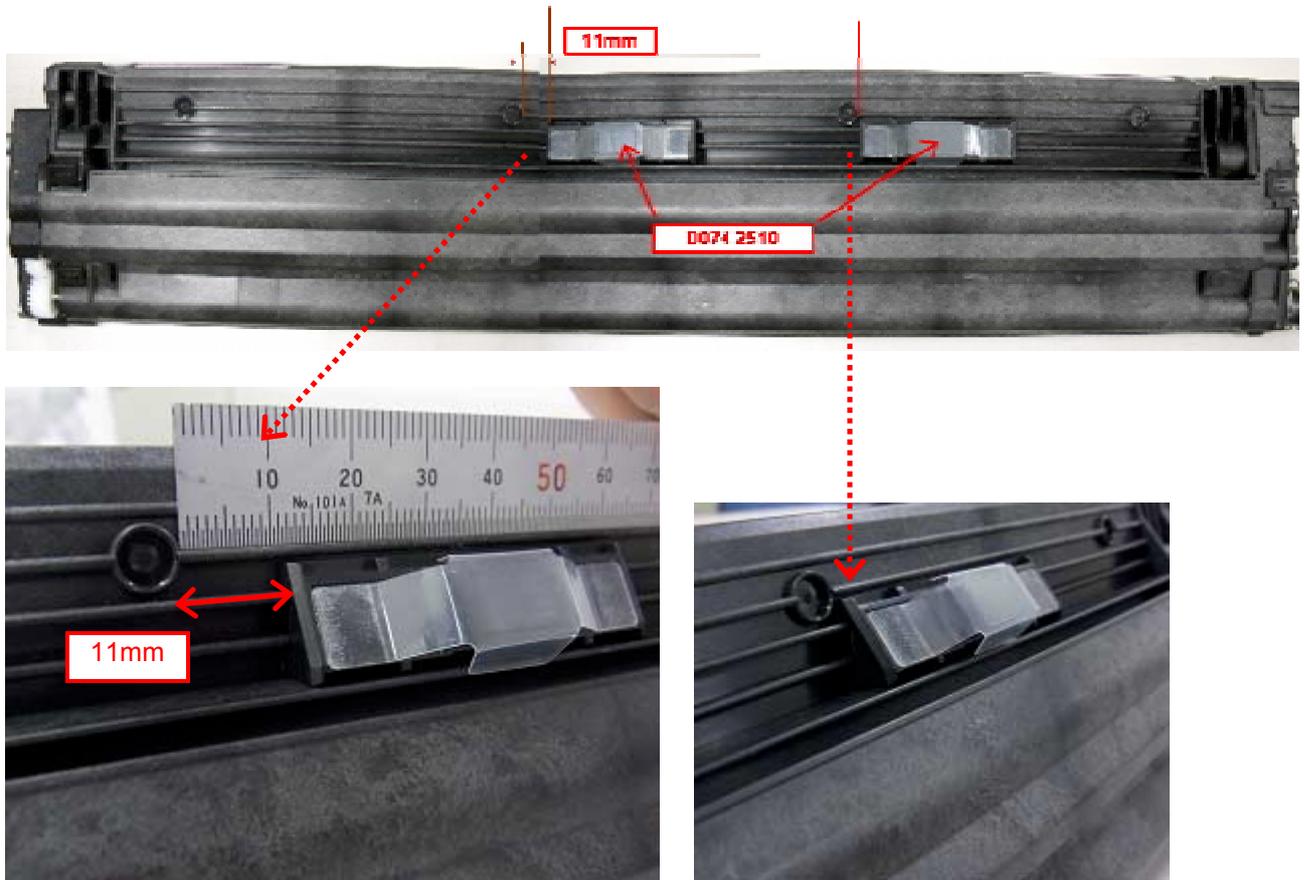
4. Attaching the anti-vibration cushion D0742510

Clean the surface of the back side of the frame and attach the cushions D0742510 (2 pcs) as shown below.

These cushions need to be replaced at 300Kp (135000m) as they will wear over time. Combine the PM for this part with other components of the drum cleaning unit that also require replacements at 300Kp.

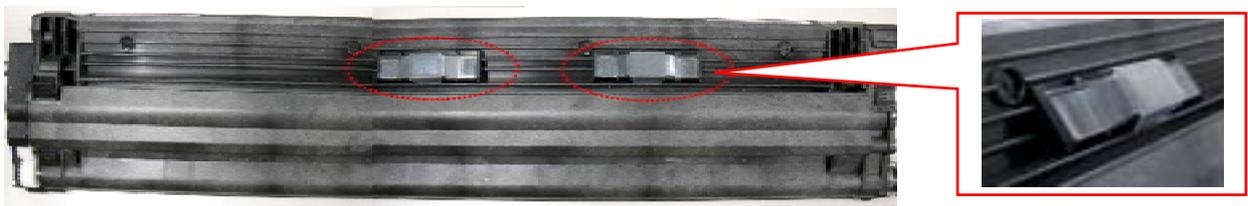
D0742510 CUSHION: CLEANING UNIT: ASS'Y

These cushions are attached to the back side of the drum cleaning unit, 2 cushions per unit, as shown in the photo below to reduce the vibration generated from the unit, which could cause short-interval banding.

These cushions do not have a PM counter but need to be replaced at 300Kp (135000m) as they will wear over time. Combine the PM for this part with other components of the drum cleaning unit that also require replacements at 300Kp.

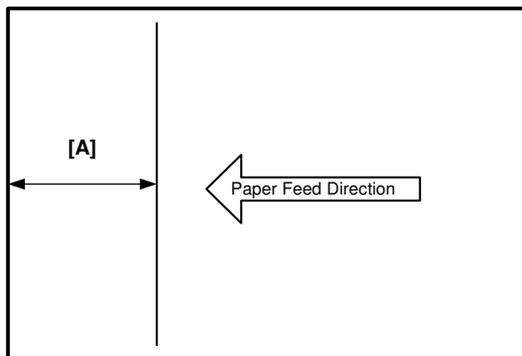
Symptom

One or several lines (jitters) appear in an area at a distance [A] from the leading edge of the 3rd page or later. *This symptom is observed especially when using Thick Paper (Paper Weight 5, 6 and 7).*

The ITB vibrates due to the shock generated when the leading edge enters the nip between the ITB and the PTR. *Troubleshooting instructions for shock jitter generated by this cause are on pages 2~4 of this bulletin.*

The ITB vibrates due to the shock generated when the trailing edge exits the nip between the ITB and the PTR. *Troubleshooting instructions for shock jitter generated by this cause are on page 5 of this bulletin.*

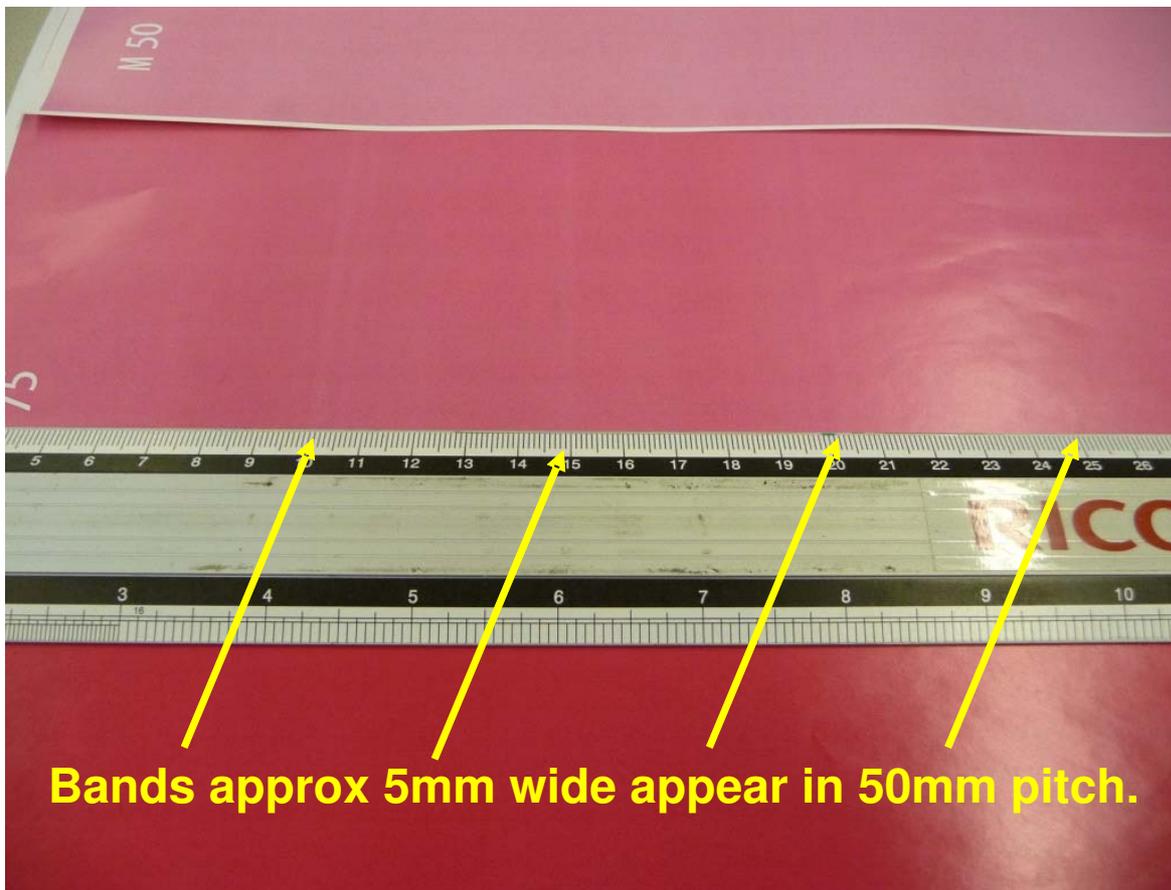
When servicing the PCDU, never remove the black plastic plate from the metal frame of the PCDU (see the next page). Removing this plate could result in sharp bands that appear at 50mm intervals as shown in the photo below.

Removing this black plastic plate could bend the spring plate and disable proper contact between the spring plate and the heat sink, resulting in the sharp bands at 50mm intervals like the picture on P.1.

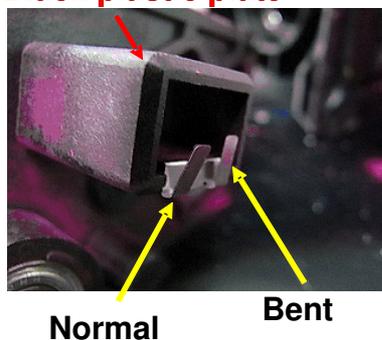
This photo shows an example of a bent spring plate.
