Model: Taurus-C1a/C1b	Date: 20-Jun-11	No.: RD074001d
-----------------------	-----------------	----------------

Subject: Firmware Release Note: OpePanel.EXP		Prepared by: S. Sasaki	
From: 1st PP Tech Service Sect., PP Tech Service Dept.			
Classification:	<input type="checkbox"/> Troubleshooting	<input type="checkbox"/> Part information	<input type="checkbox"/> Action required
	<input type="checkbox"/> Mechanical	<input type="checkbox"/> Electrical	<input type="checkbox"/> Service manual revision
	<input type="checkbox"/> Paper path	<input type="checkbox"/> Transmit/receive	<input type="checkbox"/> Retrofit information
	<input type="checkbox"/> Product Safety	<input checked="" type="checkbox"/> Other (Firmware)	<input checked="" type="checkbox"/> Tier 2

This RTB has been issued to announce the firmware release information for the **OpePanel.EXP**.

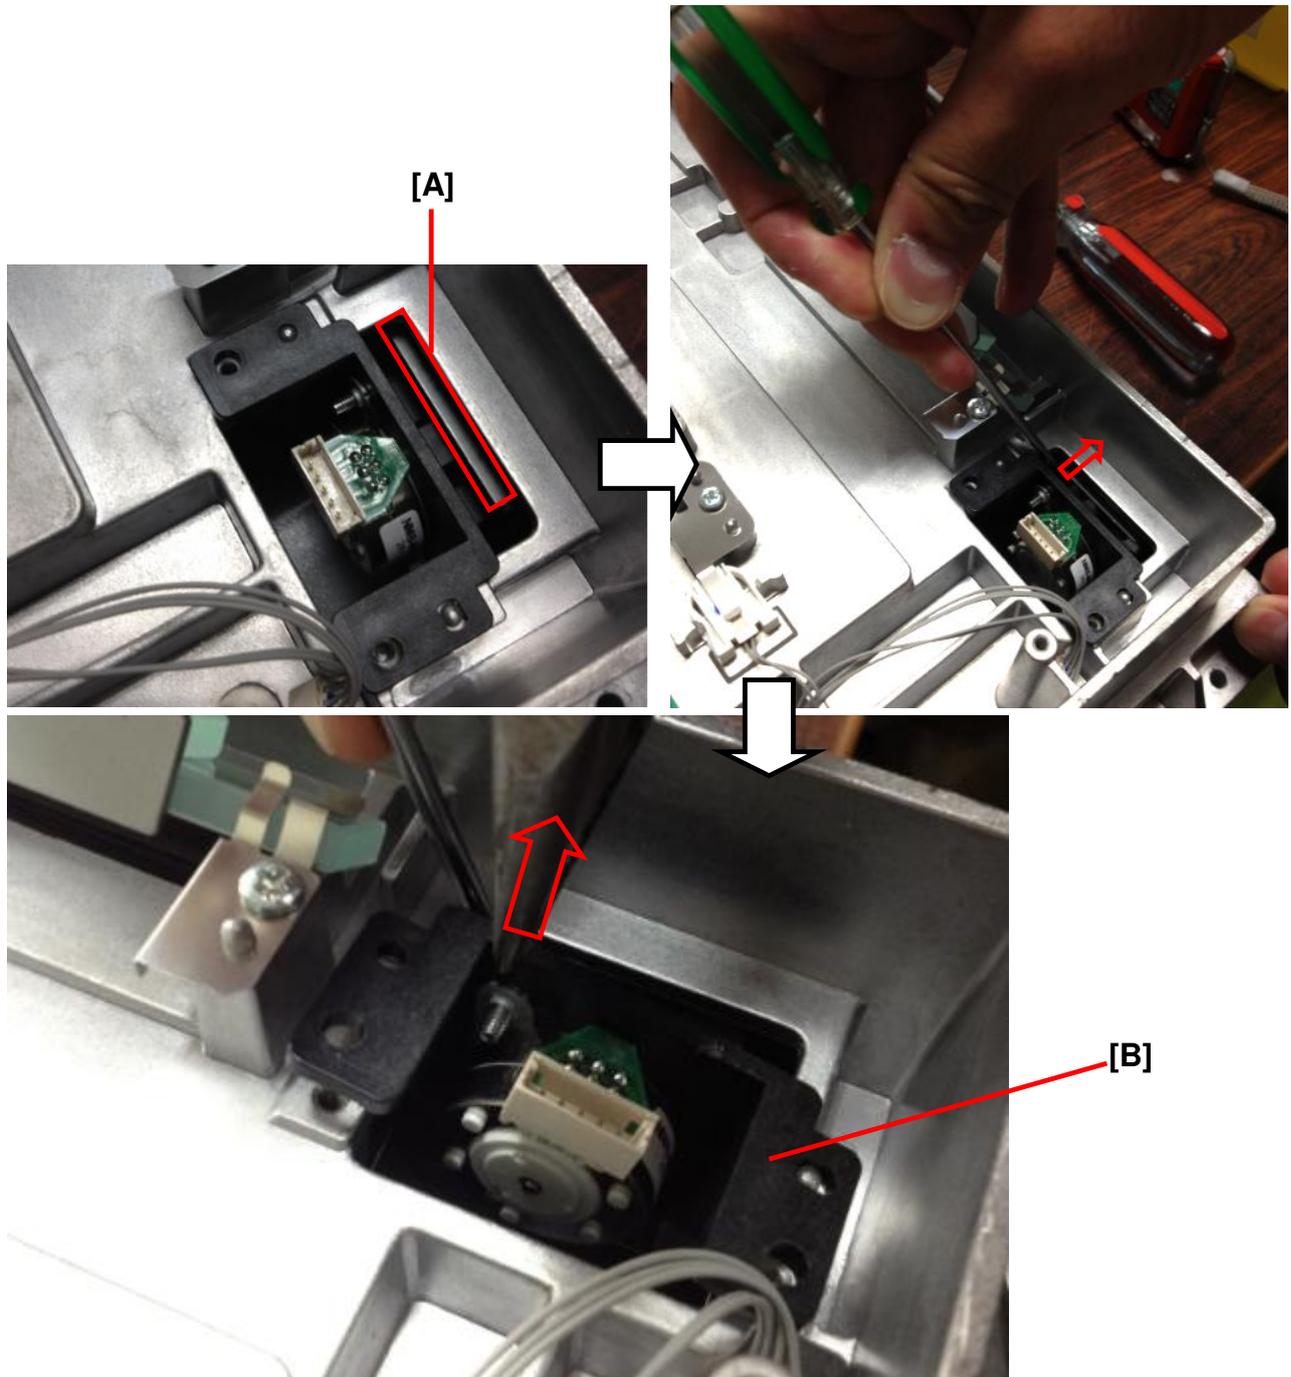
Defective skew motor

Replace the skew motor p/n ***D0741920*** (DC STEPPER MOTOR:ASS'Y) by following the procedure described below.

6. Remove the skew motor [B] with pliers while you push the lens [A] away from the skew motor with a screwdriver.

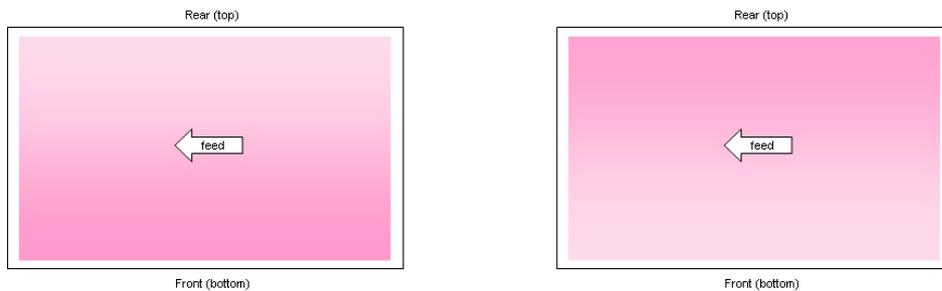
This RTB has been issued to announce the troubleshooting procedure for FR density problems in which the density at the front (bottom) and rear (top) appear uneven as in the images below.

First do procedure A, and if satisfactory results cannot be achieved, do procedure B.

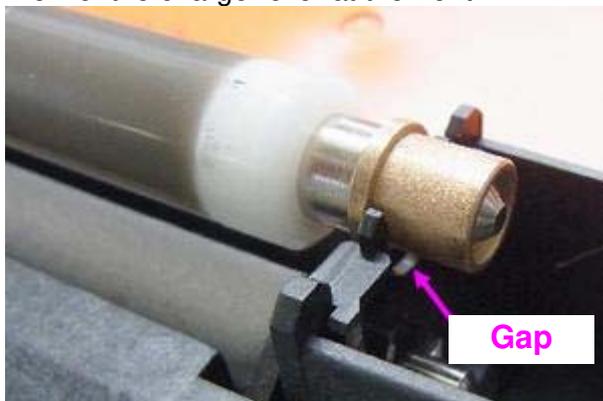
View of the charge roller at the front

Due to shipping damage, the bushing attached to the tip of the charge roller is not set correctly on the holder (as can be seen by the gap between the components in the photo below). This generates excessive friction on the bushing and prevents the charge roller from revolving, eventually causing the lubrication powder to accumulate in the gap between the charge roller and the OPC drum. Accumulation of the lubrication powder causes high resistance and insufficient charge, resulting in black streaks that appear in the sub scan direction.

Until the modified packaging becomes available for the drum charge units, when replacing the drum charge unit, make sure that the charge roller is set properly on the holder, exhibiting no gap between the bushing and the holder.

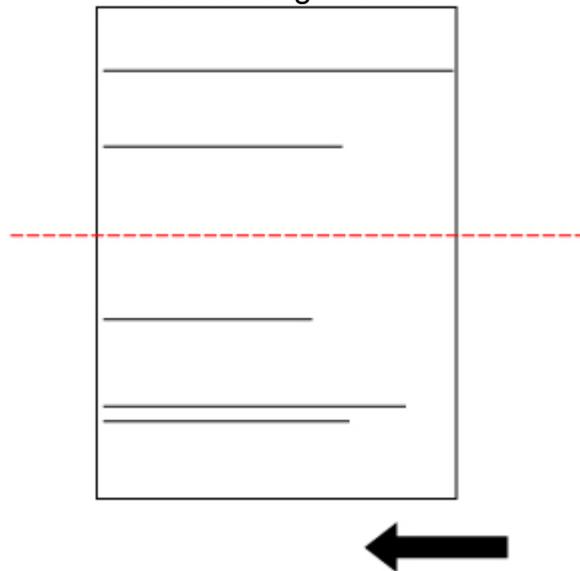
Toner offset resulting in unwanted lines/streaks in the paper feed (sub-scan) direction

Toner contamination on the rollers, ribs, or strippers

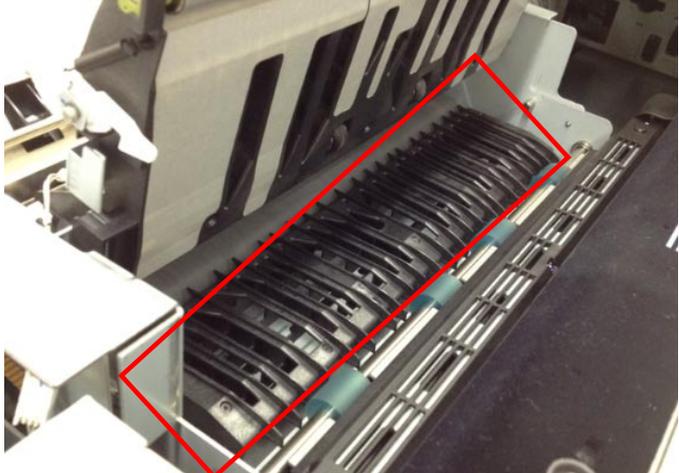
Location	Photos
[A] Paper Cooling Unit (Lever D3)

Ribs possibly causing the toner offset

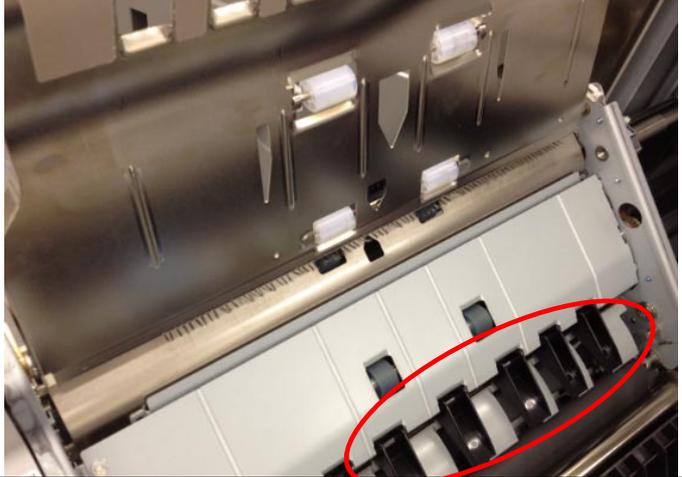
Position	Image
[A] Exit Junction Gates (Lever D4)

Rollers and Strippers possibly causing the toner offset

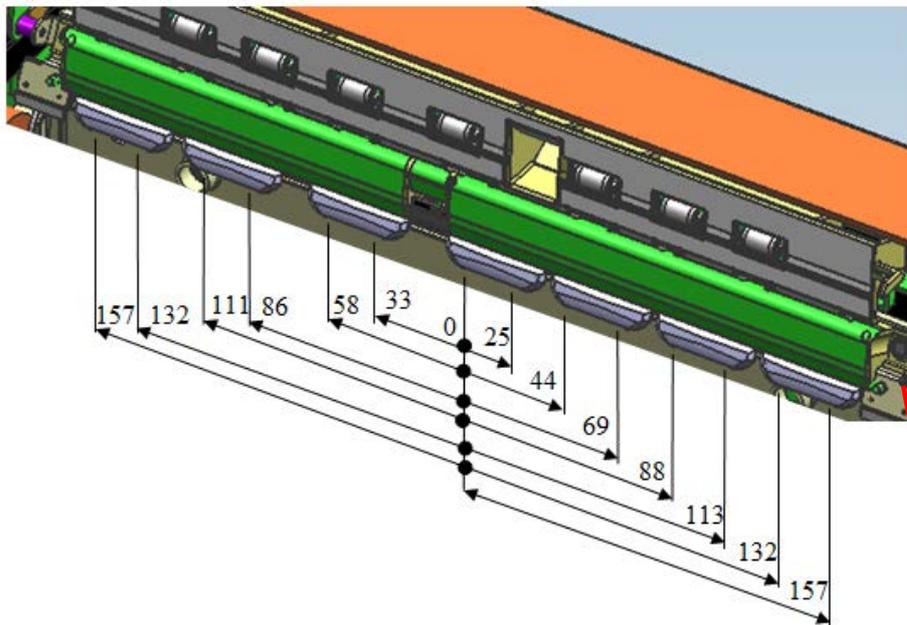
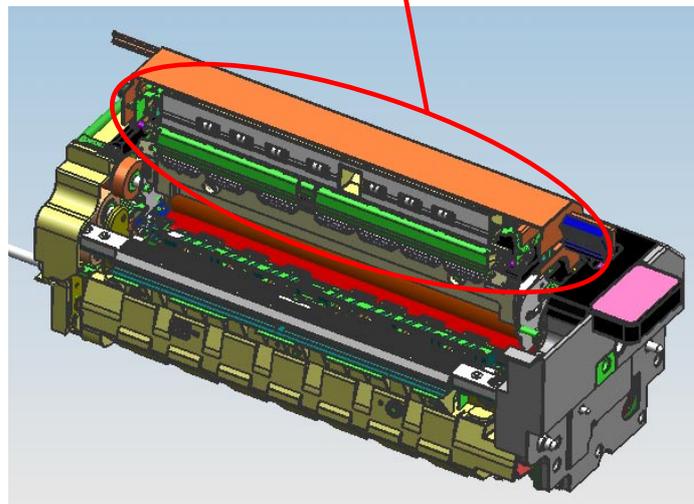
Cause 1: Fusing Belt Stripper Plate

Glossy streaks caused by the Fusing Belt Stripper Plate appear on the paper at the following locations.

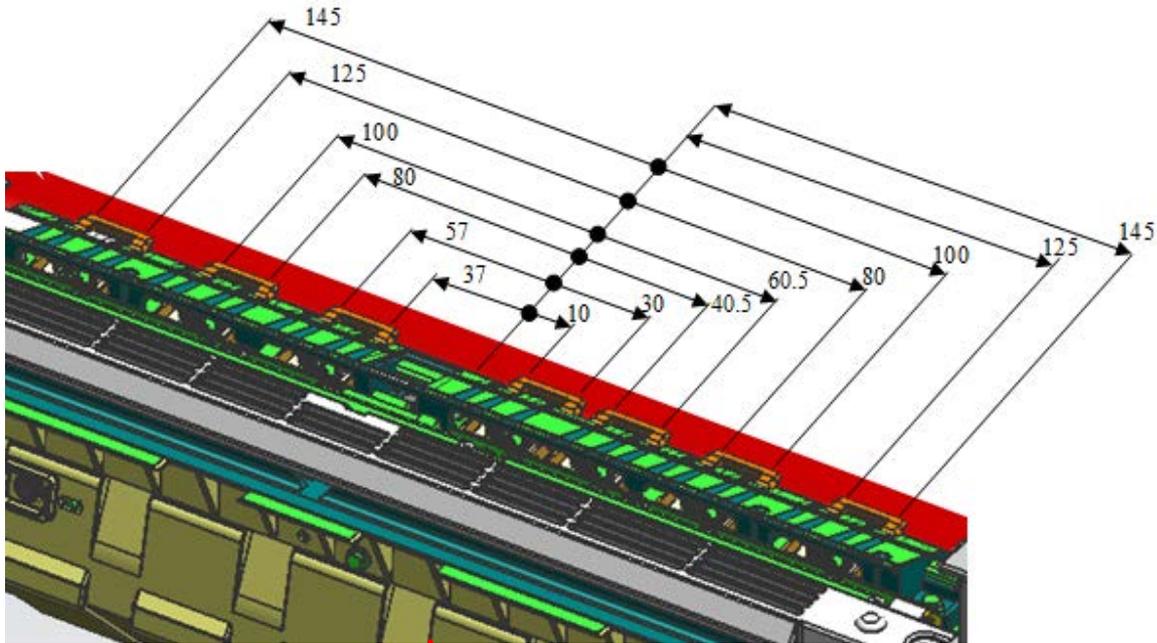
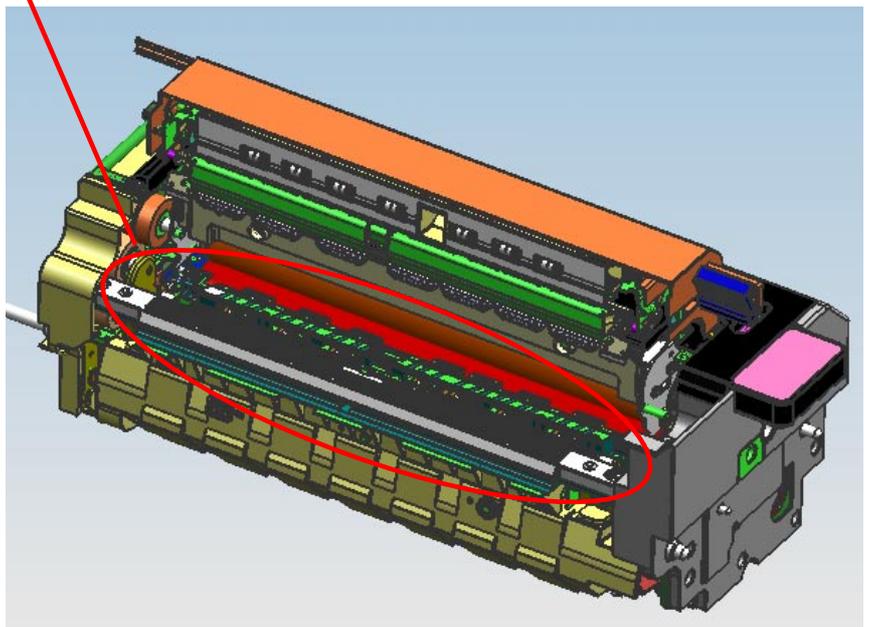
Cause 2: Pressure Roller Stripper Plate

Glossy streaks caused by Pressure Roller strippers appear on the paper at the following locations.

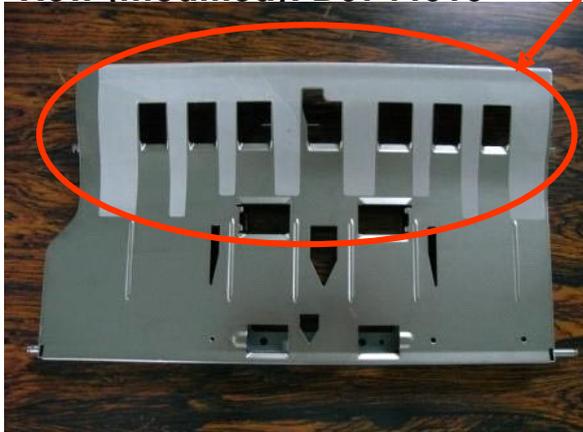
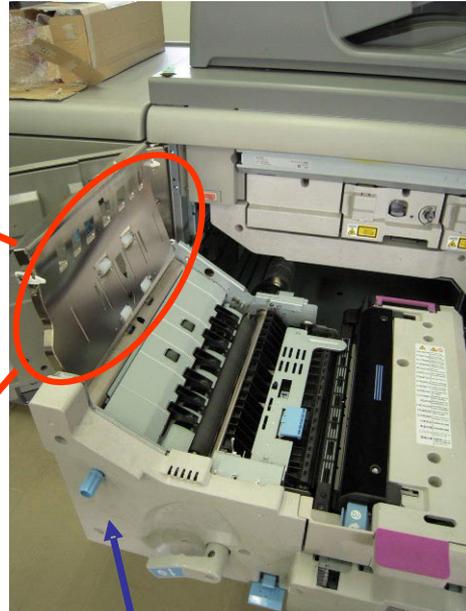
New (modified): D0744610

The strips of the PTFE sheet are longer on the modified guide plate.

In order to do so, it is recommended to replace the present guide plate with the modified guide plate (p/n: D0744610).

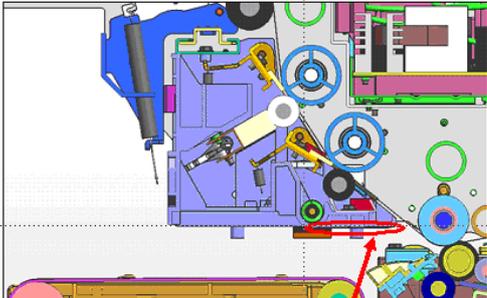
4	Toner Offset at 20mm intervals at the trailing edge	<p>[Details] Toner offset at 20mm intervals at the trailing edge. When neutralization is not enough by turning off separation bias, the paper trailing edge may touch the toner under belt cleaning case. This problem may occur in low humidity/low temperature environments. (Occurrence is not high at room temperature).</p>

<p>[Actions] Separation bias can be turned on from SP mode, but it may cause stripes on images as a side effect. SP2-825-*** (1st page) 0=>80 SP2-826-*** (2nd page)0=>80</p>
5	Limited usability on Paper Library	<p>[Details] AC transfer cannot be turned on by just selecting paper type and size.</p> <p>[Actions] When registering new textured media in custom paper, select the default textured media in the paper library then save it by changing media name.</p>
6	Toner offset on the back page	<p>[Details] After the PTR unit runs over 200kp, cleaning may not be enough for high AC. So remaining toner on the PTR may cause toner offset at the leading edge (within 60mm) on the back page. Occurrence is higher in low humidity/low temperature environments. Occurrence is higher for heavier stock.</p>

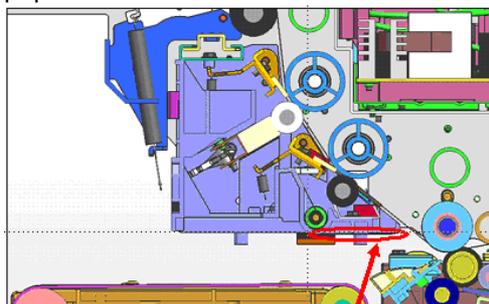
The separation bias has been turned off for textured paper so that it does not interfere with the paper transfer current. Therefore, paper might go up and attach to the belt cleaning section after going through the paper transfer area.

Adjust the separation voltage. Specify the following settings according to the thickness of the paper being used.

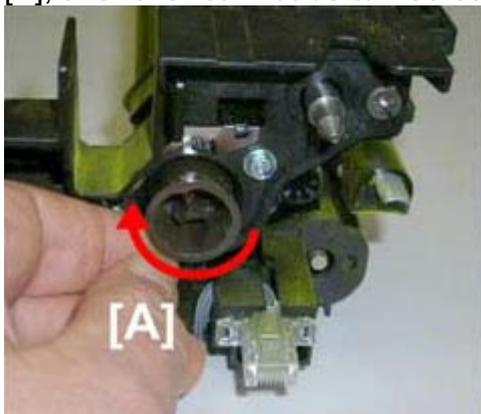
Developer replacement on the Taurus has been reported from the field difficult due to the inefficient and time consuming process needed to dispose of remaining developer in the development unit. Although the service manual mentions to turn the development roller [A], this roller cannot be turned easily due to the shape of its coupling.

To meet requests from the field, this new jig was developed and registered as a service part to allow fast and easy developer replacement. See the following page for instructions on how to use this jig.

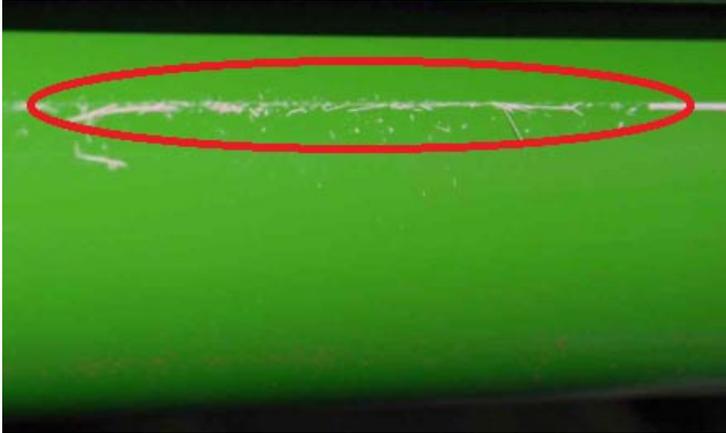
1. If clumps of lubricant (as shown in the photo above) are observed on the drum surface, gently wipe off with dry cloth. Remaining clumps of lubricant could get caught between the cleaning blade and drum surface, and cause incomplete cleaning and generate streaks on the output images.

DO NOT use a vacuum cleaner. **DO NOT** wipe the drum surface strongly.

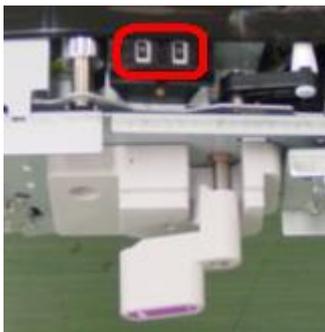
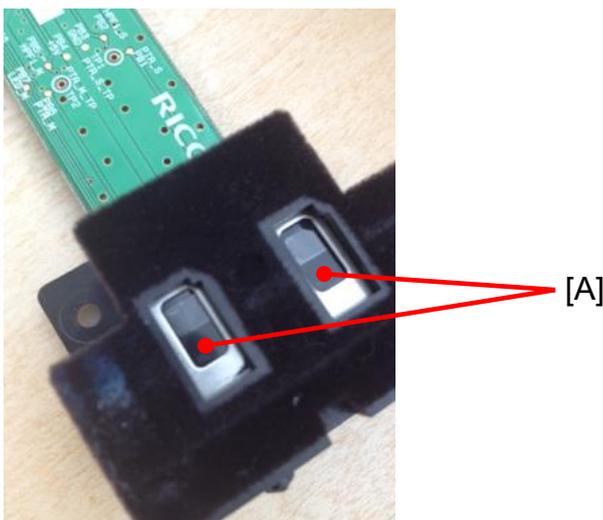
DO NOT attempt to wipe off the "black prints" [A] on the sensors. These black prints are NOT dust/dirt but are components of the sensor.

- Clean the sensor shown in the photo below.
 - Use a vacuum cleaner or an air blower to remove dust.
 - Wipe the sensor with a wet cotton swab. If a cotton swab is not at hand, wipe the sensor with a wet cloth. Use water if necessary, but DO NOT use solvent of any type (ethanol, etc).

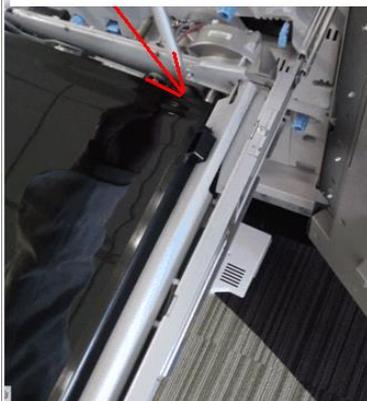
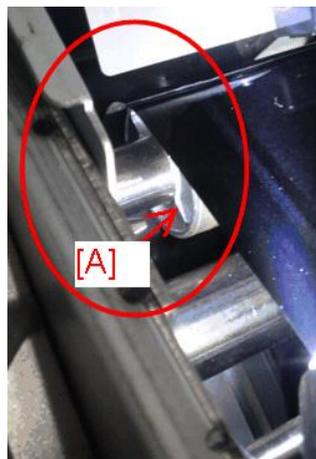
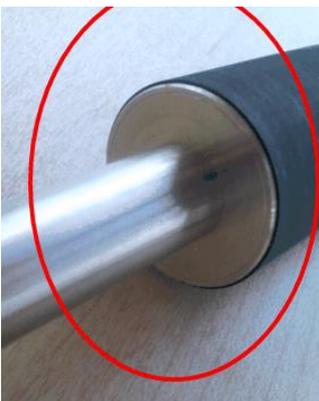
View from this direction

Basically, all mass production machines have the ITB drive shaft that incorporates the bossy cross shaped ribs [A], while there is a slight possibility of some machines installed with the former ITB drive shaft without the ribs.

Please be noted that this former type has a higher chance to loosen the encoder shaft.

Former type ITB shafts to be replaced with the new type. (All ITB drive shafts stocked as service parts are of the new type with the ribs.)

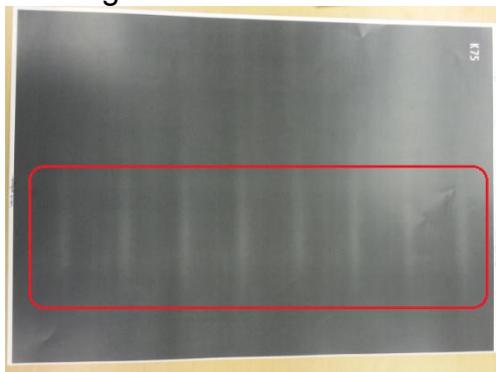
However, the procedure in the field service manual lacks detail and also advises the technician to create one's own tool to do the cleaning, which could cause incorrect cleaning that could scratch the surface of the development roller and result in severe banding.

To avoid such situations, the above tool was developed exclusively for cleaning the doctor gap for C651EX/C751EX/C751.

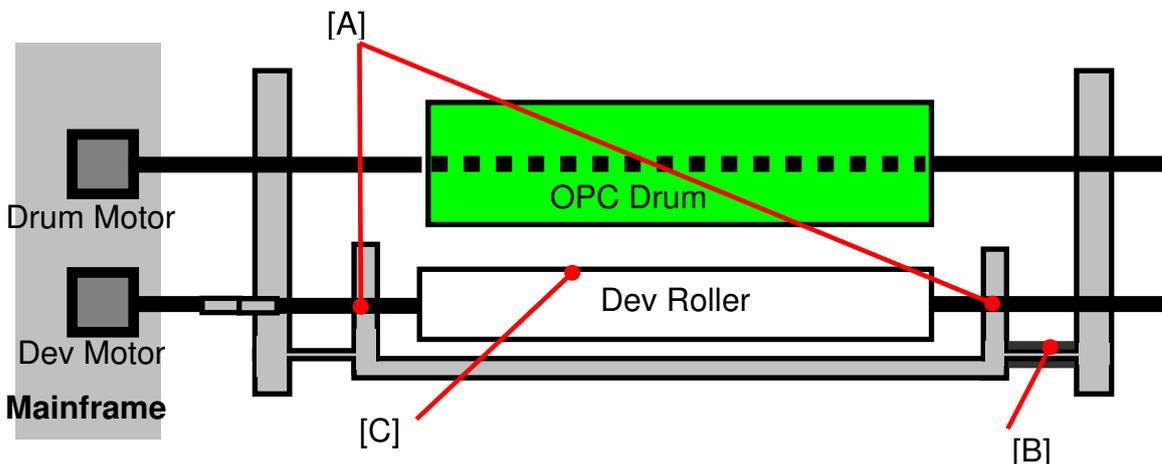
- [A] Reduced play
- [B] Reinforced housing
- [C] Increased doctor gap

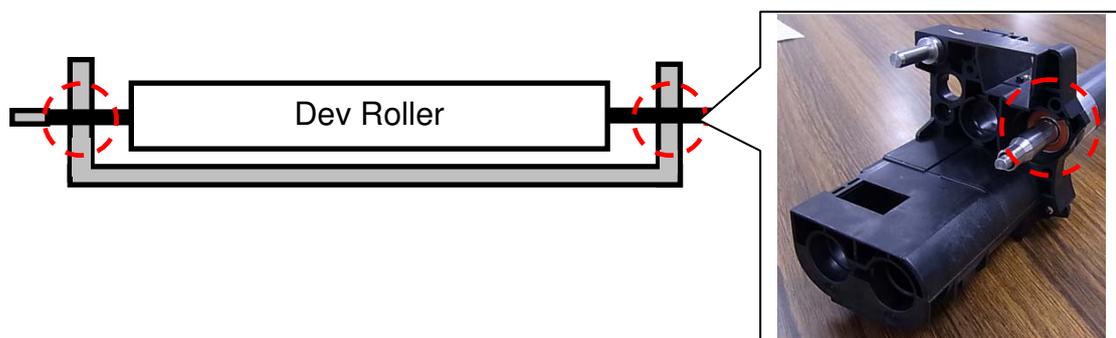
[A] Reduced play between the development roller bearing and housing

The bearing that holds the development roller was slightly increased in its diameter to fit more tightly with the housing. This enables the development roller to rotate more precisely on its axis and reduce fluctuation.

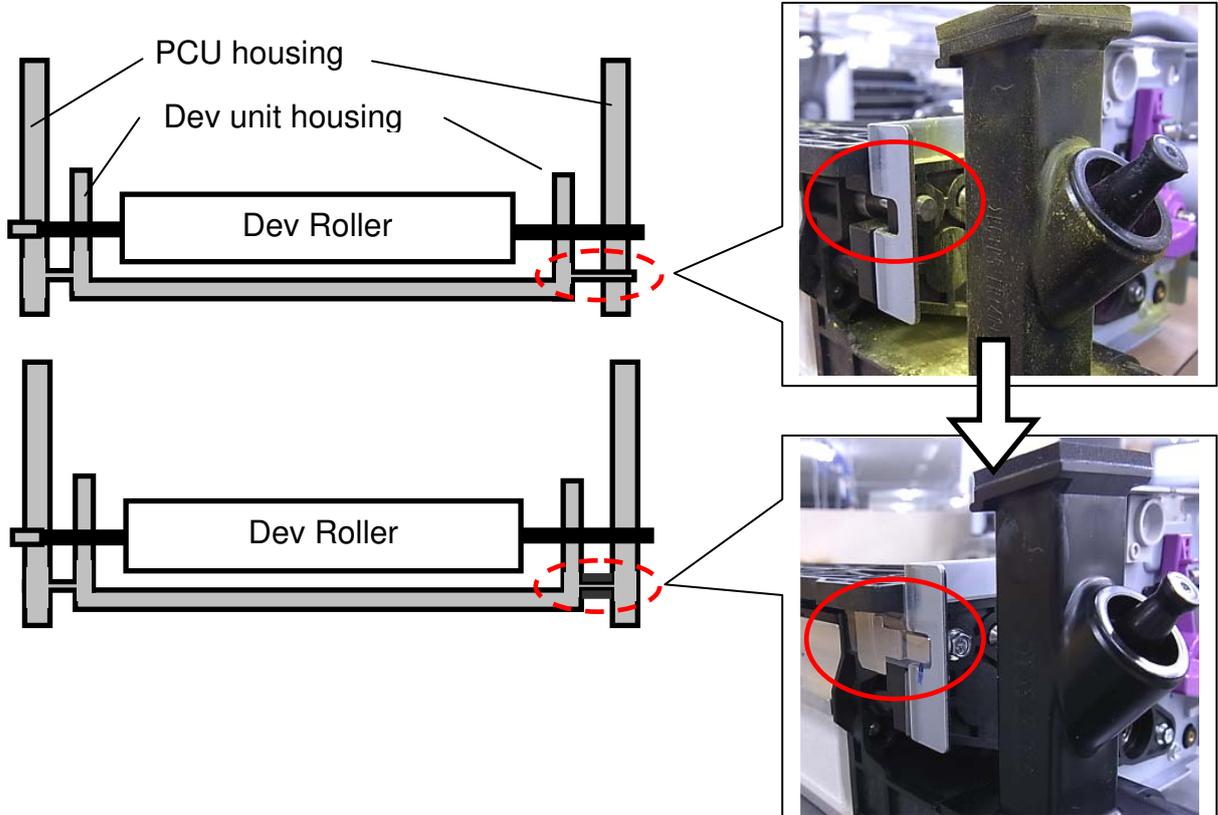
[B] Reinforced housing

A tension pole was added in between the development unit housing and PCU housing to secure consistency in the position gap.

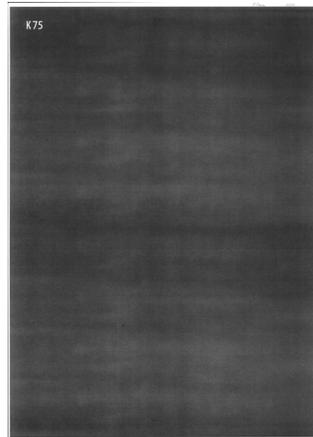
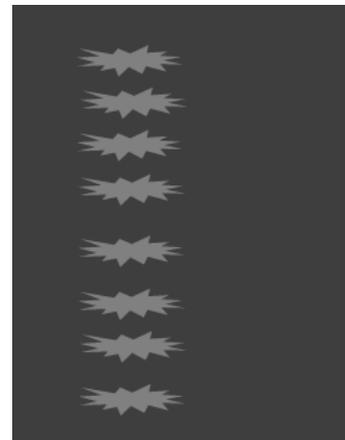
Haze-like de-colored areas are observed around the center of the page at 50mm intervals.

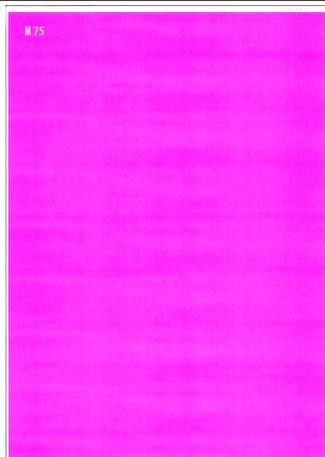
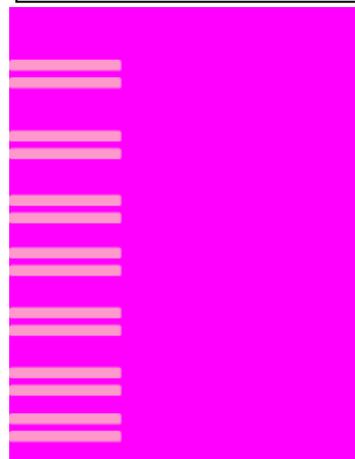
2. Double white banding

Bands in pairs appear at 50mm intervals. Unlike the de-color banding, this symptom tends to occur at the edge of the pages.

The above two symptoms could be observed together on the same page, and tend to become more noticeable over time due to the deterioration of the developer.

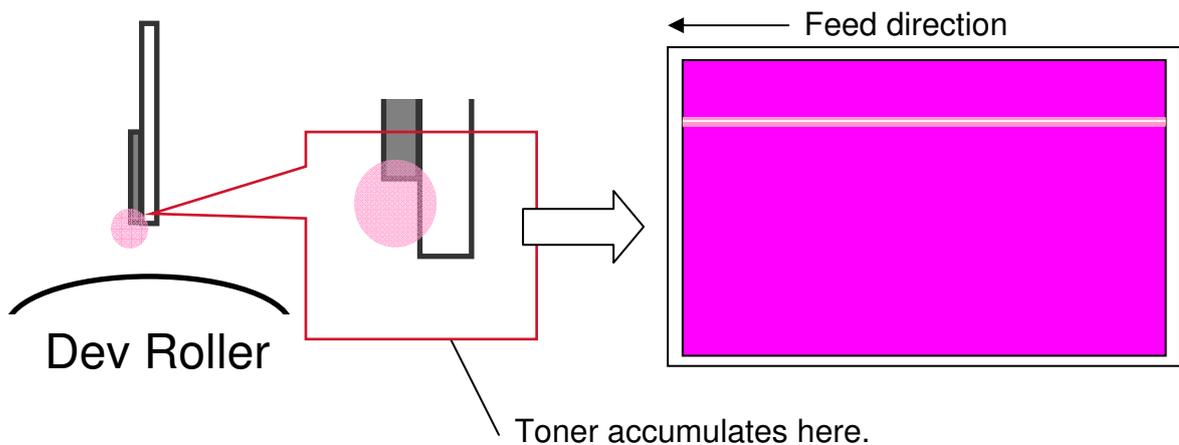
To reduce the chances of generating the image quality issue known as “in-track lines” caused by toner accumulation at the tip of the magnetic plate

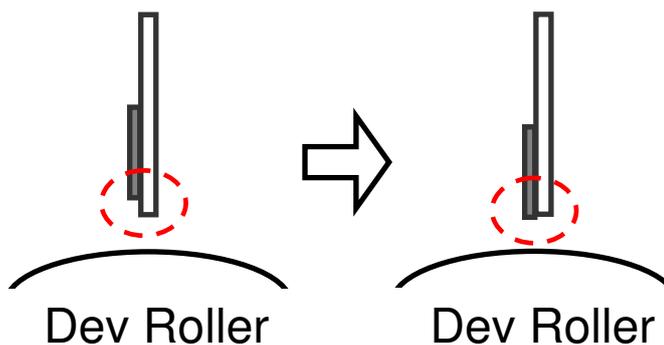
The magnetic plate was attached lower against the doctor blade so that its tip reaches closer to the development roller than that of the doctor blade, which prevents toner from accumulating.

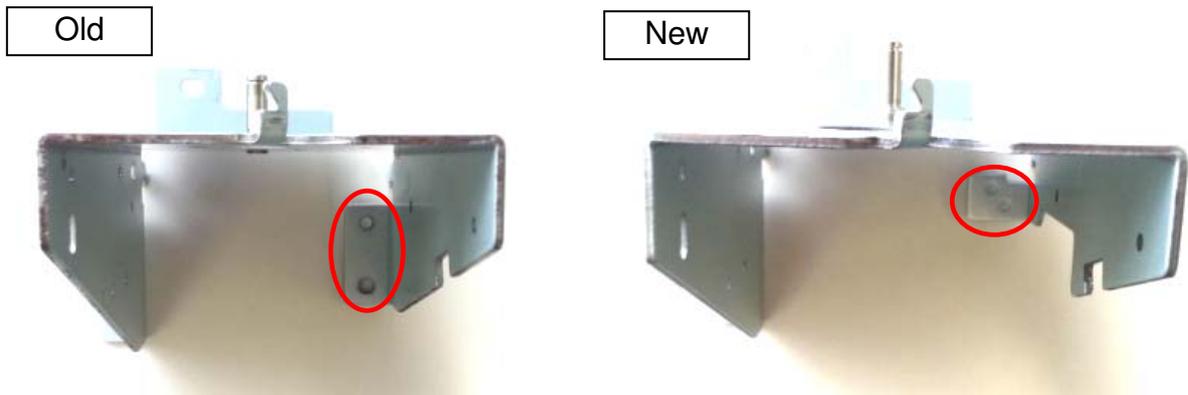
Old bracket: Cannot be used on new finishers.

New bracket: Can be used on old and new finishers.

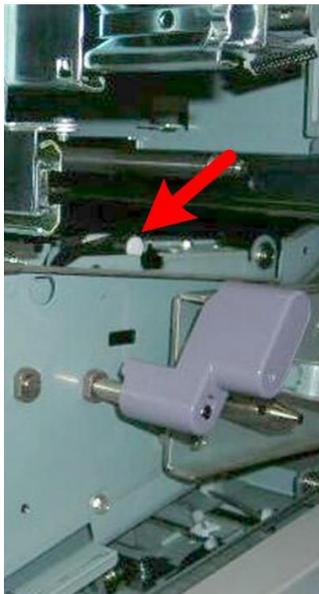
Check if the Bk image transfer roller is raised up against the drum by looking at the front edge of the ITB. If you see the white cap as shown in the photo below, the ITB lift motor has failed to lower the belt.

Following are the possible causes of this problem.

1. The 2nd lift motor or its gear is clogged with toner.
2. The 2nd lift motor sensors are dirty or damaged.
3. Damaged or disconnected harnesses

1. Open the front doors and remove the inner covers of the ITB unit.
2. Cheat the front door sensors by inserting a folded piece of paper, etc.

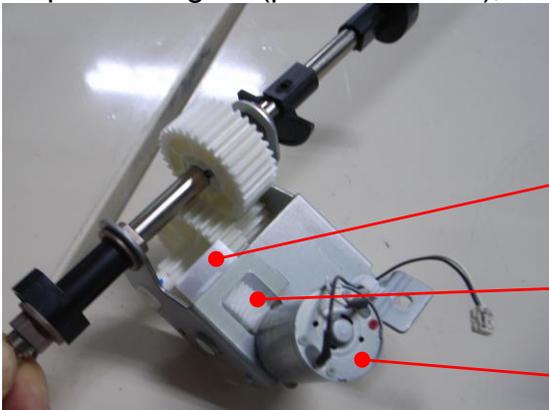
If the shaft does not rotate: The motor could be defective. Go to Step 6.

7. Replace the gear (p/n: D0746195), DC motor (D0746196), and seal (D0746128).

D0746128:
SEAL:BRACKET:MOTOR:BLACK

D0746195:
GEAR:COUPLING:ON-
OFF:BLACK

D0746196:
DC MOTOR:ON-OFF:5.28W:BRS

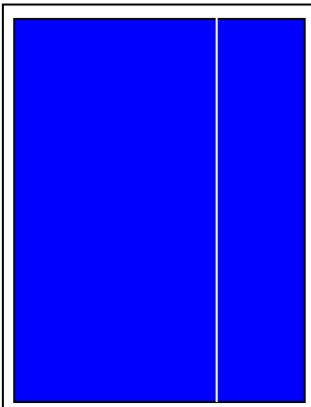
White line appears along the feed direction.

White Line is especially noticeable with solid or 1-dot halftone images.

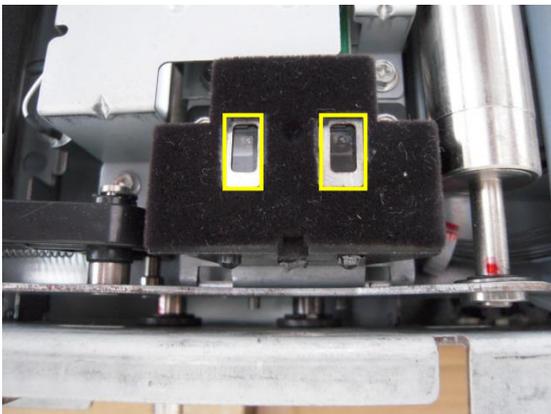
DO NOT scrub with force or apply cloth to the tip of a screwdriver when cleaning the sensors. Doing so could scrape off the coated surface and disable proper detection because the surface of the sensor is coated with slits that correspond to the slits on the ITB.

1. Use a vacuum cleaner or an air blower to remove dust.
2. Wipe the sensors with a wet cotton swab. If a cotton swab is not at hand, wipe the sensors with a wet cloth. Use water if necessary, but DO NOT use solvent of any type (ethanol, etc).

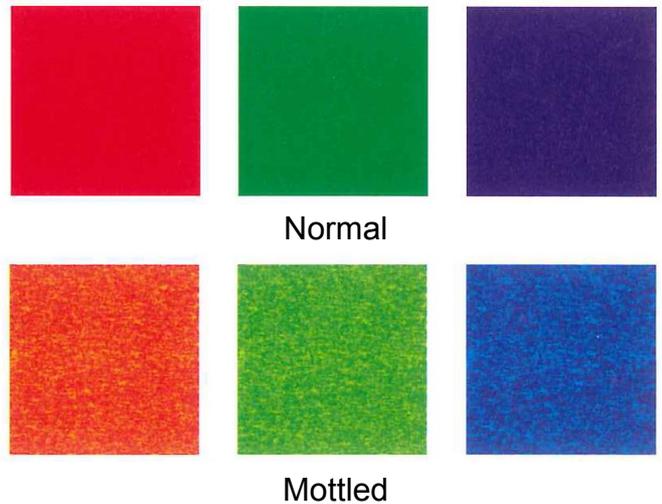
- Printing on rough surfaced paper
- Continuously printing jobs of low toner coverage
- Printing in a low humidity environment
- Printing in a high humidity environment

1. If a message prompting replacement of a unit appears, replace the unit.
2. To identify the affected color, print 3 sheets of full-page solid-fill (SP2-109-003: "26") on A3/DLT in cyan, yellow, magenta, and black.
3. Do SP3-011-002 or [0201: Adjust Image Density] in the [Adjustment Settings for Skilled Operators] menu.
4. Print the job showing the problem. Has the problem been resolved?
 - Yes: Go to step 6.
 - No : Print out 40 sheets of full page solid fills on A3/DLT in duplex in the affected color to refresh toner in the development unit. Then, do SP3-011-002 or [0201: Adjust Image Density].

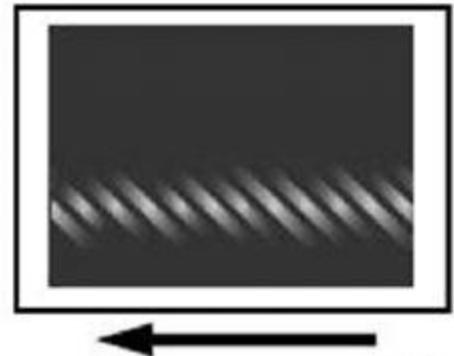
"Tiger Stripes" ("Wavy unevenness")

If the machine is used in a way that disables optimum refreshing of the developer, for example, continuous operation of low image coverage jobs or low P/J, fluidity of the mixture in the development unit degrades. This causes the amount of mixture to decrease at the front (operator) side of the development roller (because the auger rotates to convey the mixture from rear to front), resulting in the "Tiger Stripes".

1. Are there any PM parts that have already reached maximum life?
 - Yes: Replace the part(s) to complete the procedure. If the problem persists, do the next step.
 - No: Do the next step.
2. Print out 40 sheets of solid image on A3/DLT in duplex to exhaust old developer from the development unit. Then, do SP3-011-002 or [0201: Adjust Image Density] in the [Adjustment Settings for Skilled Operators] menu.
3. Print the job that had the Tiger Stripes. Is the problem resolved?
 - Yes: Do step 4.
 - No: Do step 5.
4. Since the effect expected from exhausting the developer is temporary, set the value in SP3-820-022 to "100" (default: 0) to prevent problem reoccurrence. With this setting, the system will refresh toner at the end of every job.

- Increasing the value in SP3-820-022 will reduce the toner yield.
 - To confirm the effect, monitor the machine for a while.
5. If the problem cannot be resolved even after doing the above procedure, replace the developer.

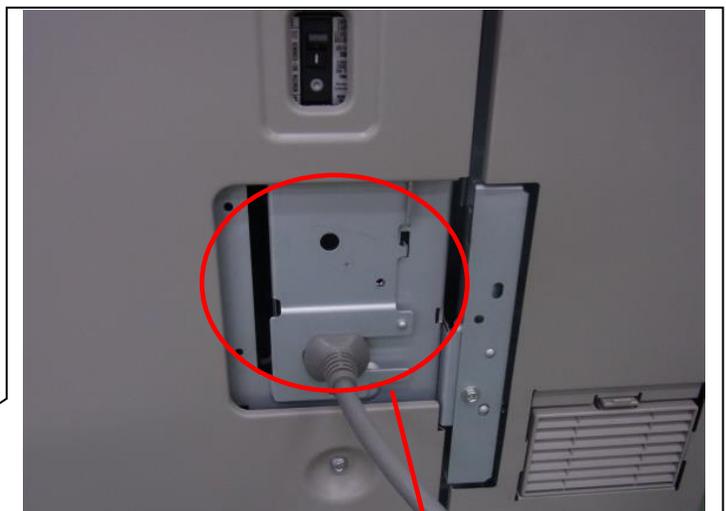
This modification enlarged the cutout for the power cord, causing the brackets and screw holes to be exposed. If the right cover has to be replaced, procure the cover together with the bracket (p/n: D0745923) to cover the exposed parts as shown on the next page.

Brackets and screw holes are exposed.

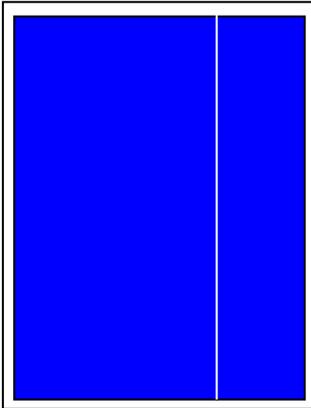
White line appears along the feed direction.

White Line is especially noticeable with solid or 1-dot halftone images.

3. Foreign substance stuck in the doctor gap in the development unit causes inconsistency in the amount of developer transferred to the drum surface.
 Running the machine continuously in a high-temp high-humidity environment can induce this symptom.

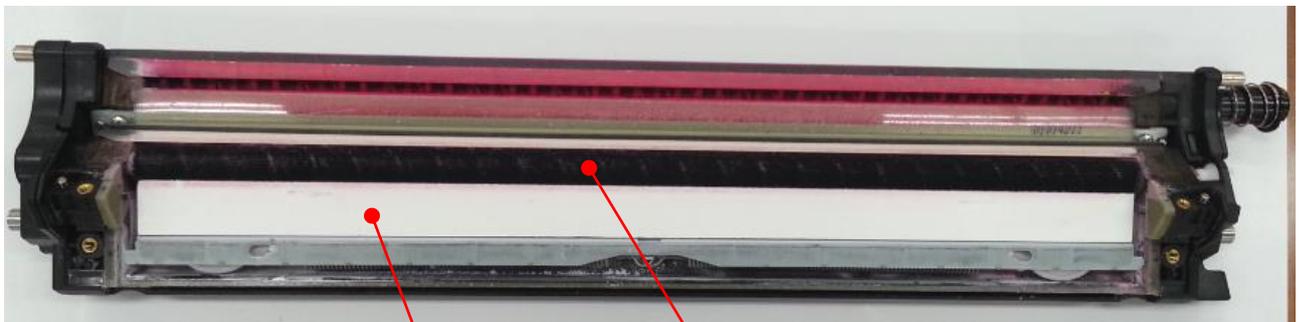
Note 1: Always replace the drum lubrication bar and drum lubrication roller as a set.

Make sure to **always replace the drum lubrication bar and drum lubrication roller as a set**, whether the replacements take place for PM or EM. Worn roller can cause unsatisfactory lubrication even if the lubrication bar is new, and vice versa.

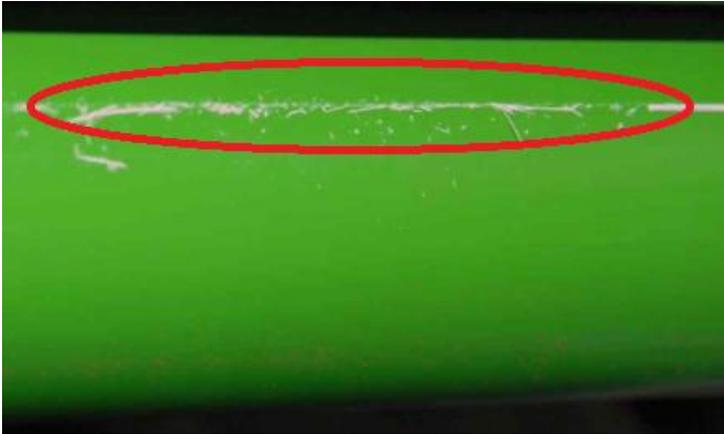
1. If clumps of lubricant (as shown in the photo above) are observed on the drum surface, gently wipe off with dry cloth. Remaining clumps of lubricant could get caught between the cleaning blade and drum surface, causing incomplete cleaning and streaks on the printouts.

DO NOT use a vacuum cleaner. **DO NOT** strongly wipe the drum surface.

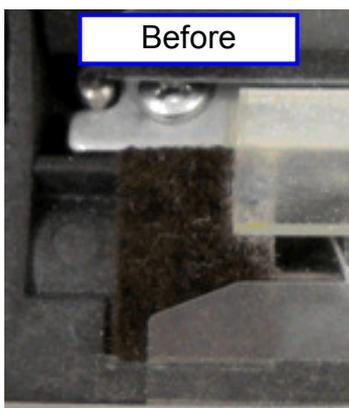
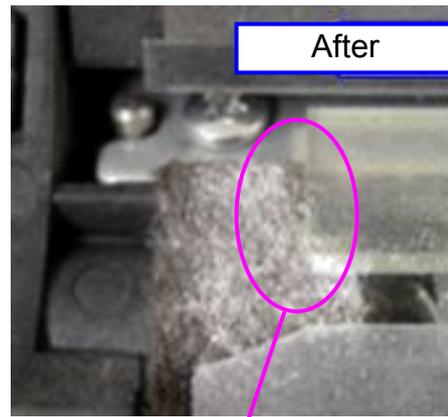
Make sure the powder covers this corner.

2. If the cleaning unit and drum are both replaced, apply lubricant powder (B1329700) on the drum surface as described in the service manual in the section:
Replacement and Adjustments > Photoconductor Development Unit (PCDU) > Drum Replacement > Installing a New Drum
3. Apply lubricant powder (D0159501) on the edges of the cleaning unit as explained in RTB # RD074071.

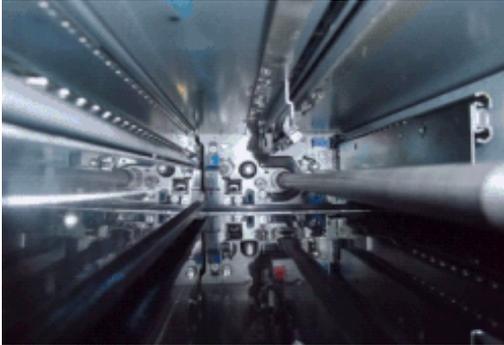
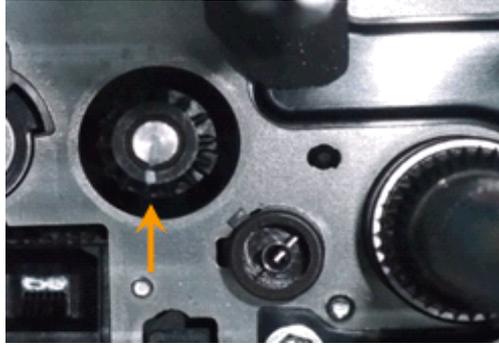
How to identify the marking on the Mainframe Drive Gear

Slide out the PCDU and look for a white marking on the gear as shown in the photo below.

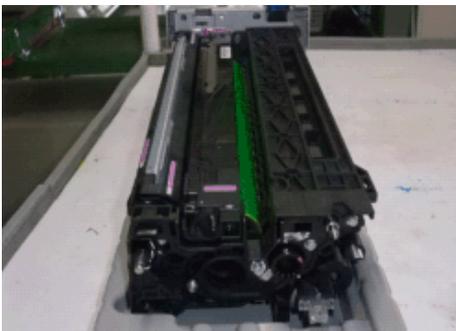
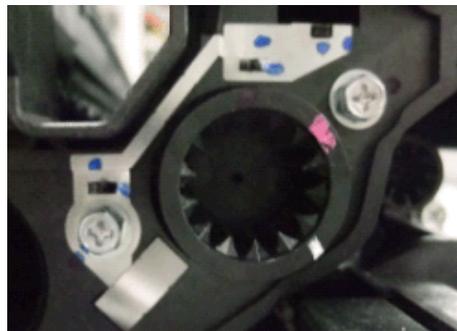
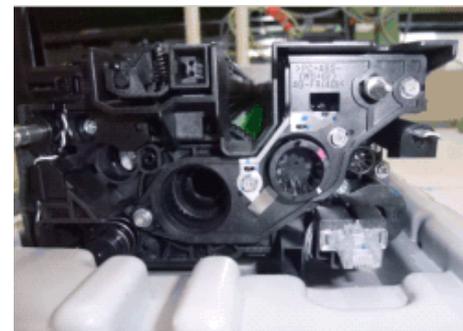
How to identify the marking on the Coupling Gear on the Development Unit

Pull out the PCDU and locate the development unit gear at the rear side. If marked, the development unit gear could be marked in two ways; either in white only or in white and pink.

- If marked only in White
 - White marking to be aligned with the white marking on the mainframe drive gear.
- If marked in White and Pink (very rare)
 - Pink marking to be aligned with the white marking on the mainframe drive gear

Align the white marking on the development unit gear to the white marking on the mainframe gear by turning the development unit gear counterclockwise. However, refer to the pink marking on the development unit gear, if marked in pink and white.

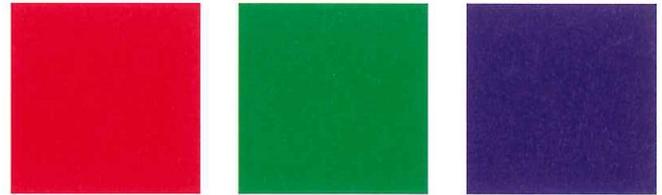
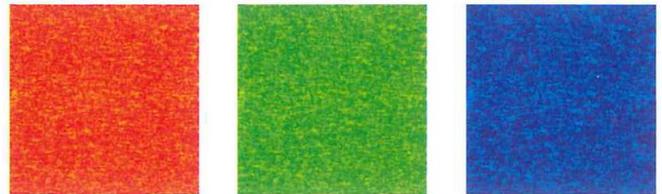
- Printing on rough surfaced paper
- Continuously printing jobs of low toner coverage
- Printing in a low humidity environment
- Printing in a high humidity environment

Normal

Mottled

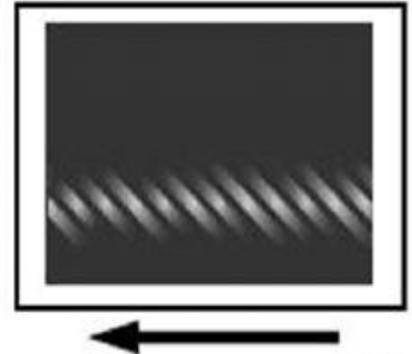
If the machine is used in a way that disables optimum refreshing of the developer mixture, for example, continuous operation of low image coverage jobs or low P/J, fluidity of the mixture in the development unit degrades. This causes the amount of mixture to decrease at the front (operator) side of the development roller (because the auger rotates to convey the mixture from rear to front), resulting in the “Tiger Stripes.”

1. Are there any PM parts that have already reached life?
 - Yes: Replace the part(s) to complete the procedure. If the problem persists, do the next step.
 - No: Do the next step.
2. Print out 40 sheets of solid image on A3/DLT in duplex to exhaust old developer mixture from the development unit. Then, do SP3-011-002 or [0201: Adjust Image Density] in the [Adjustment Settings for Skilled Operators] menu.
3. Print the job confirmed of the Tiger Stripes. Is the problem resolved?
 - Yes: Do step 4.
 - No: Do step 5.
4. Since the effect expected from exhausting the developer mixture is temporal, set the value in SP3-820-022 to “100” (default: 0) to prevent problem reoccurrence. With this setting, the system will refresh toner at the end of every job.

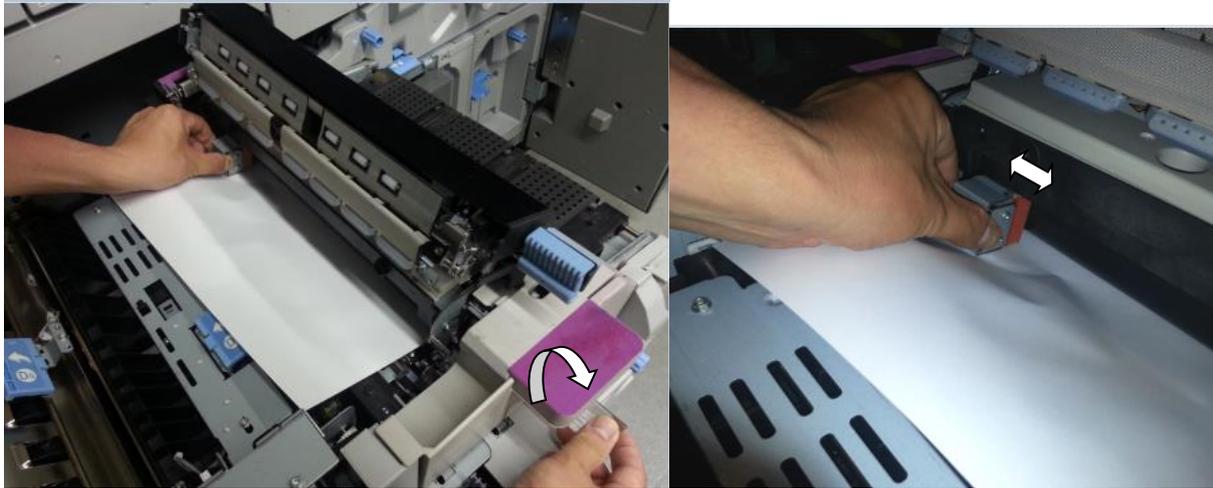
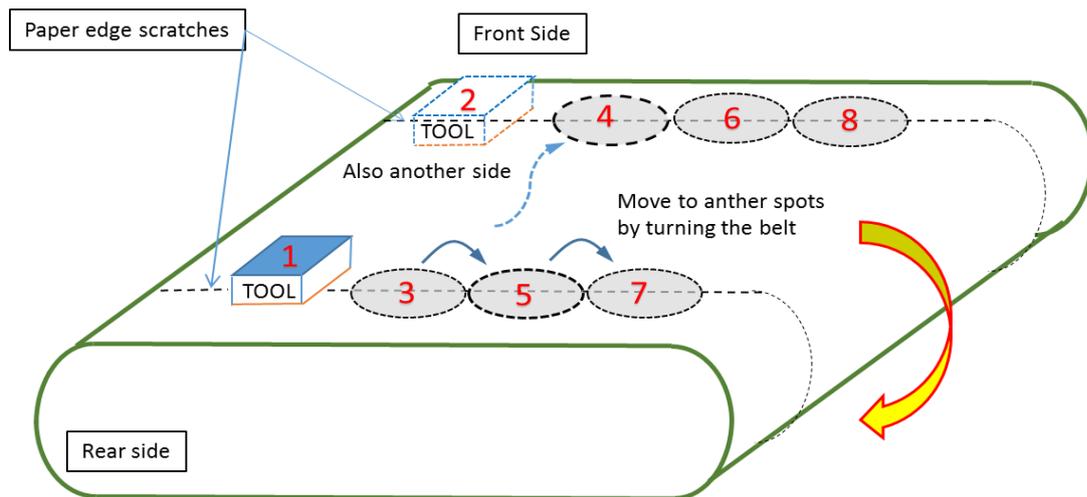
Use the polisher to smoothen the scratches on the fusing belt caused by paper edges. This will prevent "vertical lines".

- Rub the polisher against the fusing belt to smooth out the scratches. Rotate the fusing belt clockwise to polish the entire belt. **Rub approximately 30 times for each location, although this will depend on the condition of the scratches.**

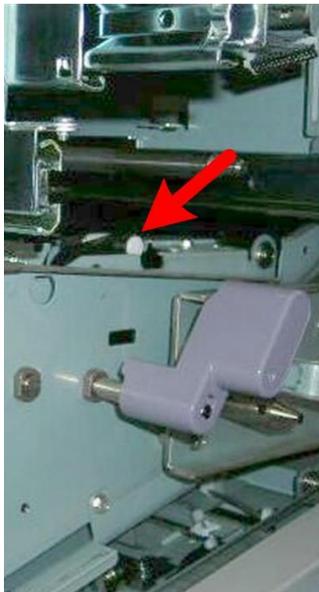
Check if the Bk image transfer roller is raised up against the drum by looking at the front edge of the ITB. If you see the white cap as shown in the photo below, the ITB lift motor has failed to lower the belt.

1. The 2nd lift motor or its gear is clogged with toner.
2. The 2nd lift motor sensors are dirty or damaged.
3. Damaged or disconnected harnesses

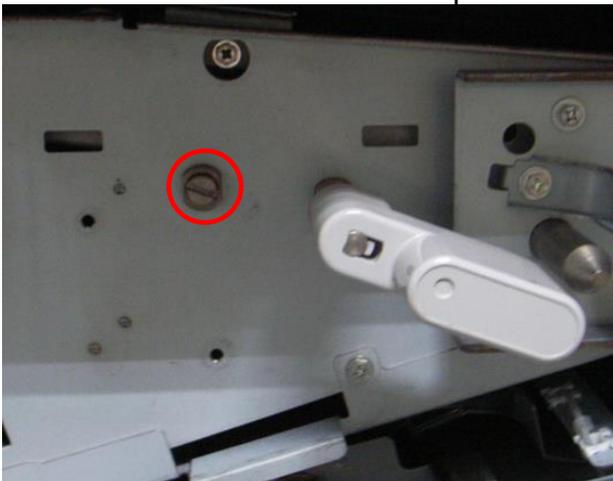
3. Turn the main switch on with the front doors open.
4. Check if the shaft circled in the photo below rotates in the initialization process.

The 2nd lift motor sensors could be dirty or the harnesses connected to these sensors could be damaged. Check the 2nd lift motor sensors and clean or replace them according to the service manual, in section: 4.
Replacement and Adjustments > Image Transfer Belt (ITB) Unit > 2nd Lift Motor Sensor 1 (K) and 2nd Lift Motor Sensor 2 (K)

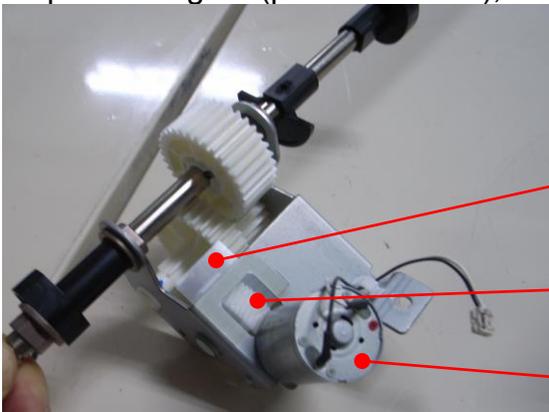
If the shaft does not rotate: The motor could be defective. Go to Step 6.

- Replace the gear (p/n: D0746195), DC motor (D0746196), and seal (D0746128).

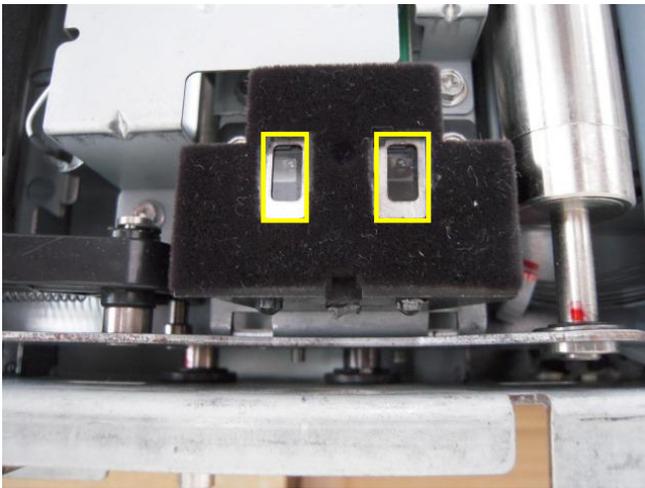
- False procedure carried out to clean the ITB speed sensor could cause SC499-40. Following are important notes on the correct procedure.

DO NOT scrub with force or cover the tip of a screwdriver with cloth to clean the sensors. Doing so could scrape off the coated surface and disable proper detection as the surface of the sensor is coated with slits that correspond to the slits on the ITB.

1. **Use a vacuum cleaner or an air blower to remove dust.**
2. **Wipe the sensors with a wet cotton swab. If a cotton swab is not at hand, wipe the sensors with a wet cloth. Use water if necessary, but DO NOT use solvent of any type (ethanol, etc).**
