Model: Taurus-C1a/C1b	Date: 20-Jun-11	No.: RD074001d
-----------------------	-----------------	----------------

Subject: Firmware Release Note: OpePanel.EXP		Prepared by: S. Sasaki	
From: 1st PP Tech Service Sect., PP Tech Service Dept.			
Classification:	<input type="checkbox"/> Troubleshooting	<input type="checkbox"/> Part information	<input type="checkbox"/> Action required
	<input type="checkbox"/> Mechanical	<input type="checkbox"/> Electrical	<input type="checkbox"/> Service manual revision
	<input type="checkbox"/> Paper path	<input type="checkbox"/> Transmit/receive	<input type="checkbox"/> Retrofit information
	<input type="checkbox"/> Product Safety	<input checked="" type="checkbox"/> Other (Firmware)	<input checked="" type="checkbox"/> Tier 2

This RTB has been issued to announce the firmware release information for the **OpePanel.EXP**.

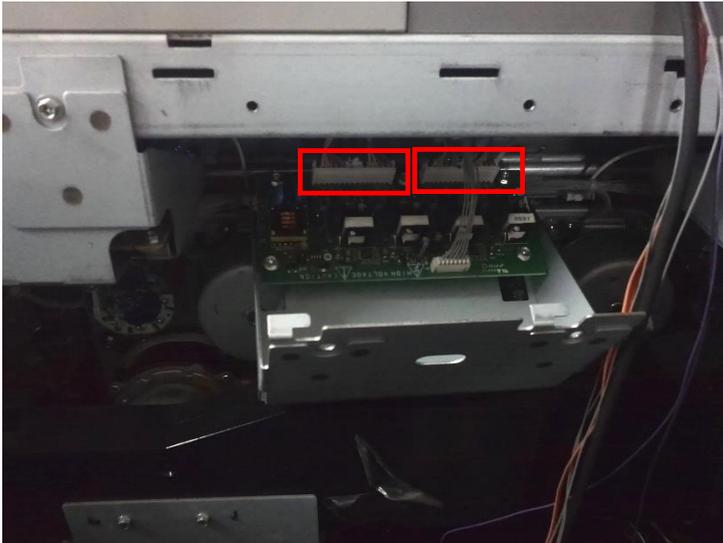
<p>The reading of the potential sensor above the drum of the affected color is incorrect. Specifically, Vd was out of range: $500 \leq Vd (700) \leq -800$</p> <p>Process control error codes: 15, 16 (displayed with SP3012)</p> <p>Note: Vd is the potential sensor reading of the unexposed surface of the OPC drum (no laser applied to the drum). This is read during the potential process control self-check.</p>
		<p>Error Code 15</p> <ul style="list-style-type: none"> • Potential sensor probe dirty. • Clean area around potential sensor with a blower brush • Potential sensor defective <p>Error Code 16</p> <ul style="list-style-type: none"> • Potential sensor board defective

- Potential Sensor Probe Dirty
- Potential Sensor Harness disconnected
- Potential Sensor Relay Board defective
- Potential Sensor Defective

1. Check if the connectors of the potential sensor relay board are disconnected, loose, or dirty.
 - If disconnected or loose, reconnect the connectors.
 - If dirty, clean the connectors.
 - If the above does not solve the problem, go to Step 2.

2. Check if the probe is dirty.
 - If dirty, clean the probe with air spray.
 - If the above does not solve the problem, go to Step 3.
3. Replace the potential sensor.

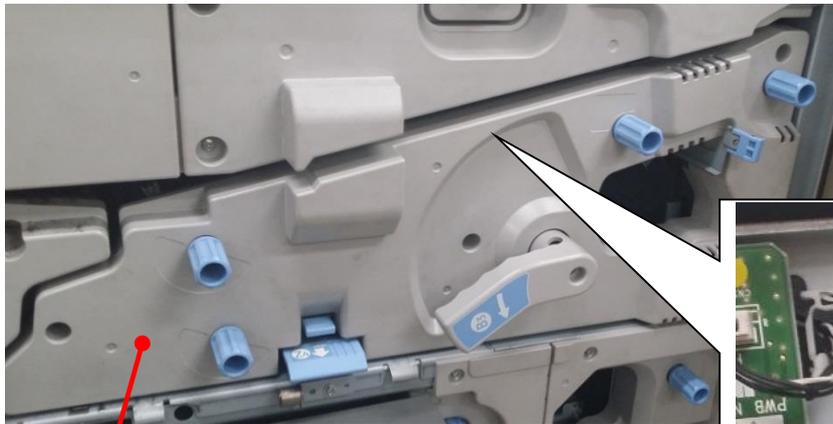
D0747844

D0747844: INNER COVER:PULL OUT:RIGHT
D0742601: PLATE:ADJUSTING PIN:GATE

- Old and new parts are NOT interchangeable.
- Both old and new parts will continue to be supplied. When these parts need to be replaced, procure the old parts for the old type, and new parts for the new type. See the next page for details.

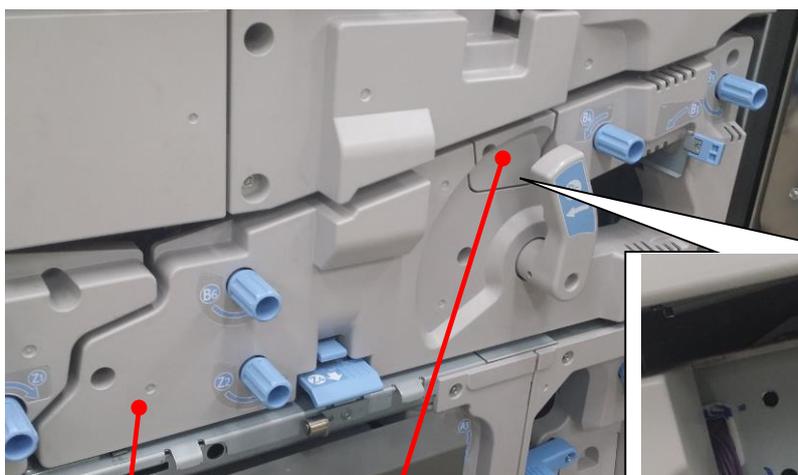
D1942991

D1942991: INNER COVER:PULL OUT:RIGHT
D1942992: INNER COVER:PULL OUT:RIGHT:SMALL
D1942989: PLATE:ADJUSTING PIN:GAT

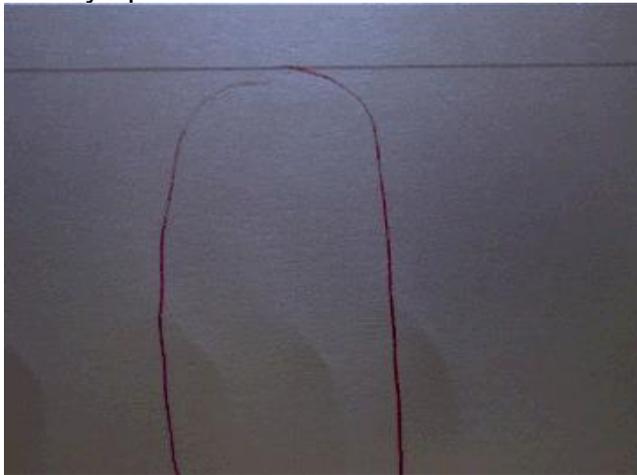
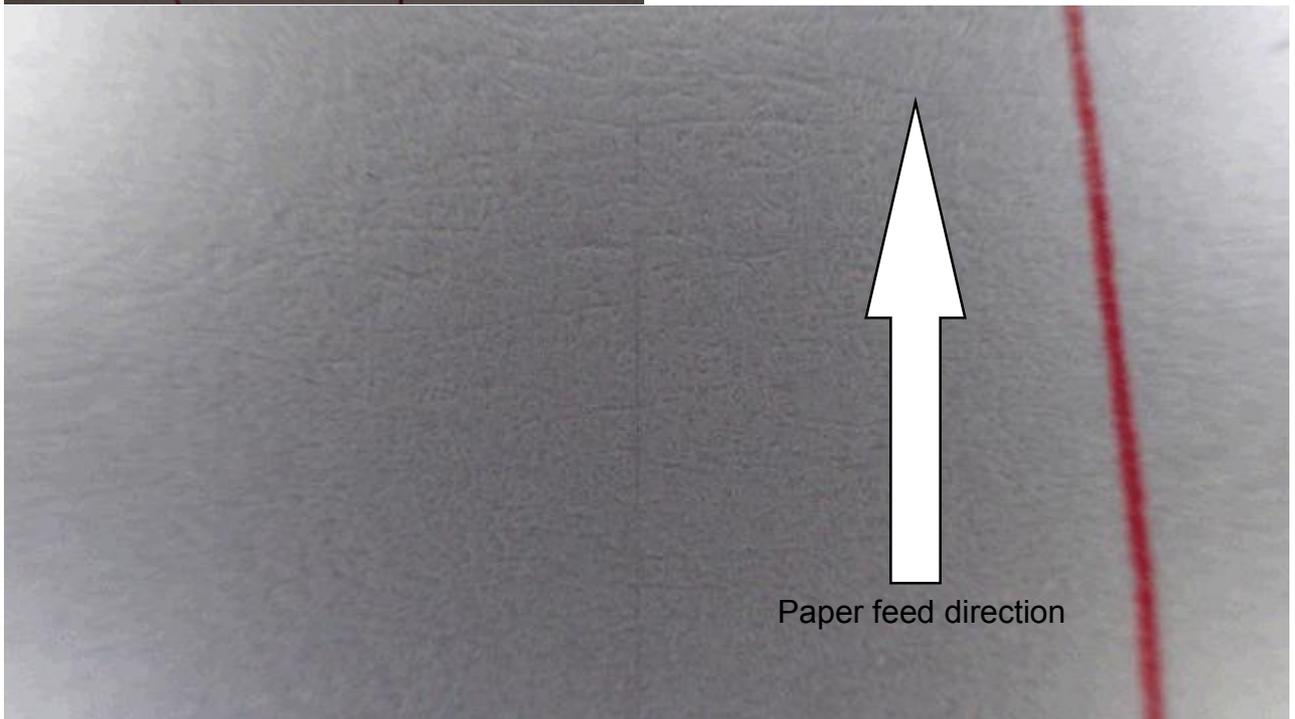
Black streaks (along the feed direction) appear on the back side.
The symptom usually occurs on the 1st and 2nd sheets of a job.

The symptom is observed in the area circled in red.

Set SP 2690-021 (Set:PTR:Standard non-image) to "0".

If this SP modification does not resolve the problem, replace the PTR and set the SP value back to default "0.83".

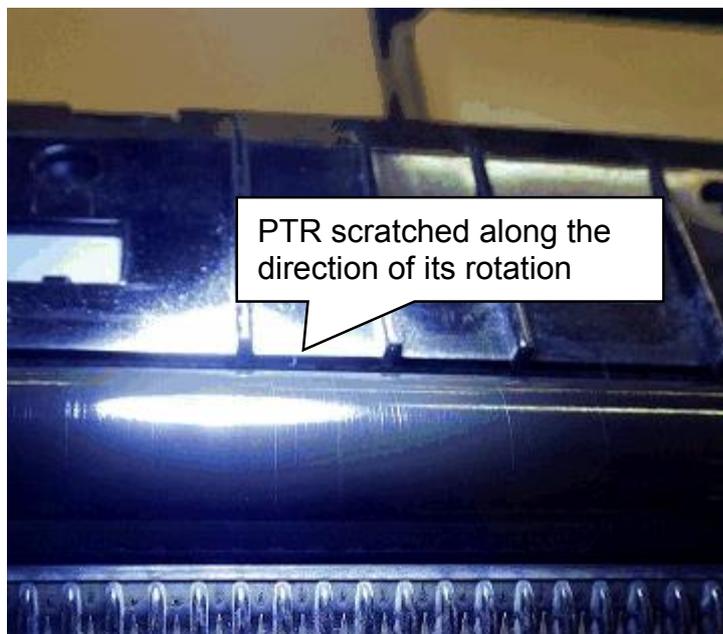
If the PTR is scratched along the direction of its rotation, toner particles infiltrate into the scratches. PTR cleaning generates an opposite charge on these toner particles, causing the unwanted toner transfer to paper.

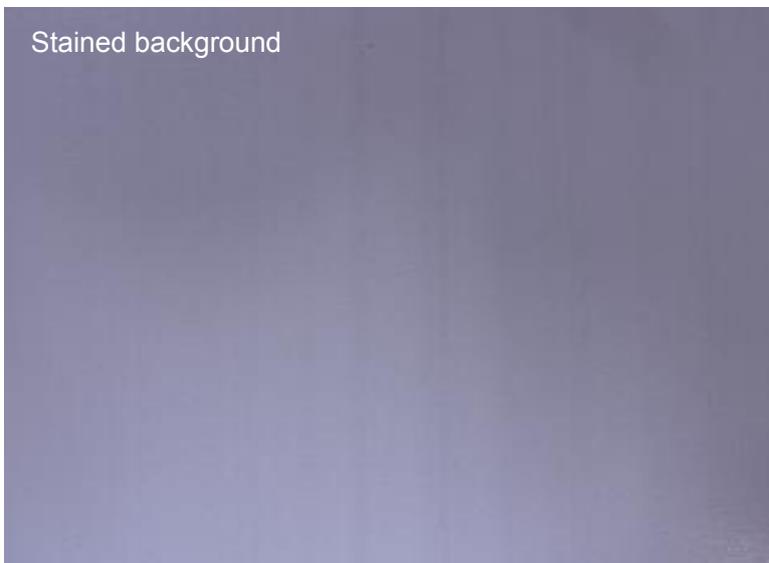
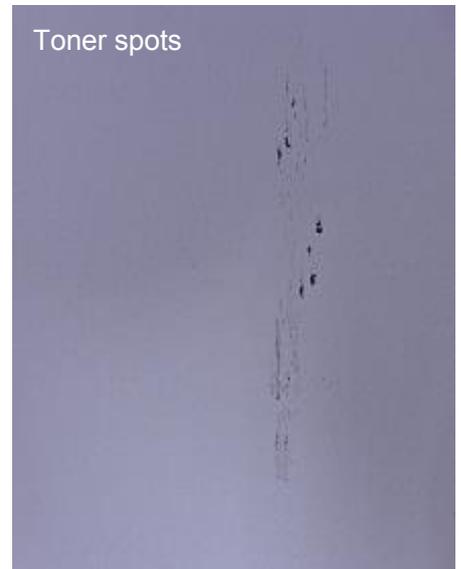
Background is stained or is spotted with toner when continuously printing low coverage and low P/J jobs.

Developer deterioration; developer mixture in the development unit cannot be refreshed because the machine continues to run low coverage (approximately lower than 3%) and low P/J jobs.

1. Clean the ITB cleaning unit, guide plates of the PTR unit, and development unit.
2. Confirm proper attachment of the development entrance seal (p/n: D0743330) and the side seals (p/n: D0743343, D0743344). If any of the seals are peeled off, replace with new seals. See RTB #RD074063 for how to replace the seals.

3. Check the PM counter value of the developer of the affected color in SP7-621-***. If the counter value has reached 750k on the 65CPM model or 900k on the 75CPM model, do the next step. Otherwise, the symptom is not suspected to be caused by deterioration of the developer. Do the troubleshooting procedure described in the following section of the FSM:

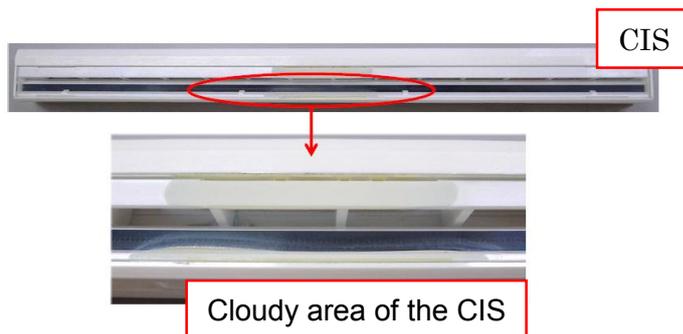
The light amount is less at the center because inside the CIS gets cloudy due to degradation of the adhesive agent inside the device.

Since the CIS device cannot be disassembled to remove the cloudy area, adjust the amount of light used for scanning, by following this procedure.

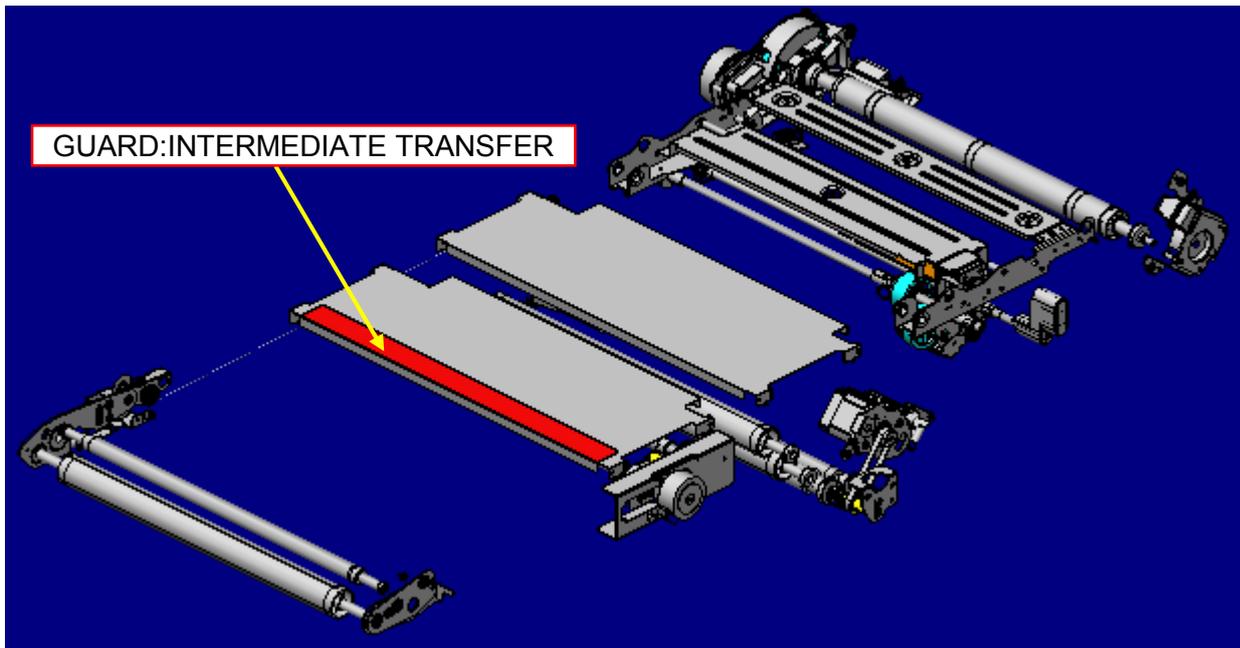
Change: The following guard was added as a new service part.

Reason: To meet requests from the field.

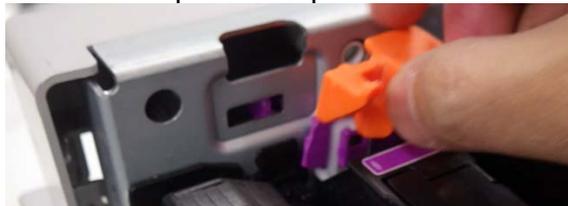
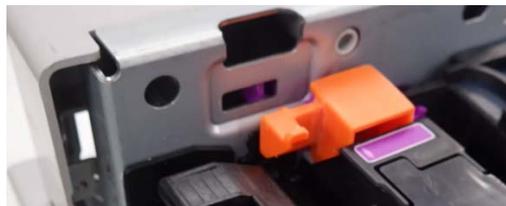
The Charge Roller Lever becomes damaged, requiring the replacement of the entire PCDU assembly.

3. Put the new part on top of the broken lever.
