# Aries Trouble Shooting

## Index

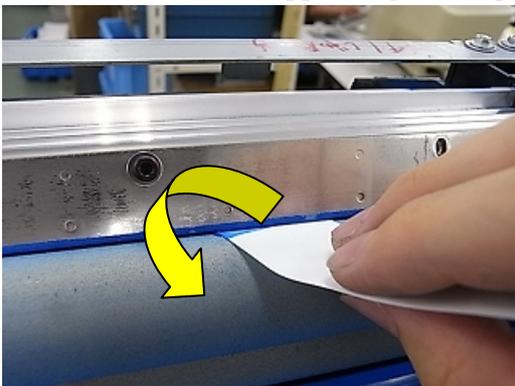
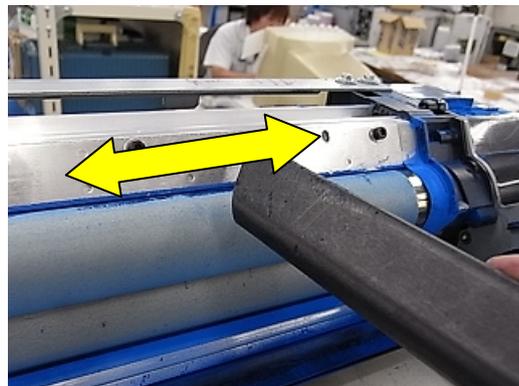
[A] developer is missing

**Note:** Do not damage the Development Rollers

**Step 6:** Exhaust the developer, and repeat Step 5. Then fill in with the new developer.

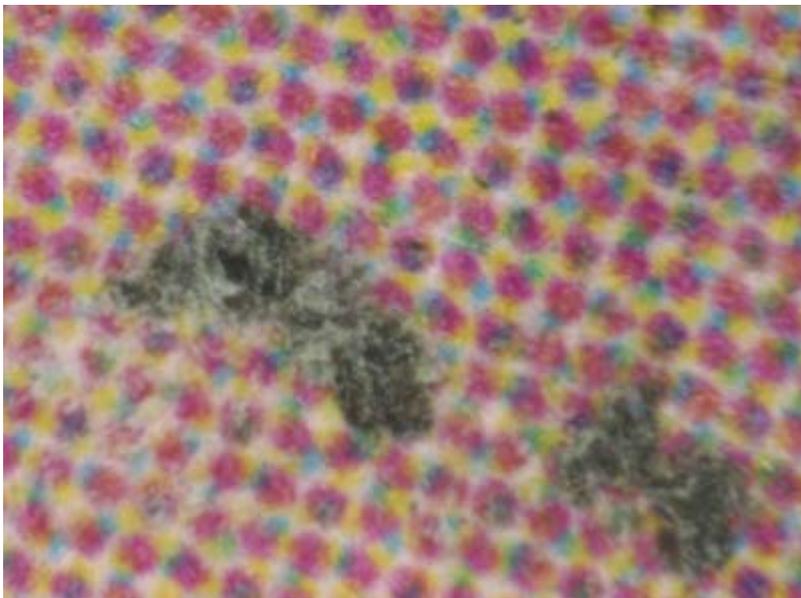
Sample of contamination

When using paper contains paper dusts, the paper dust accumulate on the Pressure Roller Stripper Pawls.

The paper with back curl picks up the paper dust on the Pressure Roller Stripper Pawls, and pressed by the roller on the downstream peripherals.

**Step 1:** Remove the paper dust accumulated on the Pressure Roller Stripper Pawls using cloth.

**Step 2:** Print the following duplex image.

Solid image on the first side, white page on the second side

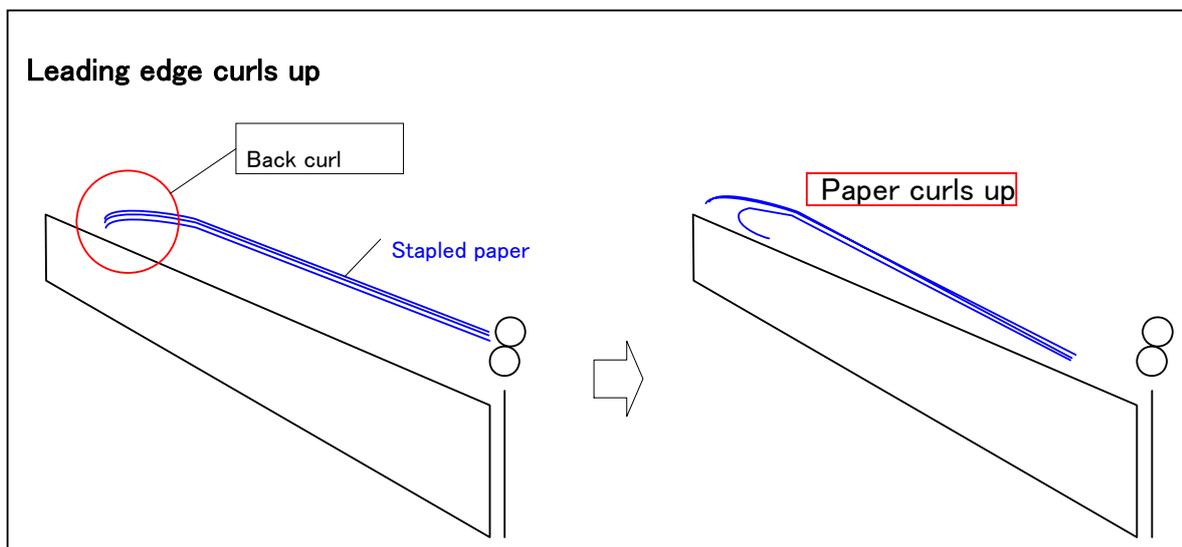
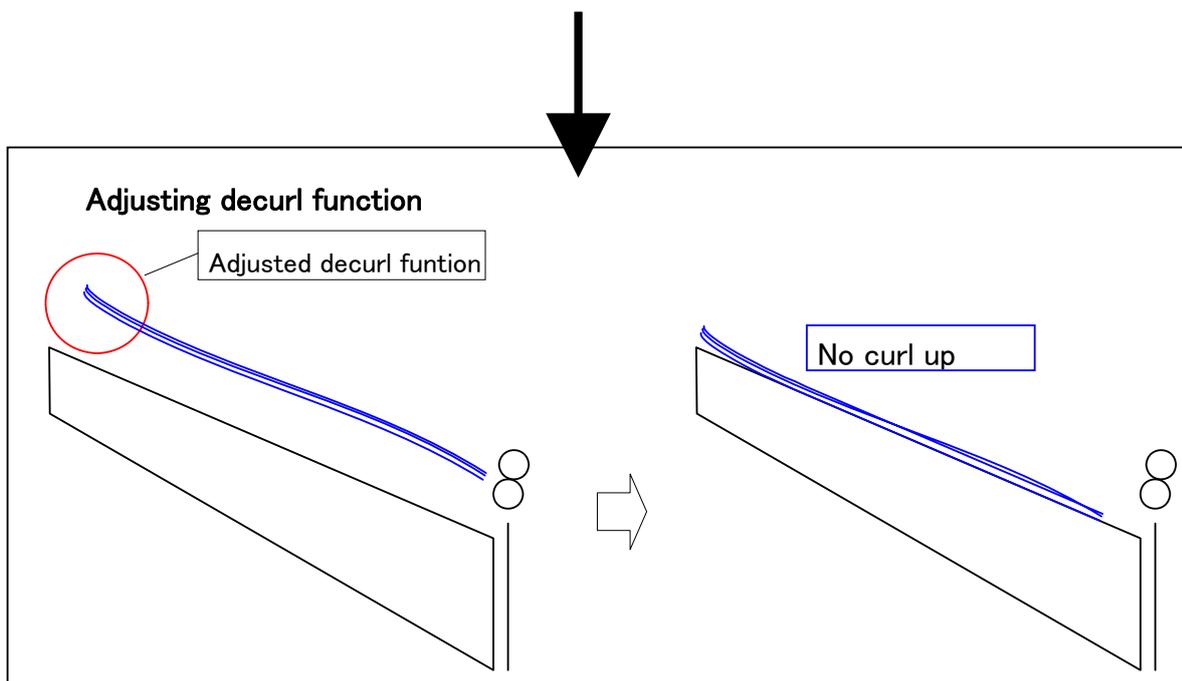
When the stapled paper stuck is exit from the finisher, if the paper is back curl, the leading edge of the papers contacts the shift tray and curled up.

**Step 1:** Check whether the paper is back curl, and if the Decurler Unit (DU5000) is attached.
