# Technical Bulletin

No.: RD016001j Date: 29-Jan-09

Subject: Firmware Release Note: Engine			Prepared by: H. Matsui	
From: PPBG Ser	vice Planning Dept.			
Classification:	Troubleshooting	Part informat	tion	Action required
	Mechanical	Electrical		Service manual revision
	Paper path	Transmit/rec	eive	Retrofit information
	Product Safety	🛛 Other (	)	Tier 2

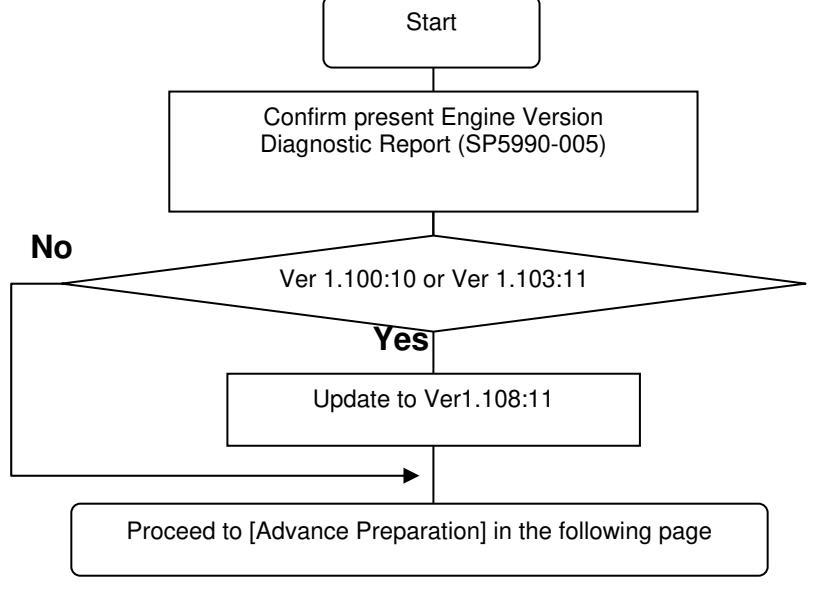
operation panel, and the machine will stop. As replacement of the BCU board will be required to resolve this error, please ensure to follow this correct procedure.

#### (\*1) WatchDogTimeOut ERROR

While the software timer resets the hardware timer in a certain interval, WatchDogTimeOut error occurs when this reset is not executed after a lapse of time specified and the hardware timer reaching a time-out state. This problem has been confirmed with versions 1.100:10 and 1.103:11 and has been resolved from 1.108:11. Hence firmware is updated in the particular order mentioned in above.

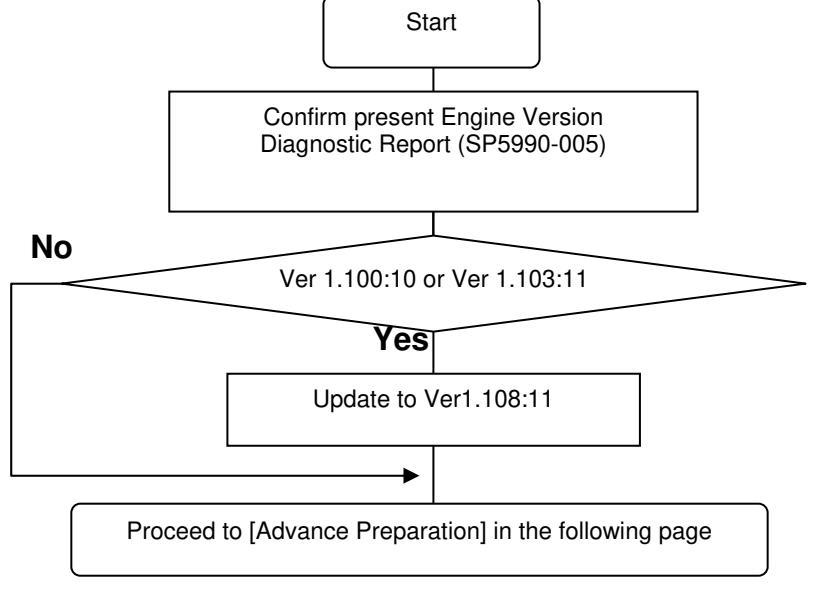
operation panel, and the machine will stop. As replacement of the BCU board will be required to resolve this error, please ensure to follow this correct procedure.

#### (\*1) WatchDogTimeOut ERROR

While the software timer resets the hardware timer in a certain interval, WatchDogTimeOut error occurs when this reset is not executed after a lapse of time specified and the hardware timer reaching a time-out state. This problem has been confirmed with versions 1.100:10 and 1.103:11 and has been resolved from 1.108:11. Hence firmware is updated in the particular order mentioned in above.

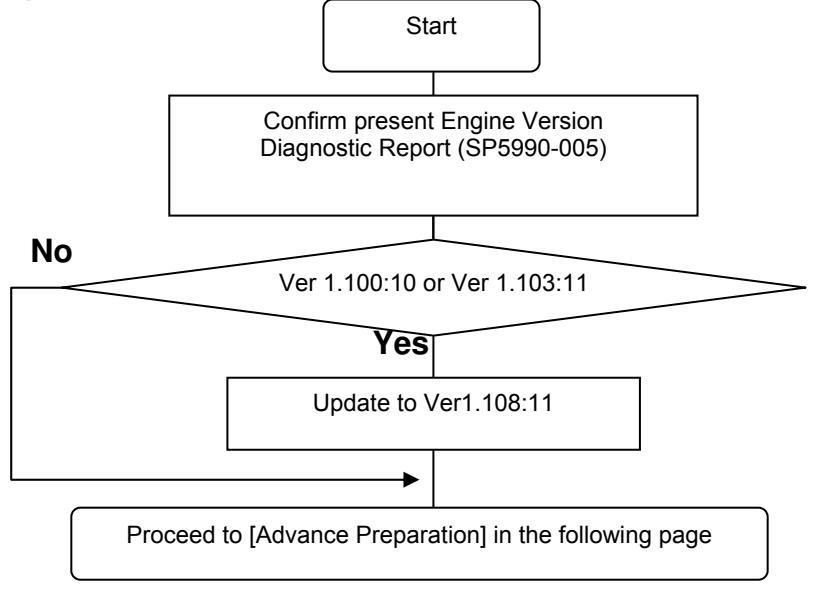
1.103:11, WatchDogTimeOut ERROR(\*1) could occur resulting in a non-functioning of the operation panel, and the machine will stop. As replacement of the BCU board will be required to resolve this error, please ensure to follow this correct procedure.

#### (\*1) WatchDogTimeOut ERROR

While the software timer resets the hardware timer in a certain interval, WatchDogTimeOut error occurs when this reset is not executed after a lapse of time specified and the hardware timer reaching a time-out state. This problem has been confirmed with versions 1.100:10 and 1.103:11 and has been resolved from 1.108:11. Hence firmware is updated in the particular order mentioned in above.

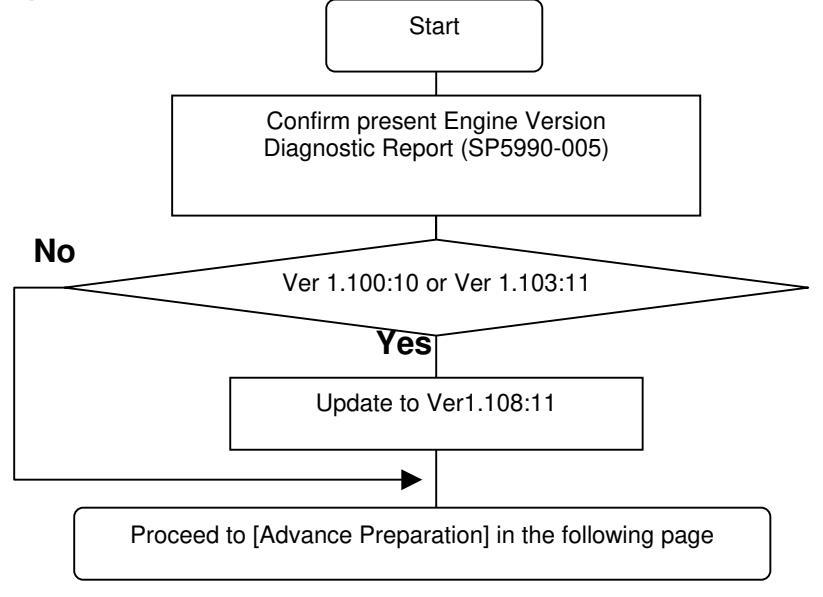
operation panel, and the machine will stop. As replacement of the BCU board will be required to resolve this error, please ensure to follow this correct procedure.

#### (\*1) WatchDogTimeOut ERROR

While the software timer resets the hardware timer in a certain interval, WatchDogTimeOut error occurs when this reset is not executed after a lapse of time specified and the hardware timer reaching a time-out state. This problem has been confirmed with versions 1.100:10 and 1.103:11 and has been resolved from 1.108:11. Hence firmware is updated in the particular order mentioned in above.

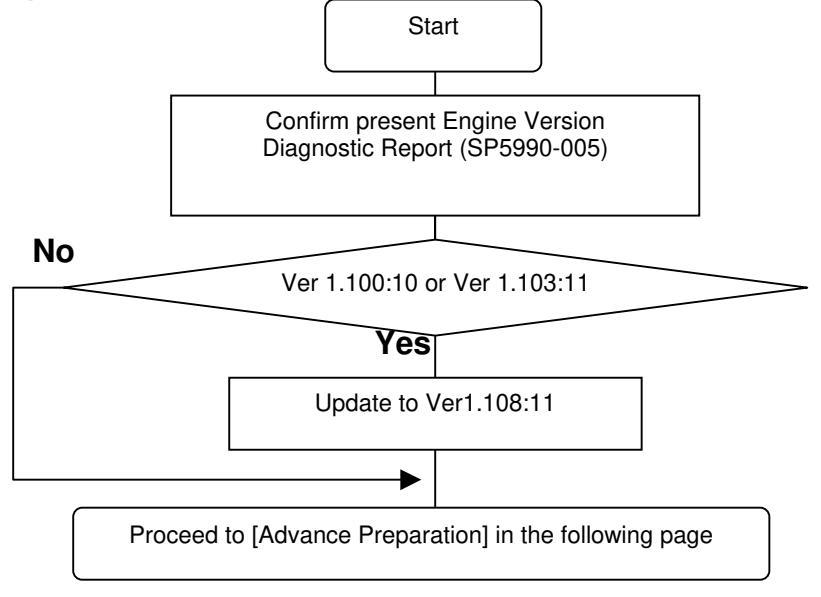
operation panel, and the machine will stop. As replacement of the BCU board will be required to resolve this error, please ensure to follow this correct procedure.

#### (\*1) WatchDogTimeOut ERROR

While the software timer resets the hardware timer in a certain interval, WatchDogTimeOut error occurs when this reset is not executed after a lapse of time specified and the hardware timer reaching a time-out state. This problem has been confirmed with versions 1.100:10 and 1.103:11 and has been resolved from 1.108:11. Hence firmware is updated in the particular order mentioned in above.

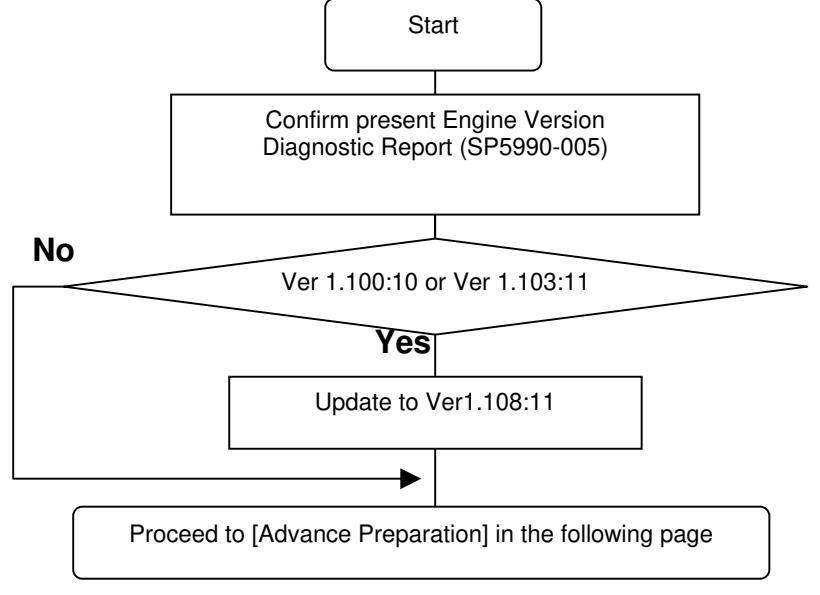
operation panel, and the machine will stop. As replacement of the BCU board will be required to resolve this error, please ensure to follow this correct procedure.

#### (\*1) WatchDogTimeOut ERROR

While the software timer resets the hardware timer in a certain interval, WatchDogTimeOut error occurs when this reset is not executed after a lapse of time specified and the hardware timer reaching a time-out state. This problem has been confirmed with versions 1.100:10 and 1.103:11 and has been resolved from 1.108:11. Hence firmware is updated in the particular order mentioned in above.

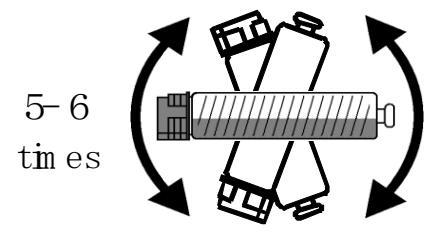
When replacing with a toner bottle that has been stored for a long period of time, the toner is stiffened and causes an increase in the initial rotation torque.

- 1) Upon machine installation and PM/EM visits, please be sure to advise the Operators to **shake** the bottle thoroughly as in the diagram below whenever installing a new toner bottle (initial machine installation, toner near-end).
- \* The swinging motion should reach 90 degrees from horizontal.
- 2) As the same symptom could occur with toner bottles installed in the machine if the machine is left unused for a long period of time, again shaking of the bottle will resolve the problem.

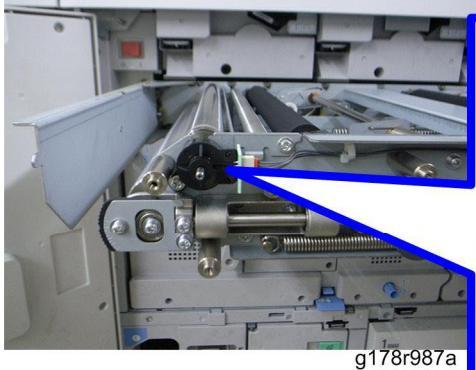
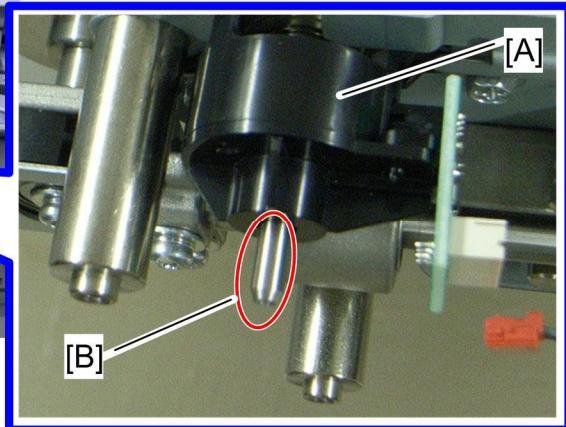
g178r881

1. Do not hold the encoder unit (black case) [A] when reinstalling the encoder roller with the encoder unit. Hold the shaft [B] of the encoder roller.

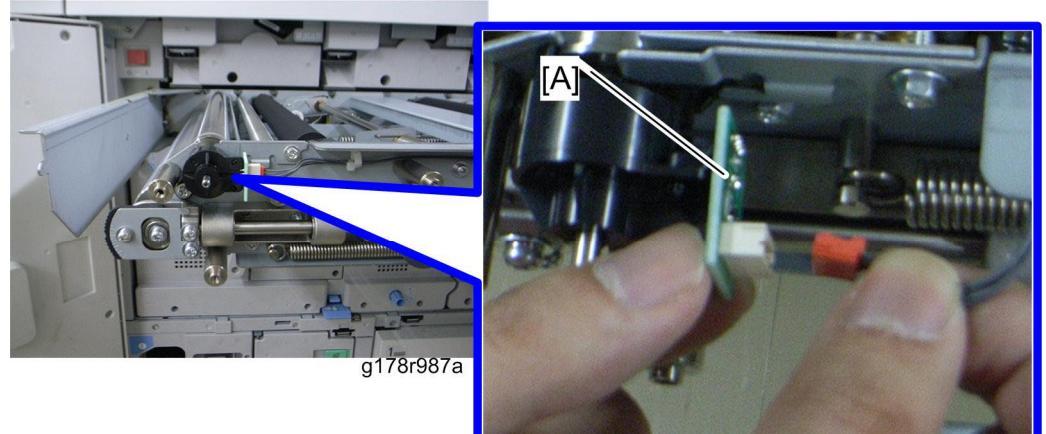
g178r882

2. Hold the sensor board [A] with your fingers when connecting the harness. Otherwise, the belt speed sensor may come off from the sensor board and the machine may not detect the belt speed correctly.

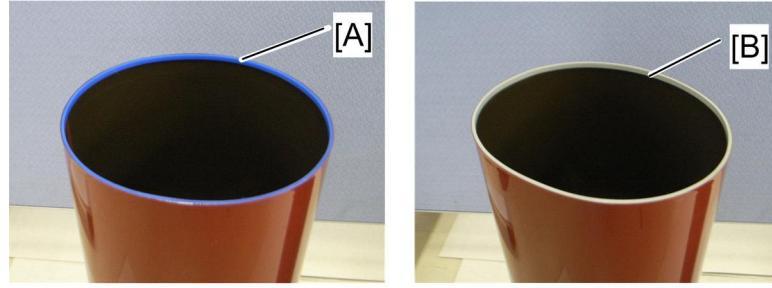
g178r525

- When installing a new fusing belt, make sure that the new fusing belt is installed with its blue rim [A] facing the front side and the gray rim [B] facing the rear side.
- On page 505

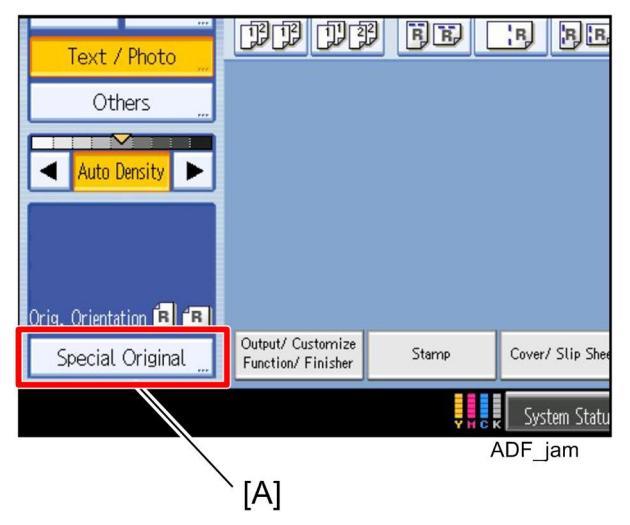
The custom size original fed from the ADF catches up with the previously fed original, and then the original is stuck at the exposure glass.

Change the setting of "Special Original ..." to "Mixed Sizes".

- 1. Press the "Special Original ..." button [A] on the LCD.
- 2. Select "Mixed Sizes", and then press the "OK" button.

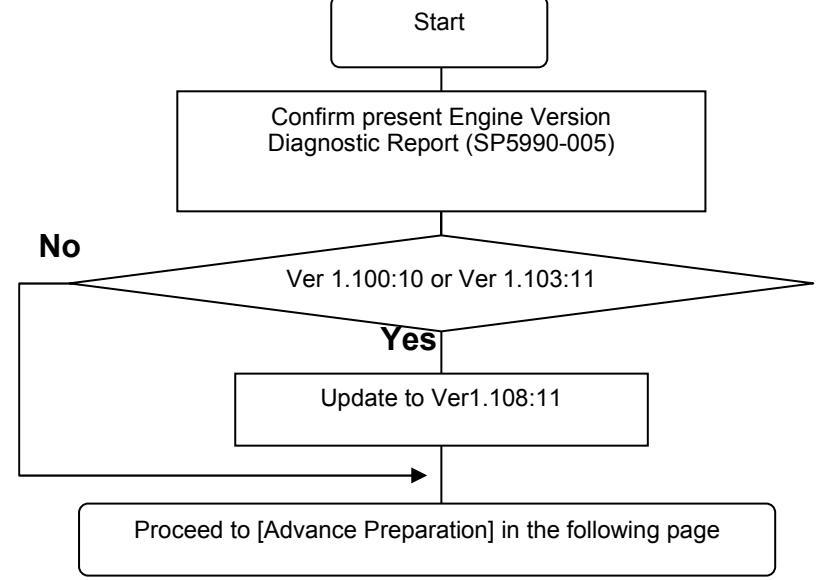
NOTE: This problem will not occur with the Aegis-C1.

(\*1) WatchDogTimeOut ERROR

While the software timer resets the hardware timer in a certain interval, WatchDogTimeOut error occurs when this reset is not executed after a lapse of time specified and the hardware timer reaching a time-out state. This problem has been confirmed with versions 1.100:10 and 1.103:11 and has been resolved from 1.108:11. Hence firmware is updated in the particular order mentioned in above.

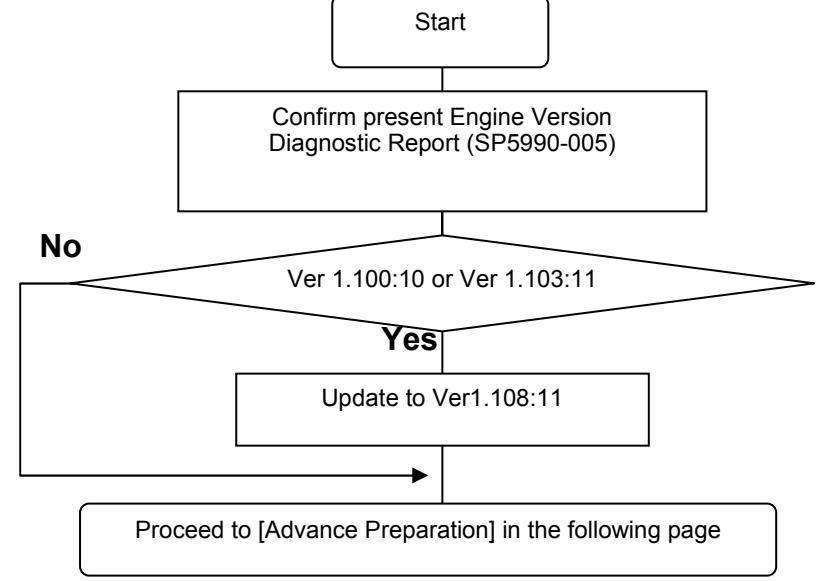
NOTE: This problem will not occur with the Aegis-C1.

(\*1) WatchDogTimeOut ERROR

While the software timer resets the hardware timer in a certain interval, WatchDogTimeOut error occurs when this reset is not executed after a lapse of time specified and the hardware timer reaching a time-out state. This problem has been confirmed with versions 1.100:10 and 1.103:11 and has been resolved from 1.108:11. Hence firmware is updated in the particular order mentioned in above.

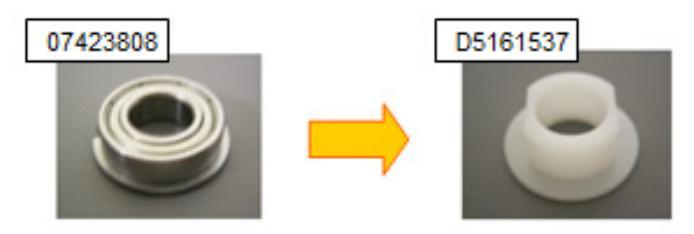
**Change:** Bearing and the shape of the accompanying plates **Reason:** To share common parts with the LCIT RT5060 (D516)

1, The bearing was changed as shown in the photo below.

• Make sure all 3 parts shown in the above table are replaced as a set.

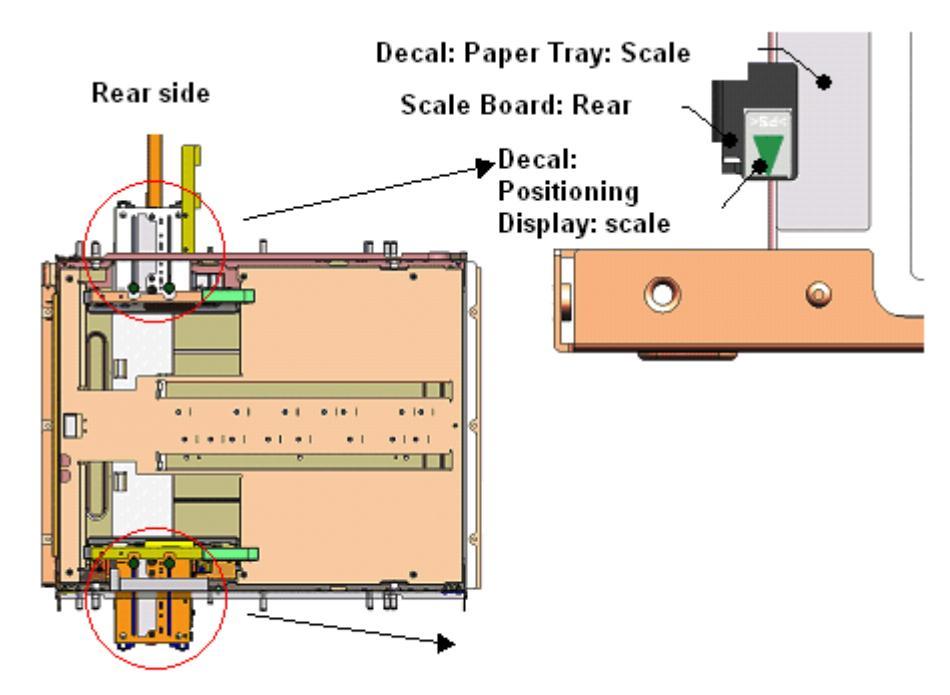
View of the LCT from the top

This RTB has been issued to announce the changes in the LCT, which need to be replaced as a set

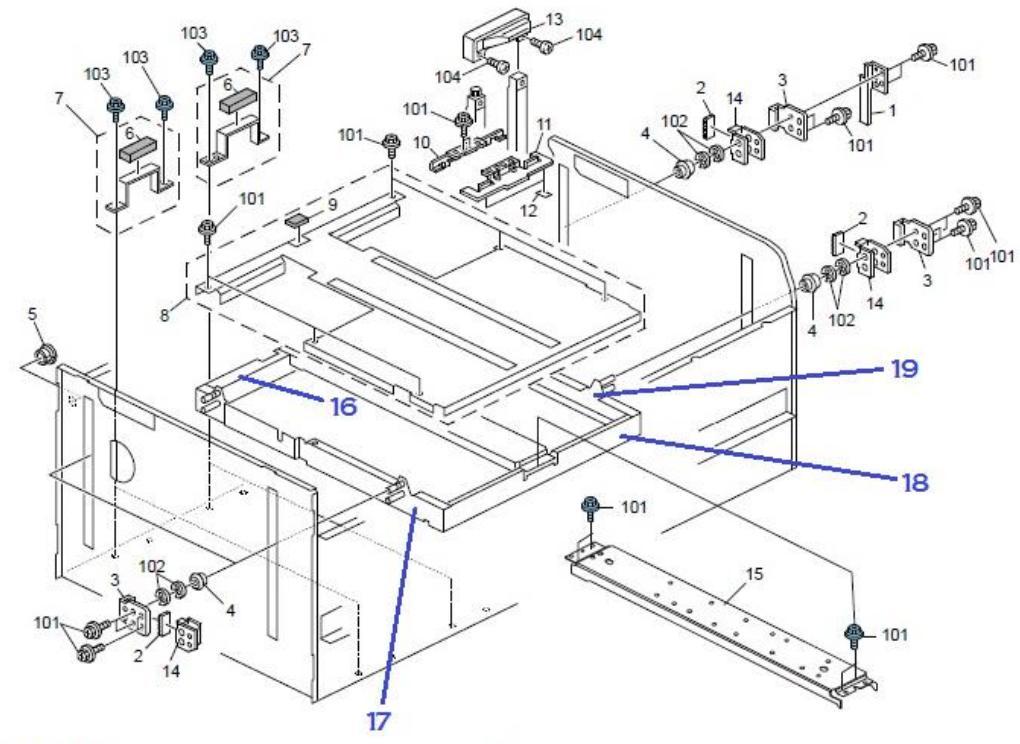
127.Paper Tray 4 (D016/D097)

Old Part Number	New Part Number	Description	Q'ty	Int	Page	Index	Note
-	D3554618	STAY:LEFT:PAPER TRAY	1	-	272	16	Add
-	D4534612	STAY:PAPER TRAY: BASE: FRONT:PEEN	1	-	272	17	Add
-	D3554615	STAY:RIGHT:PAPER TRAY: PEEN	1	-	272	18	Add
-	D4534616	STAY:PAPER TRAY:BASE: REAR:PEEN	1	-	272	19	Add

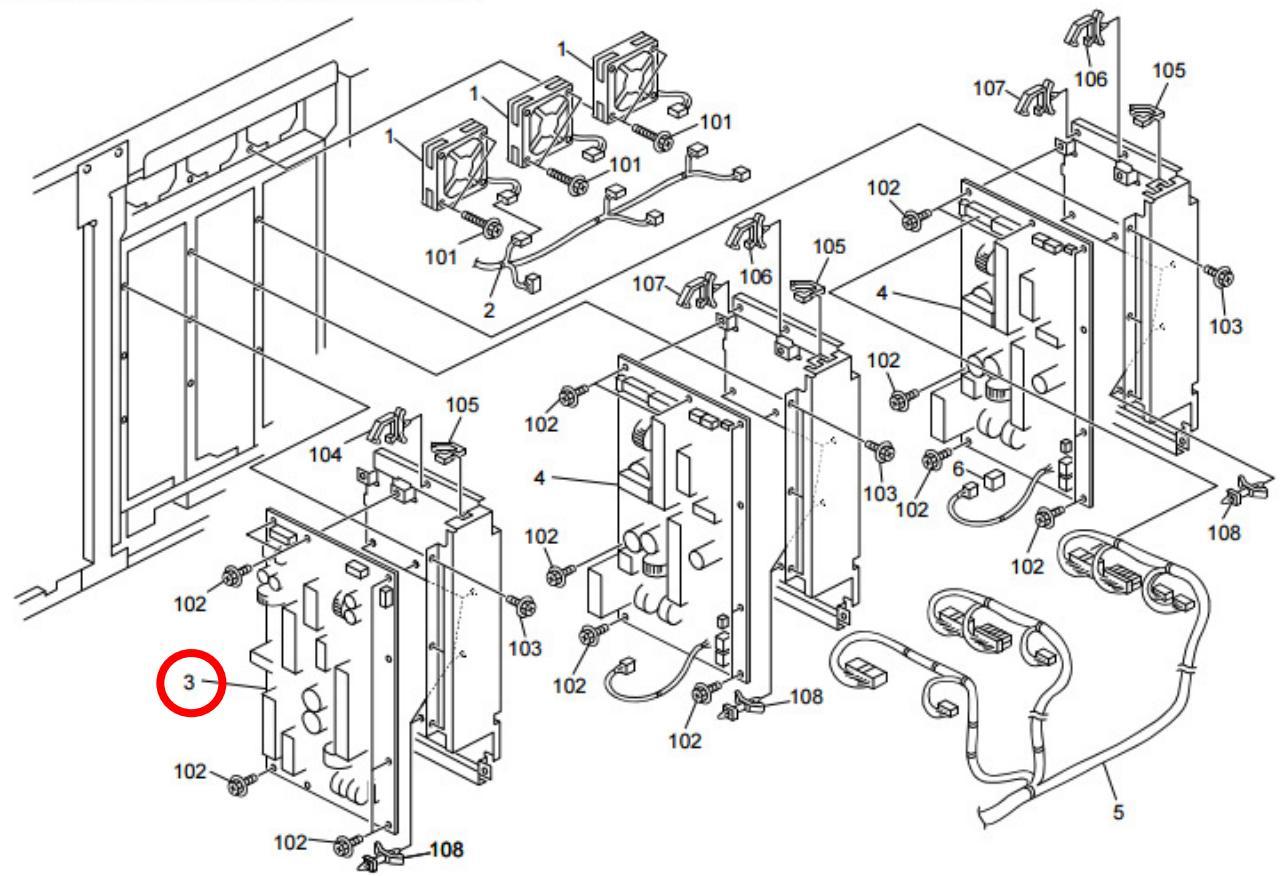
#### 91.Electrical Section 11 (D016/G178)

Old Part Number	New Part Number	Description		Int	Page	Index	Note
AZ250047	AZ250046	POWER SUPPLY UNIT:BC3:ENGINE-B	1	O/O	200	3	Change
