Model: AGL-C1	Date: 15-Jan-10	No.: RD097001d
---------------	-----------------	----------------

Subject: Firmware Release Note: Engine		Prepared by: H.kawamura	
From: PPBG Service Planning Dept.			
Classification:	<input type="checkbox"/> Troubleshooting <input type="checkbox"/> Mechanical <input type="checkbox"/> Paper path <input type="checkbox"/> Product Safety	<input type="checkbox"/> Part information <input type="checkbox"/> Electrical <input type="checkbox"/> Transmit/receive <input checked="" type="checkbox"/> Other (Firmware)	<input type="checkbox"/> Action required <input type="checkbox"/> Service manual revision <input type="checkbox"/> Retrofit information <input type="checkbox"/> Tier 2

Model: AGL-P1/C1		Date: 21-Jan-10	No.: RM078003
Subject: Notice of exclusive parts for AGL-P1/C1		Prepared by: N.iida	
From: PPBG Service Planning Dept.			
Classification:	<input type="checkbox"/> Troubleshooting <input type="checkbox"/> Mechanical <input type="checkbox"/> Paper path <input type="checkbox"/> Product Safety	<input checked="" type="checkbox"/> Part information <input type="checkbox"/> Electrical <input type="checkbox"/> Transmit/receive <input type="checkbox"/> Other ()

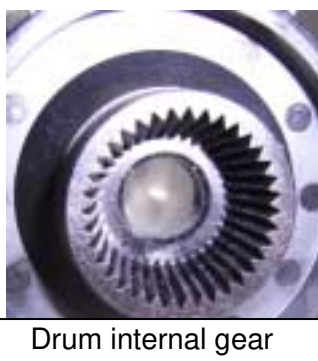
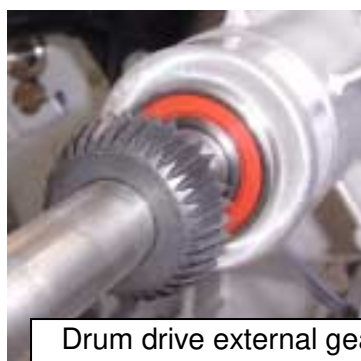
Not properly engaged

Drum internal gear

Drum drive external gear

When the gears are not engaged properly, the drum cleaning unit pushes the drum towards the direction in which the PG is narrowed. Printing in this condition will cause toner to adhere to the development rollers and generate scratches on the drum surface.

If the development unit is not correctly installed, pull out the PCDU and slightly reposition the drum so that the internal and external gears are engaged properly.

Do not attempt to forcefully fasten the (cross-shaped) drawer stop knob by shoving in the unit. Doing so will NOT help install the unit completely but will only damage the teeth of the internal gear.

If the above SC occurs and heavy scratches are observed on the drum surface, replace the drum with a new one.

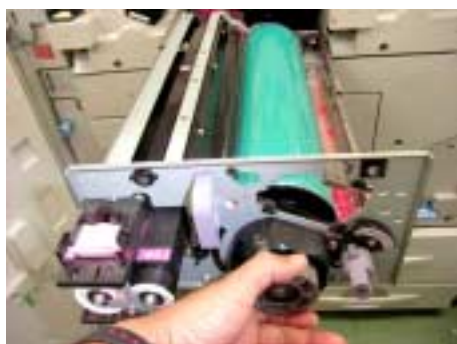
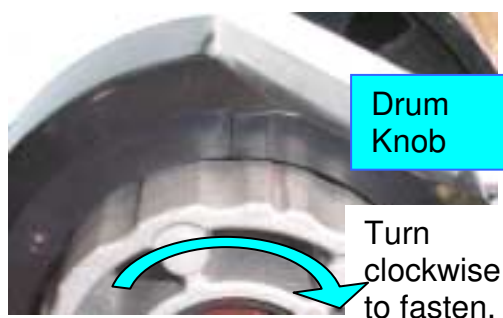
Do NOT fasten the drum knob when the development unit is installed.
Do NOT fasten the drum knob when the drum cleaning unit is installed.

Fastening the drum knob with the drum cleaning unit installed will cause the drum cleaning unit to apply pressure to the drum and narrow the PG at the front side.

If the drum knob is loosened with the drum cleaning unit installed, make sure to remove the drum cleaning unit, and then fasten the knob.

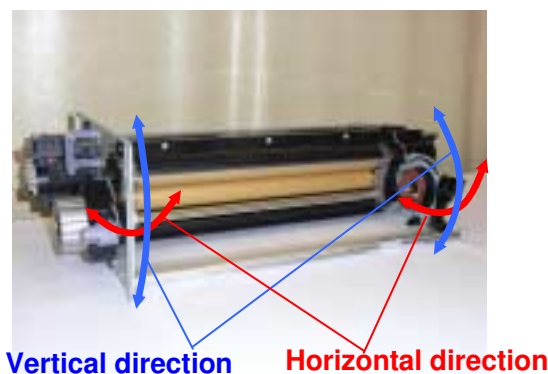
Applying external pressure will deform the front and rear plates in vertical and horizontal directions, resulting in fluctuation of the PG.

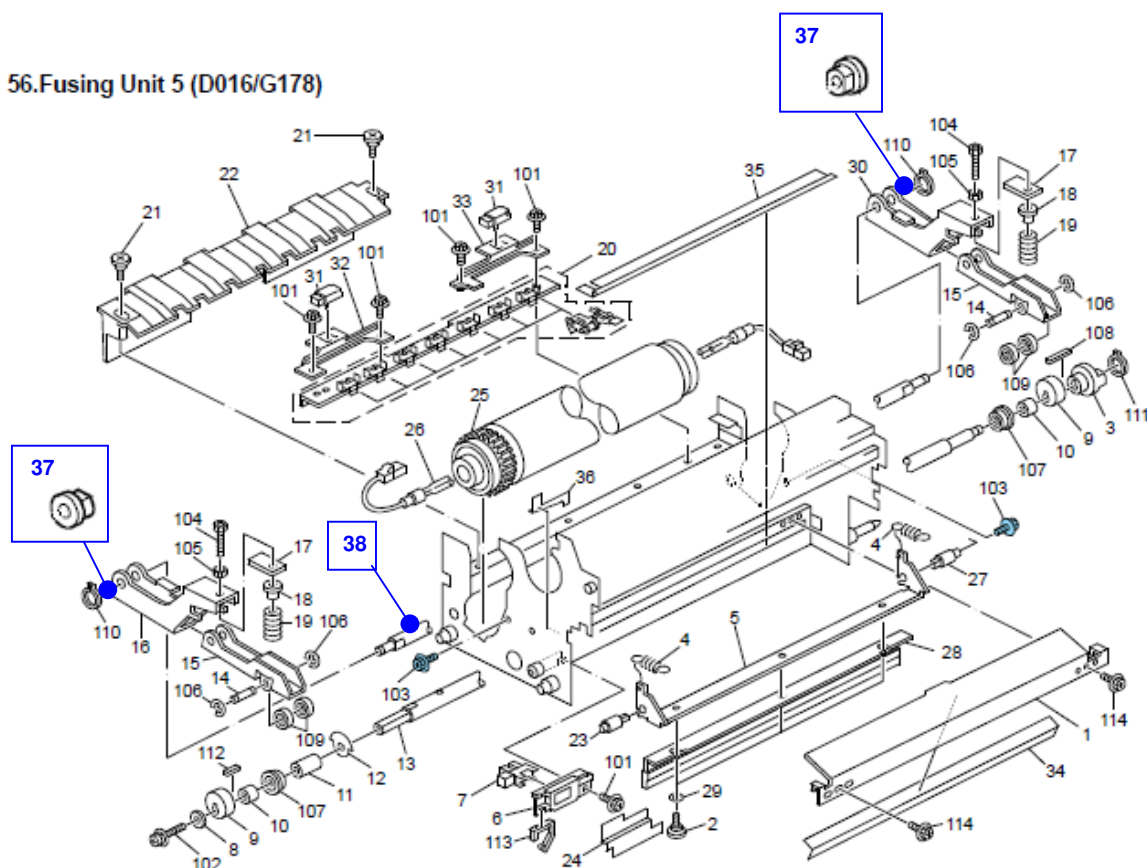
56.Fusing Unit 5 (D016/G178)

*1) Parts indexed 37 and 38 are service parts newly added for the modified fusing unit.

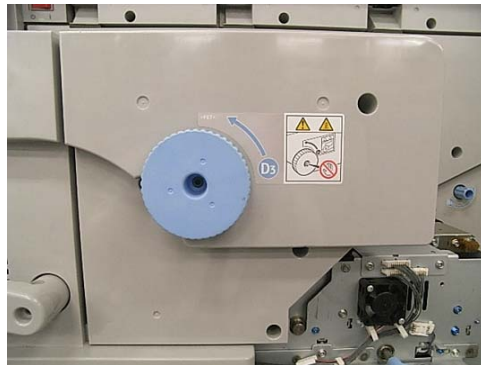
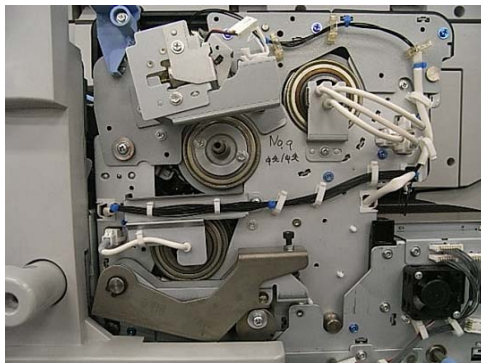
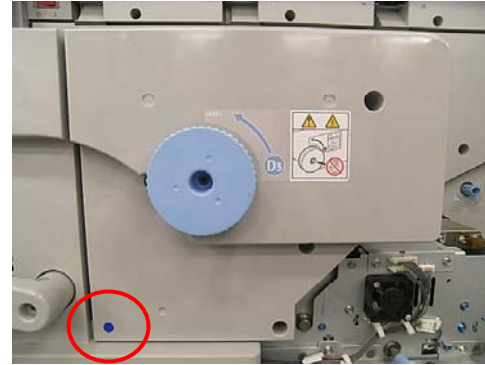
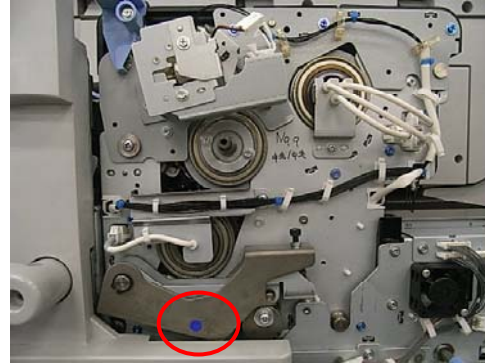
1. Fusing unit

Although the units can be distinguished by the p/n indicated on the packaging boxes, it could be tricky after the units are installed in the mainframe. To enable distinction, the modified units are marked with blue stickers on the cover and the arm as shown in the photos above.

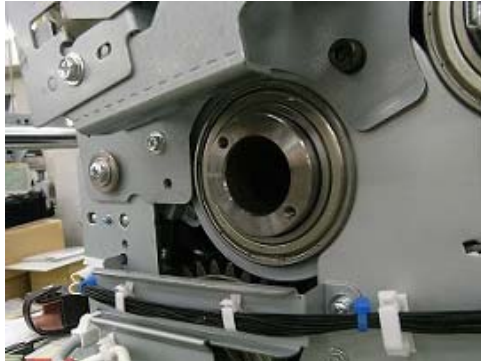
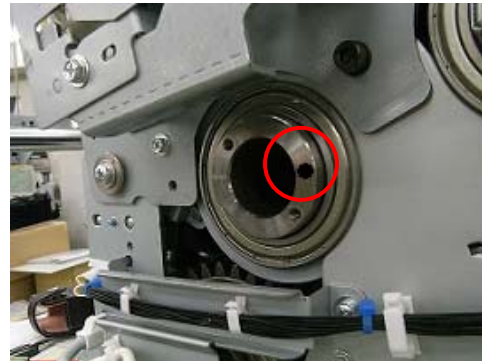
2. Hot Roller

The modified fusing unit is marked with a blue sticker on the outer ring of the hot roller, which becomes visible by removing the fusing knob.

* Do NOT attempt to install the hardened hot roller in a standard fusing unit, and vice versa.
Nip width and relative properties will not meet their target values and could result in jams, SCs, and image problems.

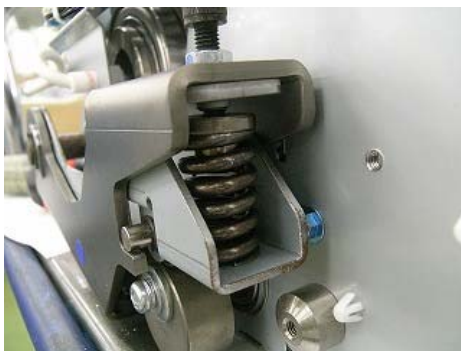
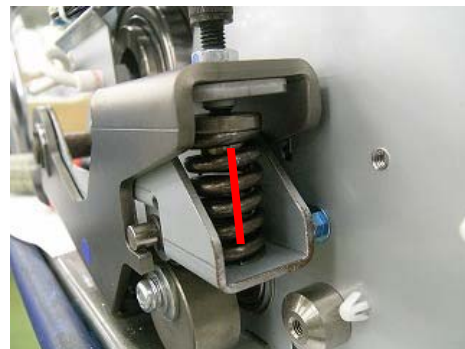
3. Pressure Spring

The pressure spring in the modified fusing unit has a marking along the side.

* The pressure spring does not require periodical replacement.

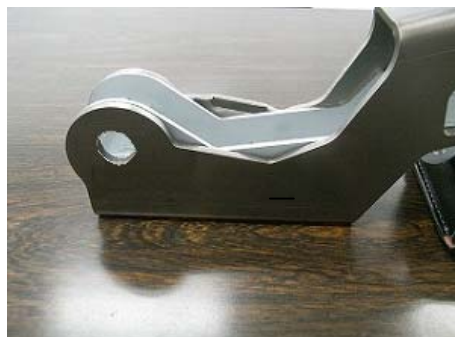
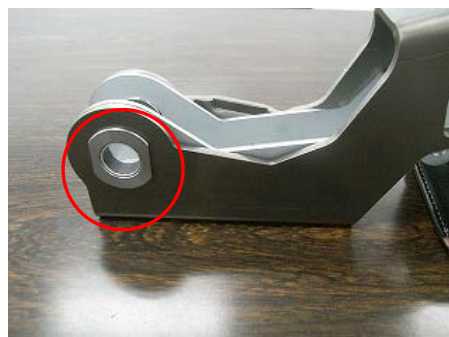
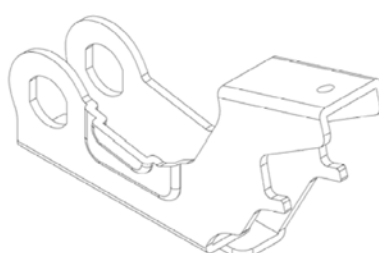
4. Pressure Arm

The arm for the standard unit is not durable enough to operate the modified unit and will cause the shaft to wear. The arm for the modified unit made of thicker plate is installed with a bushing to prevent wear and also has a different shape.

* The pressure arm does not require periodical replacement.

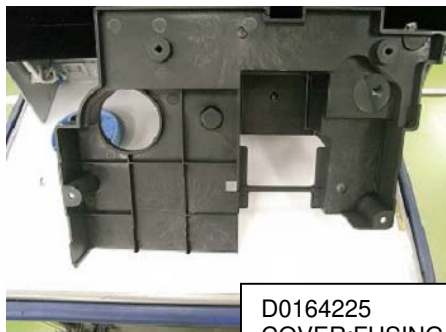
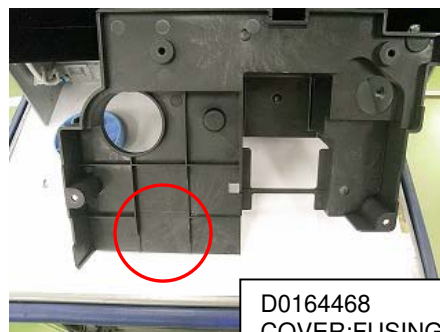
5. Rear Cover

To avoid contact between the ribs on the cover and the pressure arm caused by the shape change of the pressure arm, the ribs on the cover have been partially removed.

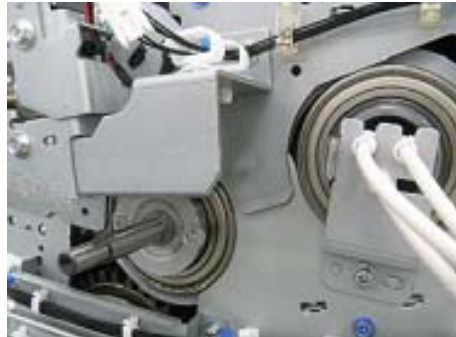
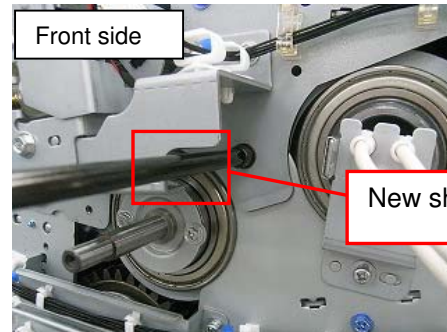
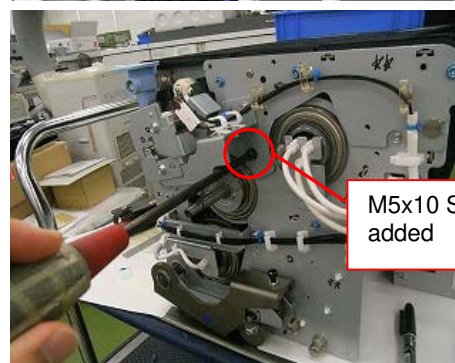
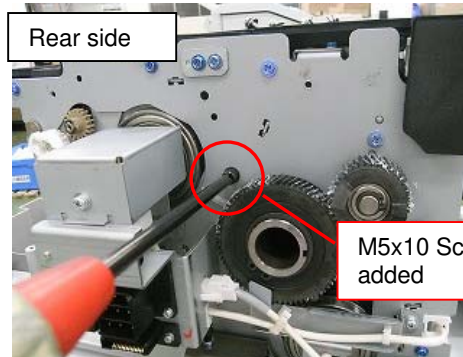
6. Addition of Securing Screws

M5x10 Screw newly added

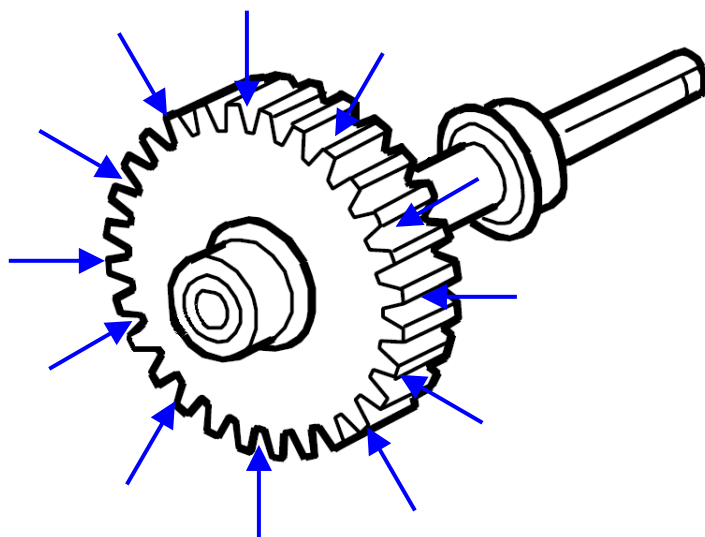
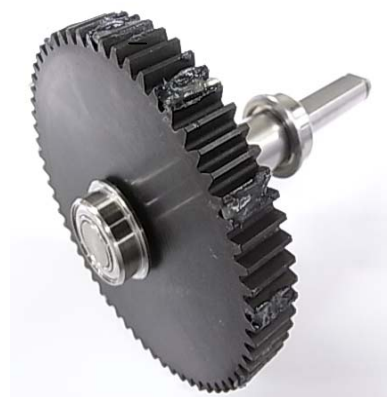
Tip 1

This gear lifts and lowers the pressure roller. The modified fusing unit will not only apply more stress to this gear but may also cause it to break due to abrasion and fatigue considering the higher pressure applied when the pressure and hot rollers are in contact, hence periodical replacement of this gear is required.

NOTE: All the teeth of gear (p/n G1781491) must be applied with 1g of Alvania Grease (p/n G1552876) upon replacement.

Divide 1g of grease equally to 12 locations on the teeth. Rotation of the gear will then distribute the grease evenly and thoroughly.

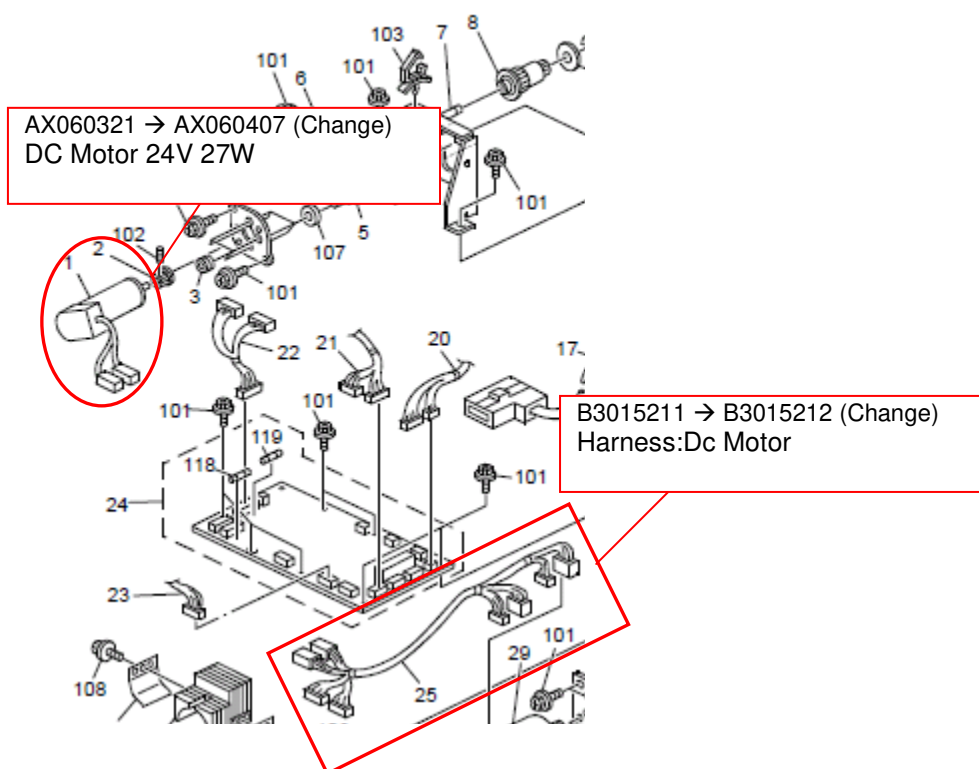
114.ADF 9 (D095)

Reason: The factory of the motor has changed; the harness connecting the motor needs to be replaced together with the motor.

NOTE: Motor and Harness need to be replaced as a set.
 Motor and Harness interchangeability is X/X individually, and O/O.as a set.
 This change has been applied from 2011 November production.
 This change is also applied to ProC900S, ProC720S
