Model: AGL-P1	Date: 15-Jan-10	No.: RM078001d
---------------	-----------------	----------------

Subject: Firmware Release Note: Engine		Prepared by: H.kawamura	
From: PPBG Service Planning Dept.			
Classification:	<input type="checkbox"/> Troubleshooting	<input type="checkbox"/> Part information	<input type="checkbox"/> Action required
	<input type="checkbox"/> Mechanical	<input type="checkbox"/> Electrical	<input type="checkbox"/> Service manual revision
	<input type="checkbox"/> Paper path	<input type="checkbox"/> Transmit/receive	<input type="checkbox"/> Retrofit information
	<input type="checkbox"/> Product Safety	<input checked="" type="checkbox"/> Other (Firmware)	<input type="checkbox"/> Tier 2

Model: AGL-P1/C1		Date: 21-Jan-10	No.: RM078003
Subject: Notice of exclusive parts for AGL-P1/C1		Prepared by: N.iida	
From: PPBG Service Planning Dept.			
Classification:	<input type="checkbox"/> Troubleshooting	<input checked="" type="checkbox"/> Part information	<input type="checkbox"/> Action required
	<input type="checkbox"/> Mechanical	<input type="checkbox"/> Electrical	<input type="checkbox"/> Service manual revision
	<input type="checkbox"/> Paper path	<input type="checkbox

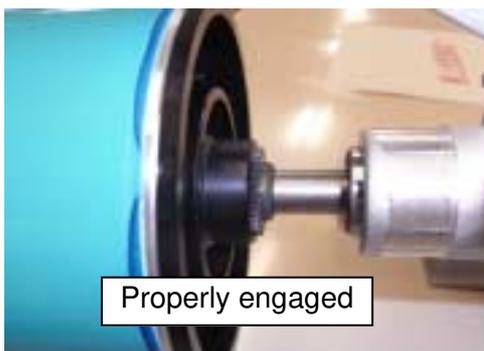
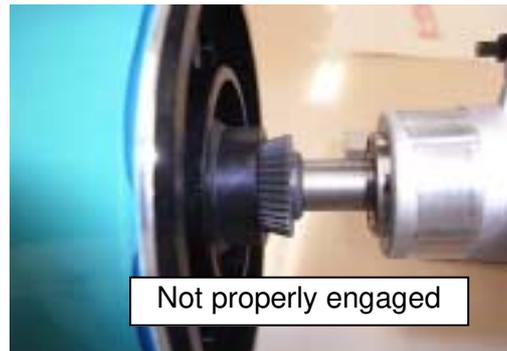
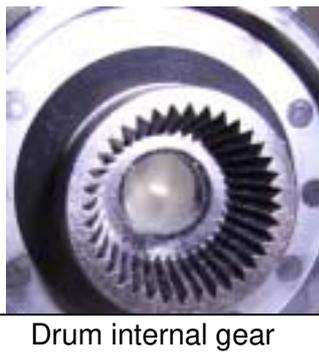
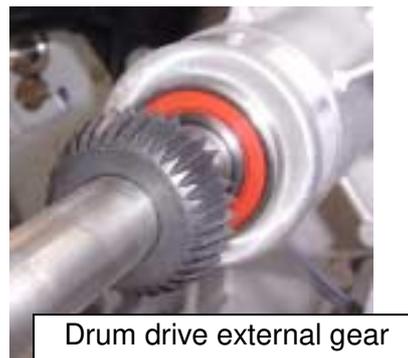
The surface of the knob is clearly protruding against the adjacent area (black-colored) and the screw holes are sunk in and are not clearly visible, as shown in the photos above. In this case, the unit is bounced back towards the front side because the drum internal and drum drive external gears are not properly engaged as shown below.

If the development unit is not correctly installed, pull out the PCDU and slightly reposition the drum so that the internal and external gears are engaged properly.

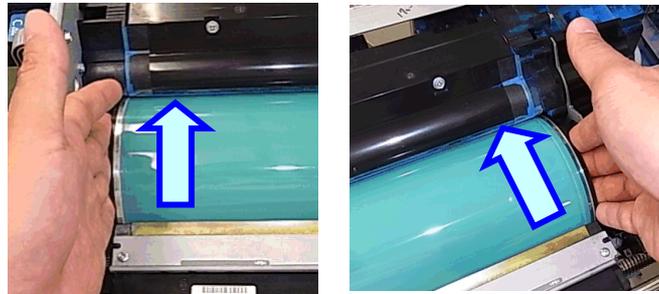
Do not attempt to forcefully fasten the (cross-shaped) drawer stop knob by shoving in the unit. Doing so will NOT help install the unit completely but will only damage the teeth of the internal gear.

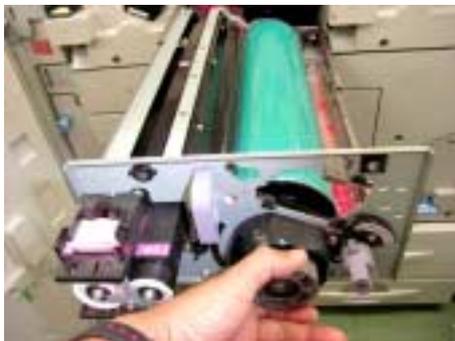
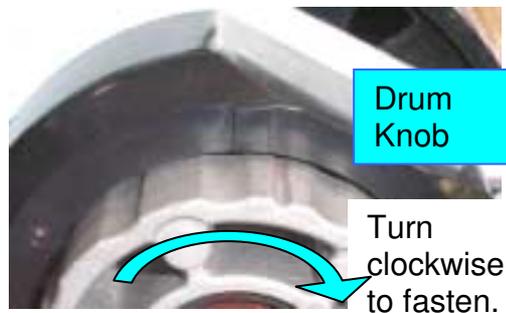
Do NOT fasten the drum knob when the development unit is installed.
Do NOT fasten the drum knob when the drum cleaning unit is installed.

Fastening the drum knob with the drum cleaning unit installed will cause the drum cleaning unit to apply pressure to the drum and narrow the PG at the front side.

If the drum knob is loosened with the drum cleaning unit installed, make sure to remove the drum cleaning unit, and then fasten the knob.

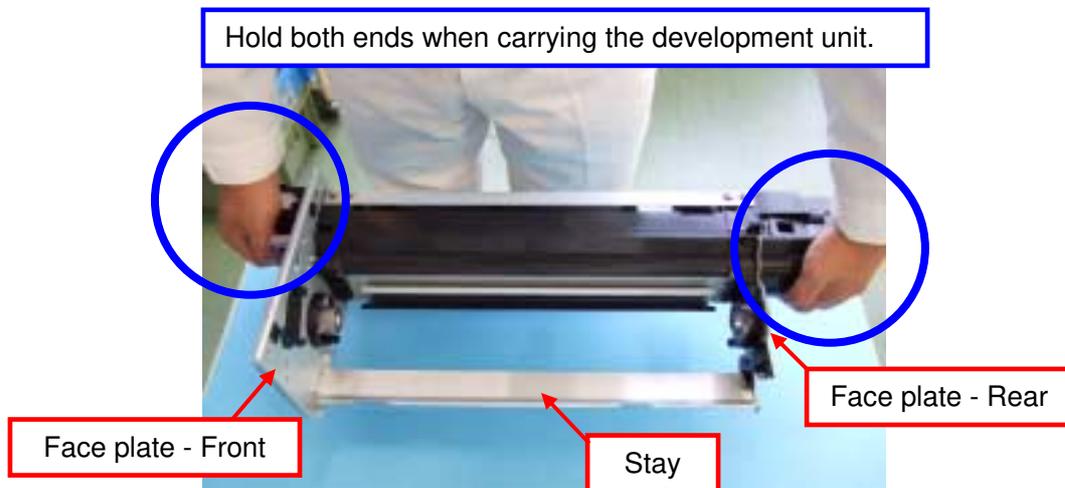
Do not grip the face plates or the stay.

Applying external pressure will deform the front and rear plates in vertical and horizontal directions, resulting in fluctuation of the PG.

- Always hold the prescribed locations when handling the development unit.
- Never apply external pressure to the front and rear plates and the stay.

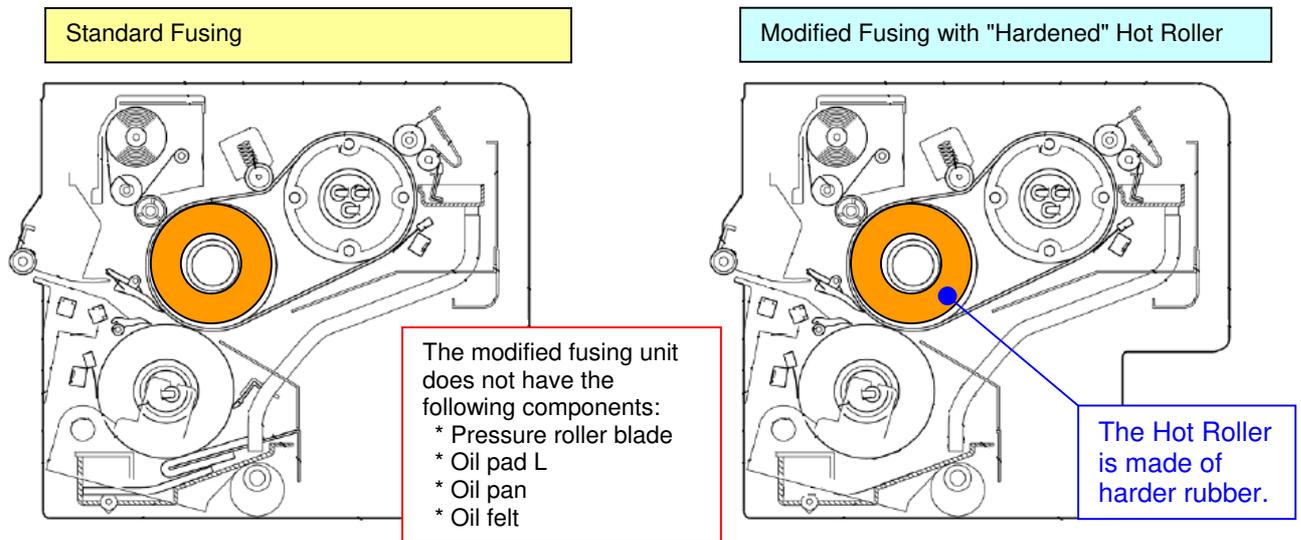
Main Modified Points

Current Fuser	Modified Fuser	Remarks
Hardness of the Hot Roller	42±3 (LTV)	55+3/-2 (HTV)	Measuring device: Asker C
Surface pressure (N/cm ²)	39.4	54.2	+37%
Nip width (mm)			
L	19.25	18.25	
M	17.75	16.75	
S	16.25	15.25	
Pressure roller blade	Included	Eliminated	Reduced torque
Oil pad			
Oil pan L			
Oil felt

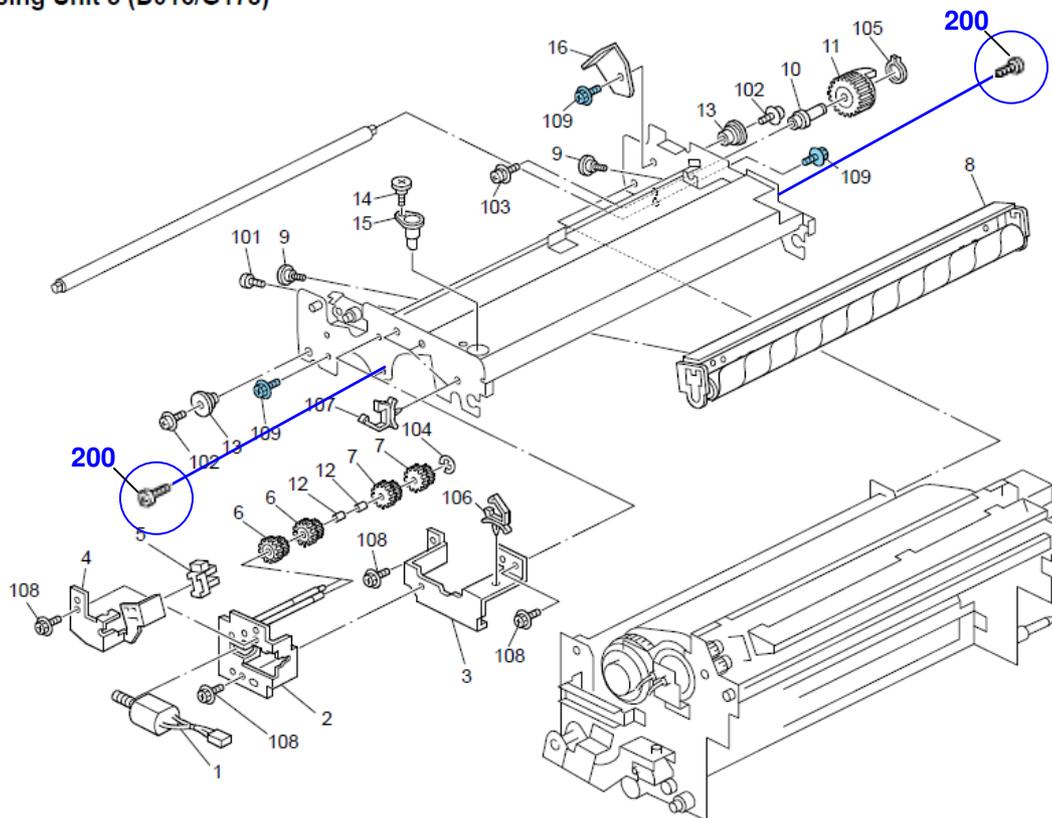
54.Fusing Unit 3 (D016/G178)

*2) The screws indexed 200 have been added to the locations shown in the diagram below in the modified fusing unit.

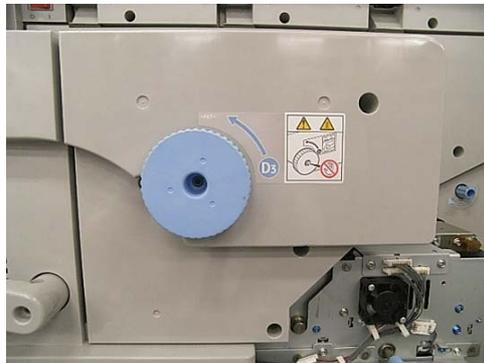
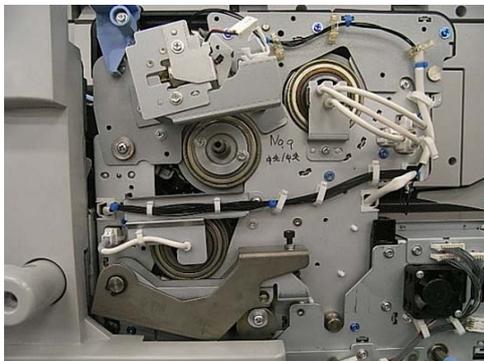
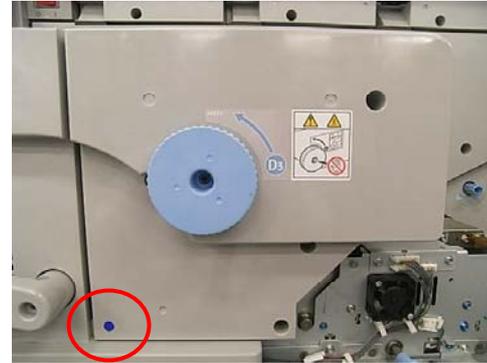
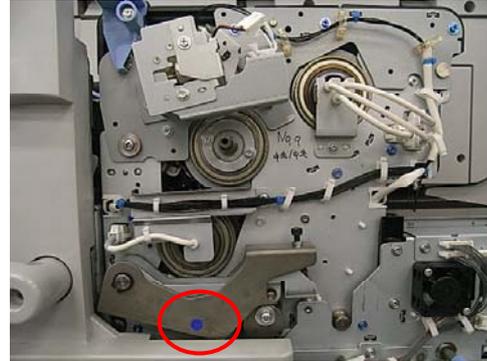
Although the units can be distinguished by the p/n indicated on the packaging boxes, it could be tricky after the units are installed in the mainframe. To enable distinction, the modified units are marked with blue stickers on the cover and the arm as shown in the photos above.

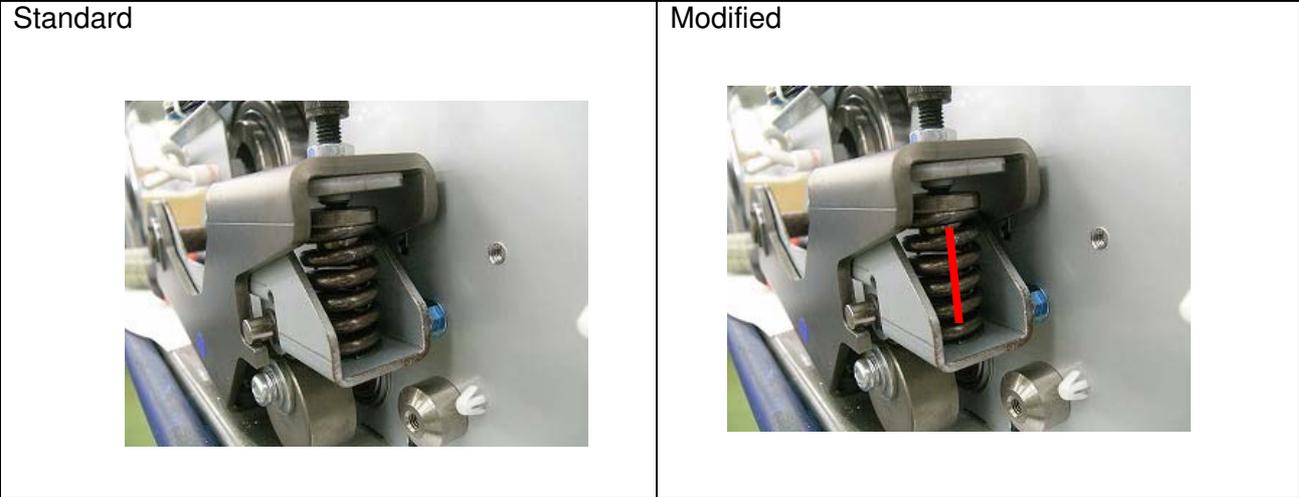
3. Pressure Spring

The pressure spring in the modified fusing unit has a marking along the side.

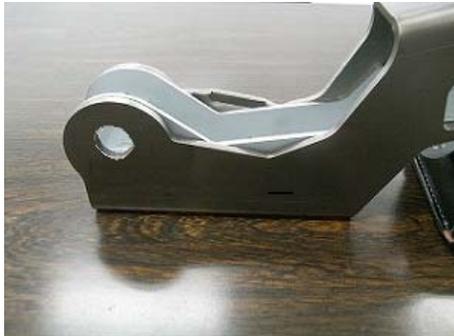
4. Pressure Arm

The arm for the standard unit is not durable enough to operate the modified unit and will cause the shaft to wear. The arm for the modified unit made of thicker plate is installed with a bushing to prevent wear and also has a different shape.

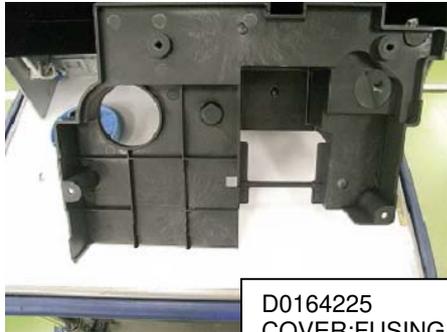
5. Rear Cover

To avoid contact between the ribs on the cover and the pressure arm caused by the shape change of the pressure arm, the ribs on the cover have been partially removed.

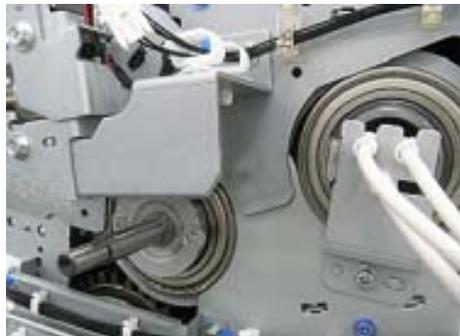
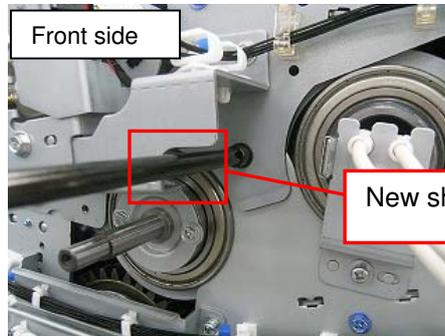
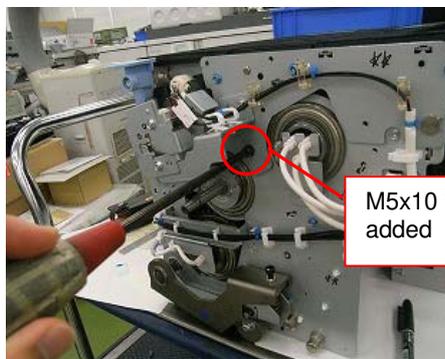
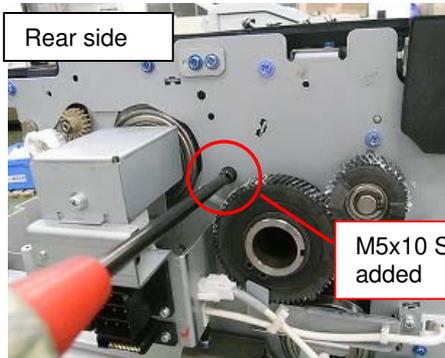
6. Addition of Securing Screws

Screws to attach the upper and lower frames have been newly added to secure higher durability of the entire unit and Bracket:Web:Drive(p/n:G1784354) has been changed in shape to allow easy access to the screw.

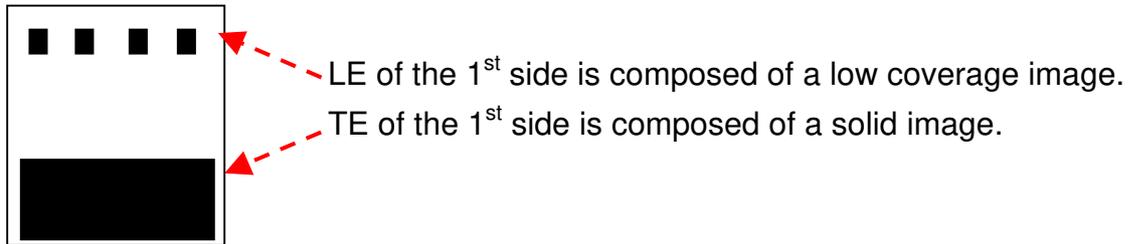
Issues	Cause	Solutions and Workarounds
4	<p>Gloss Residues: Pressure Roller</p> <p>If the LE on the 1st side contains a low coverage image and the TE on the 1st side contains a solid image (high coverage), the low coverage image on the LE could overlay on the TE while fusing the 2nd side (1st side is in contact with the pressure roller) under these conditions:</p> <ul style="list-style-type: none"> * Coated paper * 1 original fed in automatic duplex, or 1-3 original fed in manual duplex <p>The overlaid (residual) image will gradually become less noticeable over time.</p> <p><i>See additional explanation on the following page.</i></p> <p>LE: Leading edge TE: Trailing edge</p>	<ul style="list-style-type: none"> * Due to the elimination of the oil application components, oil is applied to the pressure roller via the fusing belt. Therefore, the first sheet fed attracts the largest amount of oil from the pressure roller while the amount of oil transferred to the following sheets gradually decreases. * When fusing the 2nd side, oil on the surface of the pressure roller is absorbed by the low coverage image on the LE of the 1st side resulting in a residual image being created on the pressure roller, which is then overlaid onto the TE consisting of a solid image. Uneven oil on the pressure roller surface is essentially caused by the elimination of the pressure roller blade. 	<p>When observed with 1-3 original manual duplex:</p> <ul style="list-style-type: none"> * Switch to automatic duplex * Feed a test sheet to absorb (erase) the overlaid image * Switch the LE and TE so that the solid image is on the LE <p>When observed with 1 original automatic duplex:</p> <ul style="list-style-type: none"> * Feed a test sheet to absorb (erase) the overlaid image * Switch the LE and TE so that the solid image is on the LE <p>Note</p> <p>The same problem will occur with standard units if the oil application components are eliminated.</p>

The following is an example of a 1st side image likely to cause the side effect.
